DATE: December 5, 2023; 10:45 am – 11:30 am

WORK IN PROGRESS: Installation of replacement stone; Repointing of stone

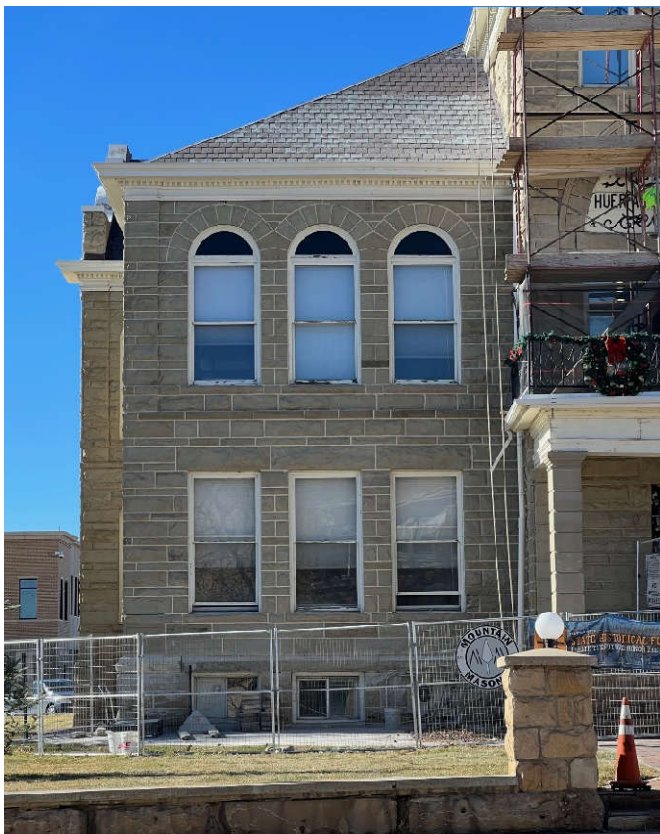
Photo #1: Now that the scaffolding has been removed, work at this end of the wall is now visible.

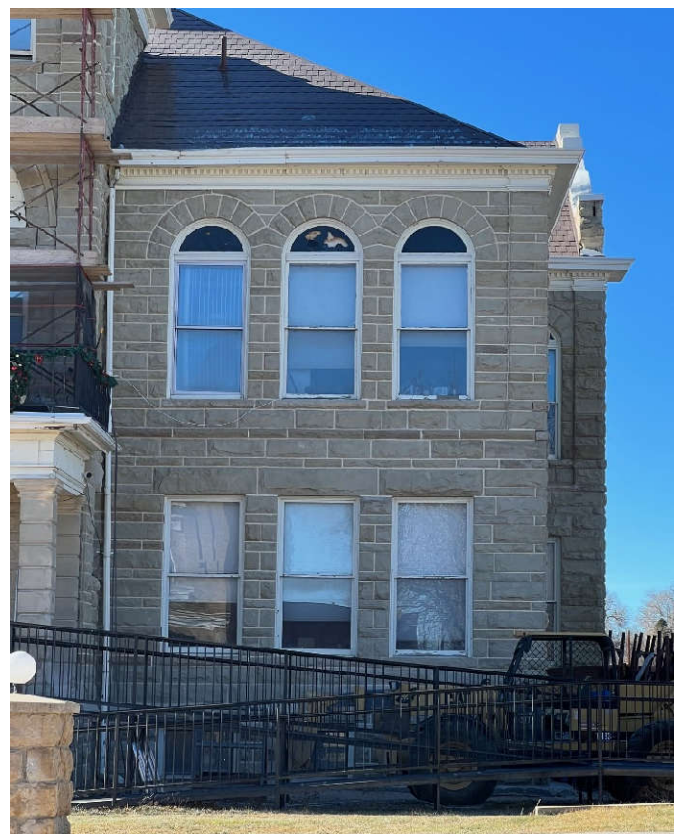
Photo #2: The work at the north end of the east elevation is close to completion with most mortar joints now repointed.

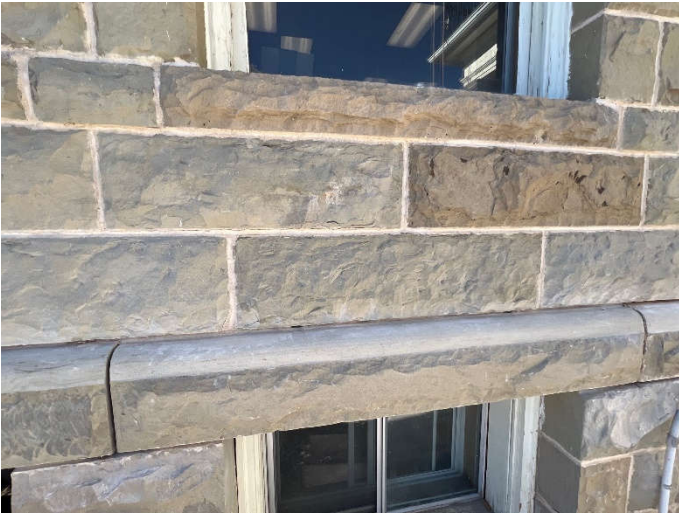
Photo #3: Most of the new water table stones have been installed on the south side of the east wall.

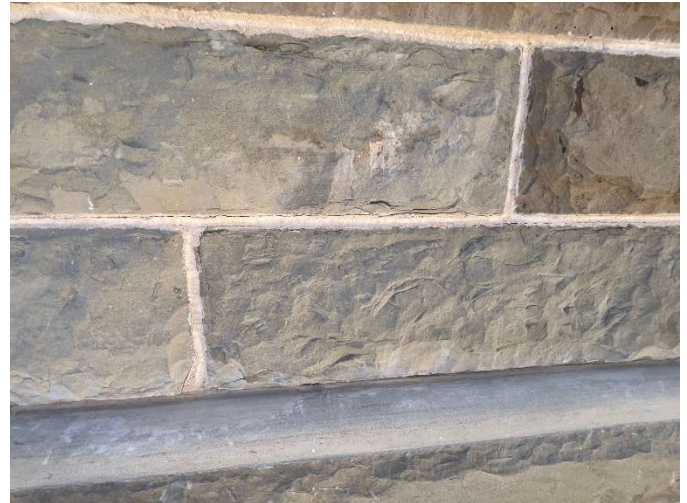
Photo #4: Hairline cracks have developed in some of the repointed mortar joints above the water table stones, which will be repointed.

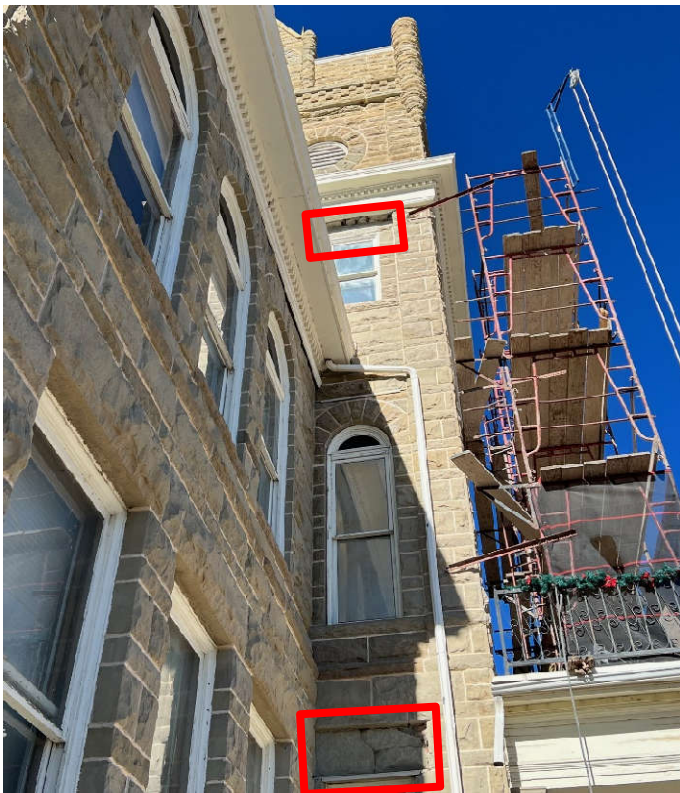
Photo #5: Two lintel stones remain to be installed on the tower's south face.

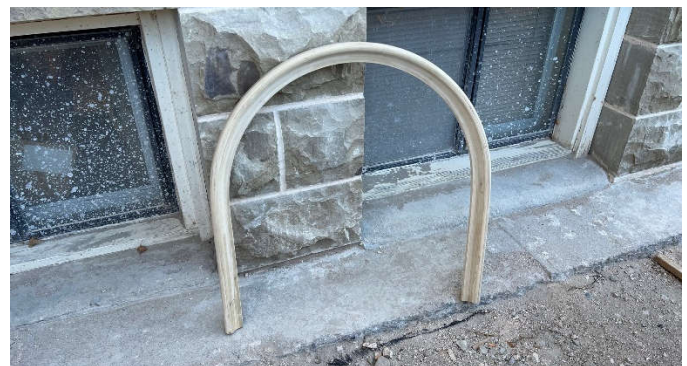
6. The replacement wood brick mould for the second floor window on the north face of the tower is now on site and ready for installation. (Re: Photo #7.)
7. Work on the plaster sign will soon begin. An observation was shared regarding the treatment of two stones below the sign at the top of the north and south ends of the two second floor balcony windows.
 - a. At the south end, the drawings call for pinning both stones and refacing the upper (wider) stone but the lower stone has also developed a crack. (Re: Photo #8.)
 - b. At the north end, the drawings call for pinning both stones and refacing the lower (narrower) stone. However, the upper (wider) stone is also cracked. (Re: Photo #9.)

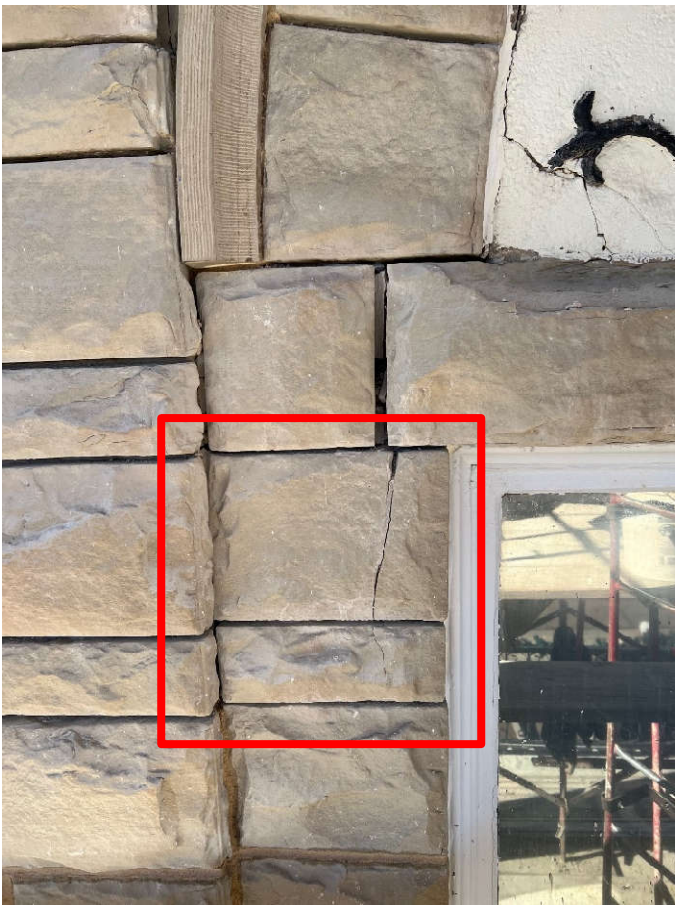
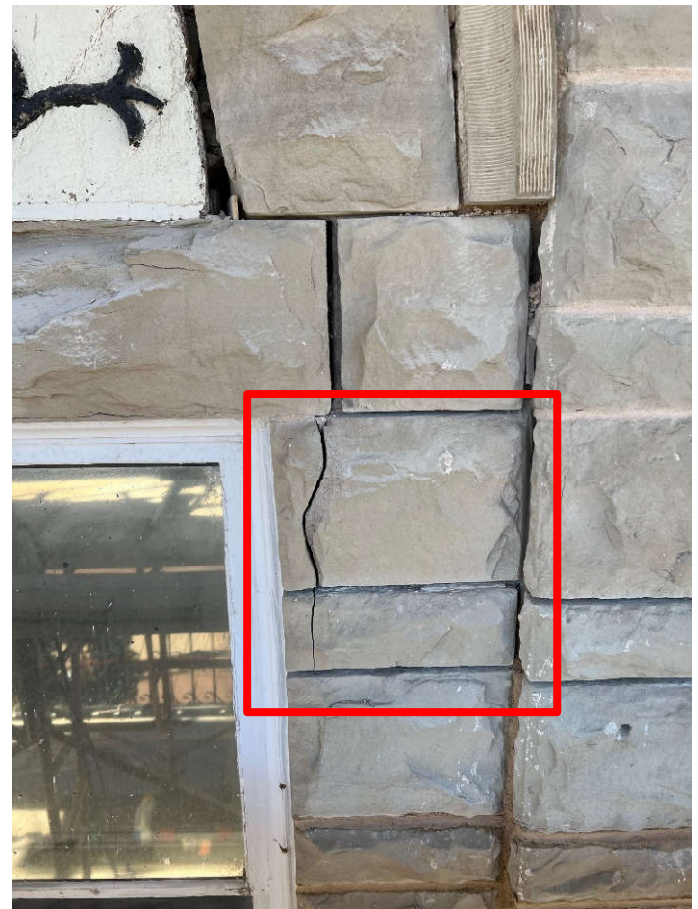
Photo #8: The two stones on the south side of the southernmost window at the second floor balcony are cracked and will be replaced.

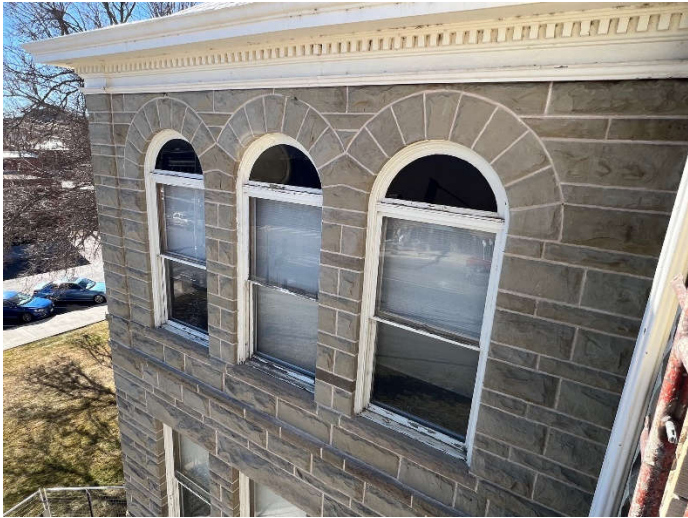
Photo #10: The repointing at the top of the south end of the east wall is completed with the exception of filling two holes below the cornice, which will be accomplished when the boom lift is on site.
