## Field Observation Report #02

Project Title **Fox Theater Roof Rehabilitation**  
 Project Address **715 Main Street**  
 Architect Project # **23-029**  
 Observed By: **Natalie Lord**

Date of Visit **12/01/2023**  
 Time of Arrival **10:30am**  
 Time of Departure **12:15pm**

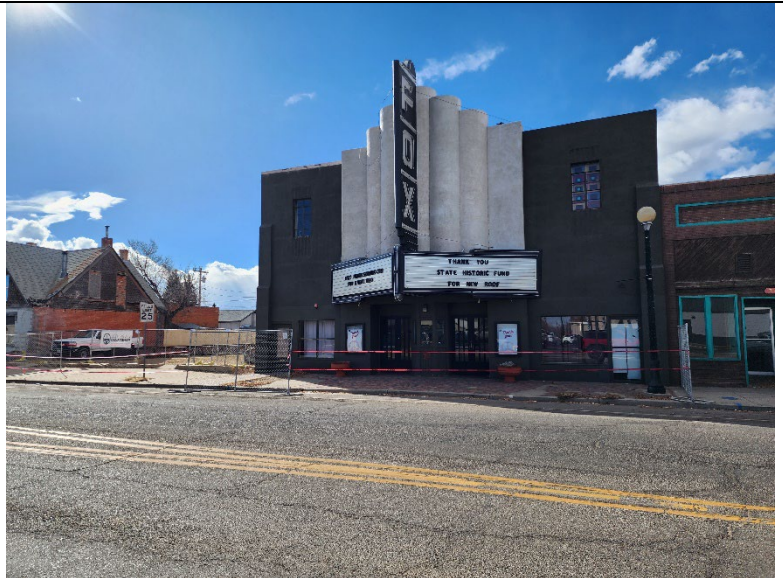
Overall view of east elevation from Main Street. Portion of the stucco at the south end of the parapet has been removed from the top and down the face of the façade to review conditions with Architect and History Colorado.

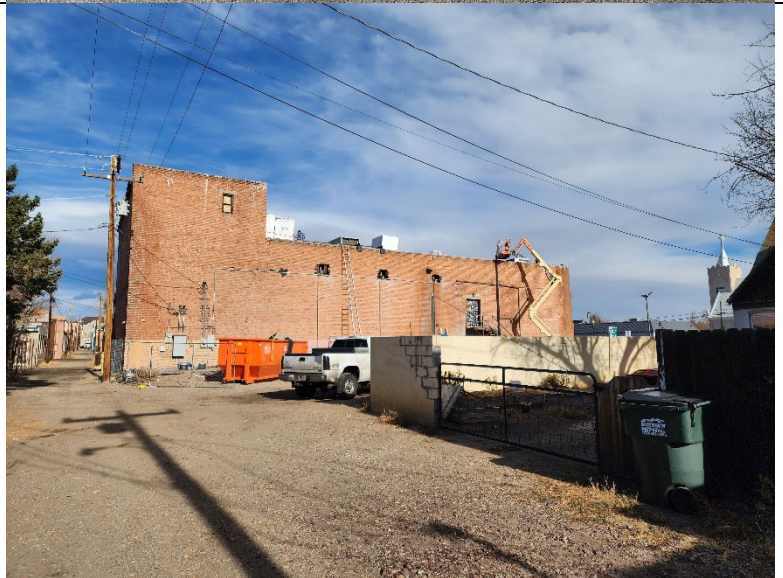
Overall view of south elevation from alley. Roof insulation is staged on the building. Openings are in place in the masonry for new steel beam installation. West truss beams are inside the building.

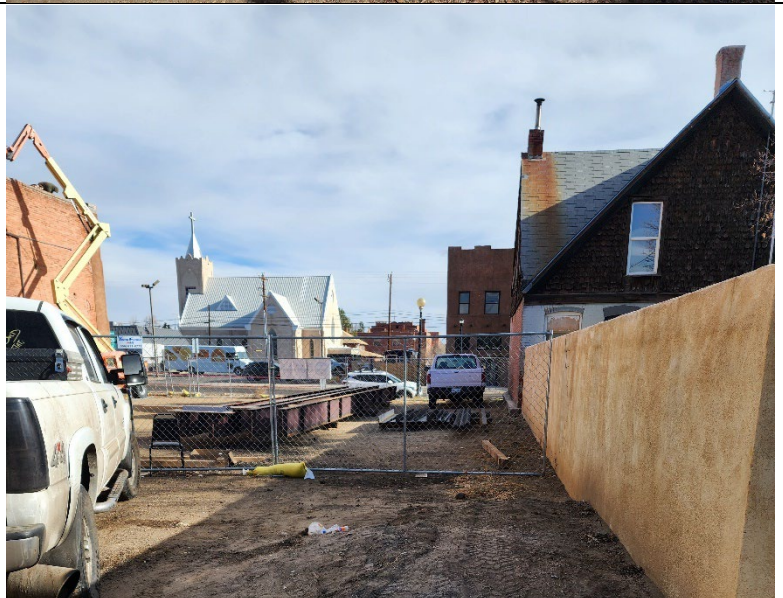
South staging area – The steel beams for the middle and east truss are on-site.

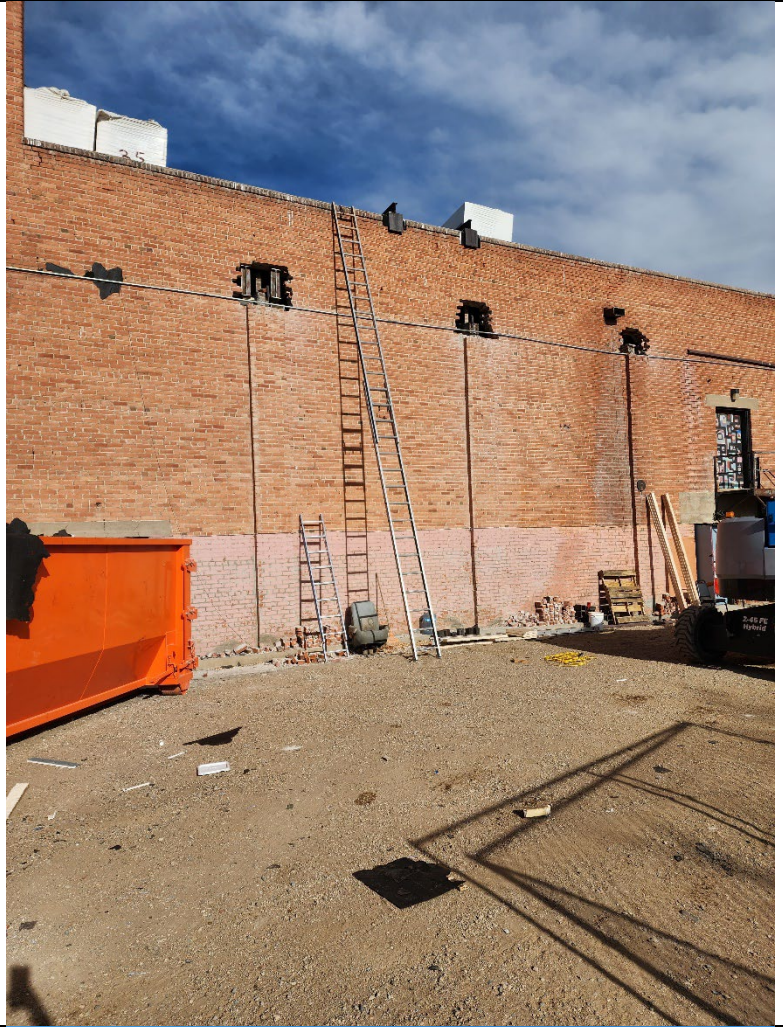
South wall exterior – View of masonry openings for new steel beam installation. New steel beam ends visible at the west truss.

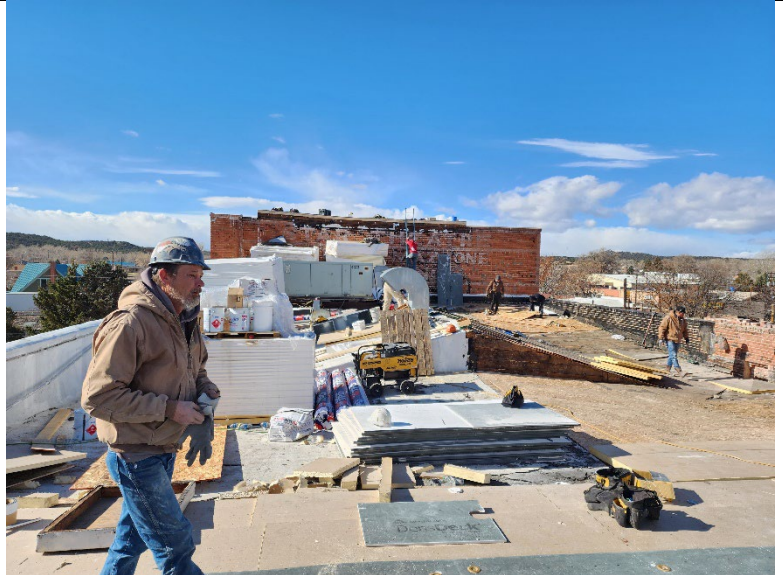
Main roof from east parapet looking west. Demo of north and east areas of the main roof are complete. Installation of new insulation is in progress at the east-most section. Sheathing installation in progress at the middle and northwest section.

Parapet masonry rehabilitation is in progress along the north parapet.

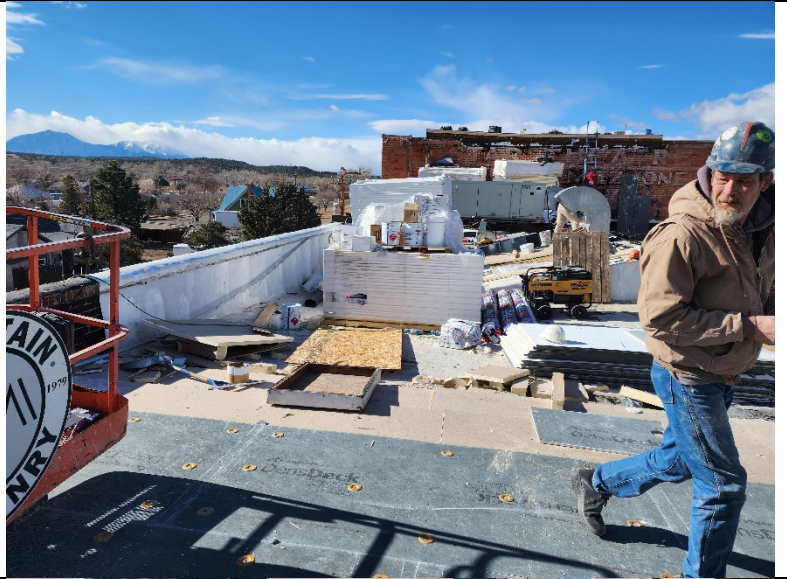
Former roof remains partially in place at the southwest area of the main roof. Material staging has been established in this area.

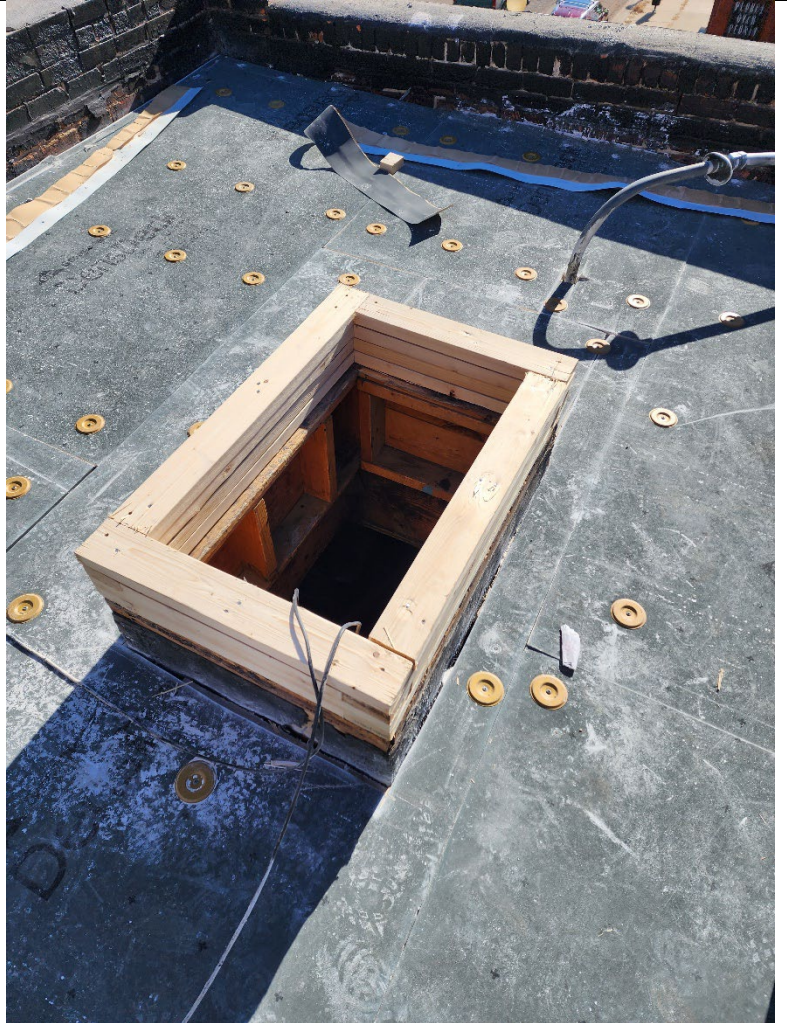
New wood is in place to build up the existing roof hatch curb (northeast corner).

Densdeck is in place.

Parapets are exposed in preparation for masonry rehabilitation.

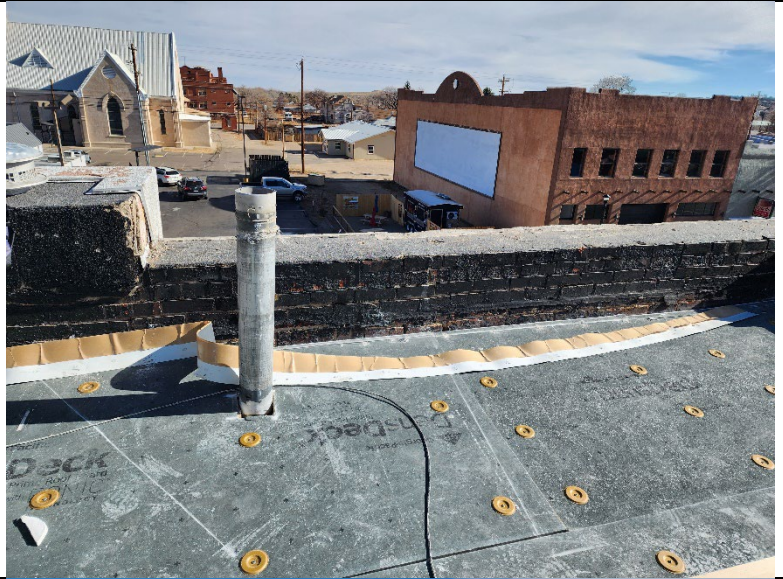
Southern portion of east parapet. Edge of marquee visible at left.

Densdeck is in place. Existing pipe penetration remains in place.

Parapets are exposed. Contractor removed the stucco from the top face of the parapet along this section to review conditions with Architect and History Colorado and discuss details at roof to stucco transitions.

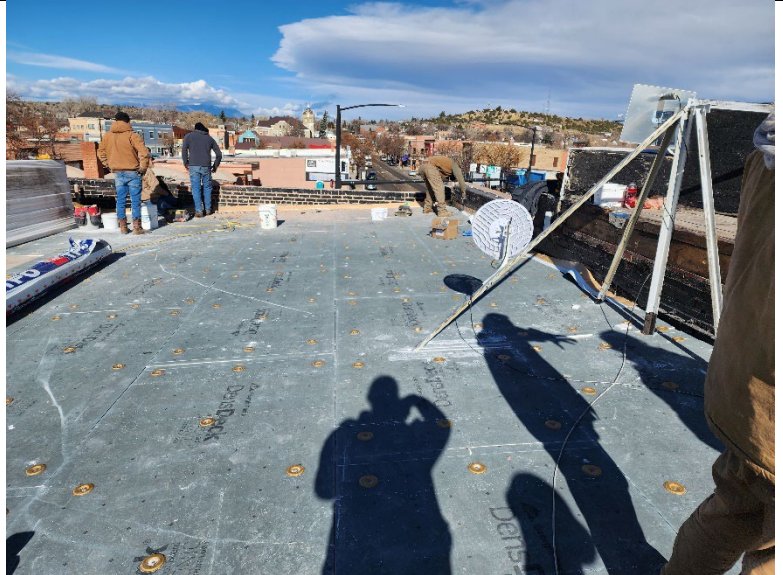
View of northeast corner of the main roof.

Masonry rehabilitation of parapets is in progress in this area.

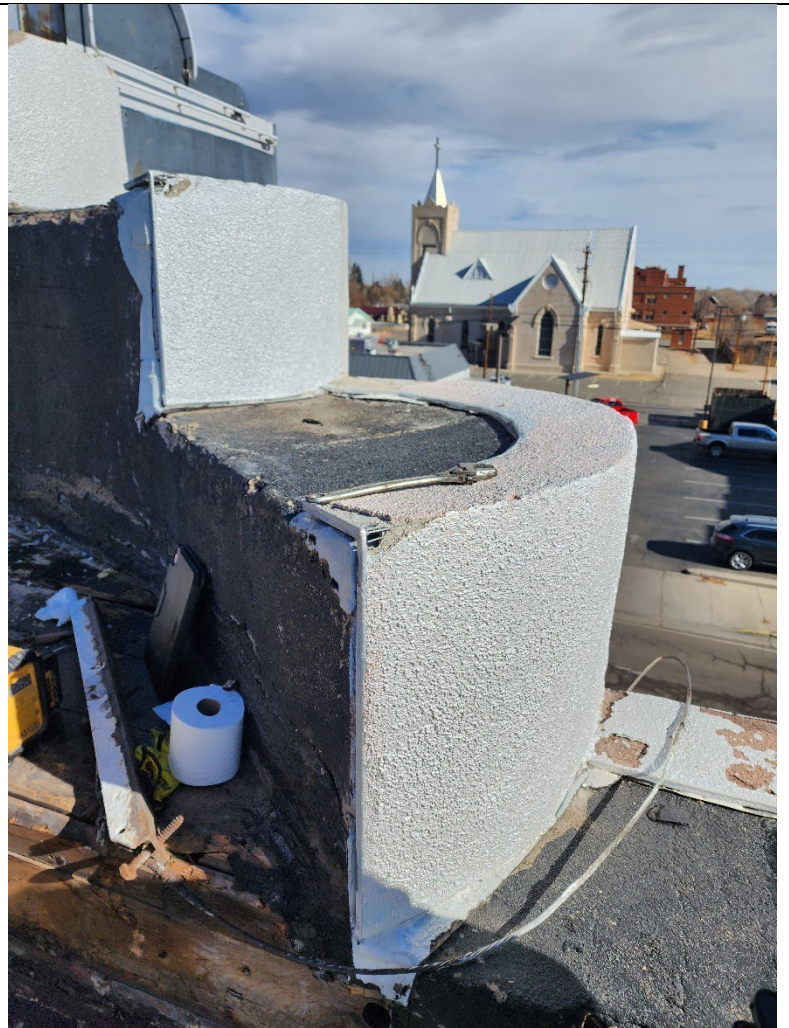
Architect, Contractor and History Colorado discussed options for the termination of roofing and flashing at the existing marquee and parapets where stucco wraps up and over the sky facing areas (east parapet with corners wrapped at north and south). Several options were brainstormed.

Contractor and his roofing subcontractor will review the options discussed and come back to the Team with a proposed detail.

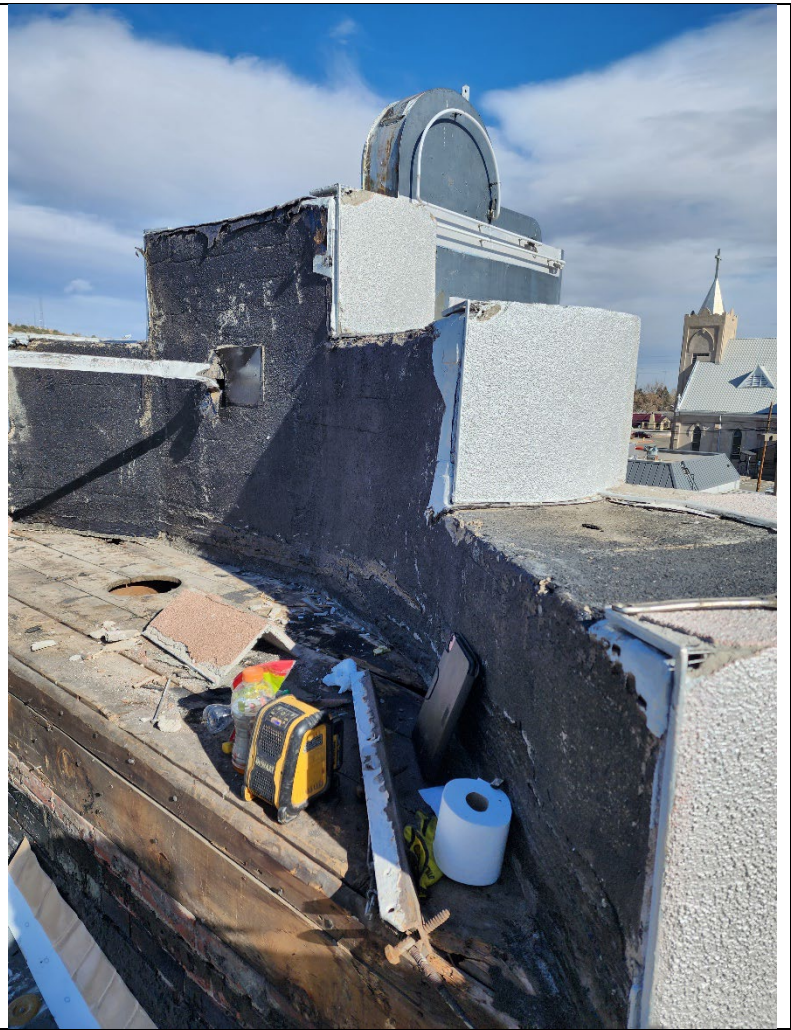
Backside of marquee. Roofing has been removed. Substrate is visible.

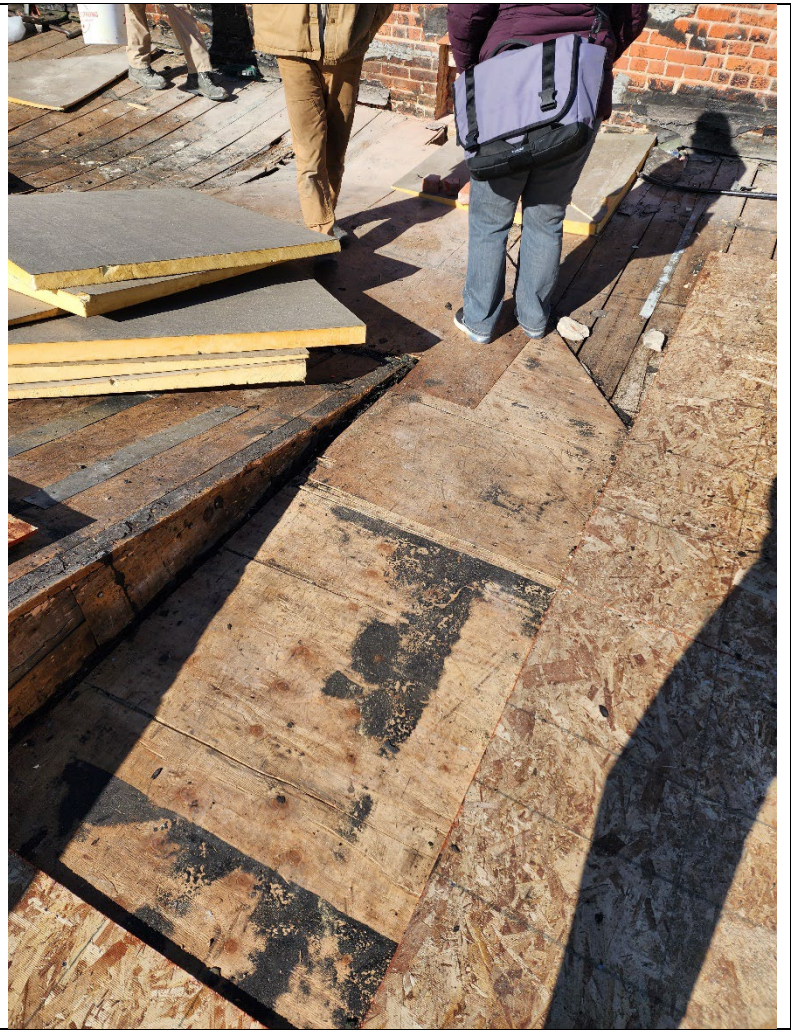
North portion of roof near scupper roof drain.

Existing substrate is exposed and new sheathing installation is in progress.

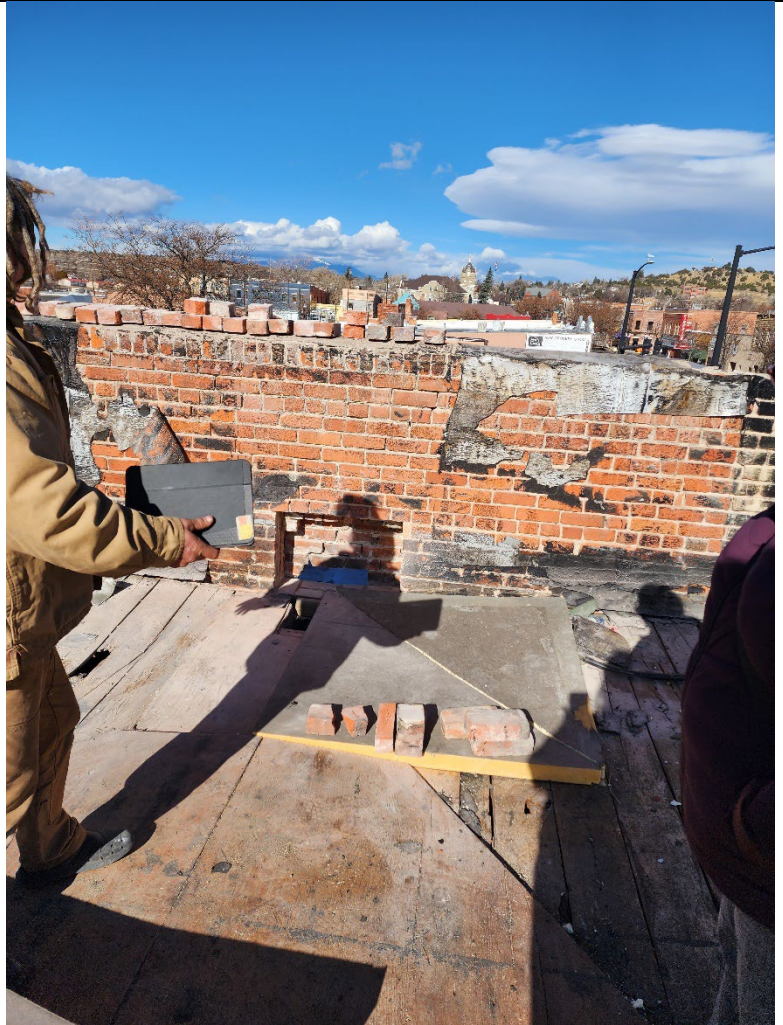
North scupper roof drain – Contractor has enlarged the roof scupper opening at the interior wythes of the brick wall for review (former scupper opening is visible in outer wythe). The opening will allow for better drainage, since clogging and flooding at the former drains has occurred several times at the building.

Architect and History Colorado approved new opening.

Tapered insulation mock-up is in place for drainage to the scupper.

**Note: collector box sizing and downspout sizing will need to be confirmed by manufacturer based on new scupper size.**

South scupper will match.

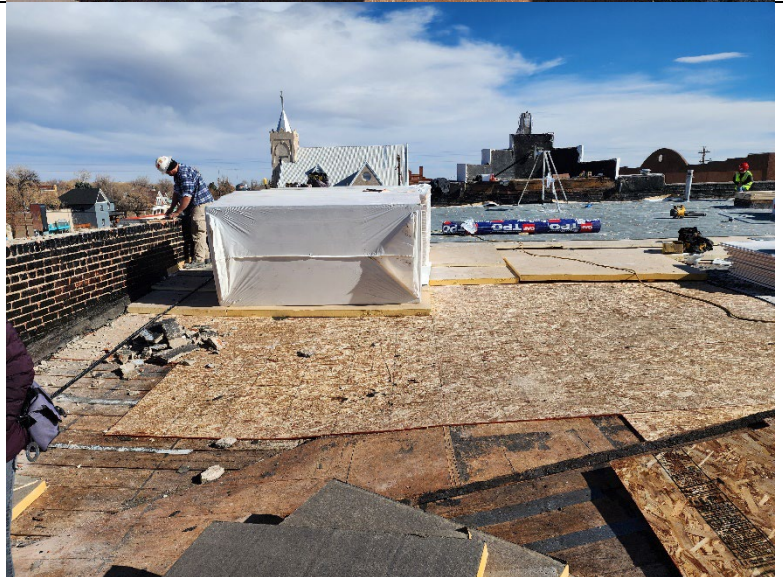
View standing near north scupper looking east – Roof sheathing installation in progress in foreground, new insulation installation in progress beyond, and densdeck in place at eastern portion of main roof. Crew is working north and westward.

Masonry rehabilitation of north parapet is in progress.

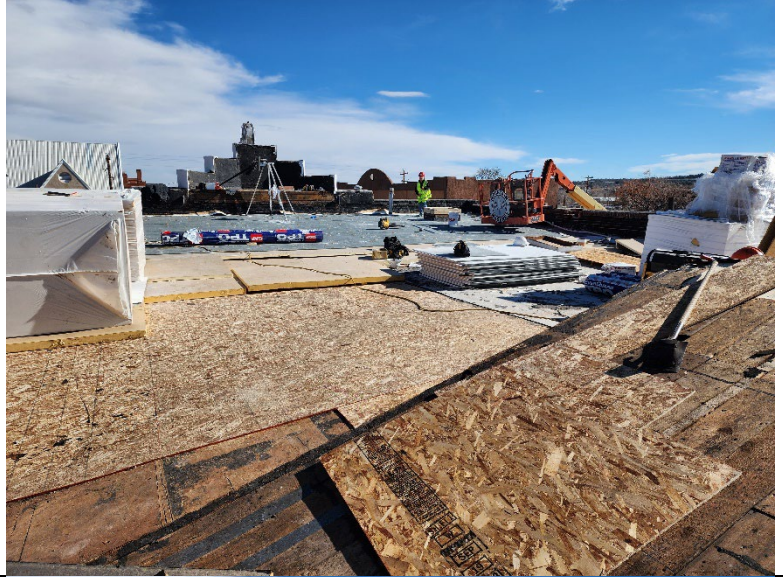
View standing near north scupper looking southeast - Roof sheathing visible, new insulation in place beyond, densdeck in place at eastern portion of main roof. Crew is working north and westward.

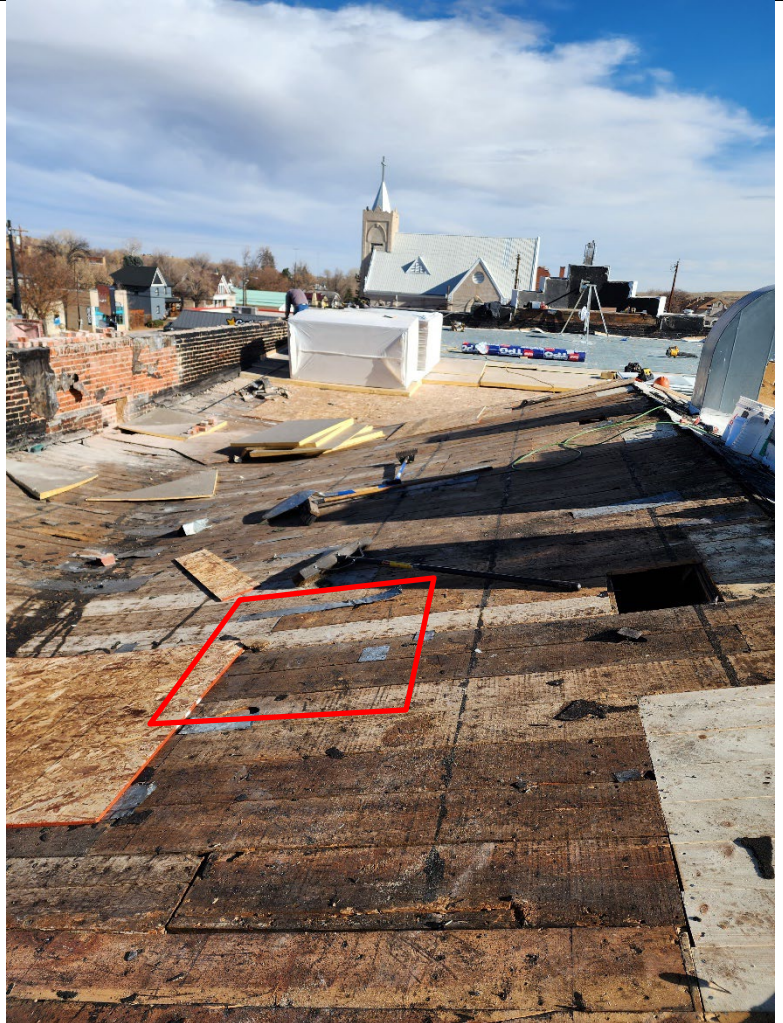
Architect, Contractor and History Colorado discussed potential location of new roof hatch. Contractor is proposing to locate the new roof hatch roughly in the red outlined area. This location appears to work with the former ductwork layout in the attic below.

Note: new mechanical design is not included in this project and will be part of a future building project. Therefore, coordination with future mechanical design is not achievable.

**Owner to review and confirm location.**

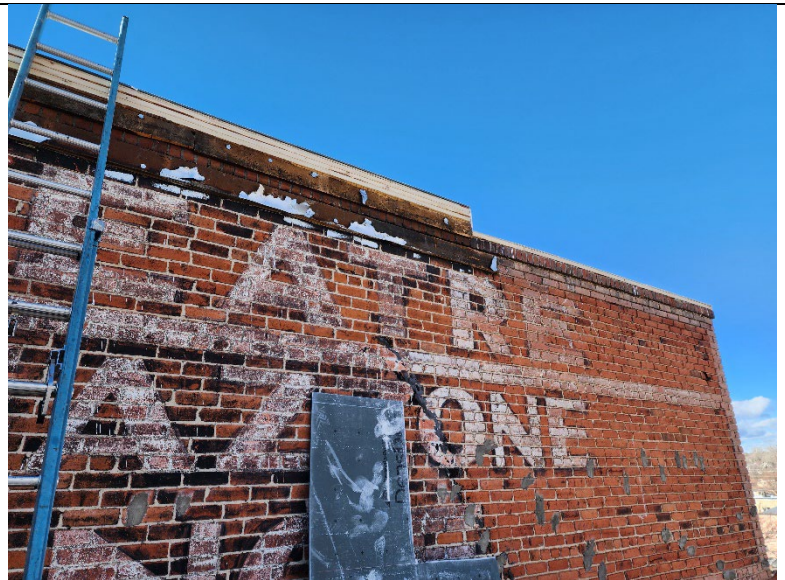
East wall of Fly – Former roofing has been demolished. Existing wood boards formerly covered up are now visible.

Architect, Contractor and History Colorado discussed roof detailing at this location. If the existing boards are required to remain in place (Contractor to investigate at interior of Fly), new flashing shall extend down and cover the boards. If lowest board can be removed, the flashing can run in line with the lower stepped edge at the parapets to the north and south of the bump up. Contractor will investigate and report back on function of existing boards inside of the Fly.

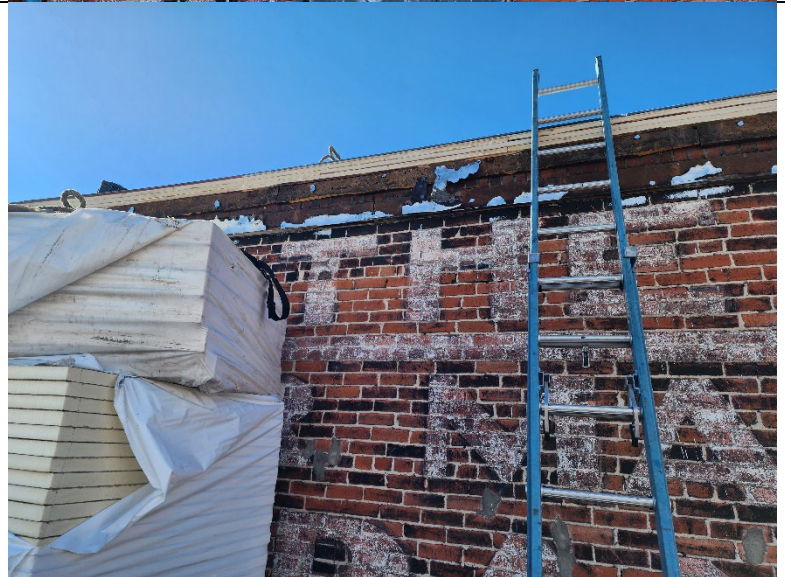
East wall of Fly – New edge blocking in place. Densdeck in place above.

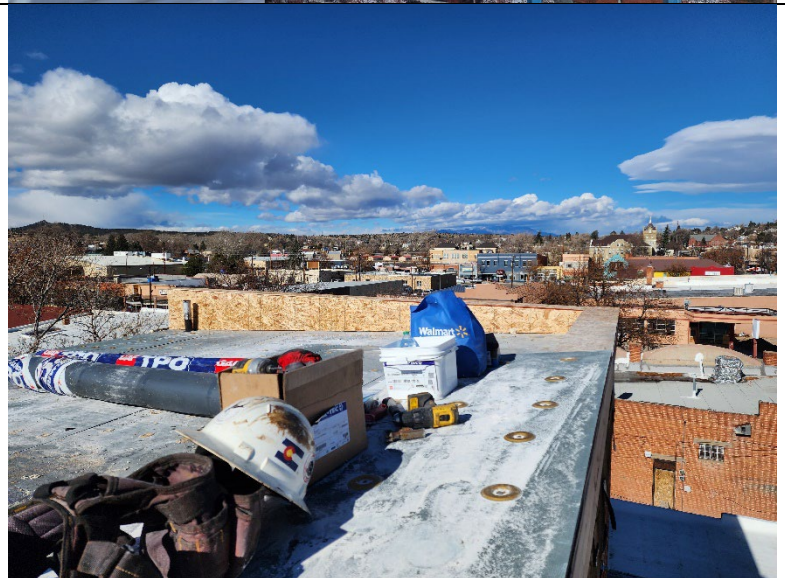
Fly roof looking north – New sheathing at backside and top of parapets is in place at the north parapet. Densdeck is in place. New TPO is staged for installation.

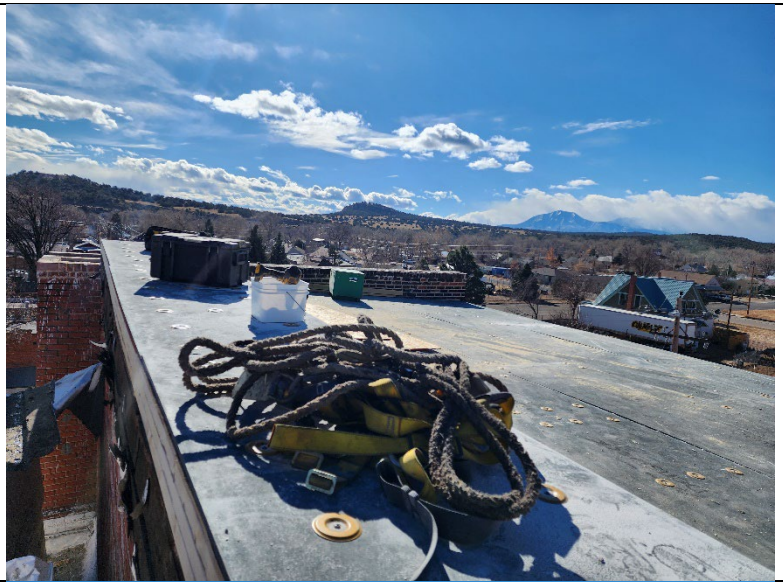
Fly roof looking south – Sheathing in progress, but not yet complete at south parapet. Densdeck is in place up to the parapet wall.

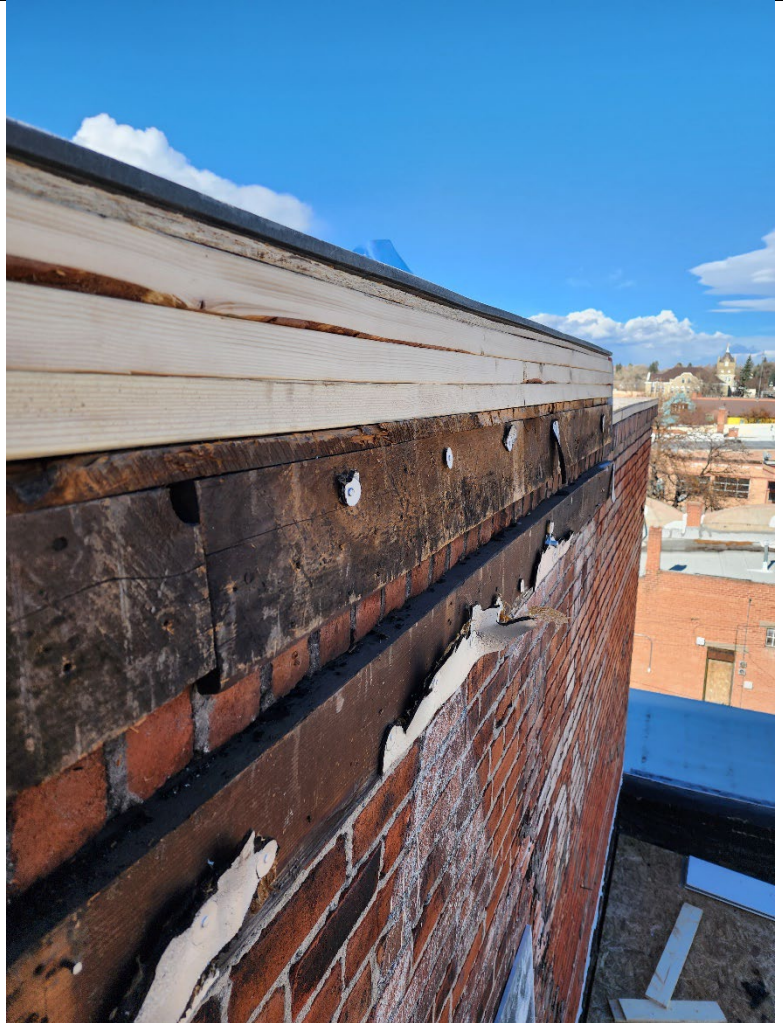
Existing wood at east Fly wall visible. New blocking in place at edge. New sheathing and Densdeck in place.

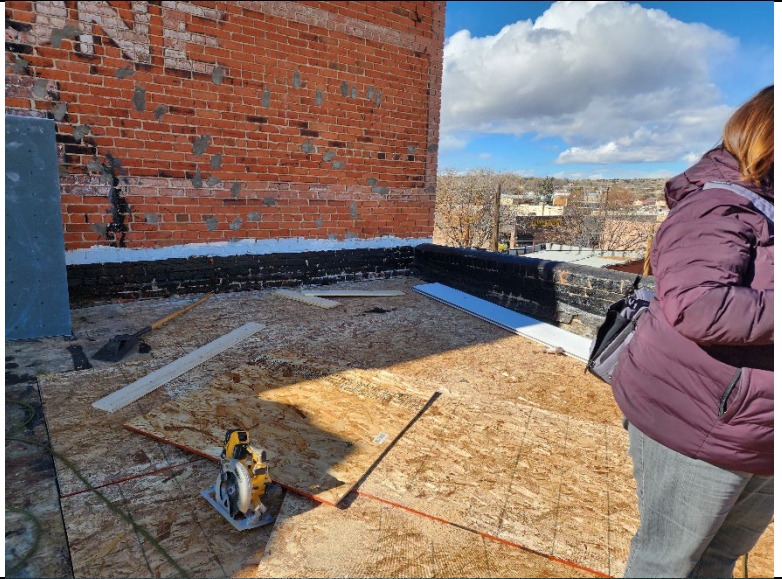
Plywood sheathing in progress at the northwest corner of the main roof. Parapets are exposed for masonry rehabilitation.

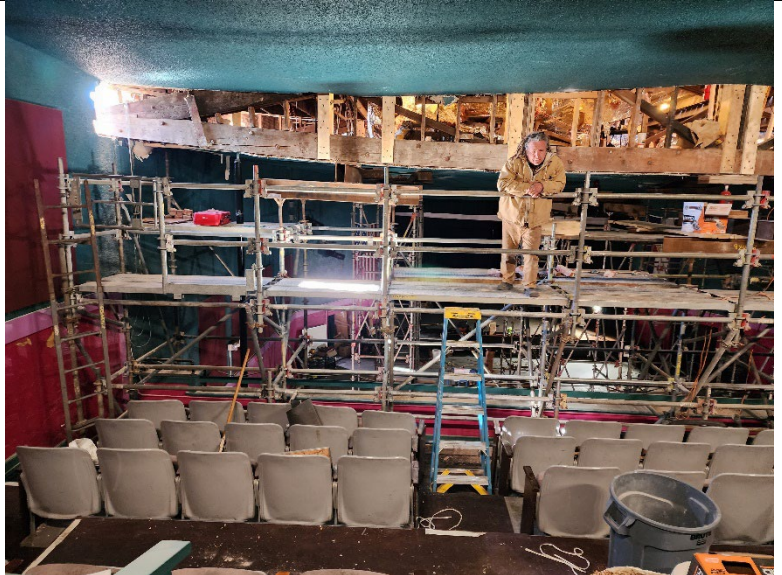
Interior – standing on balcony looking west – Scaffolding in place for attic access.

Plaster has been removed to expose the east truss and install the new steel beam.

New wood supports / bracing have been installed at the trusses

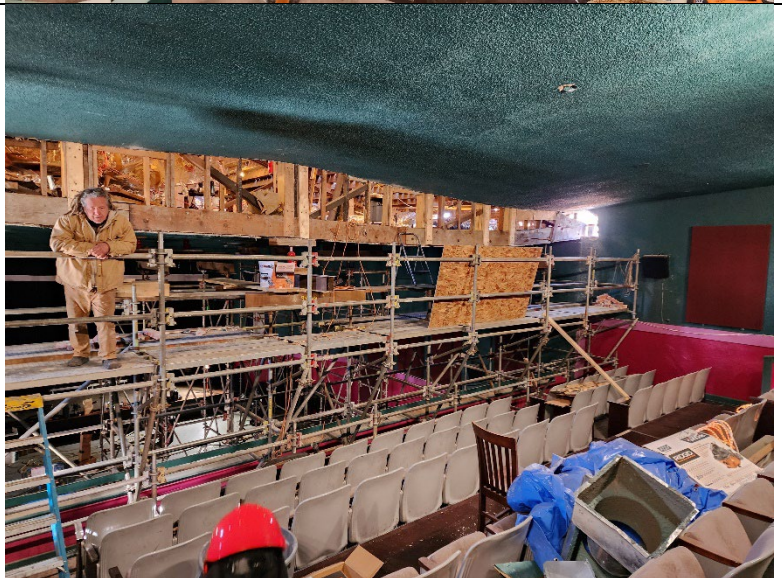
Interior – standing on balcony looking northwest.

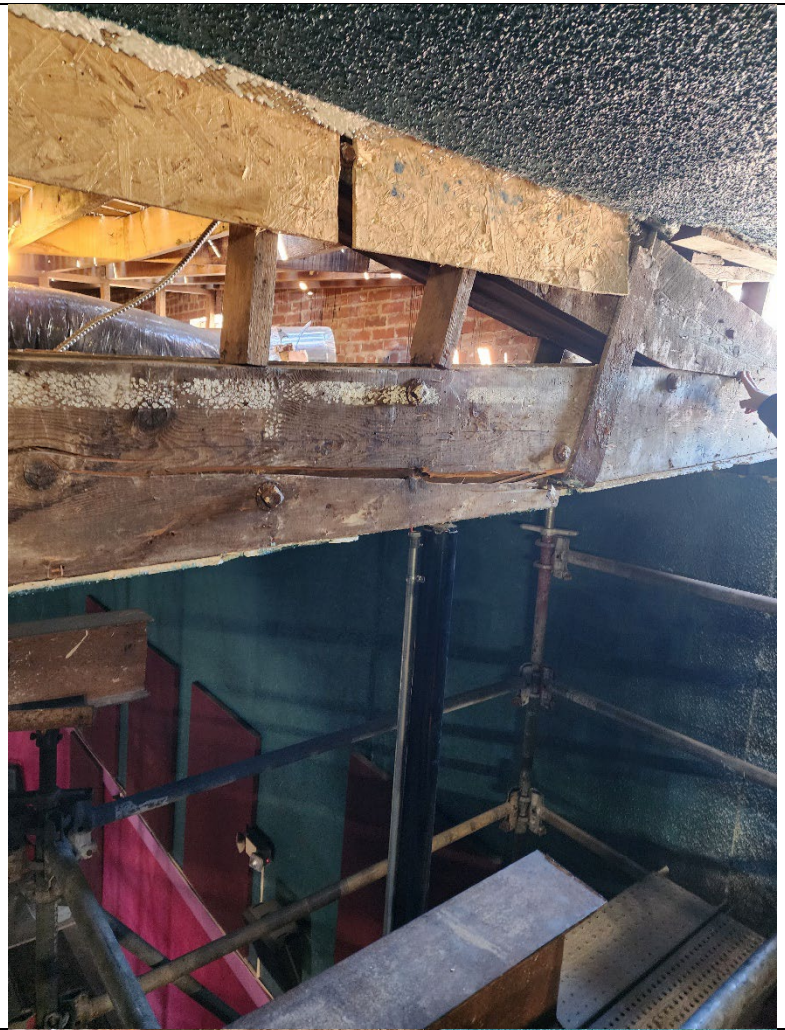
North end of east truss. Split in bottom cord visible following plaster removal.

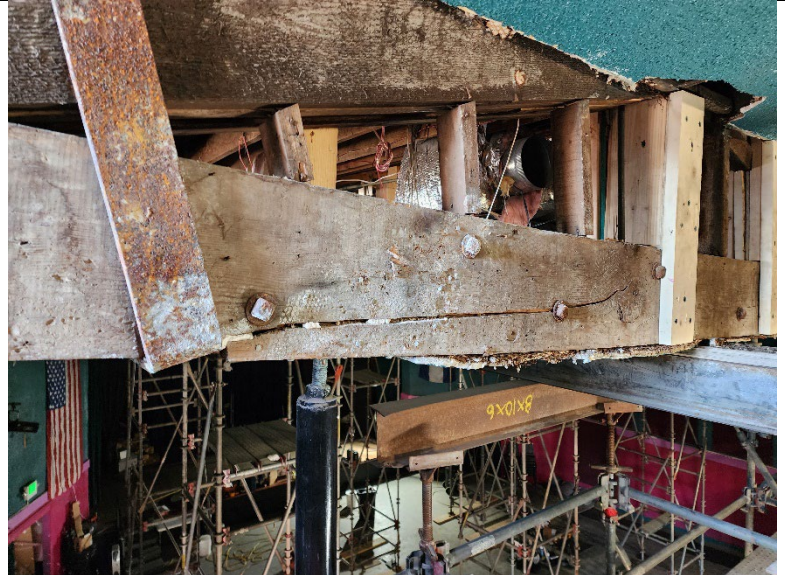
South end of east truss. Split bottom cord visible following plaster removal.

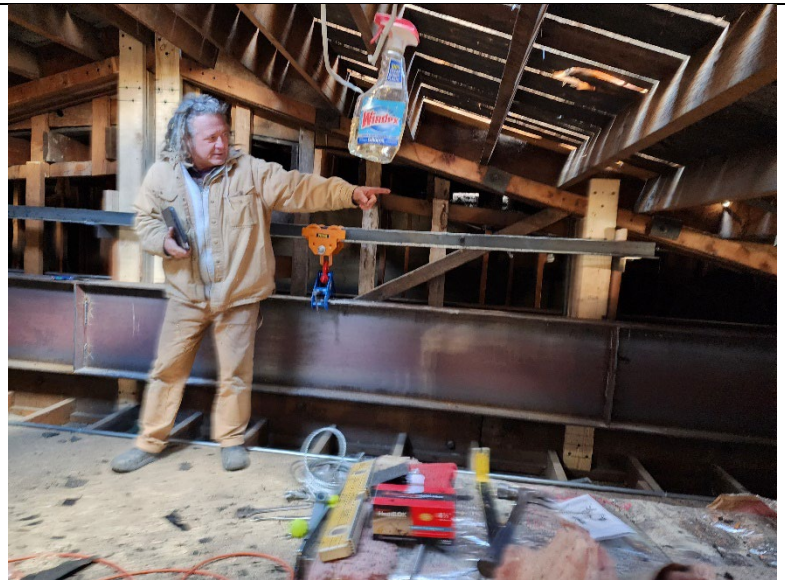
West truss – Steel beams and trolley system visible. Contractor explained to Architect and History Colorado the process of getting the beams into the attic space.

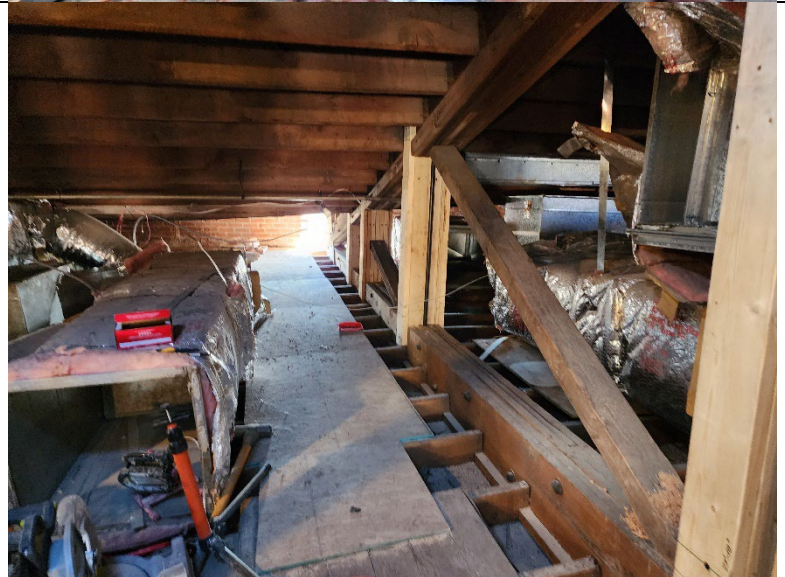
East side of middle truss looking south. New wood bracing / supports are in place. Openings are in place for bringing the new steel beams into the building.

Once the Contractor attaches the west beams, he will move the trolley system and bring in the next set of beams.

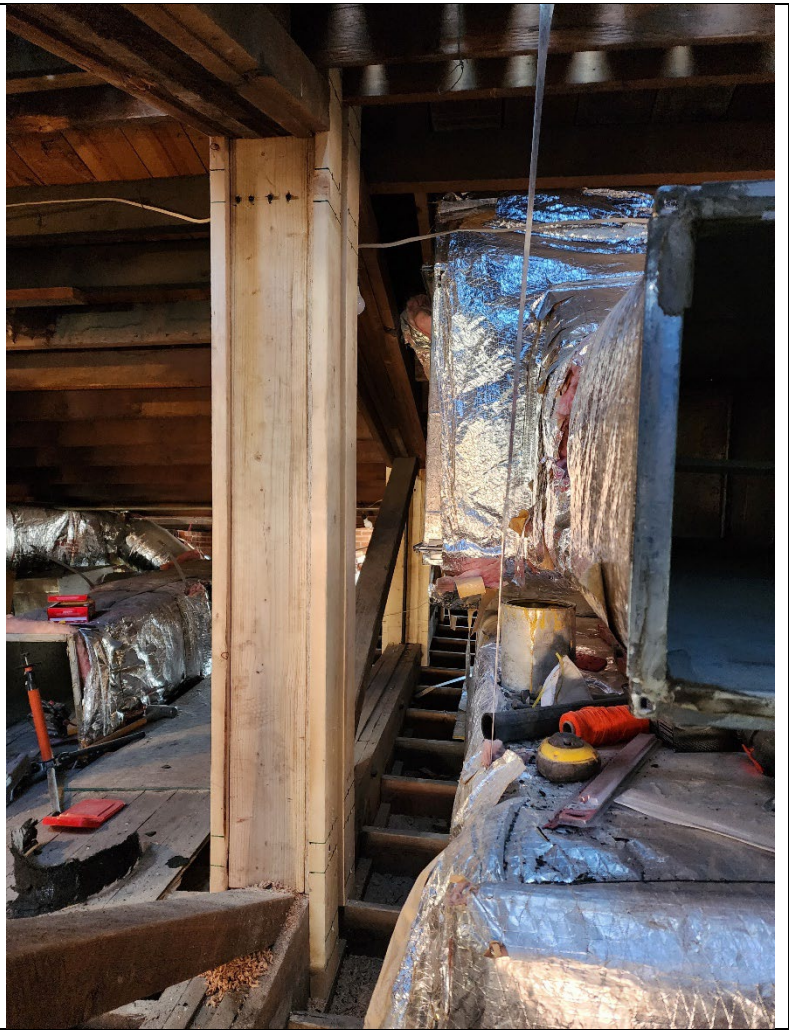
West side of middle truss looking south.  
New wood bracing / supports are in  
place at peak of truss.

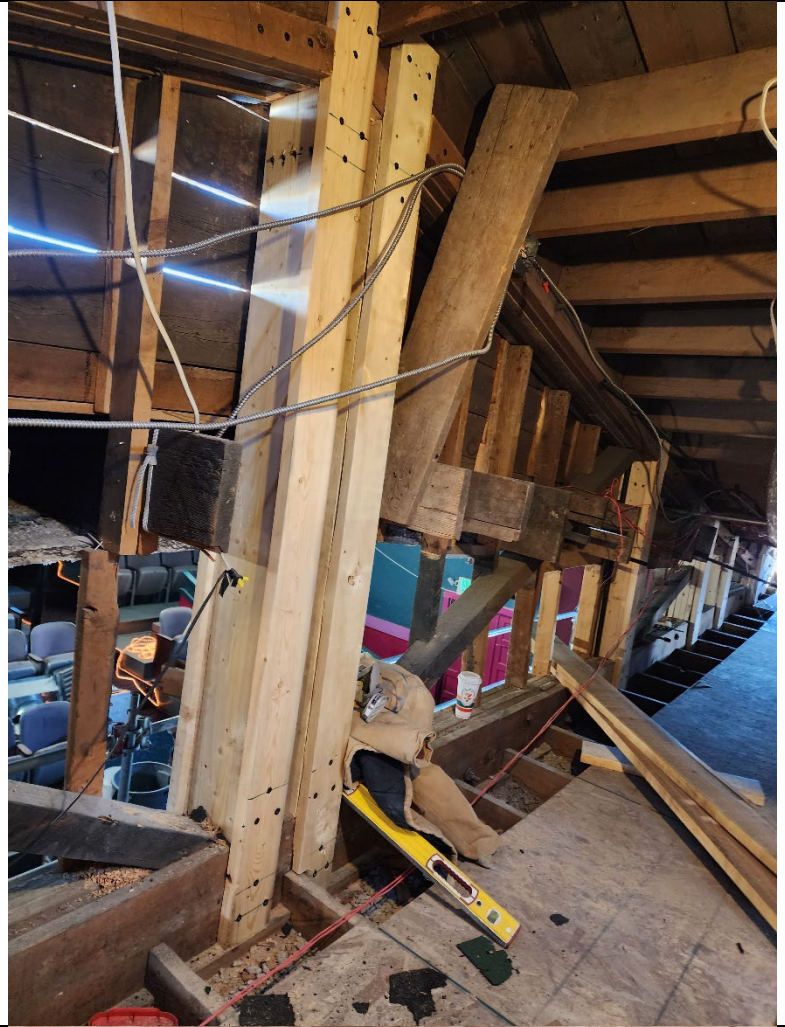
West side of east truss looking southeast - New wood bracing / supports are in place at peak of truss.

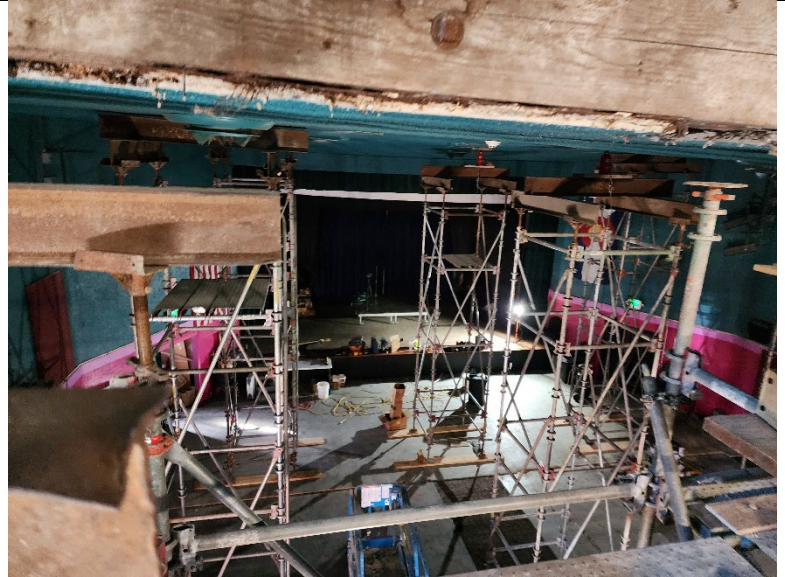
View from balcony scaffolding down into main theatre space. Temporary shoring is in place
