Technical Memo

To Ken Clayton, Jon Hotaling, Panadero Ski Corporation
From: Mike Deiparine, PE
Jamie Bunch, PE
Date: August 22, 2023
Project: Cuchara Chair 4
Subject Entrance Beam Failure and field observations

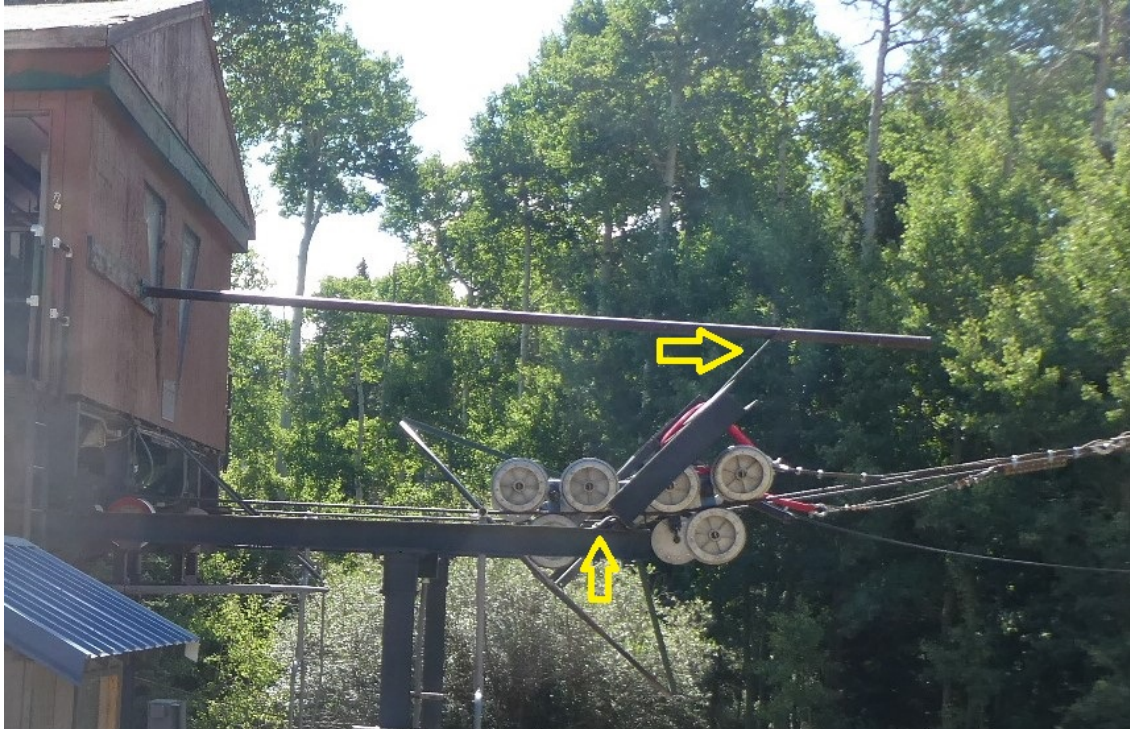
Figure 1 Lower Terminal Portal Structure Deformed

While the lift appears to be in a safe condition, the current factor of safety of the portal frame connection as compared to the forces is not known. The lift should not be operated for any reason until all repairs on the portal frame are completed.

In order to repair the damaged structural frame, the plate connections at the base of the vertical columns must be rebuilt. CPTSB will require design of the connection repairs to be performed by a Qualified Engineer. The repairs shall define specification for dimensions, materials, welding, and installation.

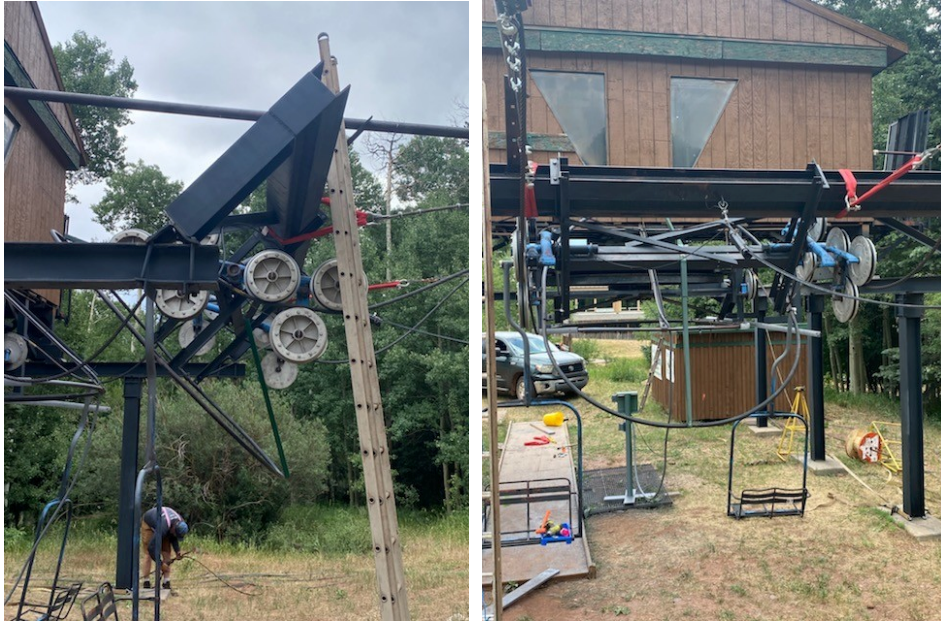
Figure 2 Original incident photos from Panadero staff

The structural portal frame in question supports the depression combination sheave assemblies at the uphill end of the terminal. Photos of the original incident condition provided by Panadero staff (Figure 2) show the sheave assemblies upset without rope tension. While the connection at the bottom of the frame is severely distorted and broken (Figure 3), it appears to have sufficient strength to hold the frame in the current position. According to Panadero staff, following the failure, they pulled in the counterweight rope enough to stabilize the rope, sheaves, and frame. Sheave assemblies are currently pressing against the frame cross member and the tension rigging is not tight. The frame does not appear to have moved from the deformed position resulting from the incident.

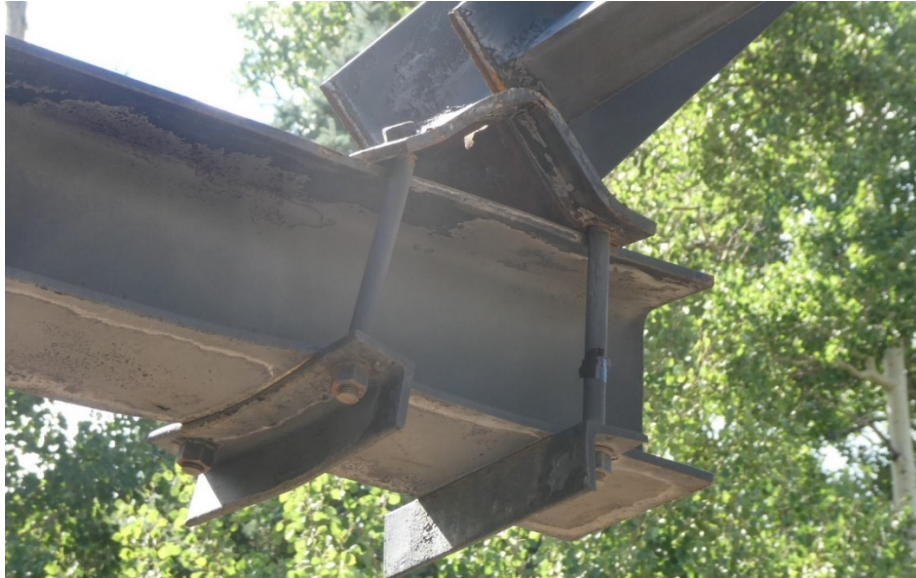
Figure 3 Frame connection Damage

The lift rigging installed to hold the rope tension while the counterweight rope was changed was attached to the top of the sheave support portal frame. The connection point is about 3 feet above the connection plate. The haul rope tension is about 15,000 pounds. The rigging on the top beam caused a significant moment force on the connection plate on the order of 45,000 lb-ft. The welding on the base plate appears to have had adequate penetration and much of the weld is broken in the weld metal. Panadero staff stated that the broken connection did not have rust indications immediately after the incident. The base plate is distorted and broken along the weld line of the column web. The failure of the connection plate appears to be the result of over stress and not poor welding or fatigue cracking. Figure 4.

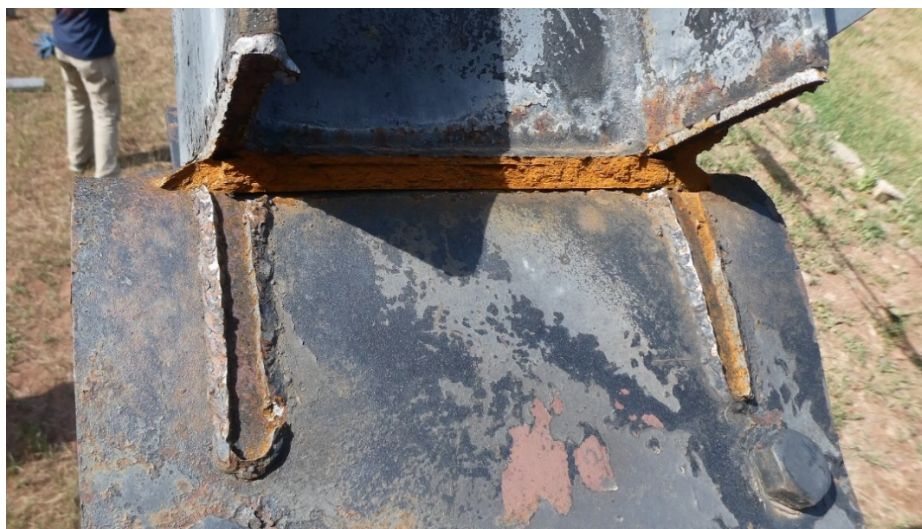
Figure 4 Failed Base Plate Weld Connection

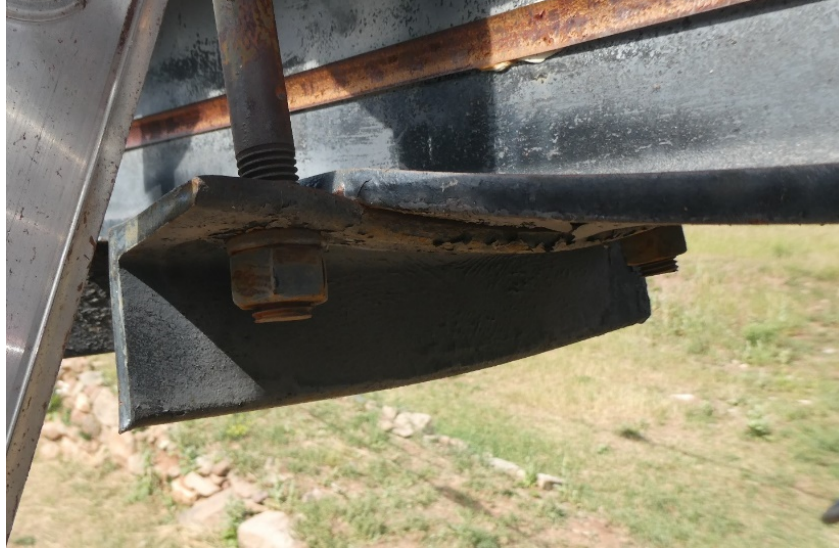
The damaged portal frame was bolted to two wide flange beams that cantilever past the two uphill columns of the terminal structure. Observations with a straight edge did not indicate any observable distortion or bending of the support beams at the cantilever. The flanges of the support beams are distorted at the bolted connections to the portal frame, as shown in Figure 5.

Figure 5 Distorted Support Beam Flanges

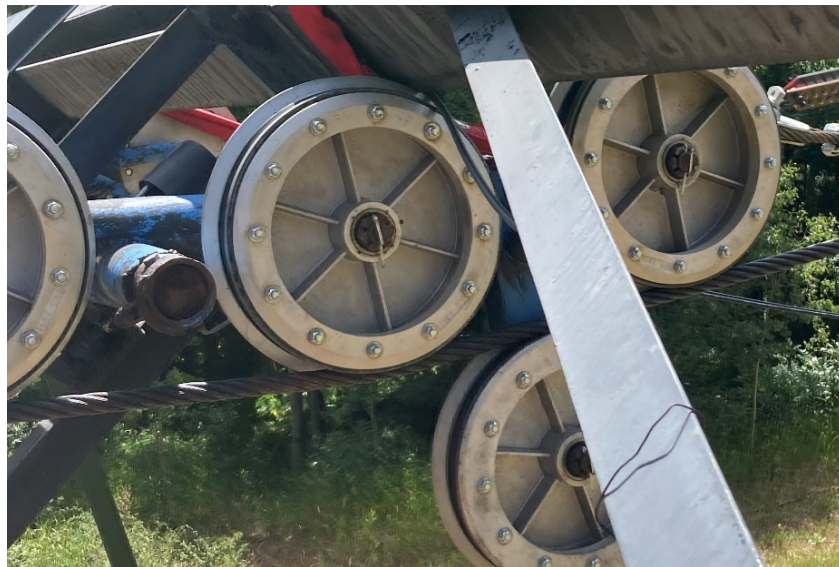
When additional tension was applied to the haul rope to stabilize the beam after the incident, the sheave assembly came in contact with the cross beam (Figure 6). The sheaves should be inspected when the beam is repaired. Since the contact was slow with the retention process, it is not anticipated that the sheaves would be damaged, but a careful observation of the entire assembly should be performed.

Figure 6 Sheave Assembly Against cross beam

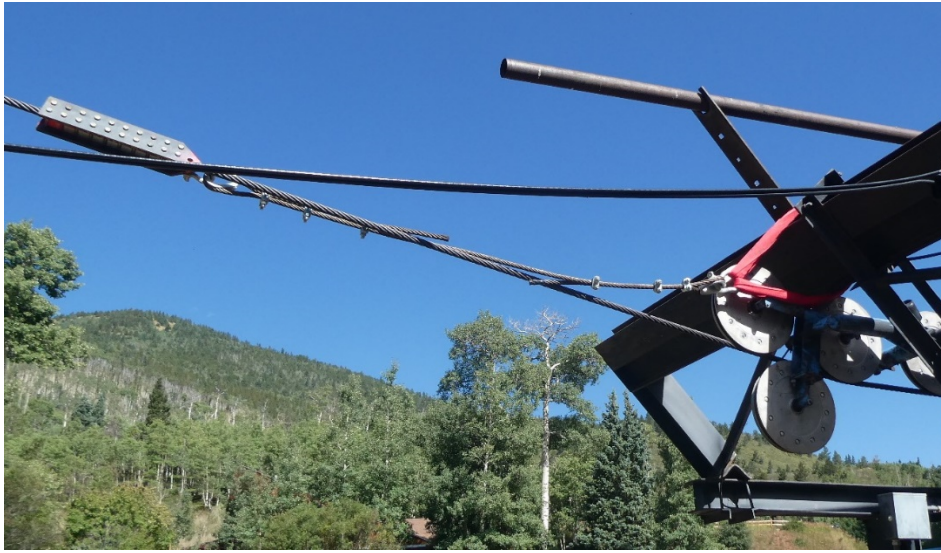
Figure 7 Single 3/4" Rigging Sling

One side of the haul rope tension setup is connected using a single 3/4" sling to the connection point on the cross beam (Figure 7). This sling is rated for 4.9 tons of load, 9,800 pounds. The haul rope tension at the lower terminal is about 15,000 pounds. While the tension reduces as the counterweight is lowered, this is poor practice. The actual tension is unknown until the rope is slack. Rigging should be sized for the maximum anticipated load with adequate design factors.

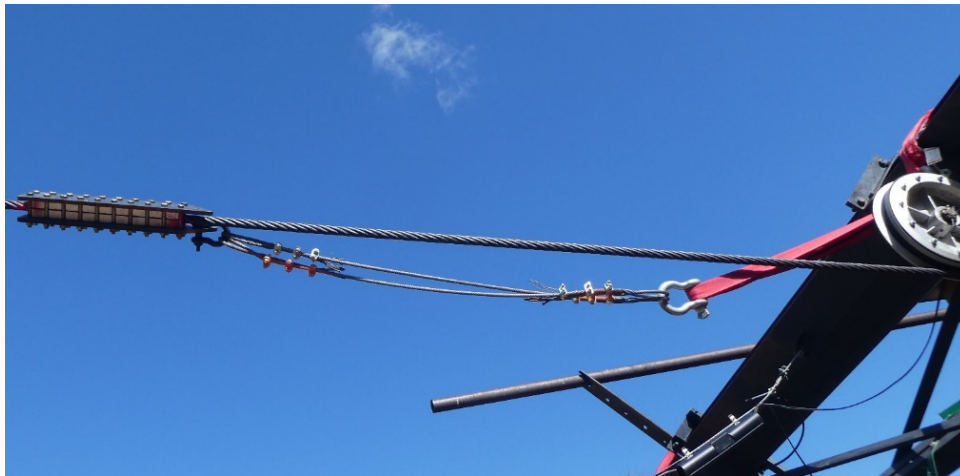
Figure 8 Parallel Slings of Small Size.

The other side of the haul rope rigging is much weaker. There are two parallel slings on a single load (Figure 8). The two slings cannot be equal length by definition and cannot share the load. This is equivalent to a single sling for rating. The slings appear to be constructed with ½" wire rope. A single ½" wire rope sling is rated for 2.2 tons, 4,400 pounds. This connection is severely under-rated, and the crew is fortunate that it did not fail catastrophically. These types of rigging errors can result in severe injury or death. The owner should consider formal rigging training for the staff prior to any future heavy load rigging. Rigging is one of the most dangerous procedures performed by lift maintenance personnel. It is important to have a proper rigging plan, calculations of the anticipated loads, an understanding of how a failure might occur, proper well-maintained rigging equipment, team safety talks, and a means to verify the loads.

A defined procedure should be developed to provide safe rigging techniques for the maintenance procedures. The procedure should include process options for holding the haul rope tension and pulling the rope down on the depression sheaves. Procedures should include required design loads, required rigging components, and arrangement of rigging.
