HUERFANO COUNTY COURTHOUSE MASONRY RESTORATION PROJECT
Field Report No. Six **SHF Project #2022-01-009**

DATE: March 22, 2024; 9:00 am – 10:15 am

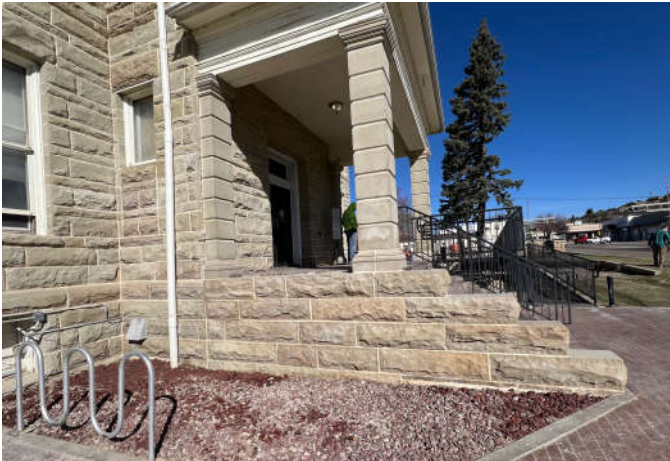
Photo #1: New reconstructed south cheek wall.

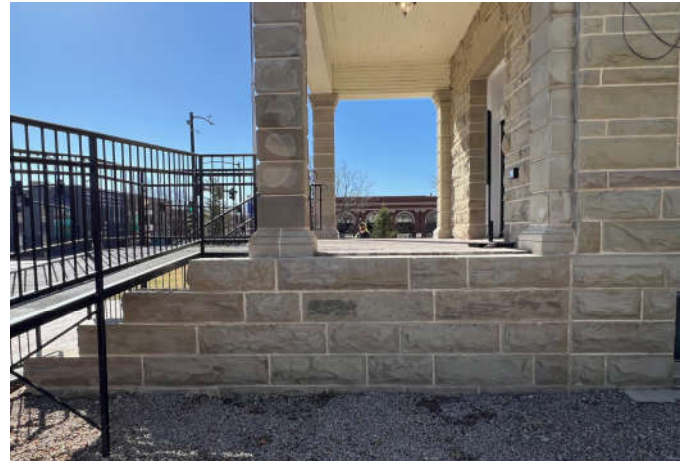
Photo #2: New reconstructed north cheek wall.

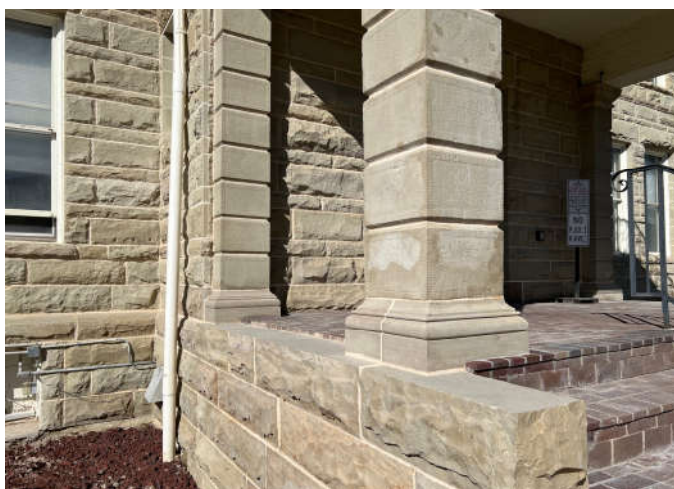
Photo #3: New reconstructed stone column and pilaster bases.

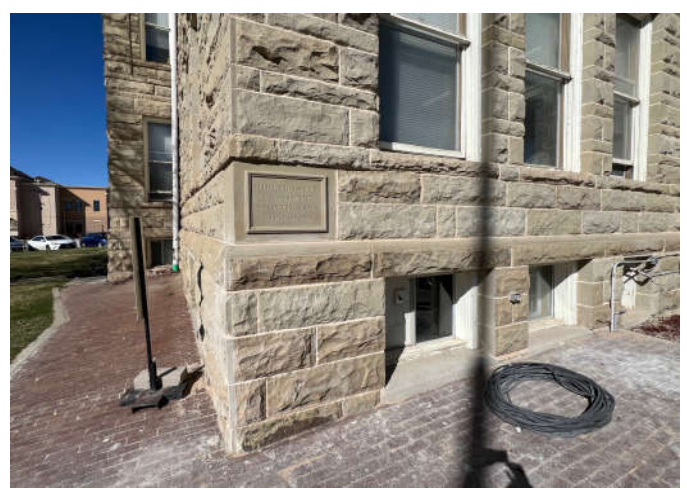
Photo #4: Replacement stone at the bottom of the southeast corner.

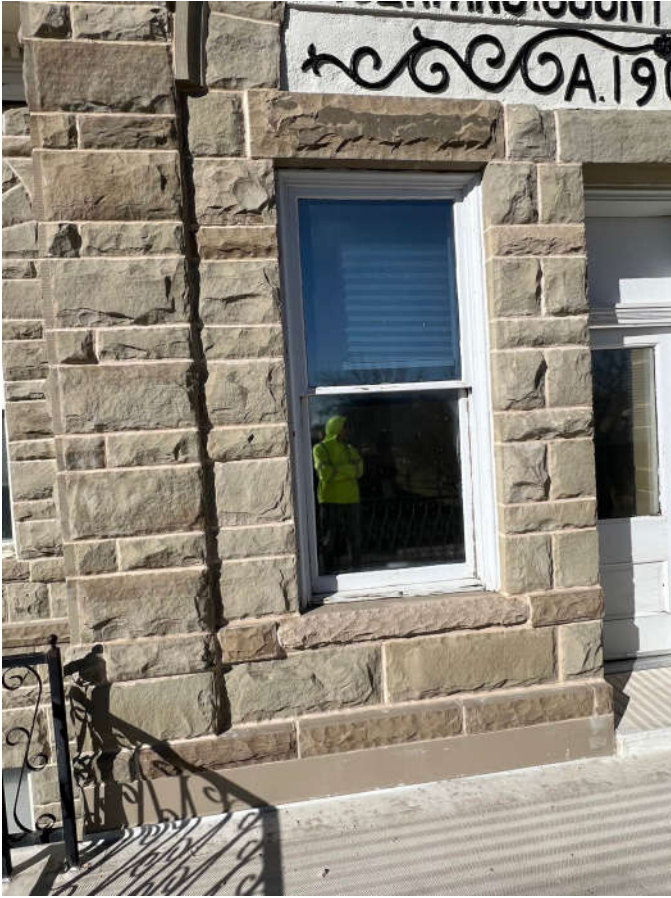
Photo #5: Replacement stone, both above and below the window, was installed along with metal counter flashing at the east balcony wall.

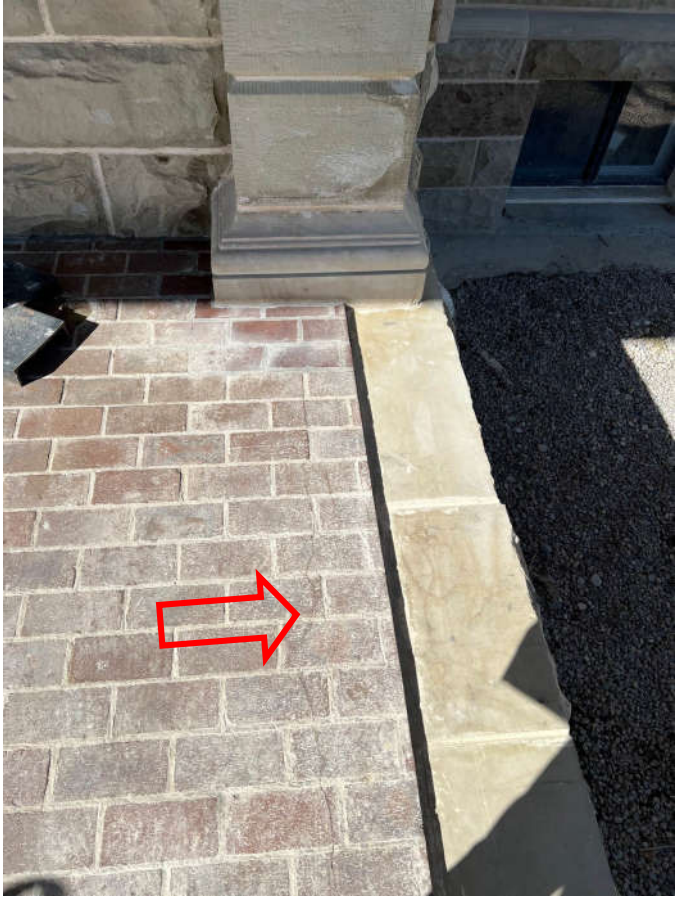
Photo #6: The new guardrails will be installed in the brick pavers rather than the new stone. A crack in the brick pavers was observed. Brick pavers were patched around the pilaster base.

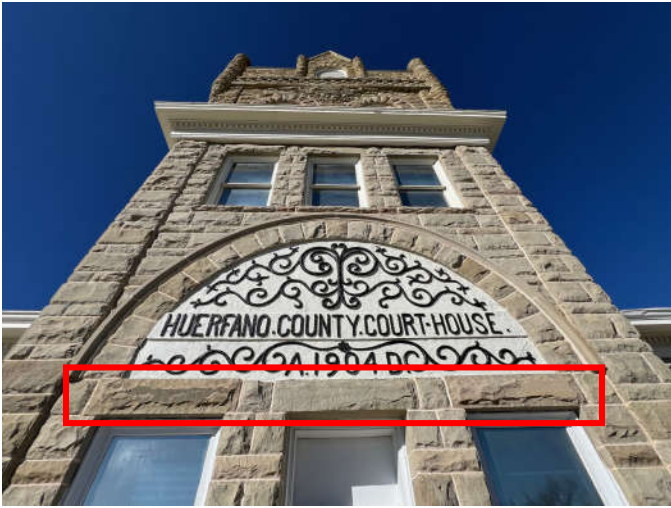
Photo #7: The plaster sign was repaired and repainted. Replacement lintel stones were installed above the second floor windows.

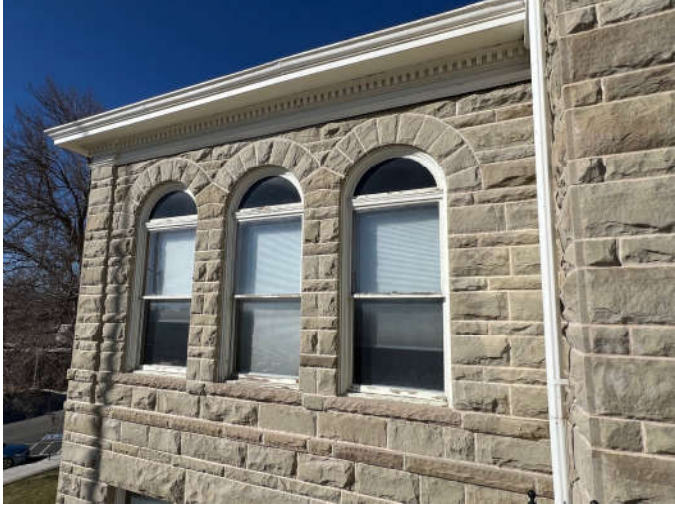
Photo #8: Two holes in the stone located below the frieze were filled.

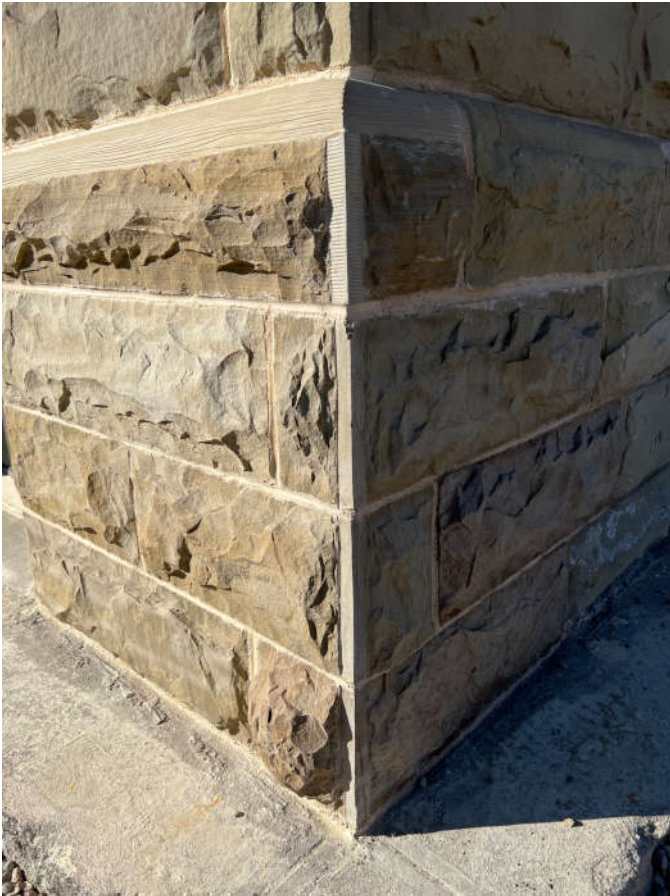
Photo #9: Some tooling remains to be done at the northeast corner.

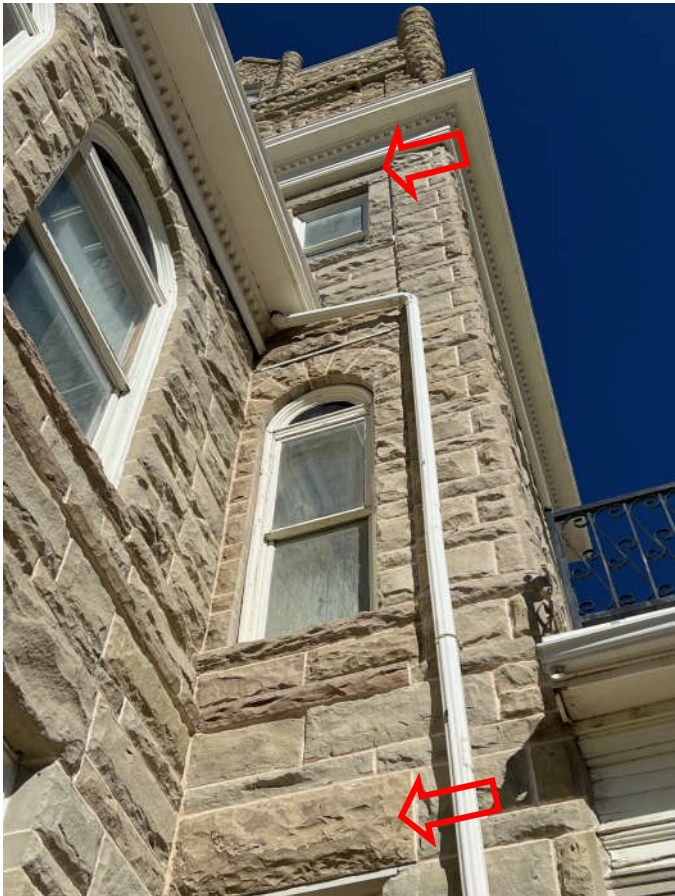
Photo #10: Since the last site visit, two lintel stones were installed on the tower's south face.
