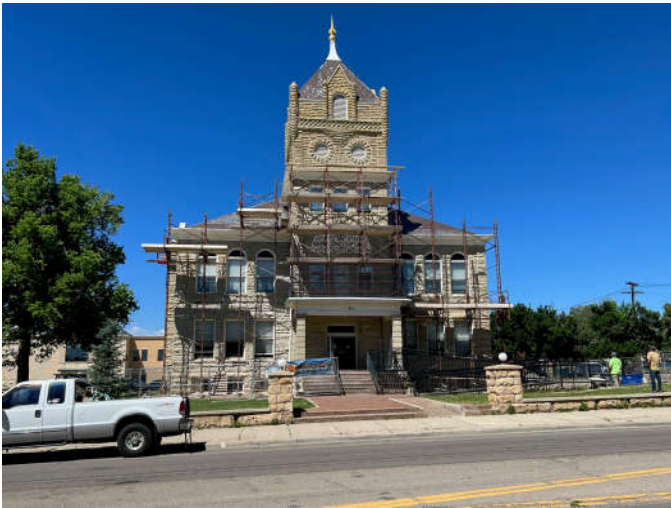
Photo #1: Scaffolding was erected to allow the masons access to all areas of the east elevation. The front entry remains open to the public.

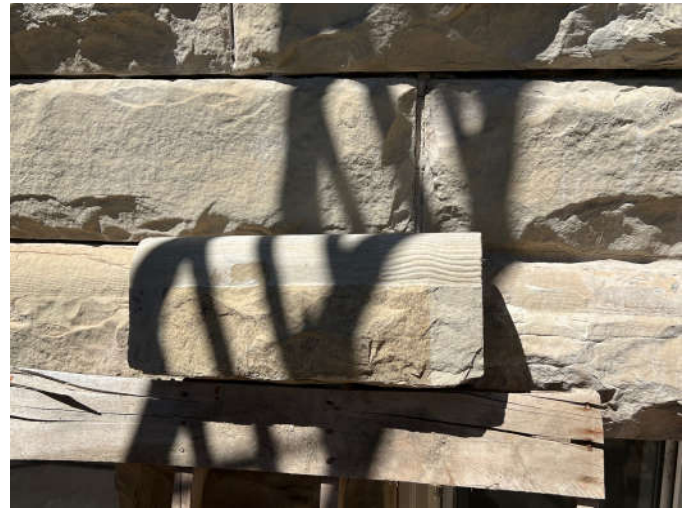
Photo #2: The stone was sandblasted at its end to match the color of the original stone more closely. A sample of the tooling at the radiused top surface of the water table stones was approved.

2. Mock-ups were provided for review.
 - a. A sample of tooling on the radiused top surface of a stone at the water table was approved. (Re: Photo #2.)
 - b. A corner of the southeast entry porch column was patched with Jahn mortar. A custom color to match the stone has been ordered but was not available for this mock-up. The tooling was approved with future review to occur when the custom color is available. (Re: Photo #5.)

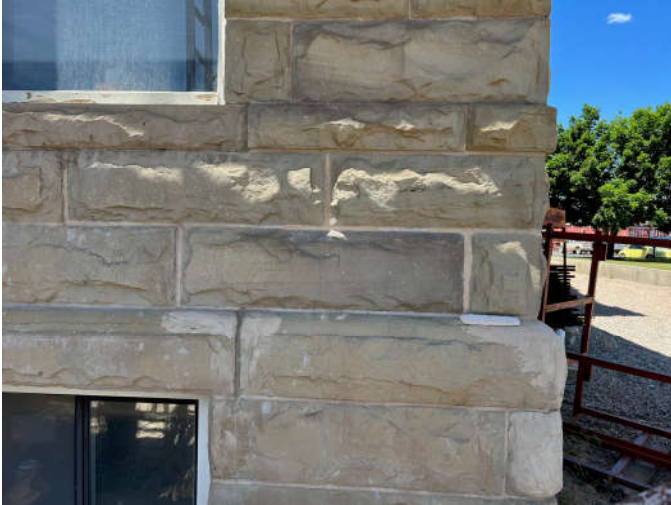
- c. Two different mortar pointing samples were provided for review; one sample reflects the mortar mix and color used on the tower while the other sample is whiter in color. The mortar used at the tower, which was previously approved, was chosen. (Re: Photo #3.)

Photo #3: An area of the east wall was used for two mortar pointing samples. The mortar approved for the tower was selected.

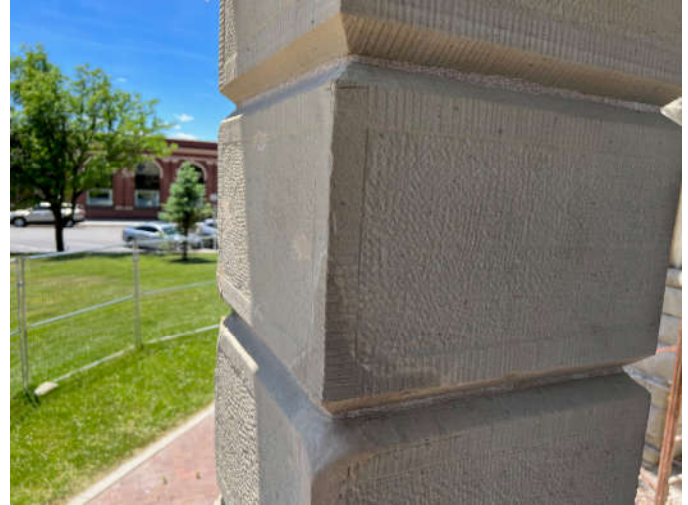
Photo #5: A corner of the entry porch column was patched with the tooling approved. Jahn mortar matching the stone will be provided.

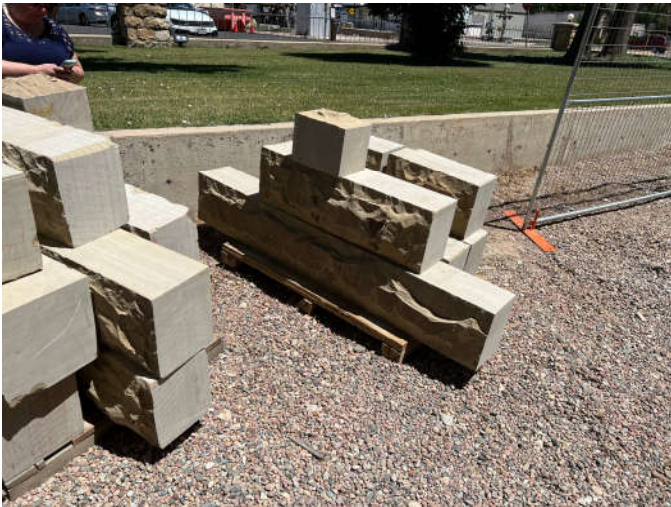
- c. Pine’s Stone both cut and tooled the replacement stone. Most of the stone currently on site was cut with the bedding planes oriented vertically, which may have been done for ease in tooling. However, this bedding plane orientation allows for cracking and delamination. Ideally, future stone should be cut with the bedding planes oriented horizontally.

- i. One of the large lintel stones is cracked, which may have occurred in transport, so it will be replaced. The stone may be able to be cut beyond the crack and used in another location. (Re: Photo #4.)

Photo #4: A load of replacement stones was delivered to the site. The large lintel stone at the bottom of the pile is cracked along one of the bedding planes.

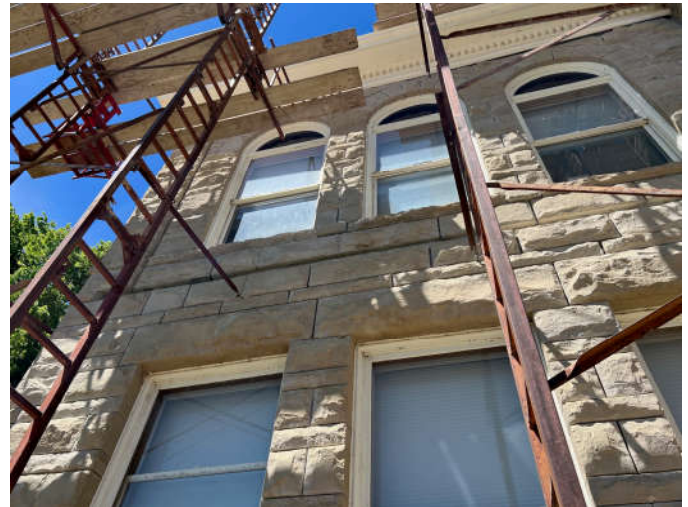
Photo #6: A replacement stone was laid between two second floor window sills. The new stones should align with the adjacent existing stones.

4. A replacement stone was provided between two window sills on the second floor. It should be laid to align with the adjacent stone sills rather than at the original projected (uneroded) location. (Re: Photo #6.)
5. An existing vent on the south wall of the main east entry should be retained.
6. Mike indicated that the project will be completed by the beginning of November.
