**Exhibit 3 – Photos from September 22, 2021 cursory inspection**

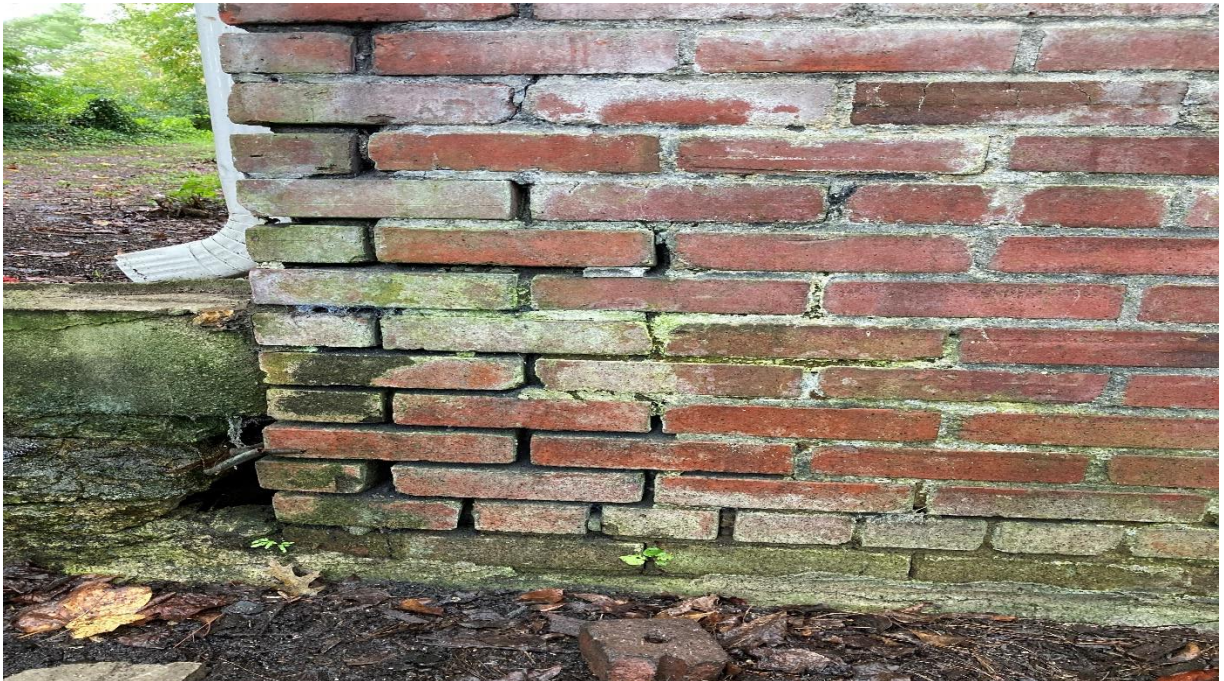
*Figure 1 - Missing Mortar*

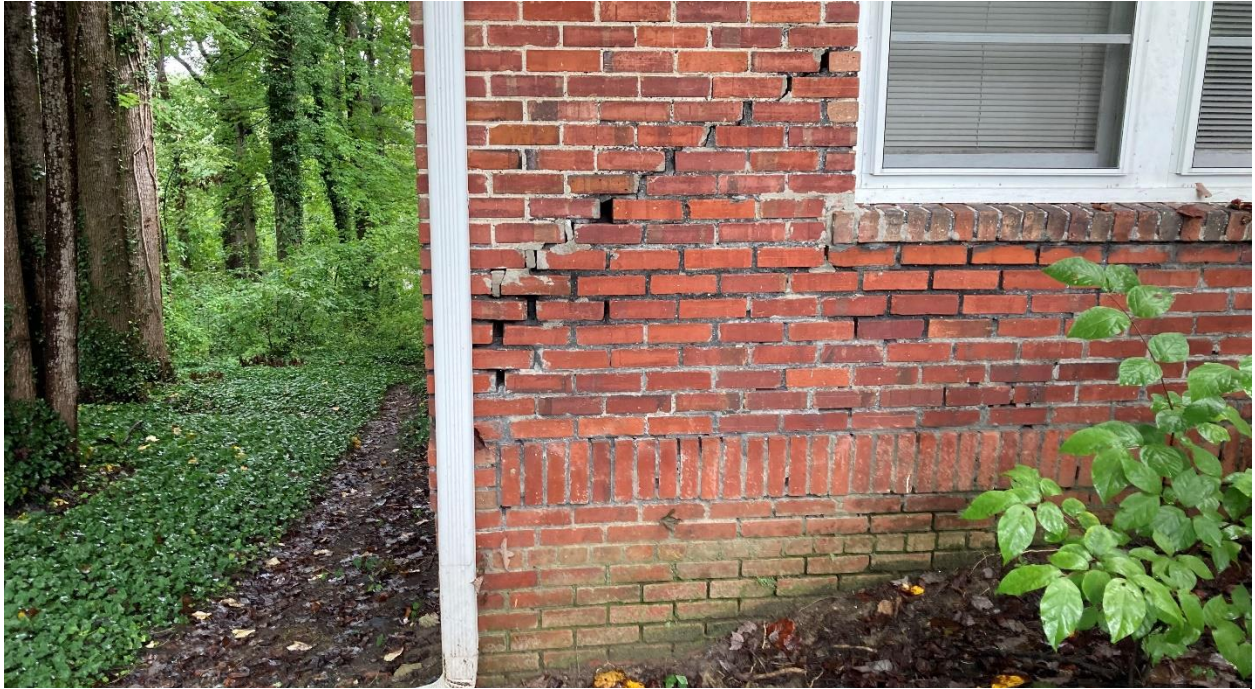
*Figure 3 - Missing/Damaged Mortar*

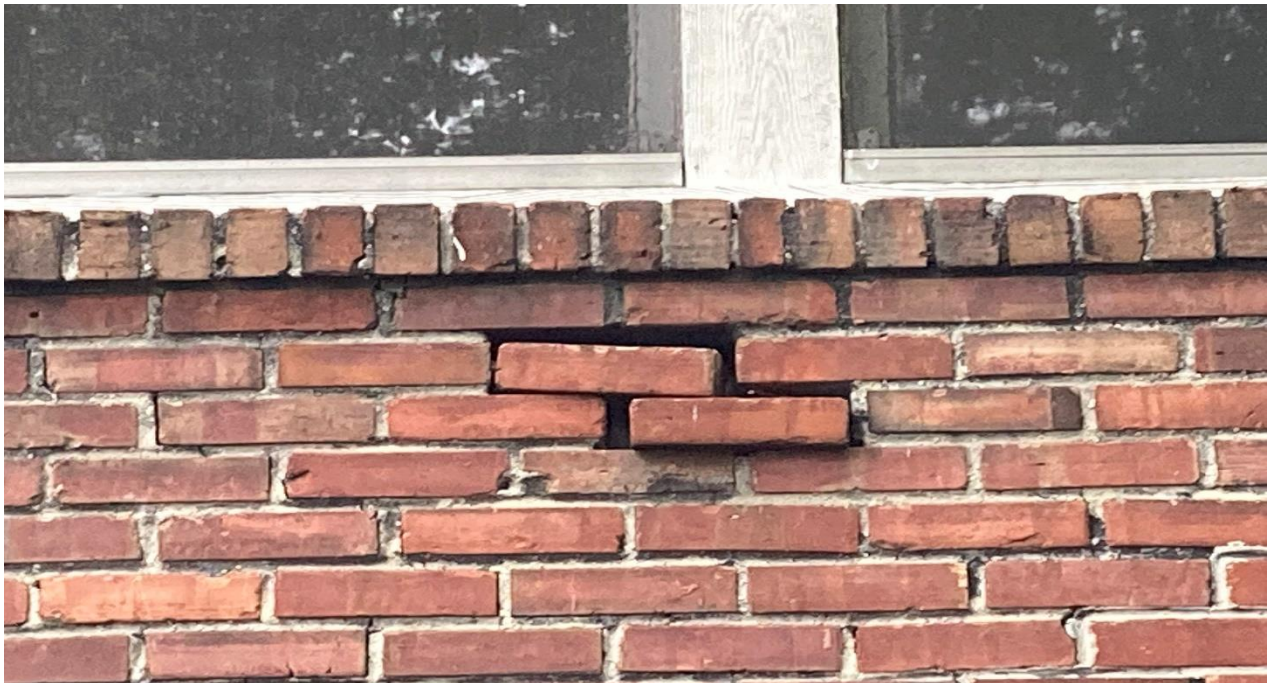
*Figure 4 - Missing Mortar/Loose Brick*

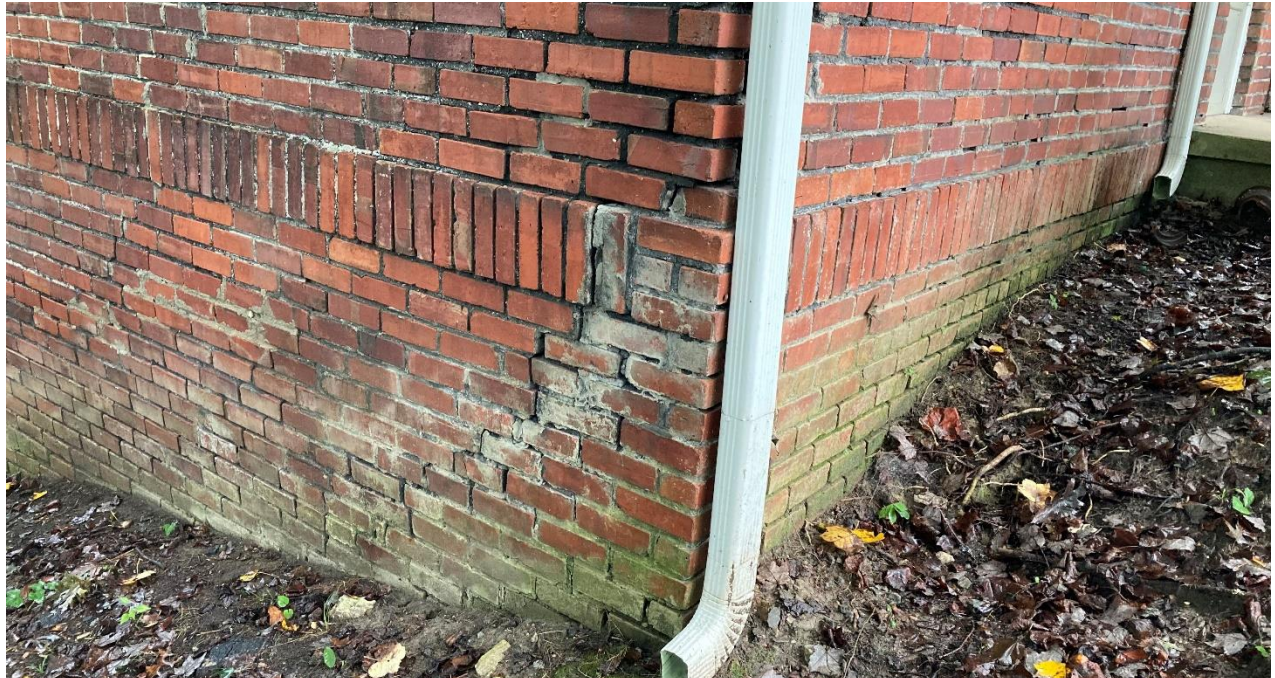
*Figure 5 - Cracks in Foundation Masonry*

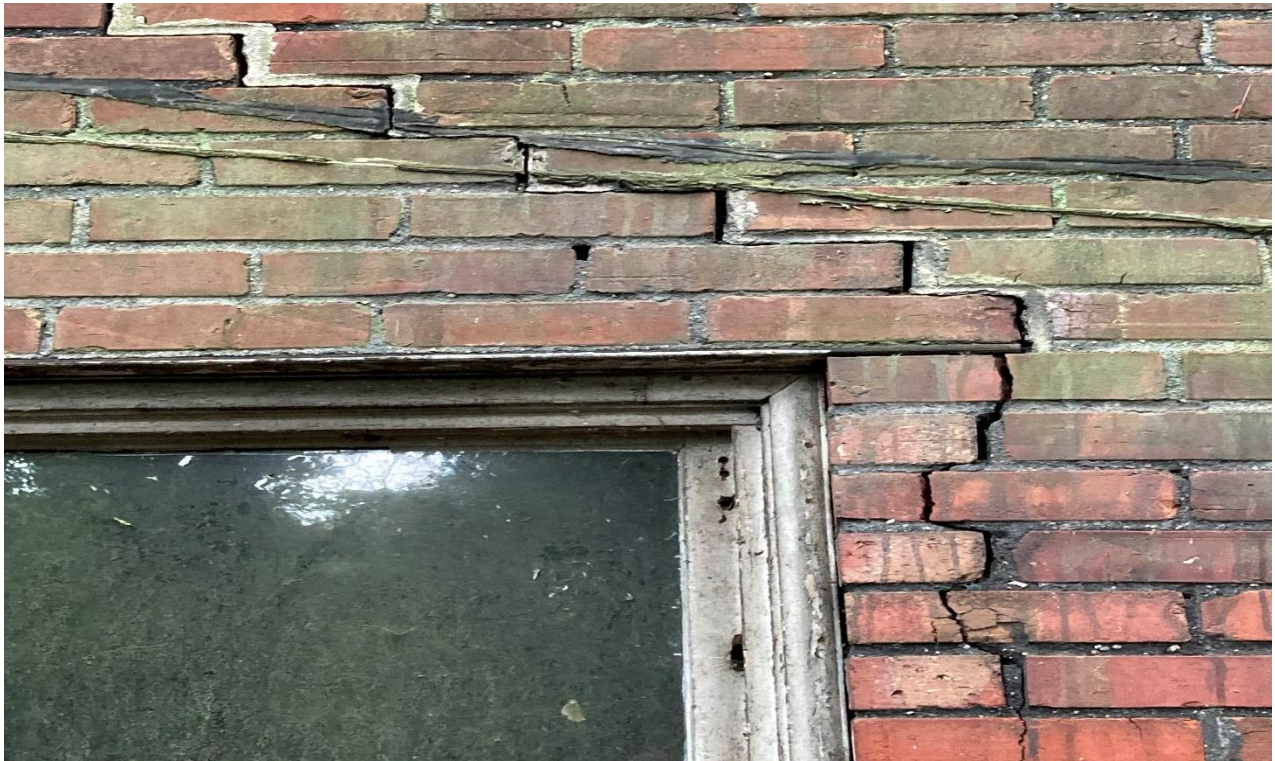
*Figure 6 - Missing mortar and crack above window; rotting window frame*

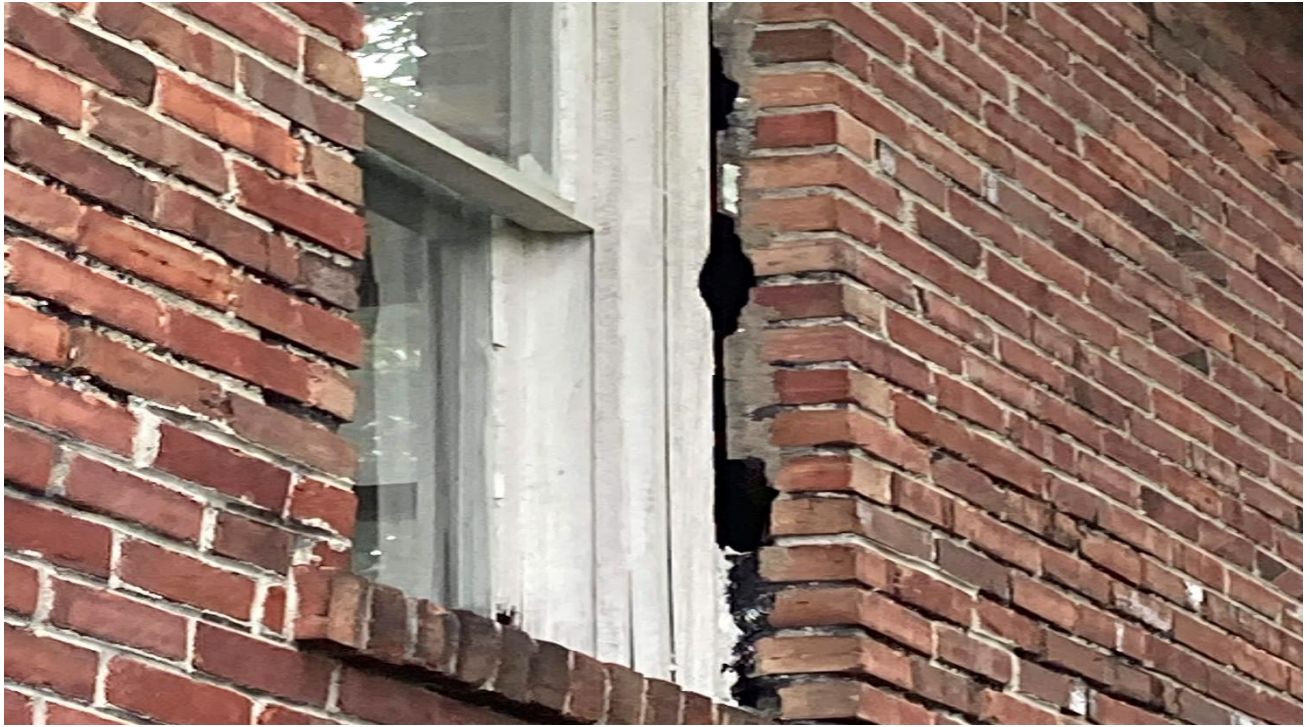
*Figure 7 - Gaps between window and frame*

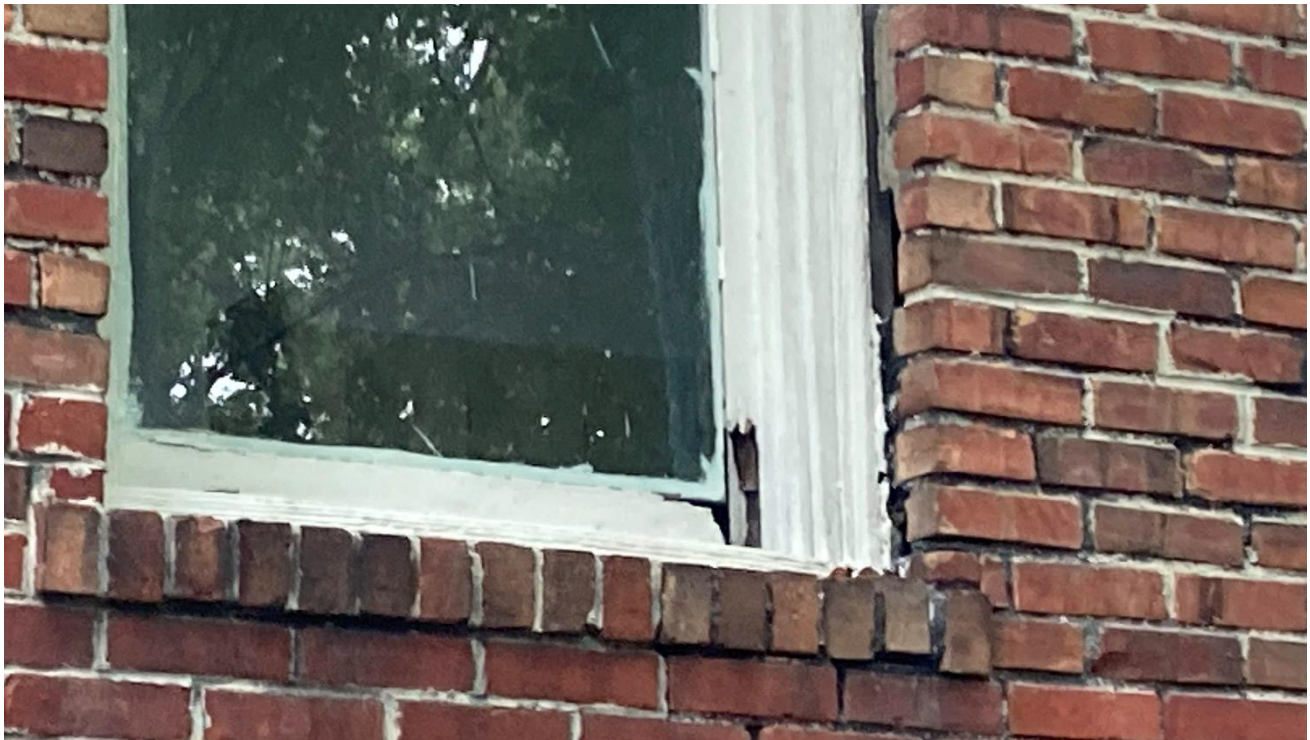
*Figure 8 - Rotten/Damaged Window Frame*

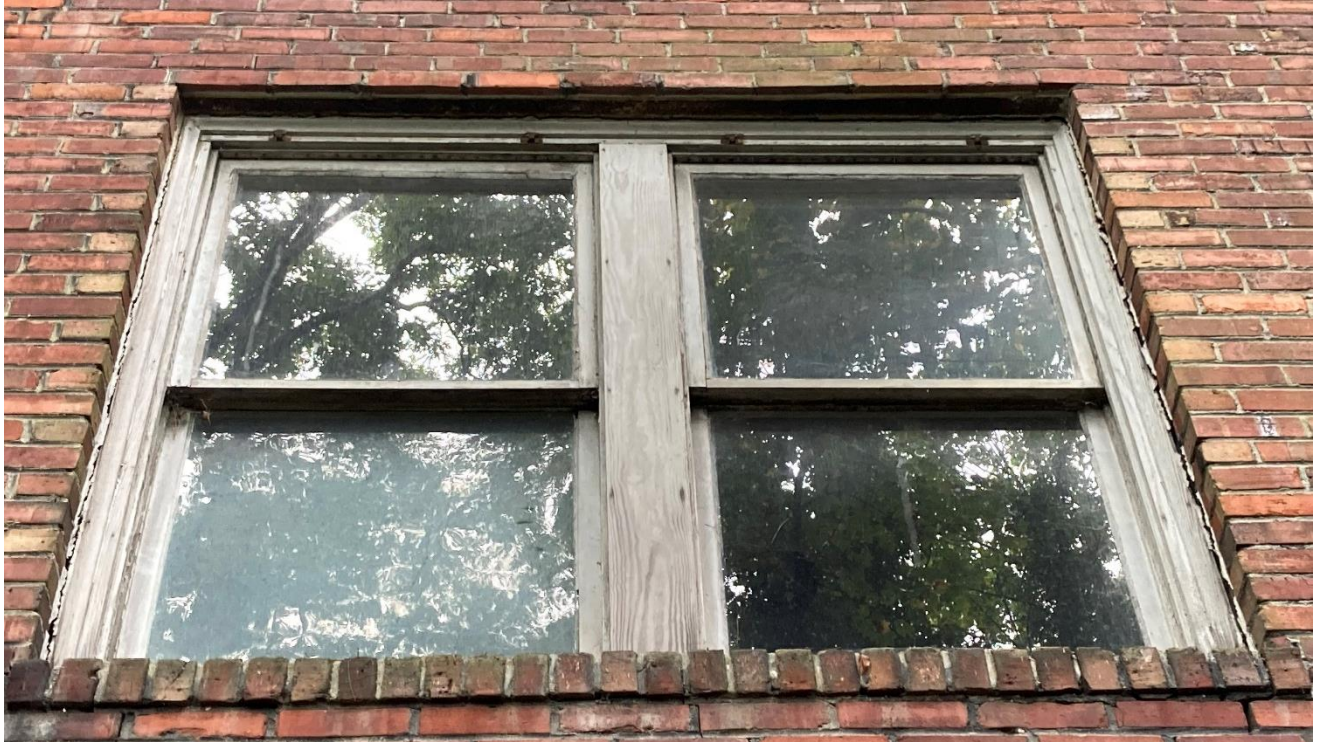
*Figure 9 - Exposed/Unpainted Wood Window Trim*

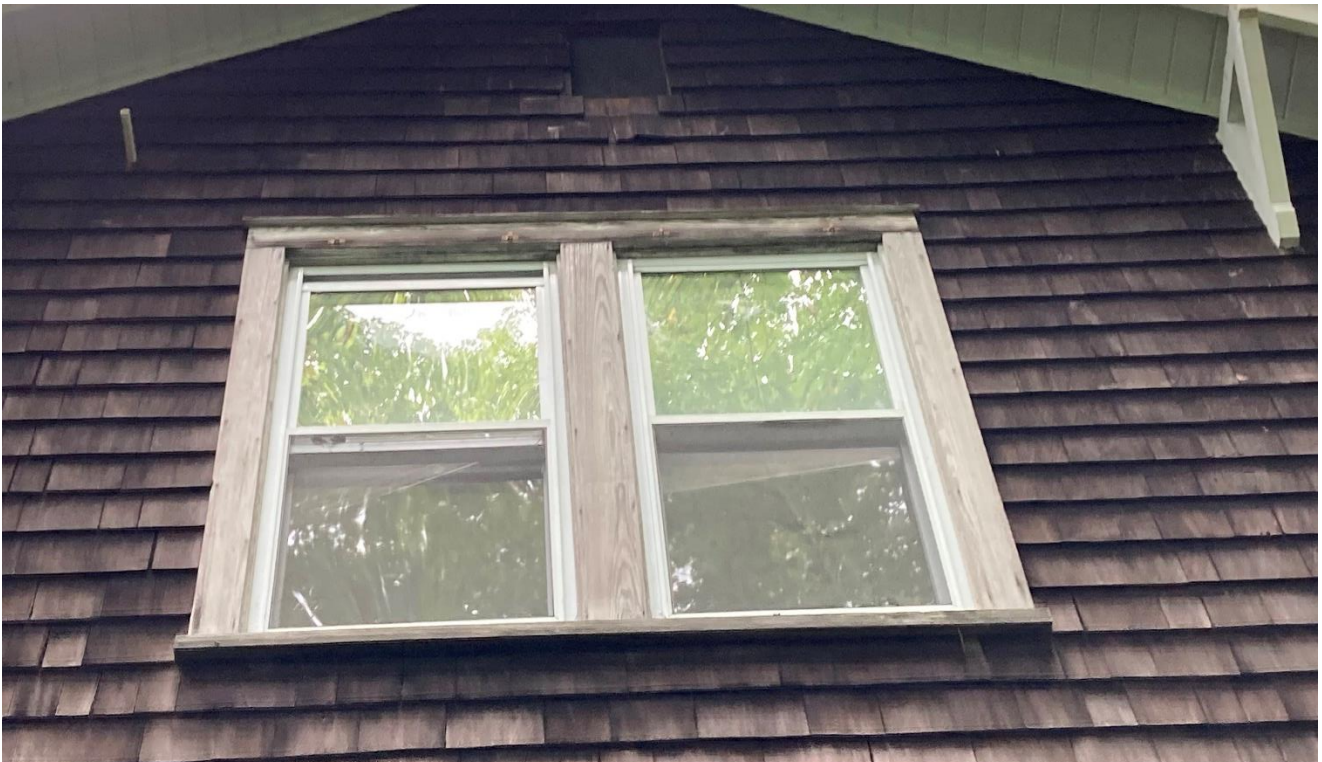
*Figure 10 - Exposed/Unpainted Wood Window Trim*

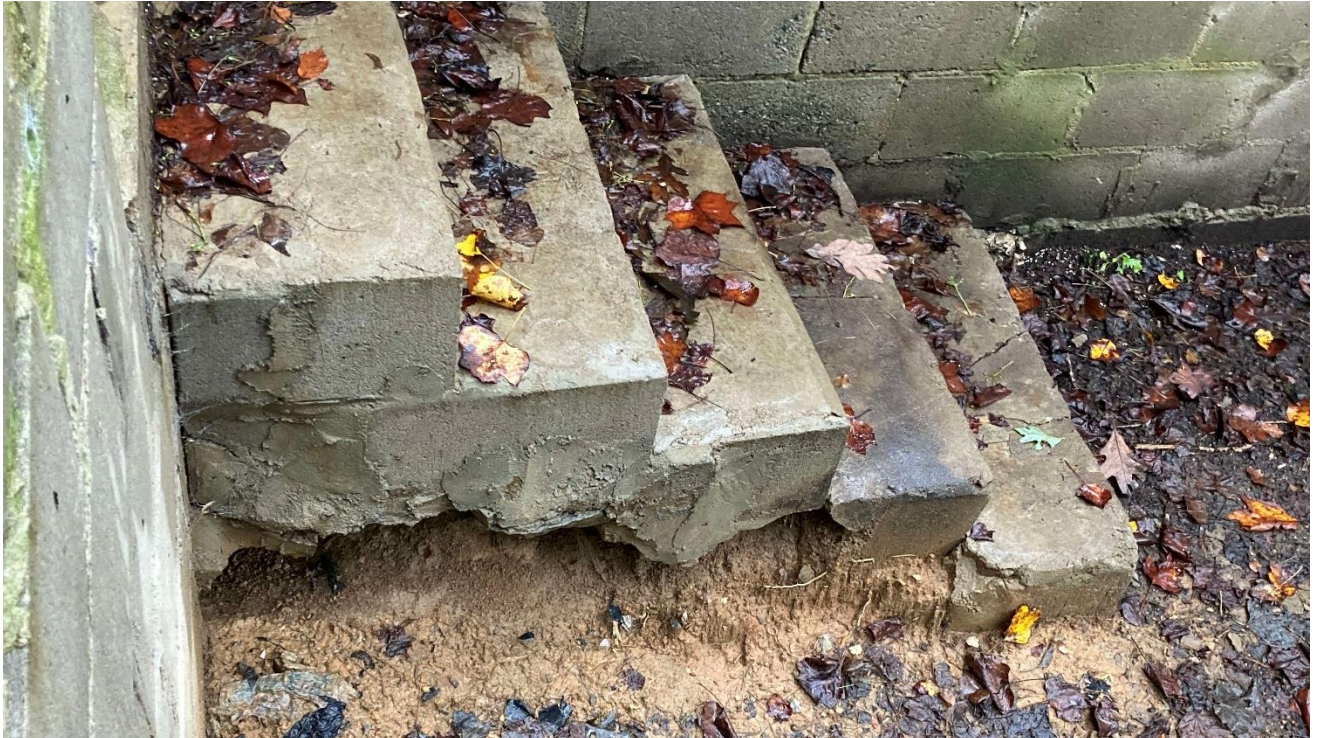
*Figure 11 - Erosion Underneath Exterior Concrete Stairs*

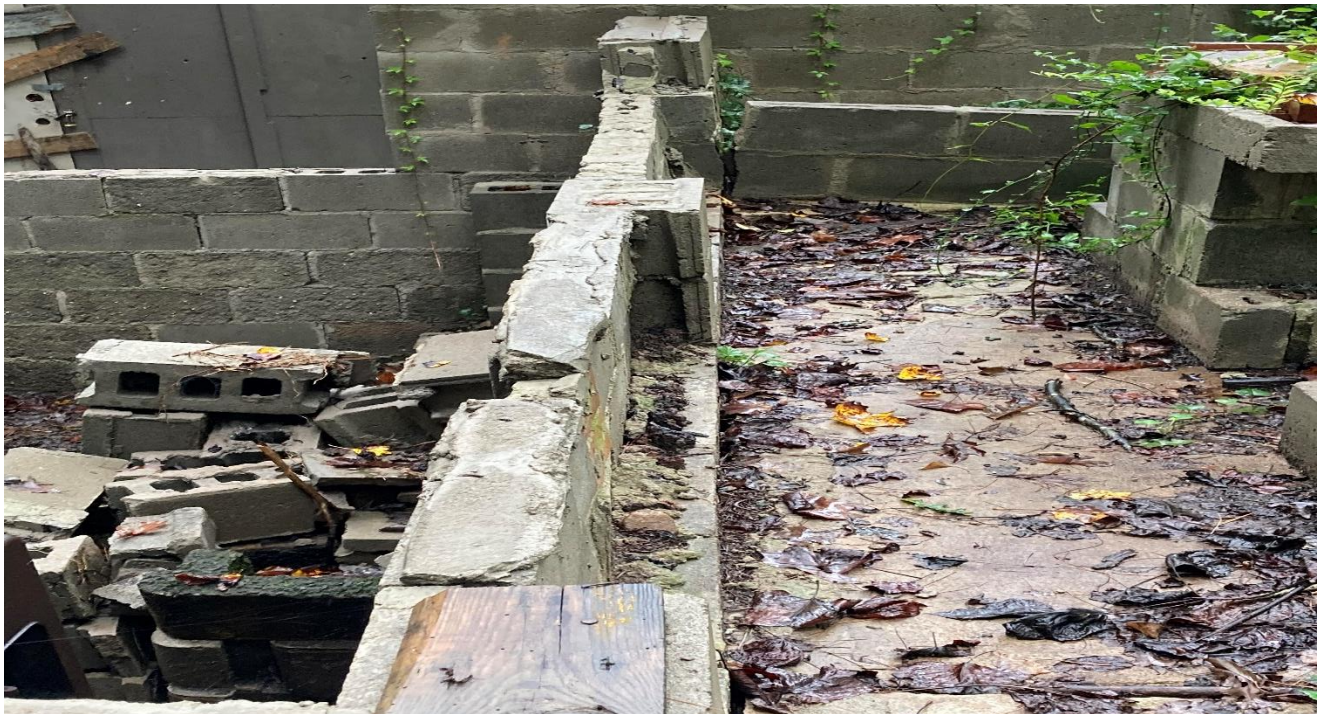
*Figure 12 – Leaning Foundation/Wall for Former Boiler Room /Greenhouse*

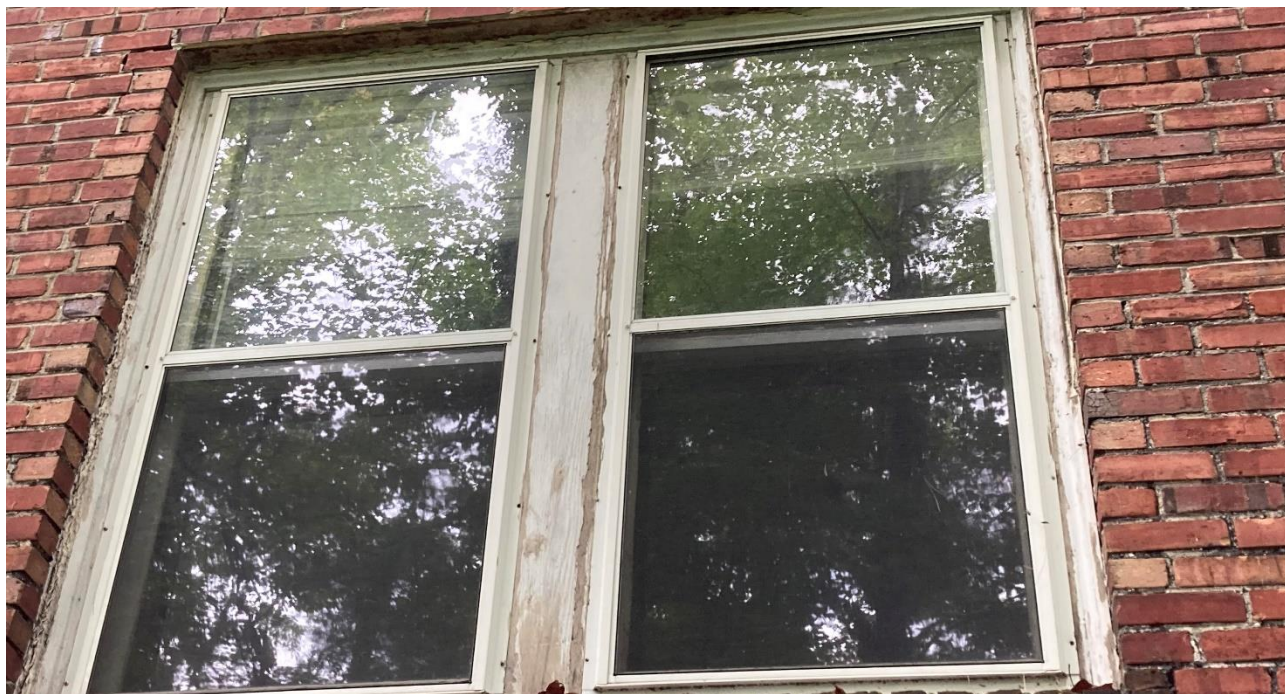
*Figure 13 – Rotting/Exposed/Unpainted Wood Window Frame*

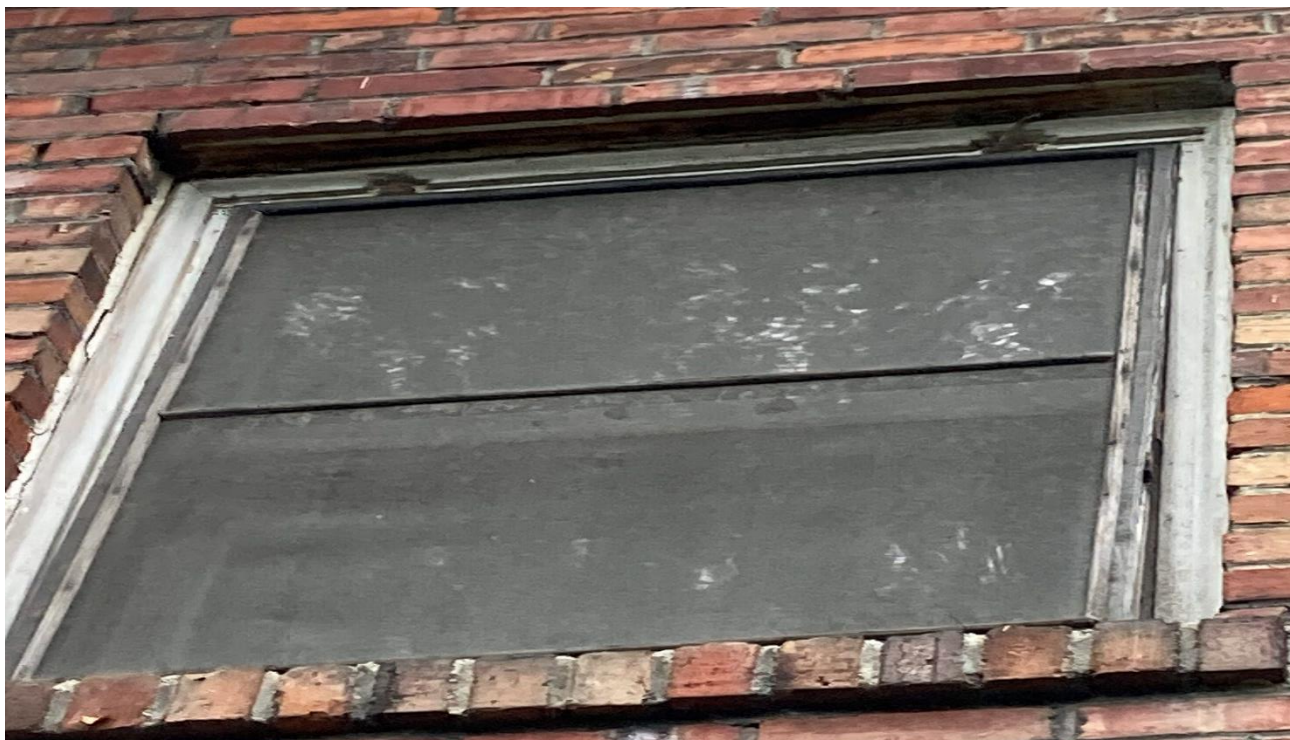
*Figure 14 - Rotting Wood Window Frame*

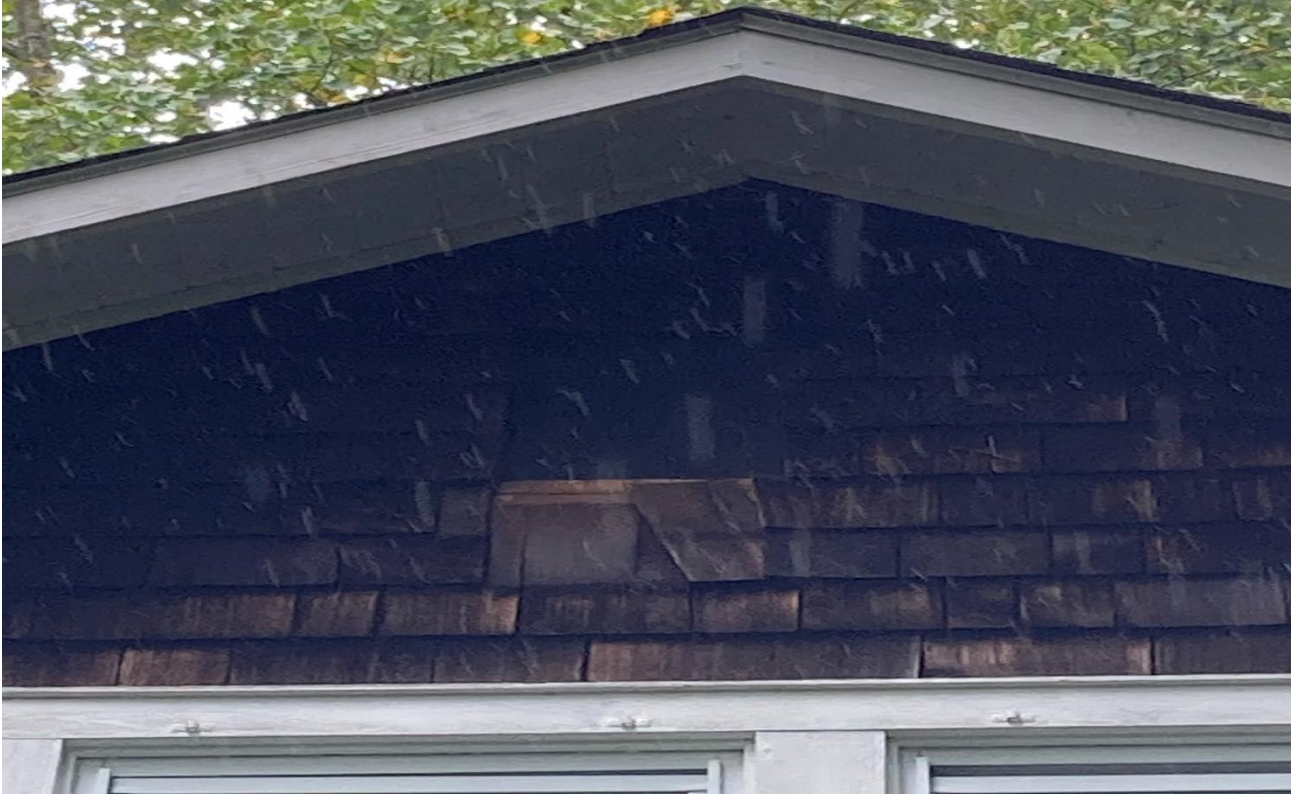
*Figure 16 - Damaged Shingle*

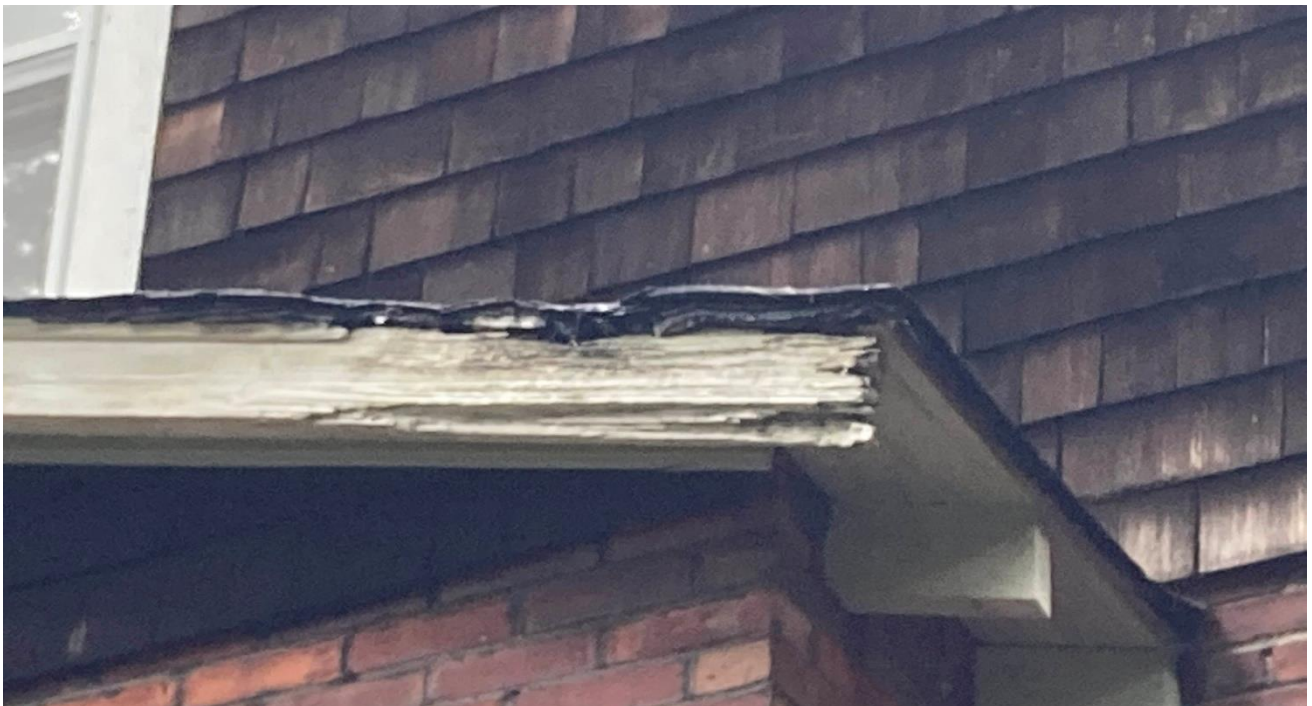
*Figure 17 - Damaged/Rotten Eaves and Shingles*

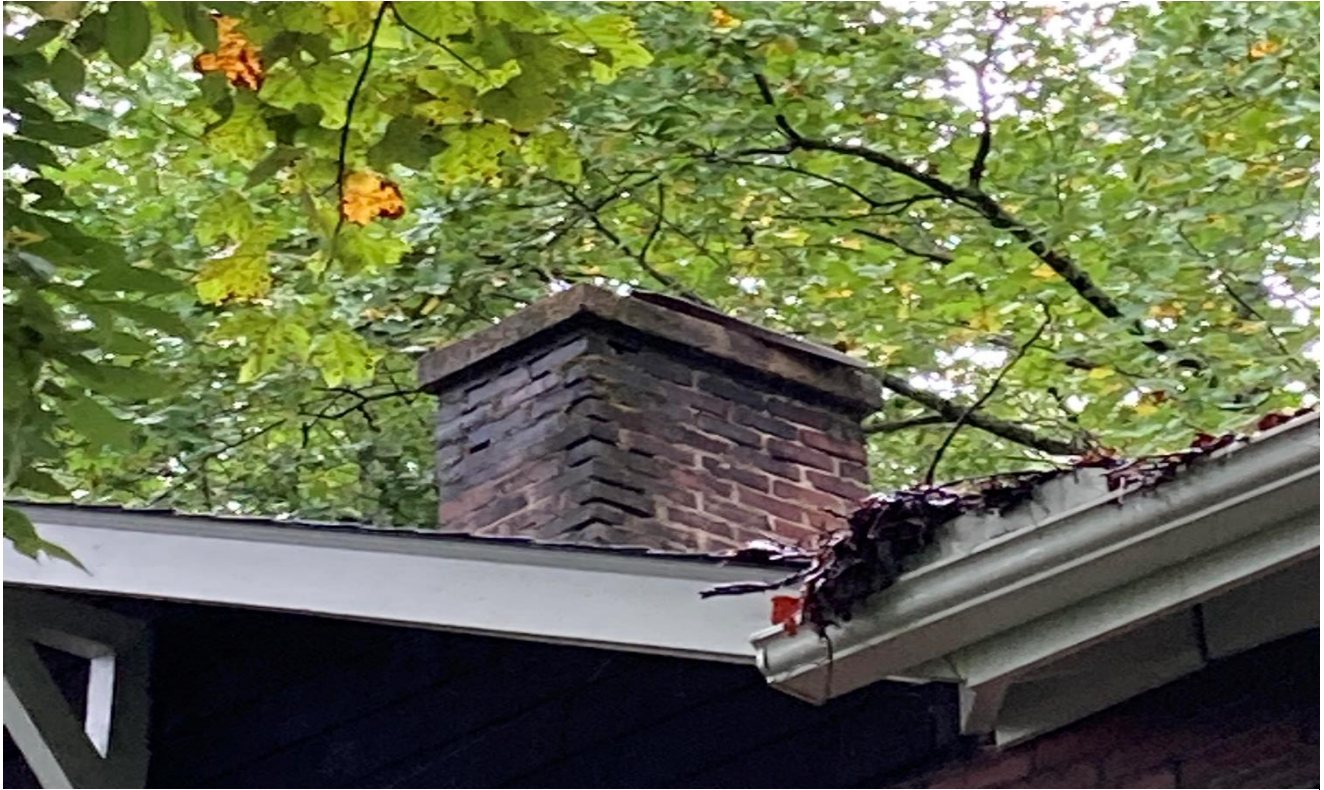
*Figure 18 - Missing Mortar on Chimney*
