Bridges and Structures Bureau

Bridge Maintenance and Inspection Unit

Bridge Condition Report

Bridge ID:	3RD ST NORTH-EAST	FHWA B.ID.01) Number:	006240
Inspection Type:	In-Depth (SNBI)	District:	07
Location:	T89N-R9W-S35-N15.3-E11.8	Carrying:	3RD ST NE
Approved By:	Davis,Alex	Inspection Group:	Buchanan County

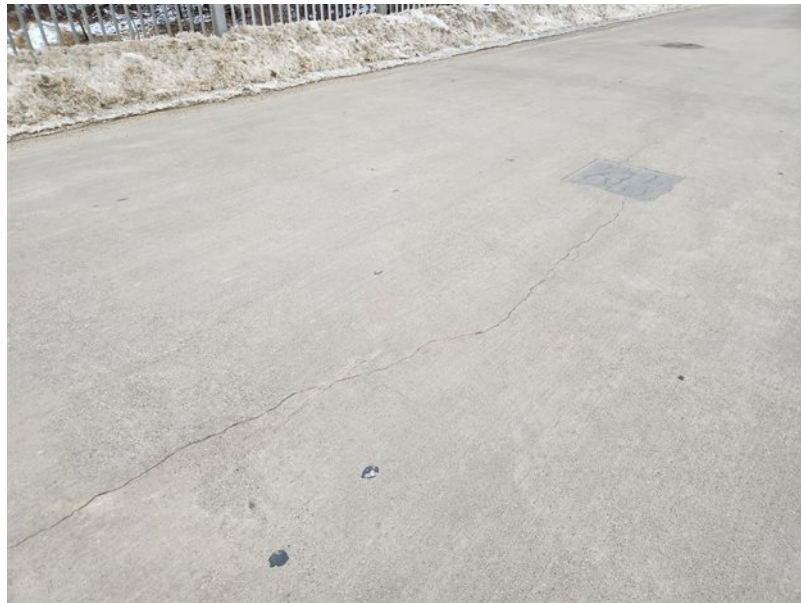
Condition Rating	Remarks
1. Wearing Surface	5	AREAS OF SPALLED CONCRETE ON DECK. SOME AREAS OF SPALLING CONCRETE ON DECK PATCHED WITH CONCRETE AND ASPHALT. MAP CRACKING OF CONCRETE PATCHES. LONGITUDINAL CRACKING IN DECK.

File Description Longitudinal centerline crack on surface of deck

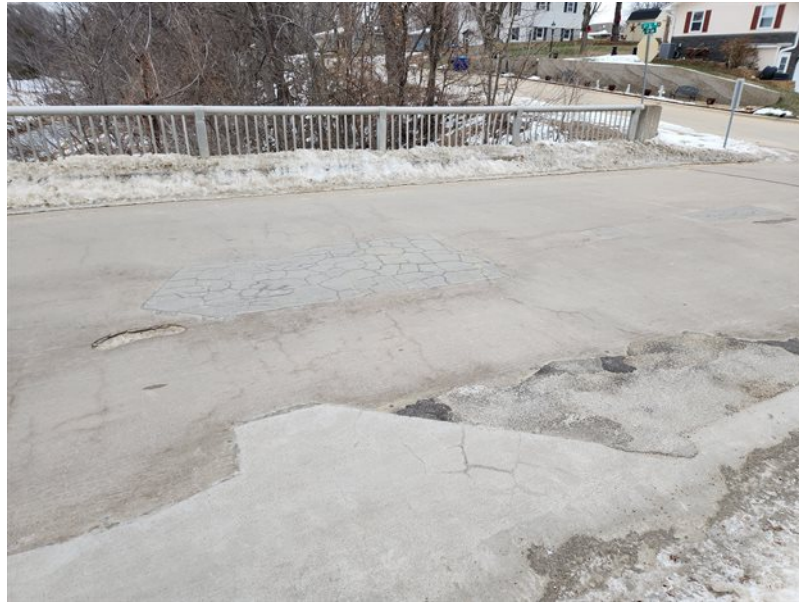
File Description Area of deck spalling and patched with concrete and asphalt

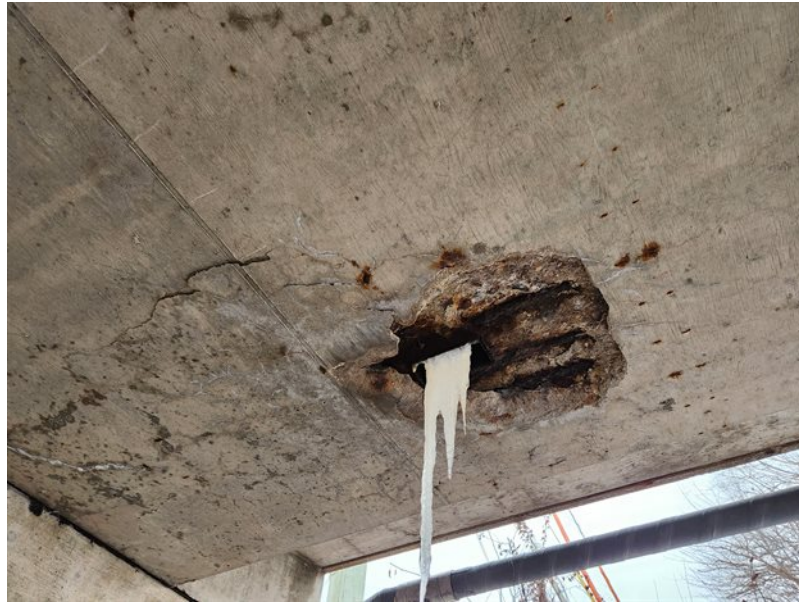
8. Drains	4	DELAMINATION AND SPALLING CONCRETE WITH EXPOSED REINFORCING AT DRAINS ON UNDERSIDE OF DECK.
9. Utility Connections	5	GAS PIPELINE AT SOUTH EDGE OF DECK.

File Description Spalling concrete with exposed reinforcing around drains on underside of slab (typical throughout)

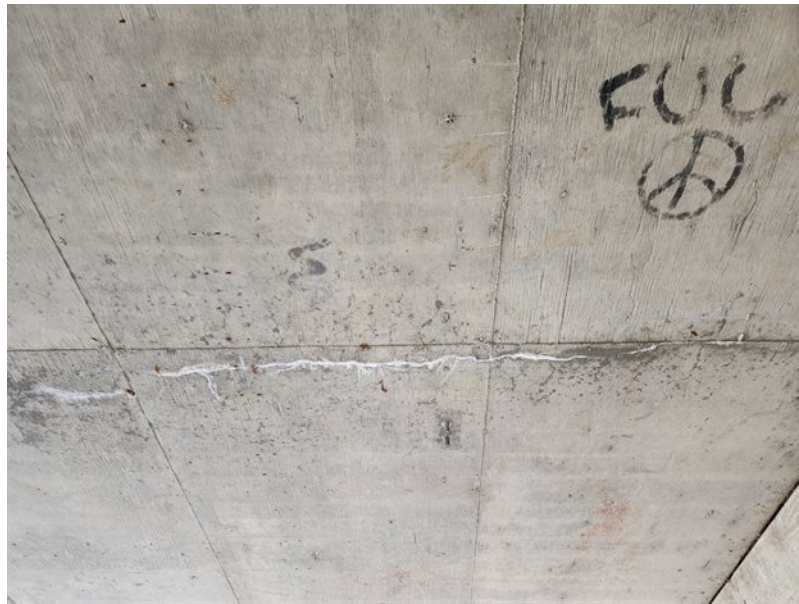
CENTERLINE CRACK WITH EFFLORESCENCE ON SURFACE AND UNDERSIDE OF SLAB. SPALLING CONCRETE WITH EXPOSED REINFORCING AT DECK DRAINS ON UNDERSIDE OF SLAB. SCATTERED CRACKING AND DELAMINATING CONCRETE ON SOUTH EDGE OF SLAB.

File Description Centerline crack with efflorescence on underside of slab

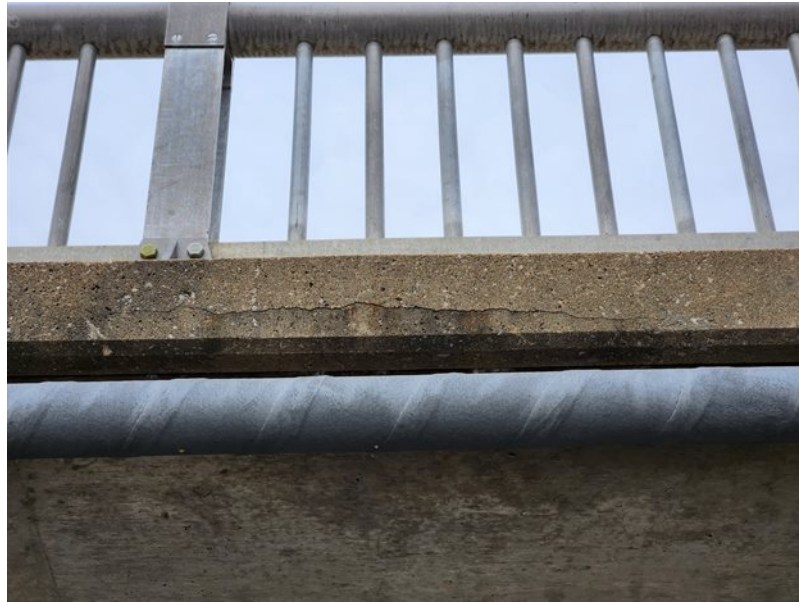
File Description Cracking with delaminating concrete on South edge of deck

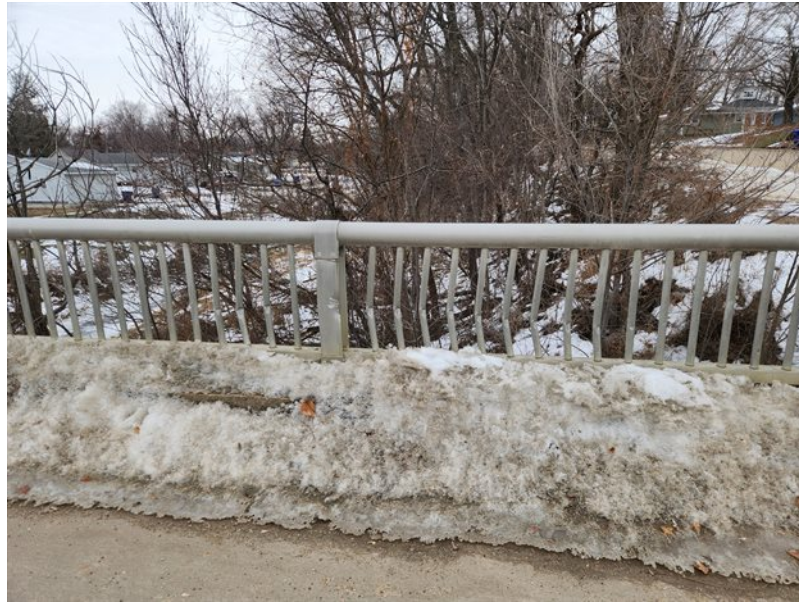
5. Railings (B.C.05)	6	ALUMINUM WITH CONCRETE END SECTIONS. COLLISION DAMAGE AT NORTH RAIL.
6. Transition Rating (B.C.06)	6	
7. Rail Protection System	N

File Description Collision damage in North rail near East abutment

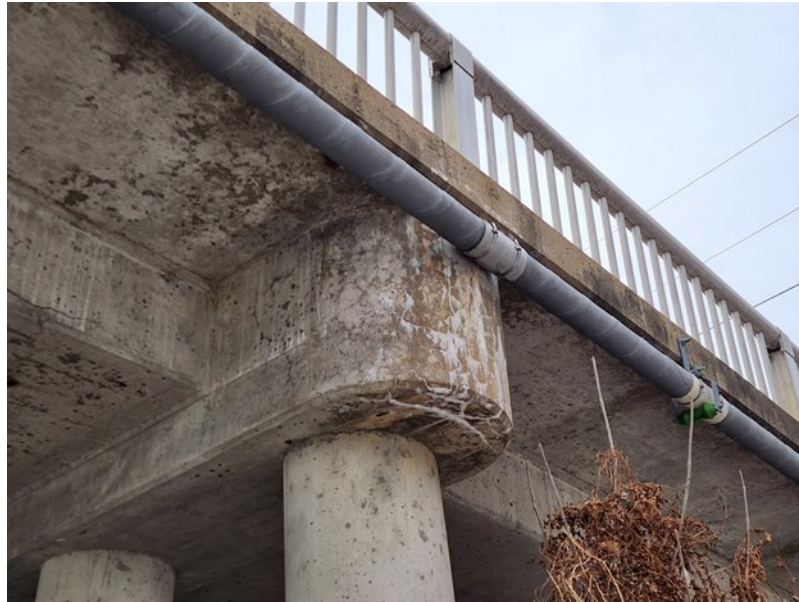
HEAVY CRACKING WITH EFFLORESCENCE OF SOUTH SIDE OF EAST PIER CAP.

File Description Heavy map cracking with efflorescence on South side of East pier cap
