**Office of Bridges and Structures
Bridge Maintenance and Inspection Unit**

Bridge Condition Report

Bridge ID:	2ND ST SOUTH-WEST	NBI (FHWA) Number:	006220
District:	0	Inspection Group:	Buchanan County
Inspection Type:	Routine	Inspection Date:	12/29/2023
Location:	T88N-R9W-S04-N90.9-E87.3	Carrying:	2ND ST SW
Approved By:	Davis,Alex

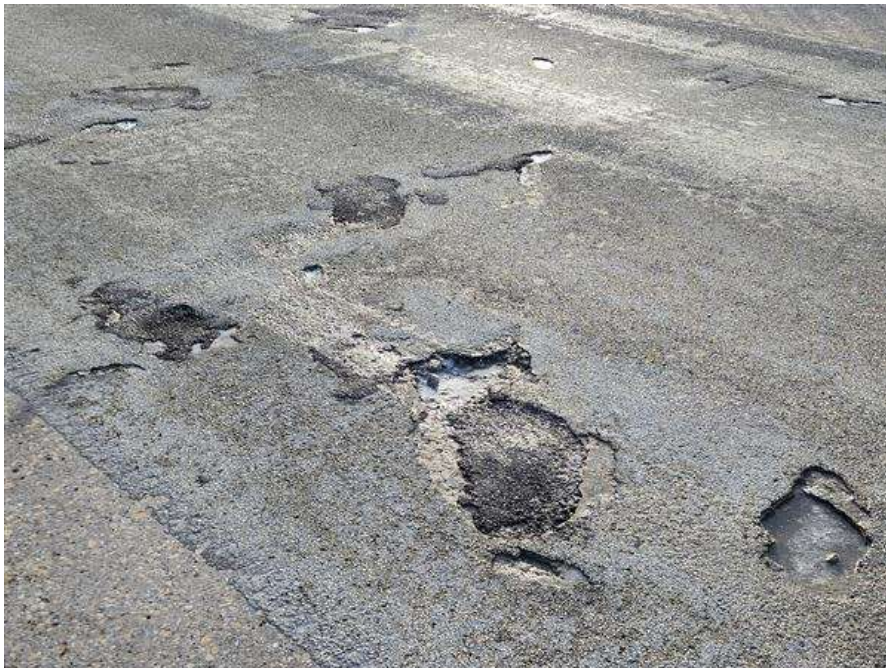
Photo Number: 4

DECK ITEM	CONDITION RATING	REMARKS
1. Wearing Surface	5	NUMEROUS DECK SPALLS SCATTERED THROUGHOUT. SOME FILLED WITH A.C. DETRIMENTAL TO CONCRETE DECK.
2. Deck - Structural Condition	5	SCATTERED SPALLING CONCRETE WITH EXPOSED REINFORCING ON EDGES OF DECK. CRACK DEVELOPING ON OUTSIDE EDGE OF DECK AT COLD JOINT WHERE CURB MEETS SLAB. SEVERAL AREAS OF TRANSVERSE CRACKING ON SURFACE OF SLAB. ISOLATED TRANSVERSE CRACKING WITH EFFLORESCENCE ON UNDERSIDE OF SLAB.

Spalls in deck surface throughout

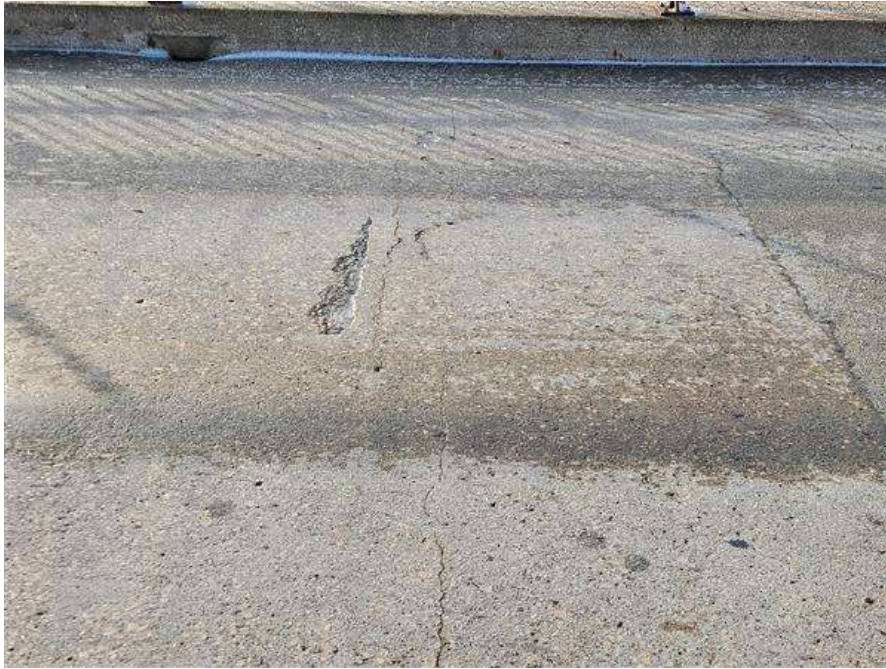
Photo Number: 5

Transverse cracking of deck surface scattered throughout

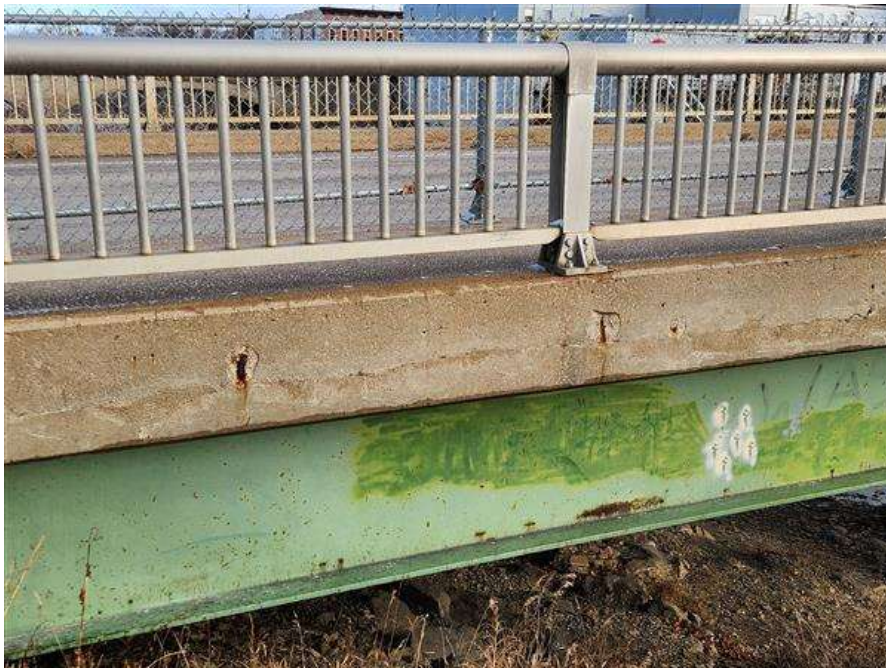
Photo Number: 6

Scattered concrete spalls with exposed reinforcing on South outside edge of deck

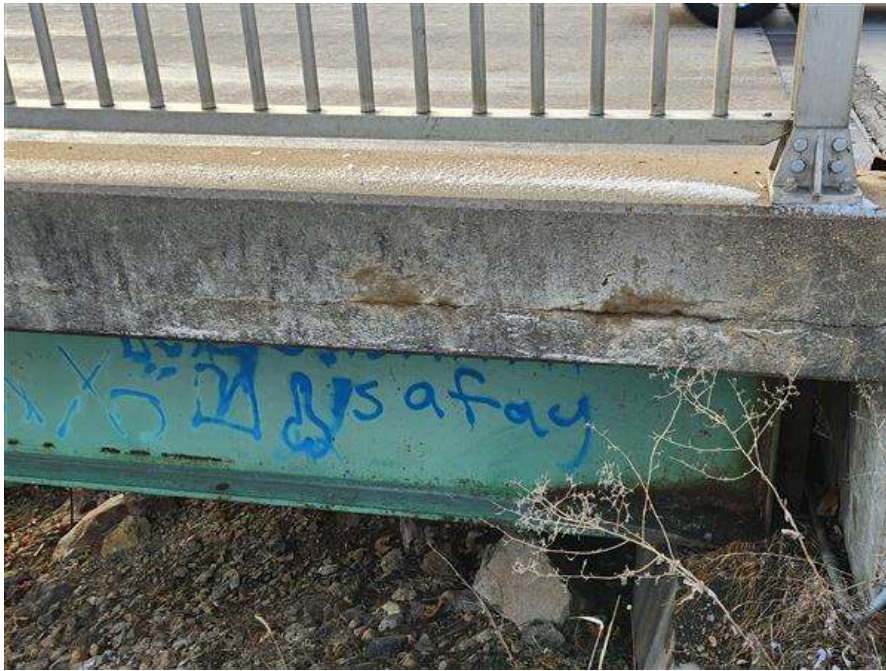
Photo Number: 7

Crack developing in edge of slab where curb meets deck (typical of both sides)

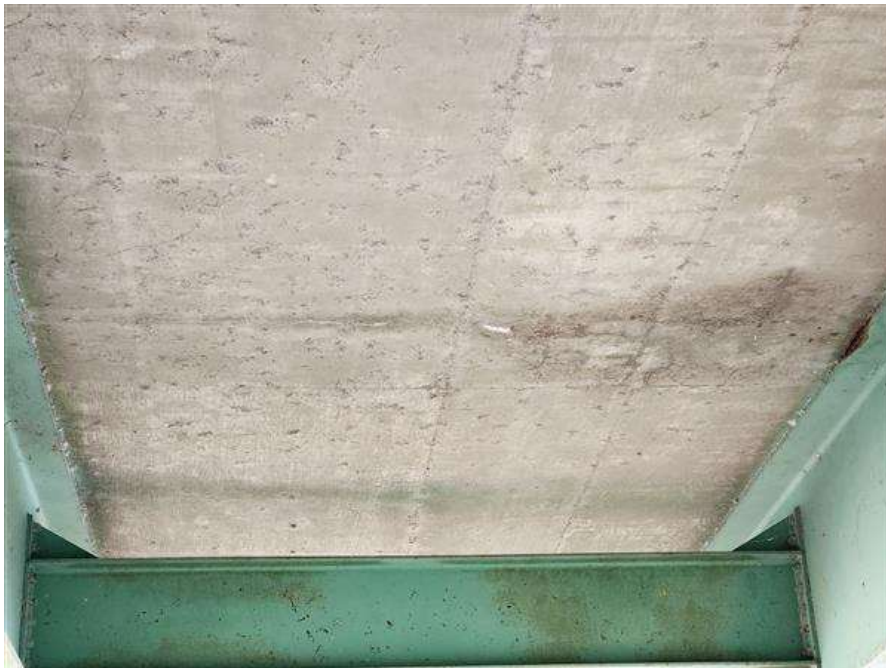
Photo Number: 8

Scattered traverse cracking with efflorescence on underside of deck

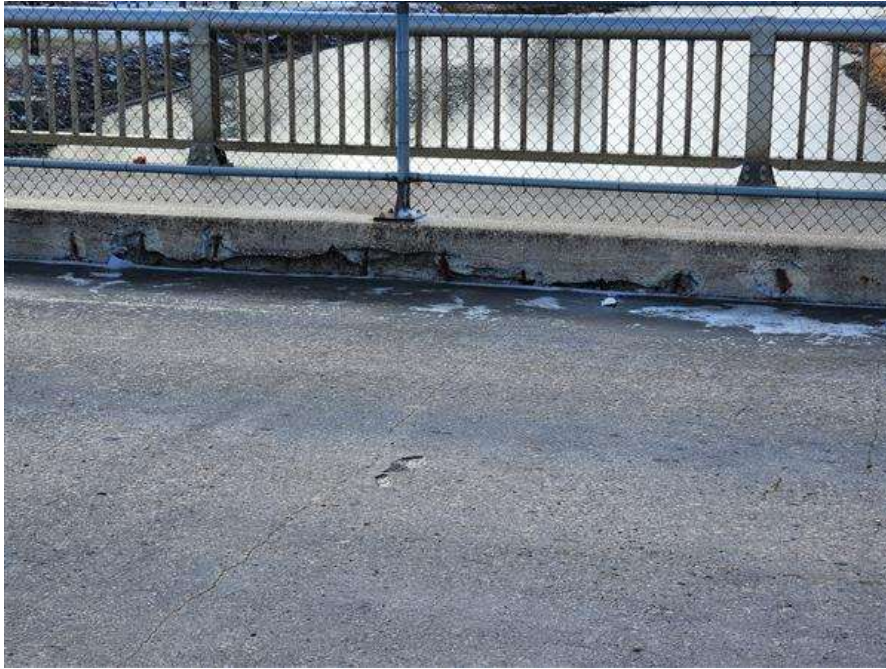
Photo Number: 9

3. Curbs	5	SPALLING CONCRETE WITH EXPOSED REINFORCING ON CURBS.
4. Median	N	
5. Sidewalks	4	EAST SIDEWALK SETTLED. 6" GAPS BETWEEN SIDEWALK AND BRIDGE FILLED WITH ASPHALT AT BOTH APPROACHES, CAUSING TRIPPING HAZARDS.

Cracking and spalling of curbs with exposed reinforcing scattered throughout

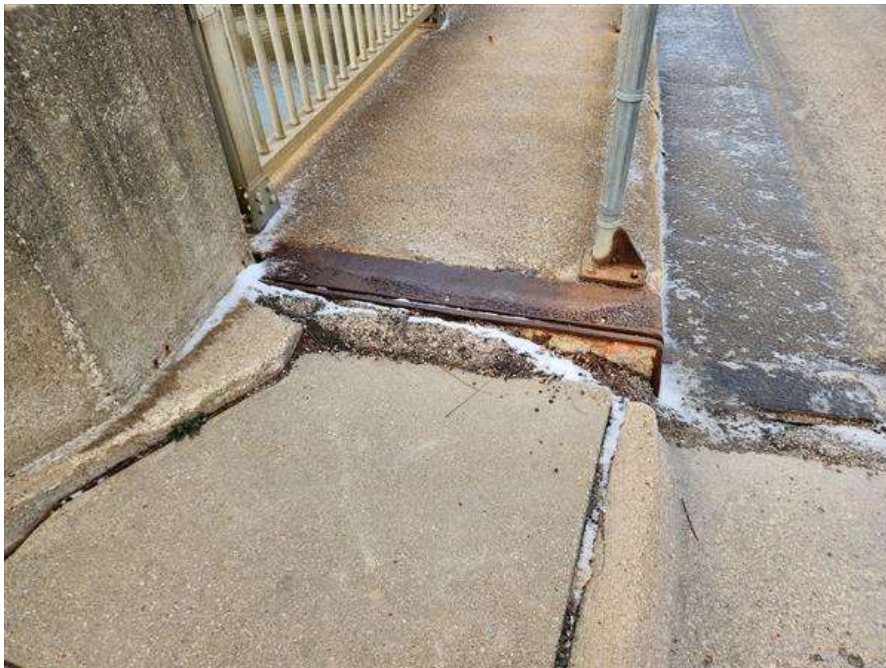
Photo Number: 10

Settlement of East sidewalk approach causing tripping hazard

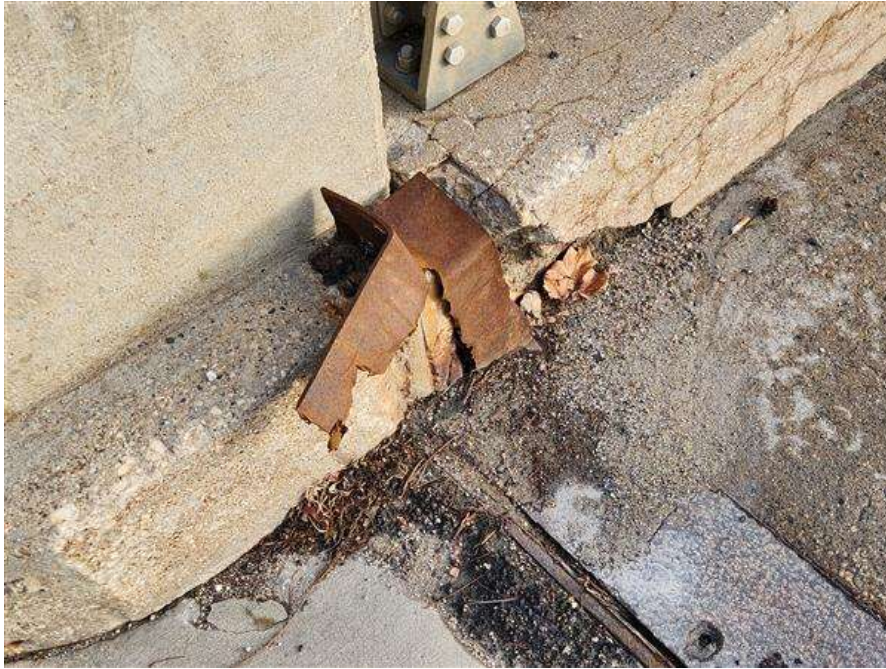
Photo Number: 11

10. Joint leakage	5	LEAKAGE AT BOTH ABUTMENTS.
11. Expansion Joints and Devices	4	EXPANSION JOINTS DAMAGED ON BOTH APPROACH SLABS, WORST AT WEST APPROACH. VOIDS AT EAST JOINT.
General Comments

West expansion joint cover at North curb damaged

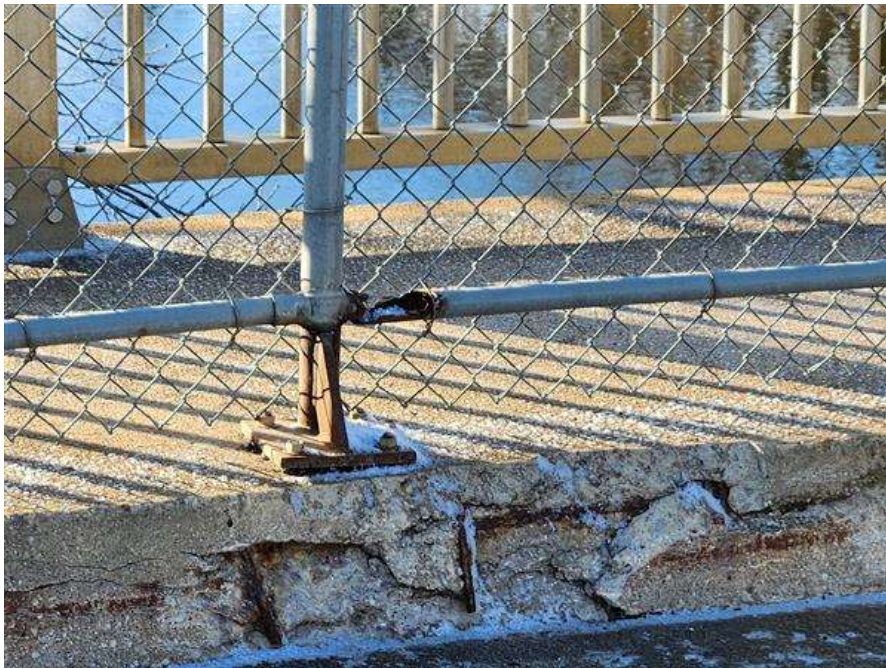
Photo Number: 12

6. Railings	5	ANCHOR BOLTS LOOSE/NUTS MISSING AT E POST ON SOUTH FENCE. SCATTERED DINGS AND DENTS TO STEEL RAILINGS. CORRODED RAIL POST BASES, TOTAL SECTION LOSS OF BOTTOM RAIL AT (5) LOCATIONS.

Bottom rail completely corroded through in chain link fence rail (typical in several locations)

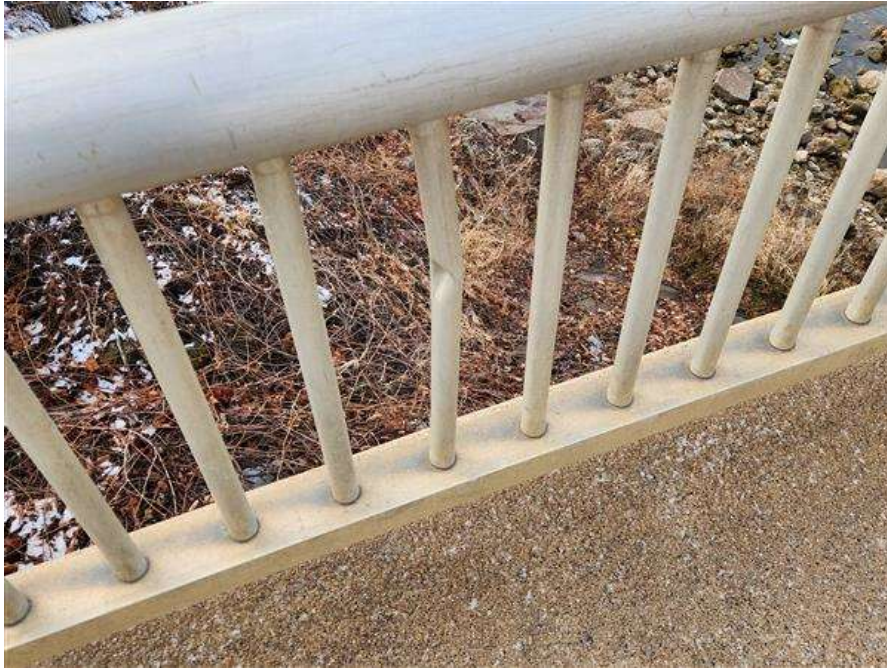
Photo Number: 13

Minor damage to steel railing scattered throughout

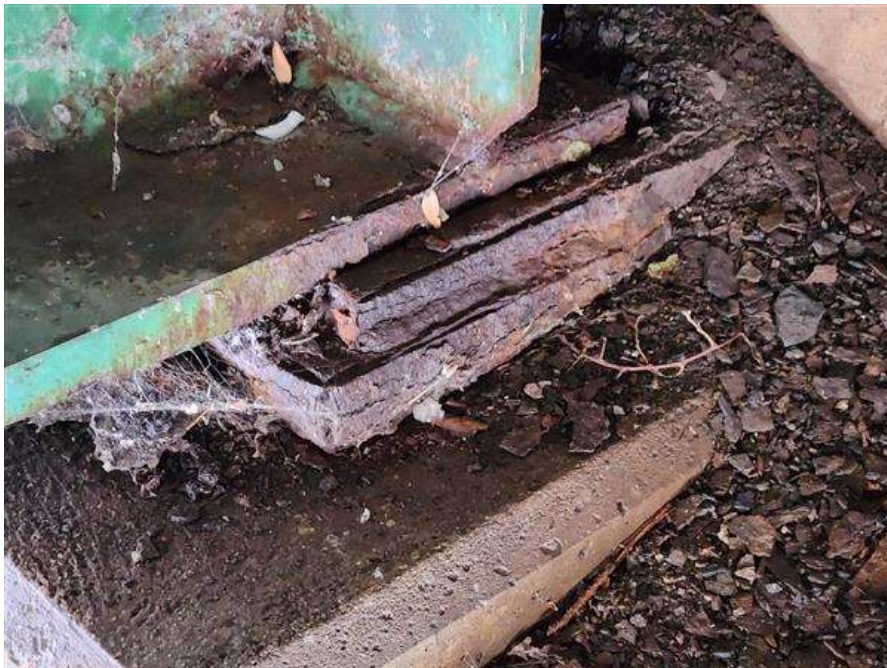
Photo Number: 14

SUPERSTRUCTURE	CONDITION RATING	REMARKS
1. Bearing Devices	5	CORROSION OF BEARING PLATES AT ABUTMENTS. ROAD DEBRIS AROUND ABUTMENT BEARING DEVICES.
2. Stringers	N	
Lateral Support ()	N

Heavy corrosion of bearing devices at abutments

BEARINGS. RECOMMEND REPAINTING SUPERSTRUCTURE AND
CLEANING BEARINGS.

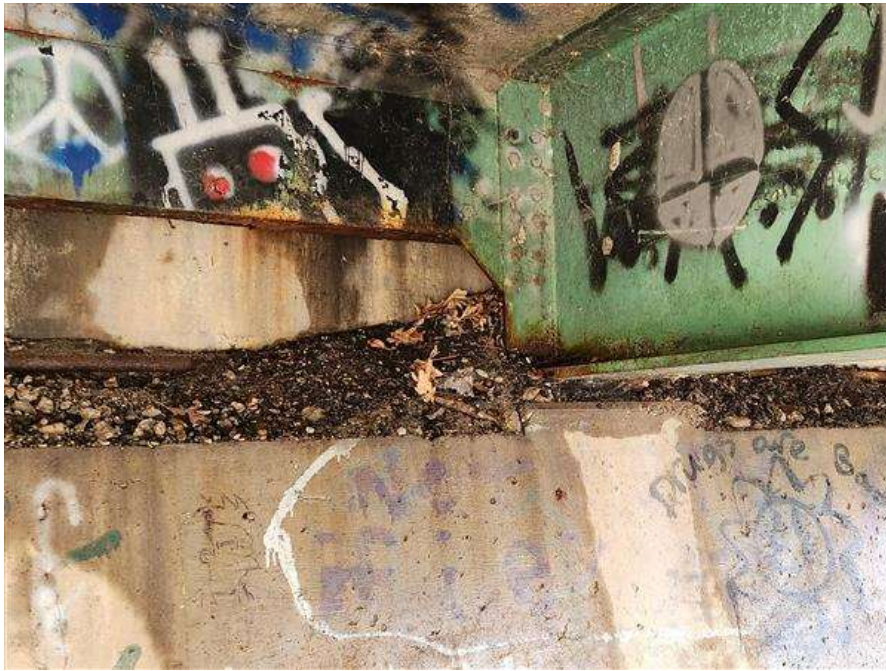
Photo Number: 15
Photo Taken: 12/29/2023
Heavy buildup of road debris around abutment beam bearings (typical of both sides)

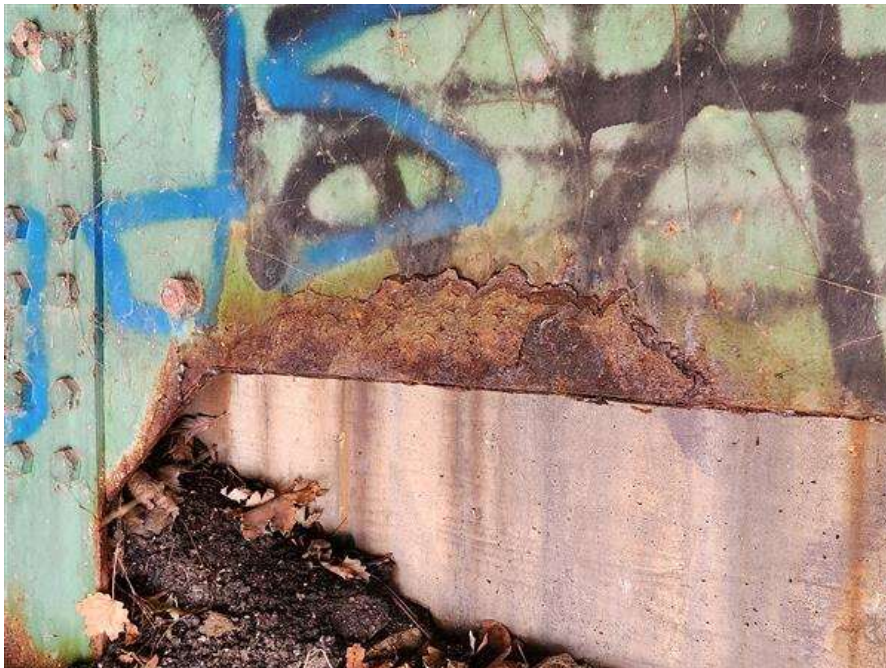
9. Rust	5	ISOLATED SURFACE CORROSION AND INITIAL SIGNS OF SECTION LOSS IN BEAMS. DELAMINATIONS IN WEST ABUTMENT DIAPHRAGMS.
10. Timber Decay	N	
11. Concrete Cracking	N

Photo Number: 16
Photo Taken: 12/29/2023
Steel corrosion with delaminations on West abutment diaphragms

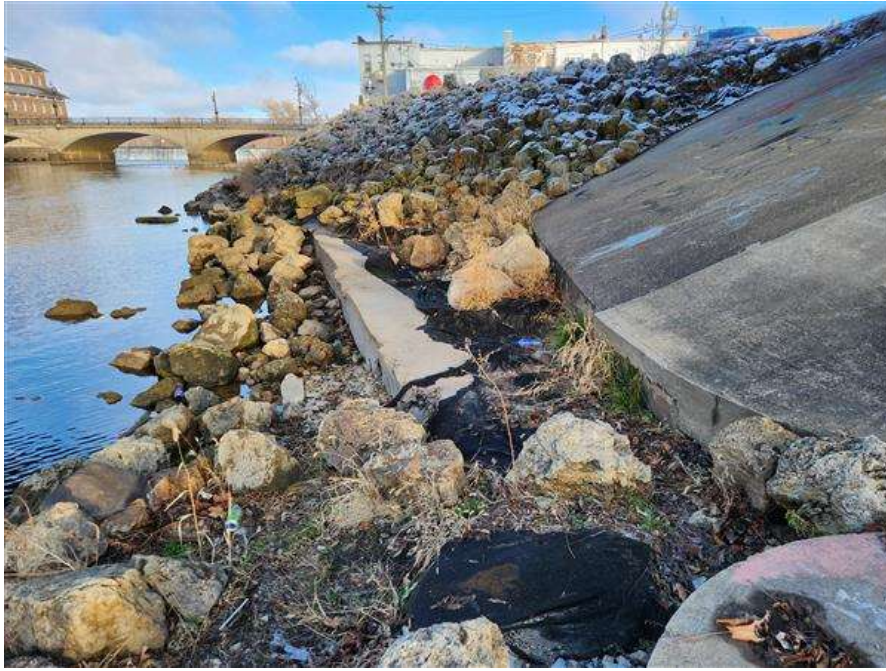
Photo Number: 17

Channel and Channel Protection	Condition Rating	Remarks
1. Channel Scour	6	STREAMBED <1' BELOW PIER FOOTINGS.
2. Embankment Erosion	6	EROSION AT EAST EMBANKMENT WITH EXPOSED ENGINEERING FABRIC.
3. Drift	7	
4. Vegetation	7	
5. Channel Change	7	WATERWAY FLOWS STRAIGHT THROUGH ALL EAST 1/4 OF WEST SPAN, CENTER SPAN, AND WEST 1/4 OF EAST SPAN.
6. Fender System	N	
7. Spur Dikes and Jetties	N	
8. Riprap	6	EMBANKMENT PROTECTED WITH REVETMENT. POURED CONCRETE SLOPE PROTECTION AT EAST ABUTMENT WITH EXPOSED ENGINEERING FABRIC.
9. Adequacy of Opening	7	
General Comments

Erosion along base of East abutment with exposed engineering fabric
