Executive Council of Iowa

Subject: Deer Damage to Vehicle #360 on December 5, 2022
Department of Public Safety – Iowa State Patrol
Claim dated July 27, 2023
AOS Claim ID: 3565

Re: ALLOCATION REQUEST - 29C20 Claim for Executive Council Consideration

Vehicle / Event	#360/Deer
Event Date	December 5, 2022
Summary	Vehicle 360 struck a deer. (248831)
Amount Requested	\$6,446.56 - Estimate
Supporting Documentation	29C20 Email Notification, Accident Report, Repair Estimate(s), Photos

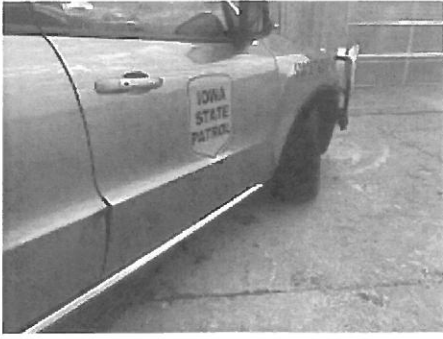
360 Pic 1.jpg
633K

Attached is the Vehicle Damage Report for Trooper Ryan DeVault, #360. A deer struck the side of Trooper DeVault's patrol vehicle.

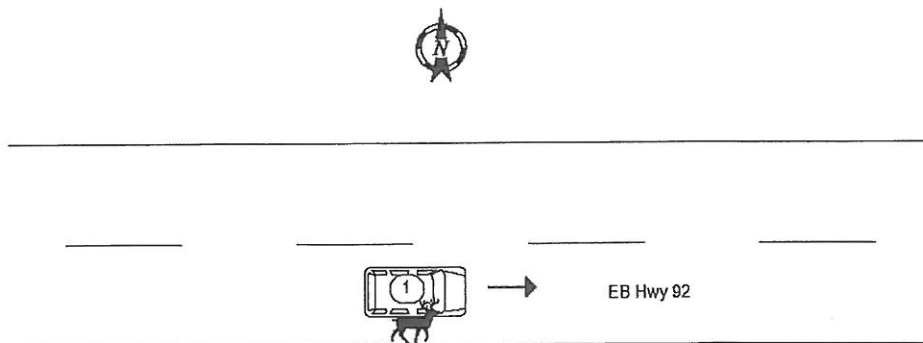
D
I
A
G
R
A
M

Vehicle 1 a Police SUV was traveling east bound on Hwy 92. Just east of Fontanelle near 255th a deer came out of the south ditch and struck the passenger side of vehicle 1. Vehicle 1 was driven away.
