Juno Beach Gazebo Condition Assessment

Limited Property Condition Assessment

Report Date: May 21, 2025

Archetype Engineering & Architecture, Inc. | 601 Heritage Drive, Suite 408, Jupiter, FL 33458

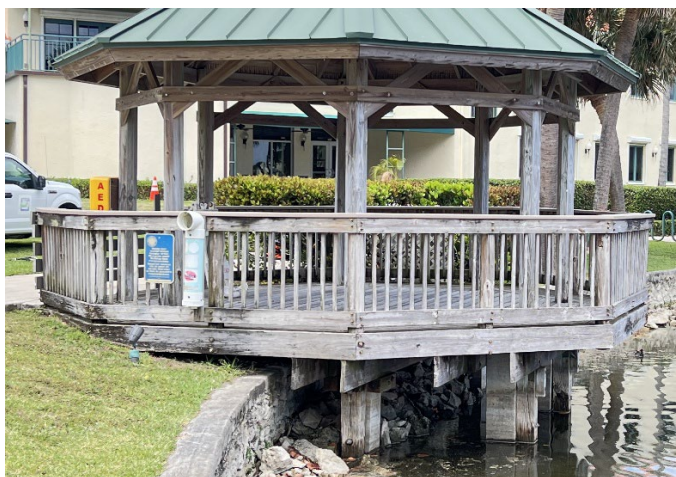
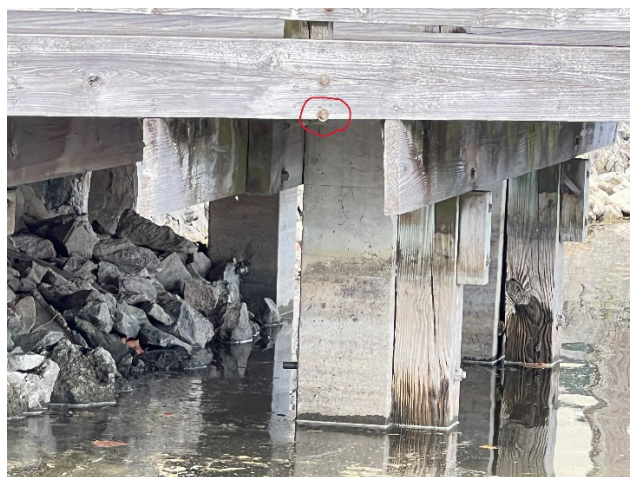
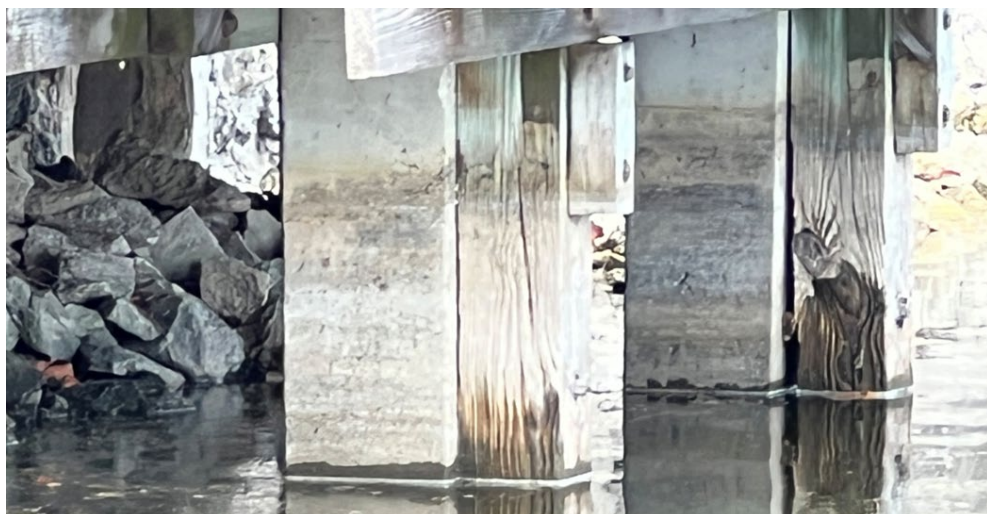
The Gazebo is sited partially on soil, behind the lake-edge retaining wall, and half over water supported by piers. The column piers are composite with a cast concrete that was believed to have been installed in an earlier structure and the wood piers that were part of the main gazebo structure. These column piers are working together, bolted together for combined load carrying capacity, and to the extent observable appear to be in good condition. No sub soil or below water problems were noted. Investigations were not considered to be needed as chemically pressure treated wood below the oxygen rich atmosphere generally suffer little deterioration. The concrete appeared to have no cracks, spalls or evidence of corrosion of reinforcing visible. The wood timber pier have normal shrinkage cracks in the wood grain which was considered typical for large timber members and were considered to be in good condition.

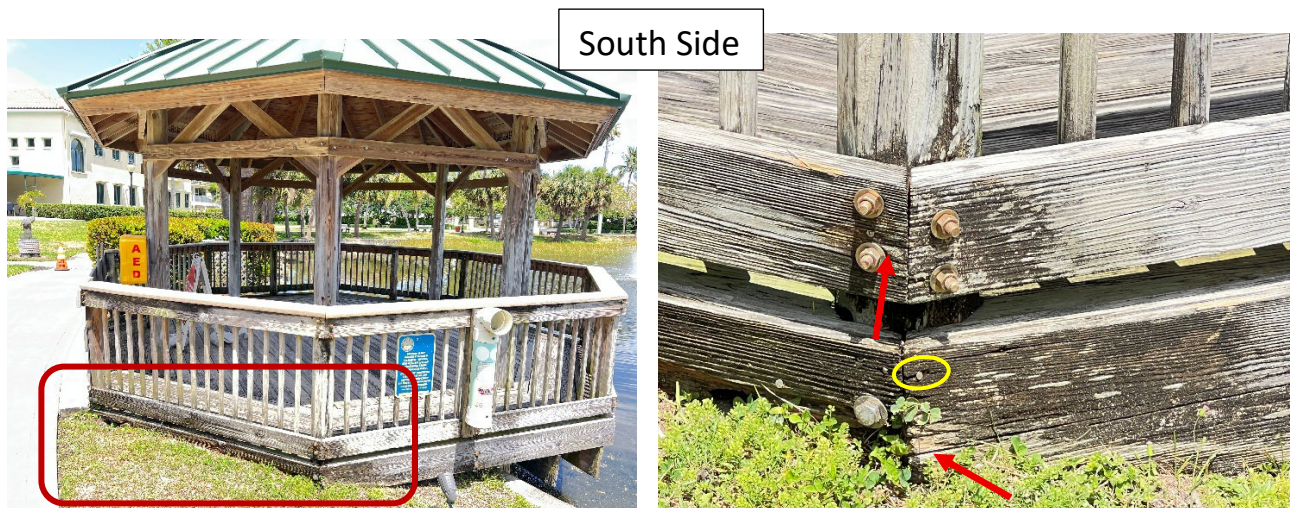
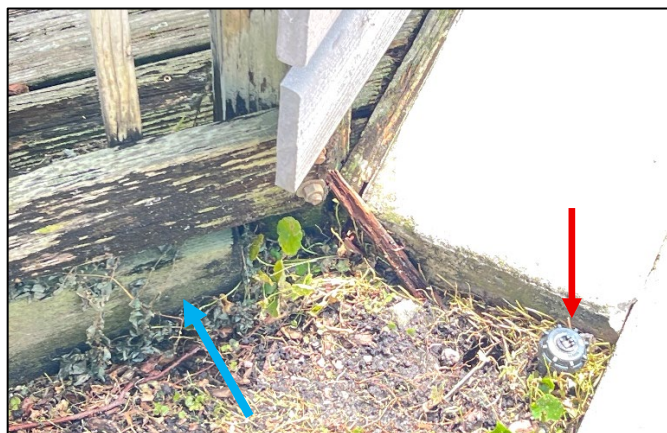
The wooden base framing of the gazebo that was constructed in contact with the soil did show signs of deterioration. The bolted ends of the edge framing is seen with fractures that are anticipated with wood that is stressed by drying and shrinking stress. The large bolts so near the end of the framing members are particularly susceptible to cracking at these ends. (see the red arrows) the yellow ellipse encloses one of several nails added extremely near the ends of the wood framing, which are also associated with end splitting of the wood. These cracks in the wood allow more moisture entry into the wood grain and cause greater cracking issues over time. The dark green surface material appears to be organic growth (moss and mildew) that is growing in the moist conditions similar to that which grows on rocks and trees in forests. Note the contrast in the wood framing over the water that is not embedded in the moist soil. Note the same moist condition is seen at the sidewalk juncture. This side of the perimeter deck framing is subject to surface water drainage from the sidewalk and has added irrigation in the worst possible location.

- 6. The engineer recommends providing a gutter to collect roof water and direct outflow to scuppers projecting rainwater out beyond the new lower deck. A downspout alternative could also be considered by the town. Replace the sidewalk and provide a concrete slab to the seawall to support the wood gazebo deck that rests on the soil area.**

- 7. Provide a new perforated drain at the upper side of the new sidewalk and extend to the lake for discharge and divert groundwater away from the entrance and land supported side of the gazebo.**

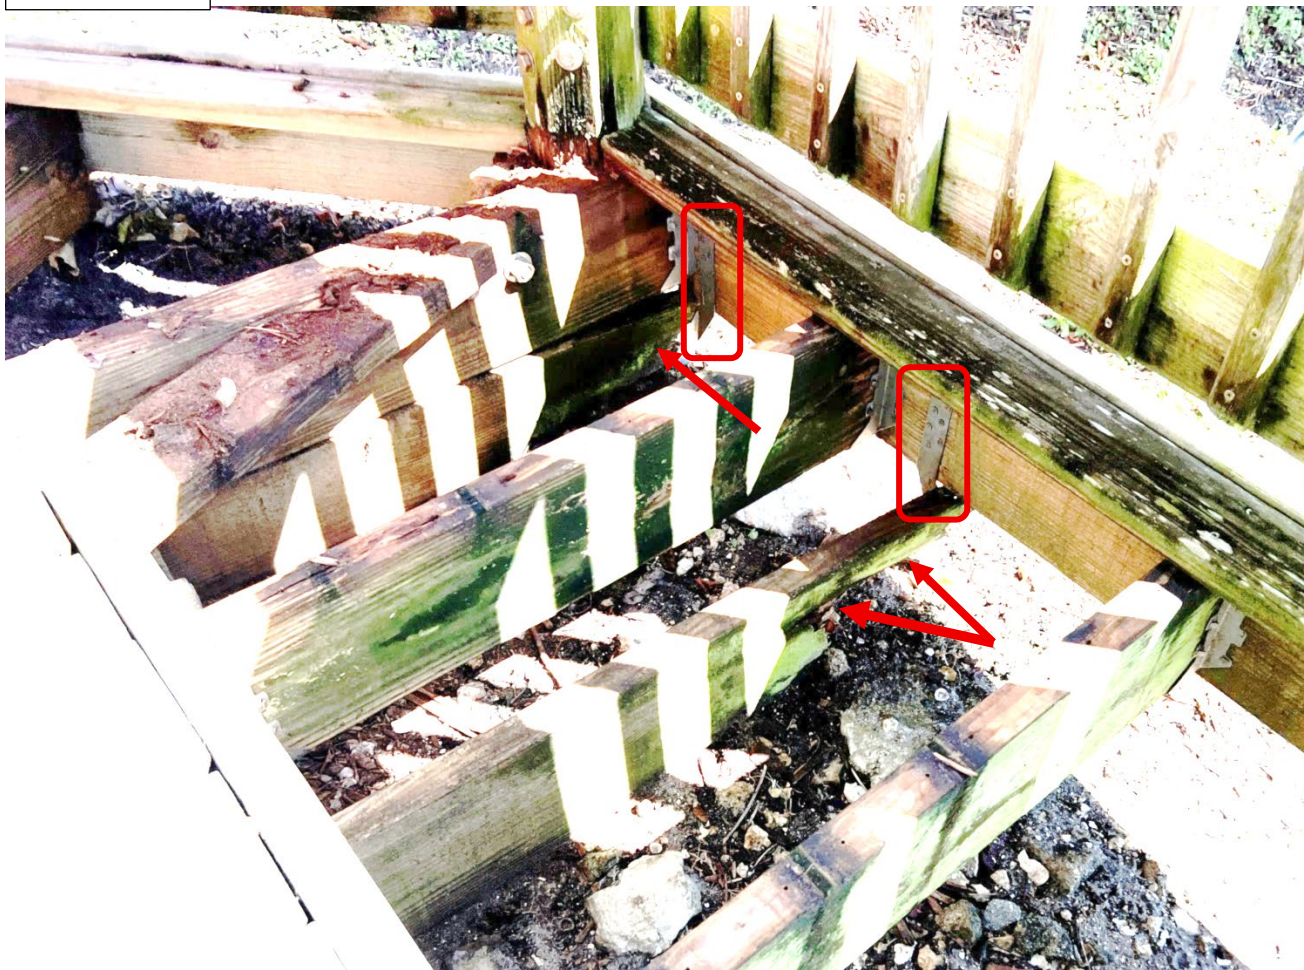
North Side

At the north side of the gazebo, at the deck perimeter, near the soil, wood has been deteriorated by the moisture. This occurred where soil was in contact with the wood members **and** underslung metal hangers. (See damage of the underslung framing at the red arrows, and the underslung metal joist hangers inside the red boxes at this lower-level framing.) There is green organic growth on the surfaces of higher elevation wood framing, but the floor framing elevated a bit above the soil (as seen on slightly higher-level framing) has suffered far less the wood-rot deterioration.

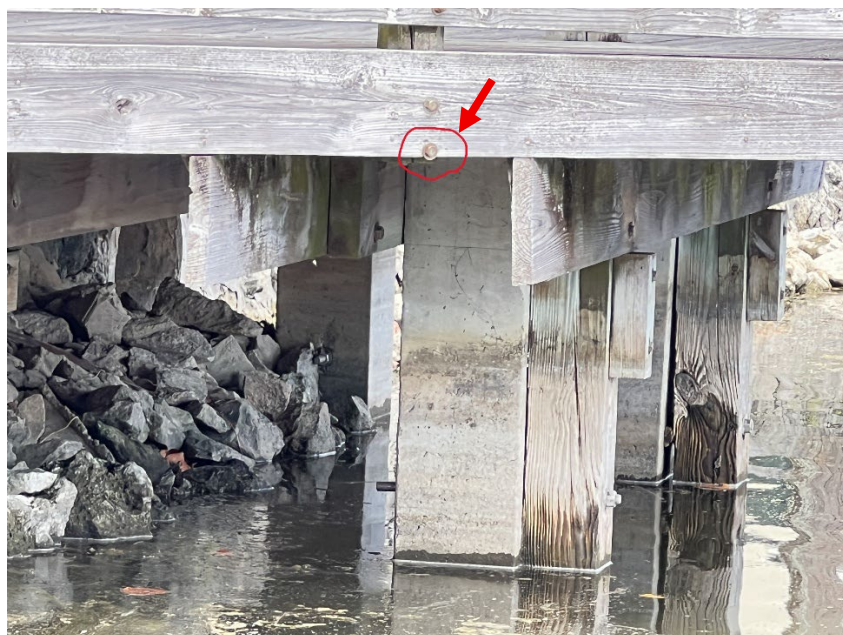
Note that this wood above the water is in generally good condition.

Bolt at the edge of wood framing is an improperly placed fastener.

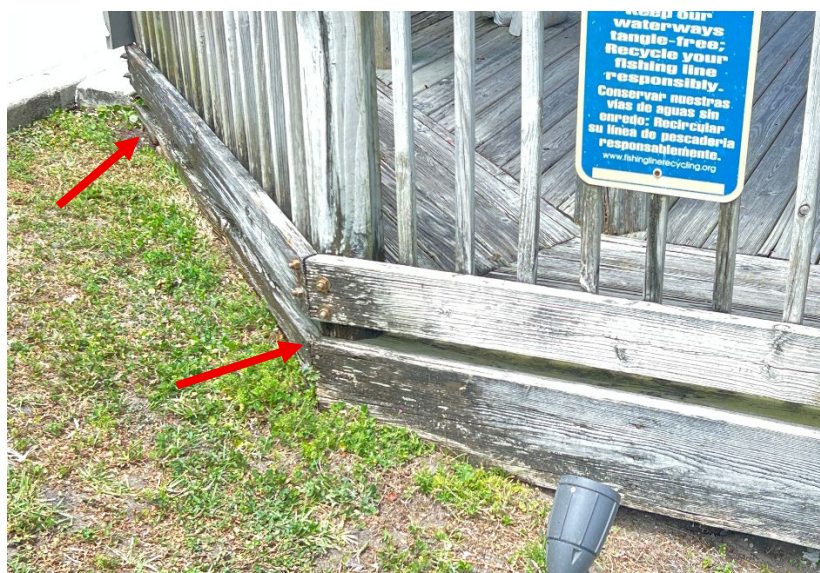
Note that this wood near the soil and sidewalk is more distressed than wood with air circulation. (South side of Gazebo, sidewalk at upper right corner of photo.)

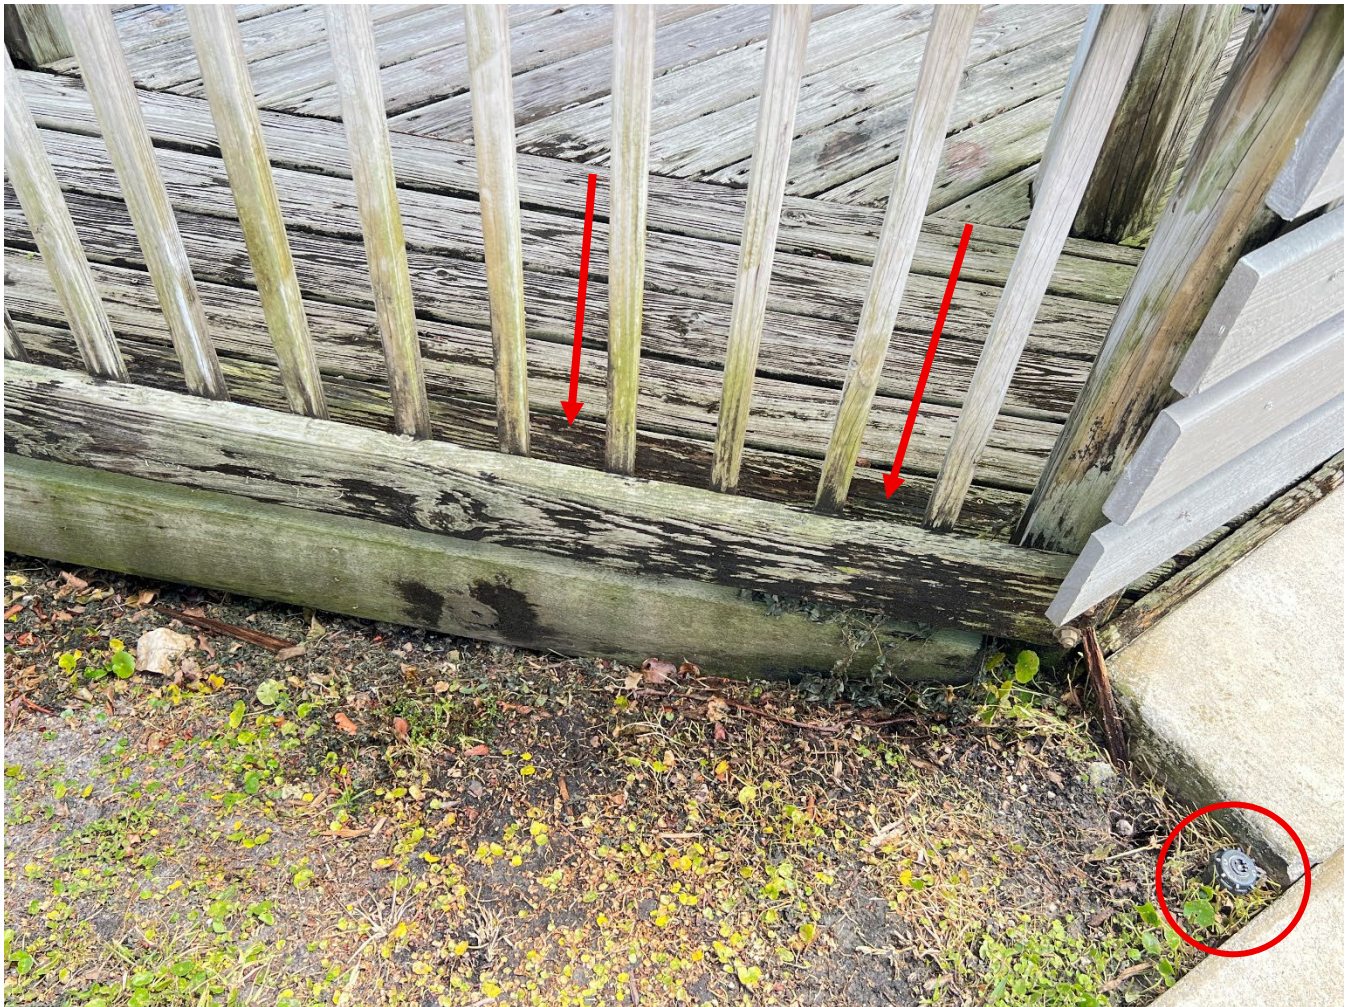
The soil moisture is made worse by the drainage of water from the sidewalk surface. The location of the sprinkler irrigation added to the other groundwater is also problematic.

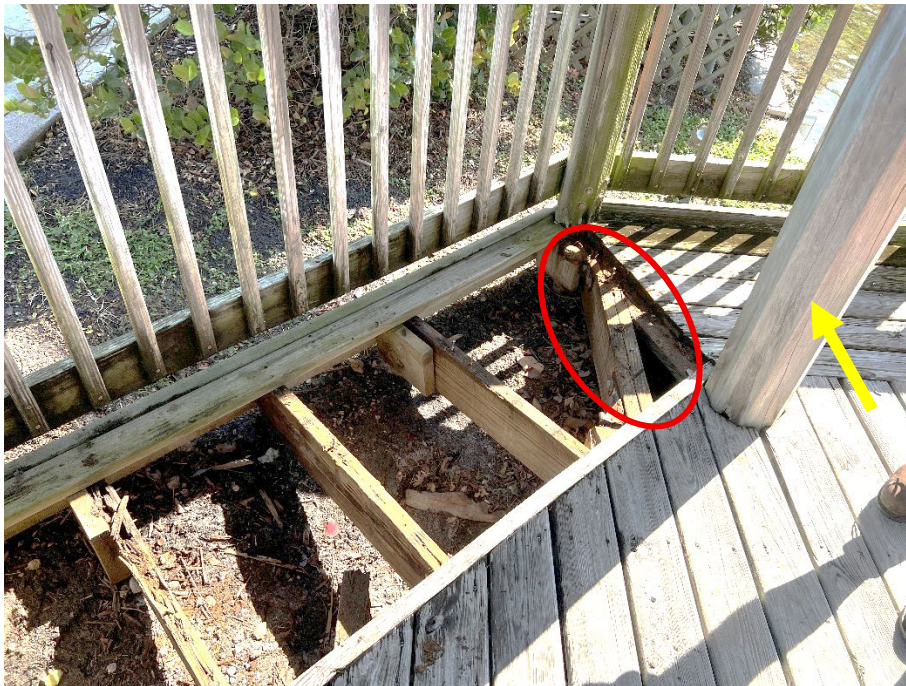
This photo shows the main gazebo columns (yellow arrow at the right side of the photo) that extend down and connect with the concrete piers in the lakebed. The deck planks placed in different directions to the interior deck planks as well as the supporting framing must rely on irregular directions and odd joist configurations and connections. (This is seen within the red ellipse located left of the main column.)

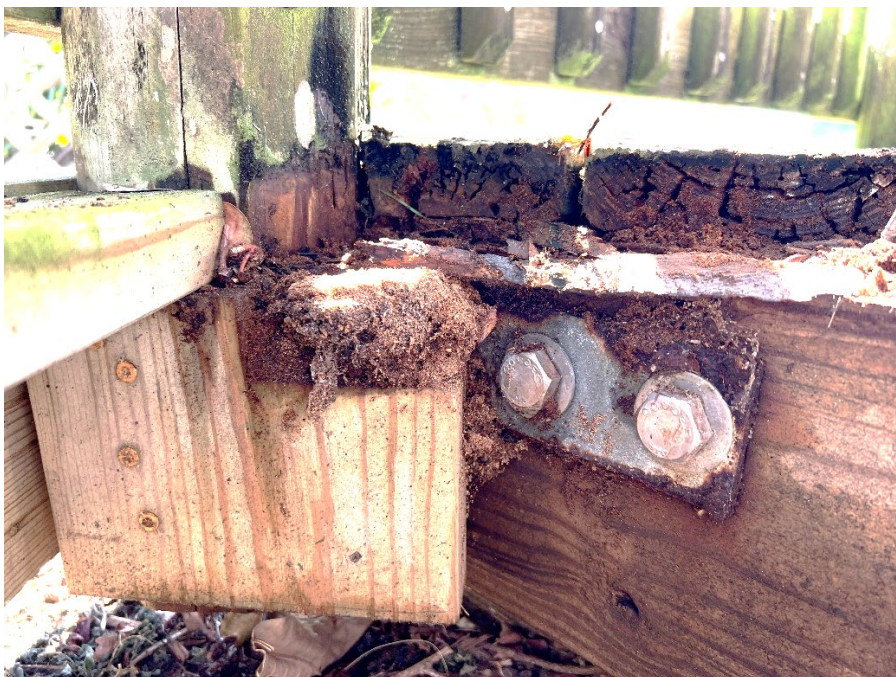
This enlarged photo shows the angled floor joist at a connection located at the octagon-shaped railing post. The framing and steel connections are complex and unusual in their configuration. The stainless-steel bolts are in contact with dissimilar carbon steel connector plates which has succumbed to galvanic corrosion. Some of the odd sizes and shapes of wood appears to have been constructed with wood that was not preservative treated lumber.

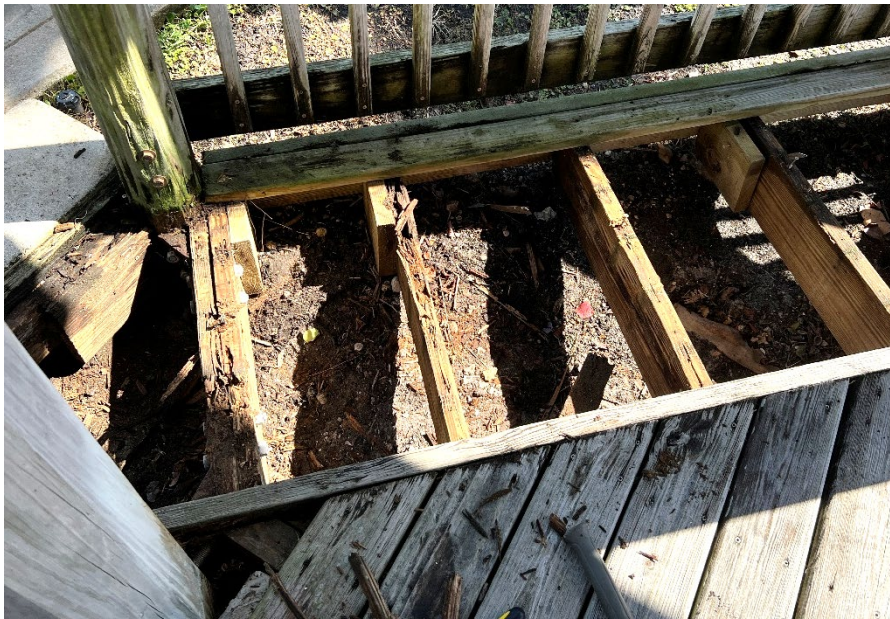
This photo shows the angled floor joist that runs around the interior octagon shaped columns and framing, to the outer perimeter railing posts. This exterior deck framing and steel connections rely on complex configurations. While the bolts are stainless steel, the connector plates are carbon steel. Physical contact of dissimilar carbon steel connector plates and stainless-steel causes galvanic corrosion of the connections and in the presence of water these steel connection components have corroded badly.

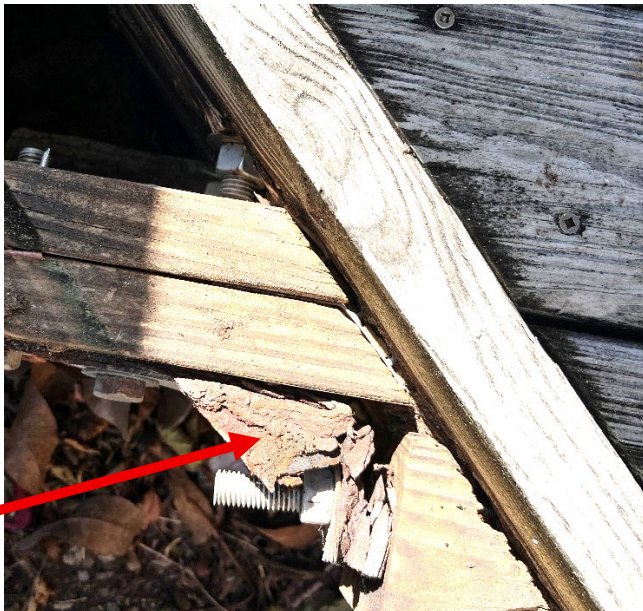
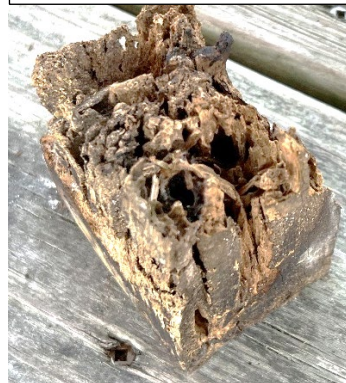
Many of the odd sizes and shapes of wood members in the extended deck exterior to the gazebo columns and interior octagon deck appear to have been constructed with wood that was not preservative treated lumber. The perimeter wood framing, decking and connections are generally in poor condition. (See left and below)

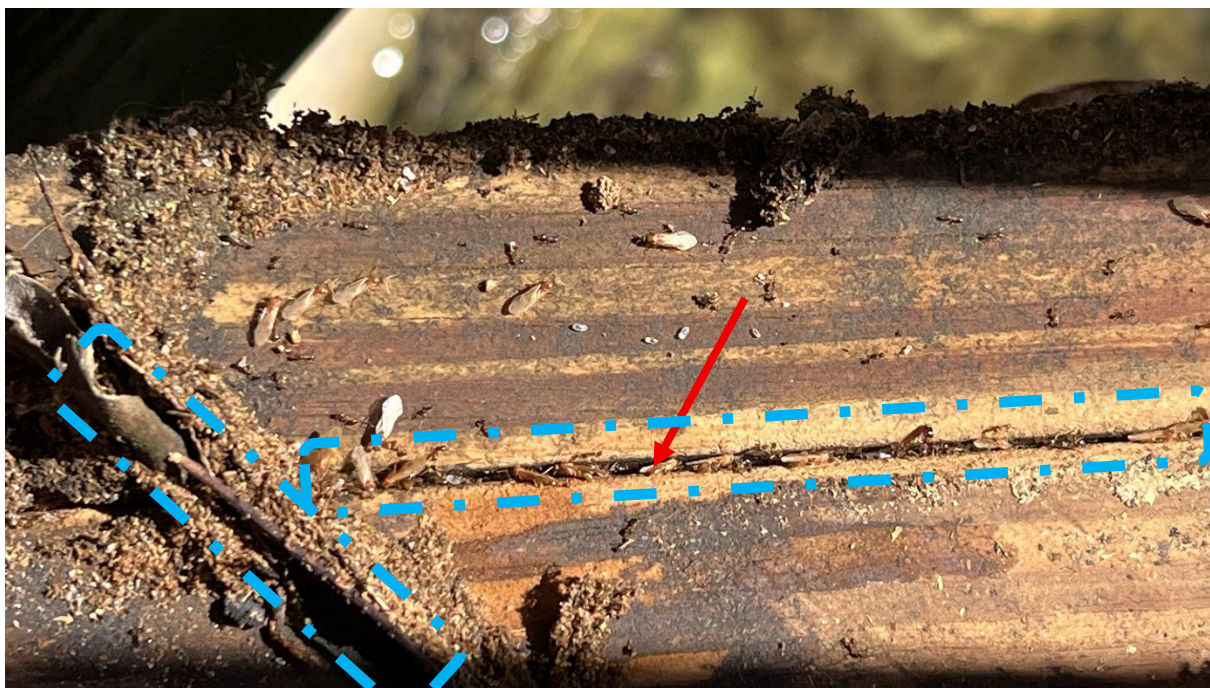
Wet and deteriorating wood is an attractive habitat for termites. The only **active** type of insect infestation noted is seen above. These particular insects are seen on two lapped 2x joints. These were considered by the engineer to be very small ants, which were seen in various locations within wet wood. The wood itself in these locations did not have significant wood damage that would be anticipated with active termite habitation. These insects appear to be very tiny ants that constructed their colonies in the small gap spaces between the joists and wood blocking. The winged insects are leaving to start new colonies. These ants likely find abundant moisture and organic growth in the gaps.

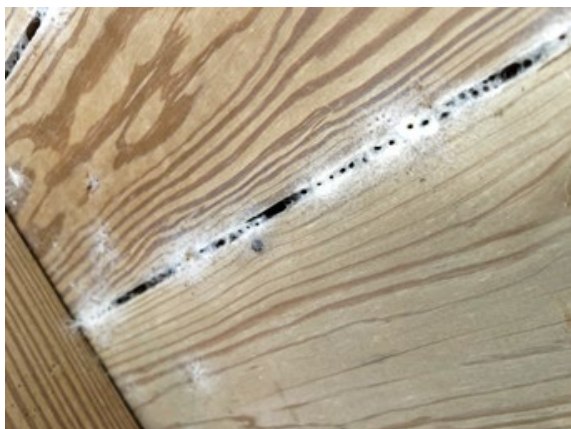
Unknown insects (or arachnids) had left fibrous or web material between the preservative treated planks of the roof. These were wiped away to reveal no damage to the wood had occurred. This could be a maintenance issue to address with cleaning. The upper gazebo wood construction appeared to be in generally good condition and would be considered to have a long remaining useful life.

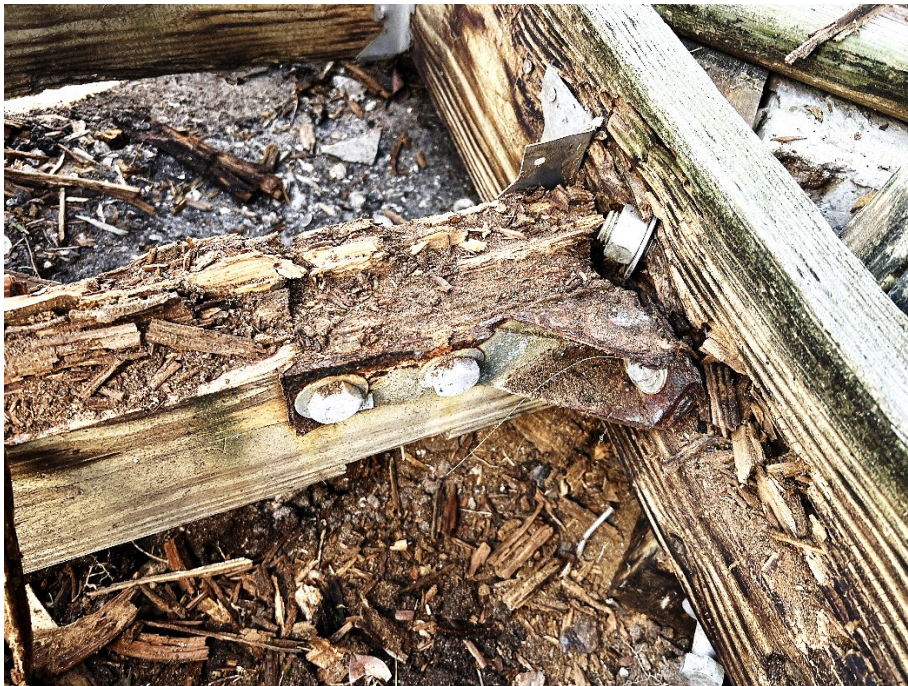
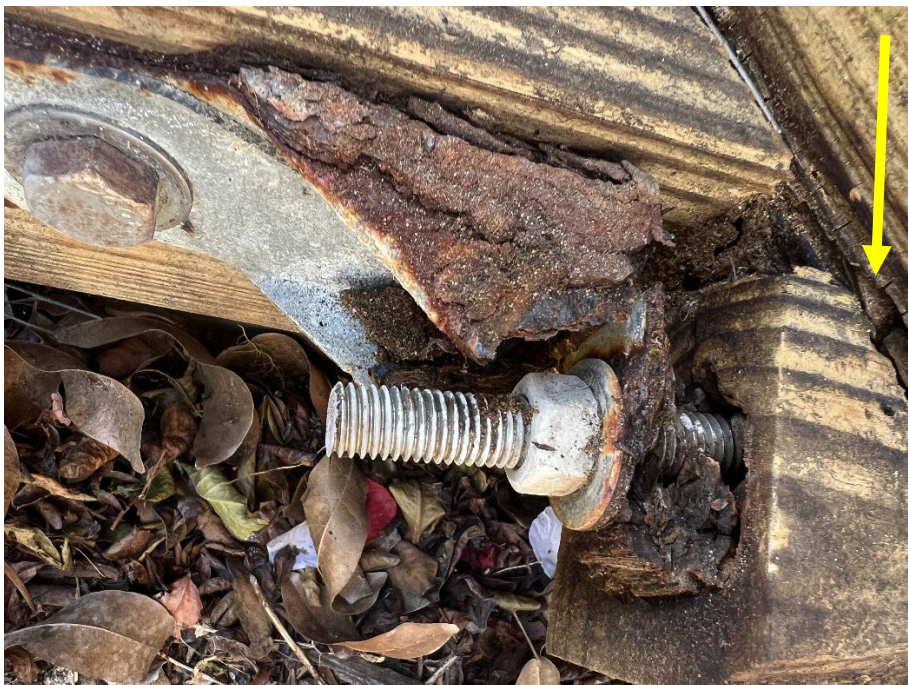
There are several locations that are noted where wood preservative treated wood has been damaged by deterioration. Most of these locations are found at wood connections where carbon steel components of those connections have suffered severe galvanic corrosion. Mixing of stainless steel, galvanized steel and copper chemical compounds in preservative treated wood cause accelerated corrosion. Apparent termite damage appears to have occurred at some of these areas of deterioration. The termite damage did not seem to be systemic, but at isolated locations. This is consistent with laboratory testing of termites and preservative treated wood which found that termites may attack treated wood but die in the process from the wood chemicals. A correlation between limited areas of termite damage and corrosion damaged wood and metal components was found. These damage areas were primarily all found in the deck framing and blocking at odd angle junctures.

Very little damage to the gazebo columns was found. Soil around one column in an area where deck framing was damaged was removed but not termite or rot damage was noted.

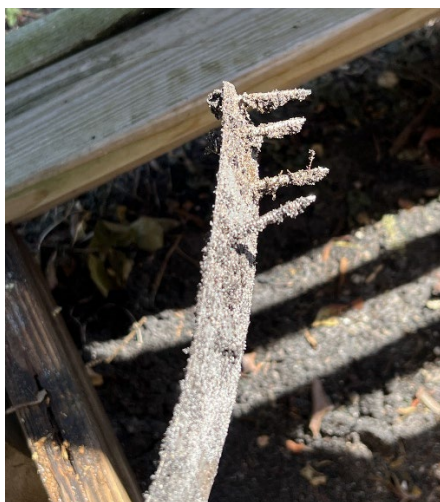
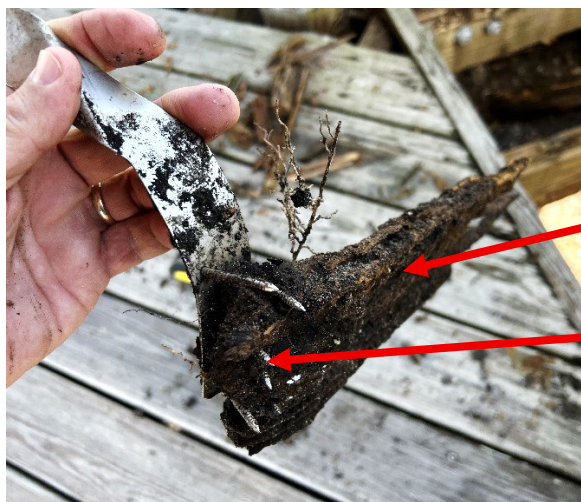
The wood member buried in the soil and nailed to wind strapping to counter wind uplift forces.

Above are two examples of metal hurricane strapping that was extending downward, into the soil below the deck of the gazebo. The strapping had been attached to wood blocking that did not appear to have been preservative treated wood. The wood blocks would have been intended to have acted as “dead-men” anchors in the soil to resist uplift forces from wind-imposed loads. The wood was essentially decomposed due to organic digestion in the moist soil. The anchors have no functional value remaining.

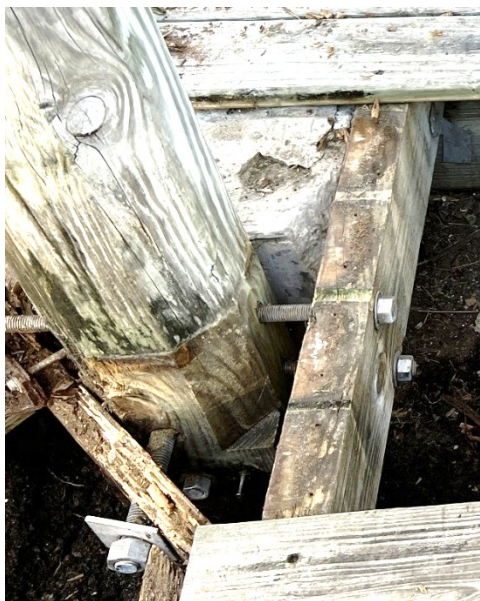
The wood column of the gazebo appears to be good despite some deterioration of the adjacent wood framing.

This was considered generally representative of the condition of the observed wood columns. While the main gazebo columns may have some issues that would warrant repair if found, the general condition of these column appeared to be sound.

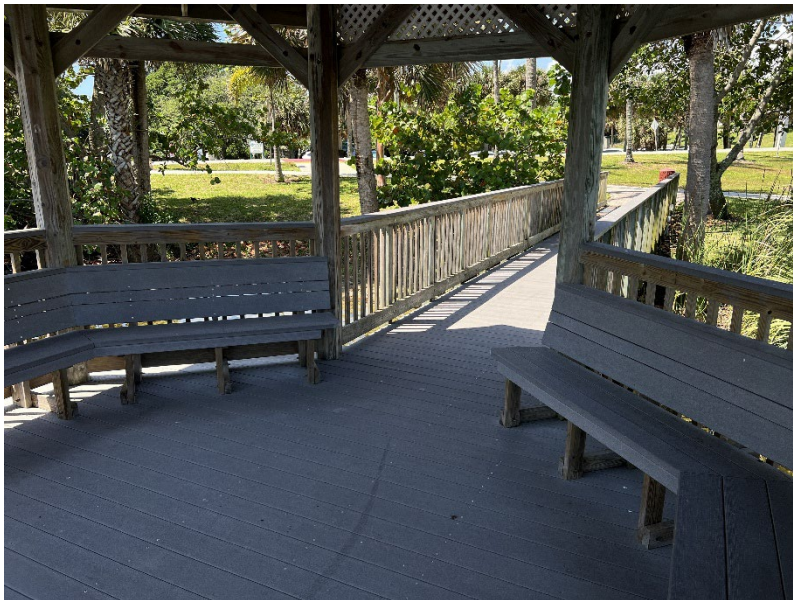
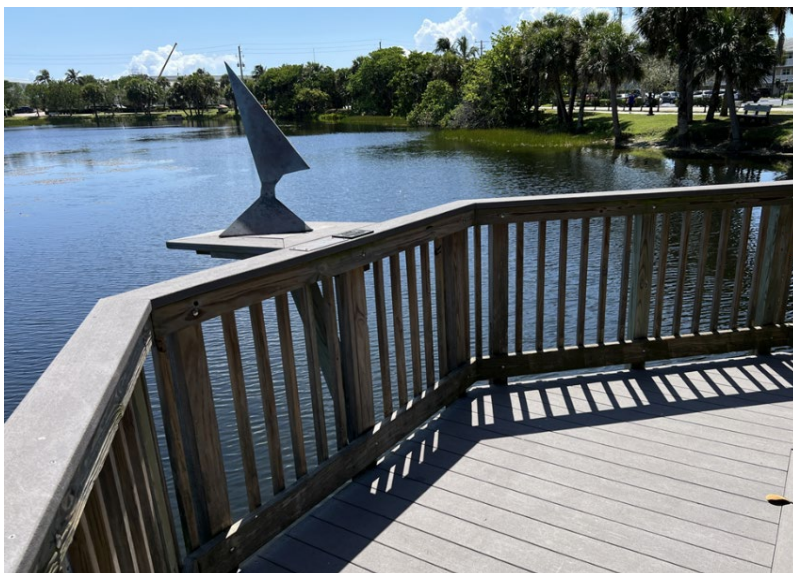
Although not part of the original scope of this assessment, the engineer was asked to observe the second town gazebo at the south end of the lake. This south gazebo provided valuable design ideas that could be incorporated in the north gazebo repairs. This gazebo was accessed with a connector pier section that got the gazebo deck framing away from the soil and lake edge. This gazebo also had an alternative deck support design that provided Framing under the deck could be rectilinear while providing a large deck extension on the water side of the gazebo. **This framing approach limits the number of metal connections and simplifies framing and deck planks with rectilinear framing. Galvanic corrosion design detailing would prevent the corrosion problem.**
