# WATER TANK INSPECTION REPORT

## Town of Johnstown, CO

01-24-2023

<b>TANK NAME:</b>	Johnstown North Tank	<b>Location:</b>	Johnstown, CO
<b>CAPACITY:</b>	750 MG	<b>STYLE:</b>	GST
<b>CONSTRUCTION STYLE:</b>	Welded	<b>CONSTRUCTION DATE:</b>	Unknown
<b>BUILDER:</b>	N/A	<b>HEIGHT/DIMENSION:</b>	50' D x 52' H

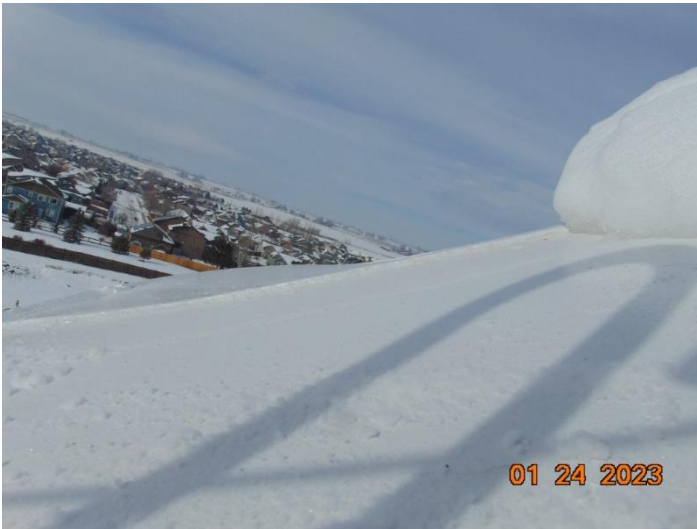
**Exterior Coating / Roof**

Roof exterior in good condition, no sponginess noticed when walking on roof sections.

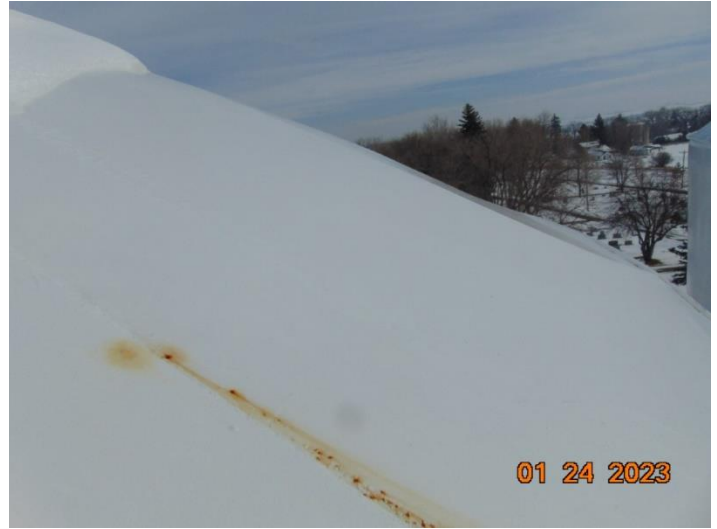
**Exterior Coating / Roof**

Roof exterior in good condition, some areas showing coatings failure on overlap weld seams. More than likely due to misses from previous overcoat.

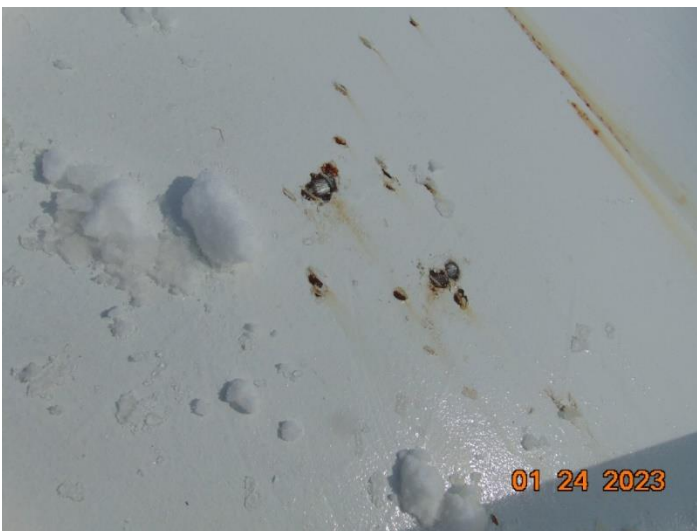
**Exterior Coating / Roof**

Overall good condition, this shot near the roof hatch, coating chips could have been result of tools and or equipment being staged in the area for maintenance.

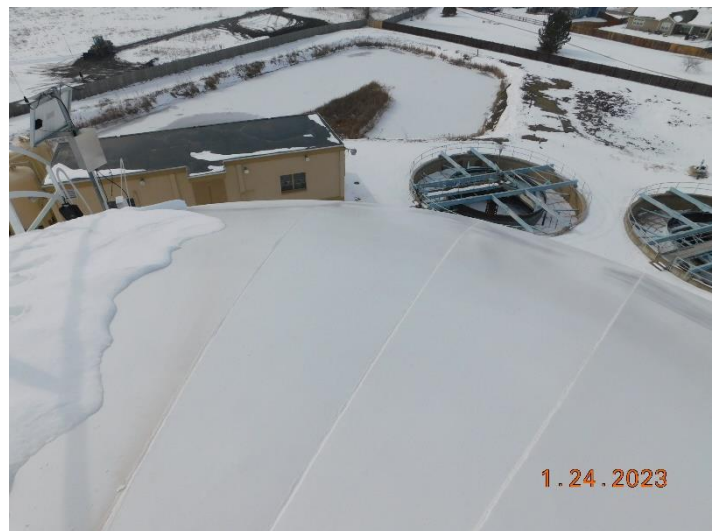
**Exterior Coating / Roof**

North section of roof in good condition, again no sponginess noted when walking on surface.

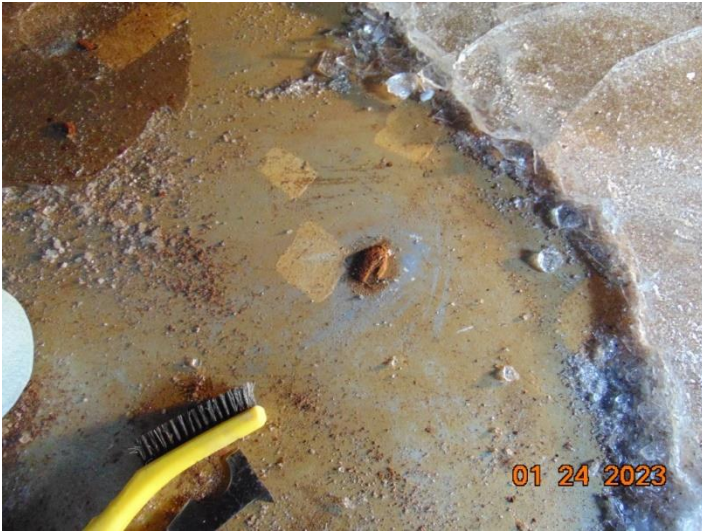
**Interior Coating / Floor**

Fair condition, with considerable number of tubercles over entire floor.

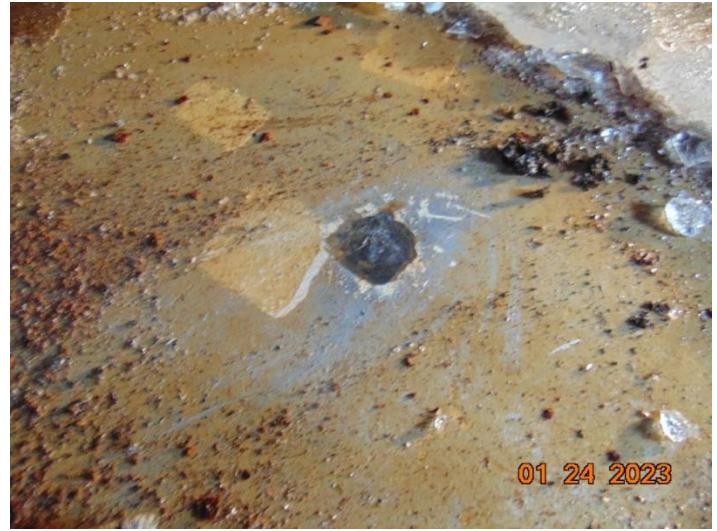
**Interior Coating / Floor**

Tubercles once removed and cleaned little to no discernable pitting present.

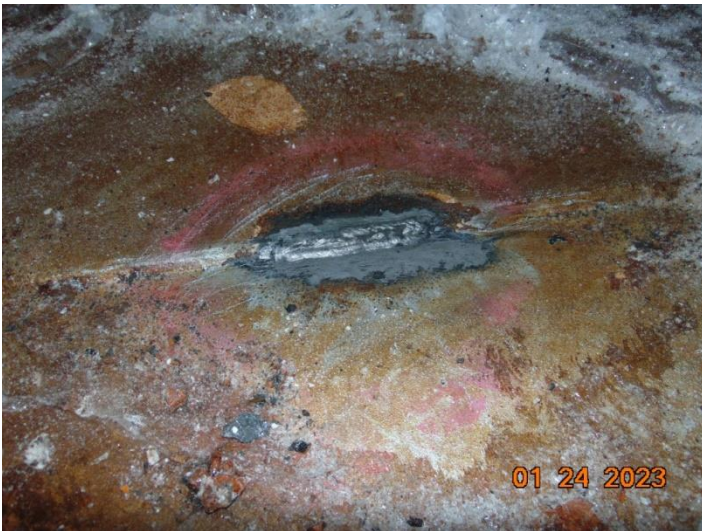
**Interior Coating / Floor**

Tubercle removed from floor seam weld, no deterioration present.

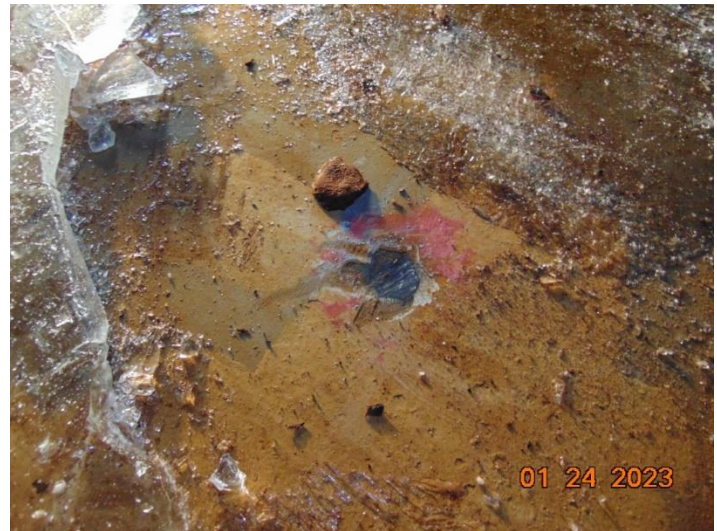
**Interior Coating / Floor**

Representative of more tubercles removed little to no discernable pitting present.

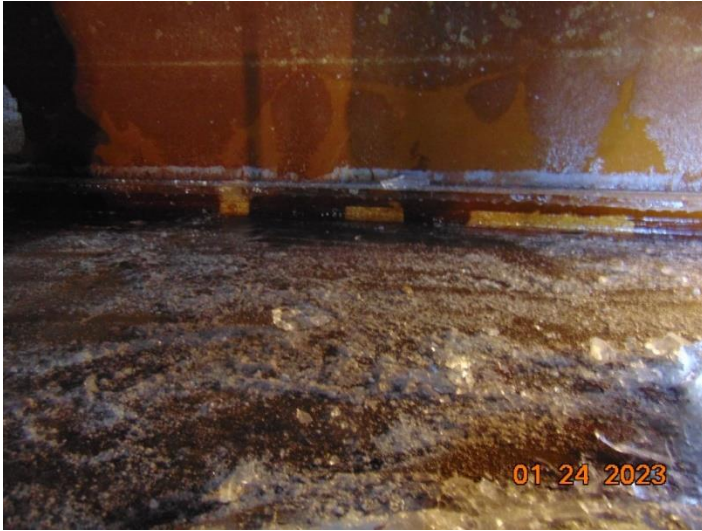
**Floor / Shell Connection**

In good condition overall, shell paint mils averaged 15 and floor averaged 14 mils

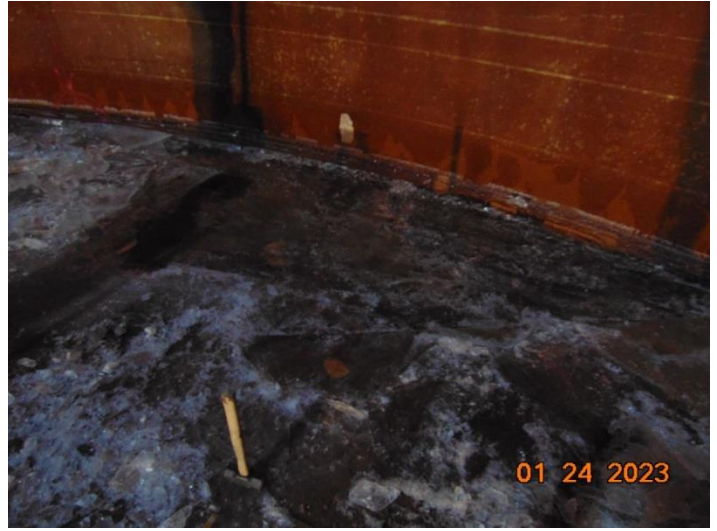
**Floor / Shell Connection**

Good condition overall, no visual concerns.

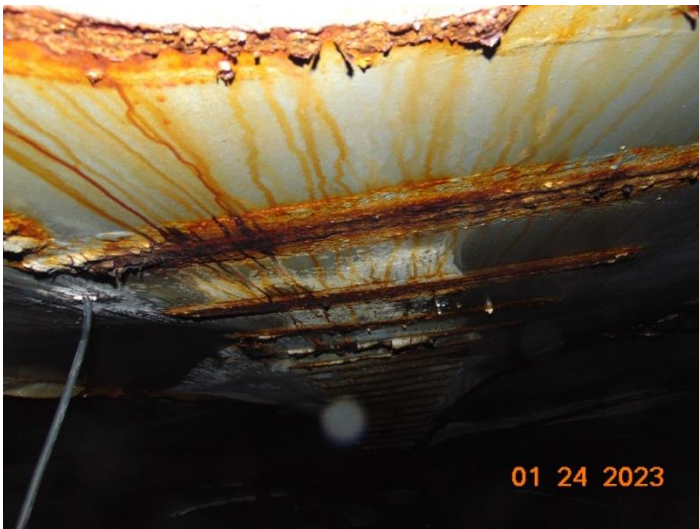
**Roof Interior**

Previous support members are all but gone and corroded away.

Fair to poor condition. Now is the time to address the interior renovation. At this time our professional opinion is the roof is salvageable. Interior of roof to be blasted, new support members to be installed between the old existing (what is left of them) old remains cut out once new supports are in place, surface area of old supports ground and prepped, blasted for proper profile.

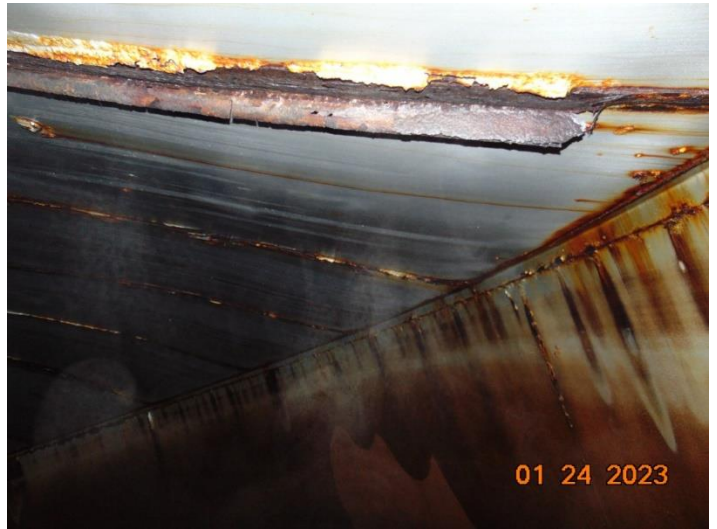
**Roof Interior**

Some old support members still present, what is left of them. Roof sheets/panels look to be in fair to good condition with some coating failures.

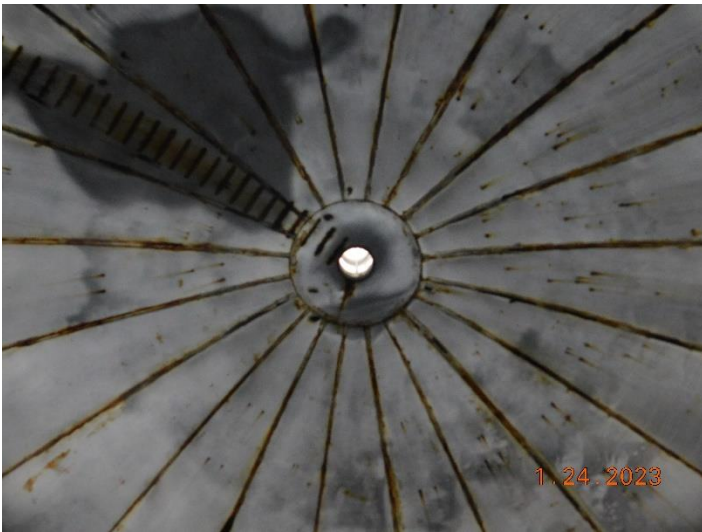
**Roof Interior from Floor**

Hard defined rust/corrosion lines from old supports. Roof panels/sheets appear to be in fair condition. See next photo close up.

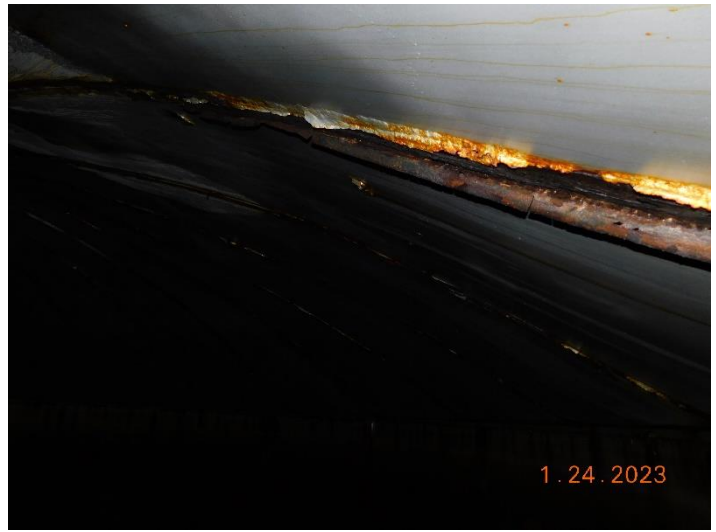
**Roof Interior**

Note old support structure all but gone, roof sheets/panels look to be in good and salvageable condition.

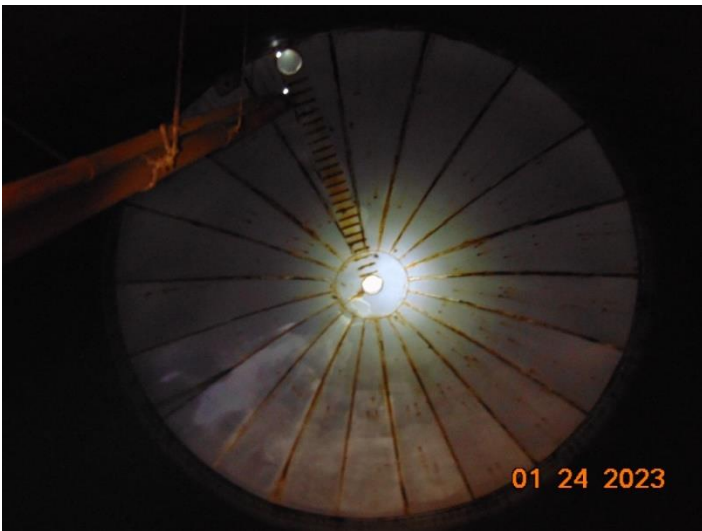
**Floor to Roof Shot**

As in above photo, vent to roof hatch corrosion due to lugs welded to roof for footing to access vent.

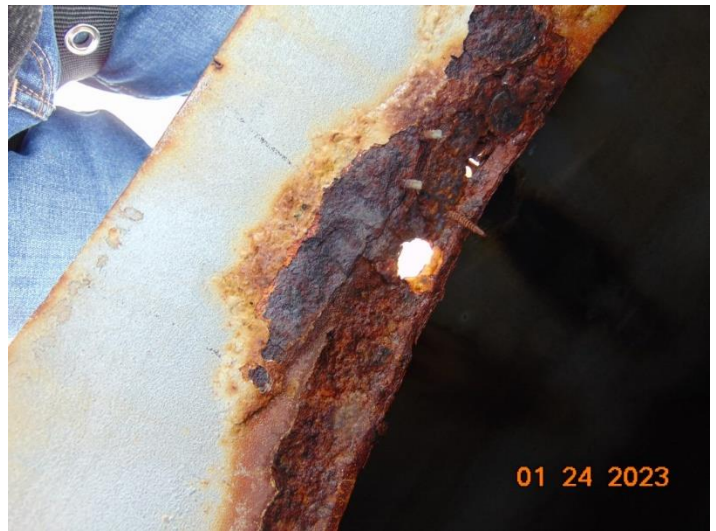
**Roof Hatch**

Roof hatch rusted out requires replacement with repositioning of hatch hinge to be operator friendly and safer when needing to access vent for inspection / maintenance.

Sanitation items; vent is screened, roof hatch to be replaced with 30" round manway and gasketed for CDPHE compliance.
