## Essential Repair Finding – JSTWN-003

**Facility Carried:** County Road 46.5

**Feature Intersected:** Little Thompson River

**Structure Description:** JSTWN-003 is a single span bridge with corrugated metal deck supported by steel girders on steel abutments.

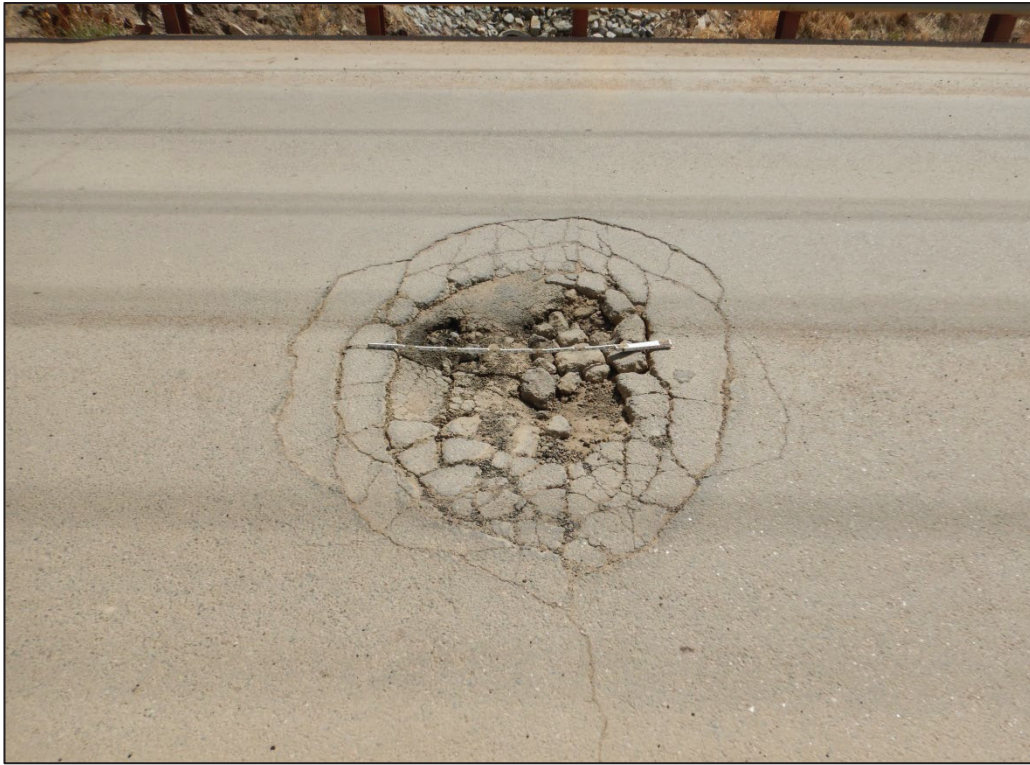
During the inspection on 4/4/2022, the inspectors noted a large pothole along the centerline of the deck, which appears to be from damage from construction equipment. This damage created a hole and numerous cracks in the corrugated deck flutes below the pothole. The pothole is 3 foot long x 4 foot wide x full depth of asphalt with a total area of broken up asphalt 5 feet long x 6.5 feet wide approximately 12 feet from the east abutment. On the underside, there is a 2 inch diameter hole punched through the deck at this location (in Bay D) with adjacent cracks along the deck flutes in Bays C through E. When driven over, the deck appears to be cracked longitudinally over Girder E based on the deck's deflection adjacent to the girder.

Full Depth Pothole and Broken-up Asphalt on Deck

Due to the unknown extent of cracking over Girder E, and the possibility for the cracks to propagate or larger local failures to occur, it is recommended that the portion of the cracked deck be replaced and the area repaved with asphalt within 90 days.

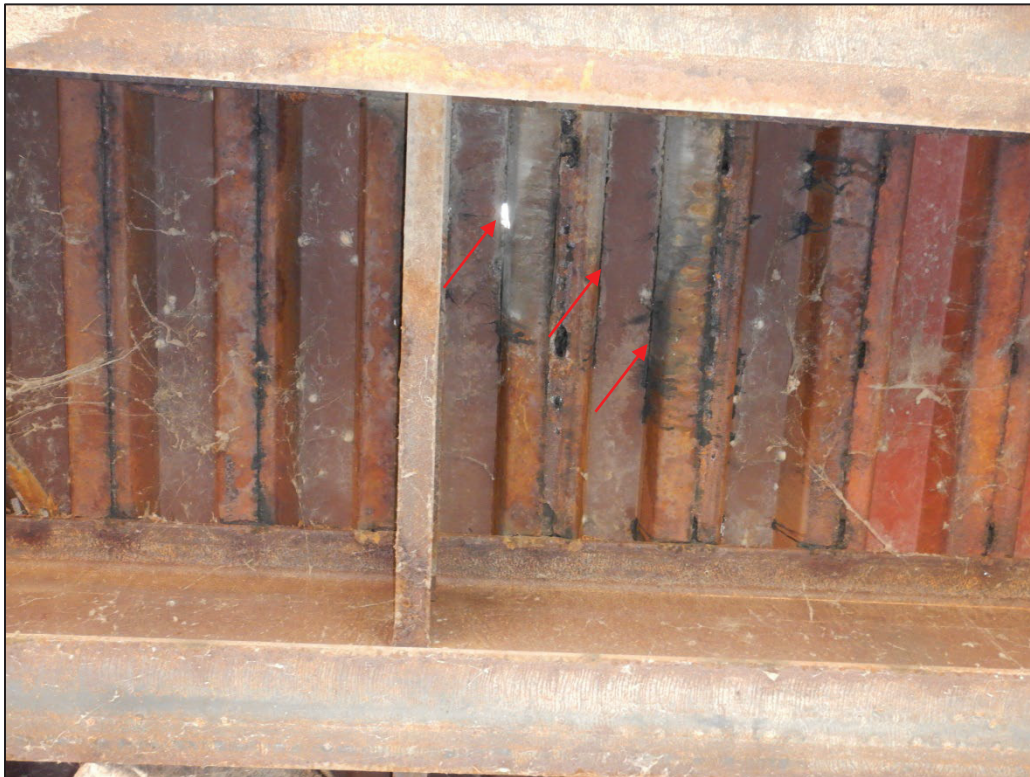
Hole and Cracking in Deck Flutes in Bay D

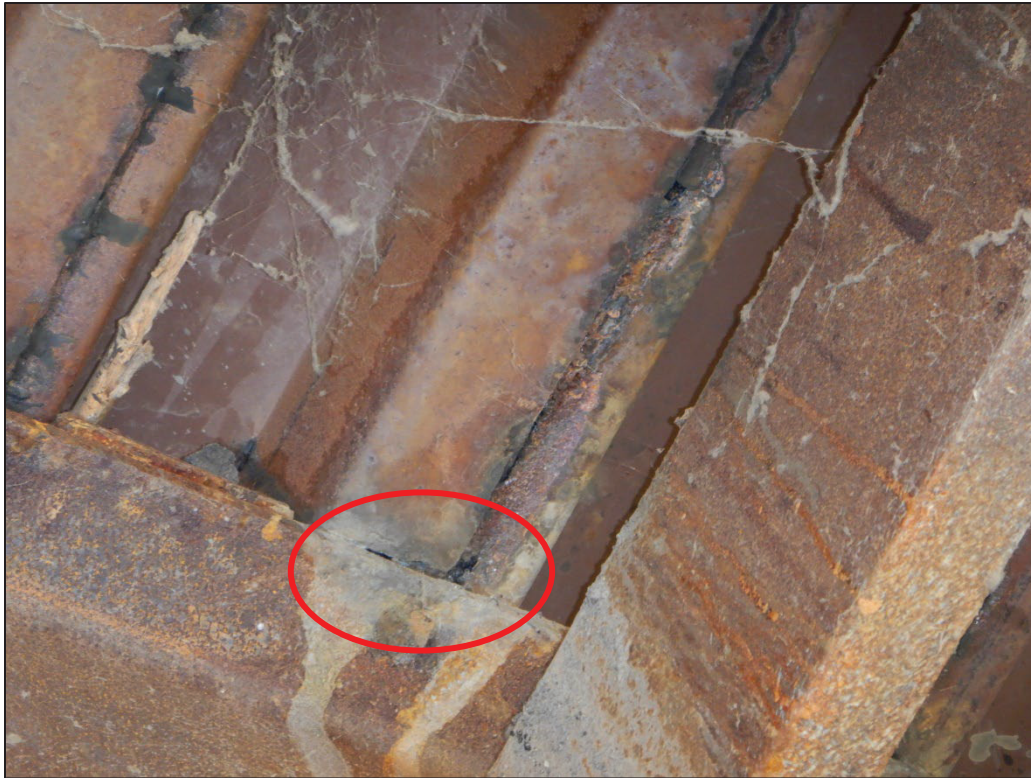
Cracking Across Deck Flute Adjacent to Hole above Girder D
