MEMORANDUM

DATE: November 4, 2022
TO: Deputy Mayor Gladziszewski
FROM: Katie Koester, Engineering and Public Works Director
SUBJECT: Gastineau Avenue Event Summary

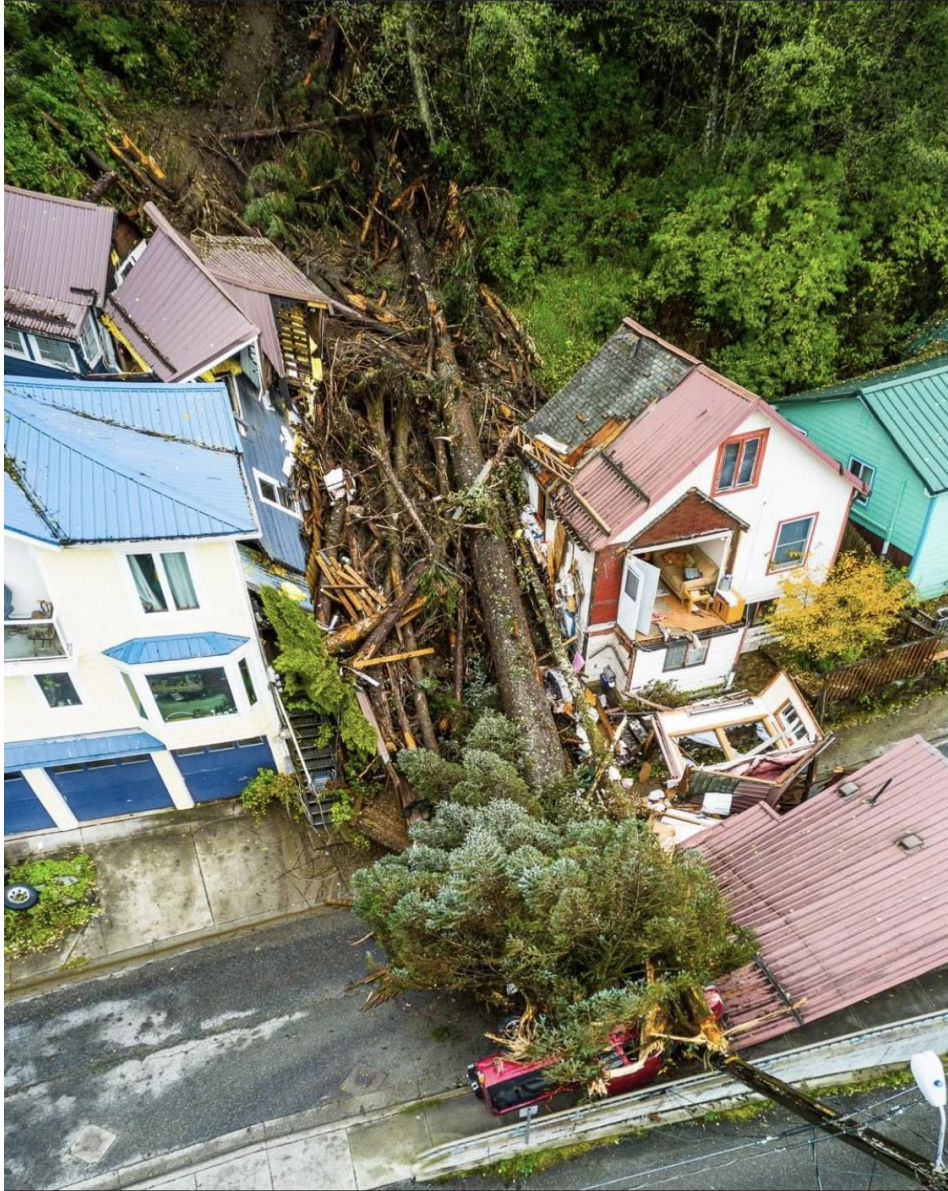
9.26.22: At 6:10PM on Monday, September 26th a channelized landslide consisting predominantly of tree debris on Gastineau Avenue damaged three homes, took out power to downtown Juneau and cut off road access. Capital City Fire and Rescue (CCFR) responded, evacuating homes in the immediate area. Engineering and Public Works Streets responded and blocked off the street. Due to poor lighting and heavy rain, site safety could not be adequately addressed that evening. CBJ did not stand up a shelter, but did provide sheltering for impacted property owners at a downtown hotel.

Drone footage from Pat Dryer, ADOT

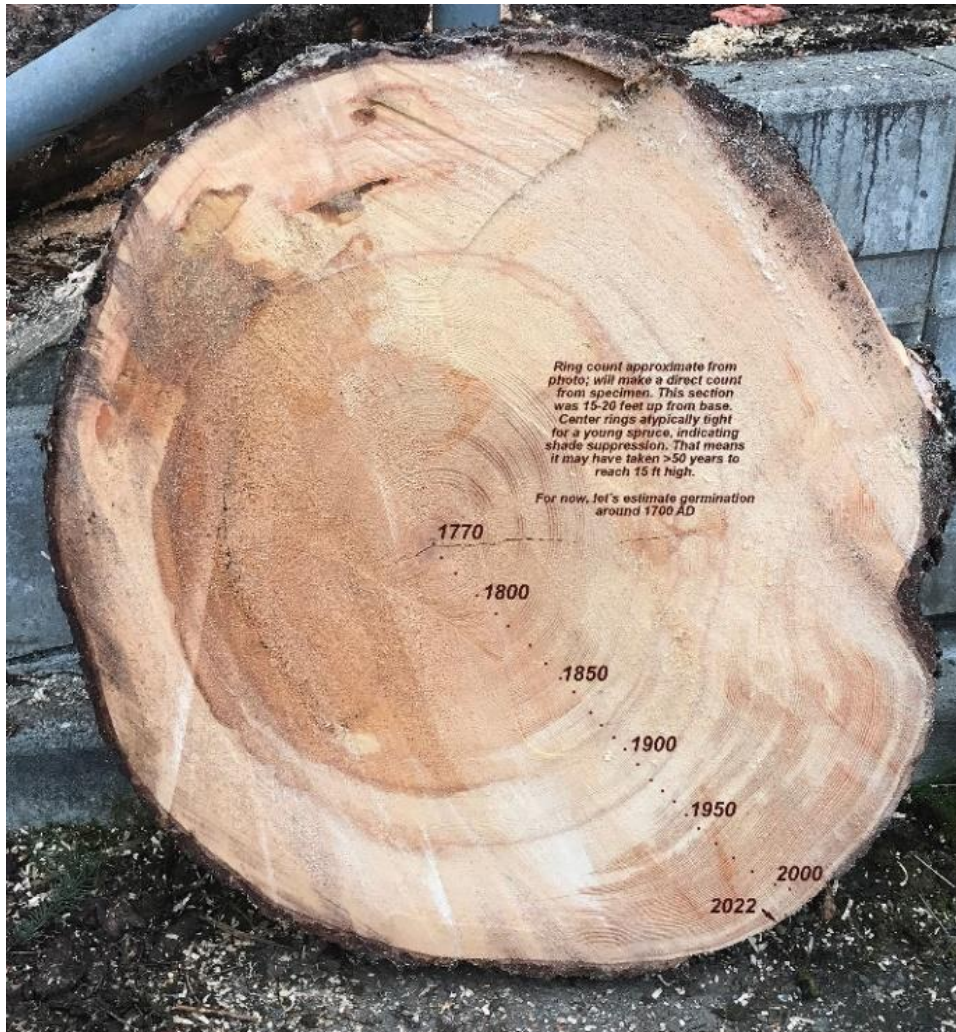
Geologists have identified this event as a shallow channelized landslide that scoured down to bedrock. This slide originated at approximately 600 feet and traveled down the mountainside, leaving a roughly 30 foot wide U-shaped channel that scoured relatively shallow surface soils until water exposed the underlying bedrock channel. It is not known if the slide was initiated by a tree toppling in the high gale force winds or if water erosion initiated the event by undercutting root systems.

While the debris pile at the toe of the slope consisted of some saturated silty soil and bedrock fragments, large woody debris (alder and spruce) was the dominant feature. Out of the 15 truckloads of woody debris hauled from the area to clear Gastineau Ave., there was soil debris reported in only one of the truckloads. The water flowing through the debris pile had very low turbidity, suggesting very little soil was associated with the event. Damage to the structures (3) and vehicles (2) appears to have been caused by a single large spruce tree, 3-4 feet in diameter. Observations from Discovery Southeast date this tree to 1770.

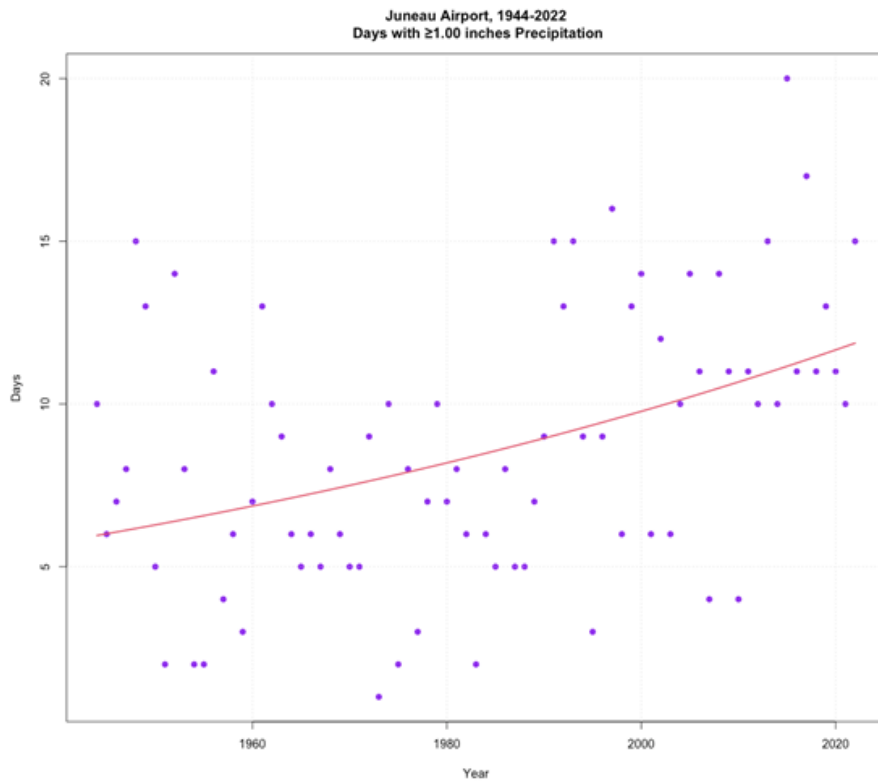
The terrain in this area is extremely steep with a thin layer of soil and organic materials over the bedrock. This creates a shallow root system for the alder and spruce trees that dominate the slope. By September 26, 2022, Juneau had experienced just shy of twice the average September rainfall (According to the Juneau Airport weather station, average rainfall in September is 6.7 inches and rainfall on 9.26.22 had already reached 11.61 inches.). Notably, rainfall had been particularly intense over the six days preceding the event. In addition to the rainfall that contributed to this event, Juneau has been experiencing an increasing amount of heavy rainfall over the past several decades. The scatterplot below tracks the number of days per year, since 1944, where we have seen more than 1 inch of rain at the Juneau Airport. A clear upward trend is noted. A rapid shift in the direction of the wind recorded at the Mount Roberts Tram Terminal weather station could have also contributed to the event.
