PND 242085

Subject: Aurora Harbor Office Site Visit

CBJ Docks and Harbors – Aurora Harbor Office & Outbuilding/Garage Condition Assessment

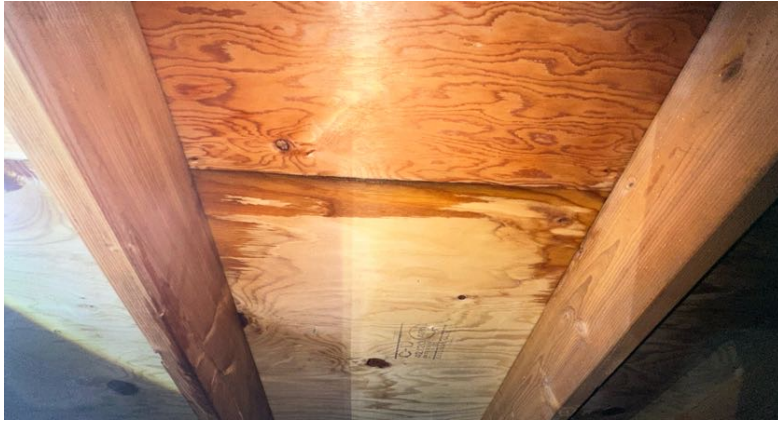
<p>Photograph 4</p> <p><u>Description</u></p> <p>Water stains on the southern gable wall.</p>

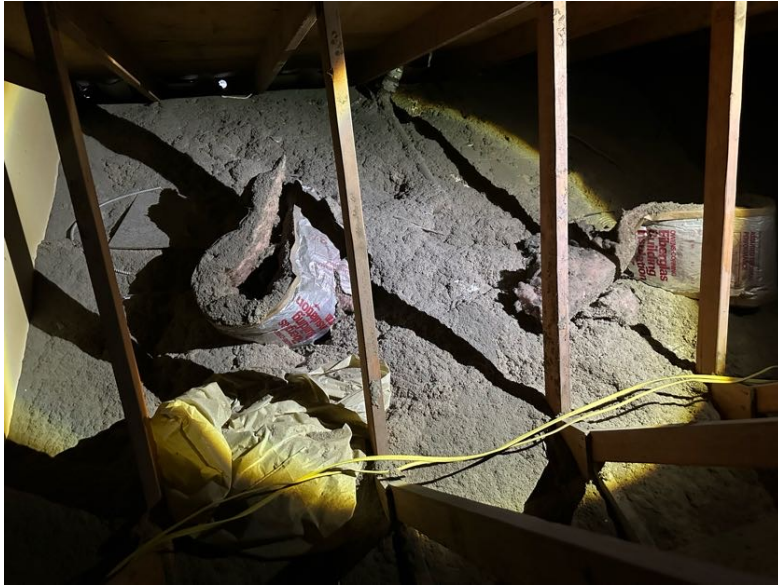
Uninsulated vent directly connecting the administration area to the attic, bridging the insulation above the office ceiling and discharging warm moist air in the attic space.

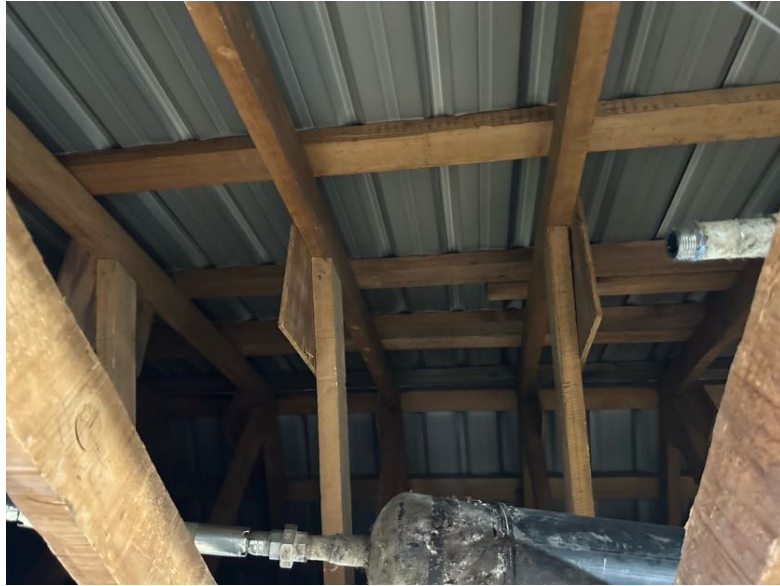
7. Within the garage, the lateral force resisting system consisted of a timber 2x4 diagonal member. The brace meets the top plate at the center of the structure with the braces mirrored about the center of the structure. The brace is nailed to the inside of the stud wall. No sheathing was present on the roof, significantly limiting the lateral load capacity of the structure.

The lateral force resisting system is nonexistent in the garage, the limited bracing and the lack of a diaphragm do not provide a positive load path for lateral loads to transfer to the foundation/ground. The damaged roof truss member has compromised bearing strength and has a reduced snow load capacity. This truss should be monitored in the winter for crushing of the bottom cord member when snow is present. Snow should be removed from the roof prior to the truss member beginning to crush at the bearing point. The snow load on this structure is somewhat mitigated due to the lack of insulation present under the roofing allowing building heat to melt snow from the underside of the roof.

Single 2x4 brace acting as the lateral force resisting member in the garage. T-111 siding is shown on the exterior side of the studs.

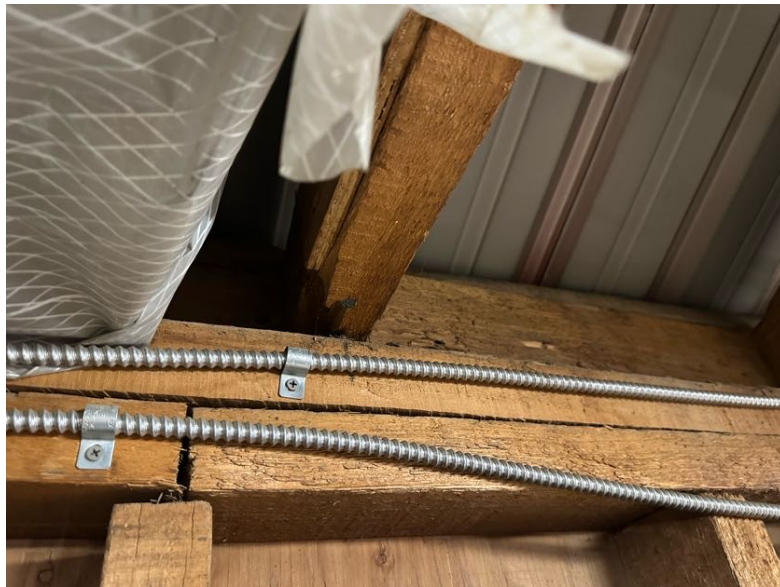
Photograph 11

Unsheathed roof in the garage.

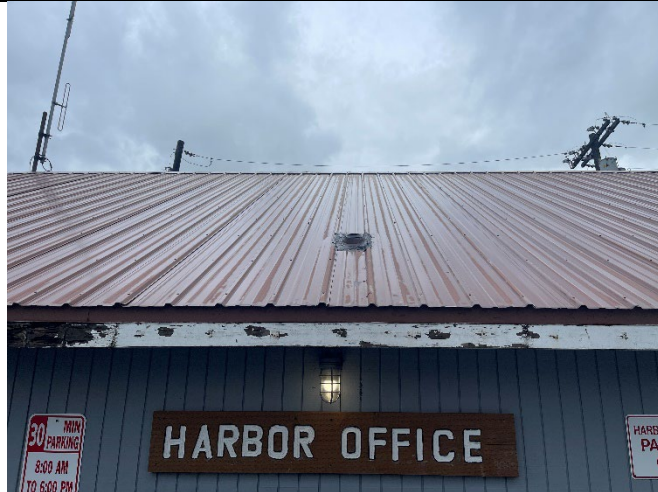
Aurora Harbor Office: Vent pipe between North and South bathrooms severed at roofline. General view of East side exterior water damage. Excessive wood decay present.

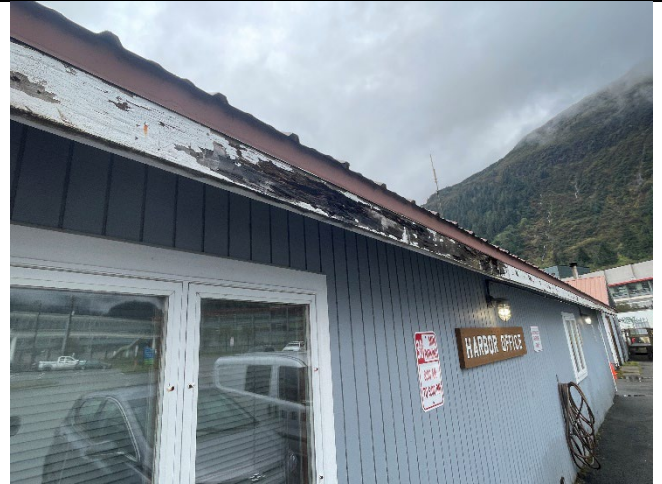
Aurora Harbor Office: General view of East side exterior water damage. Excessive wood decay present.

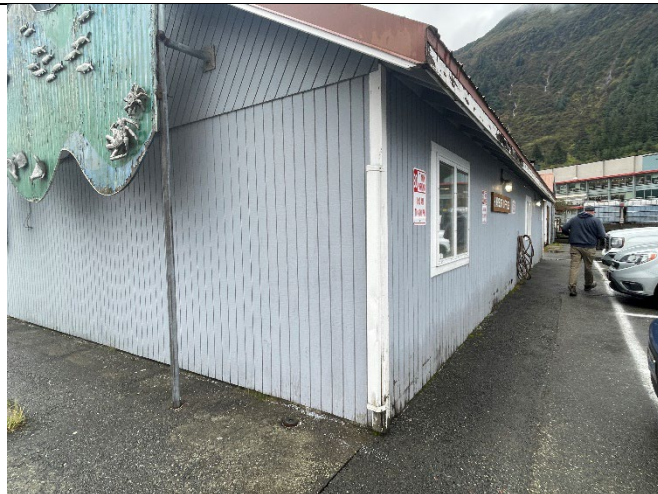
Aurora Harbor Office: Missing gutters has contributed to trim and siding water damage and wood decay.

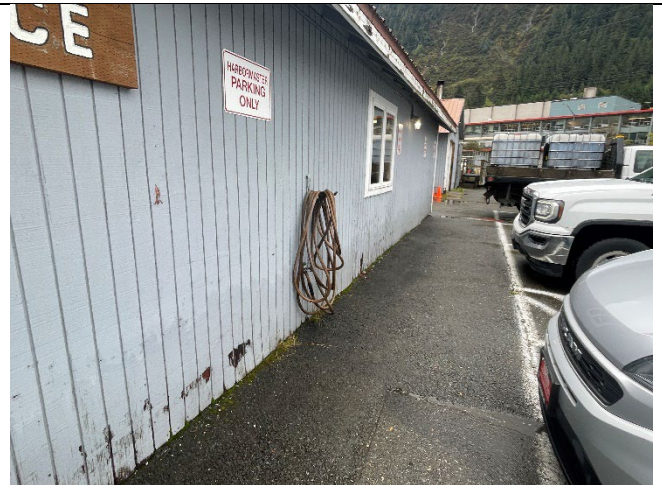
Aurora Harbor Office: Wood decay along base of siding. Appurtenances along face of structure sticking out into accessible isle.

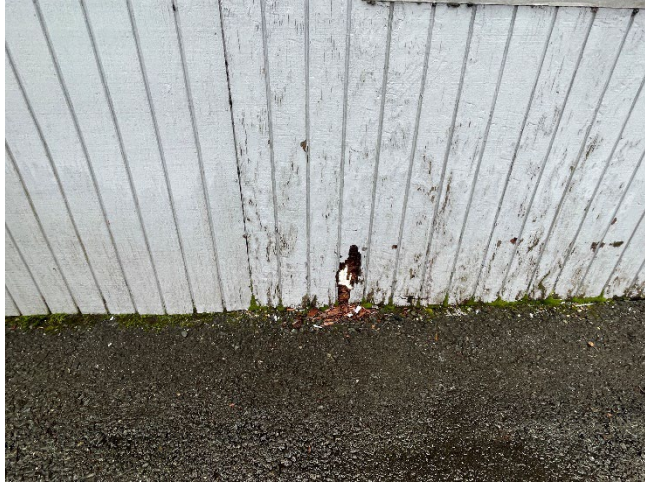
Aurora Harbor Office: Enlarged view of typical wood decay at siding.

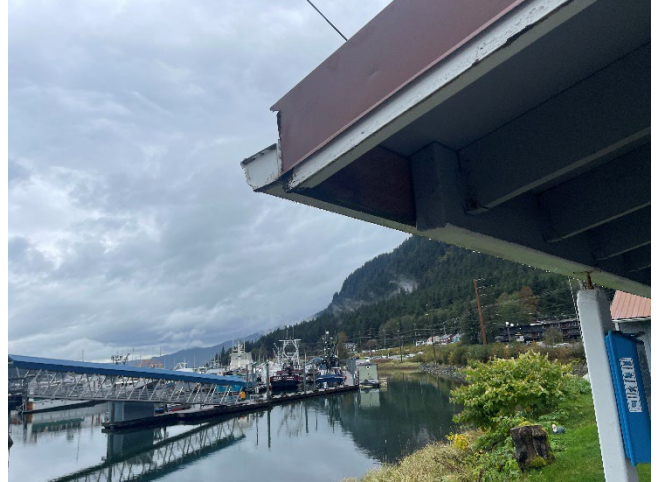
Aurora Harbor Office: Wood decay present at eaves where gutters remain intact.

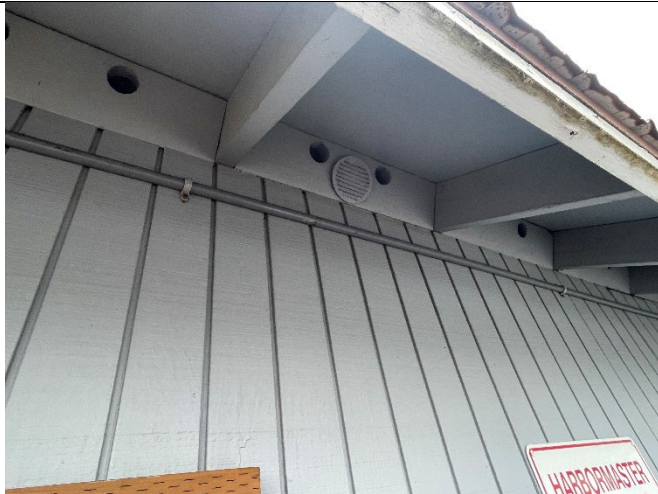
Aurora Harbor Office: Bathroom vents with non-compliant vent louvers, typical.

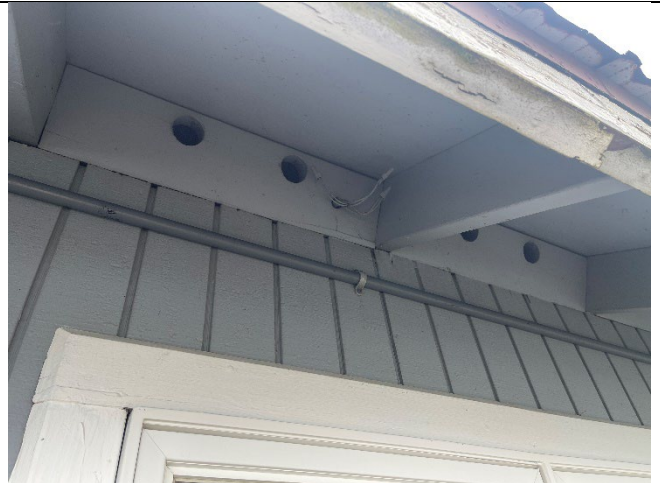
Aurora Harbor Office: Various abandoned wiring present around building outside of j-boxes.

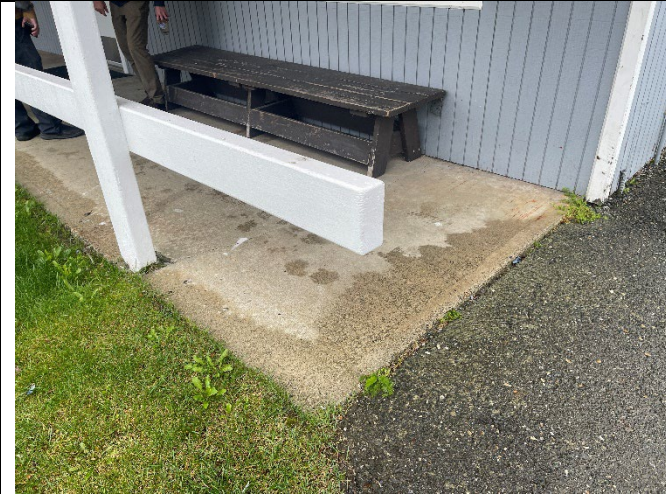
Aurora Harbor Office: Asphalt paving and concrete sidewalk not aligned and is a tripping and accessibility hazard.

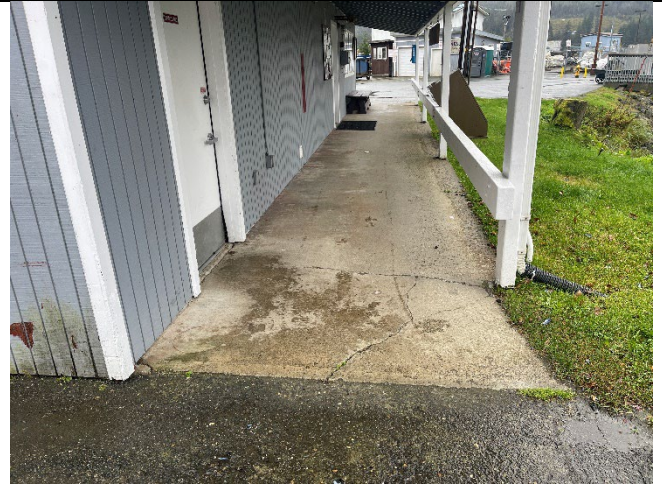
Aurora Harbor Office: Concrete sidewalk damaged and crackin along Northwest corner. Thresholds heights into office on the North end are not compliant with accessibility requirements.

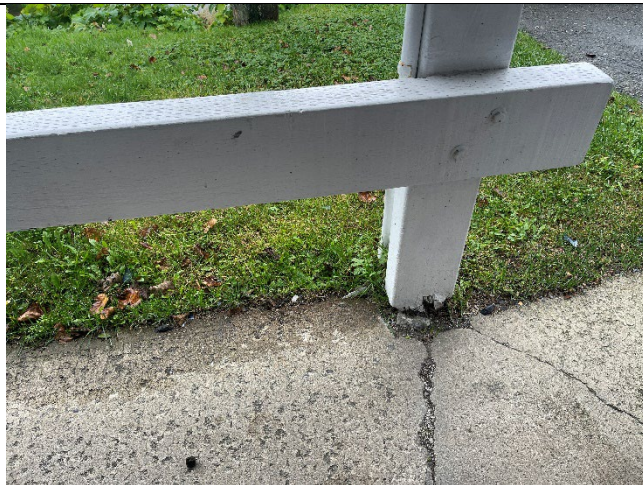
Aurora Harbor Office: Base of existing exterior canopy columns show signs of water damaged and are deteriorating.

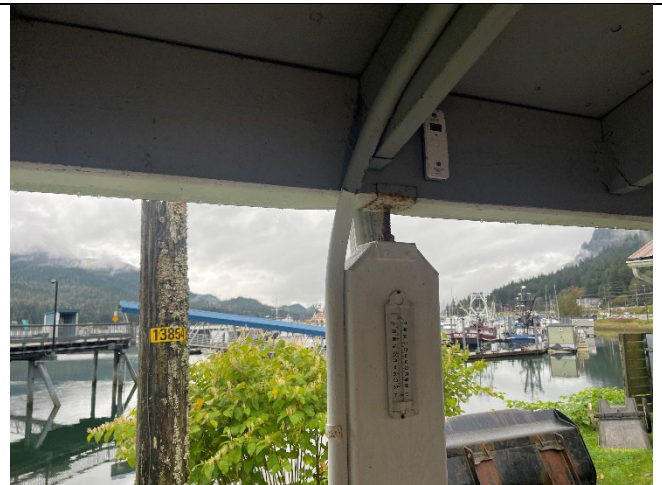
Aurora Harbor Office: Tops of columns do not appear to be appopriate use of the type of post bracket. The use of an adjustable bracket also relays that its use may be due to structural movement of the columns that should be addressed.

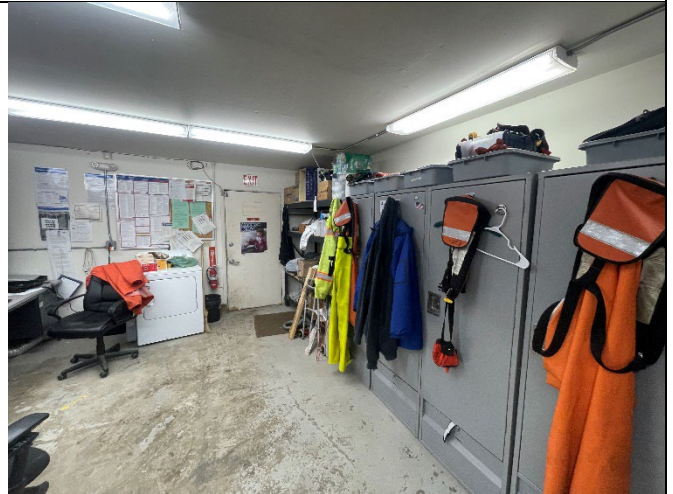
Aurora Harbor Office: Accessibility requirements at exits are non compliant. Exit signage not illuminated.

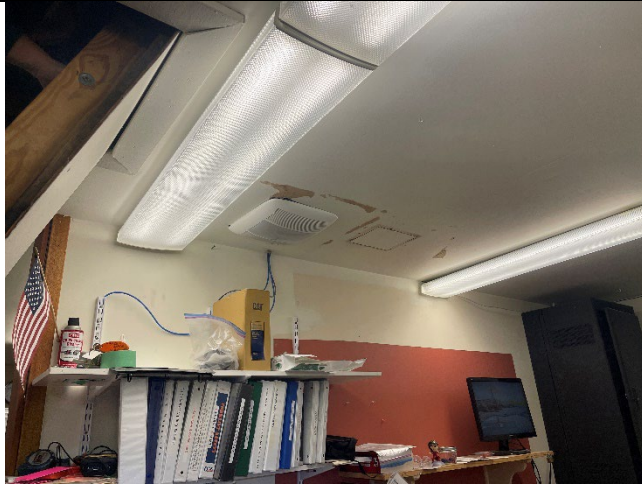
Aurora Harbor Office: Various fans in converted garage to Office area and main front office area have miscellaneous ceiling mounted exhaust fans that are piped into attic without proper roof or soffit vents.

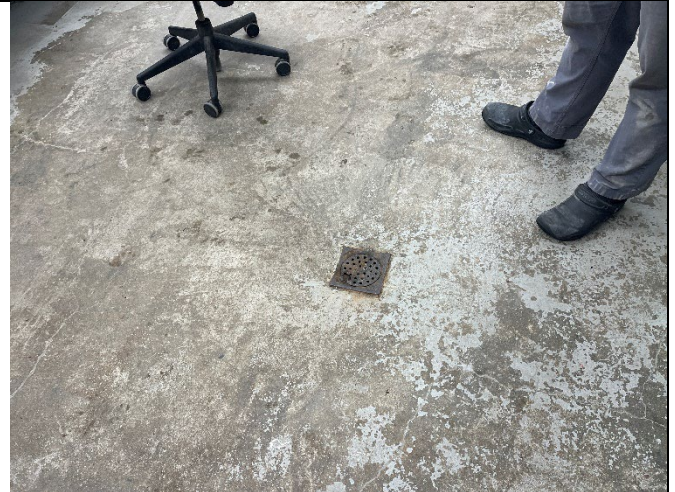
Aurora Harbor Office: Typical floor drains in the office (old garage area) smell of sewer gases.

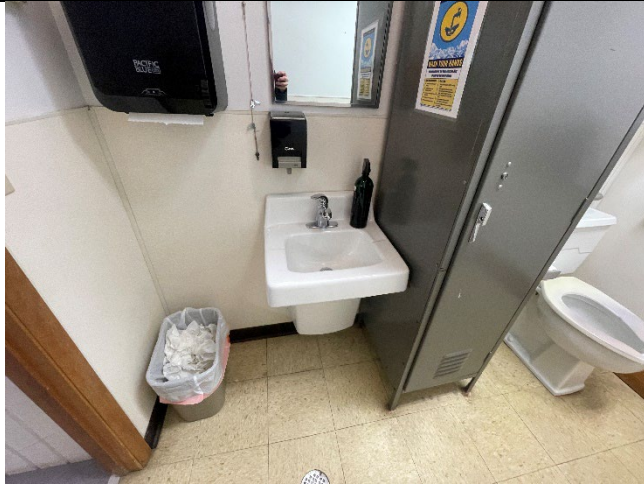
Aurora Harbor Office: South bathrooms off of the front main office does not meet accessibility requirements at toilet and lav.

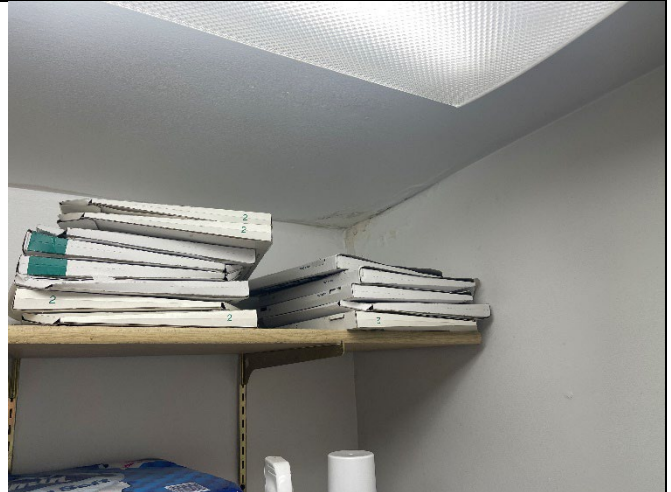
Aurora Harbor Office: South bathroom water damage at ceiling and walls from broken vent pipe through the roof.

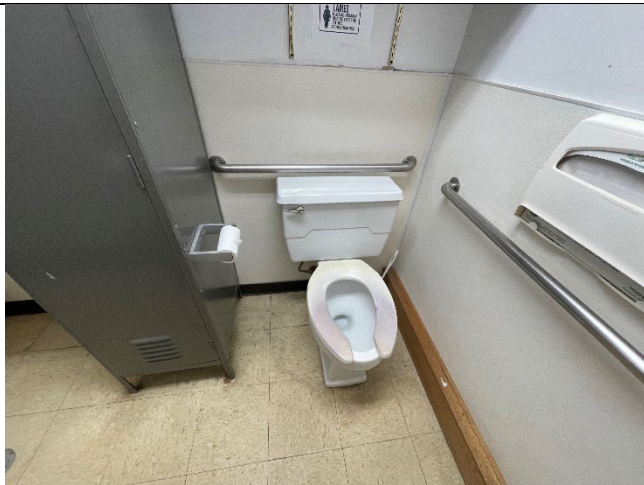
Aurora Harbor Office: South bathroom water damage at wall from broken vent pipe through the roof. Enlarged view of South bathrooms not meeting accessibility requirements at toilet.

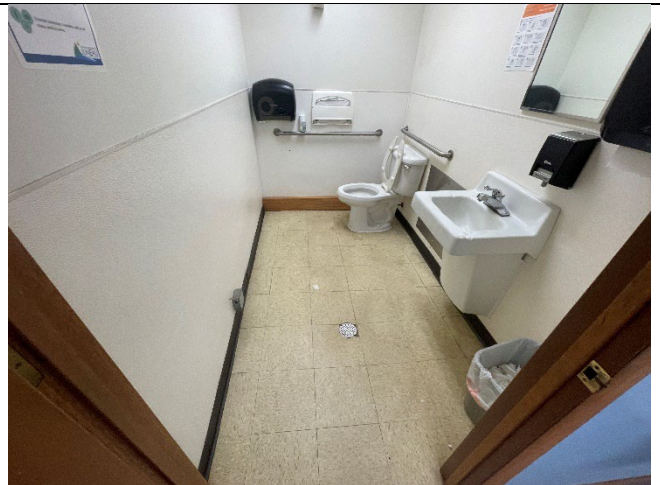
Aurora Harbor Office: North bathrooms in the facility do not meet accessibility requirements.

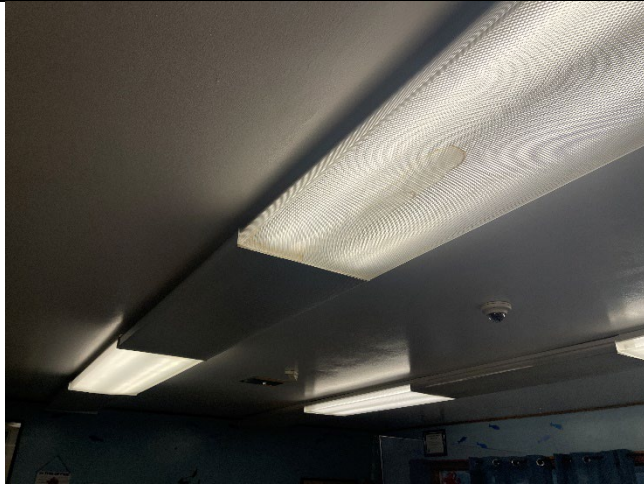
Aurora Harbor Office: Signs of water intrusion in light fixtures above the main office area.

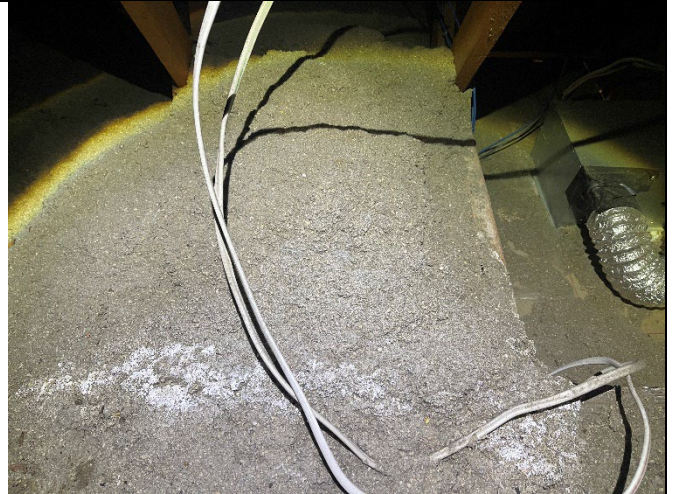
Aurora Harbor Office: misc loose wires common throughout attic space.

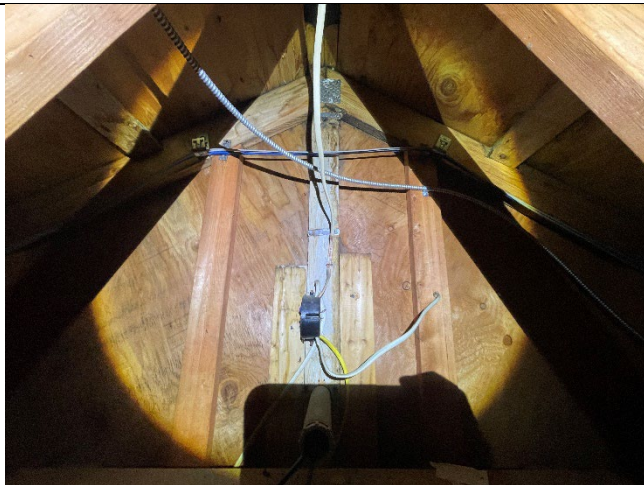
Aurora Harbor Office: misc loose wires and open j-boxes common throughout attic space.

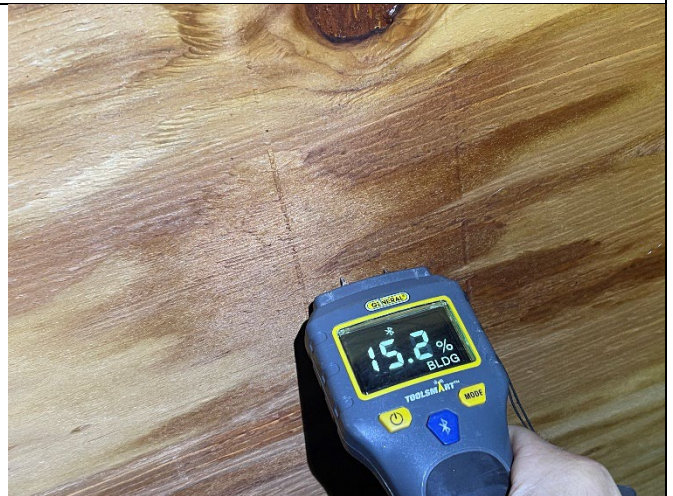
Aurora Harbor Office: Many areas of underside of roof deck have active water intrusion and high moisture levels.

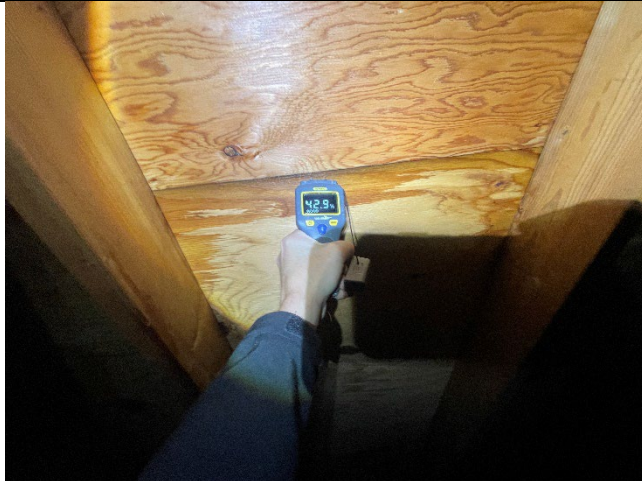
Aurora Harbor Office: Many areas of underside of roof deck have active water intrusion and high moisture levels.

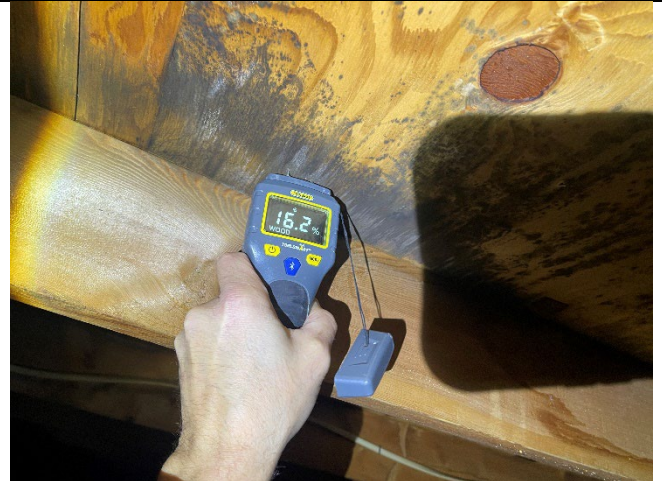
Aurora Harbor Office: Many areas of underside of roof deck have active water intrusion and high moisture levels.

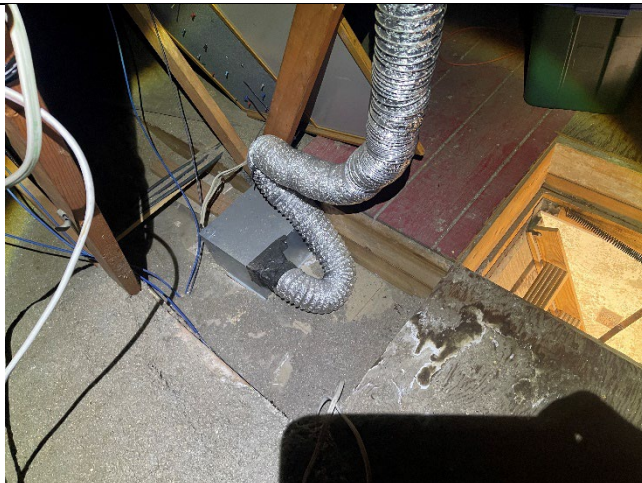
Aurora Harbor Office: View of misc exhaust fan not properly vented.

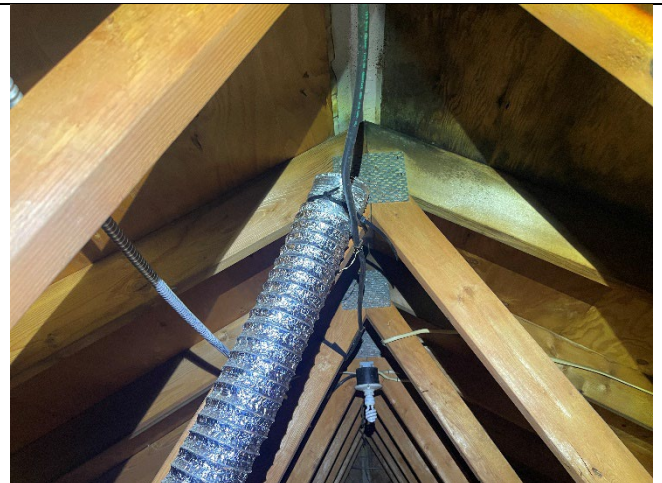
Aurora Harbor Office: View of misc exhaust fan not properly vented.

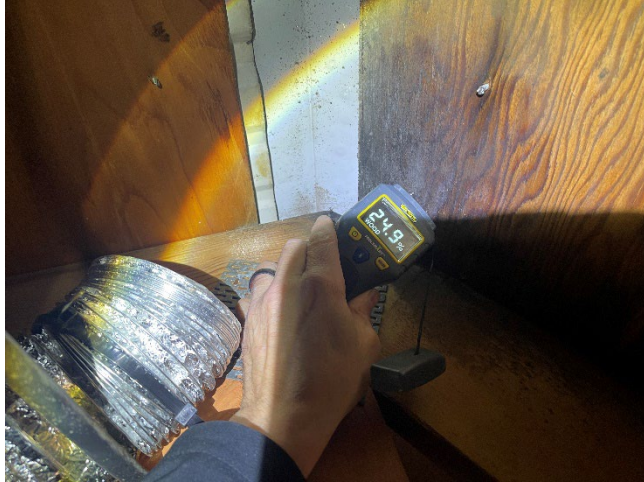
Aurora Harbor Office: View of misc exhaust fan not properly vented. High moisture content in plywood sheathing and mold present on deck and framing.

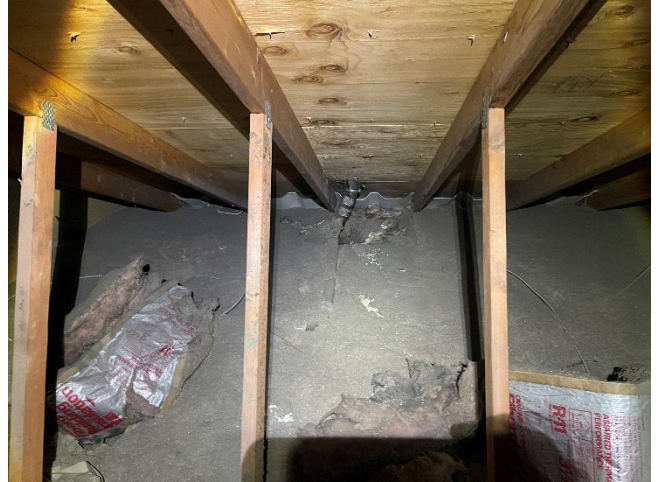
Aurora Harbor Office: View of misc broken bathroom vent through the roof at the main entry bathrooms. Vent is venting into attic space.

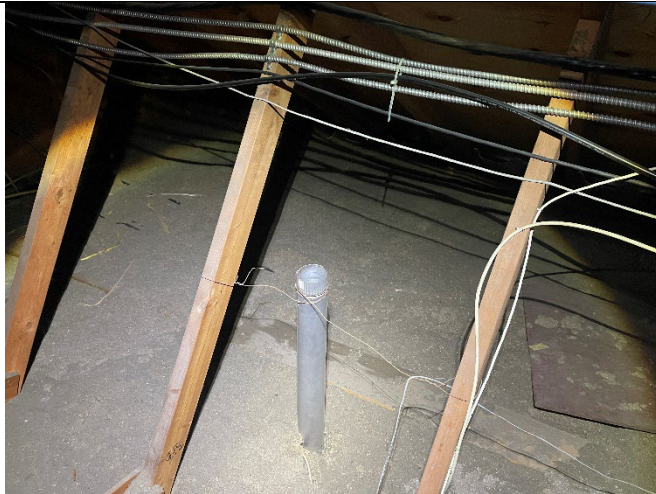
Aurora Harbor Office: View of unconnected exhaust fan from main entry office into attic space.

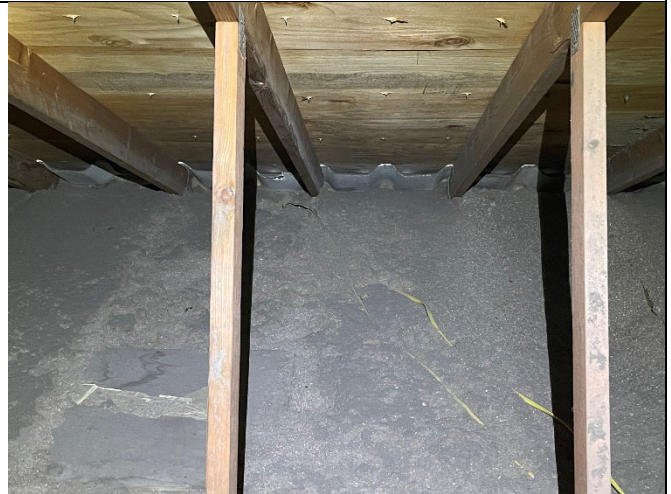
Aurora Harbor Office: Blown-in insulation should be tested for presence of ACM.

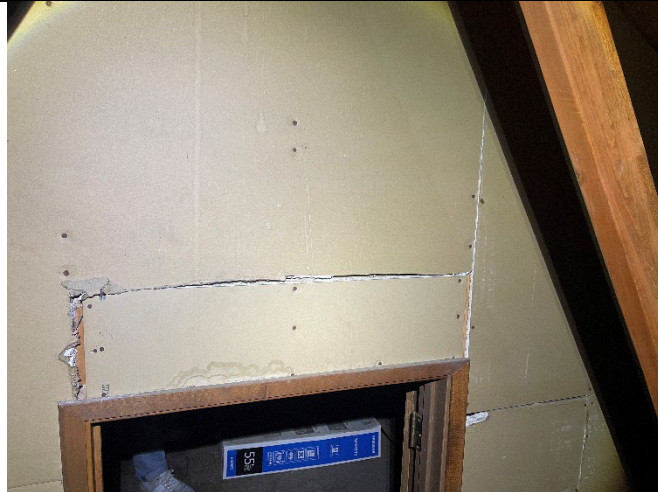
Aurora Harbor Office: Gypsum and any joint compound present should be tested for presence of ACM both attic and office areas.

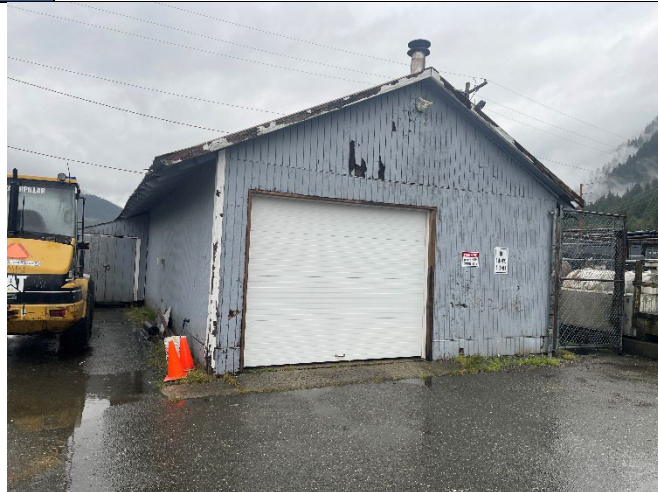
Aurora Harbor Outbuilding/Garage: General view of West side of building. In general the building has outlived its useful life and is heavily water damaged. The exterior envelope has many signs of water damage and wood decay. The structure does not meet accessibility requirements.

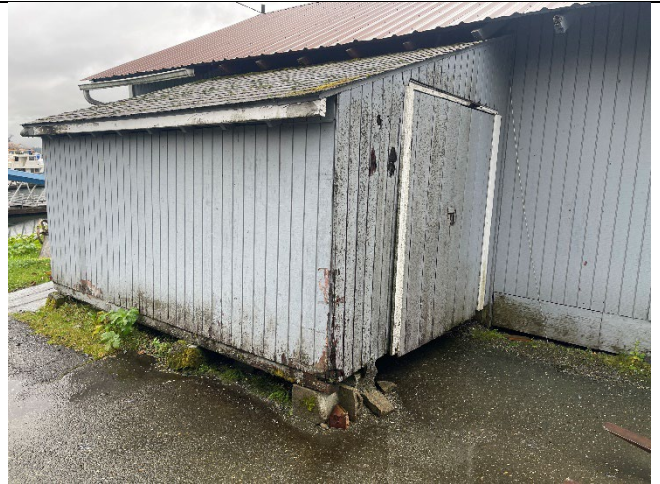
Aurora Harbor Outbuilding/Garage: General view of water damaged and decay.

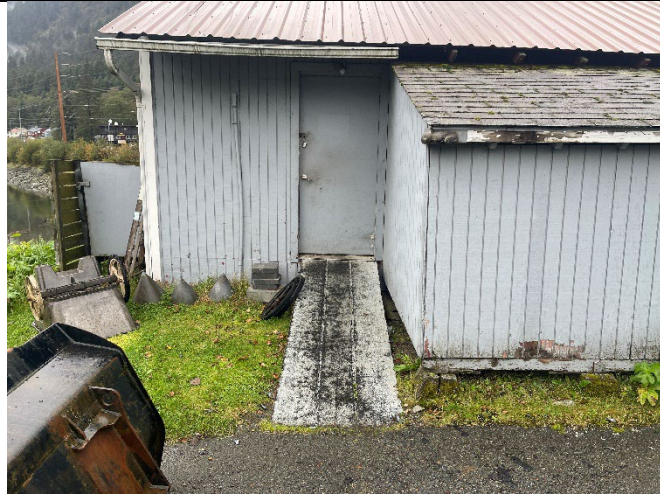
Aurora Harbor Outbuilding/Garage: General view of Southwest door. Access does not meet accessibility requirements.

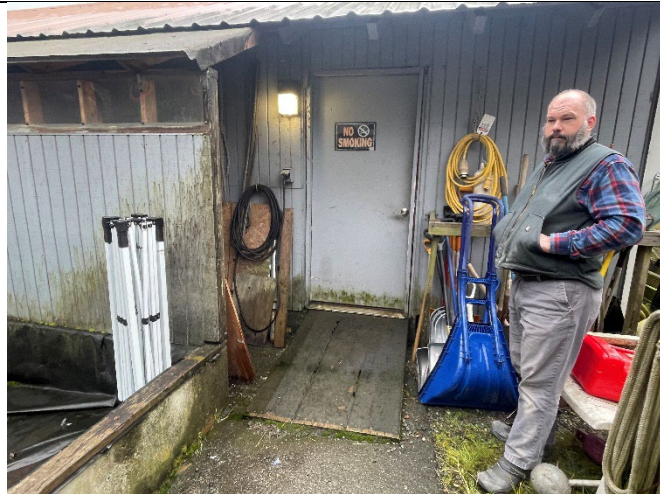
Aurora Harbor Outbuilding/Garage: General view of Northwest door. Access does not meet accessibility requirements.

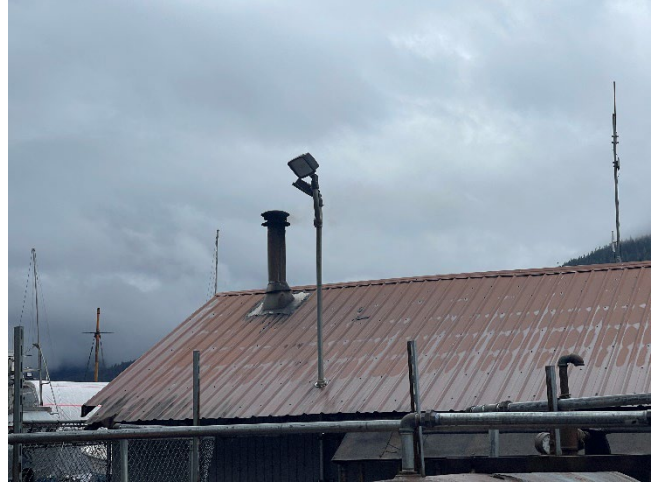
Aurora Harbor Outbuilding/Garage: Waste oil burner boiler stack has large amounts of mastic placed around perimeter to aid in reducing water infiltration.

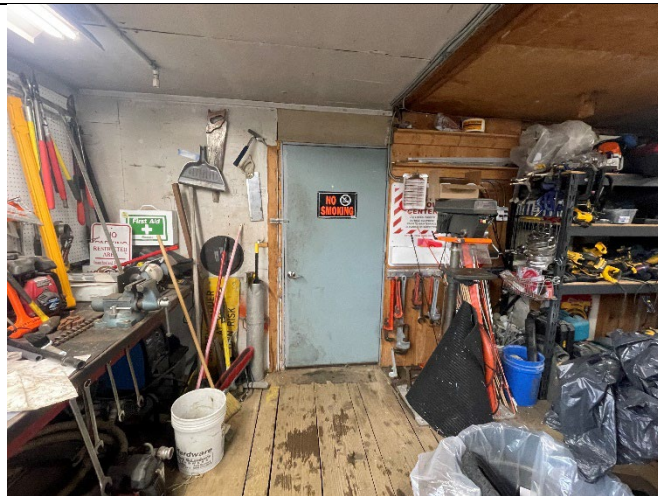
Aurora Harbor Outbuilding/Garage: General view of Outbuilding, doors do not meet accessibility requirements. Exit signs are not illuminated.

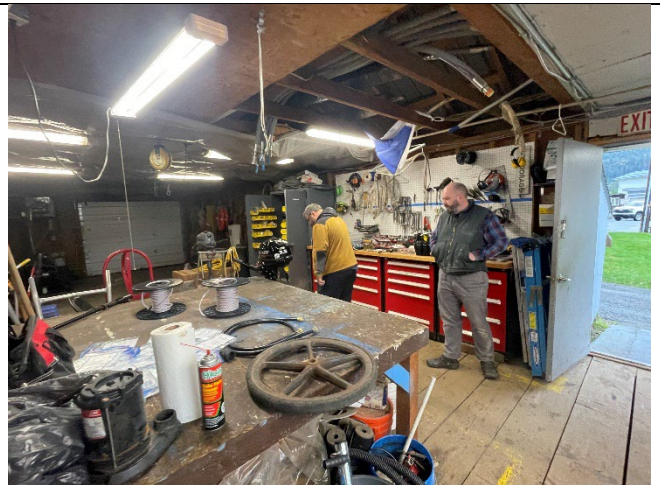
Aurora Harbor Outbuilding/Garage: General view of Outbuilding, doors do not meet accessibility requirements. Exit signs are not illuminated.

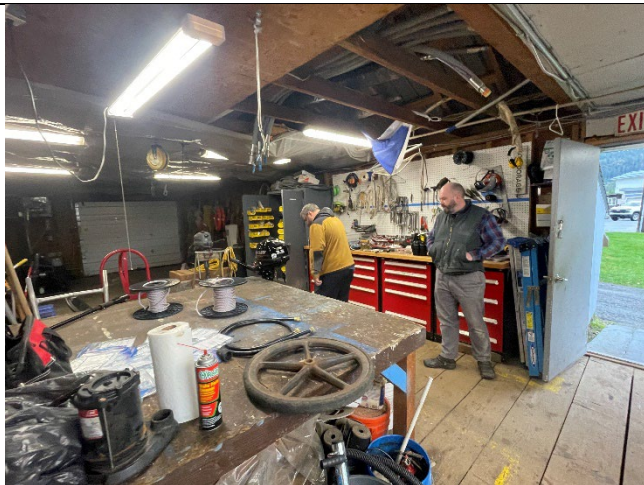
Aurora Harbor Outbuilding/Garage: General view of Outbuilding, doors do not meet accessibility requirements. Exit signs are not illuminated.

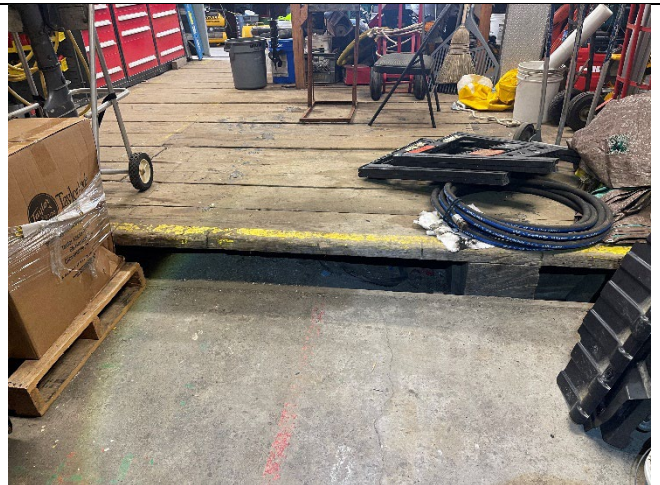
Aurora Harbor Outbuilding/Garage: General view of interior floor transitions at Outbuilding interior. Area does not meet accessibility requirements.
