# Eaglecrest Ski Area

## Facility Condition Assessment

January 14th, 2025

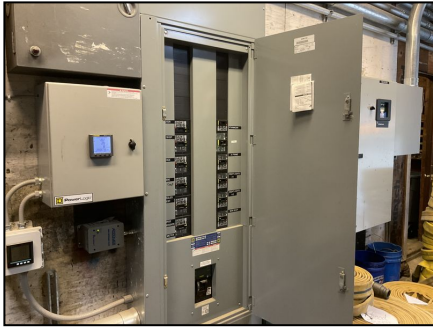
The fluorescent lighting was in fair condition due to observed inadequate lighting. The electrical branch wiring is beyond its recommended useful life. The service and distribution system was in good condition.

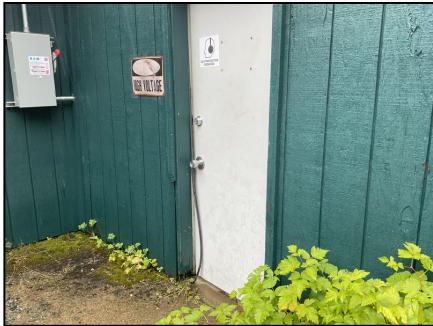
The metal and wooden doors were in good condition. The single-pane windows were in good condition. The wood siding walls were in good condition. The metal panel roof covering was within its recommended useful life.

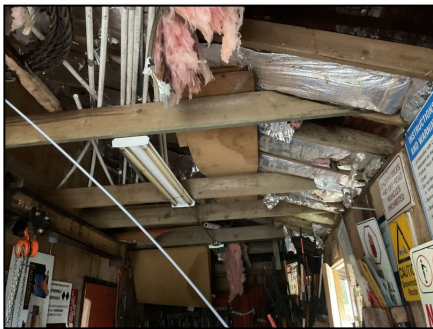
The finished concrete floor finishes were in good condition; however, the hardwood floors were in fair condition due to observed deterioration. The plywood paneling and protective wall covering wall finishes were in good condition. The plastic covered insulated batts ceiling finishes were in fair condition due to observed damage.

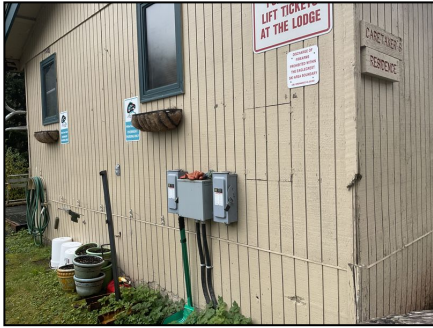
The LED lighting was in good condition. The electrical branch wiring is within its recommended useful life. The service and distribution system was in good condition.

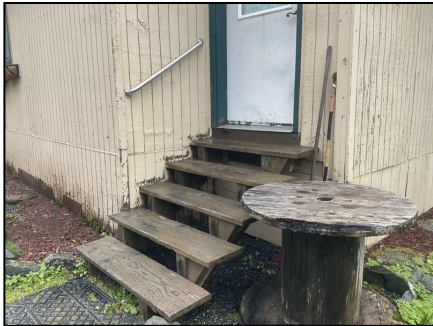
The metal door was in fair condition due to observed damage on the panel. The double-pane windows were in good condition. The wood siding walls were in good condition. The metal panel roof covering was within its recommended useful life.

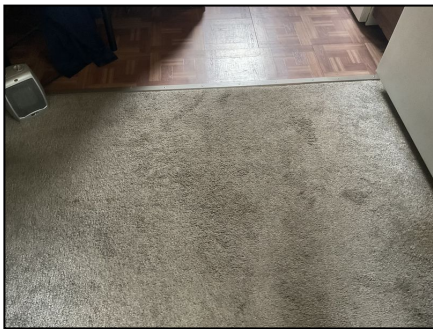
The carpet and vinyl tile floor finishes were in good condition. The painted wall finishes were in good condition. The painted ceiling finishes were in good condition.

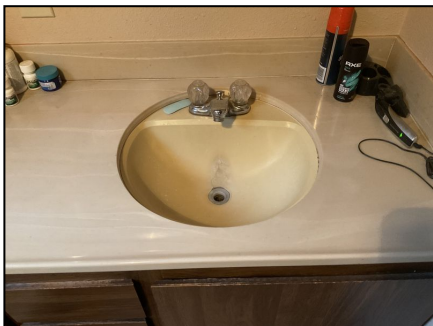
The porcelain and stainless steel and manual plumbing fixtures were in good condition. The domestic water distribution system is within its recommended useful life. The sanitary waste system is within its recommended useful life.

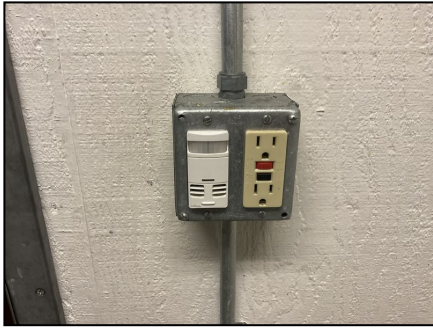
The fluorescent lighting was in good condition. The electrical branch wiring is beyond its recommended useful life. The service and distribution system was in good condition. The emergency and exit lighting is beyond its recommended useful life.

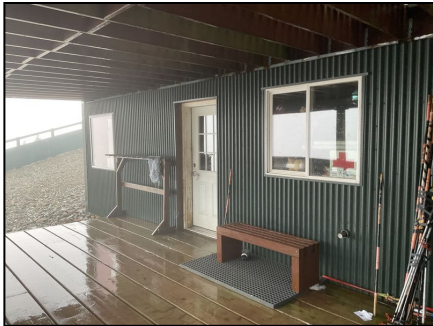
The metal doors were in fair condition due to observed damaged frames. The double-pane windows were in good condition. The metal paneling walls were in fair condition due to observed damaged finishes. The metal panel roof covering was within its recommended useful life.

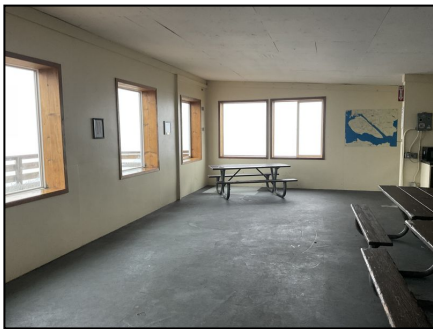
The laminate wood floor finishes were in fair condition due to observed damage, and the resilient floor finishes were in poor condition due to observed damage. The painted wall finishes were in fair condition due to observed stains. The painted ceiling finishes were in fair condition due to observed stains.

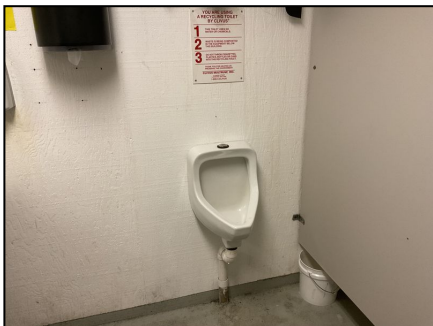
The porcelain and manual plumbing fixtures were in good condition. The domestic water distribution system is within its recommended useful life. The sanitary waste system is within its recommended useful life.

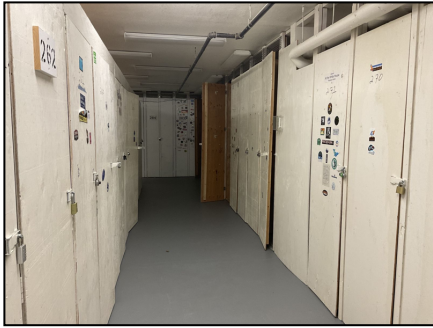
The LED lighting was in good condition; however, the fluorescent lighting was in poor condition due to observed inadequate lighting and non functioning fixtures. The electrical branch wiring is within its recommended useful life; however, a portion of the system is beyond its recommended useful life. The service and distribution system was in good condition; however, a portion of the system was in fair condition due to observed outdated panels. The emergency and exit lighting is within its recommended useful life.

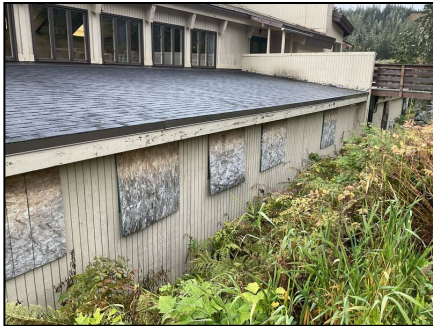
The metal doors were in fair condition due to observed damaged panels. The single-pane windows were in poor condition due to damaged panes and boarded up windows. The wood siding walls were in poor condition due to observed damaged finishes. A portion of the asphalt shingle roof covering was within its recommended useful life; however, a portion of the asphalt shingle roof was beyond its recommended useful life, and another portion of the asphalt shingle roof was in poor condition due to observed evidence of leaks.

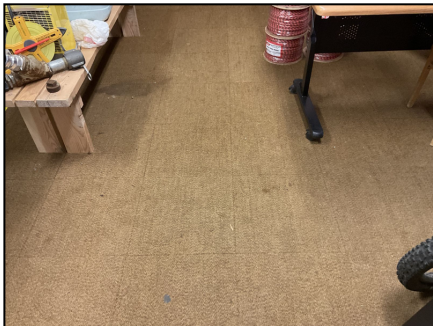
The carpet floor finishes were in good condition; however, a portion of the carpet floors and resilient floors were in poor condition due to observed damage and stains. The painted wall finishes were in fair condition due to observed damage. The painted ceiling finishes were in good condition.

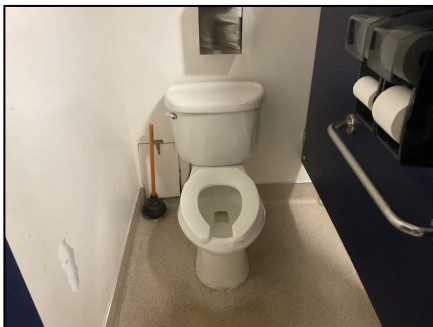
The porcelain and manual plumbing fixtures were in good condition. The domestic water distribution system is within its recommended useful life; however, a portion of the system is beyond its recommended useful life. The sanitary waste system is within its recommended useful life; however, a portion of the system is beyond its recommended useful life.

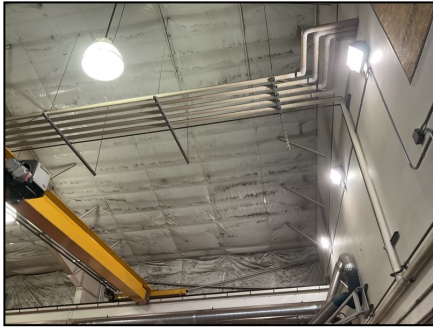
The LED lighting was in good condition. The electrical branch wiring is within its recommended useful life. The service and distribution system was in good condition. The emergency and exit lighting is beyond its recommended useful life.

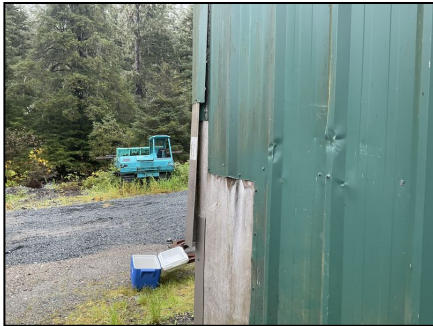
The metal doors were in fair condition due to observed . The double-pane windows were in good condition. The metal paneling walls were in fair condition due to observed damaged finishes. The metal panel roof covering was within its recommended useful life.

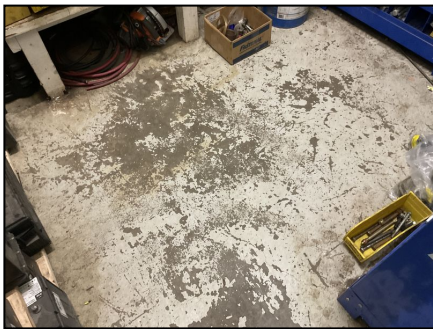
The finished concrete floor finishes were in fair condition due to observed damage. The painted and plastic covered insulated batts wall finishes were in good condition. The plastic covered insulated batts ceiling finishes were in good condition.

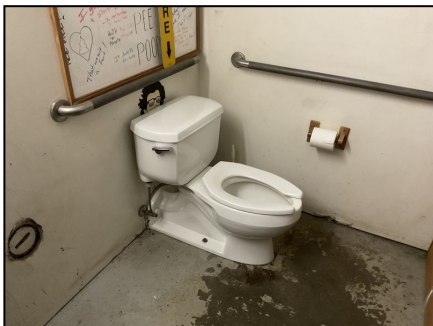
The porcelain and manual plumbing fixtures were in good condition. The domestic water distribution system is within its recommended useful life. The sanitary waste system is within its recommended useful life.

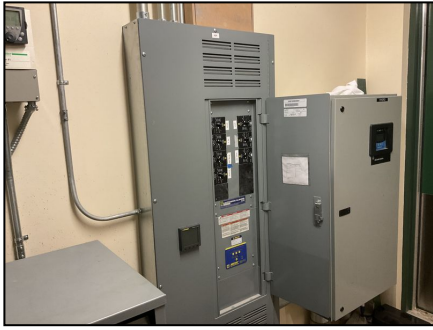
The fluorescent lighting was in good condition. The electrical branch wiring is within its recommended useful life. The service and distribution system was in good condition. The emergency and exit lighting is within its recommended useful life.

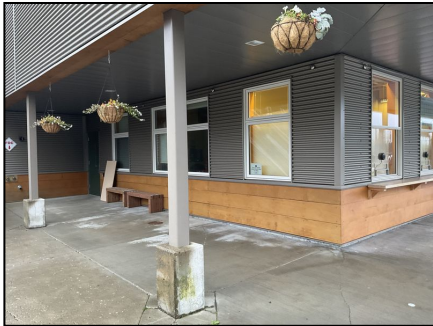
The metal doors were in good condition. The double-pane windows were in good condition. The metal paneling and wood siding walls were in good condition. The single-ply membrane roof covering was within its recommended useful life.

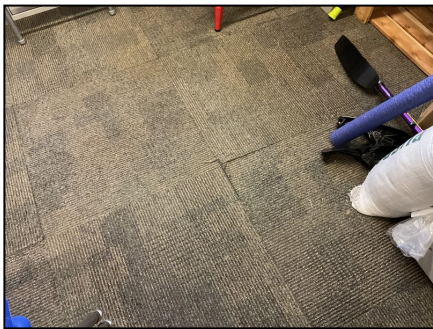
The carpet floor finishes were in poor condition due to observed damage. The painted wall finishes were in good condition. The painted and suspended acoustical tile ceiling finishes were in good condition.

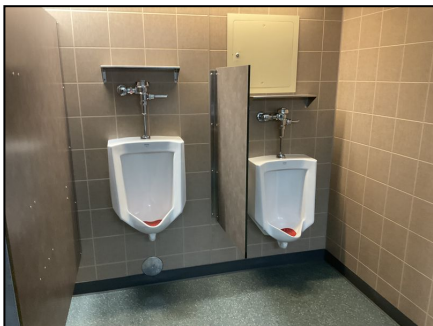
The porcelain and manual plumbing fixtures were in good condition. The domestic water distribution system is within its recommended useful life. The sanitary waste system is within its recommended useful life.
