Engineering and Public Works Department
155 South Seward Street
Juneau, Alaska 99801
Telephone: 586-0800 Facsimile: 586-4565

DATE: November 6, 2023

SUBJECT: Mendenhall River Drainage Outfall Culverts– August 2023 Glacial Outburst Flood

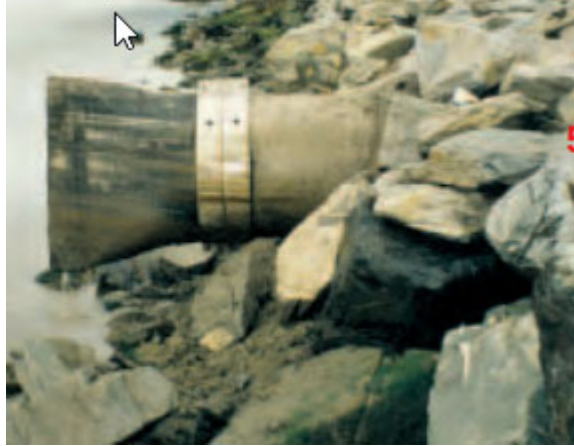
- Duck bill type: Looks as the name sounds – installed vertically on the outside of the pipe. Operation: The rubber diaphragm remains sealed closed except when the inside water pressure is greater than the water pressure outside of the pipe. (outside water pressure is typically nonexistent except during flood events.)

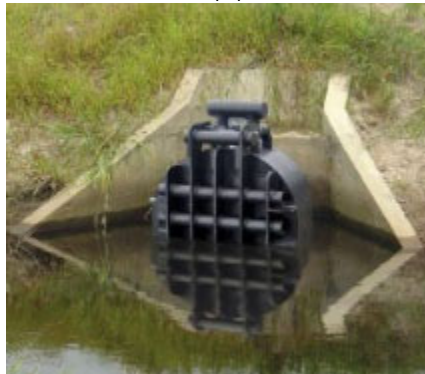
- Flap Gate type: hinged metal plate covering the end of the culvert outlet. Inside water pressure pushes the flapper open to drain the pipe. Outside water pressure pushes against the flapper to seal closed when the river water level is above the pipe outlet.

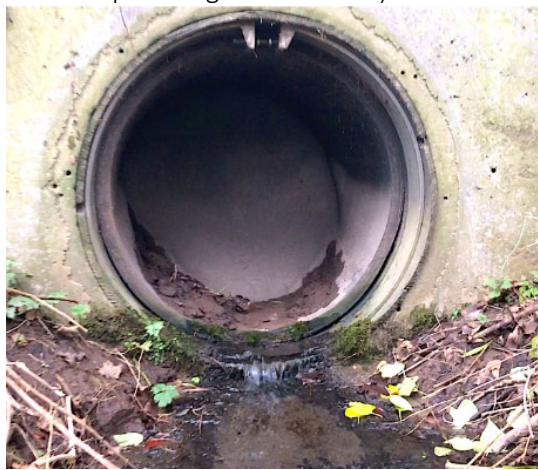
- In-line check valve: Is installed inside of the culvert with a pressure fit band sealing to the inside of the culvert. Functions similar to the duck bill – rubber diaphragm (intern to pipe) remains sealed except when inside water pressure is greater than the water pressure outside of the pipe. (outside water pressure is typically nonexistent except during flood events.)
