To: Teri Camery (CBJ) **Date:** April 27, 2022
c: Scott Ciambor (CBJ) **Memo No.:** 4
From: Rita Kors-Olthof, Alan Jones, Vladislav Roujanski **File:** 704-ENG.EARC03168-02A
Subject: Guide to Avalanche and Landslide Hazard Designations
Downtown Juneau Landslide and Avalanche Hazard Assessment

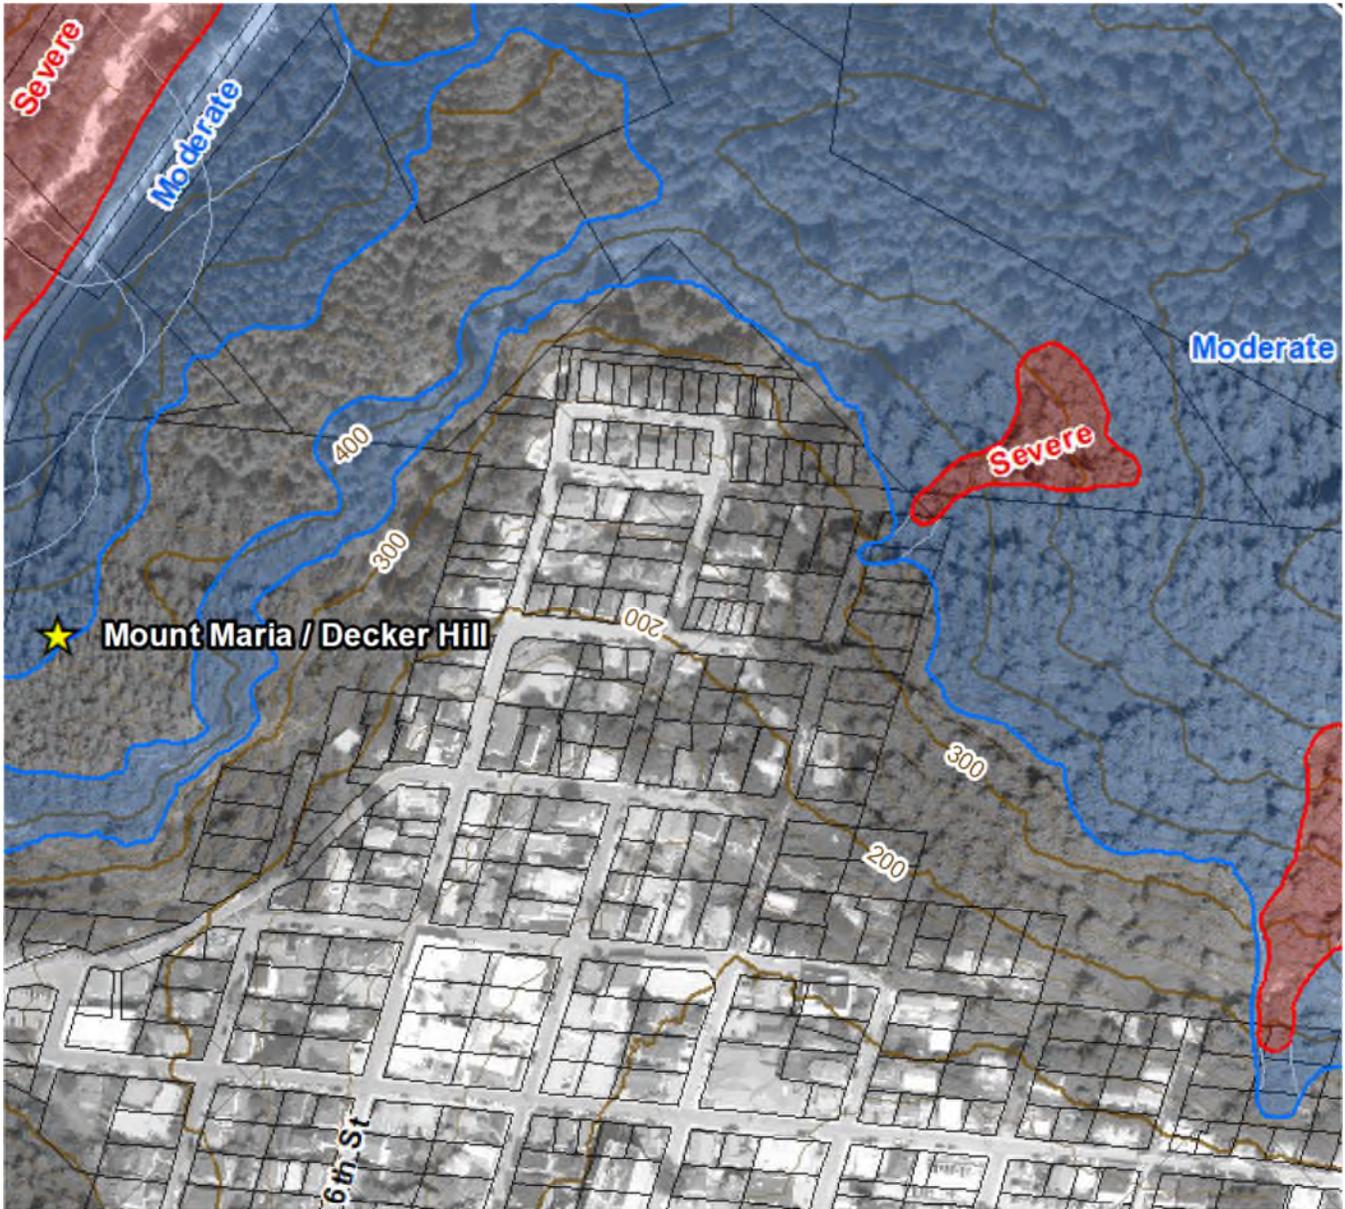
One example of terrain with an avalanche hazard designation of *Low* is most of the Starr Hill subdivision, as shown in Figure 1. Figure 2 shows a view of Starr Hill from the helicopter.

Figure 1: Excerpt from Figures 2.4c and 2.4h in the main report, showing the northeast end of the Starr Hill subdivision. Almost all of the lots are mapped with an avalanche hazard designation of *Low* (i.e., not colored as red or blue), with the only encroachment being the G000 (Park) avalanche path on the right (marked *Severe*, with *Moderate* terrain below). All the existing houses are currently located in areas designated as *Low*.

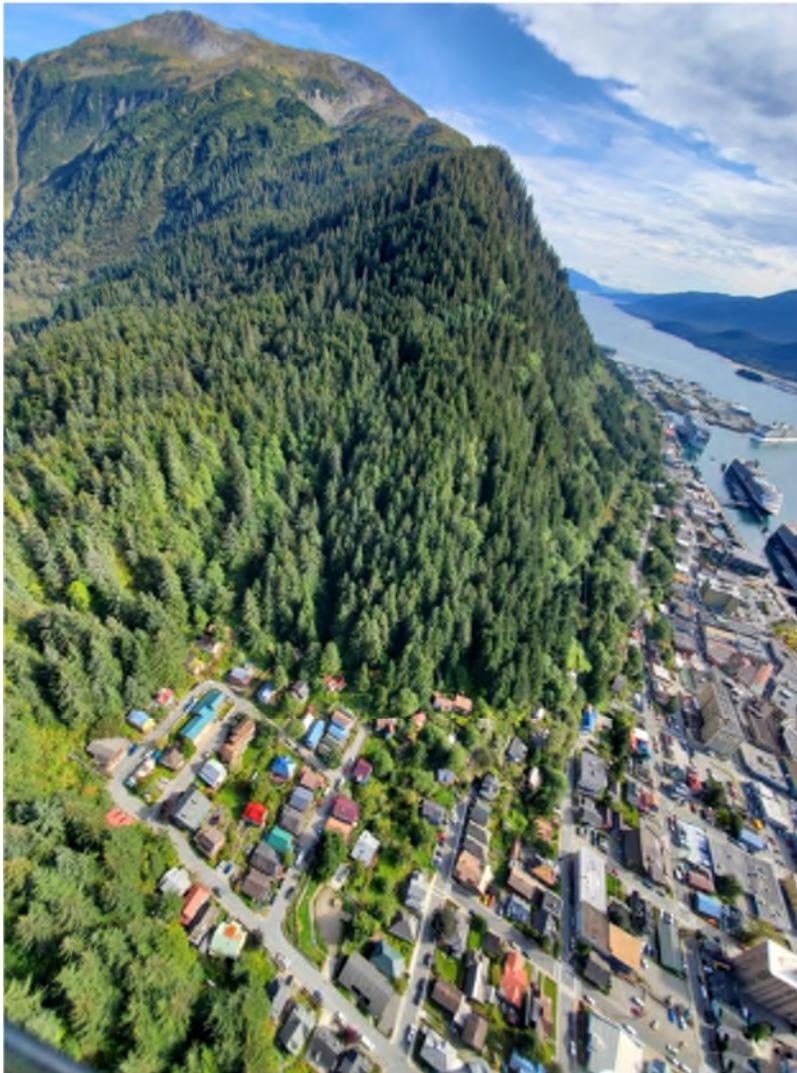
Figure 2: Looking southeast at the Starr Hill subdivision. Nelson Street is near the top left of the photo, East Street is near the photo center, Gold St. is near the photo right edge. 6th Street is in the foreground left, and the next road to the southeast is 5th Street.

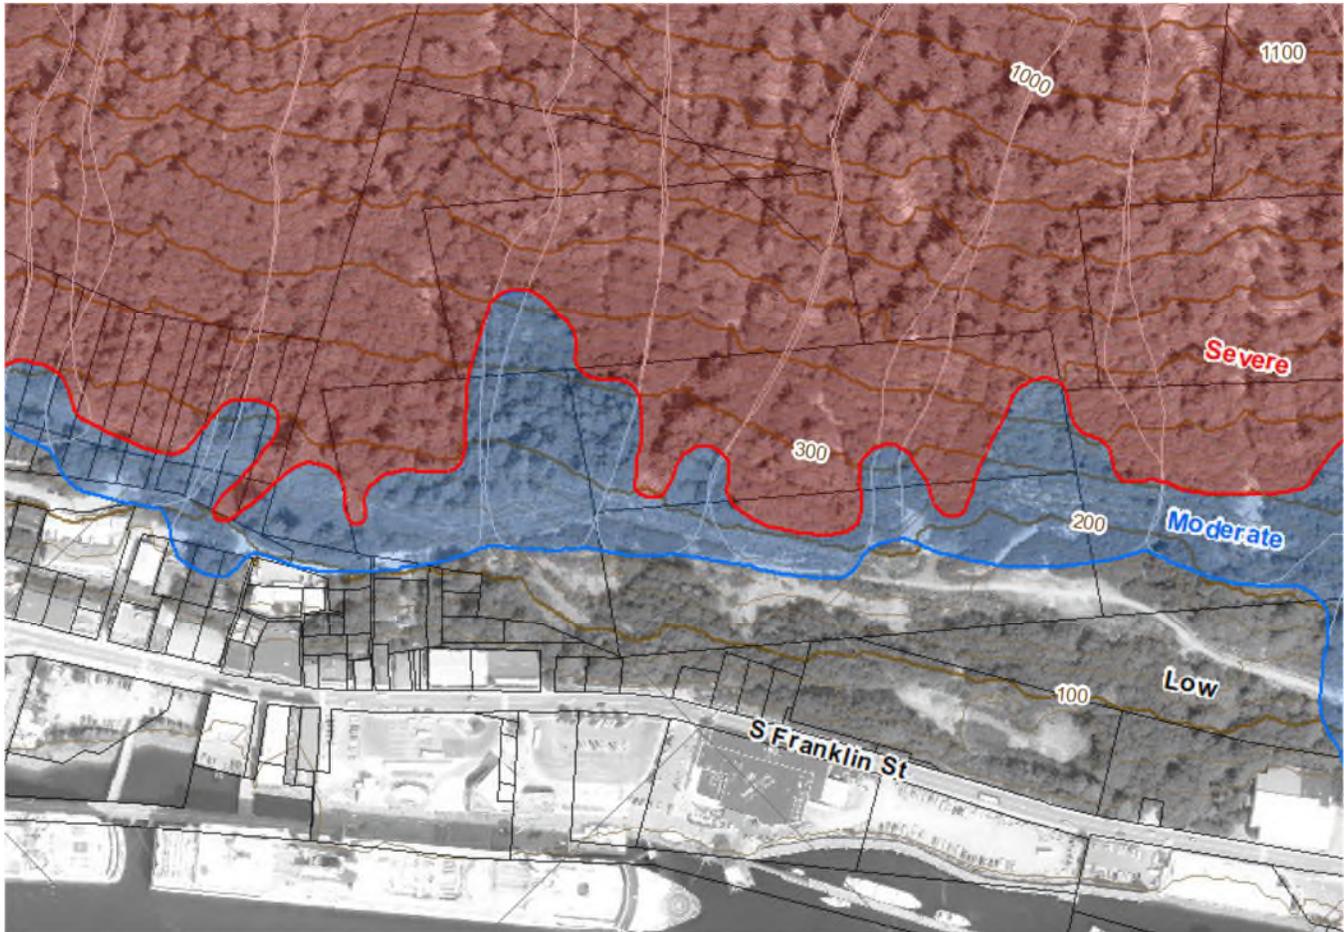
Avalanche areas mapped with a hazard designation of *Moderate* are shown in blue on the mapping. Typically, the *Moderate* zone on the larger mountain slopes forms a fringe downslope and alongside the main avalanche paths (mapped in red) that is less likely to experience an avalanche, and if an avalanche does reach *Moderate* terrain, the impact pressures are expected to be lower, and are impacted less frequently. Figure 3 is an example of this type of avalanche terrain adjacent to the southern section of Gastineau Avenue and upslope of South Franklin Street.

Figure 3: Excerpt from Figure 2.4d in the main report, showing avalanche paths G003 to G009 and T000 (from left to right). The blue fringe shows terrain designated as having *Moderate* avalanche hazard along the toe of Mt. Roberts. In this area, the *Moderate* hazard does not reach South Franklin Street, but it does reach Gastineau Avenue in several locations. Further southeast (off the right-hand side of this map excerpt), the slopes of Mt. Roberts become higher and are affected by unforested alpine terrain, and the *Moderate* avalanche terrain reaches further downslope, past Thane Road, and sometimes into Gastineau Channel.

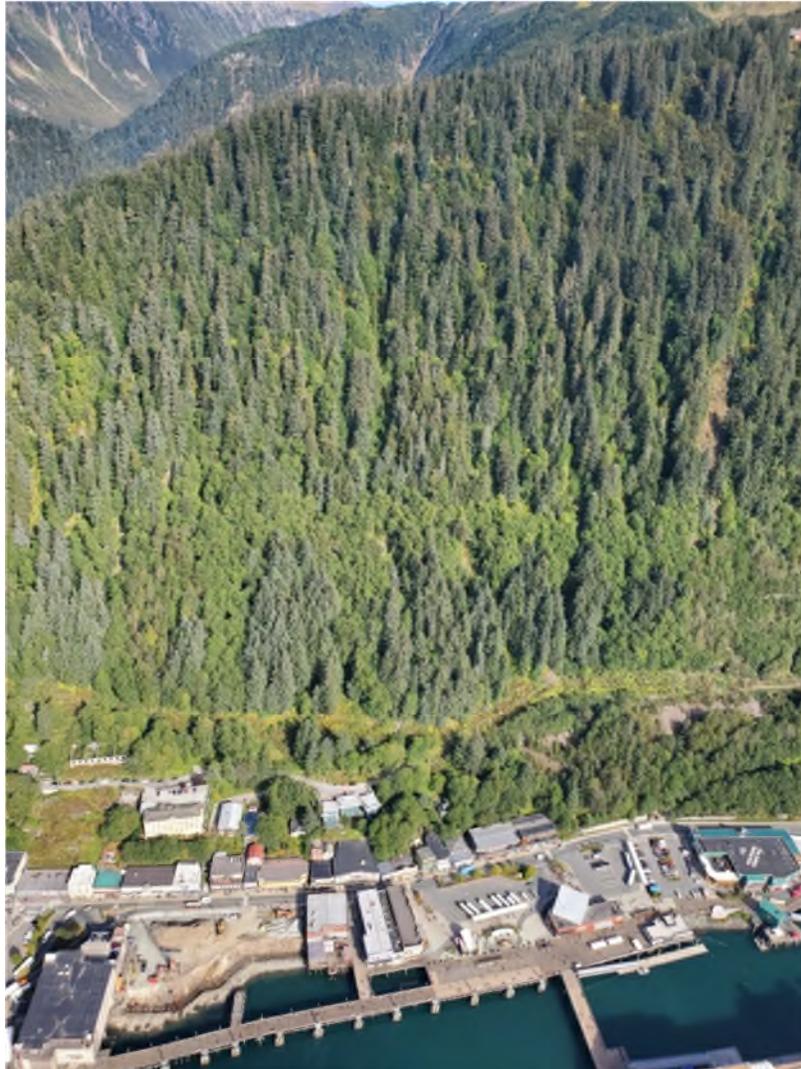
Figure 4a below shows the slope from the helicopter, which is vegetated with a relatively dense forest cover in this area. Avalanche hazards are present within the gullied parts of the slopes, and have historically affected areas close to Gastineau Avenue. Figure 4b provides a view from Google Earth that shows distinct avalanche paths and start zones within the gullies that are easily seen on the winter imagery, which highlights the differences in coniferous versus deciduous forests.

Figure 4a: View of Mt. Roberts from the helicopter showing part of the slope mapped in Figure 3. Note the increasing height of slope from left to right (northwest to southeast). The slope is fairly well-treed but is still prone to avalanching. Gullies tend to increase avalanche runouts. See also Figure 4b.

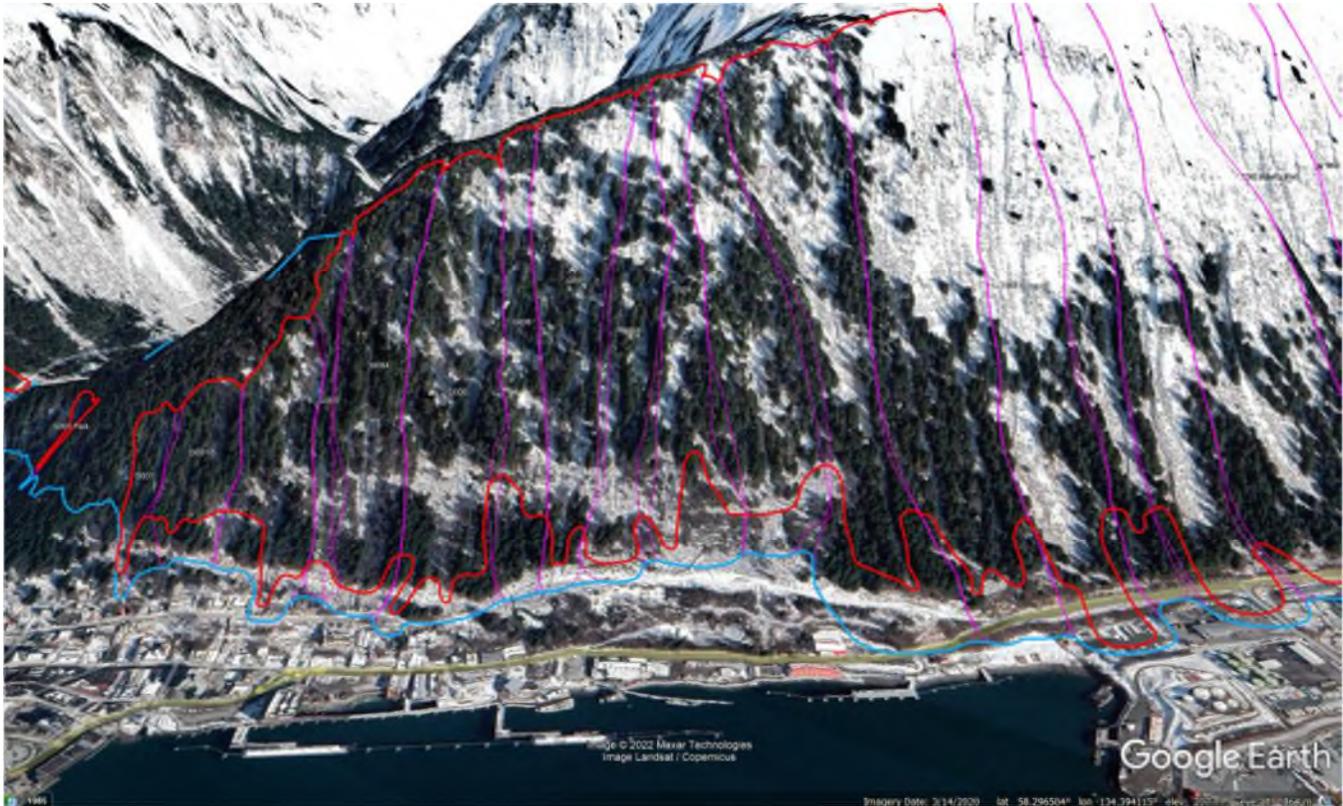
Figure 4b: View of the northern part of Mount Roberts along Gastineau Avenue and South Franklin Street, with avalanche paths and *Moderate/Severe* hazard boundaries shown. Note the increasing height (and length) of slope from left to right (northwest to southeast), which increases the runout distance and hazard to lower elevation areas towards the industrial park. Although the Gastineau Avenue area is forested, distinct avalanche paths and start zones within the gullies can be observed on the winter imagery, which highlights the forest cover differences (coniferous versus deciduous forests). (Image credit: Google Earth 2022.)

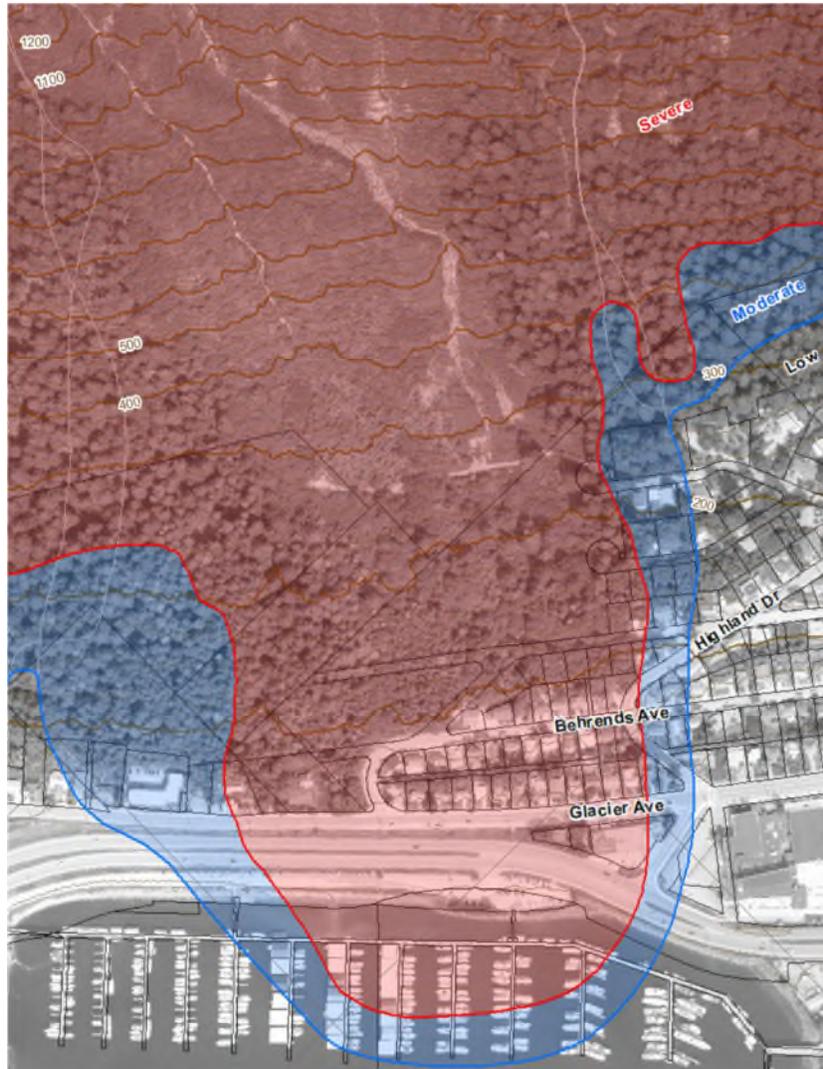
Figure 5: Excerpt from Figure 2.4b showing the major avalanche path at J010 Behrends. Note the distinct trimlines that define the edges of this path, indicating regular avalanche activity within the central part of the path and less frequent avalanche activity on the outside (lateral boundaries) of the path.

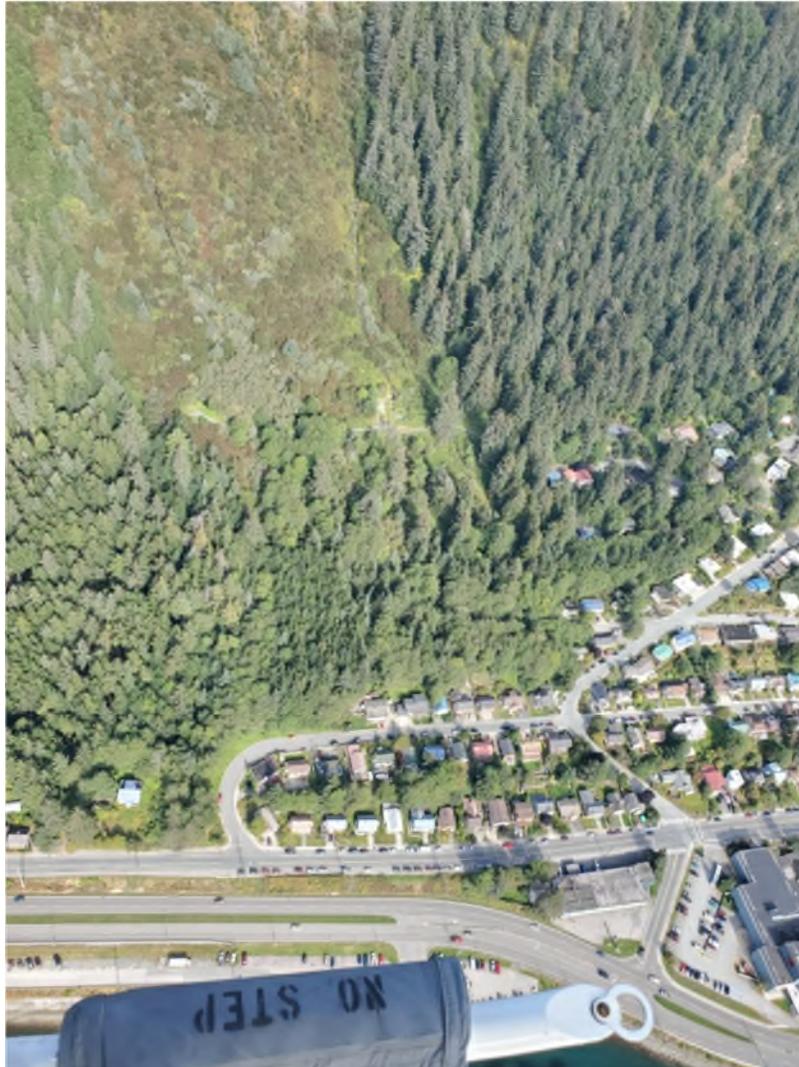
Figure 6: Looking north-northeast at the lower end of the J010 Behrends Avenue avalanche path. Note the differences in vegetation within the path, beside the path, and below it, mostly due to regular and destructive avalanche activity. The large building in the lower right corner of the photo is the high school at the corner of Glacier Avenue and Highlands Drive. The school is located just outside of the *Moderate* hazard zone. Most of the other areas (with the exception of the densely forested upper right part of the photo) are within either *Severe* or *Moderate* hazard zones.

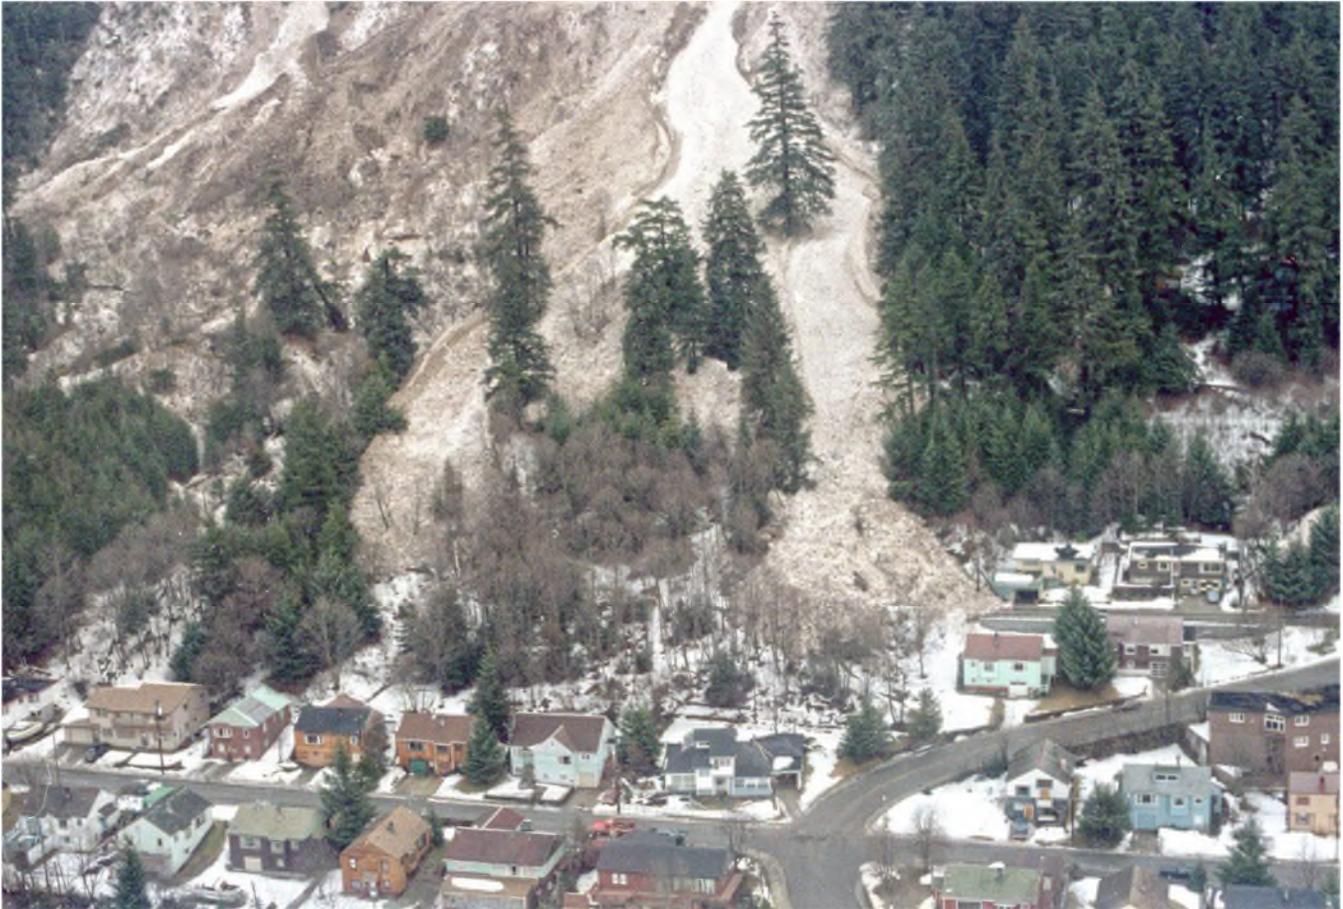
Figure 7: The aftermath of 1985 avalanche, looking north from just south of Behrends Avenue and Highland Drive. This event was the longest running avalanche in the Behrends Subdivision since the destructive 1962 event. The photo clearly shows the destructive potential of this avalanche and the way it came right into the community and was close to damaging/destroying many structures. However, it only damaged one house on Troy Avenue, the one on the right. (Photo credit: Dan Bishop 1985.)

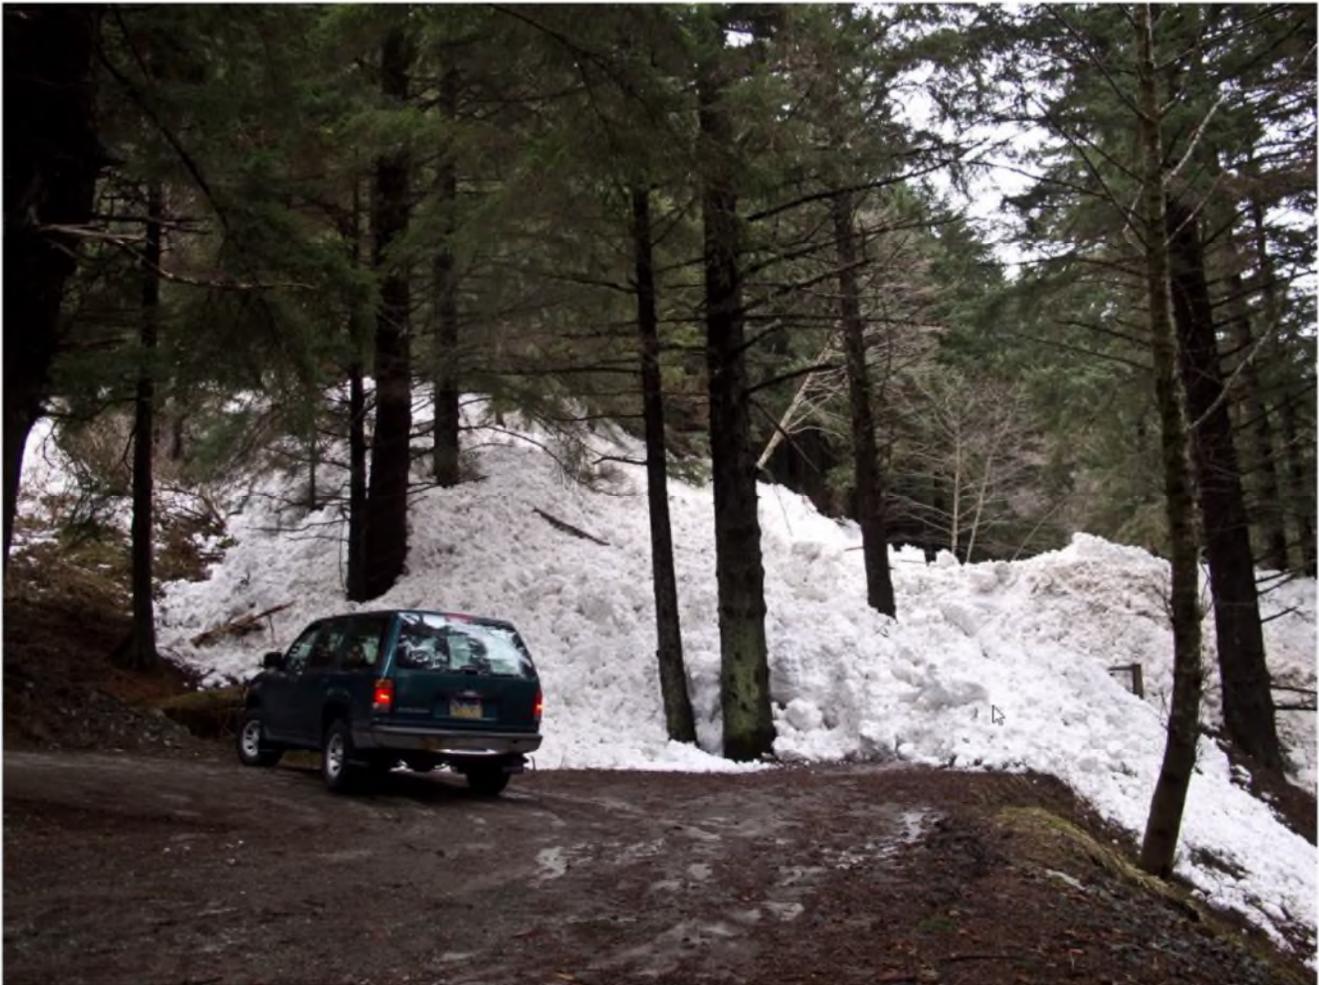
Figure 8 shows another avalanche event that occurred in 2012 further to the east of the Behrends Subdivision, at the Bathe Creek avalanche path.

Figure 8: This photo illustrates a Size D3 avalanche within a Severe (red) hazard zone. The avalanche occurred in 2012 in the Bathe Creek avalanche path. This highlights a hazard area that is both frequent (more frequent than a 30-year return period) and destructive, with an impact pressure greater than 600 lbs/ft² (30 kPa), capable of both burying/destroying a car and destroying a wood frame residence. (Photo credit: Mike Janes (AELP).)

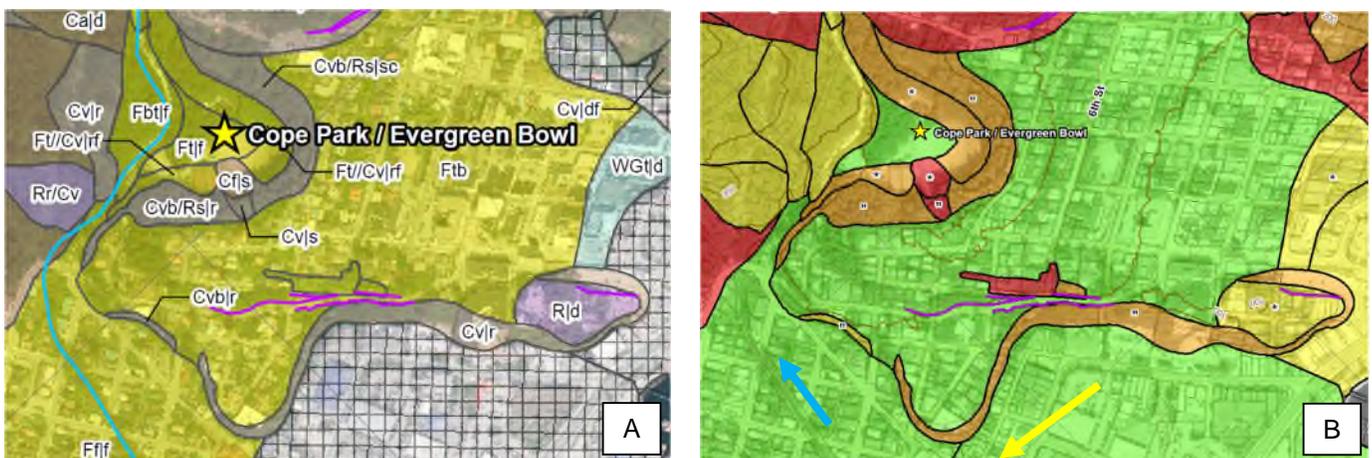
Figure 9 shows the surficial geology and the landslide hazard mapping for two areas of Downtown Juneau that are designated as having a *Low* landslide hazard. Figure 10 shows a photo for each of those areas.

Figure 9: These two map excerpts are from the mapping across the approximate middle of the downtown area. Figure 79A shows the surficial geology, and Figure 9B shows the landslide hazard mapping. Gold Creek is marked as a blue stream along the left side of Figure 9A. Willoughby Avenue is in the cross-hatched area on Figure 9A, where fill was placed to extend the land area of the city. The yellow arrow on Figure 9B shows the direction of look in Figure 10A. The blue arrow on Figure 9B shows the direction of look in Figure 10B.

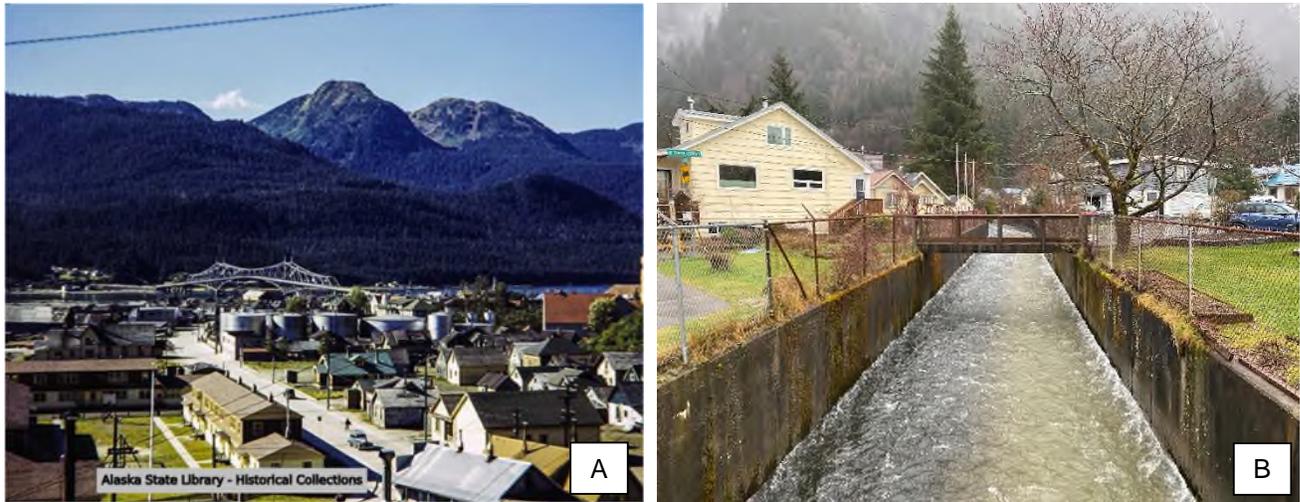
Figure 10: Views of Juneau in terrain mapped with landslide hazard designation of *Low*.

Figure 10A: Looking west from Telephone Hill at the east-west leg of Willowby Avenue. Figure 10B: Looking upstream at the Gold Creek flume, with terrain mapped in *Low* on both sides of the creek. (Photo credits: Figure 10A: Alaska State Library – Historical Collections, [ASL-P417-040](#), Caroline Jensen 1948. ASL 2022a. Figure 10B: CBJ December 4, 2020.)

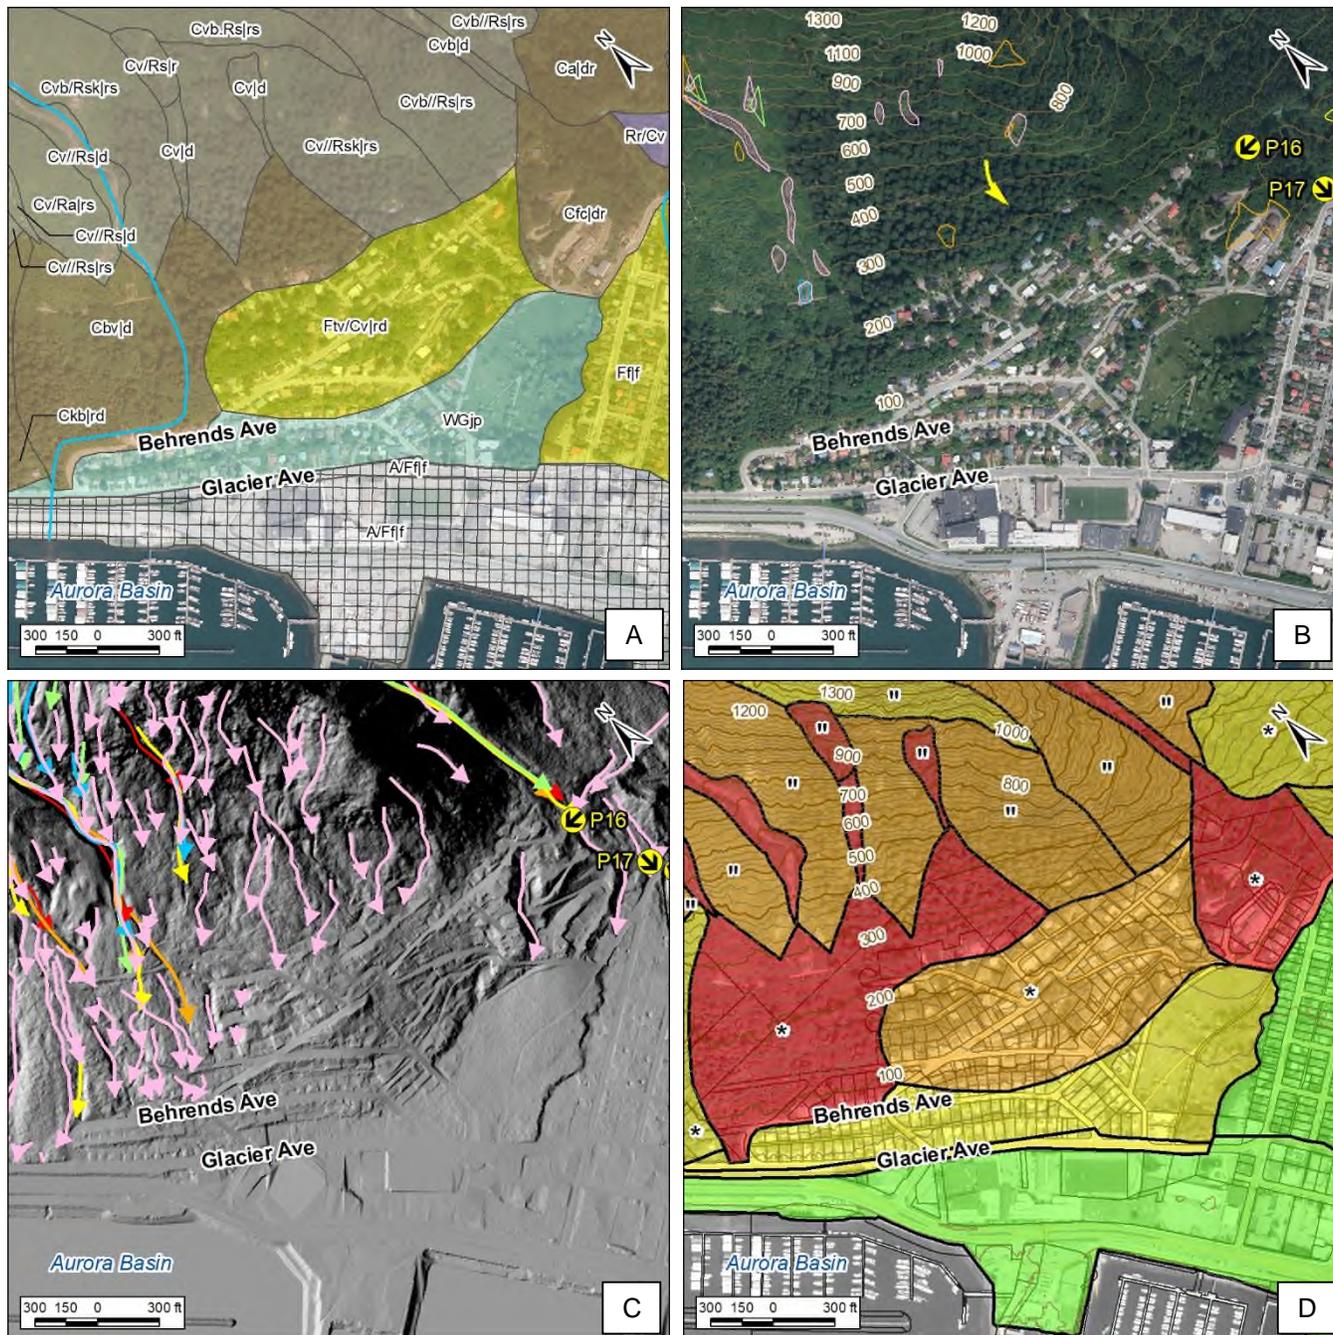
Figure 11: These mapping excerpts show *Moderate* hazard terrain from part of the Juneau Study Area. Figures 11A through 11D. The terrain mapped as glaciomarine (WG) in Figure 11A reveals no slope movement features in Figure 11B, and no gully erosion features in Figure 11C. That results in a landslide hazard designation of *Moderate*, as shown on Figure 11D. See also Figure 13 for examples of *Moderate* terrain. Events that affect mainly roads (e.g., Figure 13A) tend to be cleaned up promptly and are generally not seen on the air photos.

As shown on Figure 11D, Glacier Avenue at Ross Way is just below the *Severe* landslide designation zone at the Behrends Subdivision, at the northwest end of Behrends Avenue (left side of figure). That means Glacier Avenue could receive some smaller water-borne debris and muddy water that runs down the road, but it should not experience the more serious impacts generally seen further upslope. However, because some effects are still

possible, such as erosion (red arrow on Figure 13A), the landslide hazard designation here cannot be considered *Low*. As shown on Figure 11B, no other historical slope movement features were observed on the imagery, and on Figure 11C, the gullies appear not to extend across Behrends Avenue or Glacier Avenue, although the debris may flow onto them. Therefore, a landslide hazard designation of *Moderate* is considered appropriate.

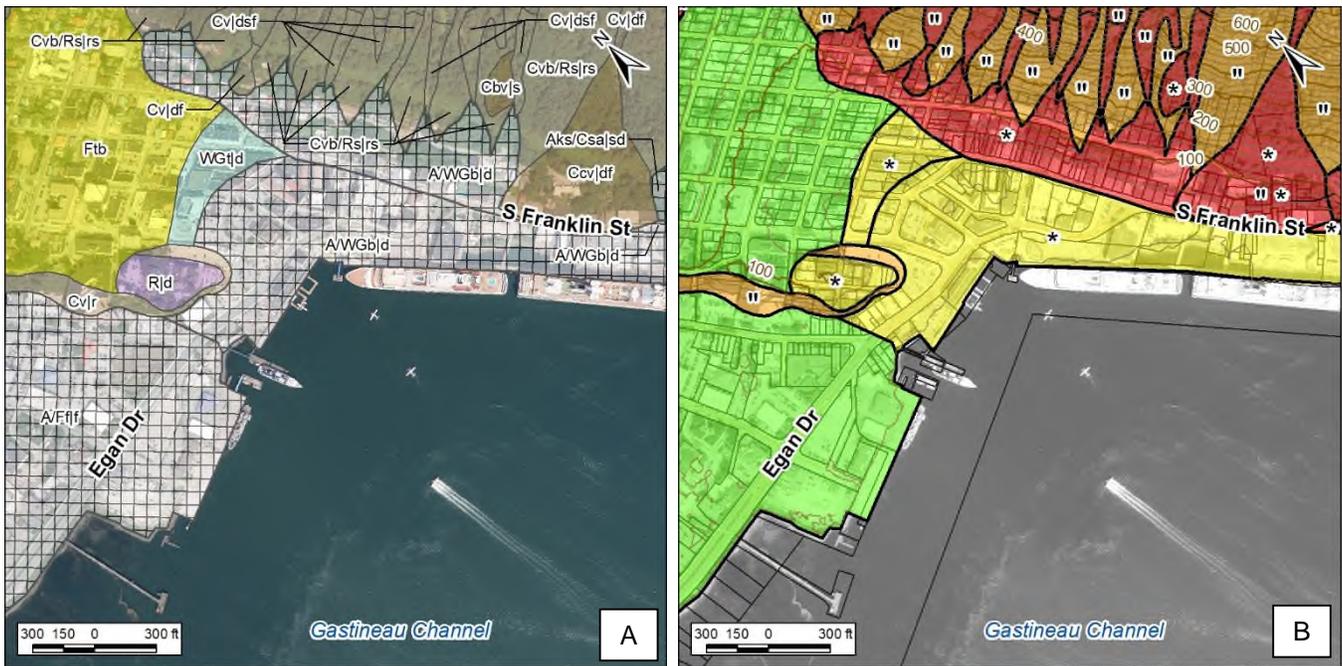
Similar conditions apply downslope of South Franklin Street. The runouts of the several landslides on this slope are represented by surficial geology shown in Figure 12A and the *Severe* landslide hazard designations shown in Figure 12B.

Figure 12: These mapping excerpts show *Moderate* hazard terrain from another part of the Downtown Juneau Study Area. Figures 12A and 12B are from the Downtown Historic District, the east leg of Tideland, and the top of Telephone Hill. At center-left of Figure 12A, there is glaciomarine terrain (WG), and a rock outcrop (R) at Telephone Hill. Southeast of these two upslope areas, the terrain has been extensively human-modified (A). In this case, new ground was made from fill to create more space for the townsite development. These three areas together (except for the steep colluvial sideslopes of Telephone Hill) result in a *Moderate* hazard designation along the shoreline. In this case, a large landslide originating from the *Severe* terrain upslope of South Franklin Street (including the apparently mining-related events of 1920 and 1936) could have the potential to affect the *Moderate* terrain, but no obvious signs remain below South Franklin Street.

No mass movement events appear to have crossed South Franklin Street recently, and it is possible that the drainage and retaining structures erected along Gastineau Avenue could mitigate the extent of future landslides, at least at the 1920 landslide location. Nevertheless, the lower edge of the *Severe* terrain has been adjusted to be located downslope of South Franklin Street to account for the possibility of debris having been cleaned up and not seen on the imagery (Figure 12B). See Technical Memos #3, #6, and #7 (Appendix C in the main report; Tetra Tech 2022c, 2022f, 2022g) for more information about the slopes on Mt. Roberts.

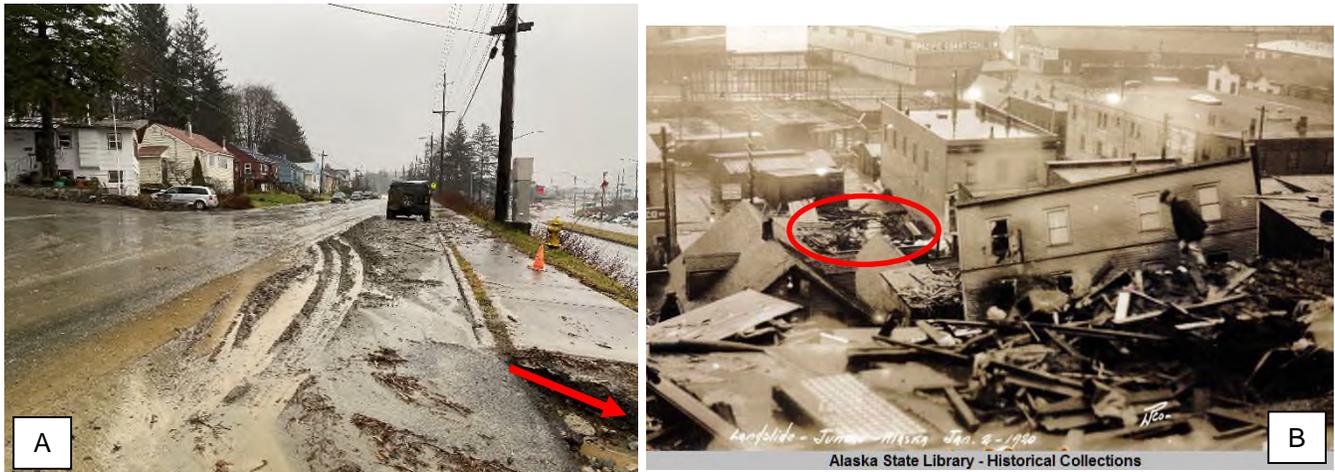
Figure 13: These photos are of *Moderate* terrain. Figure 13A is looking southeast along Glacier Avenue on December 4, 2020, where Ross Way enters. Ross Way carried debris and water from Behrends Avenue to Glacier Avenue. Debris can also run southeast on Behrends Avenue. Note the apparently eroded and failed section of the sidewalk (at red arrow) where a section of concrete slab was missing. Figure 13B is looking downslope towards South Franklin Street (formerly Front Street) on January 2, 1920, after a major landslide from upslope of Gastineau Avenue. The red circle shows possible landslide debris across the street. (Photo credits: Figure 13A: CBJ December 4, 2020. Figure 13B: Alaska State Library – Historical Collections, [ASL-P109-42](#), Katherine Shaw 1920. ASL 2022b.)

On South Franklin Street (formerly Front Street), debris has sometimes crossed the road, for example, during the November 22, 1936 major landslide when debris reached the Juneau Cold Storage building, or as seems to have happened during the January 2, 1920 landslide, based on the photo in Figure 3B. However, these appear to be relatively rare events and, in the case of the 1920 landslide, seem to have been aggravated by a leaky flume from the Alaska Juneau Gold Mining Company (AJGMC) and, in 1936, was possibly aggravated by an oversteepened fill/spoil slope, also mining-related. The October 1, 1952 landslide resulted in debris blocking South Franklin Street.

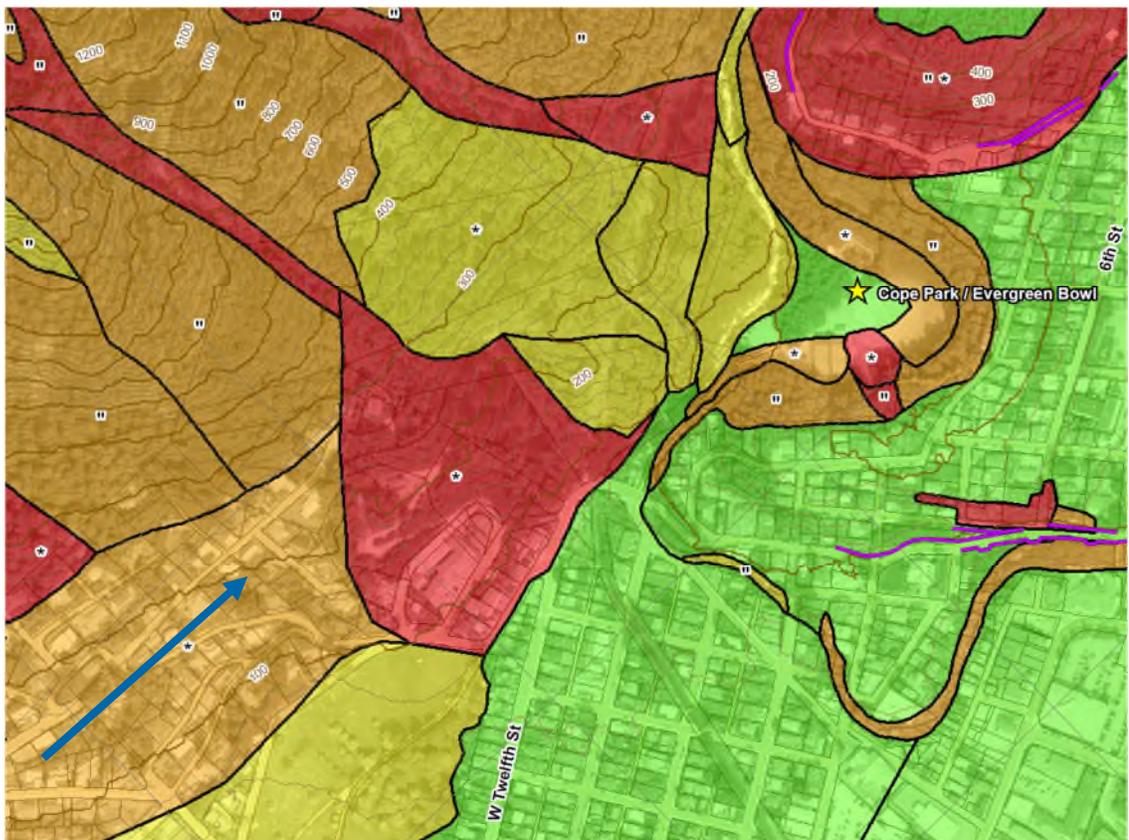
Figure 14: Excerpt from the landslide hazard mapping. Blue arrow on Figure 14 is direction of look on Figure 15, and back end of arrow is lower edge of photo in Figure 15. (See also Figures 9 and 11 for connecting map areas.)

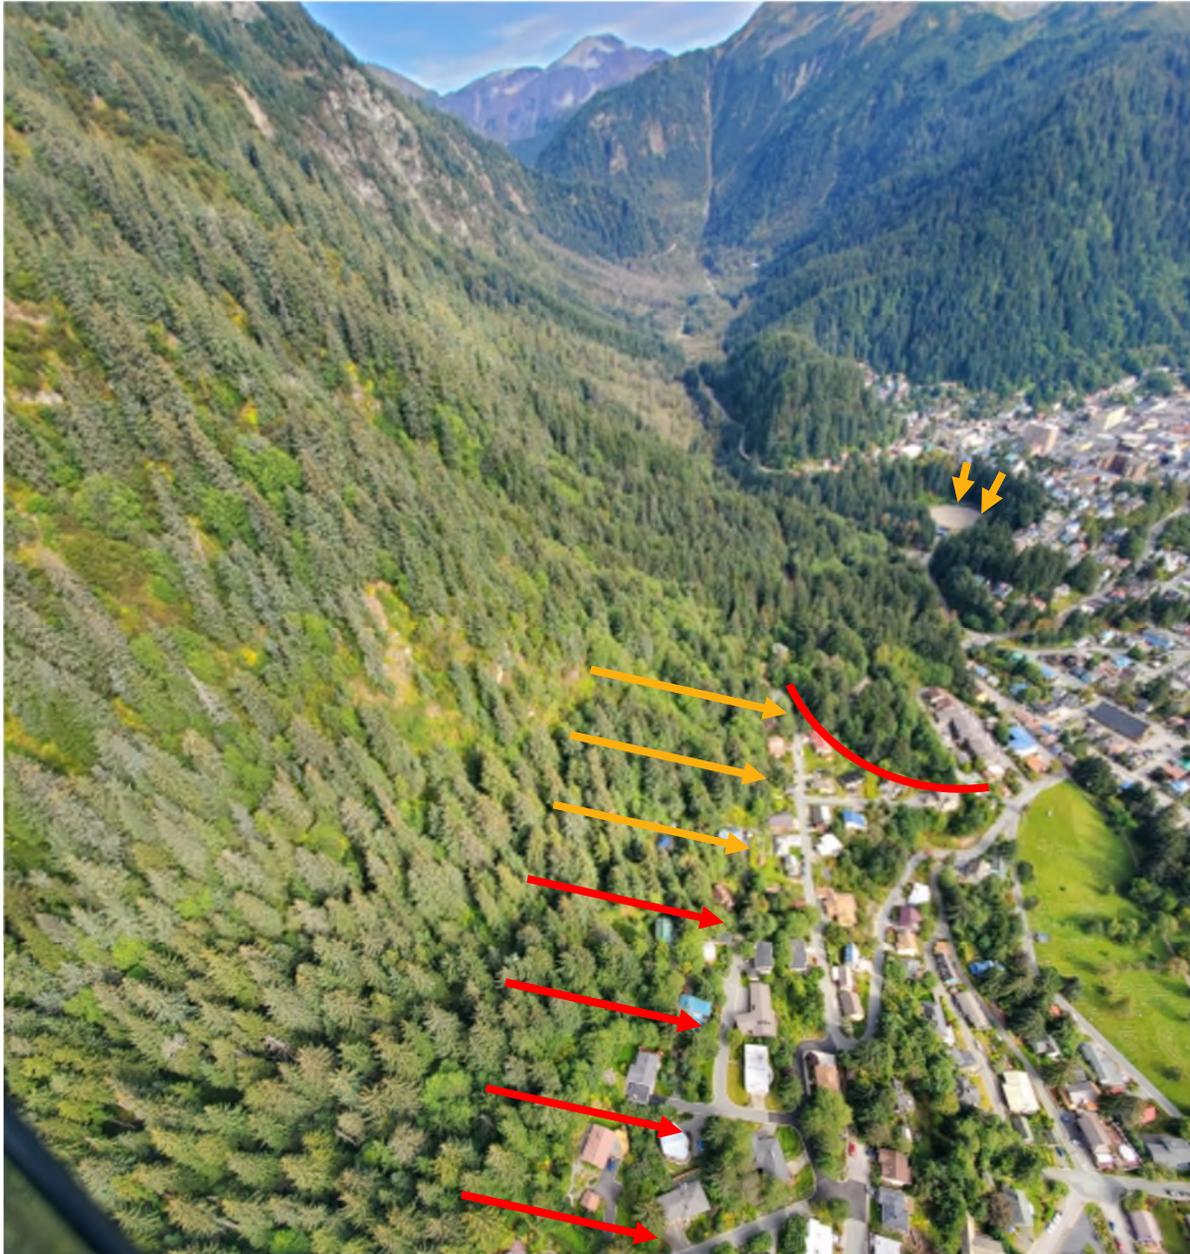
Figure 15: View from the helicopter looking east towards Last Chance Basin (see direction of look on Figure 14). Upper Evergreen Avenue is approximately in line with direction of look.

Most of the residential area in the foreground of Figure 15 is in *High* hazard zone. The upper ends of the road stubs in the foreground are mapped as *Severe* hazard (red arrows). Moving further east of the hairpin turn of Evergreen Avenue (further away from the camera), the upslope terrain is in *High* hazard zone (orange arrows) until the Bathe Creek fan/cone, where trees obscure the east end of Evergreen Avenue along the west edge of a large gully (near side outlined in red). The cemetery, which is the verdant green space at the lower right edge of the photo, is in *Moderate* hazard zone. The orange arrows at Cope Park (in the middle distance) show that most of the slope around the park is mapped as *High* hazard. See Figure 14 for more hazard mapping details. See Figure 16 for a close-up view of the slopes at Cope Park. See Technical Memo #2 (Appendix C in the main report; Tetra Tech 2022b) for more information about the Bathe Creek area.

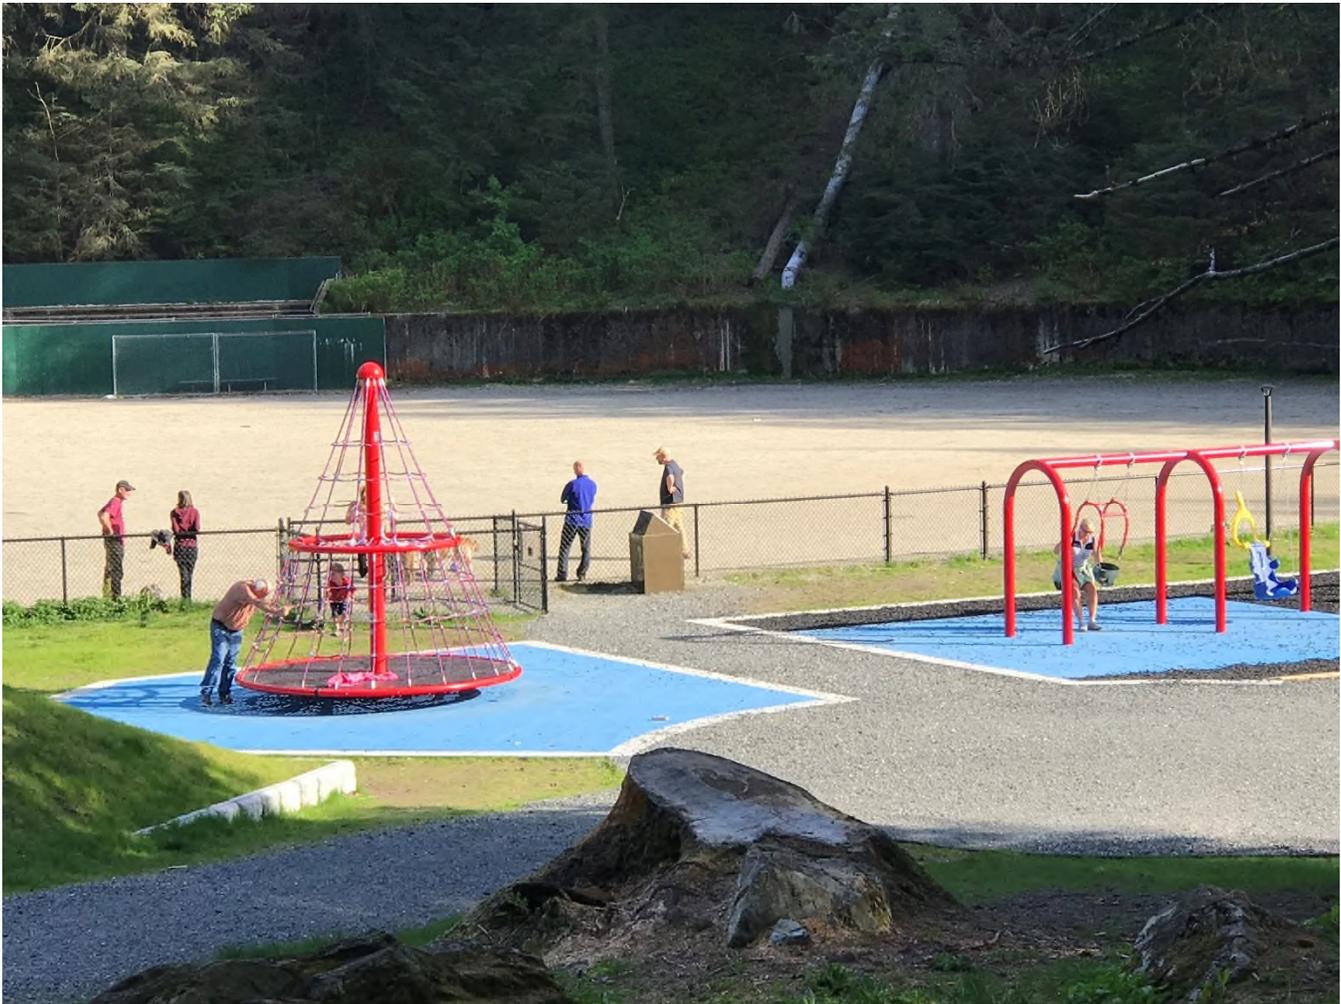
Figure 16: Looking southeast at the steep slopes around Cope Park at the ball diamond. Note the retaining wall at the toe of slope here, which is mapped as having a *High* hazard. (Photo credit: [CBJ Parks & Recreation 2022.](#))
