To: Teri Camery (CBJ) **Date:** April 27, 2022
c: Scott Ciambor (CBJ) **Memo No.:** 4
From: Rita Kors-Olthof, Alan Jones, Vladislav Roujanski **File:** 704-ENG.EARC03168-02A
Subject: Guide to Avalanche and Landslide Hazard Designations
Downtown Juneau Landslide and Avalanche Hazard Assessment

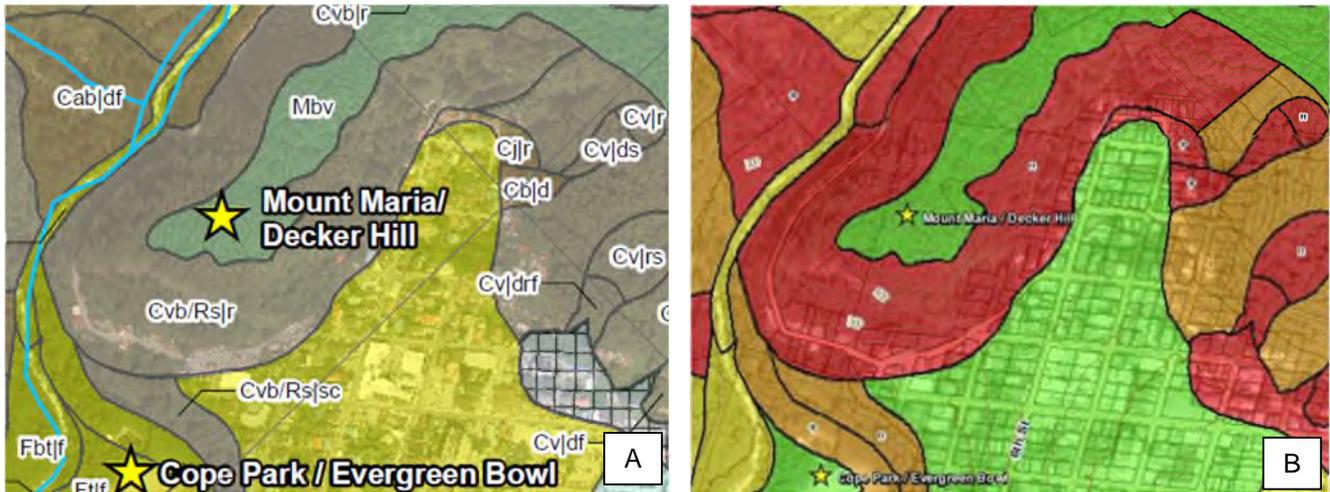
Figure 17: These two map excerpts are from the mapping slopes above Starr Hill. Figure 17A shows the surficial geology, and Figure 17B shows the landslide hazard designation mapping. Around Starr Hill, the green signifies *Low* hazard, the orange is *High* hazard, and the red is *Severe* hazard. See Figure 18 for the landslide seen in the *Severe* hazard area above Nelson Street. More information about this area is available in Technical Memo #3.

Figures 17B and 19D are hazard maps, which indicate areas that are potentially hazardous. If there was a lot of potentially hazardous geomorphic process activity on a slope, or if new activity was identified in the field, that area was mapped as having a *Severe* hazard. For instance, debris could be building up on the slope directly above a house (Figure 18), or in a location where debris can potentially run towards a house, and where it could become a more serious hazard in the future (Figures 20B and 20D). Smaller debris slides and debris flows tend to accumulate debris material in wedges within gullies. Eventually, when a critical level of debris accumulation is reached, or a significant precipitation event occurs, all that stored debris is scoured out of the gully, potentially resulting in a very large debris flow event. Similar events can occur on open slopes where slide debris piles up in lobes over days, months, or years, sometimes separated by channels of faster-flowing loose material. These debris lobes can slowly be creeping downslope, until the critical moment when there is enough mass and enough water to trigger the debris flow rapidly downslope. See also Technical Memo #2 for more mapping examples (Appendix C in the main report; Tetra Tech 2022b).

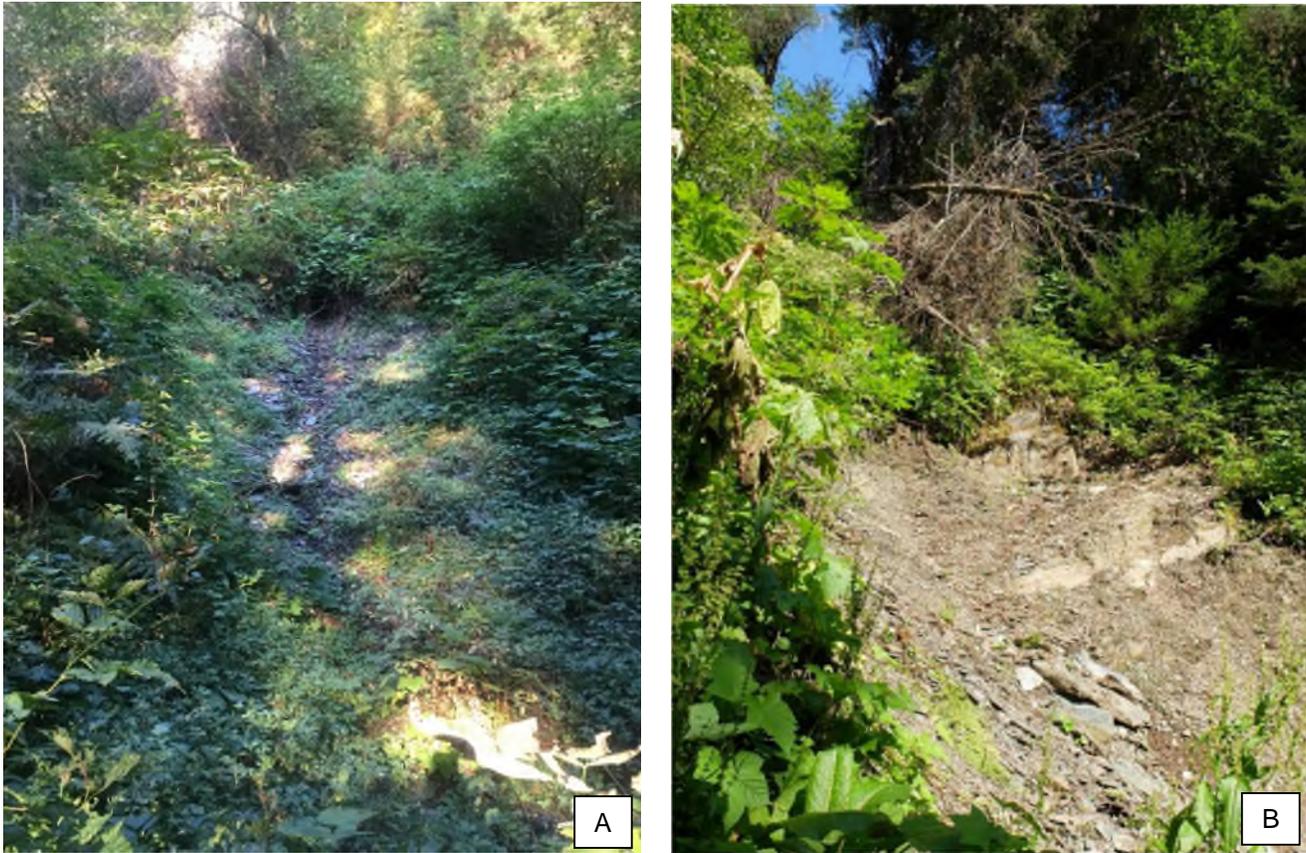
Figure 18: Compares Tetra Tech’s photo from September 10, 2019 (Figure 18A) with residents’ photo from August 1, 2021 (Figure 18B) at the same location. Slope instabilities appear to be ongoing in the historical slide paths located above Nelson Street on a slope with a landslide hazard designation of Severe. See Technical Memo #3 for more information about the slopes around Starr Hill.

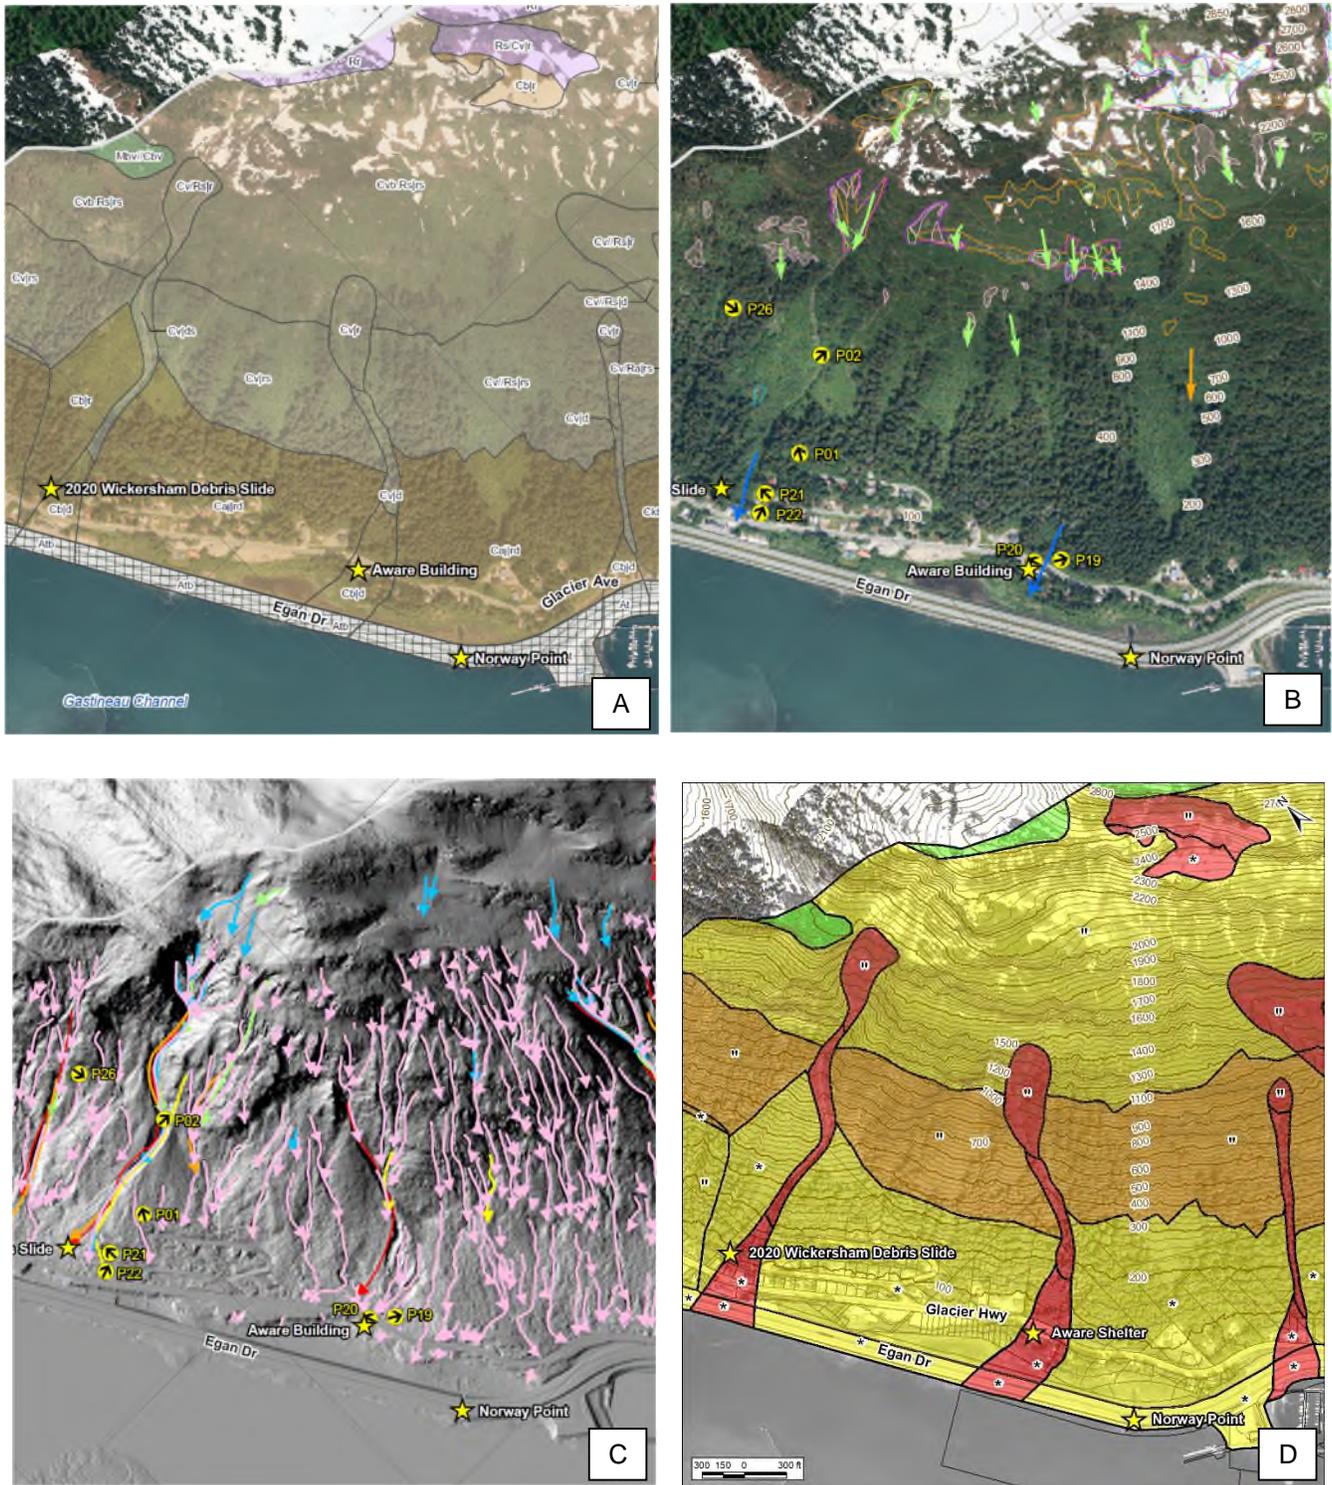
Figure 19: These excerpts are from the mapping at the slopes at the White Subdivision. Figure 19A shows the surficial geology, Figure 19B shows the slope movement features, Figure 19C shows the gully erosion features, and Figure 19D shows the landslide hazard mapping. The Wickersham slide (Figure 20) is related to a very active gully erosion feature in Severe hazard.

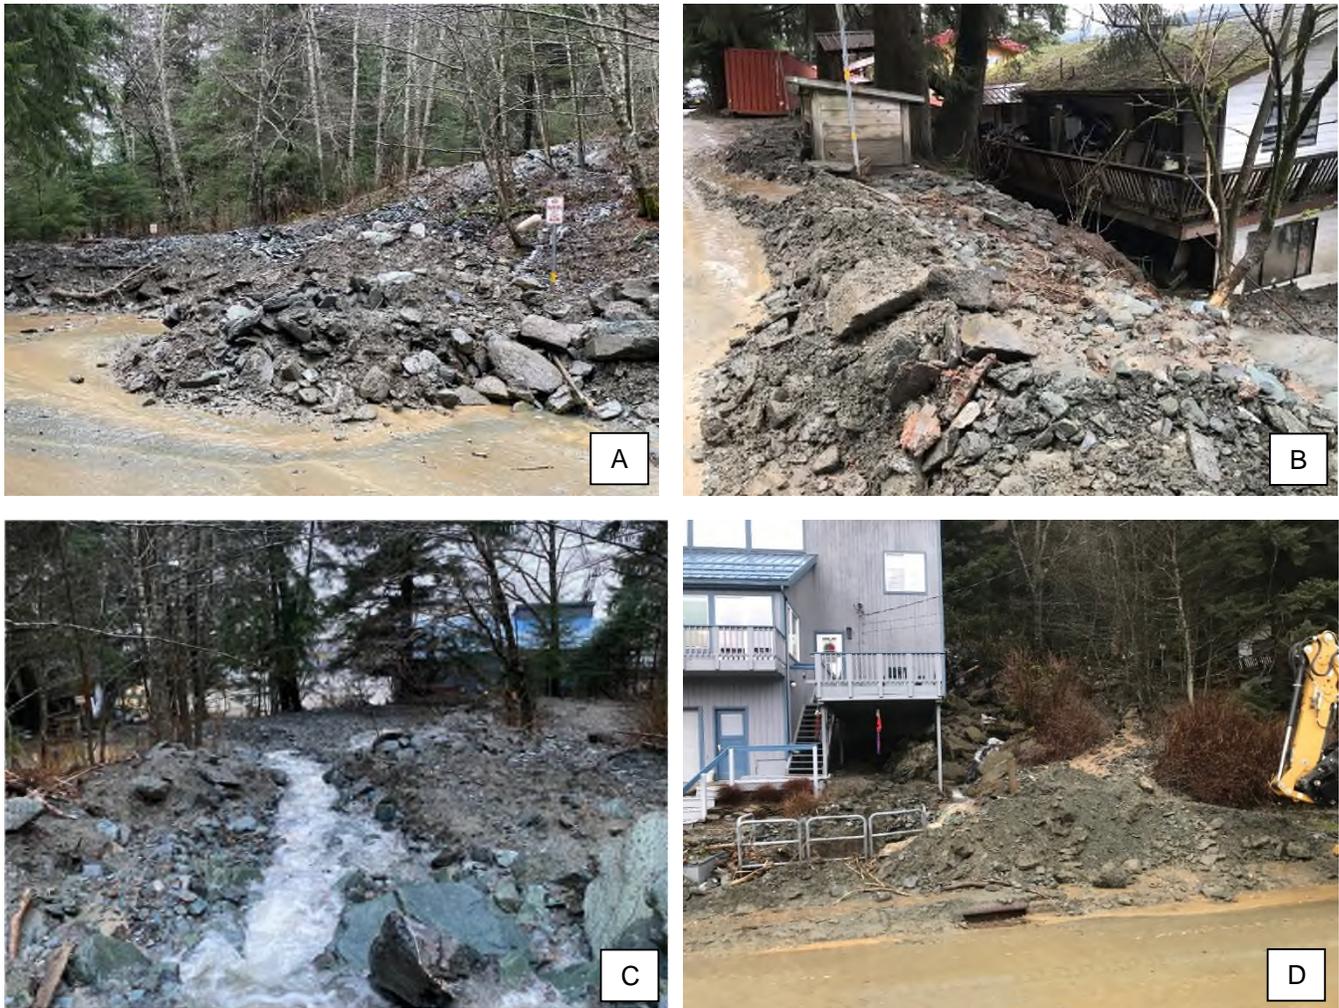
Figure 20: The Wickersham debris slide in the White Subdivision is an example of a landslide in terrain with a Severe landslide hazard designation. Figure 20A: Part of the debris deposit at the northwest end of Wickersham Avenue on the uphill side; Figure 20B: Debris on the downhill side of Wickersham Avenue; Figure 20C: Debris running down along the swale between Wickersham and Glacier Highway; Figure 20D: Debris deposit at Glacier Highway, filling a concrete sump behind the railing. (Photo credits: CBJ December 4, 2020.)

Figure 20 shows the aftermath of a large debris slide, after the roads had been mostly cleared. The debris was up to 8 feet thick at Wickersham Avenue, crossing Wickersham to impact a residence, filling a drainage path to Glacier Avenue, filling a drainage sump, and flowing out onto Glacier Avenue. By the time the photo in Figure 20C was taken, the water was running clear again. More debris is visible on the right, where it ran down to Glacier Highway.
