CONCRETE FLOAT BREAKWATER INSPECTION
CITY AND BOROUGH OF JUNEAU, HARBOR MAINTENANCE
Juneau, Alaska

1. INTRODUCTION

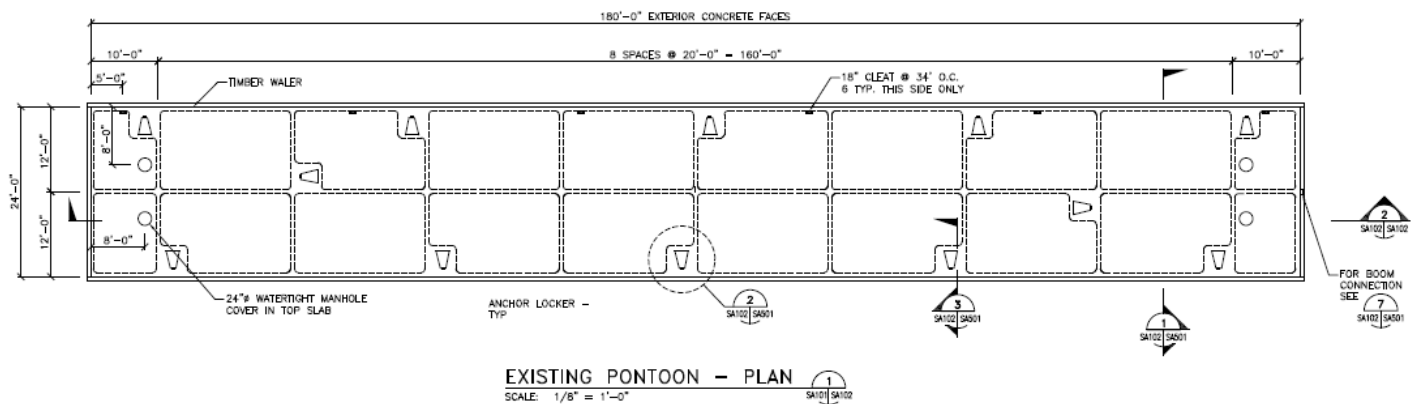
No discrepancies were found between the plans provided and the dive inspection.

Figure 1 – Breakwater design.

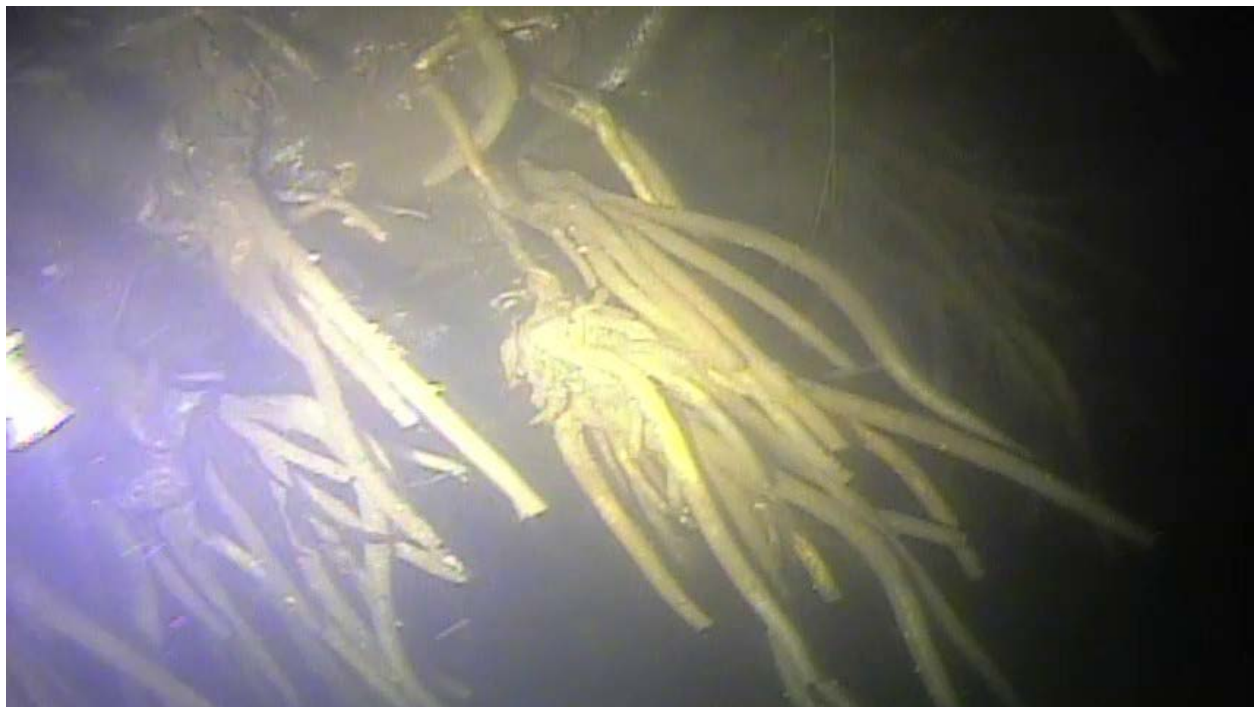
The float appears to be in excellent condition, with no signs of damage. The perimeter has a 1" chamfered edge around the bottom of the structure. With the exception of light marine growth and typical rust staining, the breakwater is in "as-built" condition.

Image 2 – Light marine growth with tubeworms throughout the surface.

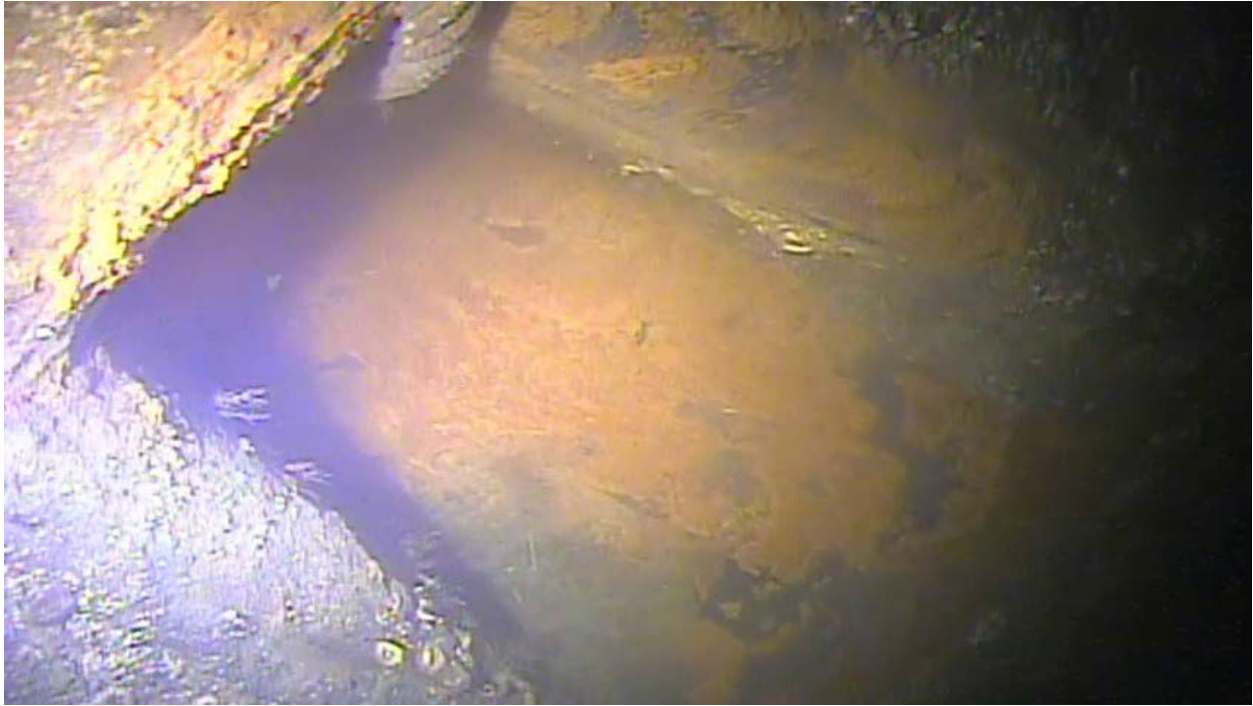
Image 3 – Typical chain hoist, very good condition with no damage noted.
