WAYSIDE PARK FLOAT INSPECTION
CITY AND BOROUGH OF JUNEAU, HARBOR MAINTENANCE
Juneau, Alaska

City & Borough of Juneau
Docks & Harbors
76 Egan Drive
Juneau, Alaska 99801
907-586-0398

Global Diving & Salvage Inc.
5304 Eielson Street
Anchorage, AK 99518
907-563-9060

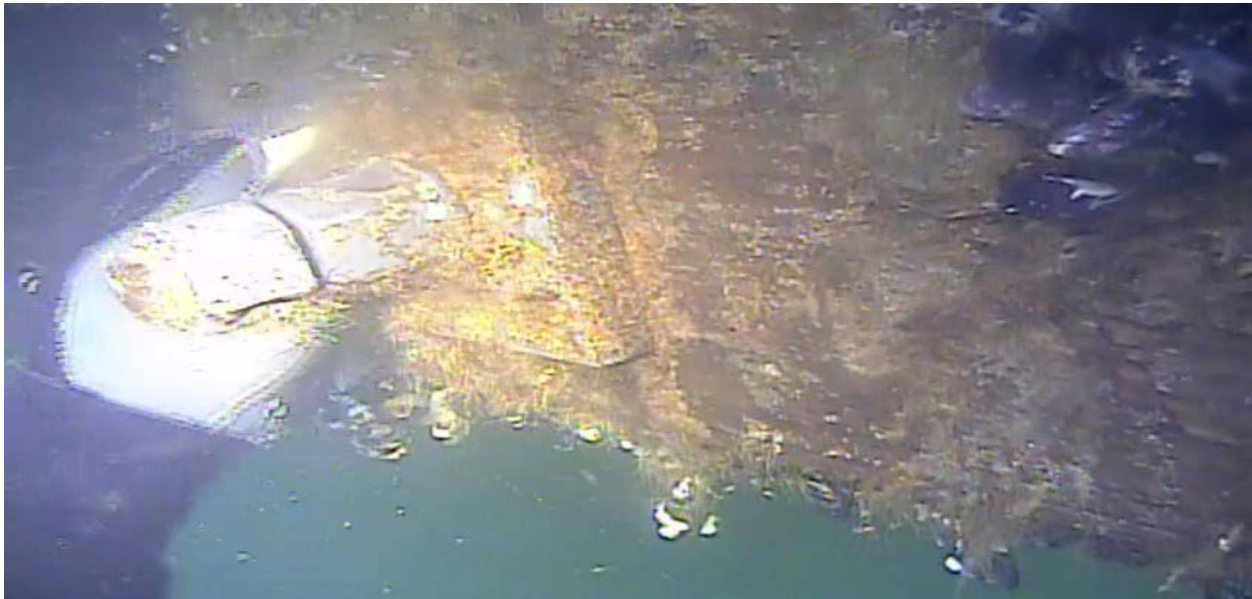
Figure 1 – Typical perimeter hardware, good condition and tight.

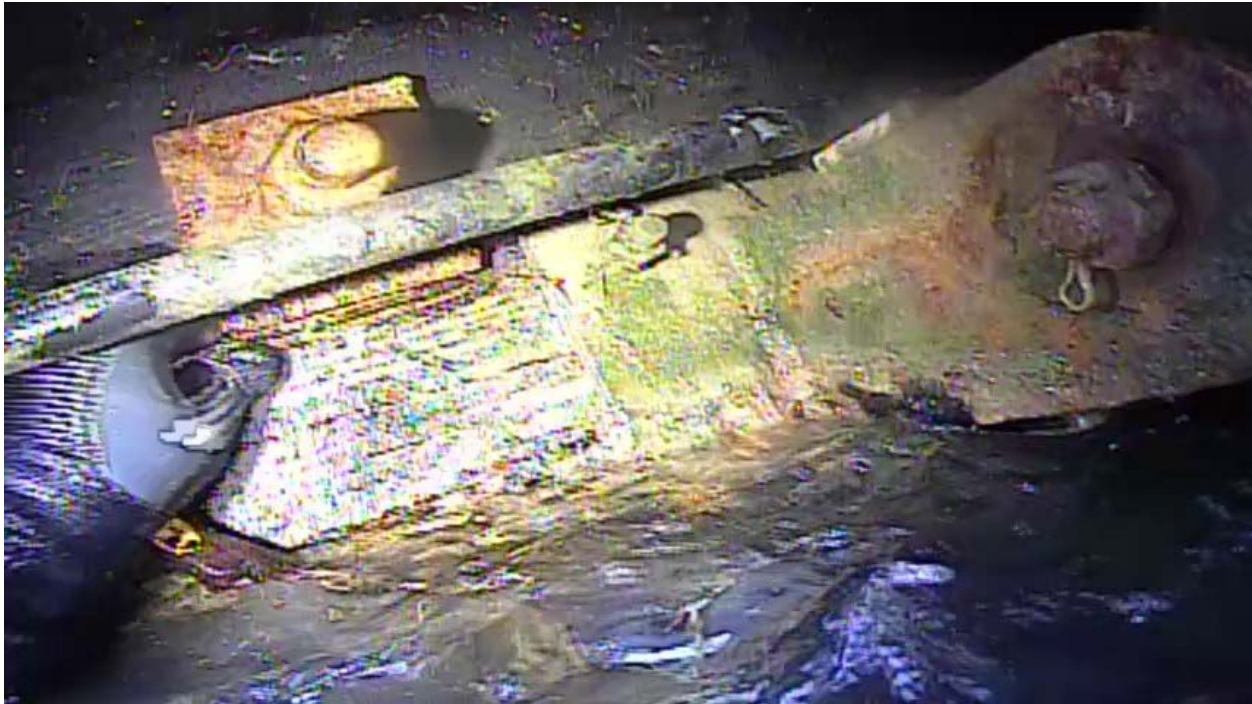
As previously stated, the float does appear to have a bow in the center. The diver inspection the joint at the intersection just to the south of the drive down ramp float, where it connects with the parent float. Cracks were located up to 8 feet in length in the parent float wailer beam. The cracks coincide with the engineer's belief that the float sat down in the southeast corner and caused stress fractures in the support. All of the hardware in this location appears to be intact and, with the exception of light surface corrosion, true to design. At the time of this survey there appears to be no sign of immediate structural failure.

Image 2 – Inshore connection to bridge cracks located at diver's hand and below.

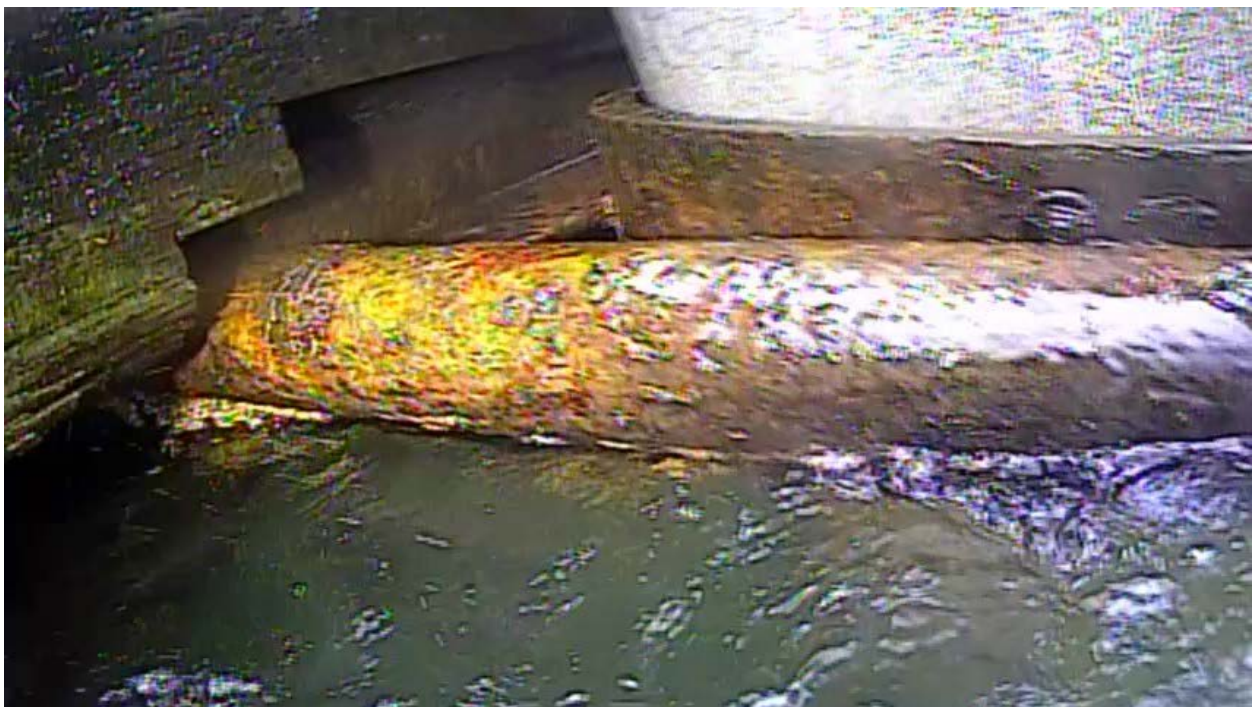
The dock is secured in position by four dolphin-piling locations. The pile hoops securing the dock appear as designed, however the pads are heavily worn and should be replaced before they fail causing the steel hoops and piling interact directly. The wear pads are below 40% remaining and will start to see failure soon, causing metal-to-metal contact. These should be repaired, and if possible repaired with in kind materials.

Image 3 – Standard piling hoop, corrosion and deflection noted
