CBJ Utility General Obligation Bond Projects - 5/29/2024

JD WWTP NEW CLARIFIER BUILDING: \$14.7M The Juneau Douglas Wastewater Treatment plant is a 50-year-old treatment plant that serves Thane, Downtown, and Douglas. It processes about one-third (1/3) of CBJ's wastewater (i.e. one million gallons per day at the JDWWTP and 2 million gallons per day at the Mendenhall Wastewater Treatment Plant). The Utility believed that the clarifier building's roof and structural supports needed to be replaced and added \$7 million to the "JDTP Improvements" CIP for FY26. CBJ hired a structural engineer to assess the building and to provide a rough order of magnitude estimate. However, the structural engineer provided a worst case estimate and stated that it is clear that the structural steel that supports the clarifier building is severely corroded and that the entire building needs to be replaced. This estimate included replacing expensive concrete beam supports. The structural engineer will conduct a site visit in June to confirm the extent of the needed structural work. An initial design cost should be available in July. The clarifier building consists of a 78' wide by 160' long room that con

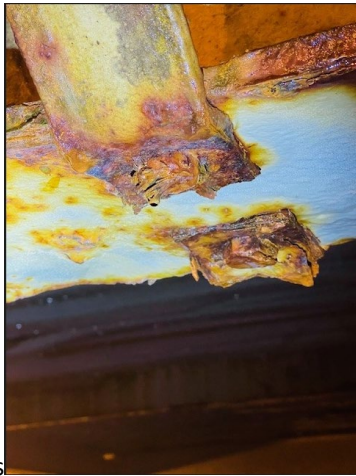
1. Corrosion of steel and kicker bracing.

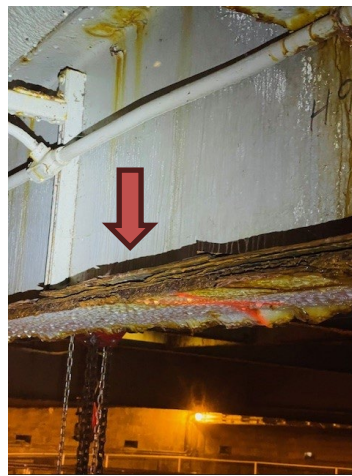
2. Corrosion at primary structural I-beam. Note significant corrosion at bottom flange causing delamination of the steel.

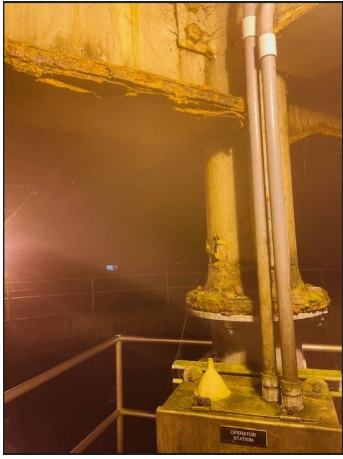
3. Corrosion of the steel beam and connection at the clarifier basin.

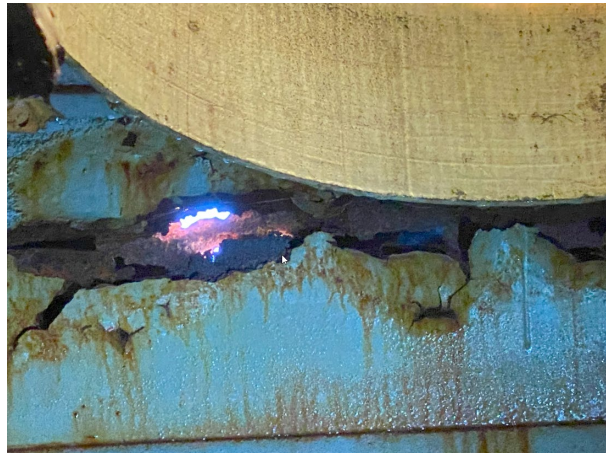
4. Corrosion of metal framing at the roof vent exhaust opening. Note daylight showing.

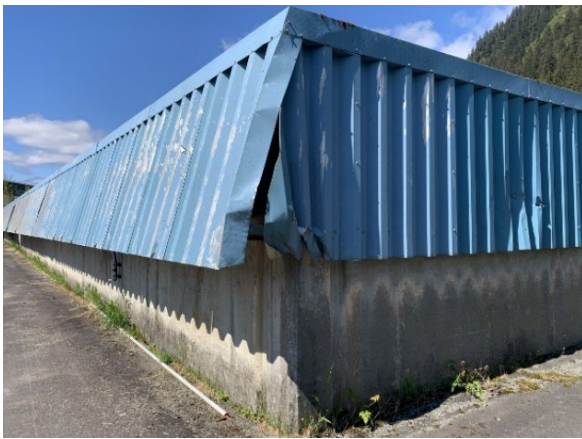
5. Numerous holes and gashes in 1973 metal siding are open to the interior of the building.

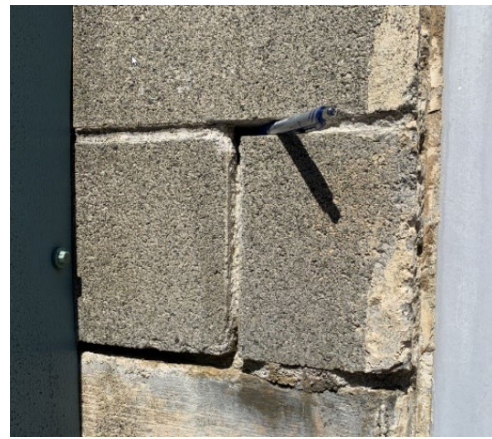
6. Mortar at concrete blocks has deteriorated. Spalling due to winter freeze-thaw cycles evident.

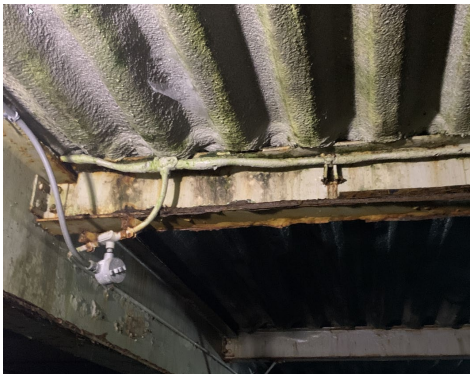
7. Underside view of metal roof decking. Foam insulation is saturated with water. Note algae growth.

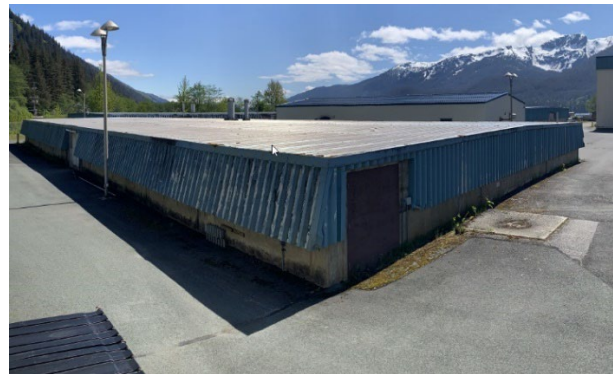
8. Low slope metal roof missing fasteners, lacks water drainage via gutters and downspouts.

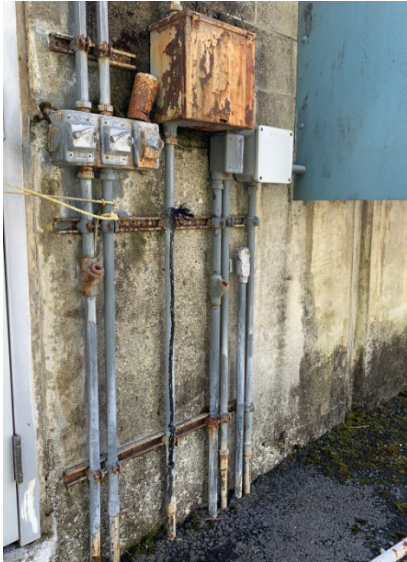
9. Switches & Conduits show heavy corrosion at exterior wall mounts.

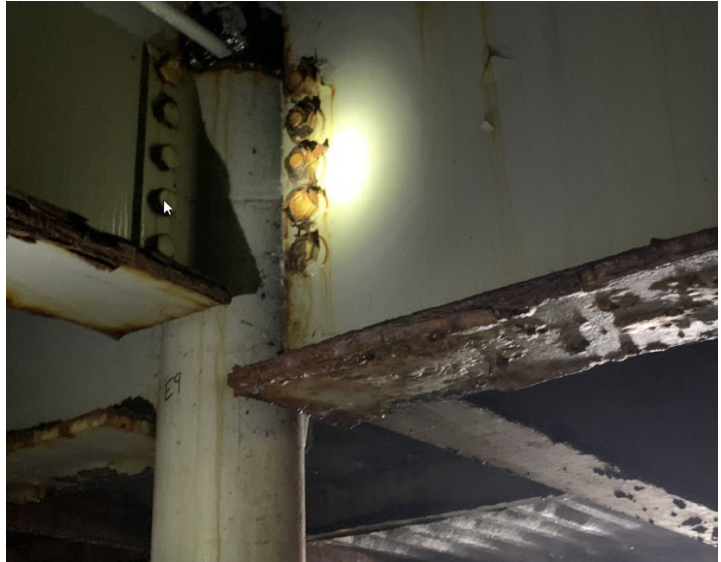
10. Corrosion at connecting bolts. This is the central 9" diameter support column for the roof between the two effluent tanks.
