**SITE CHARACTERIZATION INVESTIGATION
CULTURAL IMMERSION PARK
4400/4402 THANE ROAD, JUNEAU, ALASKA
FILE #1513.38.125
HAZARD ID 27727
MAY 22, 2023**

City and Borough of Juneau, Docks & Harbors
155 S. Seward Street
Juneau, Alaska 99801

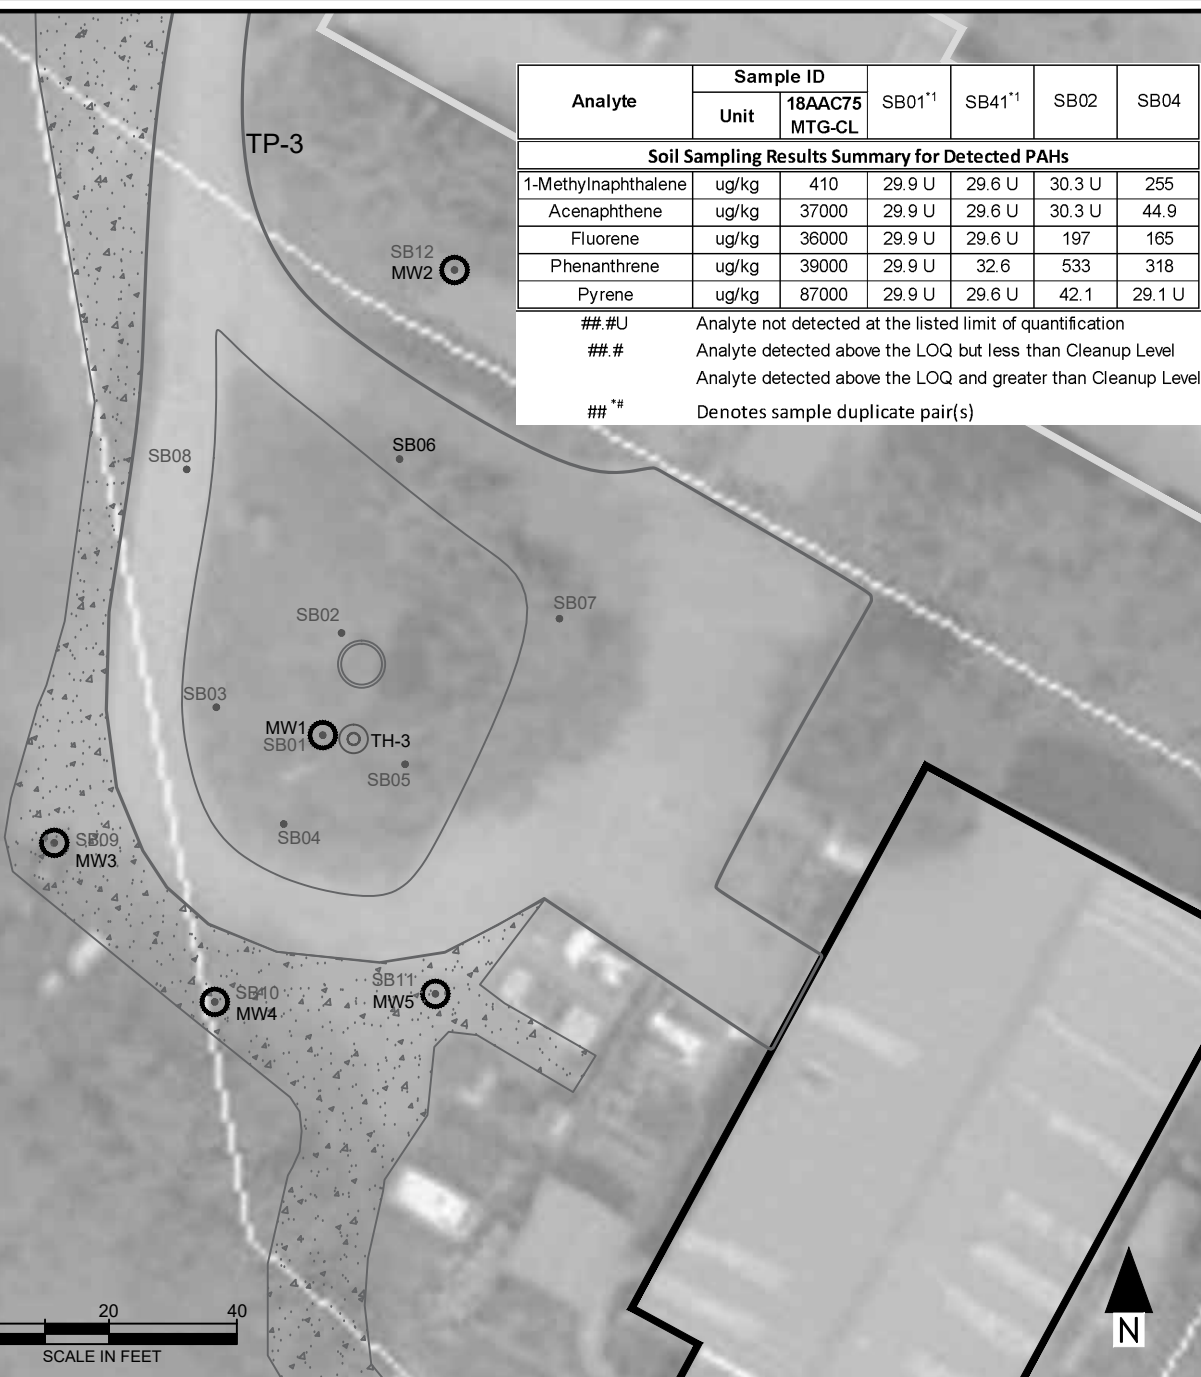
FIGURE
3

DRO was detected in a total of five borings (SB-01 through SB-05) with concentrations that ranged between 29.5 mg/kg and 2150 mg/kg. Four samples (SB-01 through SB-04) and the sample duplicate (SB-41) had DRO concentrations exceeding the migration to groundwater (MTG) cleanup level (CL) of 230 mg/kg (Table 3, Appendix 2). GRO was detected in a total of two samples with concentrations of 3.18 mg/kg and 5.66 mg/kg, both well below the MTG-CL of 260 mg/kg.

The highest DRO concentration (2150 mg/kg) was found in SB02. SB02 was also the only soil boring to yield a field screening reading above the project fsal in the upper five feet of the soil surface (see Boring Log for SB02 in Appendix 4). The impacted area is shown in Figure 5, Appendix 1. Clean soil limits, or the extent of the impacted area, are defined by samples SB06

Sample Locations and Laboratory Results Diagram
CBJ D&H Immersion Park Site Characterization Investigation
4400/4402 Thane Road, Juneau, Alaska

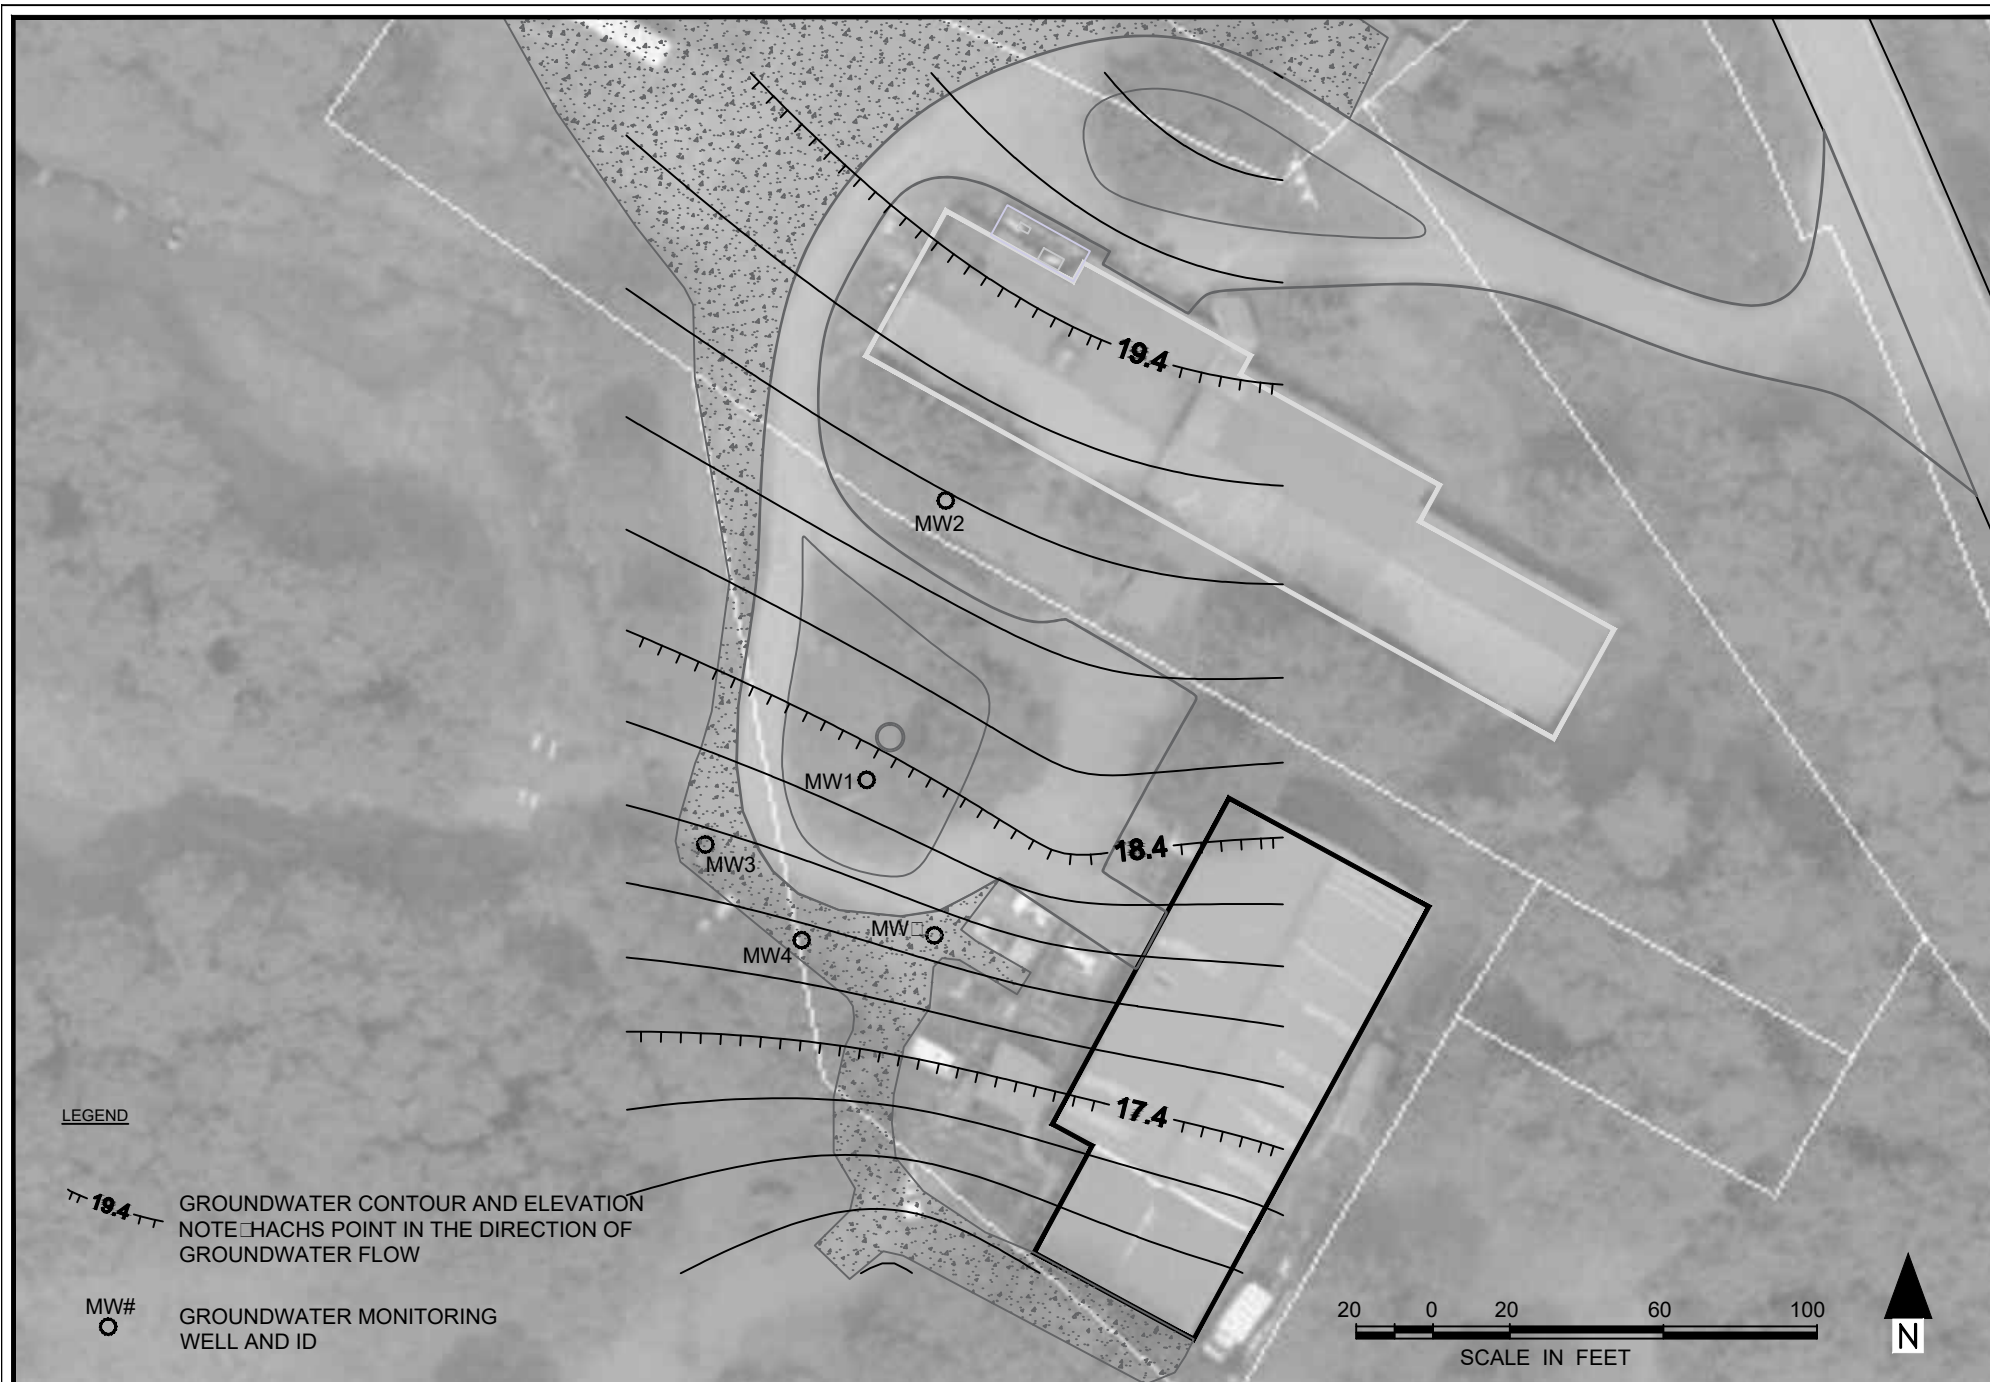
FIGURE
4

Groundwater beneath the Site exists within an unconfined aquifer within the tailing deposits. The groundwater elevation is directly influenced by precipitation, surface infiltration, and runoff from the mountain slopes to the northeast. During periods of high precipitation and/or seasonal snow melt, significant recharge to the aquifer occurs and the water table rises to less than five feet below the ground surface. Groundwater beneath the Site flows in a south direction at a hydraulic gradient of 0.02875 feet per foot.

Groundwater Gradient Map (4/27/2023)
 CBJ D&H Immersion Park Site Characterization Investigation
 4400/4402 Thane Road, Juneau, AK.

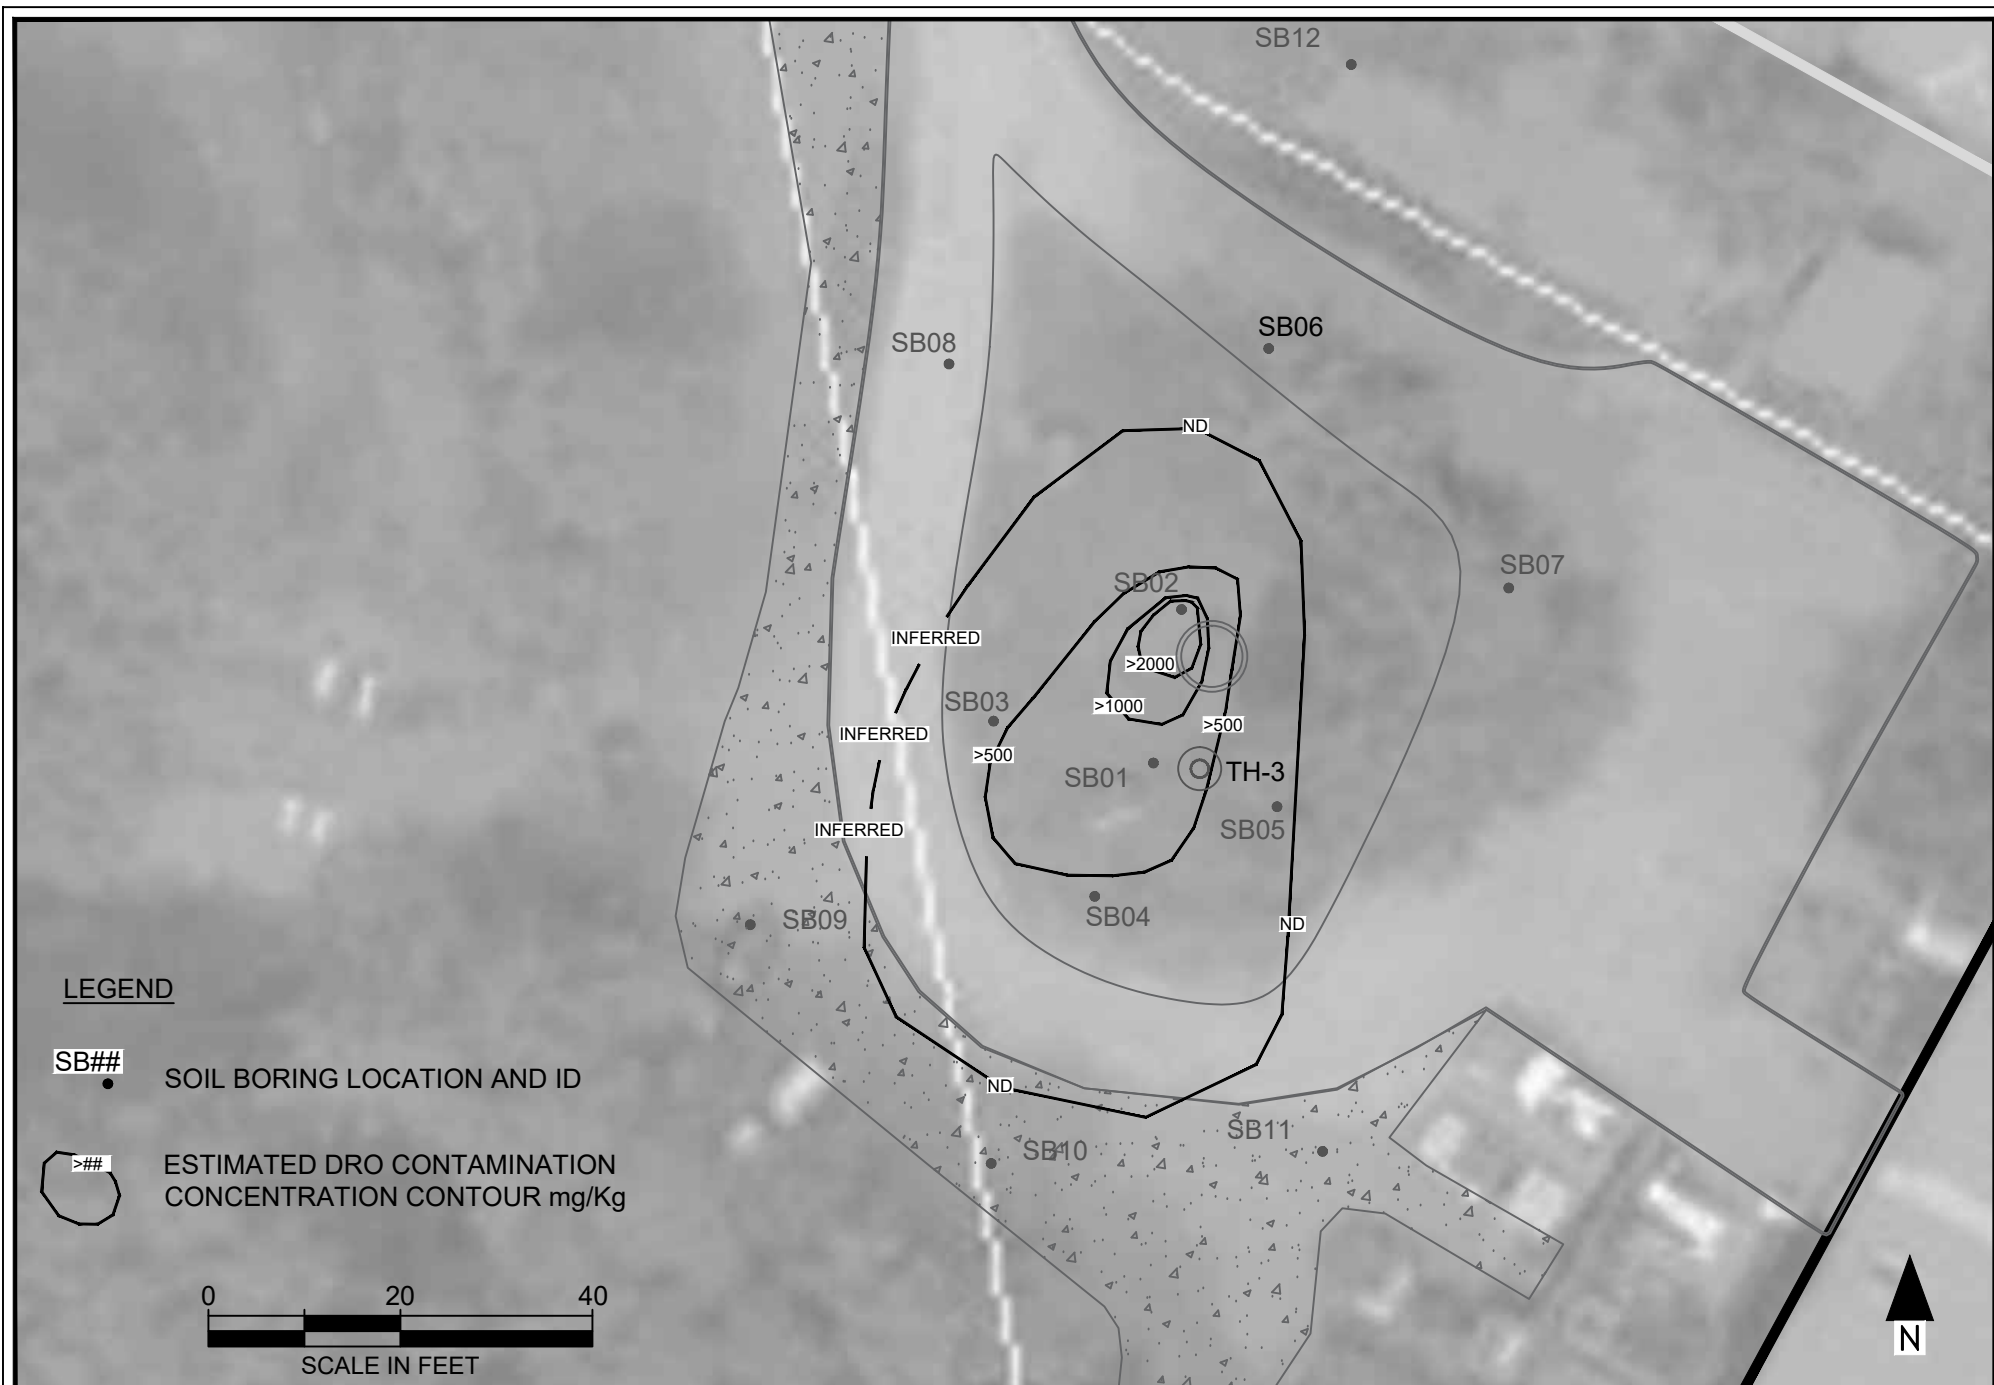
An estimated volume of between 250 and 470 cubic yards soil contamination remains in place at the Site. No definitive source for the contamination has been noted. Laboratory results indicate soil contamination has not impacted Site groundwater in concentrations above Table C Cleanup Levels. The Conceptual Site Model indicates that open exposure pathways are unlikely to impact human health or the environment. **NORTECH** recommends that CBJ Docks and Harbors consider either full site remediation, or negotiating institutional control measures with ADEC.

Estimated Limits of Soil Contamination
CBJ D&H Immersion Park Site Characterization Investigation
4400/4402 Thane Road, Juneau, Alaska

Soil contamination is located four or more feet below ground surface. Laboratory samples indicate that soil contamination is currently impacting Site Groundwater, and the Conceptual Site Model indicates potentially open exposure pathways are unlikely to pose a risk to human health or the environment. Based on these findings, **NORTECH** recommends that CBJ Docks and Harbors either consider Site remediation via excavation or negotiating institutional control measures with ADEC.

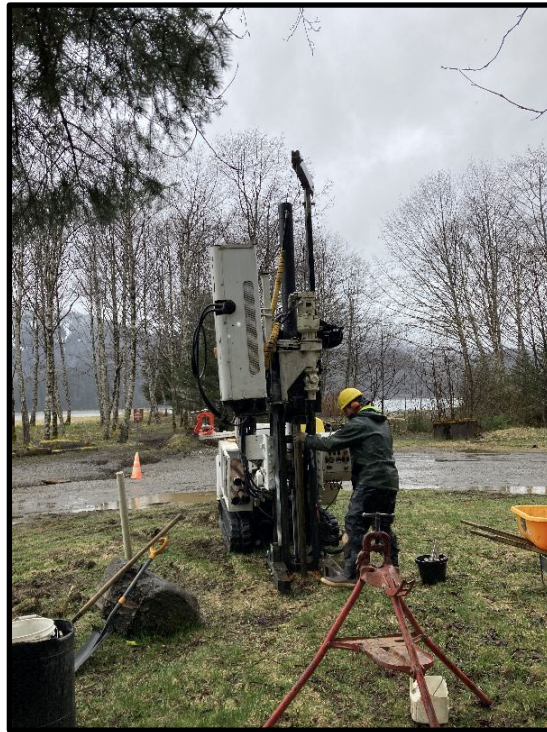
Photo 1: Looking south at soil boring SB01 being advanced next to the 2019 G.E.C. water sampling point TH3 (white pipe sticking up from ground left of the drill rig). SB01 was subsequently converted into monitoring well MW1.

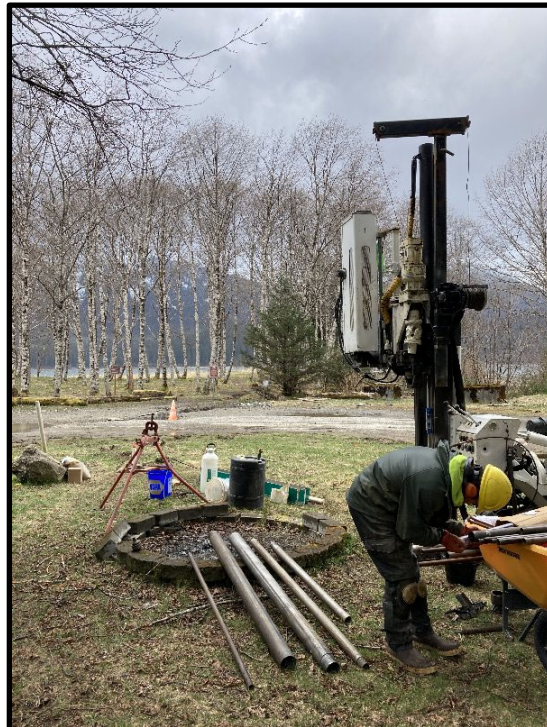
Photo 2: Looking south at soil boring SB02 being advanced next to the fire pit.

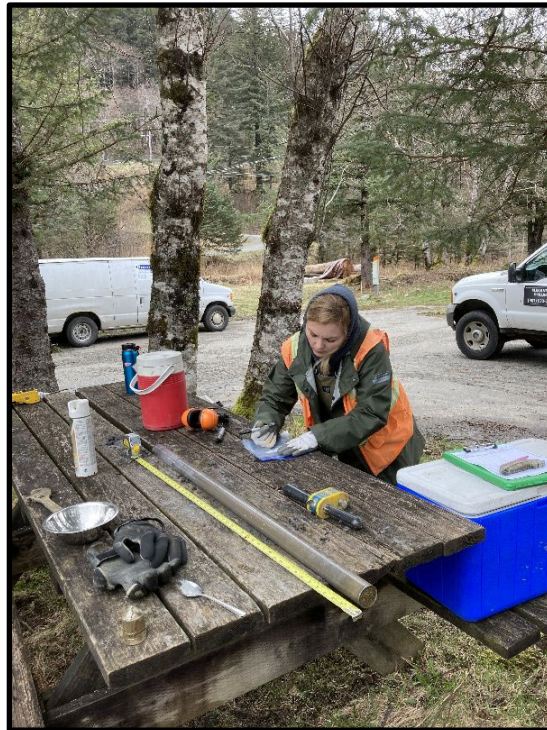
Photo 3: Looking north at a soil core retrieved from soil boring SB02.

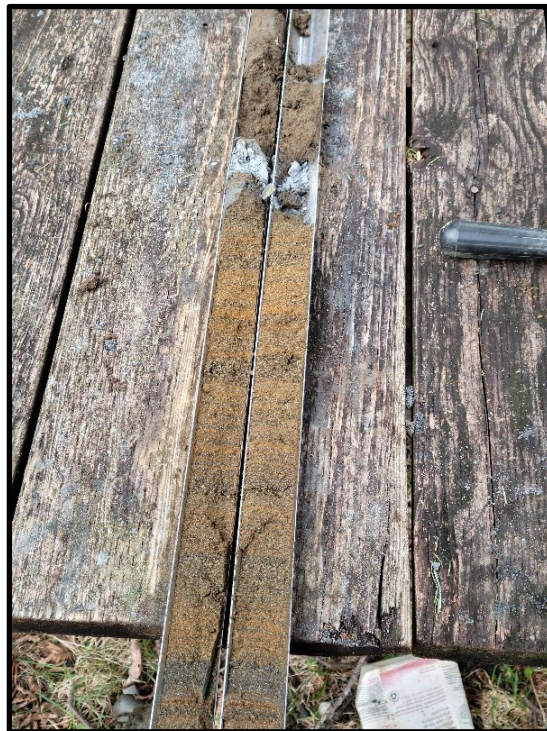
Photo 4: Looking down at the opened soil core retrieved from boring SB02 (0 to 5 feet). Note the coarse sandy tailing soil material.

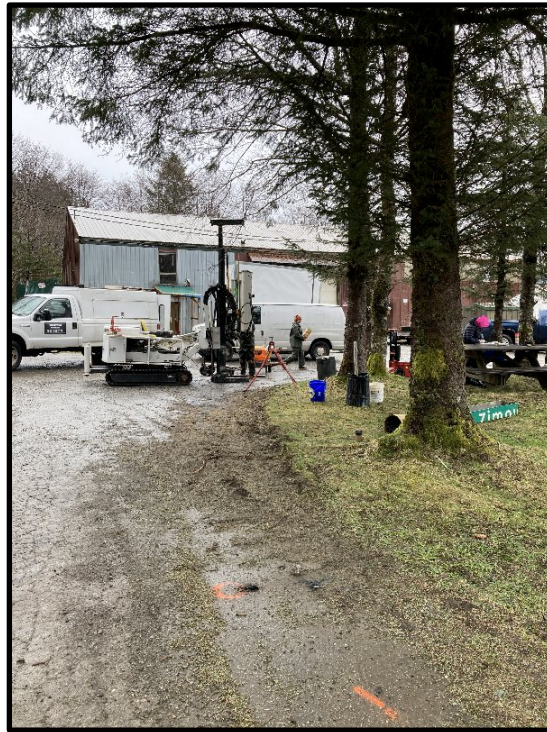
Photo 5: Looking east at soil boring SB07 being advanced. Note the hole for boring SB06 is visible in the foreground.

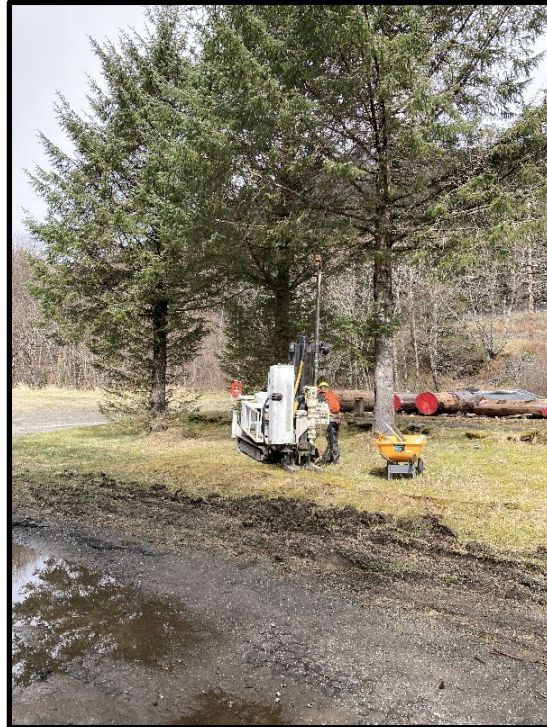
Photo 6: Looking north at soil boring SB12 being advanced north of the paved driveway. SB12 was subsequently converted into monitoring well MW2, the up-gradient sentinel well.

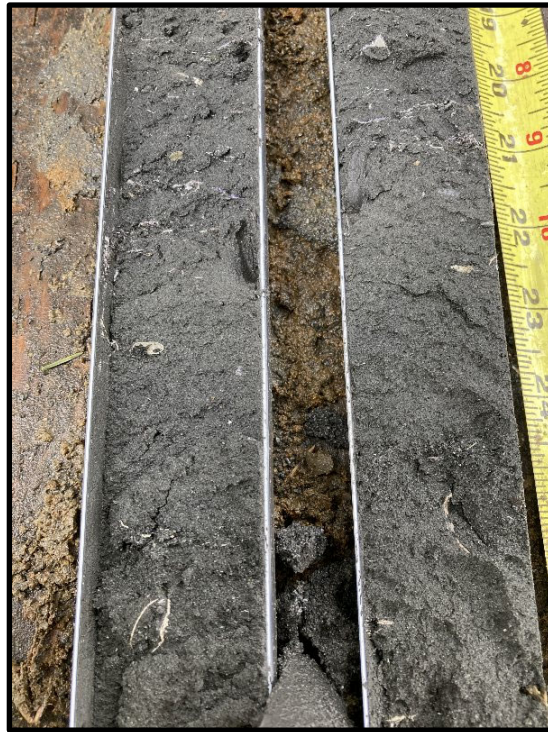
Photo 7: Looking down at a soil core retrieved from boring SB12 (5 to 10 feet). Note the very fine sandy silt with shell fragments is a native marine sediment which directly underlies the sandy tailings soil material.
