June 10, 2022

Subject: Notice of Noncompliance (NON) resulting from site visit for the closed CE Land Landfill located at 512 East Ann Street, City of Kaukauna, Outagamie County, Wisconsin, DNR License No. 0073

COMPLIANCE MONITORING  
AND EVALUATION FORM

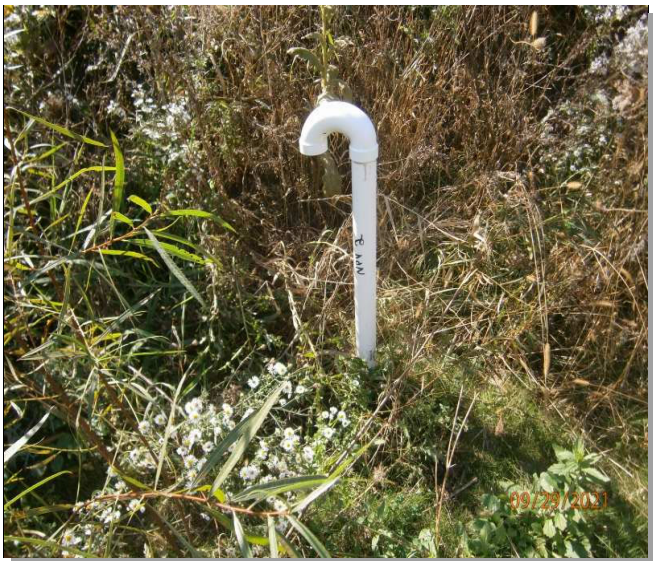
Photo # 82601 Photo 1 of 10

example of passive gas vent

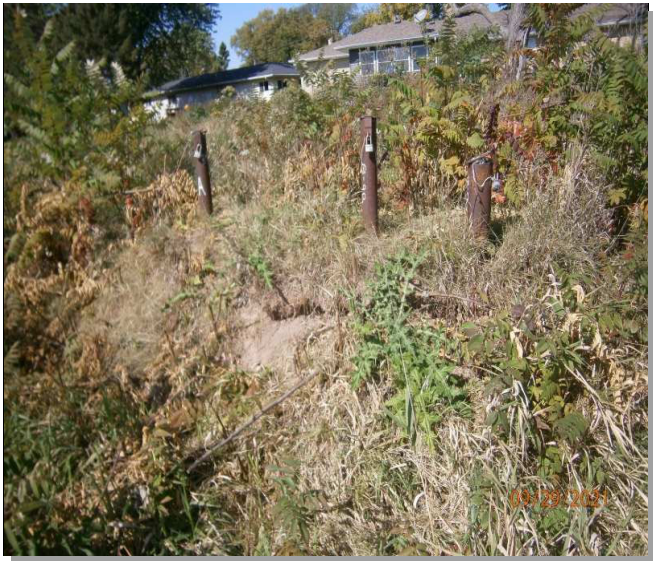
Photo # 82602 Photo 2 of 10

example of monitoring wells that are locked, labeled, and secured

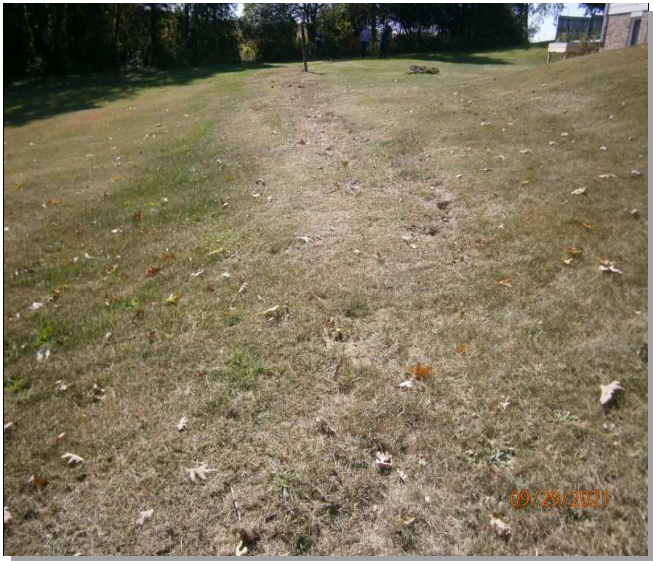
Photo # 82603 Photo 3 of 10

| <b>E. The finished surface of the disposal area is covered with a minimum of 6 inches of topsoil.</b><br>Verhagen trench appears to be lacking vegetation along trench line (on the Vantoll/Armstrong property); it is unclear if the area is lacking topsoil or if there is a gas migration issue; additional follow up is needed | <b>CA</b> | 506.08(3)(d) |

| <b>A. Effective means being utilized to prevent migration of explosive gases generated by the waste fill (e.g. no noticeable gas odors or indication of stressed vegetation, and gas control system operating, if applicable).</b><br>larger northern portion managed by City of Kaukauna has passive gas trenches and passive gas vents; perimeter berm at toe of slope appears to have stressed and or is lacking vegetation on Condo Association side; Verhagen trench appears to have stressed vegetation along trench line (on the Vantoll/Armstrong property); it is unclear if the area is lacking topsoil or if there is a gas migration issue; additional follow up is needed | <b>CA</b> | 506.07(4) |

Area lacking vegetation on area where gas cut-off trench is located on Vantoll/Armstrong property

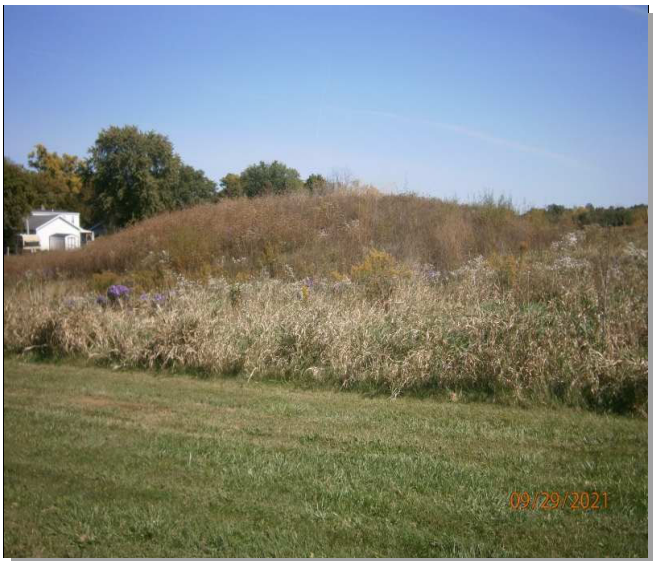
Photo # 82604 Photo 4 of 10

on site soil stock pile seeded and vegetated

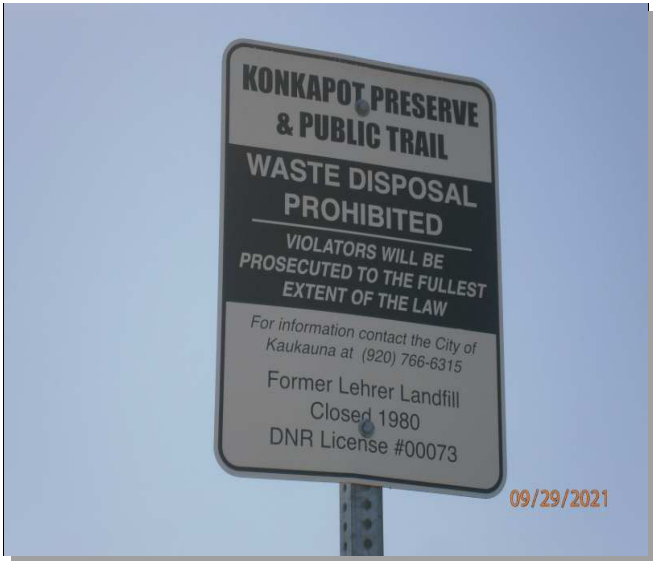
Photo # 82605 Photo 5 of 10

Sign posted denoting public access area

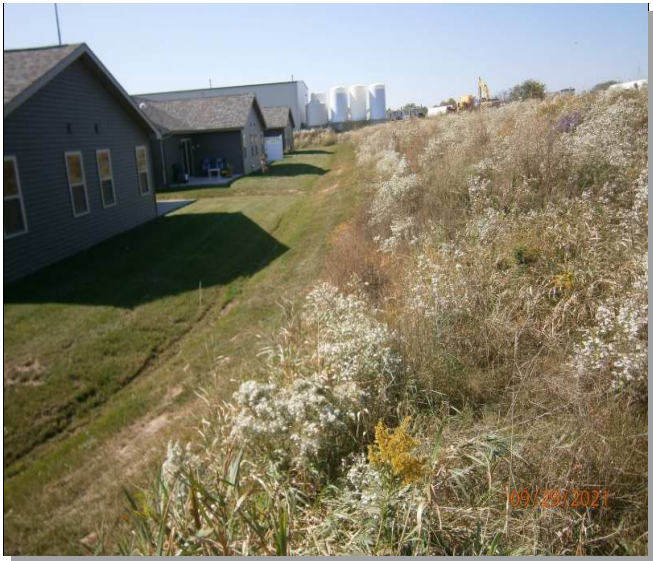
Photo # 82606 Photo 6 of 10

1. Section NR 506.07(4), Wis. Adm. Code, requires effective means be utilized to prevent the migration of explosive gases generated by the waste fill area, and s. NR 506.08(4), Wis. Adm. Code, requires established vegetation. It was noted that there is bare ground on the southwestern perimeter slopes of the landfill along the Coffee Hill condo development. Since it is unclear whether this is a lack of topsoil or indications of migrating gas, the department requests you add at least 6-inches of topsoil, seed, fertilize, and mulch the finished surface. Please monitor the area for the next growing season. If the area does not establish vegetation, additional investigation will be needed.

Areas lacking vegetation and stressed vegetation on condo area of perimeter slope; it is unknown if it is from mowing technique, lack of topsoil, or gas migration

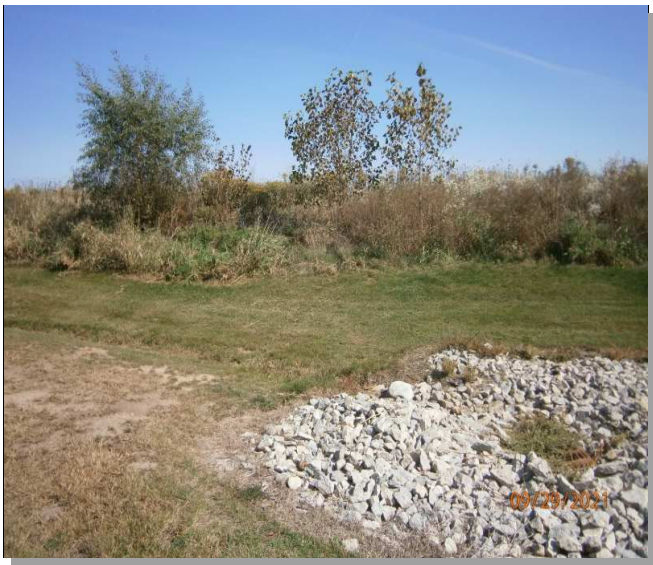
Photo # 82607 Photo 7 of 10

2. Section NR 506.08(4), Wis. Adm. Code, requires vegetation approved by the department. During the inspection, woody vegetation was noted growing on the final cover area of disposed waste along the southwestern perimeter berm of the landfill along the Coffee Hill condo development.

| <b>F. Vegetation established to minimize erosion (e.g. no bare spots or woody vegetation).</b><br>areas on the western portion and on top of the perimeter berm have new growth trees that need to be cut to ground level and steps taken to prevent new tree growth; remaining areas with woody vegetation have DNR approval and these areas include the Kaukauna preserve area; Laur portion; and Vantoll/Armstrong private property - in these areas, tree health should be monitored and dying trees should be cut to ground level | <b>X</b> | 506.08(4) |

CE Land new tree growth; example of woody vegetation on perimeter berm along condo association side

**Action needed:** On the perimeter berm, please cut woody vegetation to ground level so as not to disturb the berm material and in-place waste, add at least 2-feet of compacted earth and at least 6-inches of topsoil, seed, fertilize, and mulch the finished surface. Unless otherwise approved by the department in writing, seed mixtures and sowing rates shall be those specified for right-of-ways in accordance with section 630, Wisconsin Department of Transportation standard specifications for highway and structure construction.

It should be noted, the entire perimeter berm should not be disturbed, and should have at least 6-inches of topsoil and vegetation established. In addition, the perimeter berm surface should not be tilled and posts should not be installed into the surface without prior written department approval.

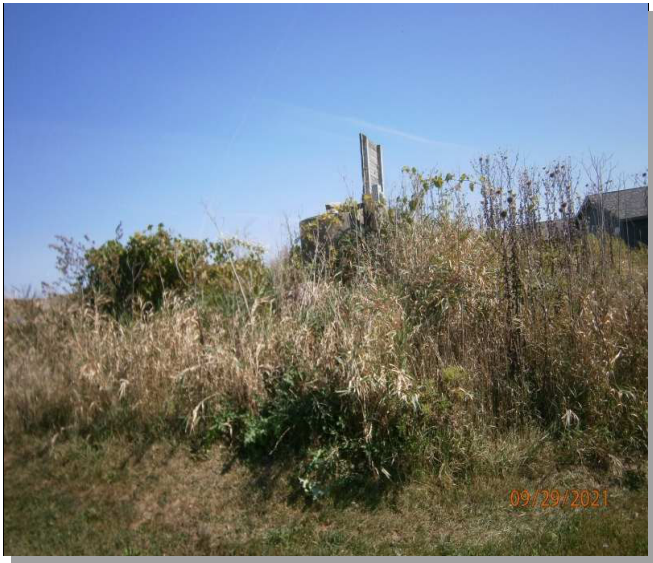
Photo # 82608 Photo 8 of 10

example of manhole in engineered 5A cell that is clay lined but manhole is not double-cased

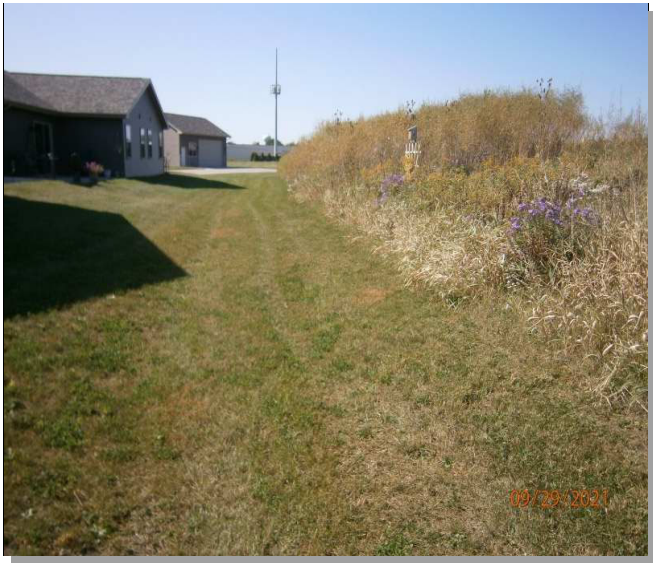
Photo # 82609 Photo 9 of 10

Condo side slope with willow tree growth; no stressed vegetation in lawn area

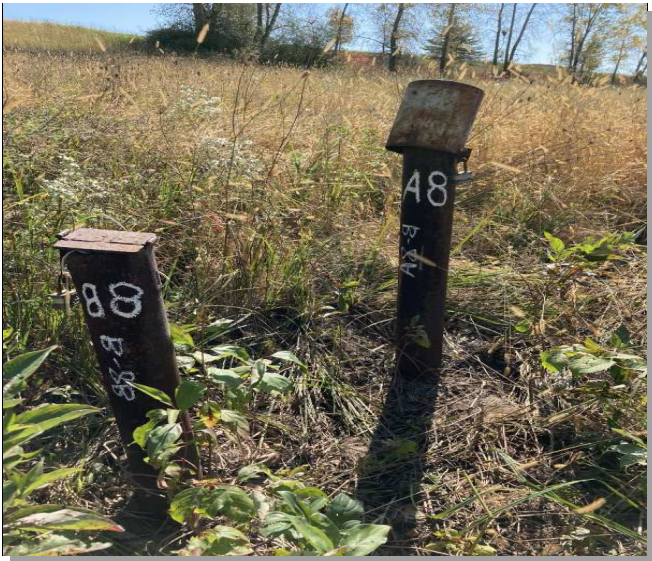
Photo #83892Photo 10 of 10

at time of visit: B-8A locked, but it is not secure - cap is too big for the protective casing and the well could still be opened without needing a key to unlock; item addressed per 10/21/2021 email from Robert E. Lee and noted returned to compliance in a letter to Greg Lauer
