September 3, 2024

FID 445014350
Outagamie County
SW / Correspondence

Subject: Notice of Noncompliance (NON) for June 27, 2024, Inspection at the Closed CE Land Landfill, City of Kaukauna, Outagamie County, License No. 0073

**COMPLIANCE MONITORING
 AND EVALUATION FORM
 CASE PACKAGE**

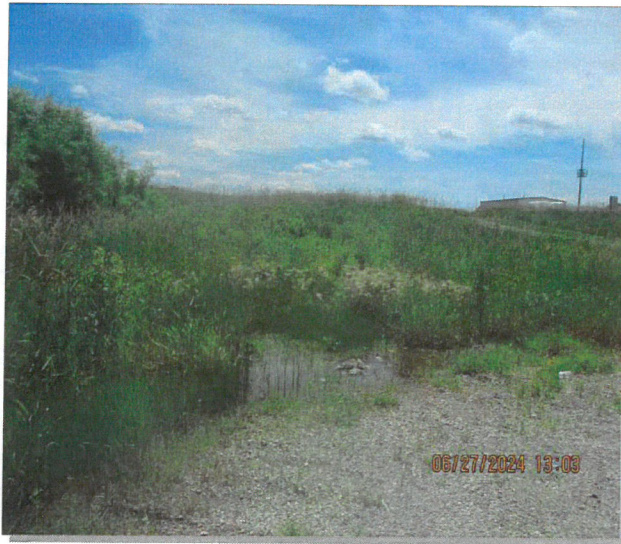
Photo # 105800 Photo 1 of 30

Ponding water on ground surface over NPV trench. Low spots collecting ponding water on and immediately near the passive gas vent trench should be regraded to preventing ponding water and ensure passive gas vent trench is functioning as intended.

- b. The department observed areas of ponding water on or in close proximity to the North Passive Vent (NPV) trench. The areas of ponding water are recommended to be graded to promote storm water drainage away from the NPV to ensure the trench continues to function as intended.

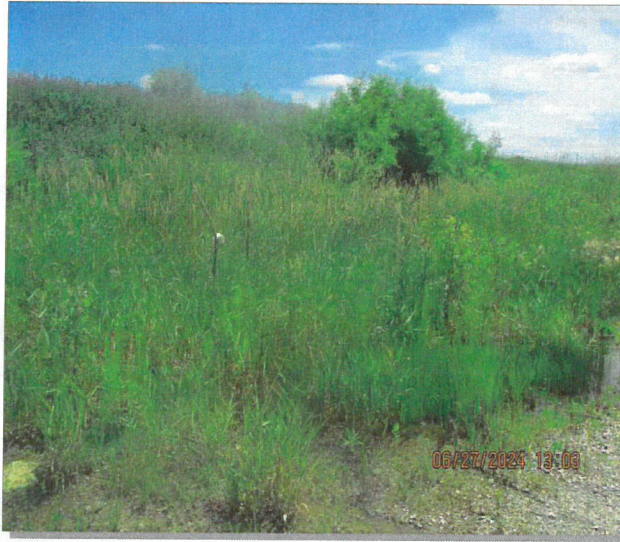
Photo # 105801 Photo 2 of 30

Ponding water on ground surface over NPV trench. Low spots collecting ponding water on and immediately near the passive gas venting trench should be regraded to prevent ponding water and ensure the passive gas vent trench is functioning as intended. Woody vegetation establishing near passive gas vent trench (bottom left of photo) should be removed to prevent damage to the trench from the tree roots.

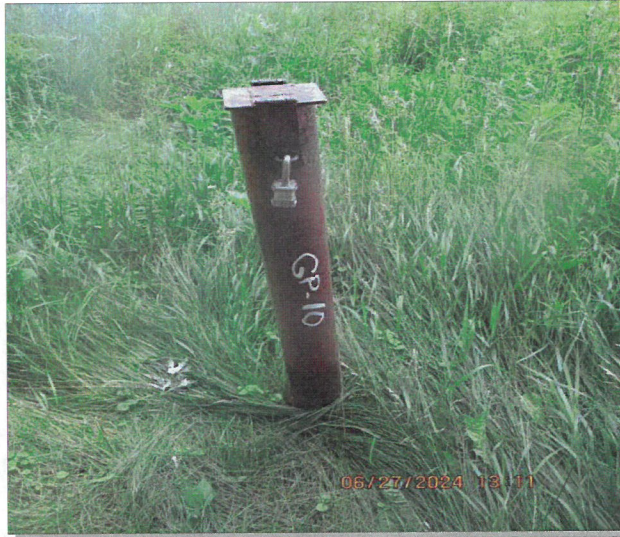
Photo # 105803 Photo 4 of 30

Gas probe GP-10 locked and labeled.

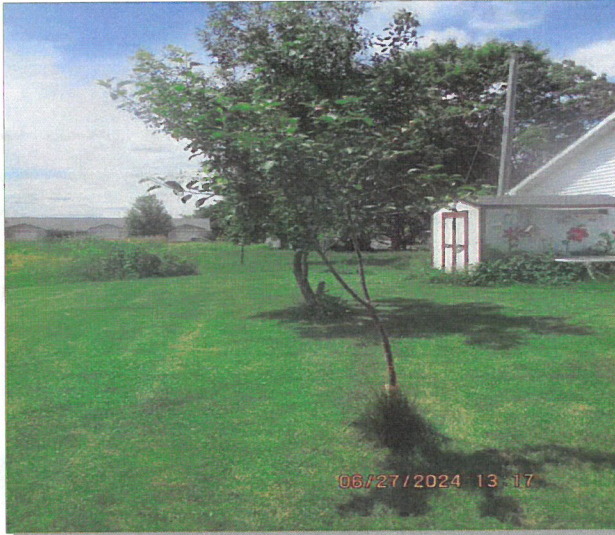
Photo # 105831 Photo 5 of 30

Woody vegetation planted immediately near or on the 20th Street trench, near gas probe GP-5. Woody vegetation establishing near passive gas vent trench should be removed to prevent damage to the trench from the tree roots.

- c. The department observed woody vegetation is on or in close proximity to the NPV trench and 20th Street vent. The woody vegetation is recommended to be removed to prevent damage from the tree roots to the passive gas vent trenches to ensure the trenches continue to function as designed.

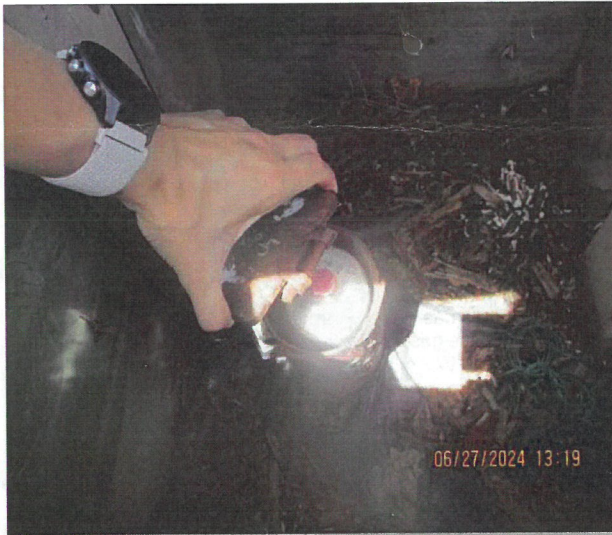
Photo # 105832 Photo 6 of 30

Gas probe GP-5 labeled. Hinge to the lockable cover on the device is rusted through, not allowing the gas probe to be properly locked. The cover on the gas probe needs to be replaced to allow the device to be properly locked.

- abandonment and replacement of the monitoring devices or contact the department to schedule a meeting to discuss alternative actions.
- b. Gas probe GP-5 was observed to not be lockable due to the hinges on the protective cover rusting through. The lockable cover to gas probe GP-5 needs to either be repaired or replaced, in accordance with s. NR 507.13, Wis. Adm. Code. Provide the department photo documentation of the repair or request an alternative timeline for repairs by **October 3, 2024**.

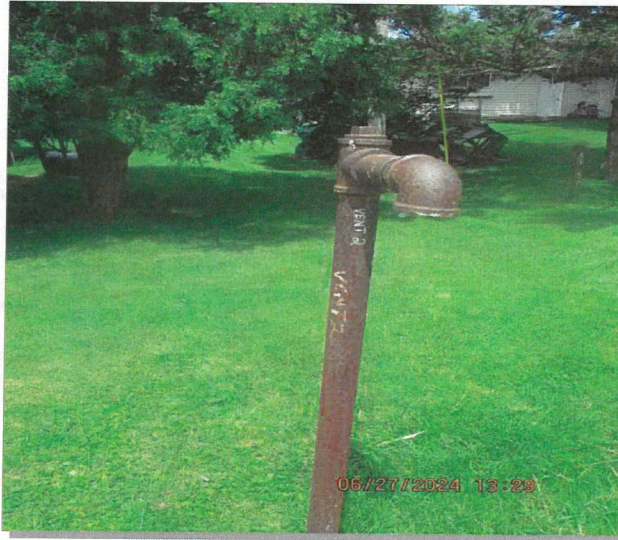
Photo # 105834 Photo 8 of 30

Passive gas vent 2. The DNR recommends that the opening to the passive gas vent is covered with a mesh material to prevent insects from inhabiting the passive gas vent.

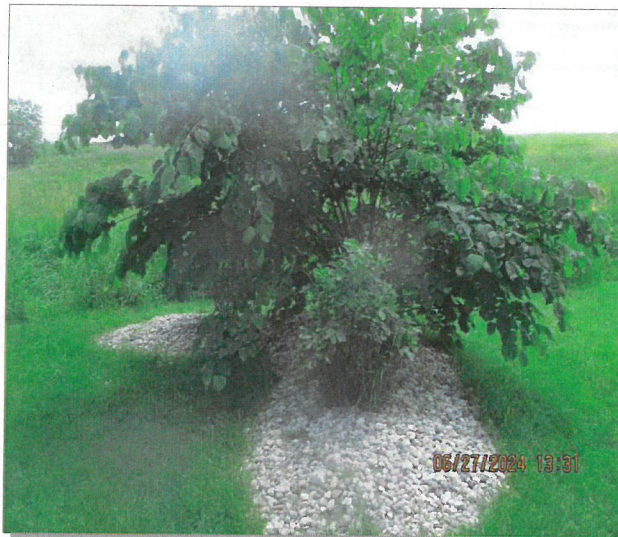
Photo # 105835 Photo 9 of 30

Woody vegetation established near gas probe GP-7. Woody vegetation should be removed if it is on or immediately near the passive gas venting trench to prevent damage to the trench due to the tree roots.

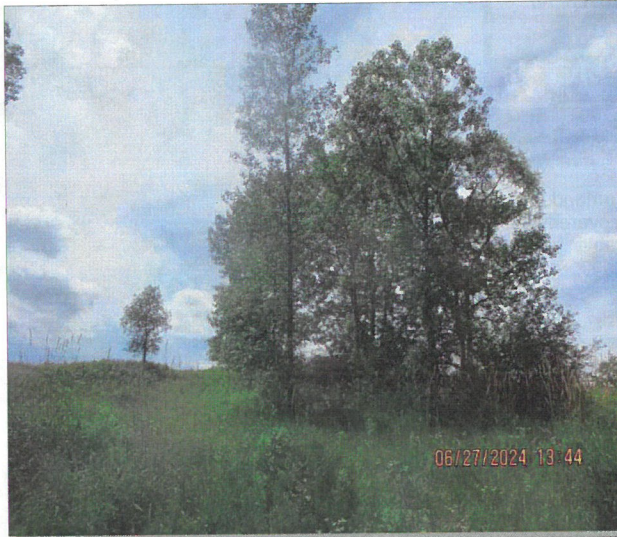
Photo # 105837 Photo 11 of 30

Woody vegetation established on east side of CE Land property, west of the public trail. Woody vegetation needs to be removed if the woody vegetation is within the limits of waste of the landfill.

- c. During the inspection, woody vegetation was observed growing on the eastern side/sideslope of the landfill, along the public access trail. The department could not determine if the woody vegetation was on the final cover. If on the final cover, the woody vegetation needs to be removed to prevent damage to the landfill cover. Please evaluate if the woody vegetation is on the final cover and provide documentation of the evaluation to the department in writing by **October 3, 2024**. If determined to be on the landfill cover, please include next steps to remove woody vegetation on the east side of the landfill.

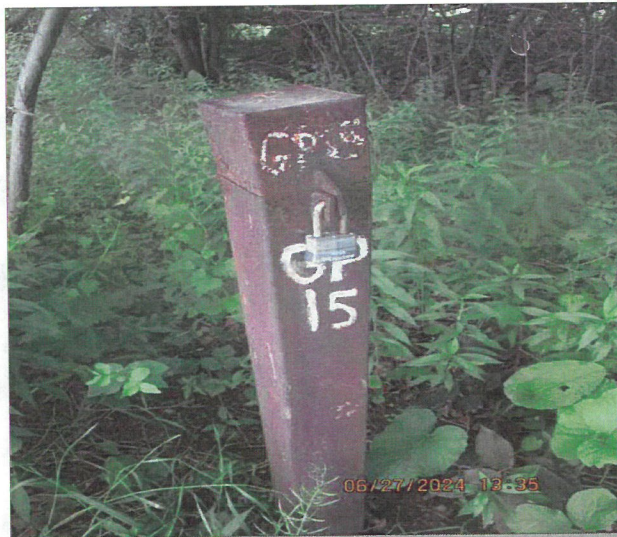
Photo # 105838 Photo 12 of 30

Gas probe GP-15 locked and labeled.

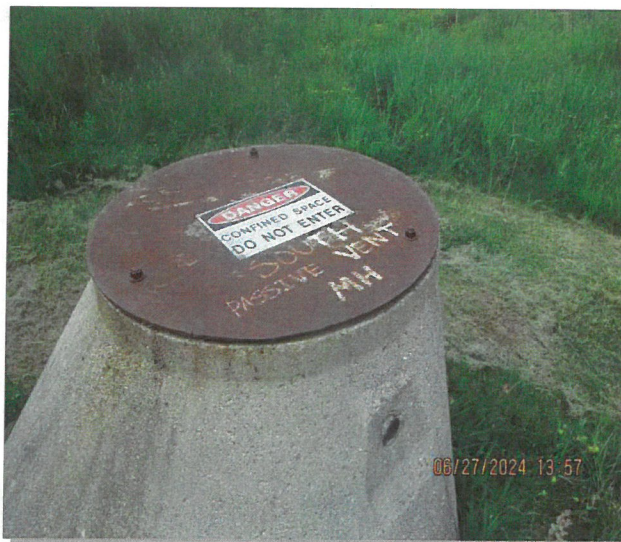
Photo # 105839 Photo 13 of 30

South passive manhole vent labeled. Manhole appeared to be in a condition to prevent unauthorized access.

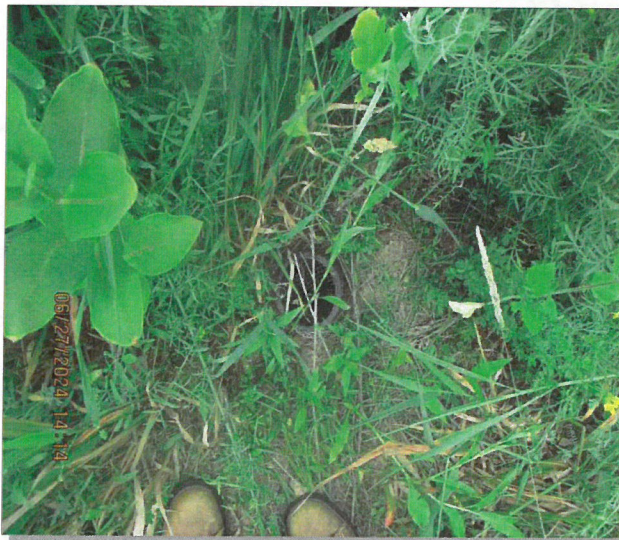
Photo # 105840 Photo 14 of 30

Unidentified broken pipe located adjacent to passive gas vent SPV-5. Pipe penetration needs to be identified and properly repaired or abandoned depending on what the device is identified to be.

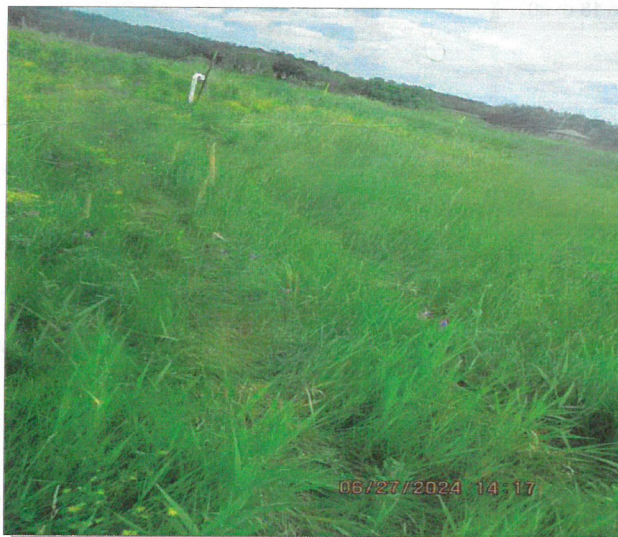
Photo # 105841 Photo 15 of 30

Final cover of landfill along south passive gas vent trench (passive gas vent in distance).

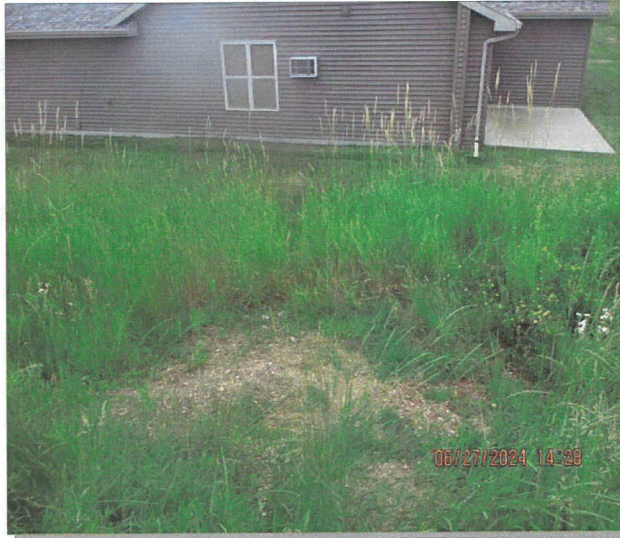
Photo # 105842 Photo 16 of 30

Approximate 3-foot diameter bare spot located east of the northernmost condominiums. Condominium in background.

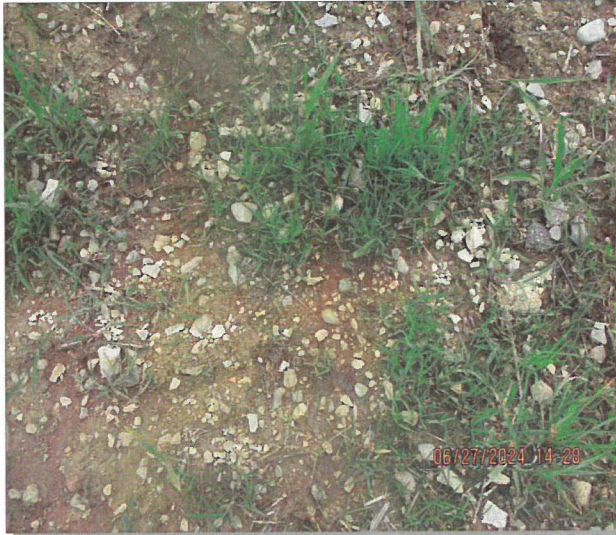
Photo # 105843 Photo 17 of 30

During the inspection, a bare spot located east of the northern most Coffee Hill condominiums contained rust colored staining on the soil surface that has the potential to be caused by a leachate release or gas stress. The department recommended adding clean fill to the area and vegetating as an initial step to remediating the area. If additional fill does not prevent future seeps or new seeps form, additional actions may be needed to remediate leachate/gas releases.

Close up of approximate 3-foot diameter bare spot located east of the northernmost condominiums with indications of rust colored staining that could be caused by gas and/or leachate. The DNR discussed adding additional clean fill over the area and stabilizing (vegetating) the added soils.

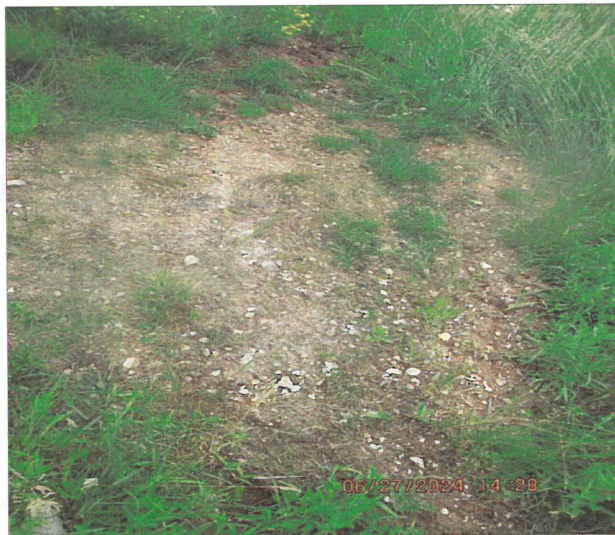
Photo # 105844 Photo 18 of 30

Close up of approximate 3-foot diameter bare spot with indications of rust colored staining that could be caused by gas and/or leachate. The DNR discussed adding additional clean fill over the area and stabilizing (vegetating) the added soils.

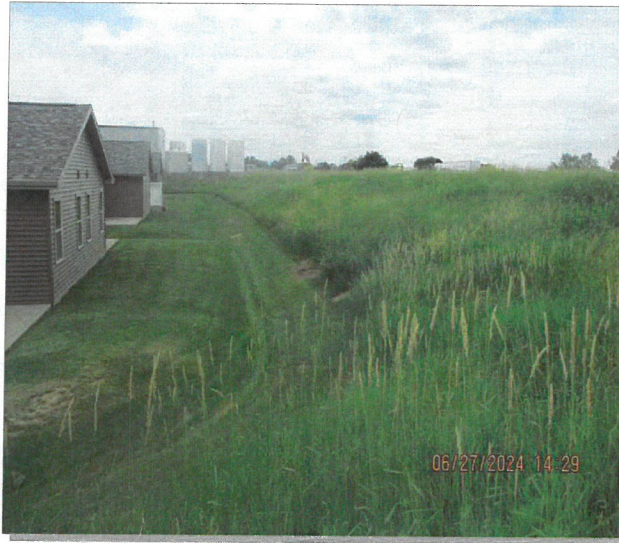
Photo # 105845 Photo 19 of 30

- b. Four bare spots located on the sideslopes of the landfill adjacent to the northernmost Coffee Hill condominiums were observed during the inspection. The bare spots need to be stabilized to prevent erosion of cover soils. Please provide photo documentation of the repairs completed or a response to the department in writing by **October 3, 2024** for next steps to correct the bare spots located near the Coffee Hills condominiums.

Southern boundary of landfill and Coffee Hills condominiums. Three bare spots observed on the sideslope between the landfill and condominium (center of photo).

- ii. The cause of the bare spots located on the sideslope of the landfill adjacent to the northernmost Coffee Hills condominiums needs to be determined. If topsoiling and seeding the bare spots does not result in vegetation establishment, additional measures will be needed to determine the cause of the stressed vegetation and measures needed to vegetate the bare spots. The department recommends performing a surface emission scan for landfill gases to determine if the bare spots are caused by gas stress.

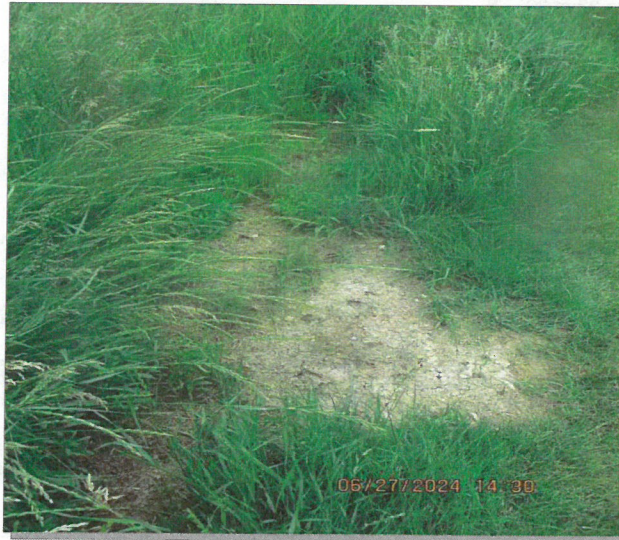
Photo # 105846 Photo 20 of 30

Close up of bare spot 1.

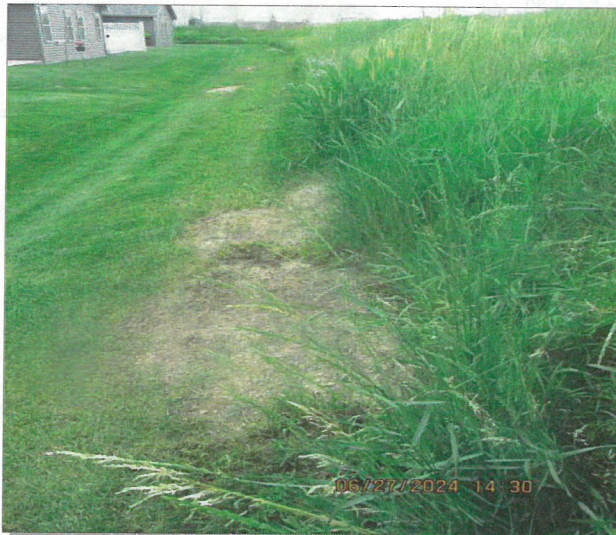
Photo # 105847 Photo 21 of 30

Close up of bare spot 2. Bare spot 2 in the background.

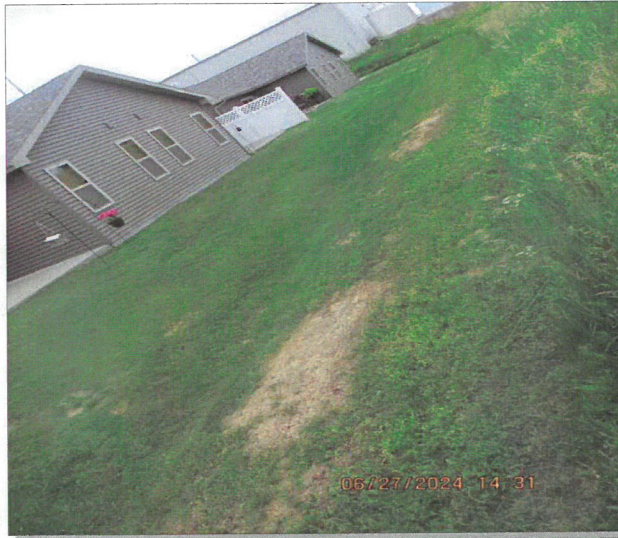
Photo # 105848 Photo 22 of 30

Close up of bare spot 3. Bare spot 4 in the background.

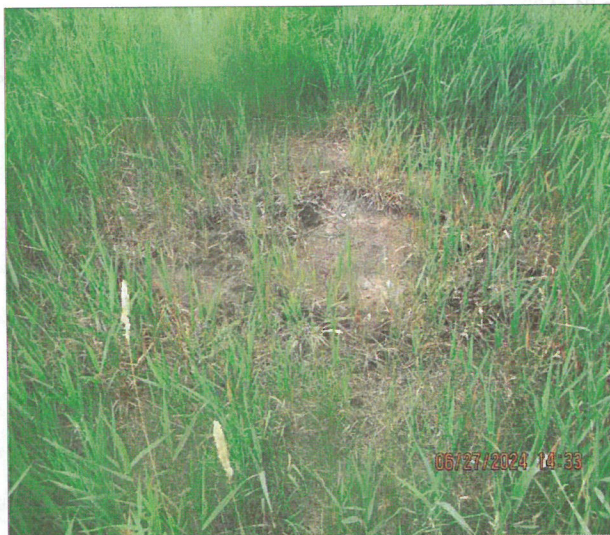
Photo # 105850 Photo 24 of 30

Ponding water located in the central portion of the landfill (closer to western side of landfill). Area needs to be graded to prevent ponding water.

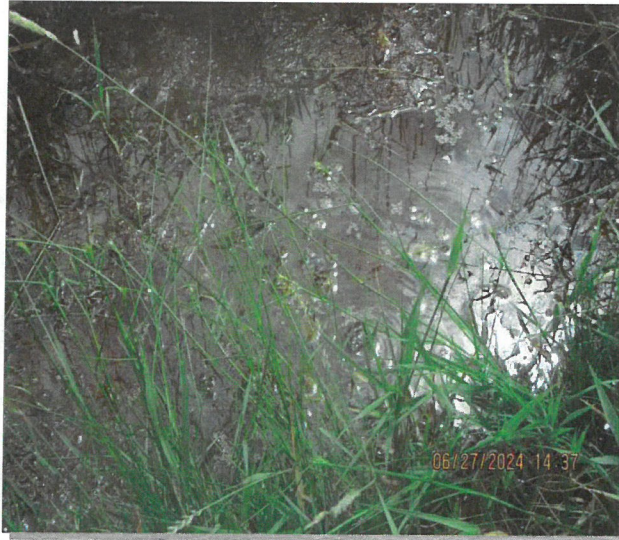
Photo # 105851 Photo 25 of 30

- a. During the inspection, the department observed two areas of potential gas stress related to noncompliance item numbers 2a and 2b, discussed above.
 - i. An area of ponding water located in the northwest portion of the landfill, adjacent to the mowed trail on the south side, was observed bubbling. At the time of the inspection, the department discussed adding additional clean fill to the area to prevent the gas from migrating through the final cover.

Gas observed actively bubbling in ponding water located adjacent to the mowed trail (south side), in northwestern portion of landfill. Area needs to be graded to prevent ponding water. Additional measures may be needed to mitigate gas.

The department additionally recommends that due to the current use of the landfill as a public park, measures should be taken to ensure that the bubbling water, and all areas specifically used for public recreation, are not emitting landfill gas at concentrations that may cause negative affects to citizens utilizing the park (i.e., explosion hazard from open flames/grilling activities).

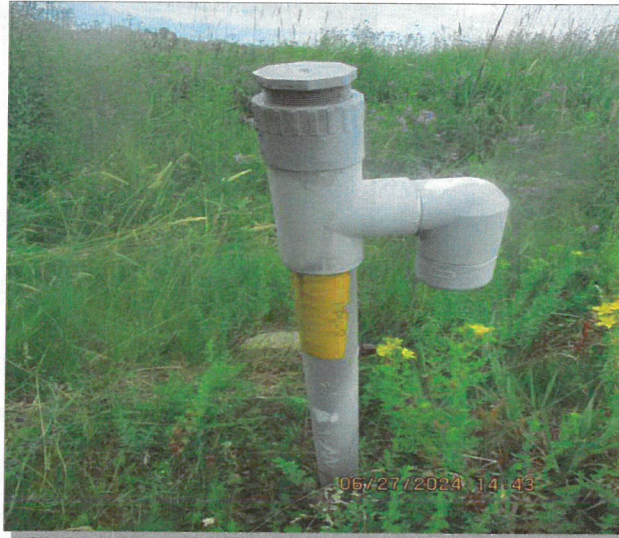
Photo # 105852 Photo 26 of 30

Passive gas vent NPV-8.

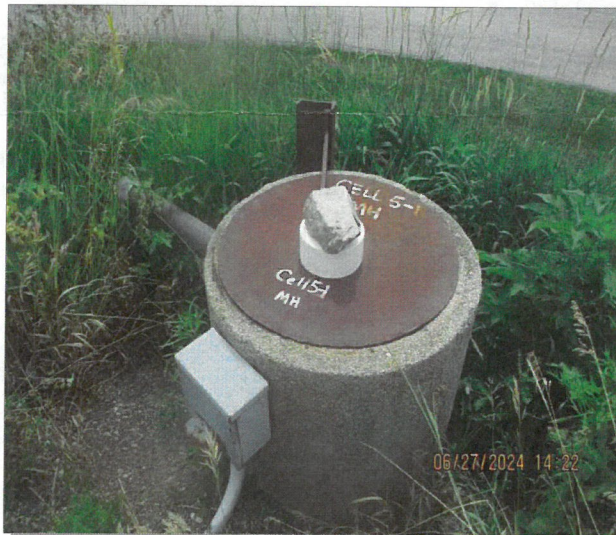
Photo # 105853 Photo 27 of 30

Cell 5-1 manhole.

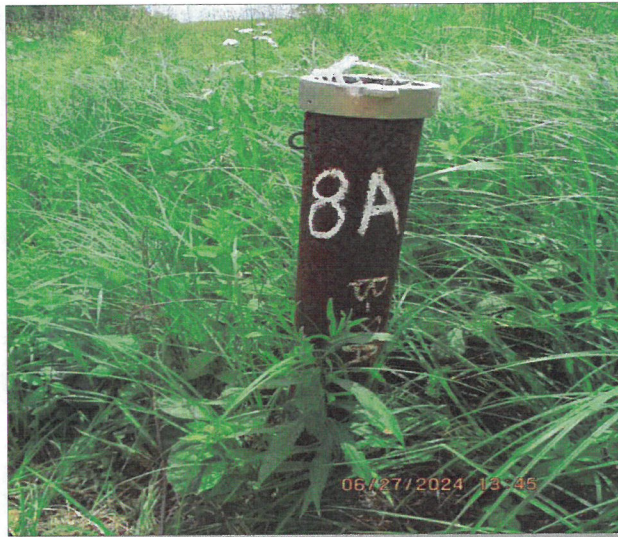
Photo # 105855 Photo 28 of 30

Groundwater monitoring well MW-8A (cover removed by REL prior to photo).

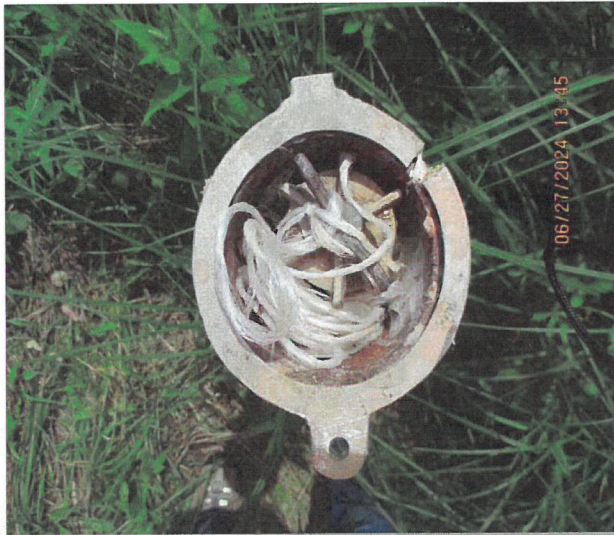
Photo # 105856 Photo 29 of 30

Inside of groundwater monitoring well MW-8A.

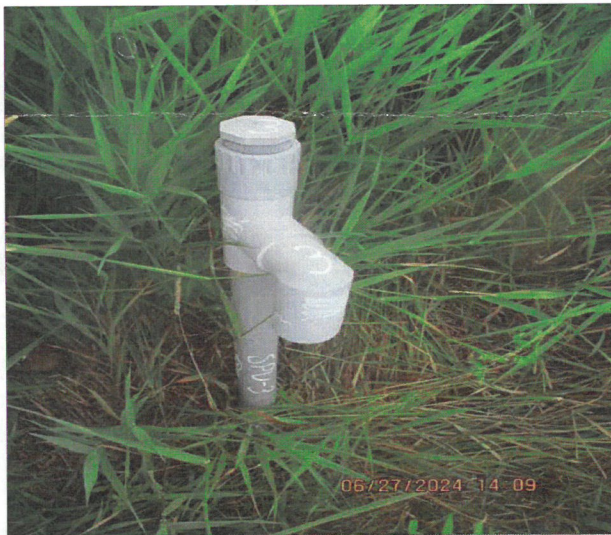
Photo # 106098 Photo 30 of 30

- c. Two passive gas vents along the Southern Passive Vent (SPV) trench require repair, including SPV-5 which was observed to be broken and uncovered at the ground surface and SPV-3 that was observed to be broken and unstable/wobbly. Provide the department photo documentation of the repairs or plan outlining a timeline for the repairs to the department by **October 3, 2024**.

Passive gas vent SPV-3 broken (not viewable in photo) and unstable/wobbly
