**STAFF REPORT
HISTORIC PRESERVATION COMMISSION
MEETING OF NOVEMBER 2nd, 2021**

PROJECT: Formula Sports/Former Post Office A-Frame Historic Building Demolition

FILE NUMBER: H21-079

LOCATION: 460 N Main Street (Ketchum Townsite: Block 5: Lots 3 & 4)

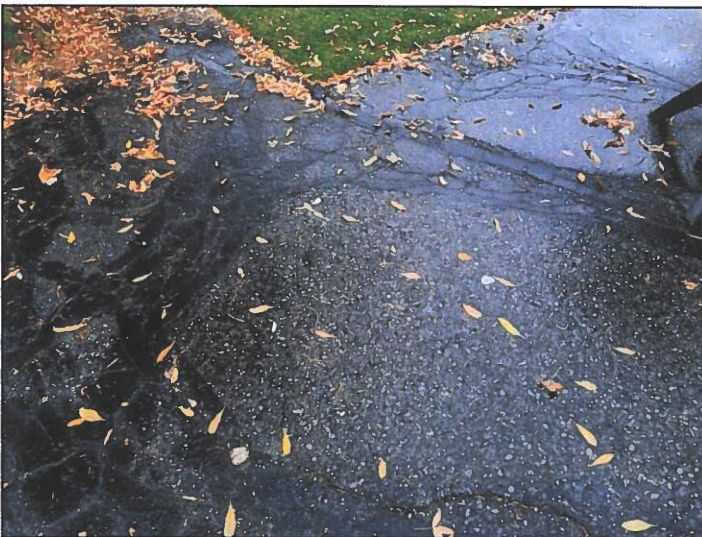
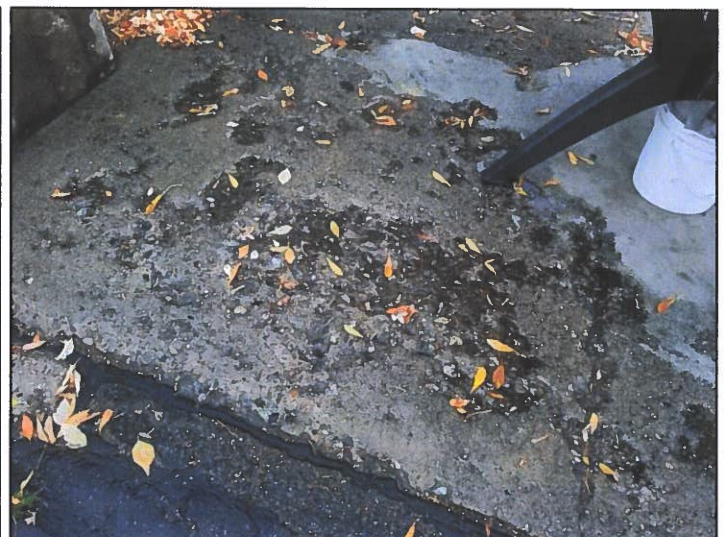
1. Driveway and Walkway Condition

- Asphalt is deteriorated. Recommend replacing.
- Spalling noted at concrete from snowmelt usage. Recommend repair.

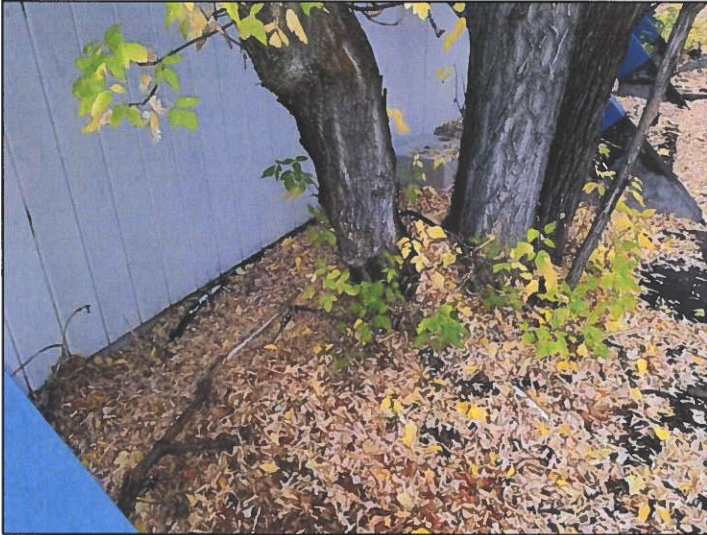
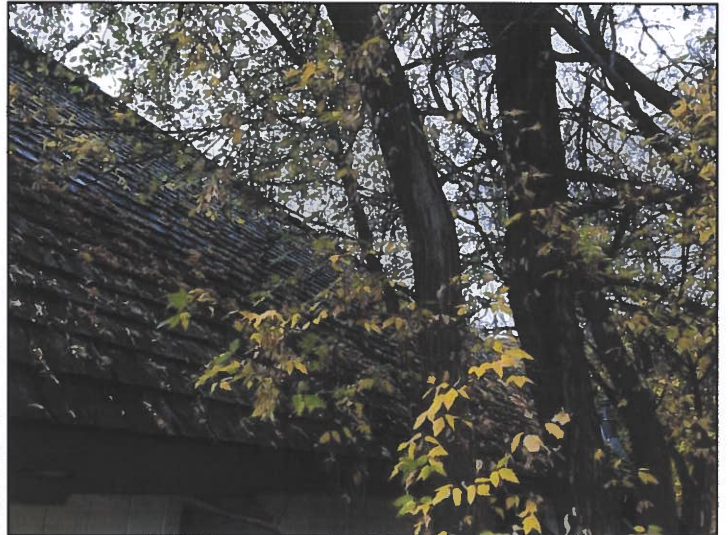
- Vegetation was inspected around the home to ensure that it had adequate clearance from the structure, and was not impacting the structure. No significant deficiencies were observed unless otherwise noted in this report.
- Trim trees that are in contact or close proximity to home, as branches can abrade roofing or siding. Recommend trimming back any vegetation within close proximity of the structure.
- **Trees are within 6 feet of foundation. Monitor for potential root damage.**

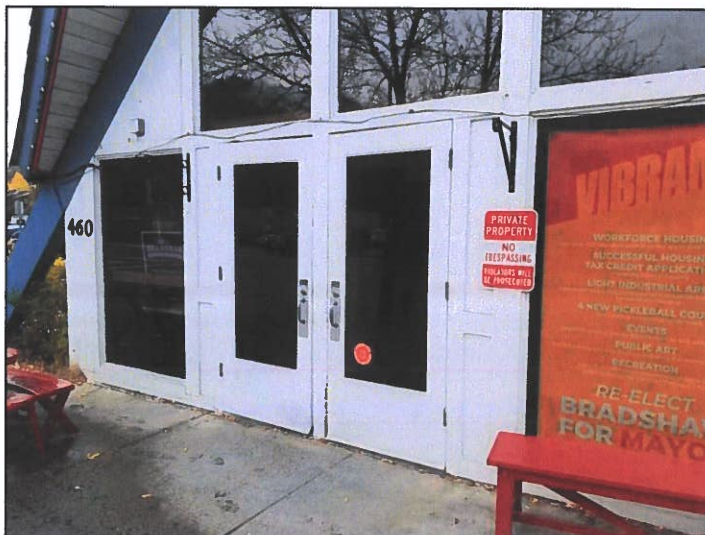
1. Doors

- Doors are warped and do not seal correctly.

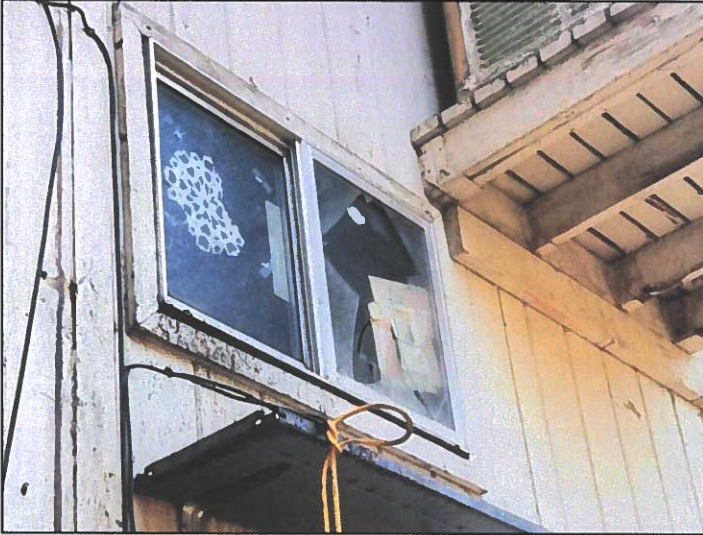
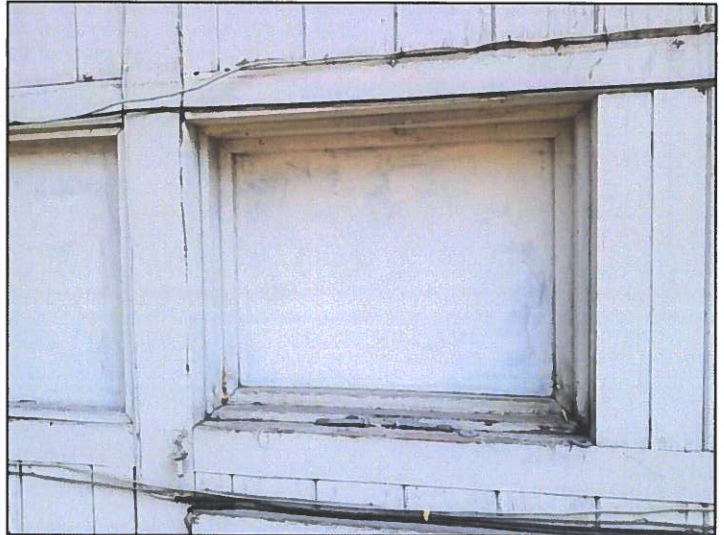
2. Window Condition

- Components appeared in satisfactory condition at time of inspection. Specific defects if present will be noted in room sections of this report.
- Broken and painted windows noted. Some single pane. Recommend replacing all windows with double pane efficient type.

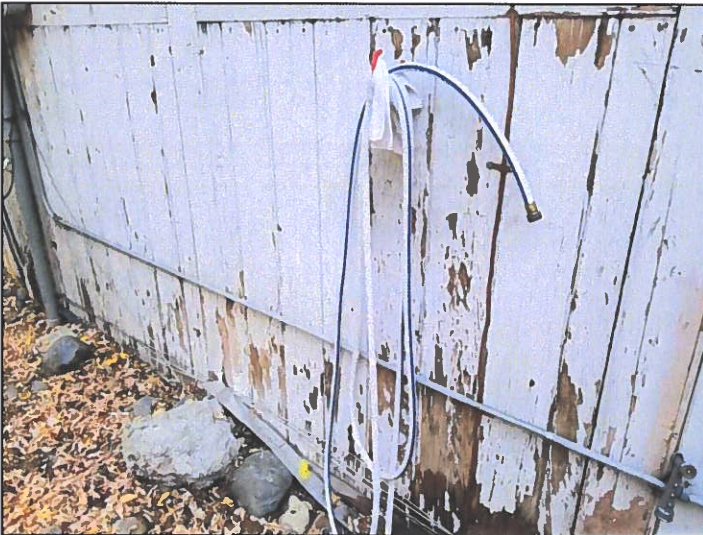
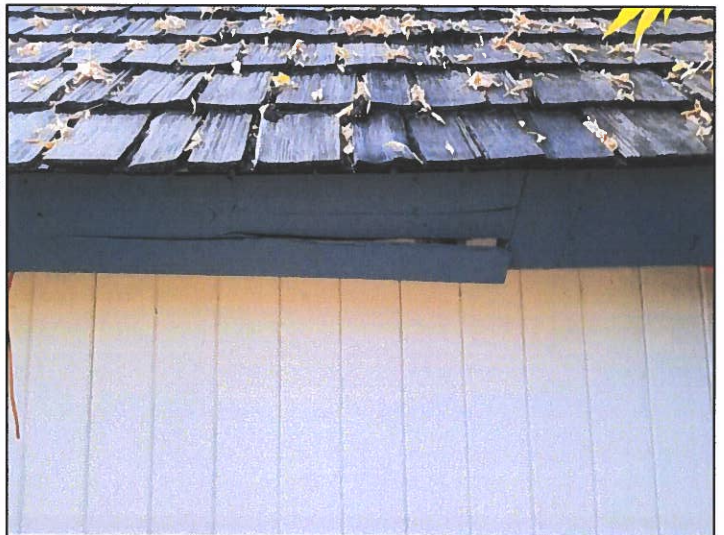
3. Exterior Walls, Siding & Trim Condition

- The walls and wall cladding were inspected looking for significant damage, presence of proper flashings, and potential water entry points, etc. No reportable deficiencies were visibly present at the time of inspection unless otherwise noted in this report.
- Damage noted to exterior surfaces. Recommend repair.

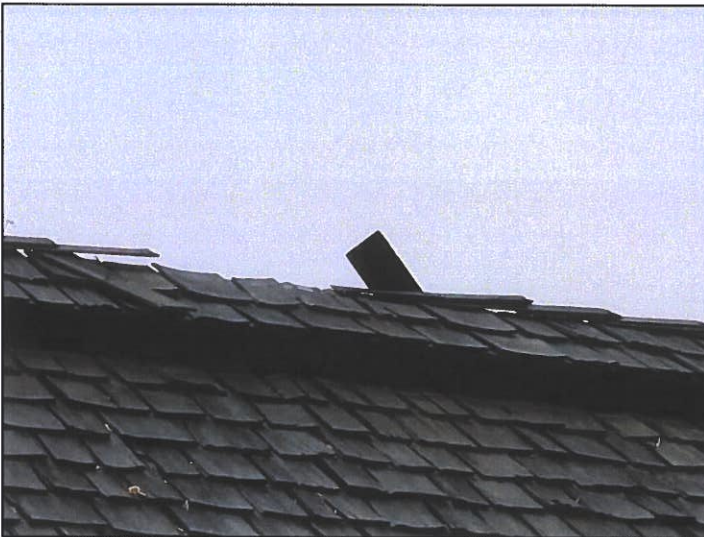
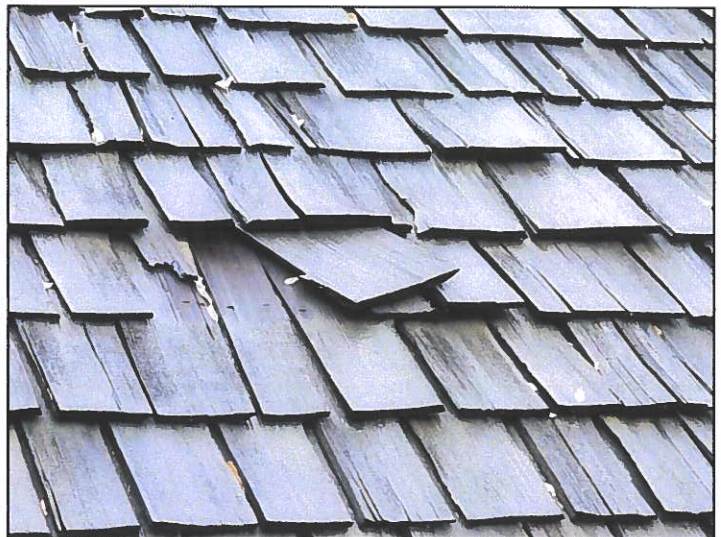
1. Roof Condition

- Wood shingle roofs of this type in the Wood River Valley generally have an average service life of 20 to 25 years. The roof is considered in poor condition due to worn or deteriorated shingles were the underlayment is the waterproofing factor. Recommend review by Roofing Contractor for serviceability, repair or replacement.
- Ridge is deteriorated. Recommend repair.

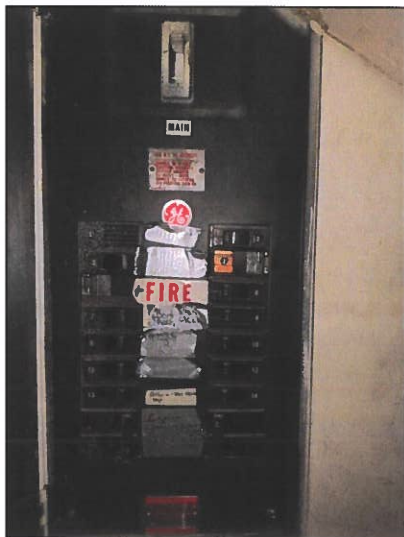
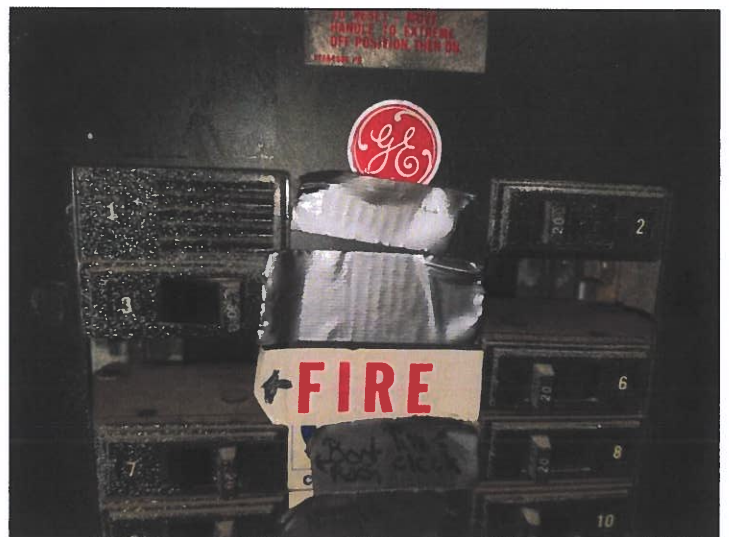
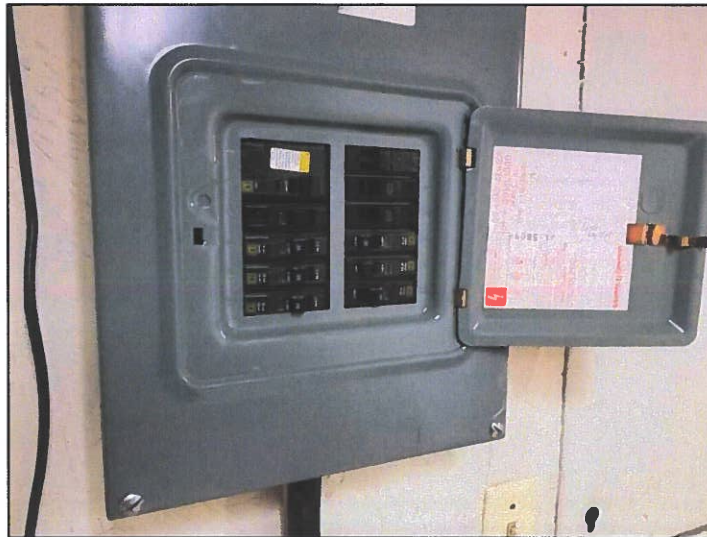
- Knockouts need snap-in caps inside panel box. Should be installed to keep mice out of panel box and to avoid potential electrocution hazard.
- Panel cover missing, exposing live electrical wires as an electrocution hazard.

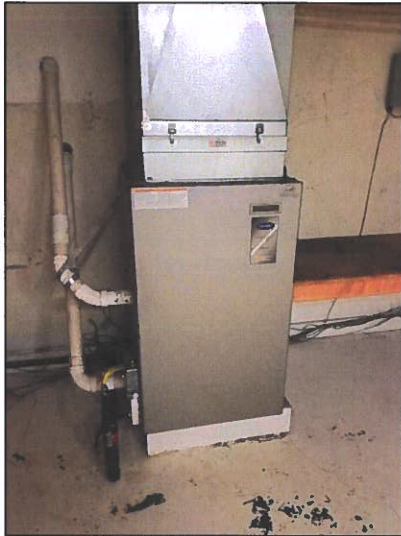
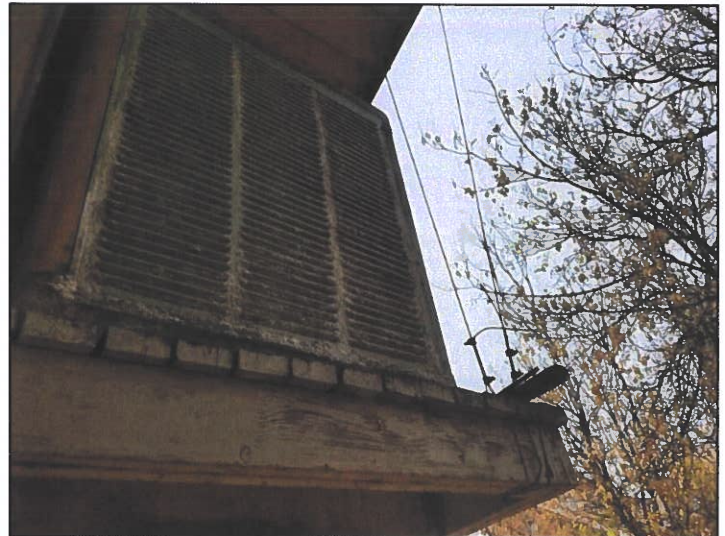
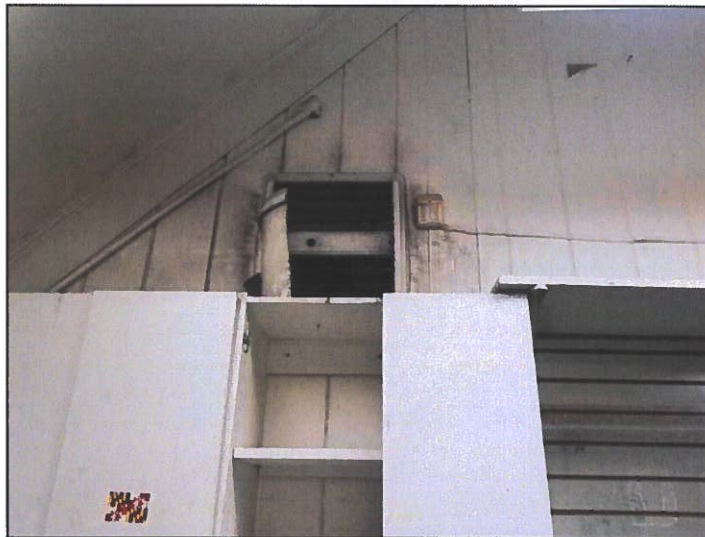
- The International Association of Certified Home Inspectors specifies the average service life of a Gas Furnace as 20 - 25 years. If your furnace is in this range you are advised to budget for future replacement.
- The heating system appeared serviceable at the time of inspection. Due to the complex nature of the operating systems it is recommended that all equipment is serviced by a HVAC contractor.
- **Swamp cooler appears inoperable.**

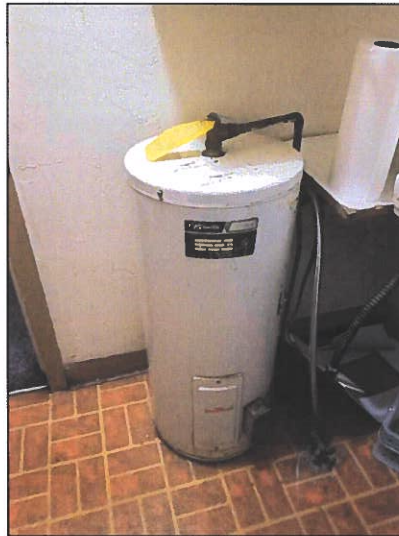
- The International Association of Certified Home Inspectors specifies the average service life of a electric water heater as 12 to 15 years.
- **Water Heater manufacture date was beyond average service life. Recommend replacement.**

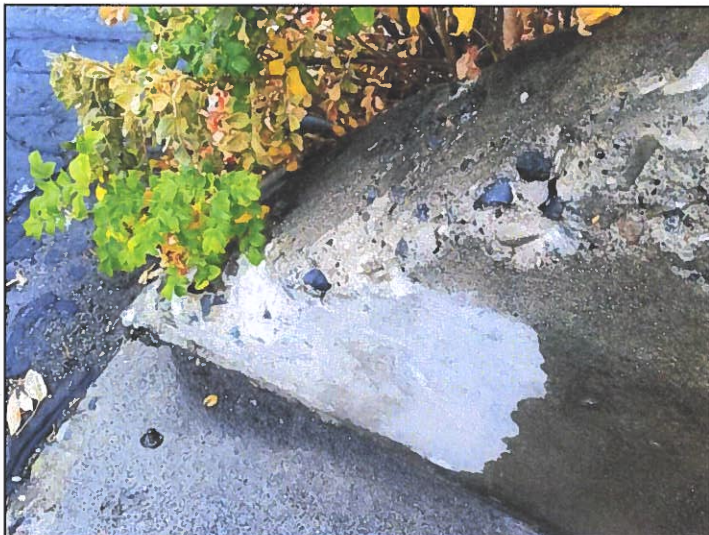
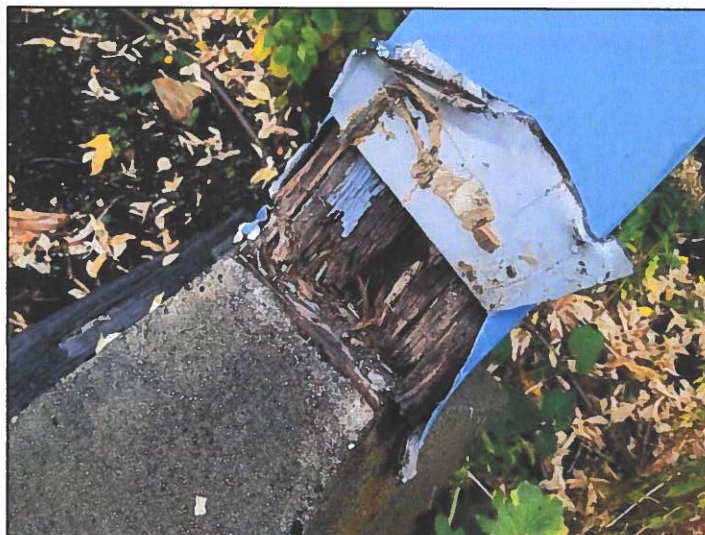
- **FOUNDATION:** No foundation inspection was performed as Structure is "Slab On Grade Construction". Visible portions of exterior foundation supports showed significant concrete deterioration. Recommend review by structural engineer.
- Major wood rot noted at support beams. Recommend replacing all structure supports.

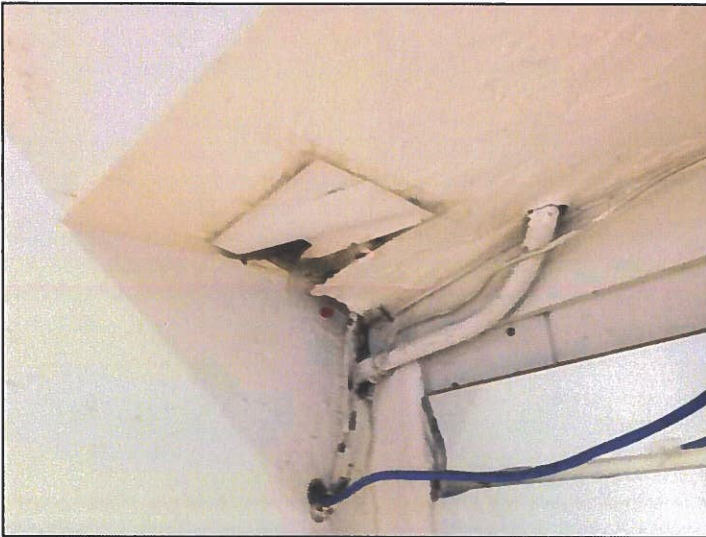
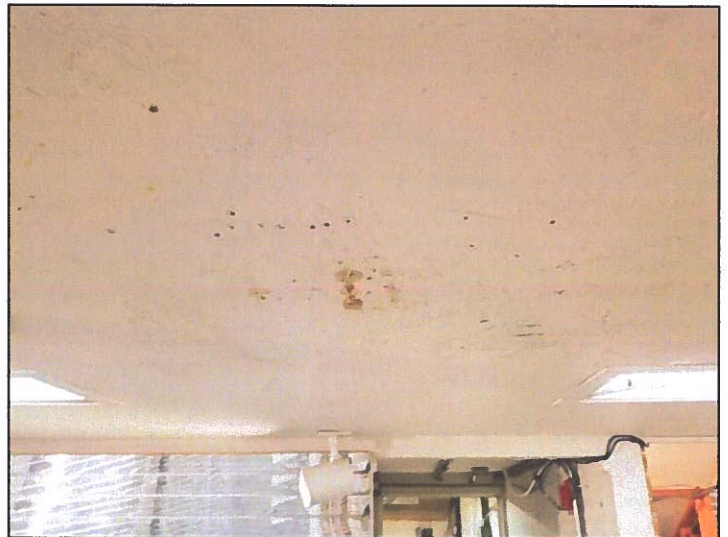
- Interior area ceilings are noted in fair condition with areas of damage noted.

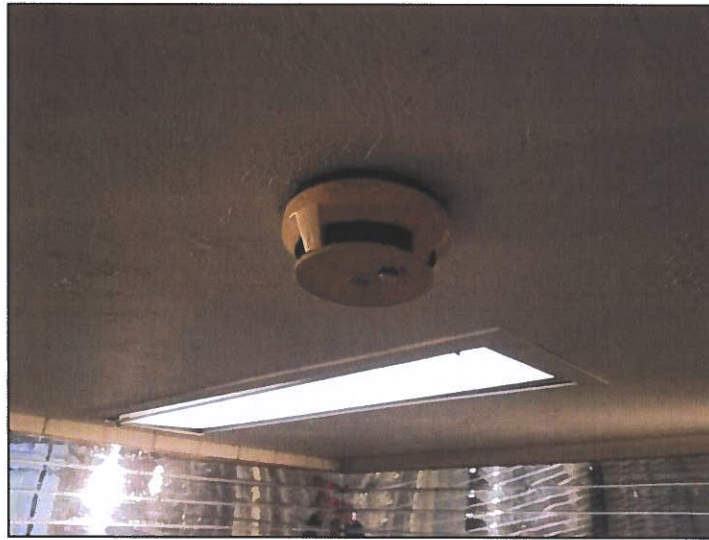
2. Smoke or Safety Detectors

- Smoke detector noted as non functional.
- The lack of an alarm monitoring system was noted. No commercial sprinkler system installed. Recommend review and installation.

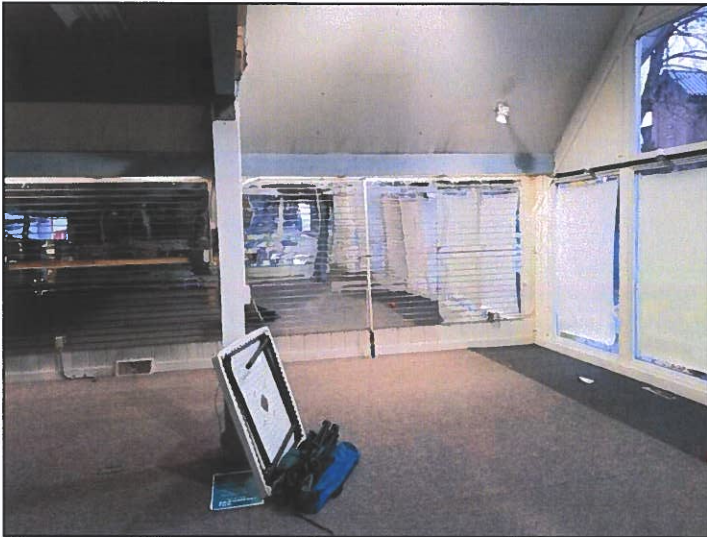
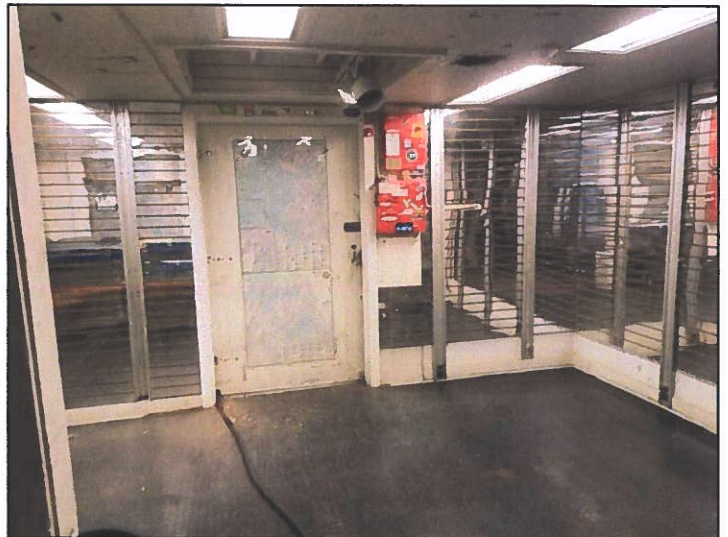
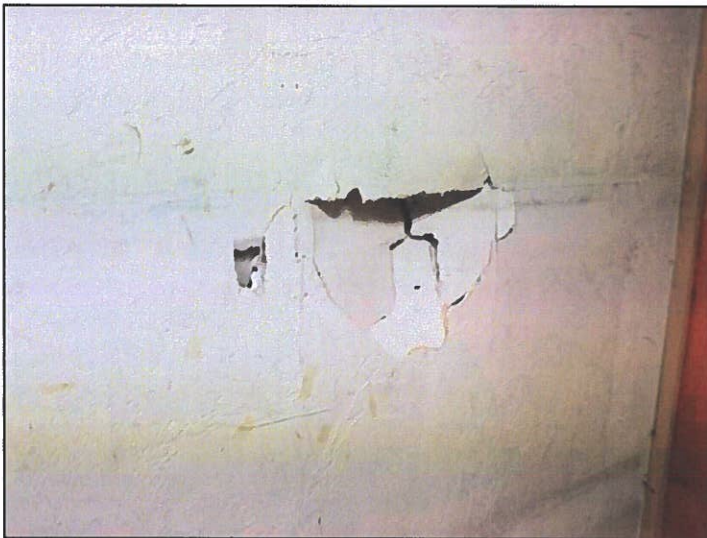
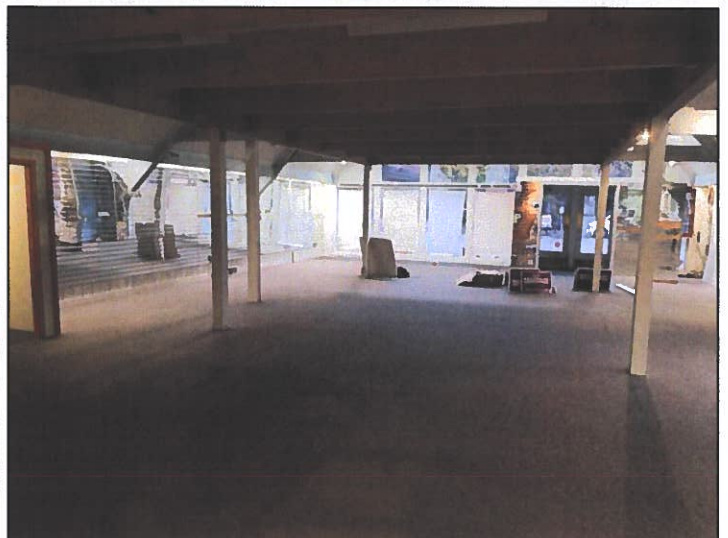
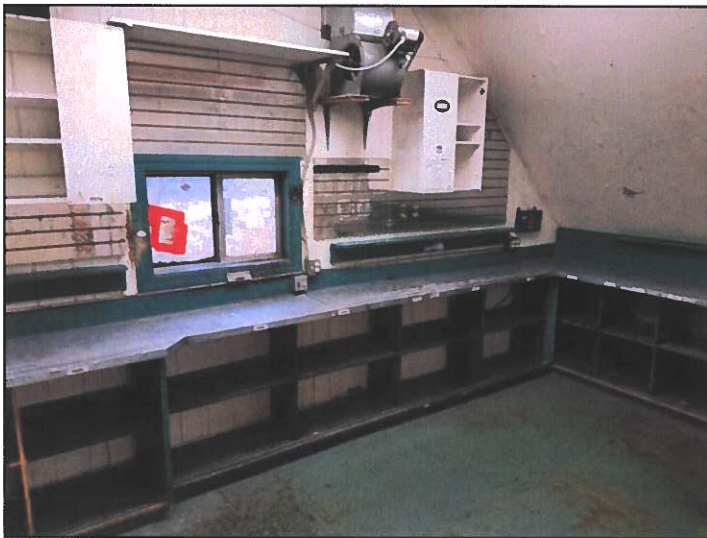
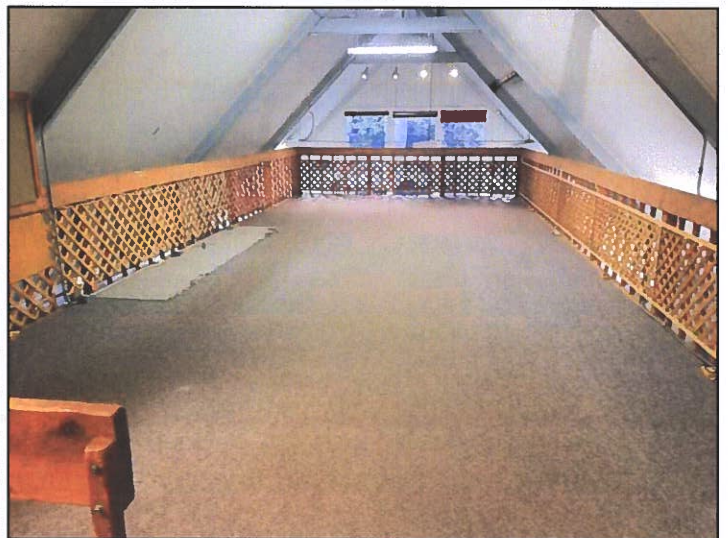
3. Wall Condition

- Damage to walls noted in numerous locations. All surfaces covered with damaged glass and damaged hanger system. Recommend removal and repair.

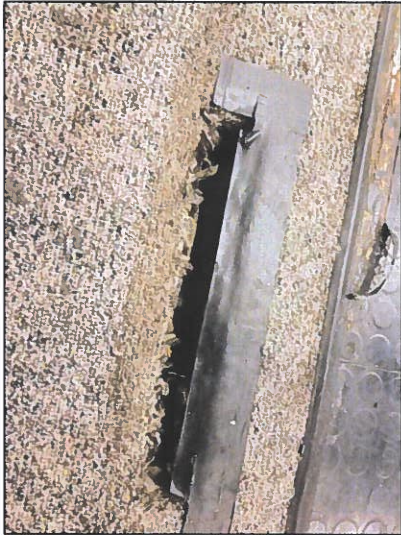
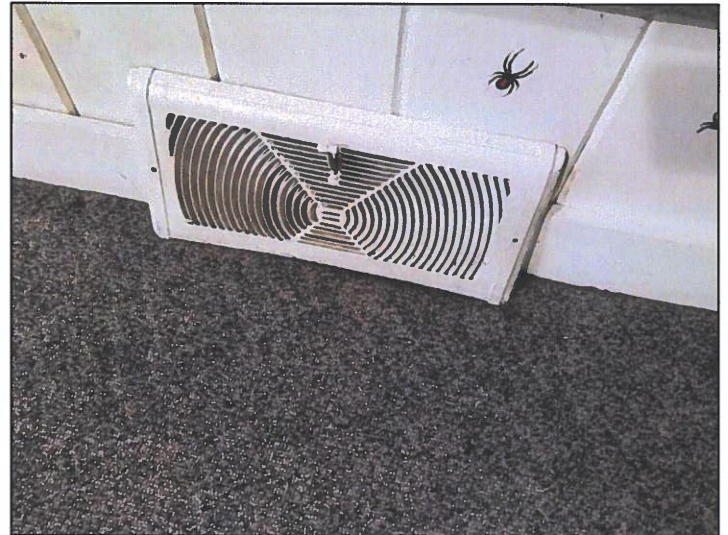
- HVAC is missing register covers. HVAC ducting is permanent. (encased in concrete floor)

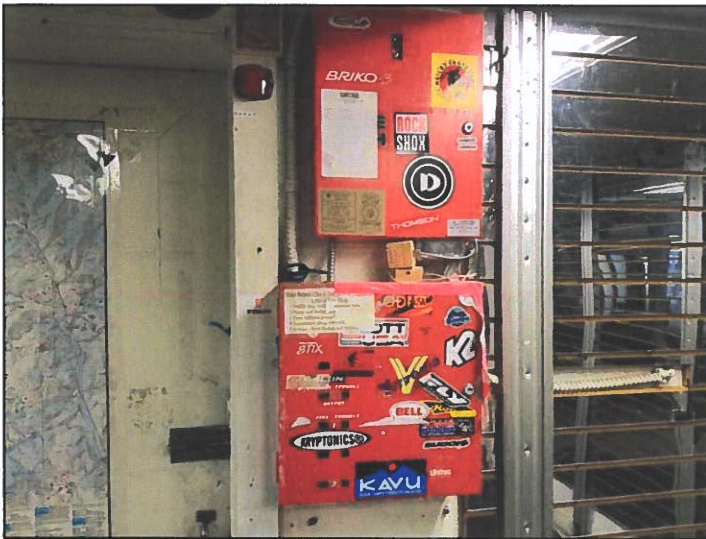
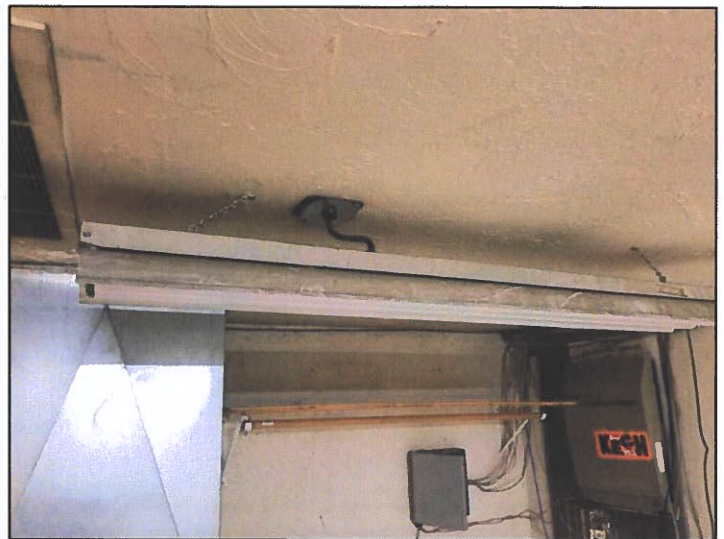
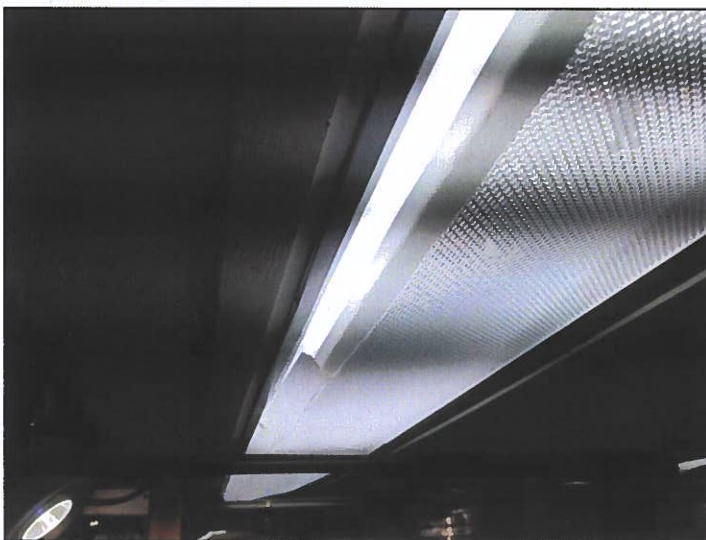
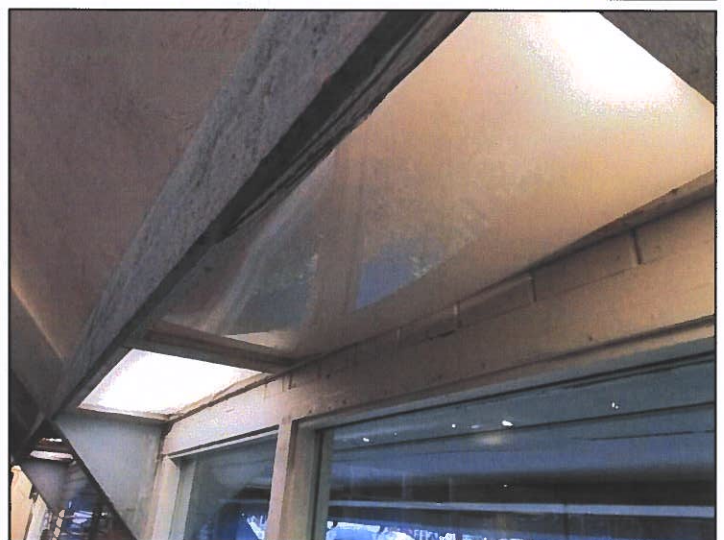
6. Electrical

- Lighting inoperable and damaged in multiple locations.

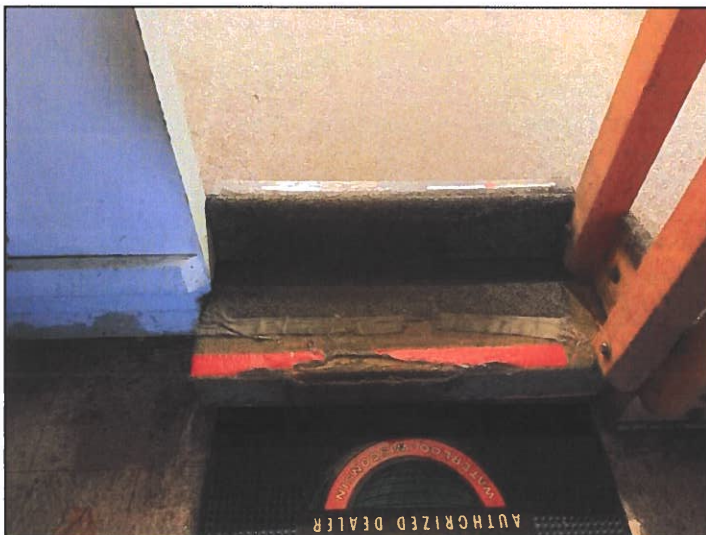
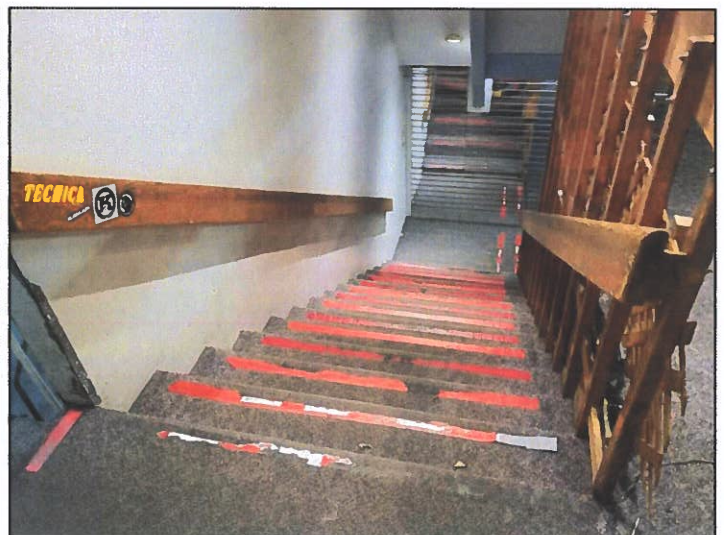
7. Stairs & Handrail

- Stairs deteriorated. Recommend repair.
- Handrail present does not comply with current building codes. ie: Min 1 1/2" space between wall and handrail, minimum 1 1/4" to max 2" diameter, if larger (capped wall) a finger recess required.

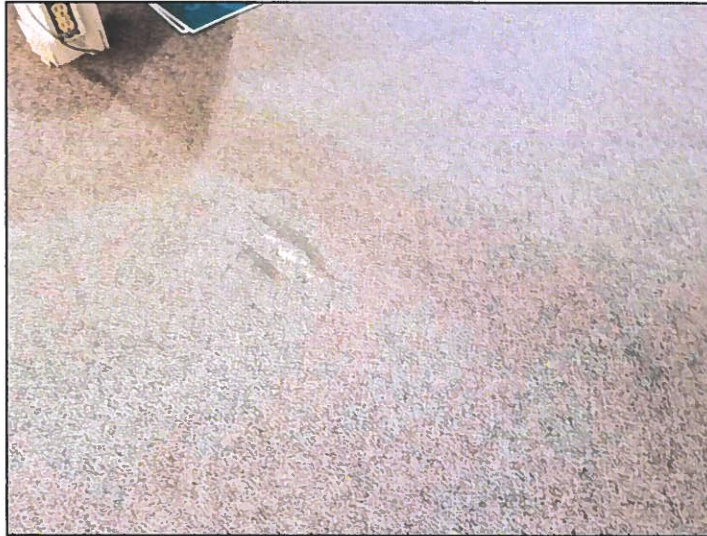
8. Floor Condition

- Carpet appeared worn and dirty in some areas.

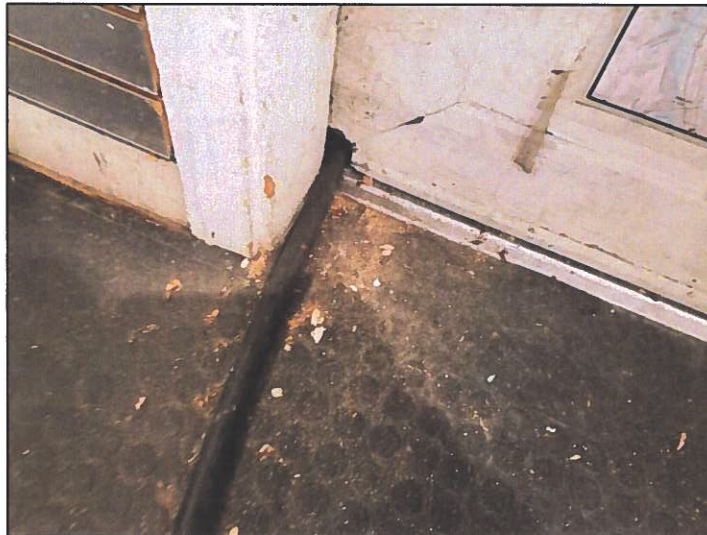
9. Doors

- Rear door damaged. Recommend replacement.

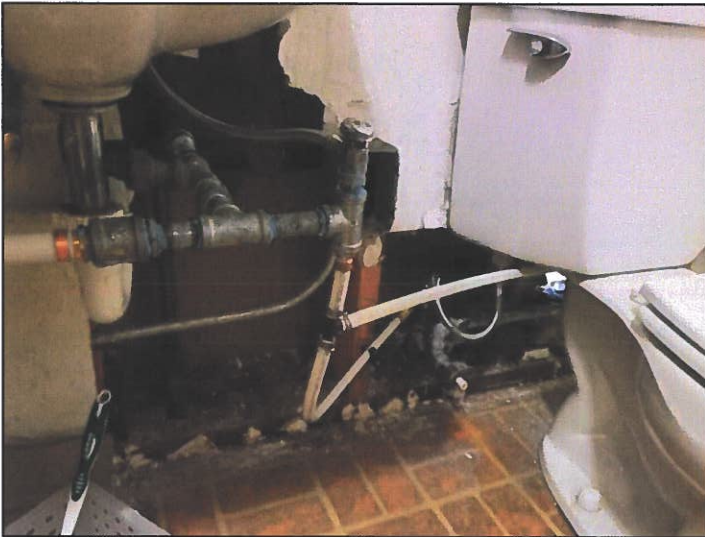
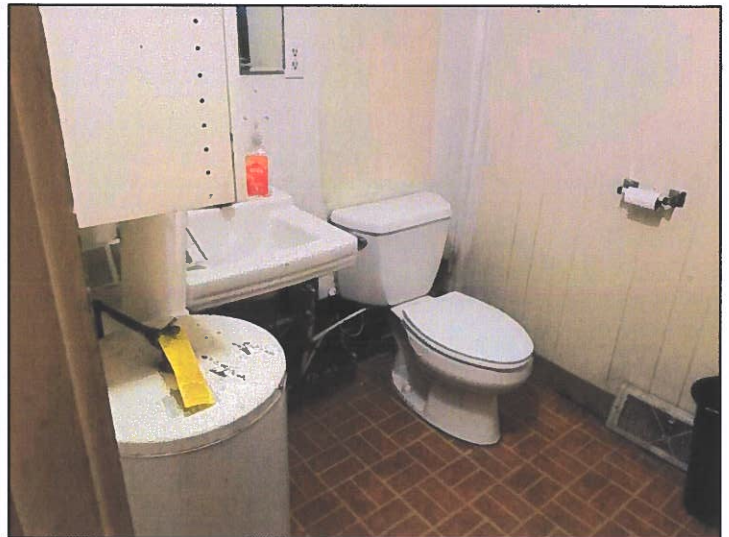
- Major wall damage noted around plumbing. Recommend review of plumbing and repair of wall.
- Bathroom does not meet commercial bathroom ADA requirements.

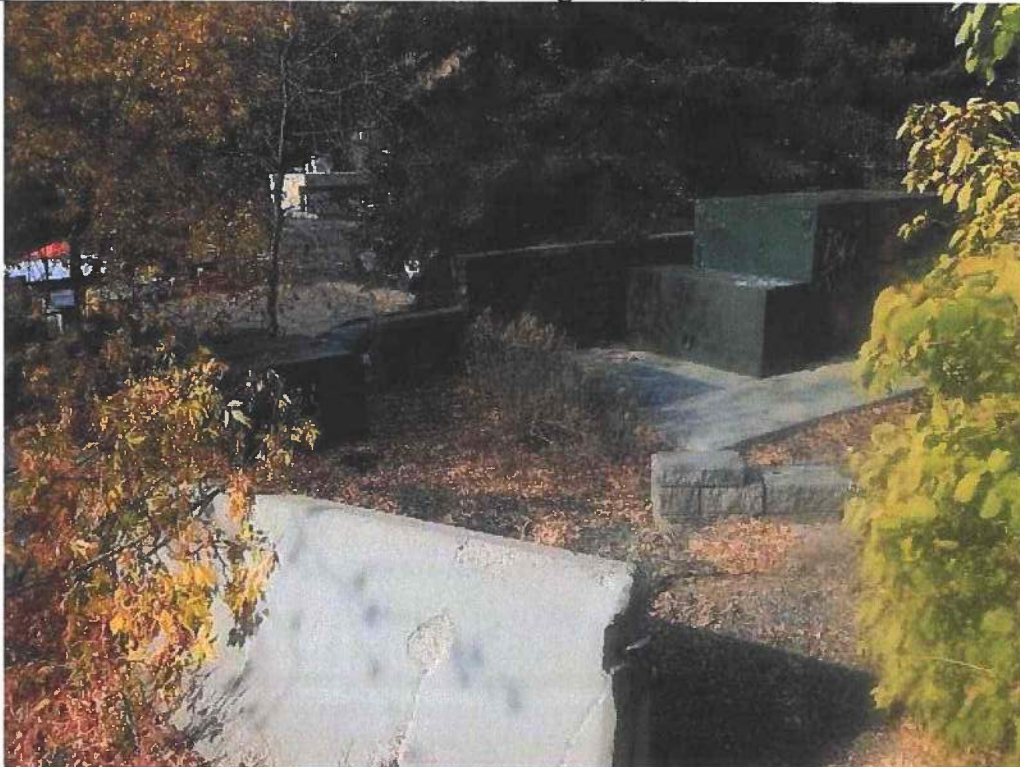
Photo 6: Nearest electric transformers within concrete walled area NE of subject property

Note: no evidence of leakage of transformer oil observed

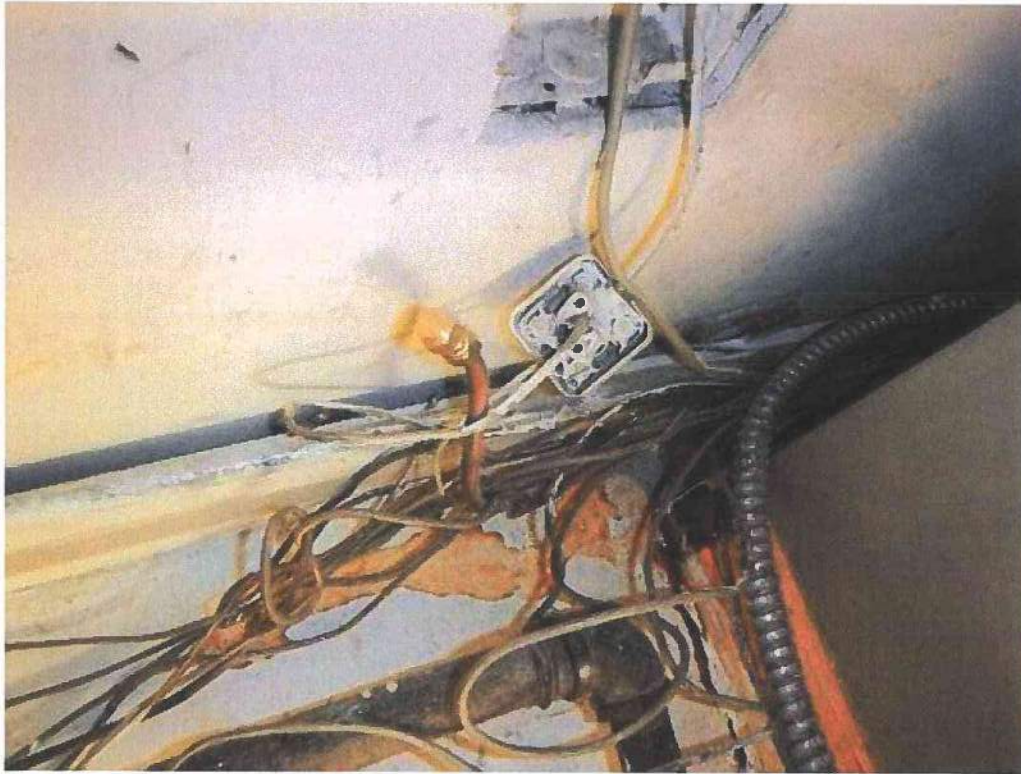
Photo 21: View of piping, conduit and wiring behind furnace

Note: Two copper tubes (vent/fill) of the size observed in this photo are associated with heating oil tanks

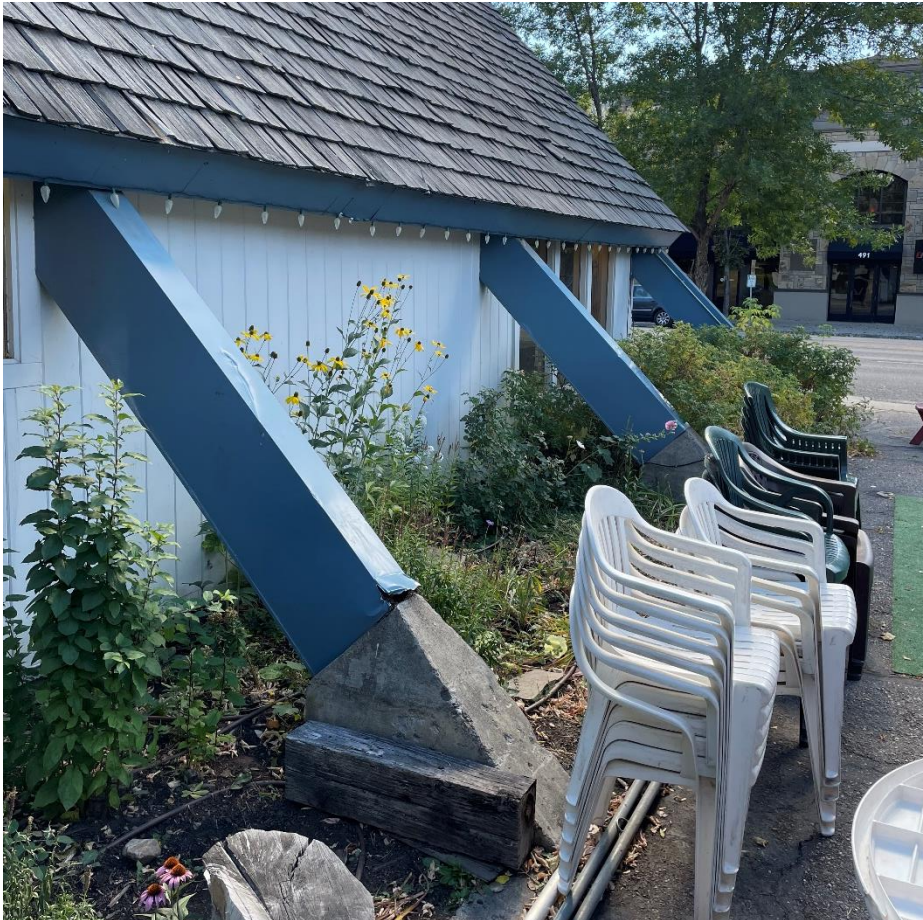
4. Typical Thrust with Typical Rot as Reviewed

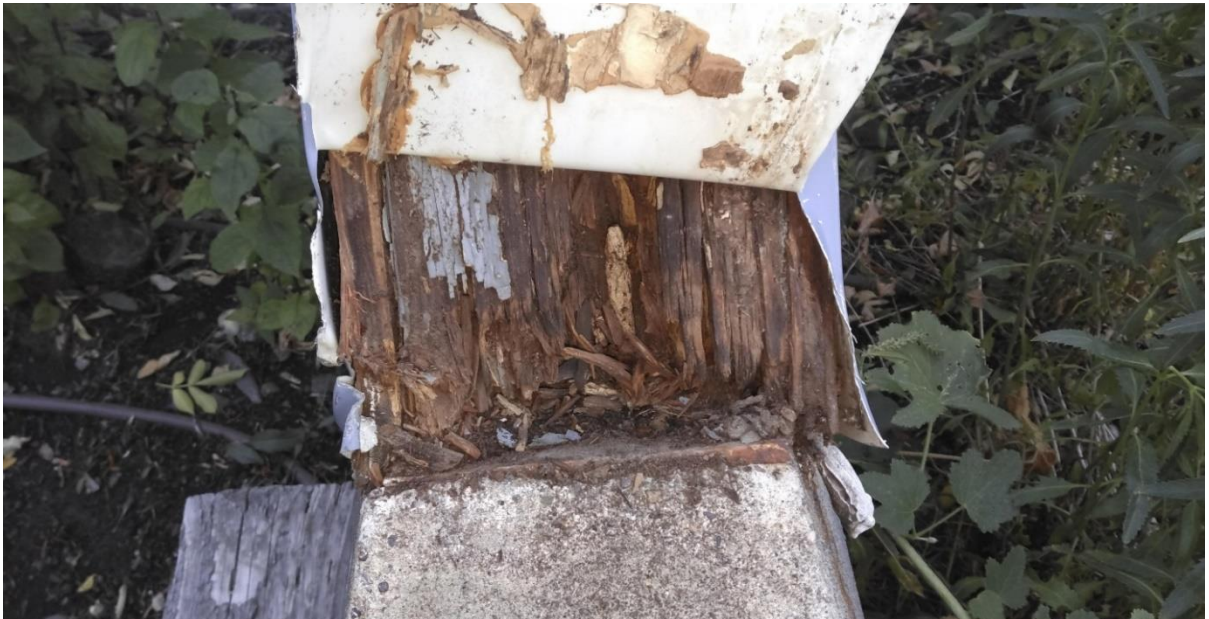
5. Existing Thrust Timber Base Rot

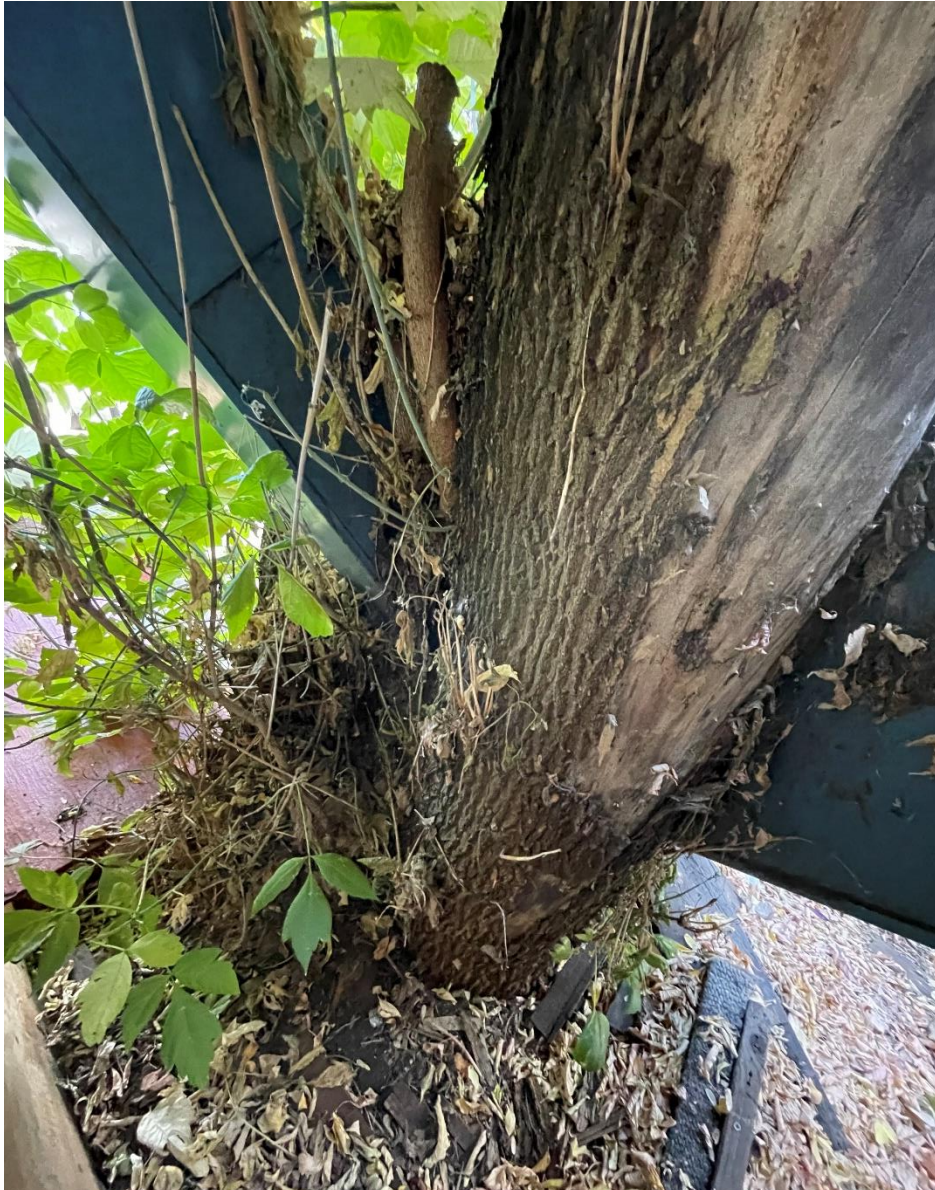
6. *Tree Growth Compromising Foundation*
