Allandale Mansion
City of Kingsport
Tyler Wicks
444 West Stone Drive
Kingsport, TN 37660

Re: Facility Evaluation

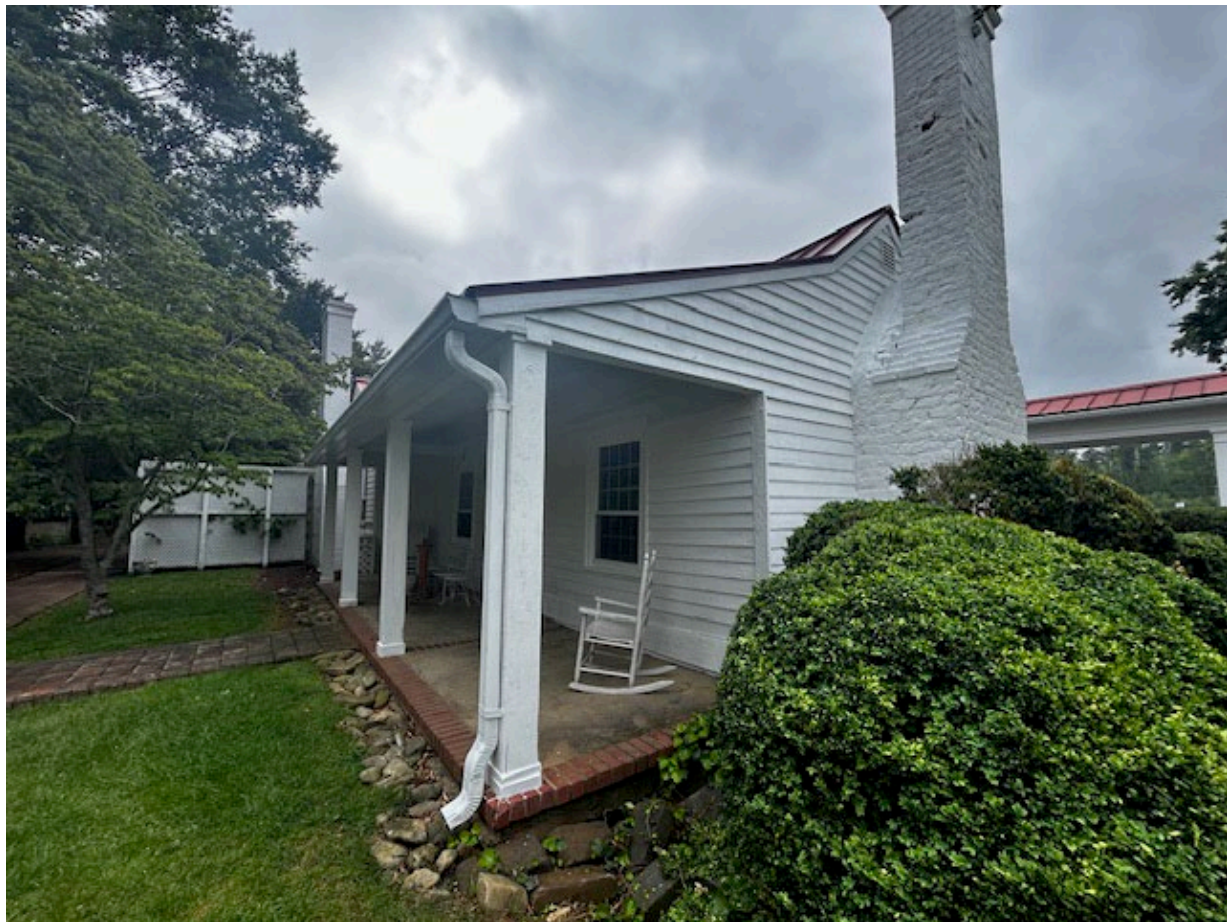
Brown House – The front porch foundation has slab washout at the corners of the porch. There are floor joist failures in the hours itself. The interior does not heat and cool well currently. See photos below.

Corner of Brown House that shows washout in corner of porch.

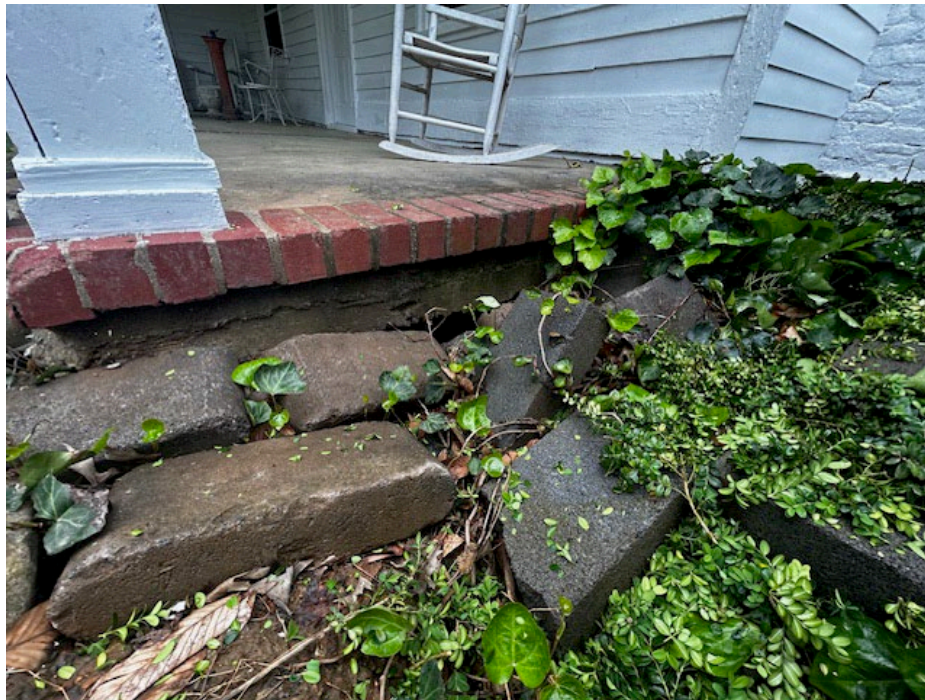
Brown House: Close up of the corner of the porch that has significant washout from either poor drainage and/or vermin.

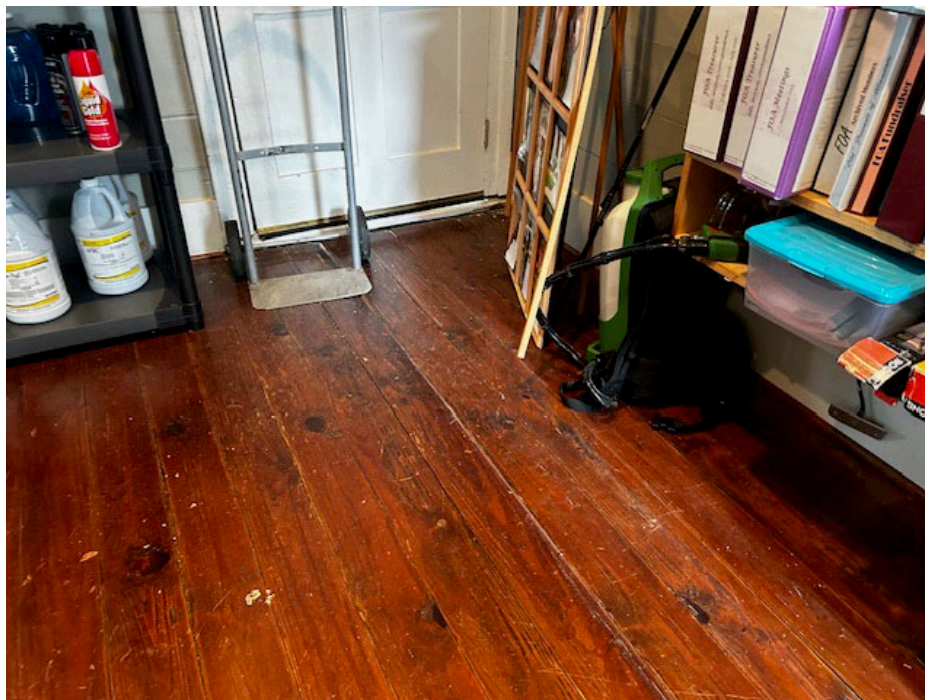
Brown House: Interior photo of floor sagging toward front door.

Recommendations: The floor joists need to be sistered together and add additional piers. At this time it would be ideal to slowly jack the floor joist up minimally to help with the floor sag but also give room for the new piers. We would recommend adding a vapor barrier in the crawlspace as well to avoid any future moisture issues. Narratives and/or drawings would need to be created for these corrections.

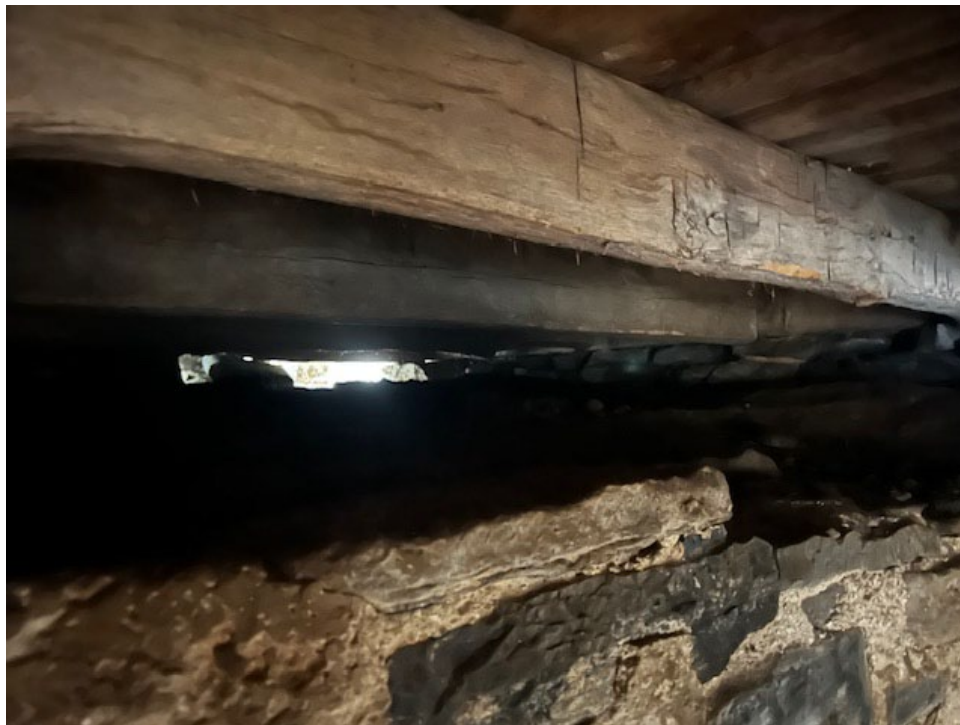
Brown House – Crawlspace looking at condition of floor joists.

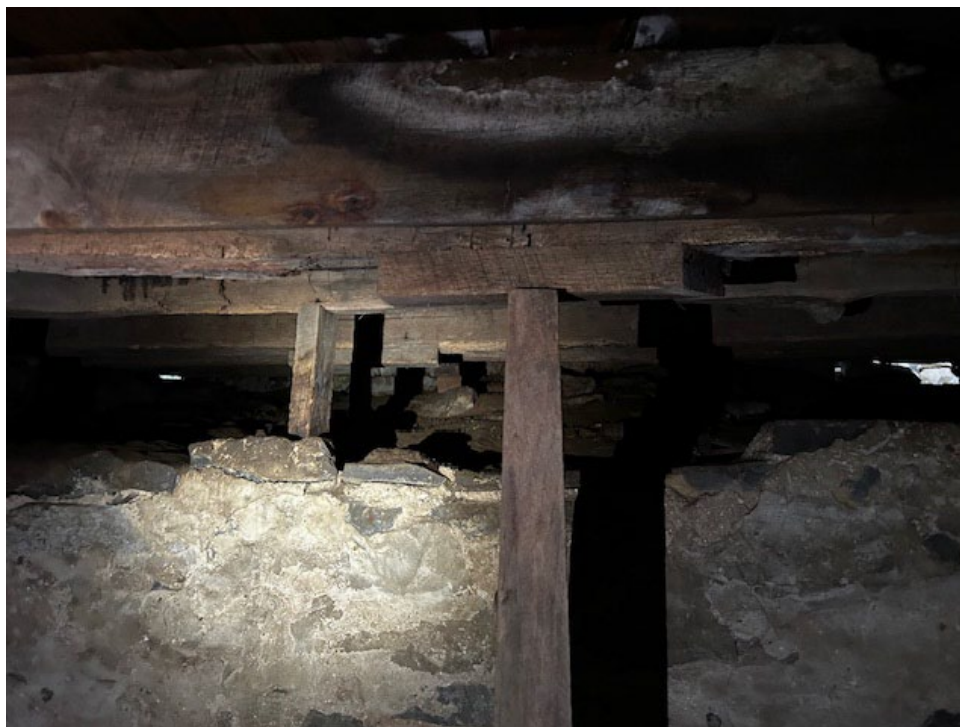
Brown House – Crawlspace looking at condition of floor joists and current supports.

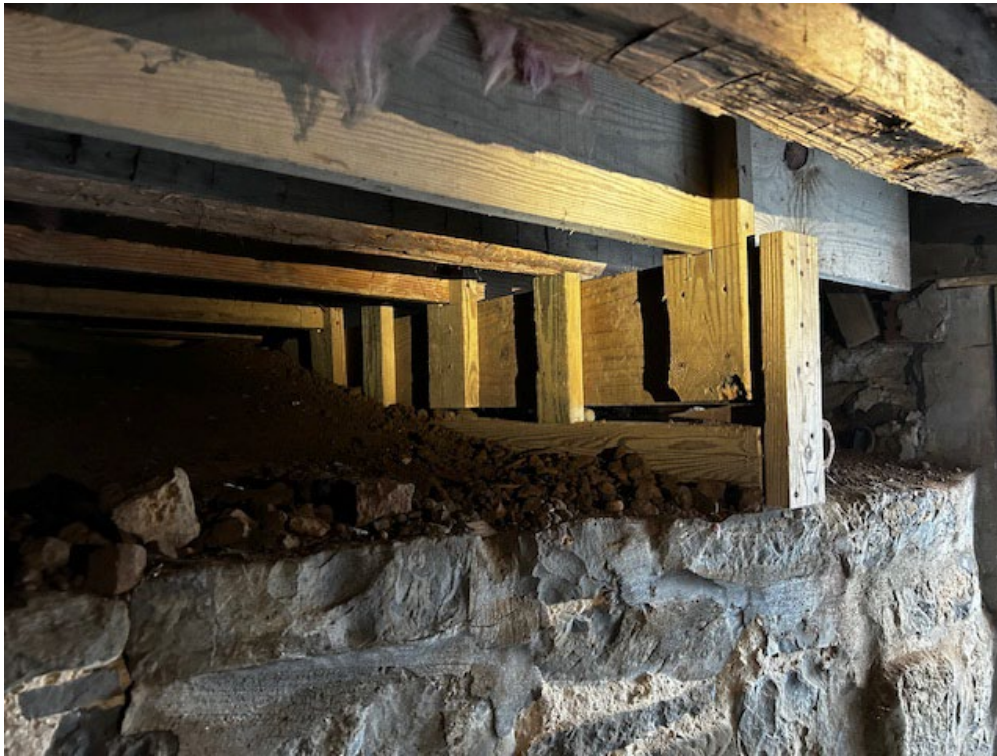
Brown House – Crawlspace looking at condition of floor joists where repairs have previously been made.

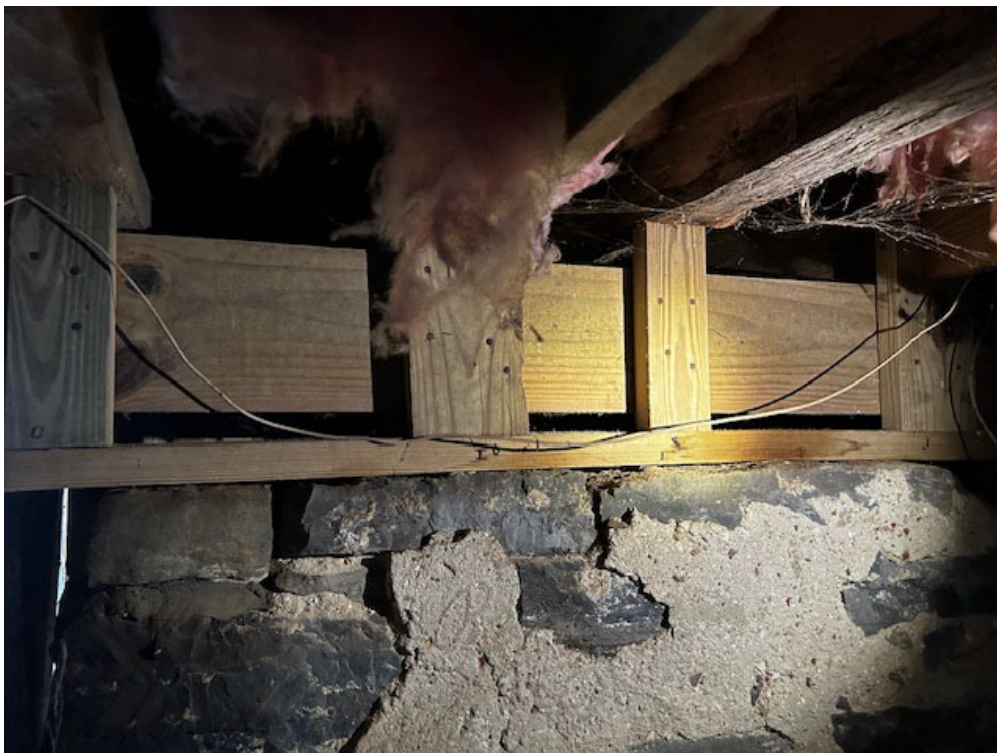
Brown House – Crawlspace looking at condition of floor joists where repairs have previously been made.

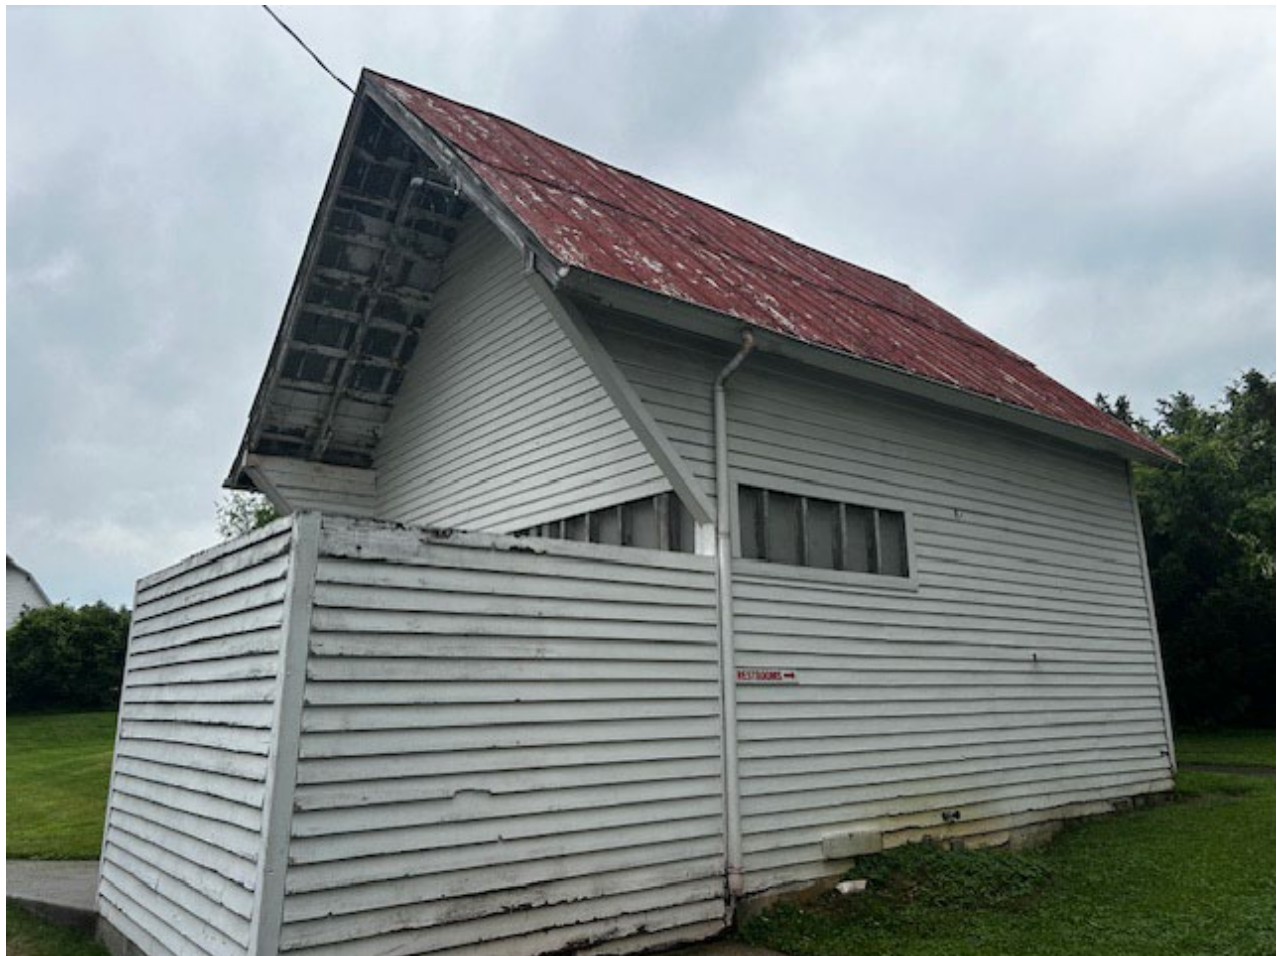
Freestanding Bathroom Building – The current state of the bathroom building closest to the Brown House has foundation issues and rotting wood on the building. The toilet vent currently vents into the storage unit on the opposite side from the bathrooms.

Photo of the outside of the freestanding bathroom building.

Recommendation: Need to excavate around foundation, would recommend underpinning the foundation and pouring an additional extended concrete foundation around the building. The bottom rotted clapboard should be removed and the sill will need to be replaced. The venting of the toilets should be fixed to meet current standards. Where the bathrooms are in poor condition, it may be more cost effective to build a new free standing bathroom building and remove the existing building.

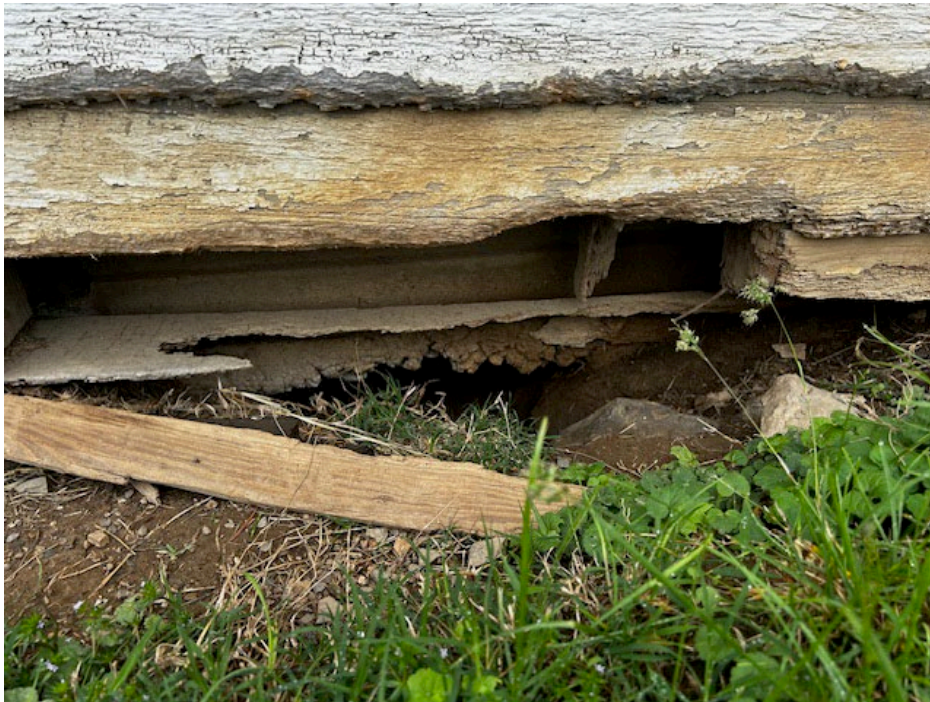
Bathroom Building: Photo of rotting boards at bottom of building and foundation failure.

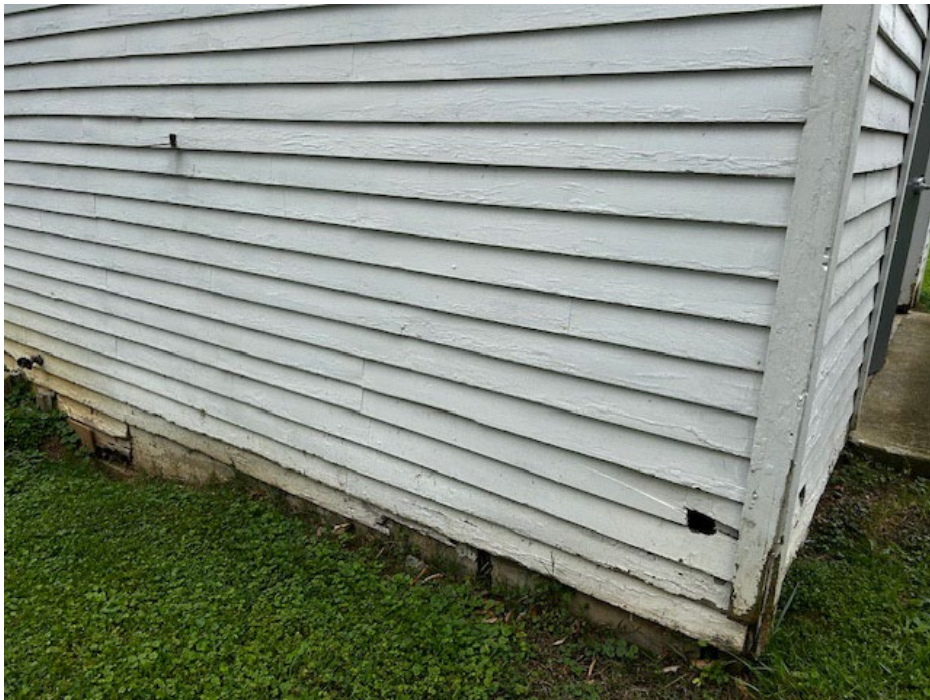
Bathroom Building: Photo of rotting boards at bottom of building and foundation failure.

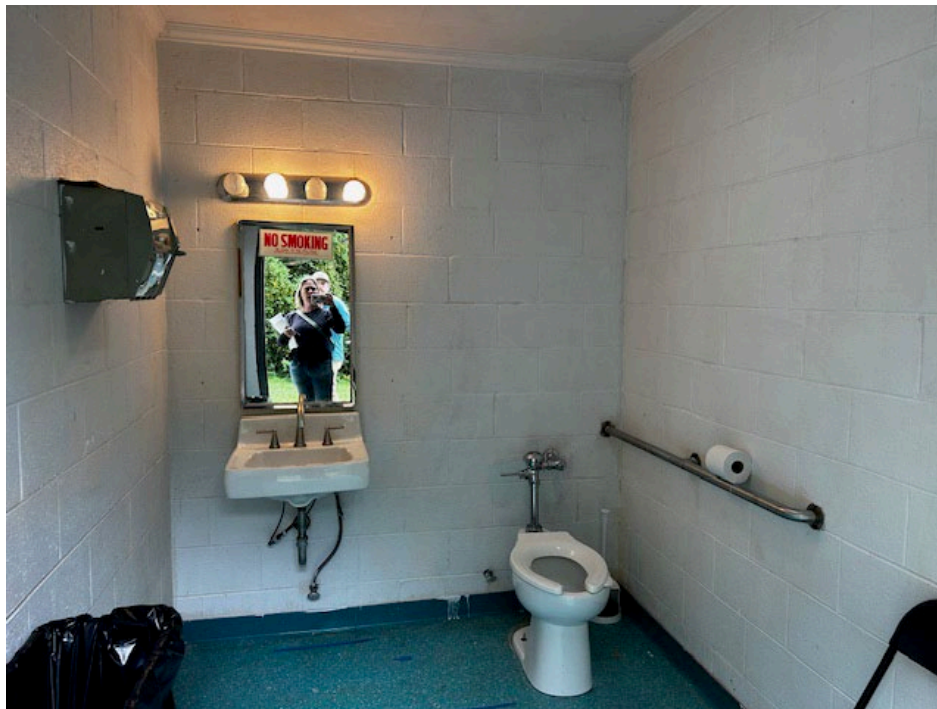
Bathroom Building: Photo of women's restroom.

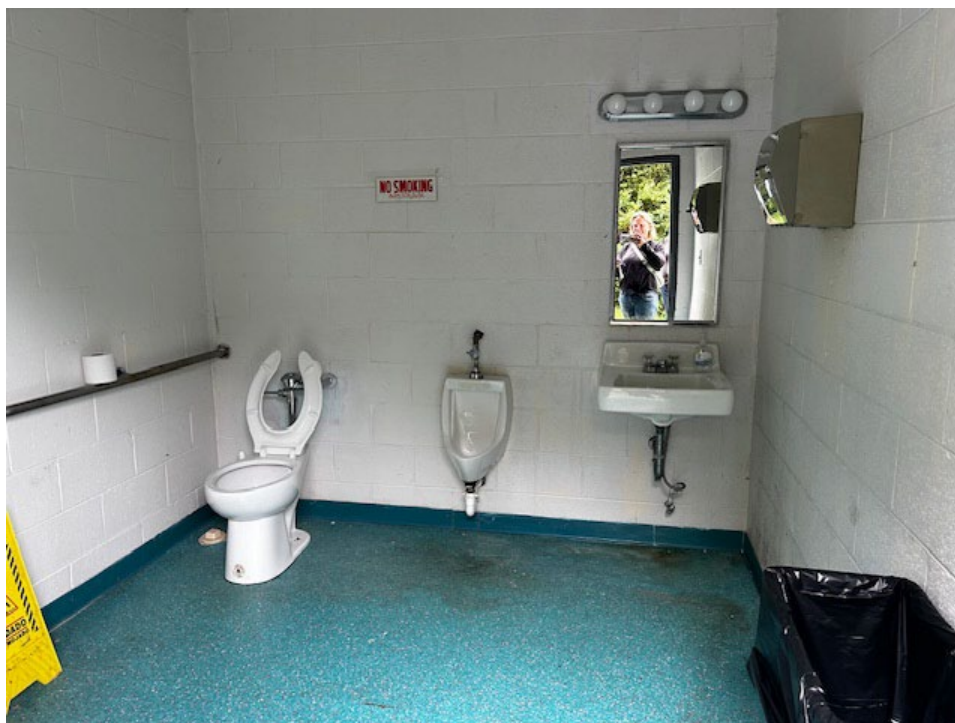
Bathroom Building: Photo of men's restroom.

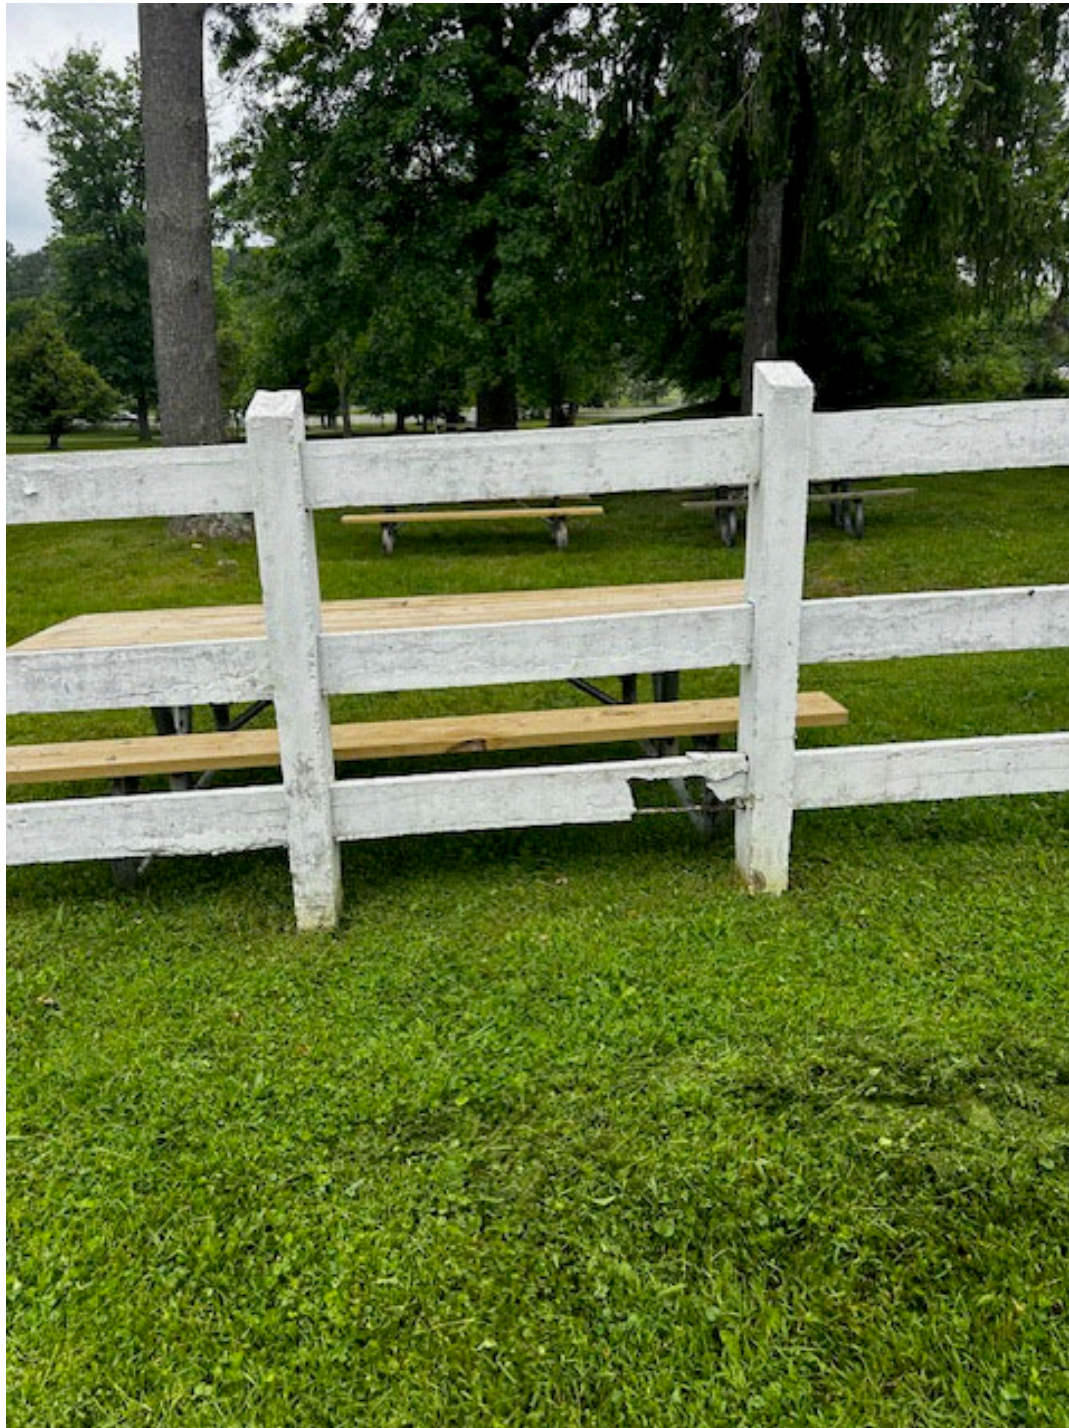
Below is a picture of the split rail fence that is currently concrete planks with exposed rebar. Would recommend either repairing the rails or removing the damaged concrete rail pieces and putting in a new composite rail in its place.

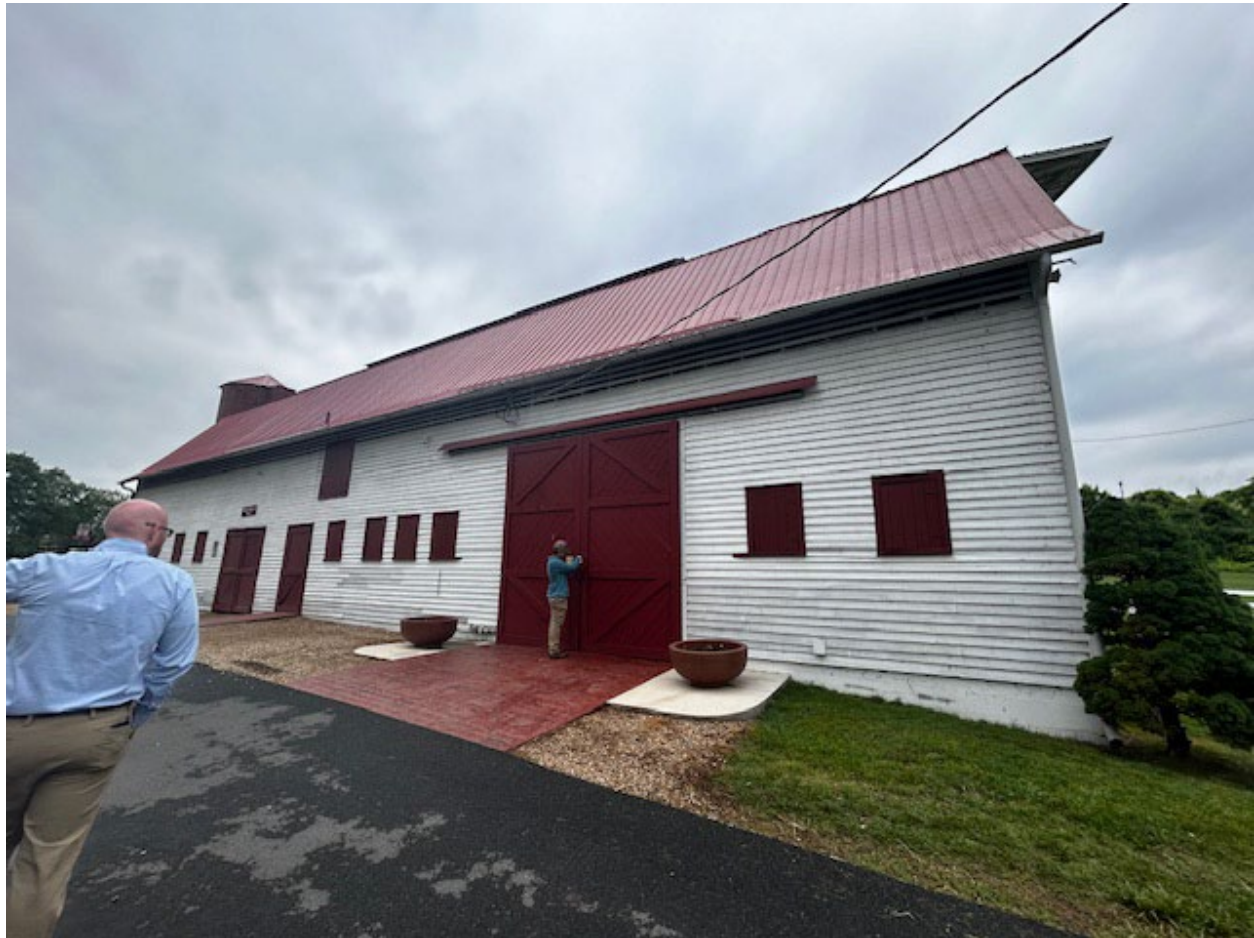
Harvey's Barn – It was mentioned that in an ideal world it would be great to heat and cool the building, however this would be a huge undertaking as the building is not currently insulated and part of the appeal to the current appearance is all the exposed wood. The stairs leading to the second floor are not currently code compliant. The floor under the chandelier could use some reinforcing. There was mention of upgrading of bathrooms and lighting. It was also discussed that the current space is not ADA accessible.

Recommendation: I would recommend that this building be looked at in depth with a preliminary design to utilize the first floor area that is currently being used as storage into an event room. This would allow for a first level event space that would be ADA accessible and would open directly to the patio / yard space as well as design for upgraded bathrooms and catering space. The upper level area should be looked at during this time as well with design for modifications to the stage / dancing area to fix the floor and the non-compliant stairs.

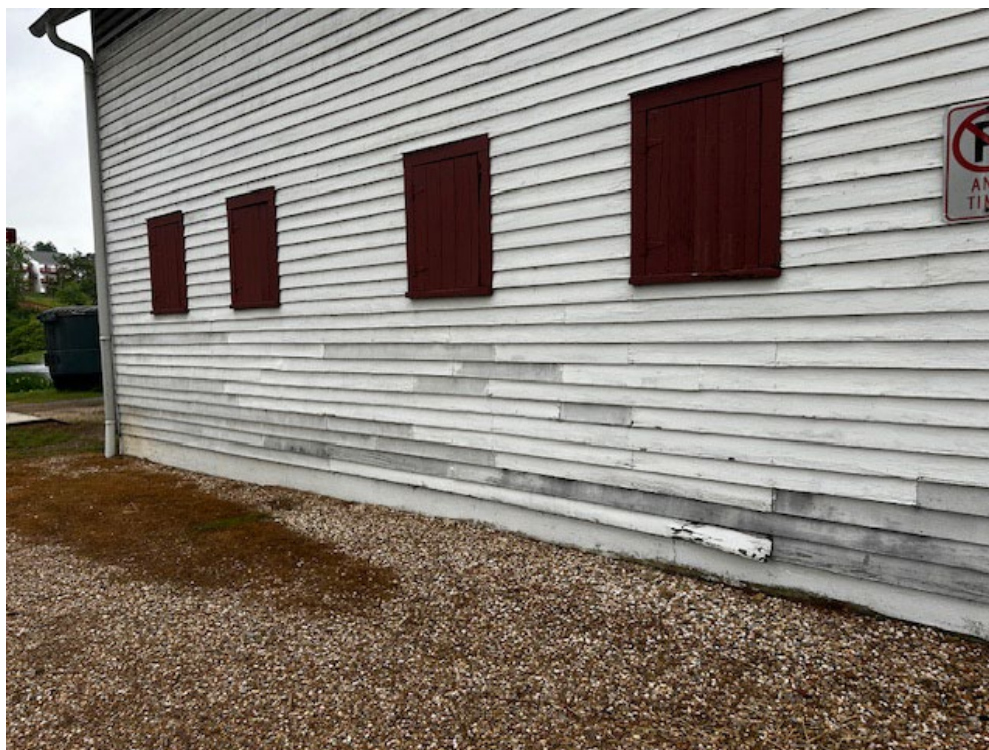
Harvey Barn – Area showing rotted boards and deterioration of paint.

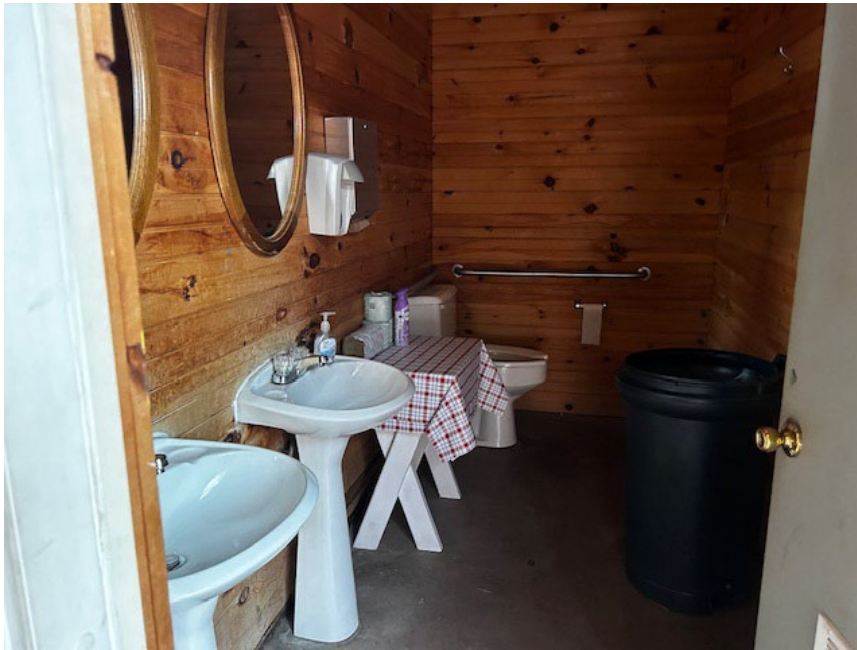
Harvey Barn – Bathroom photo showing multiple sinks but no partition between toilet.

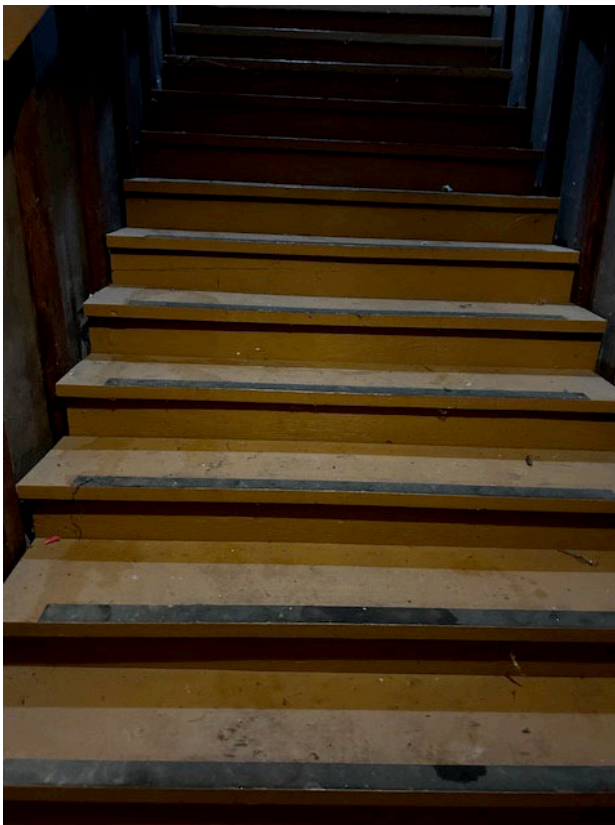
Harvey Barn – non-code compliant staircase.

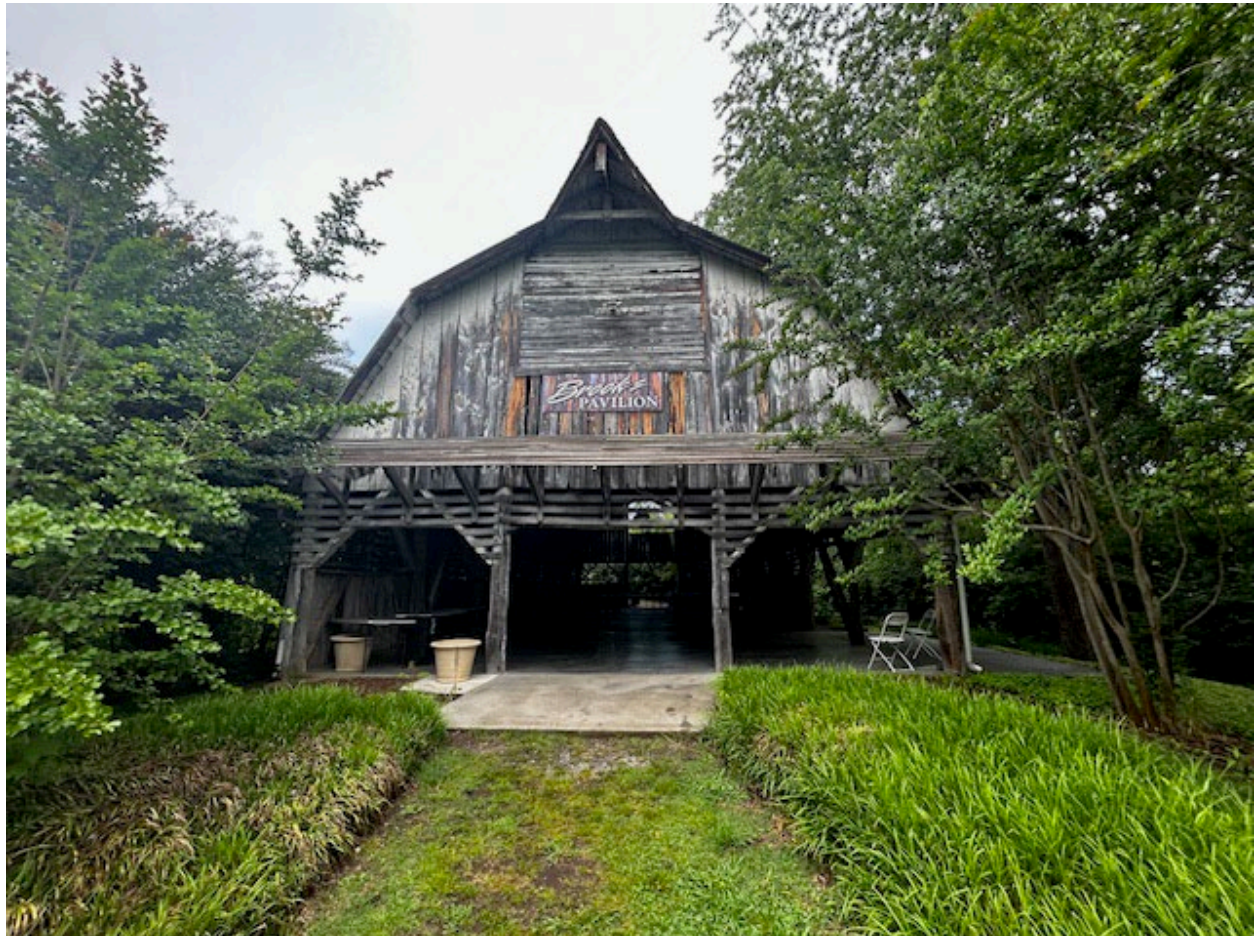
Brooks Pavilion and bathrooms – While walking the Brooks Pavilion there were areas that were noted to be deteriorating due to wood being against dirt / mulch. It would be pertinent to either cut the boards up from the edge to get it out of the dirt or to remove dirt around the edge to get the earth away from the wood. See additional pictures below. It is my understanding that this area is of lower priority and the conditions are ok at this time.

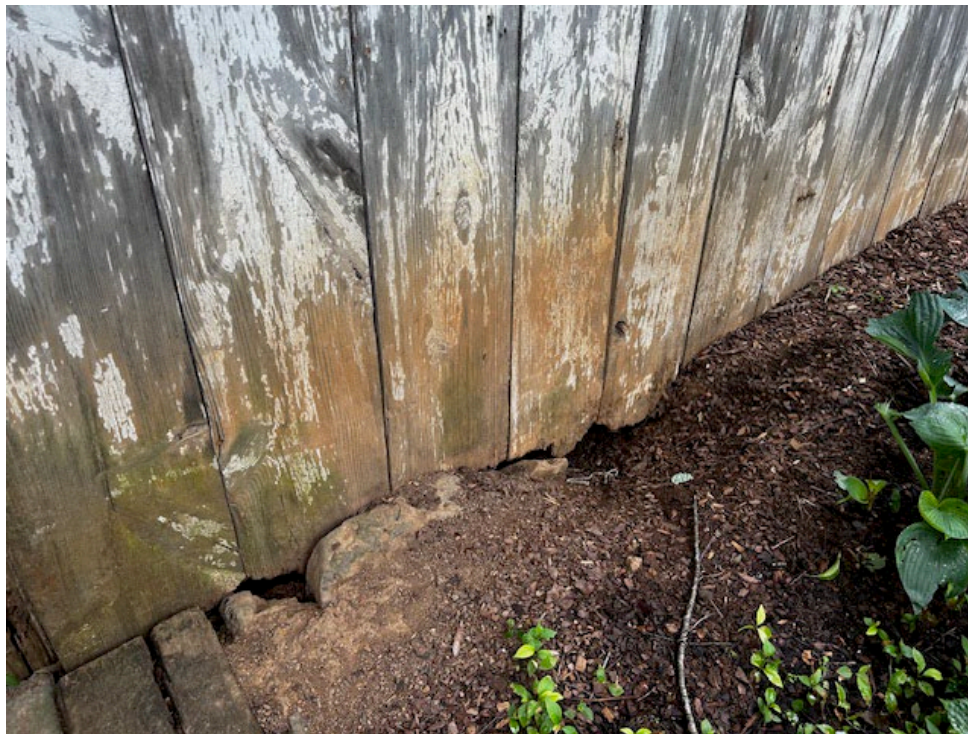
Brooks Pavilion – Area showing dirt/mulch in contact with the wood which will cause deterioration and rot.

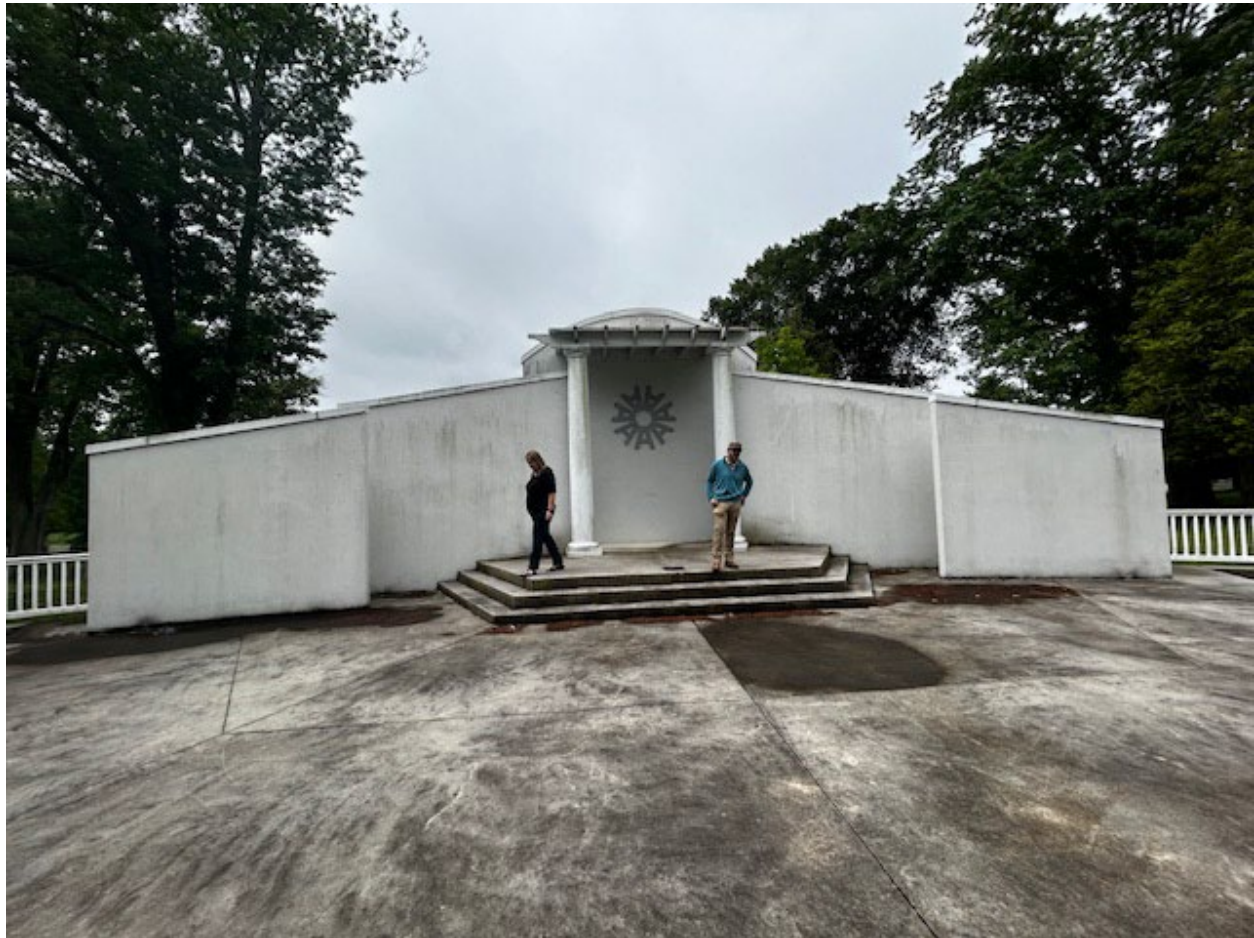
Amphitheater – This area was again identified as a lower priority area, however there are some maintenance items that should be taken care of in the near future. It was noted that the restroom areas should be renovated if / when this building were to be modified.

Recommendations: It would be advised to pressure wash the building and verify all weather covers on outdoor electrical are intact. There are rotten boards that should be replaced on the walkway leading to the amphitheater. It is our understanding that the electrical would need to be upgraded as well for current performance needs.

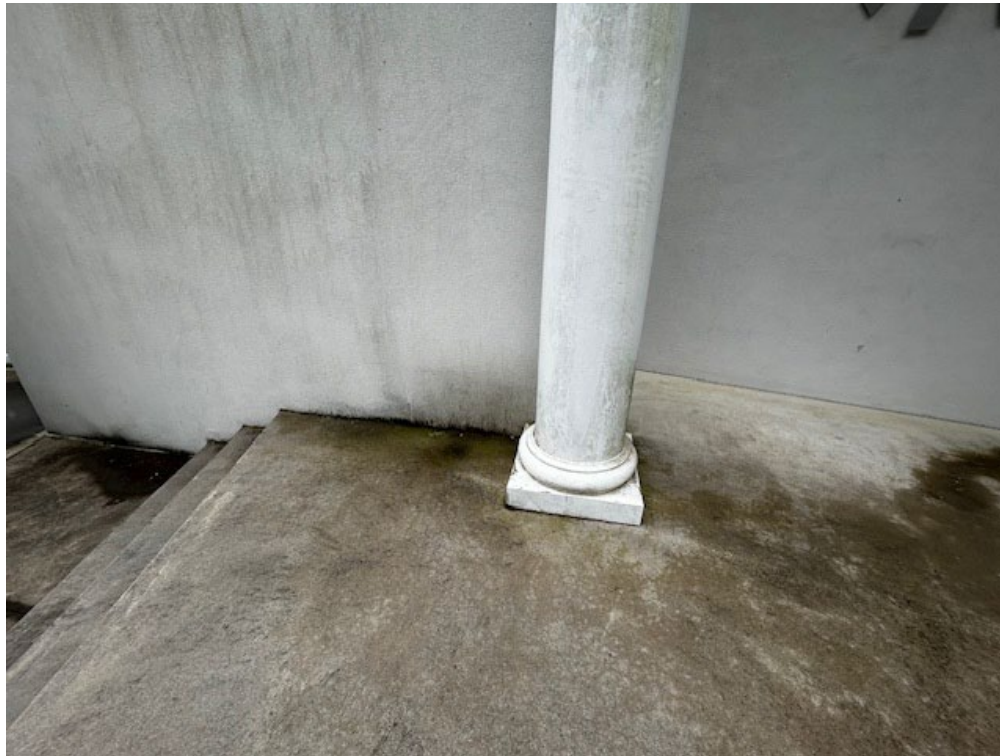
Amphitheater – Area showing discoloration / mildew on concrete and walls.

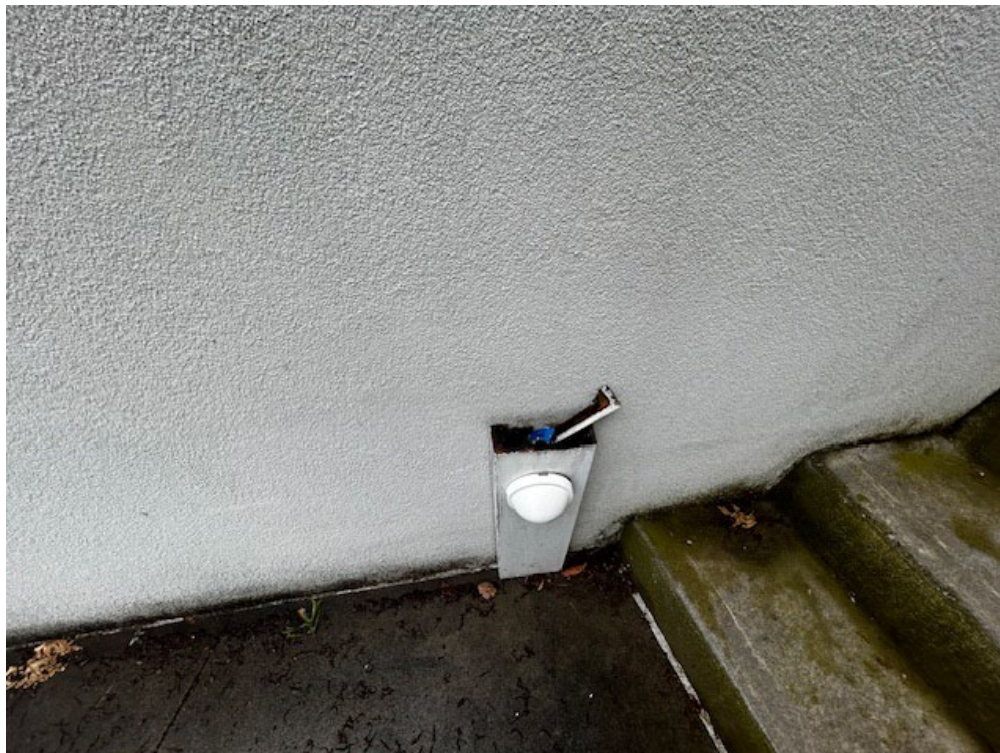
Amphitheater – Area showing a light that needs attention where the cover has been removed / broken.

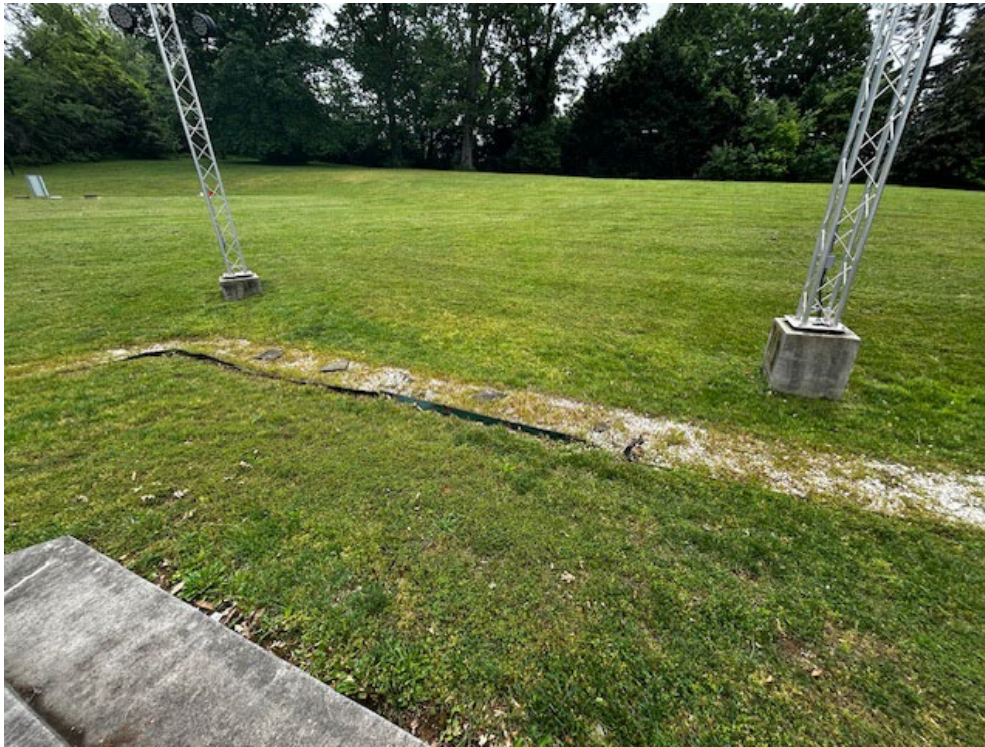
Amphitheater – Area showing a gravel path around lawn area could use maintenance / cleaning.

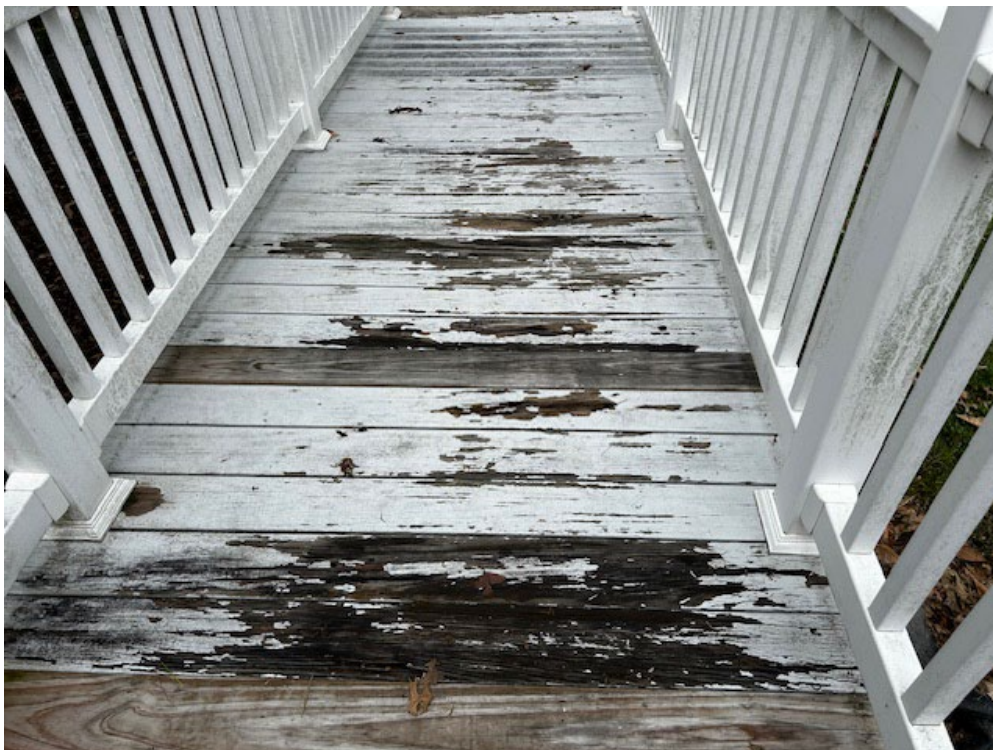
Amphitheater – Area showing deteriorated walkboards.
