# LIFT STATION CLEANING COMPLETION REPORT

**Village of Kronenwetter**

2025 Spring Lift Station Cleaning

03.20.2025

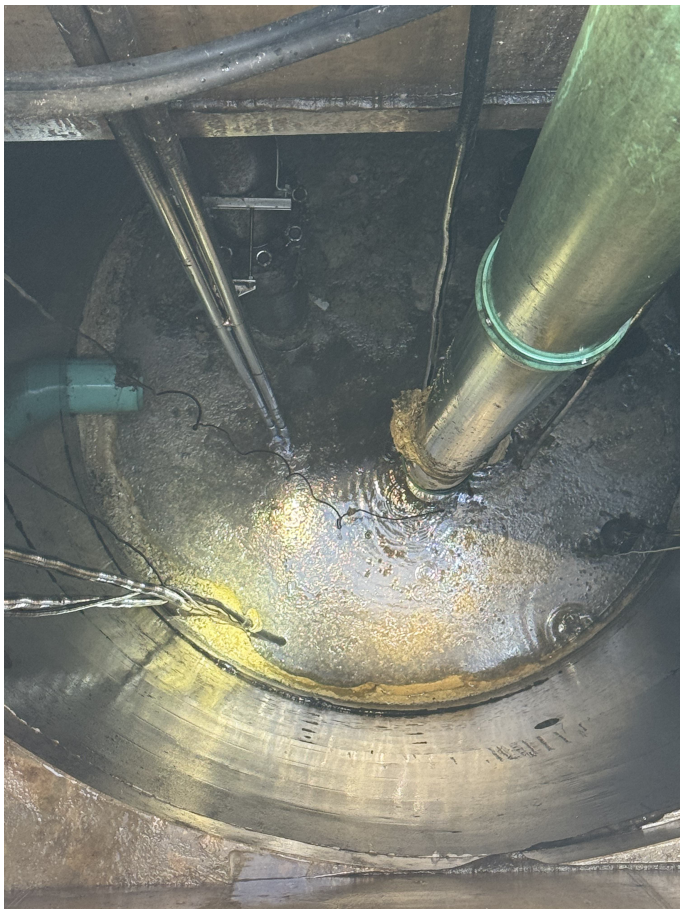
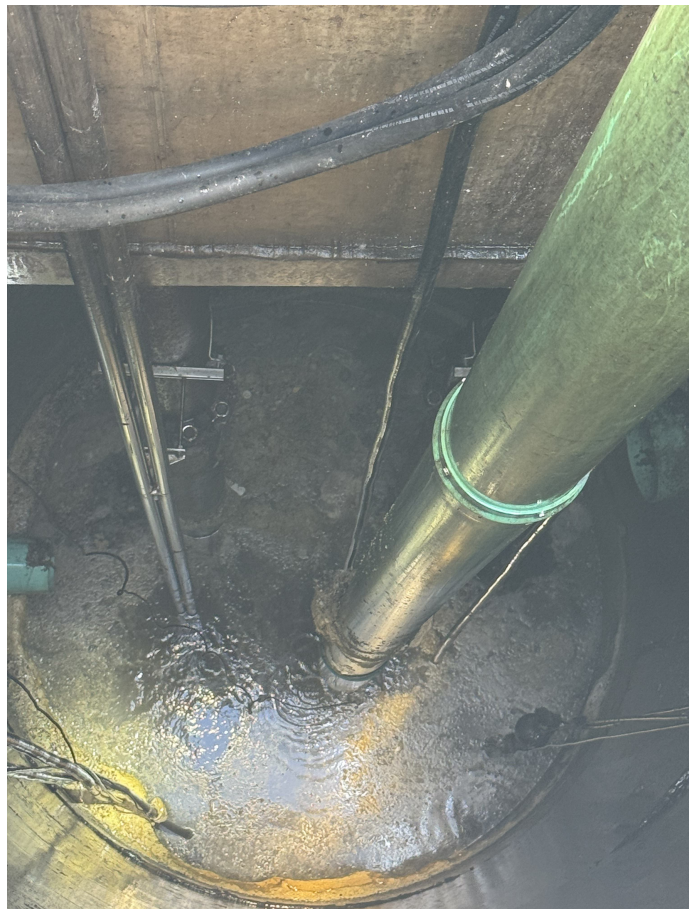
Lift Station Number: L/S 1 Lift Station Location: 2201 Tower Rd

Heavy Grease

- ☒ Good  
☐ Fair  
☐ Poor

Evidence of Infiltration: ☐ YES ☒ NO

Pump retrieval cable is hung up poorly.

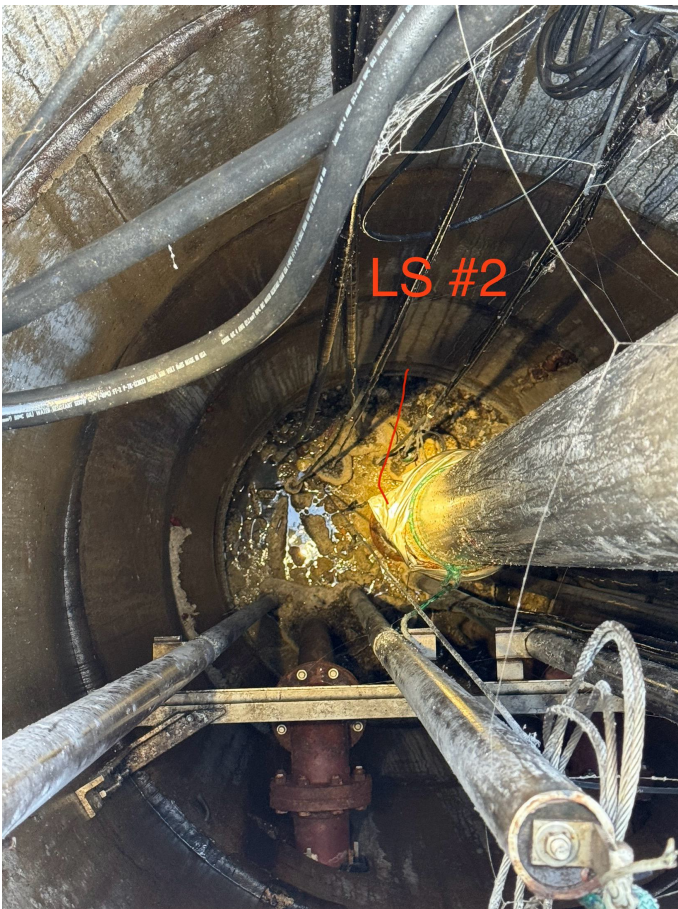
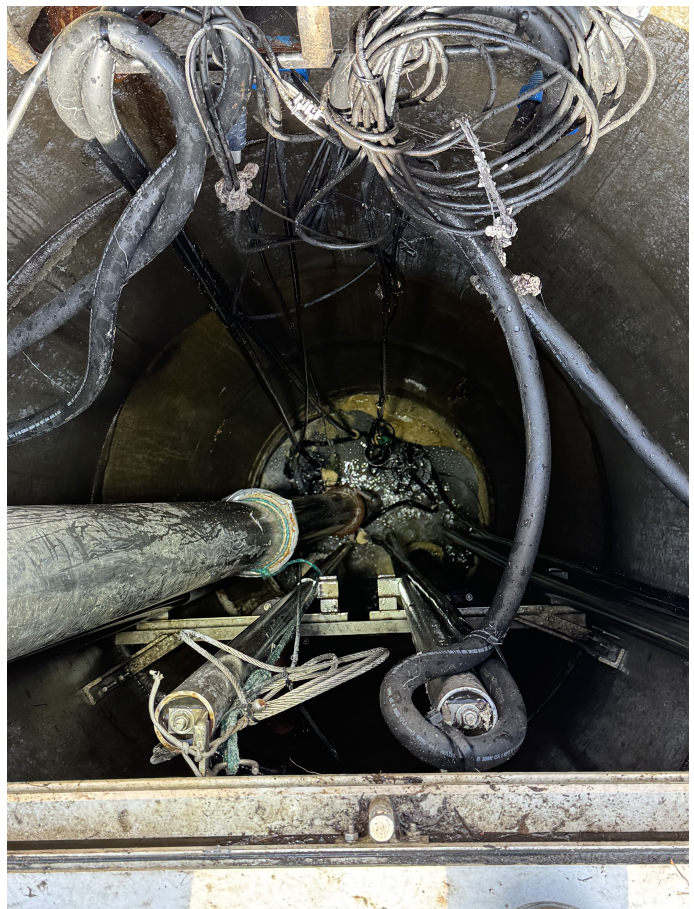
Lift Station Number: L/S 2 Lift Station Location: 1929 Kimberly Rd

Heavy Grease

- ☒ Good  
☐ Fair  
☐ Poor

Evidence of Infiltration: ☐ YES ☒ NO

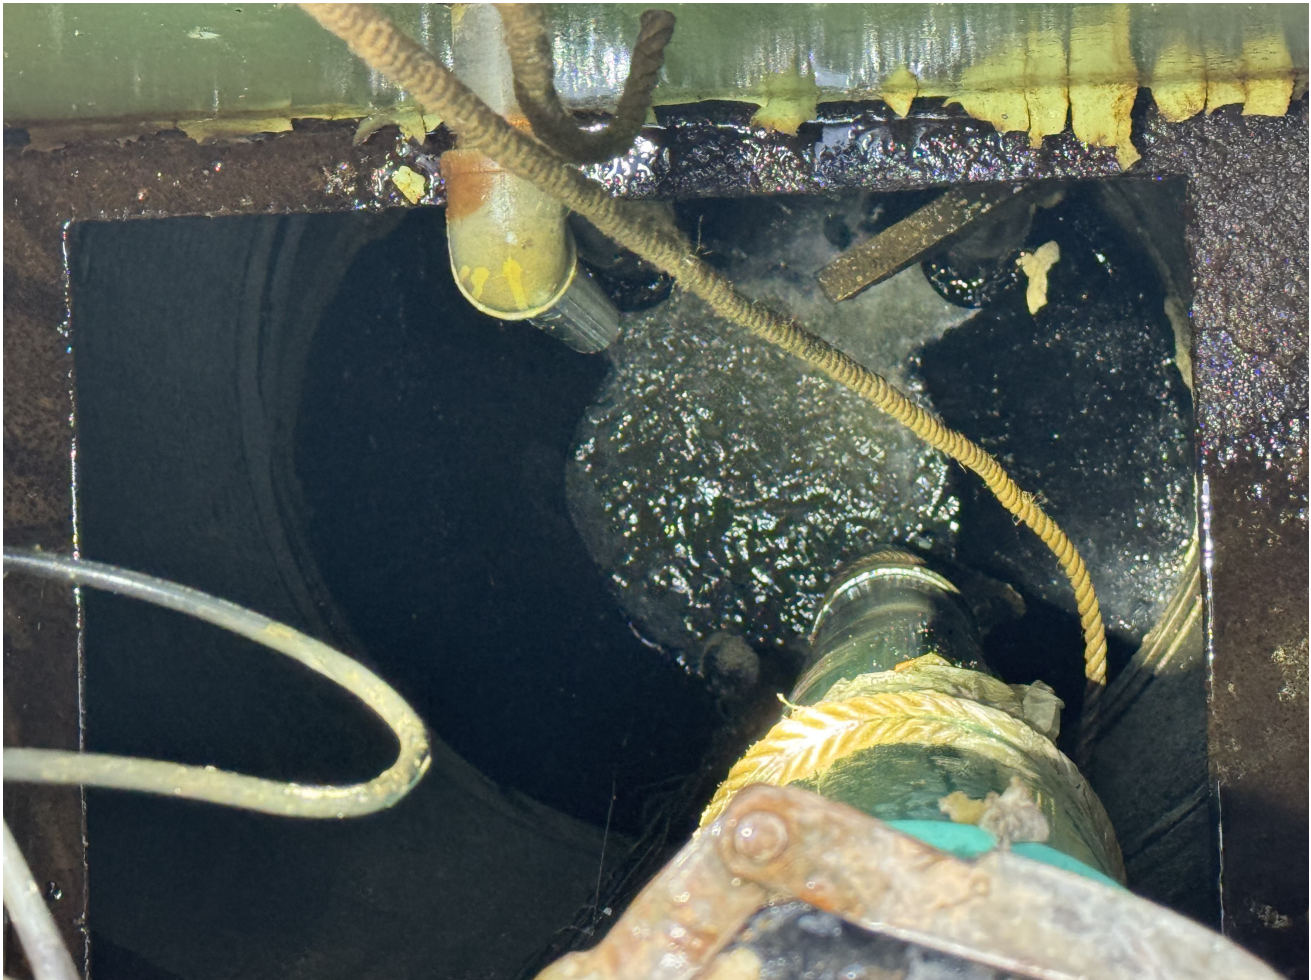
Lift Station Number: L/S 3 Lift Station Location: 2361 Tower Rd

Heavy Grease

- ☒ Good  
☐ Fair  
☐ Poor

Evidence of Infiltration: ☐ YES ☒ NO

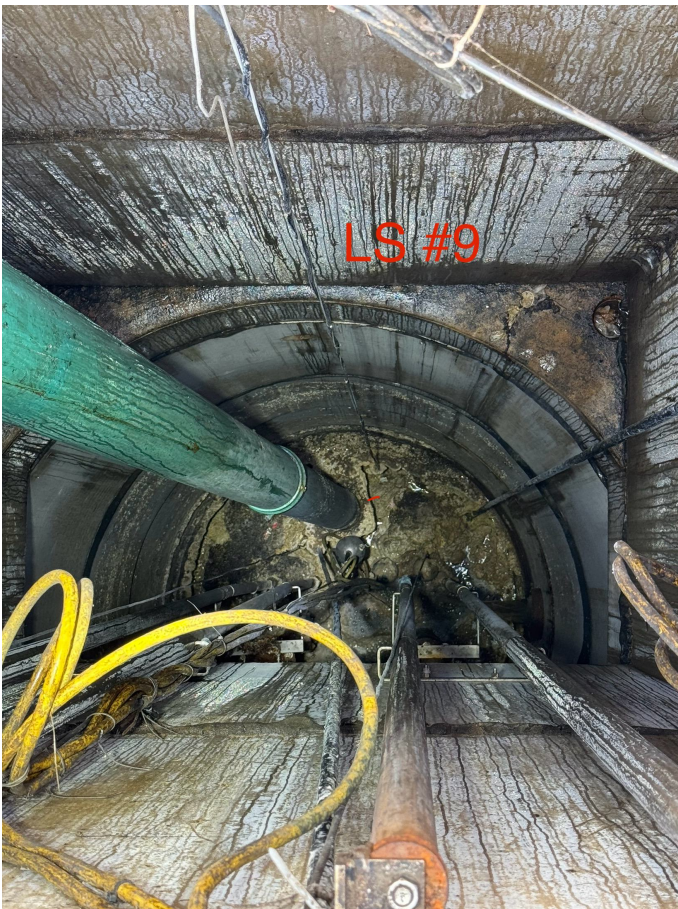
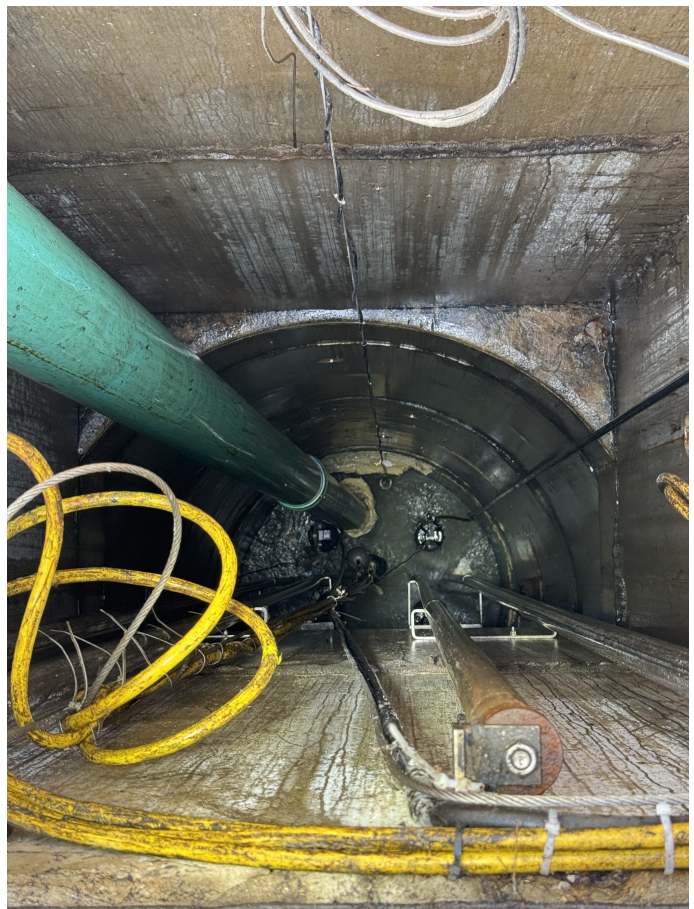
Lift Station Number: L/S 9 Lift Station Location: 2099 West Rd

Very Heavy Grease

- ☒ Good  
☐ Fair  
☐ Poor

Evidence of Infiltration: ☐ YES ☒ NO

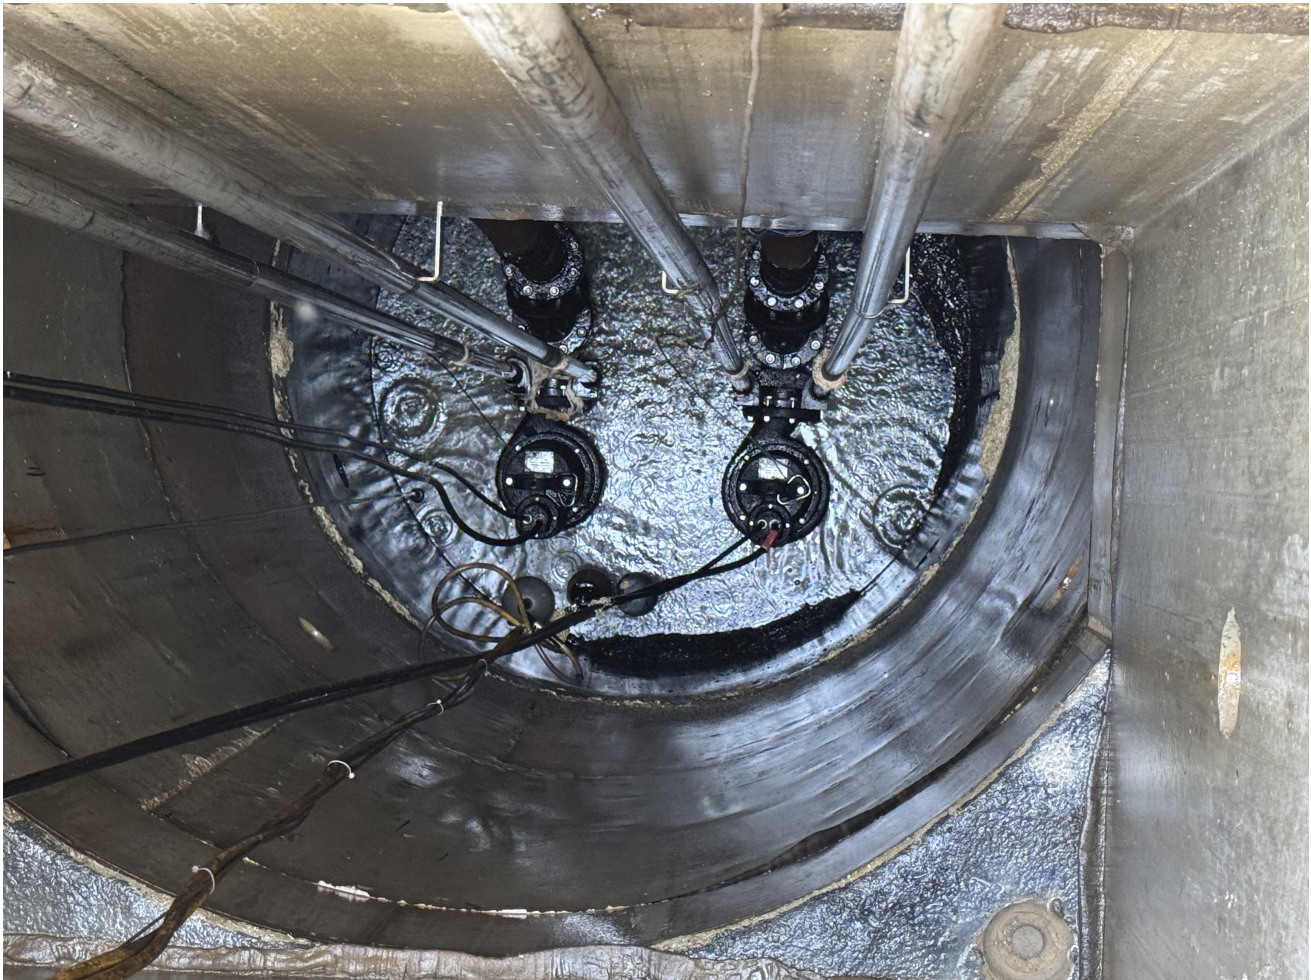
Lift Station Number: L/S 10 Lift Station Location: 2505 Sussex Pl

Light Grease

☒ Good

Evidence of Infiltration: ☐ YES ☒ NO

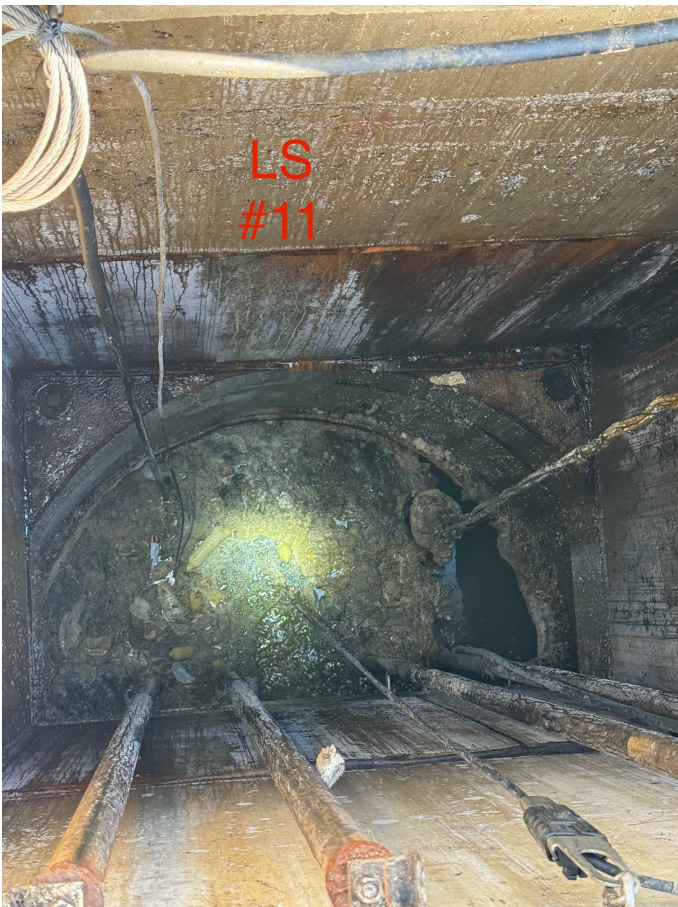
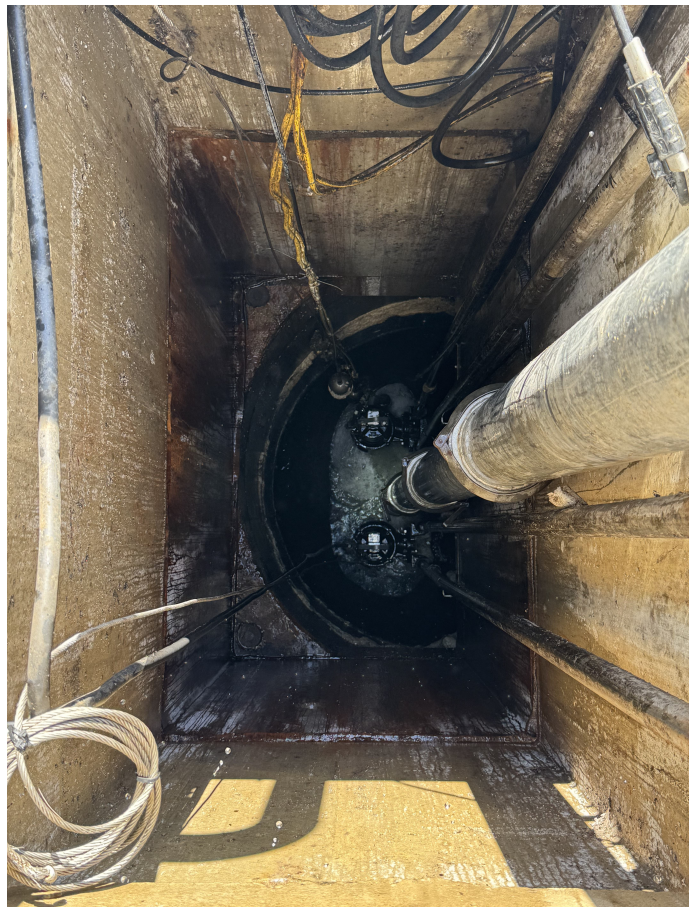
Lift Station Number: L/S 11 Lift Station Location: 805 Glade Ct (back of subdivision)

Heavy Grease

- ☒ Good  
☐ Fair  
☐ Poor

Evidence of Infiltration: ☐ YES ☒ NO
