# MEMO

**Subject:** City Hall Building Façade and Structure Reassessment

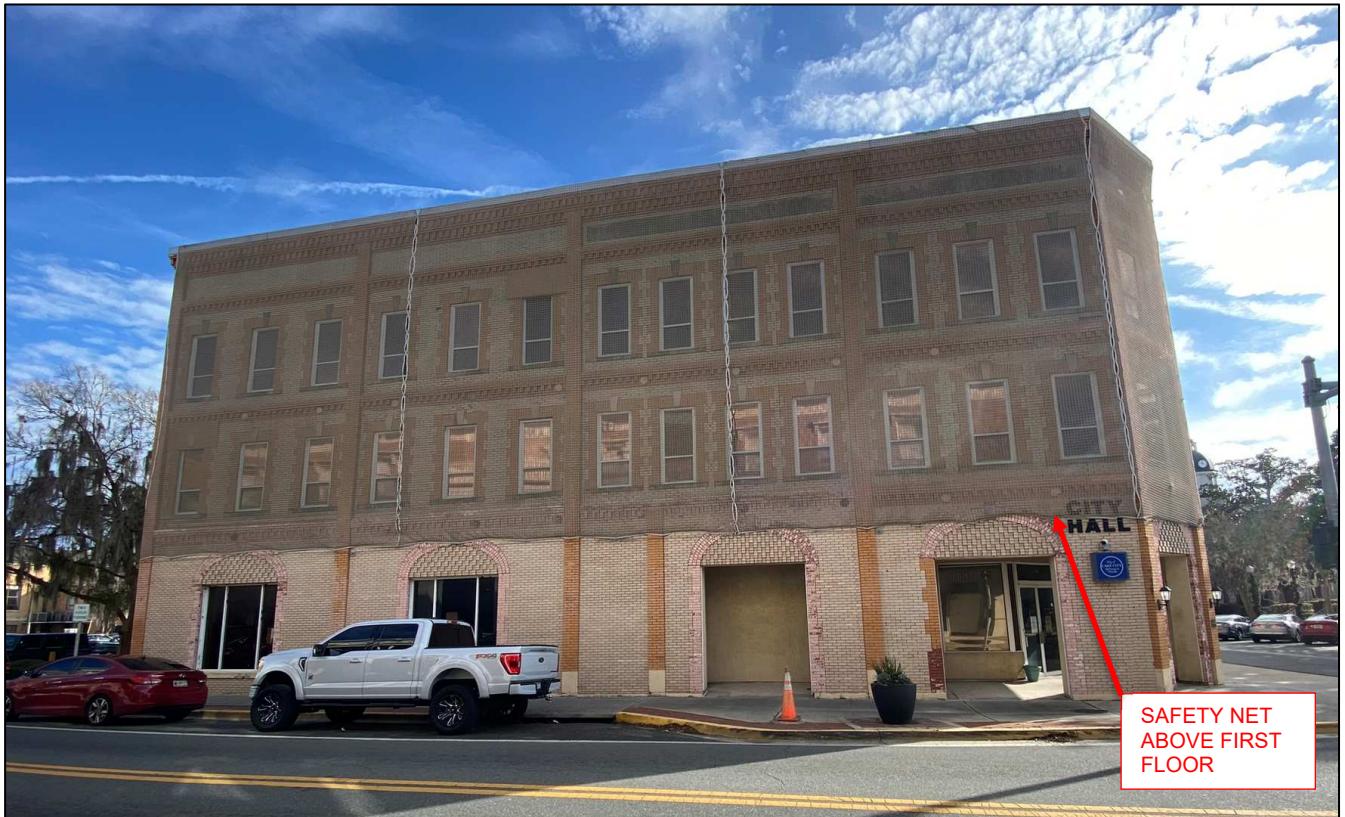
**Photo 1: West Building Face**

1. Netting has been installed on the South and West faces of the building above the first floor where there is exposed brick. The netting appeared to be in good condition and securely anchored to the roof parapet. The South and West walls appeared to be in the same or similar condition as observed in our original assessment. It should be noted that the netting did obscure visual observations slightly and made it difficult to follow mortar joints and judge their alignment. It is recommended to monitor the integrity of the netting for signs of dry rotting over time and check the manufacturer's literature for life expectancy. The safety net needs to be in place and of sound strength until the brick façade is restored or the hazard is mitigated.

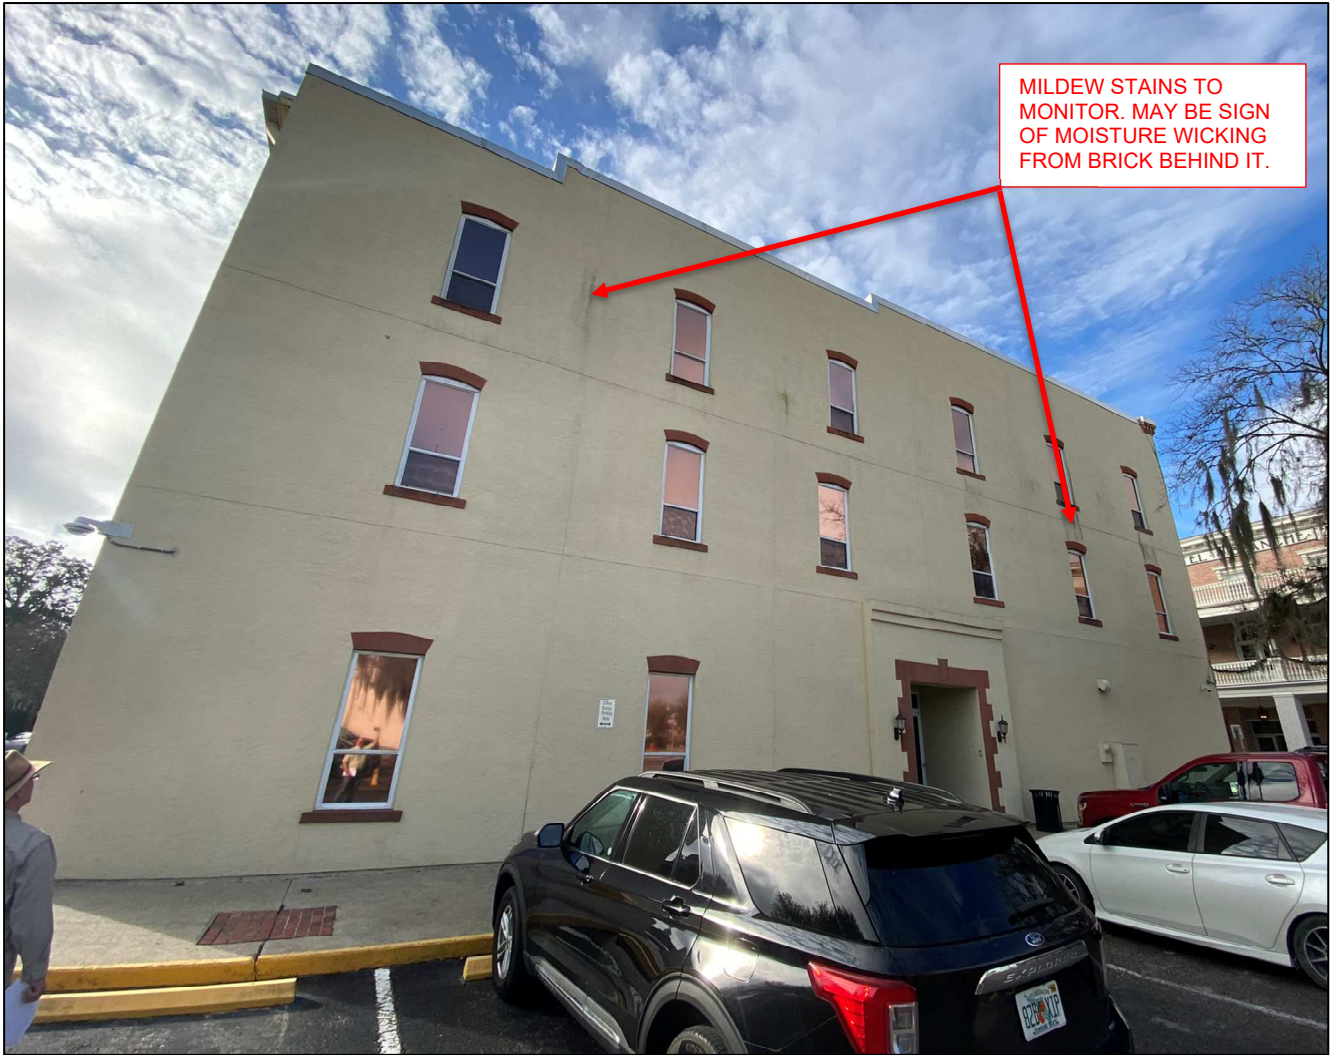
**Photo 3: North Building Face**

2. Mildew on the north face of the building in select locations below windows and near stucco joints. Our recommendation is to clean the wall to remove the mildew and monitor these locations to see if the mildew returns or if water is wicking from the brick wall that is behind the stucco. If water is in the multi-wythe brick wall, it will lead to deterioration of the wall section and compromise its integrity. If there is a point of water intrusion (i.e. at the parapet or around the window) it needs to be located and sealed to prevent damage.
