City of Lake City

City Hall Structural Assessment

#200-08521-18002
September 6, 2018

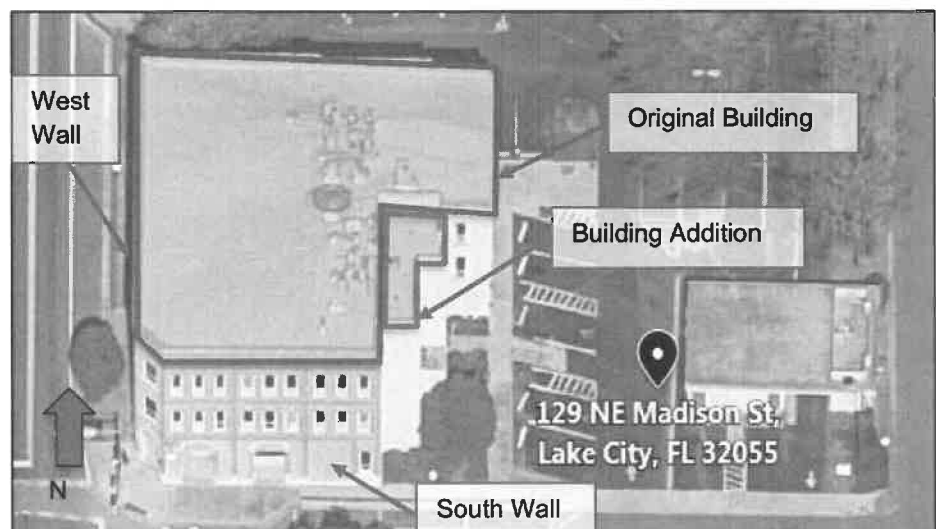
Figure 1: Building Aerial View (Looking North)

The building was originally constructed as a bank and hotel but has undergone many different renovations and uses throughout its lifespan as noticed in **Photo 2** and **Photo 3**. Most of the changes to the brick façade have been made along the first floor. The original arch shaped openings have since been restored, but the current condition varies from the original in that there is a recessed corridor and entry along the southwest corner of the building. Record drawings were provided for a major renovation and addition project that was performed around 1985. As part of that renovation three interior, load-bearing, multiwythe brick walls were removed and replaced with steel columns and beams. This is the focus of this study and report. The 1985 renovation also included a three-story reinforced cmu addition on east side of the building for a stairwell and elevator (See **Figure 1**).

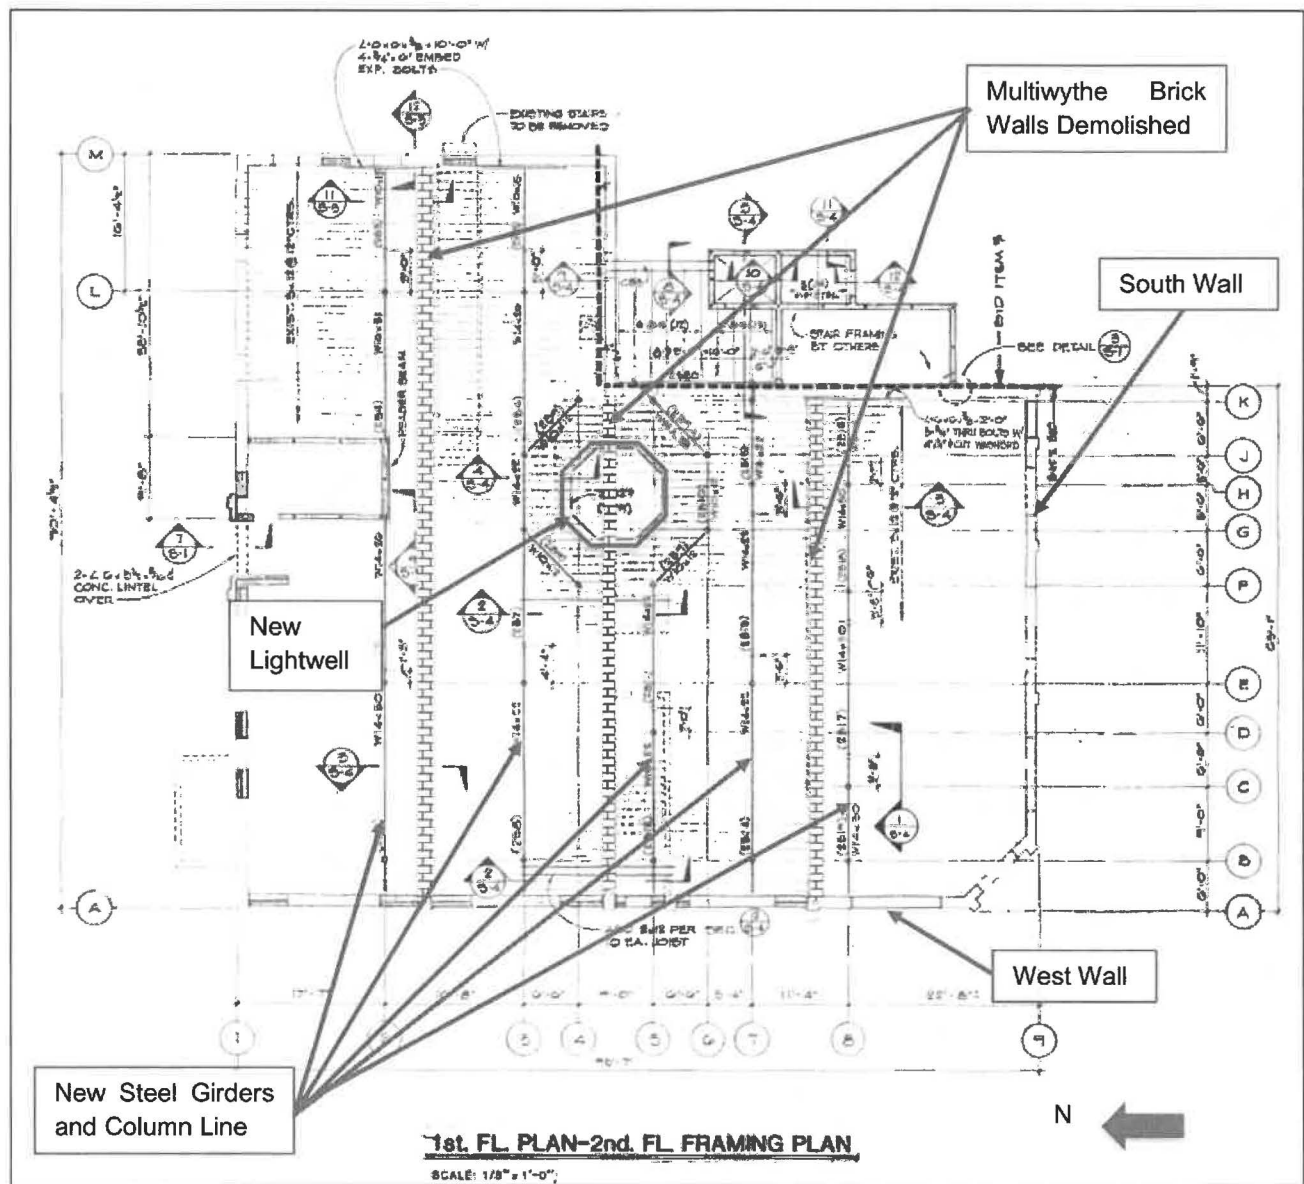
Figure 2: 1985 Renovation - Demolition Plan

When the building was originally constructed, there were three interior load bearing multiwythe brick walls that aligned with the pilasters on the west face of the building. However, the 1985 renovation removed these load bearing walls and replaced them with five new steel girder lines, see **Figure 2**. The member sizes and connection detailing for this steel framing appears to be just for gravity loads and does not indicate that they were designed as moment frames to resist lateral loads. So, there is no indication that the new steel framing is meant to replace the lateral stability and strength of the original brick walls. Furthermore, the new steel girders are not connected to the east and west brick walls, so no bracing support is provided by them.

The floor and roof decking were assumed to act as flexible diaphragms that transfer laterally applied wind loads based on tributary area and not stiffness. Usually, flexible diaphragms only transfer wind loads to walls that are parallel to the direction of the applied wind load. For wind loads in the E-W direction the lines of lateral resistance are exterior brick walls along grids 1, 4.4, and 9, as shown in **Figure 2**. Wind loads in the N-S direction are transferred to walls along grids A, K, and M.

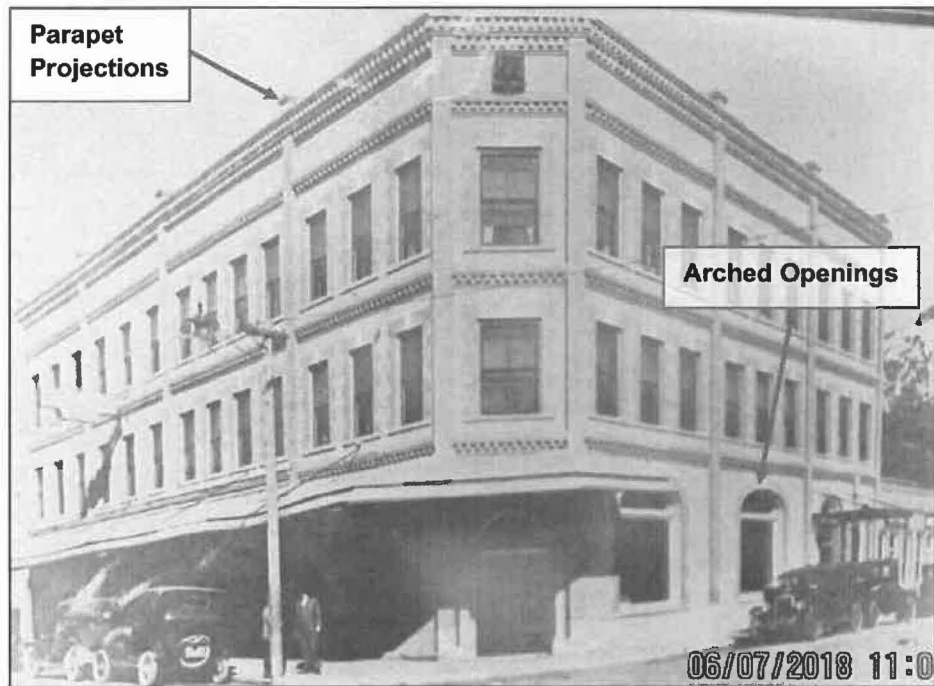
Photo 1: Original Building

The City purchased the building around 2005 and currently occupies all three floors. As-built drawings were not available to review for original construction details and building age. It is a three-story building, approximately 23,000 ft² with load-bearing multi-wythe brick walls, timber floors, and timber roof framing. An engraved stone on the building façade and historical pictures in the building indicate it was built circa 1911 (See **Photo 1**).

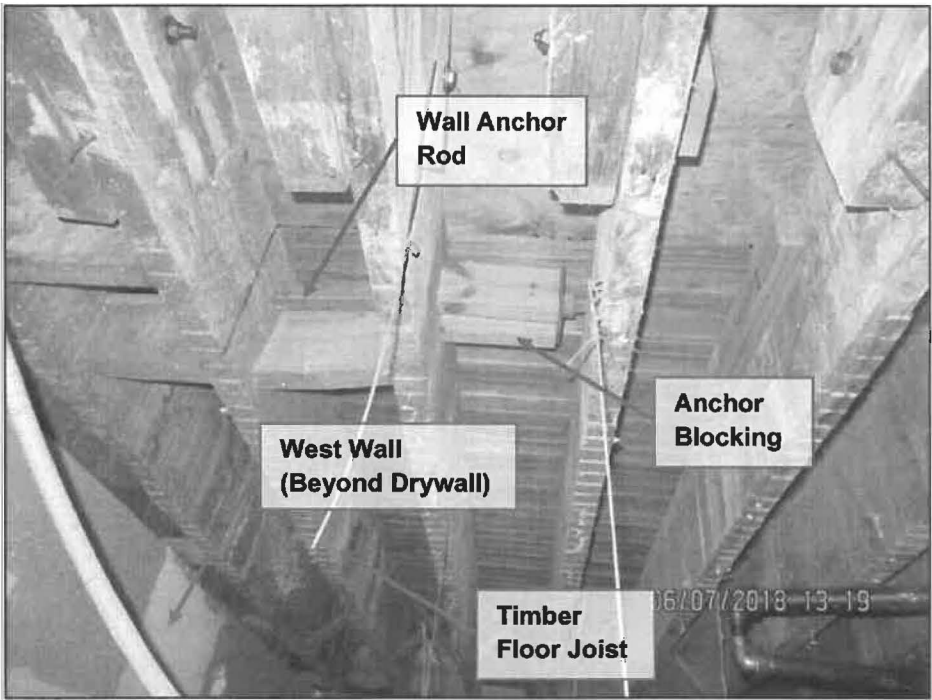
Photo 4: Retrofit Wall Anchor (West Wall)

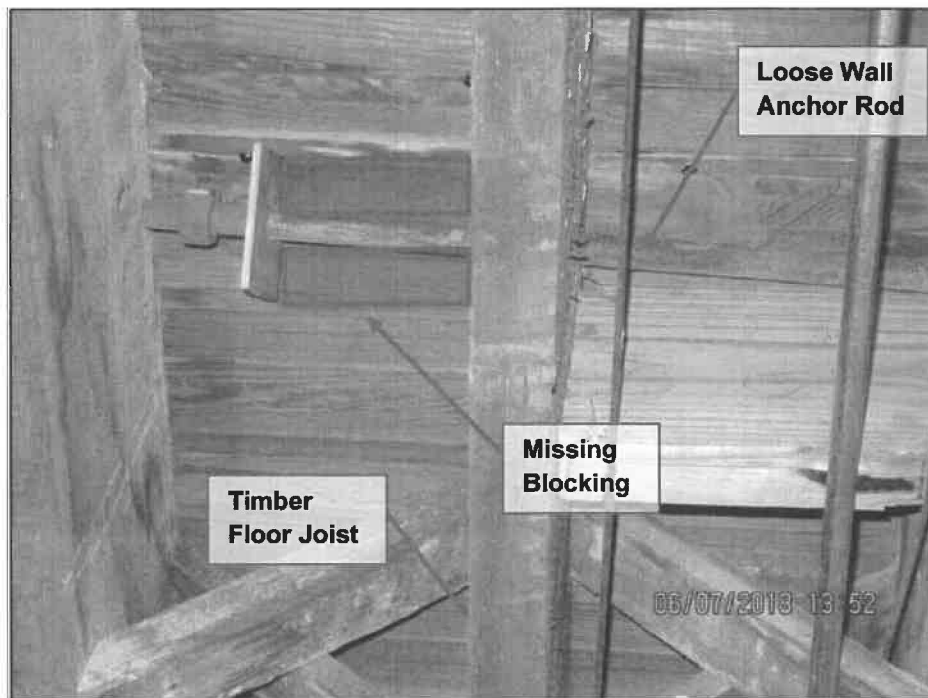
Photo 5: Loose Wall Anchor

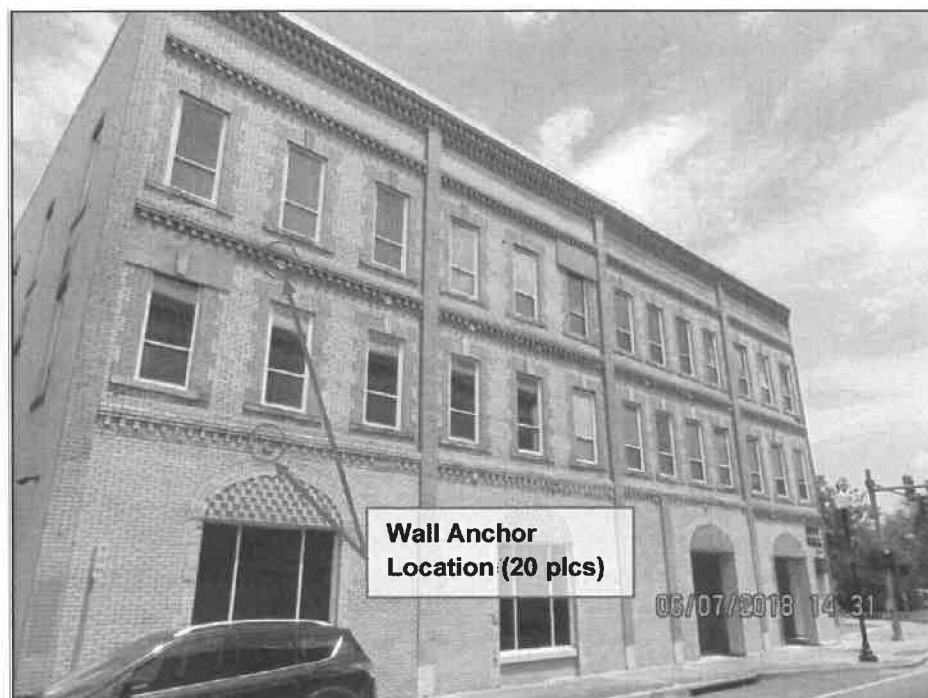
Photo 6: West Facade Anchor Locations

Older buildings like this do not typically have significant lateral load path connections from the floor deck and framing to the perimeter of the building. It was confirmed onsite that there is not an identifiable load path for in and out-of-plane loads from the east and west walls to the floor diaphragm. The timber joists bearing on the north and south walls do offer some bracing due to the friction developed by the mortar and timber interface in the wall pocket. We also discovered some tie-back rods/anchors were installed to help stabilize the west wall, but it is unknown when these retrofit anchors were installed. **Photo 4** shows a typical anchor and **Photo 5** shows an example where an anchor does not support the wall as intended due to missing blocking. There are 20 of these wall anchors installed on the west wall of the building, as shown in **Photo 6**.

Diaphragm to wall anchors are also needed to transfer in-plane and out-of-plane loads. There are some locations that already have some mechanical anchors installed. But, the east wall appears to be the most susceptible to out-of-plane wind load due to unknown connection to the floor and roof diaphragm. While the existing joist bearing pockets on the north and south walls can transfer some force, it is preferred to have a mechanical connection that is more reliable and able to be accurately quantified. Therefore, a uniform arrangement of wall anchors along all sides of the building and all diaphragm levels is recommended.
