# NFPS

## **STRUCTURAL INVESTIGATION OF THE MEMORIAL STADIUM GRANDSTAND**

**DRAFT FINAL REPORT OF FINDING  
12/20/2021**

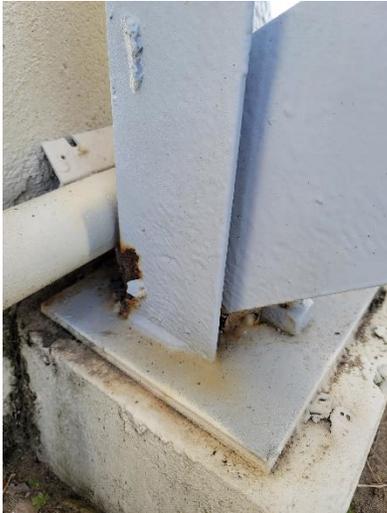
**Over CB1\*** - Active corrosion with insignificant pitting, less than 5%.

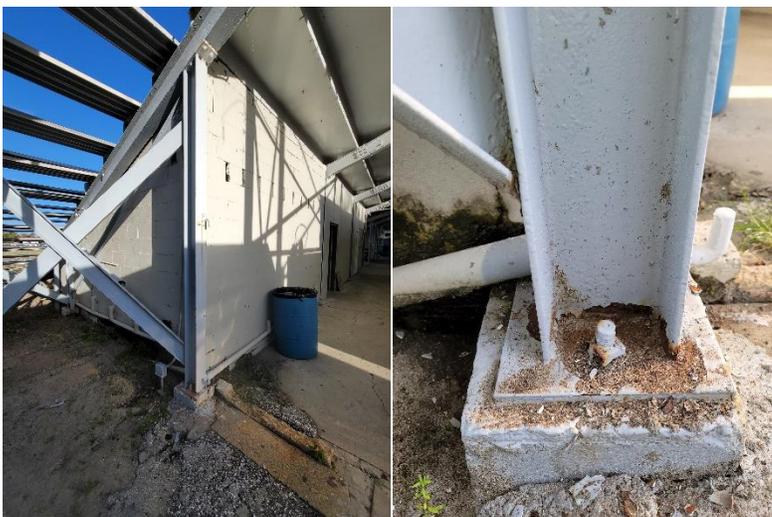
**Column 2** – 2 ½" H x 1" W area North flange with 25% loss of section and 100% section loss 2" x ¼" area of flange edge.

Corrective Action Required: Repair section loss at base of the column flange.

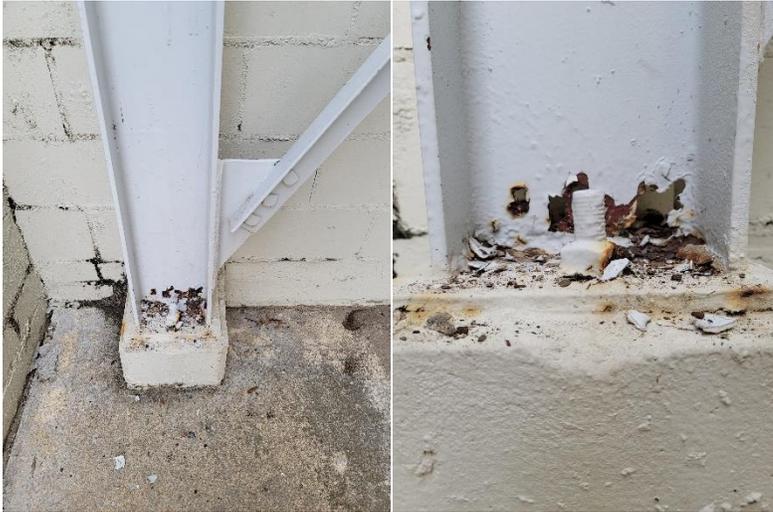
**Column 3** - Above base plate the South face of web and Southeast flange exhibit up to 10% section loss to the lower 1". The North face at this location appears similar. (Limited access due to building)

Corrective Action Required: Repair section loss at base of the column flange.

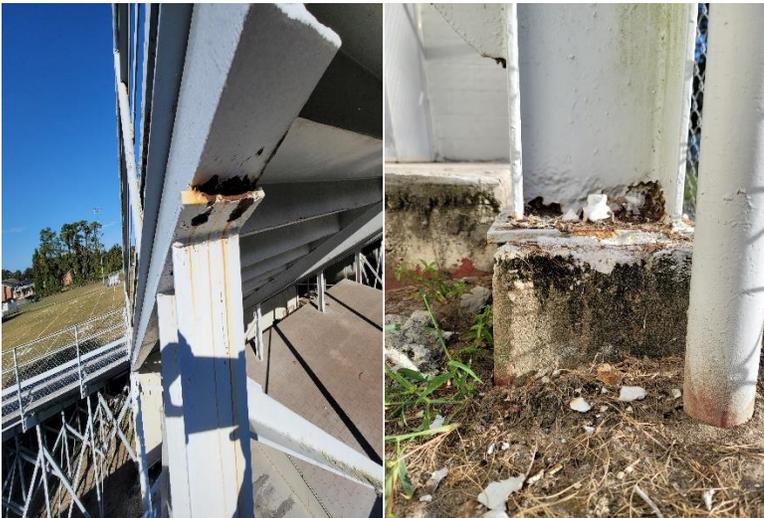
**Column 4** - The web at bearing has up to 100% section loss in a 6" wide x 3 ½" area.

Corrective Action Required: Repair section loss at base of the column flange.

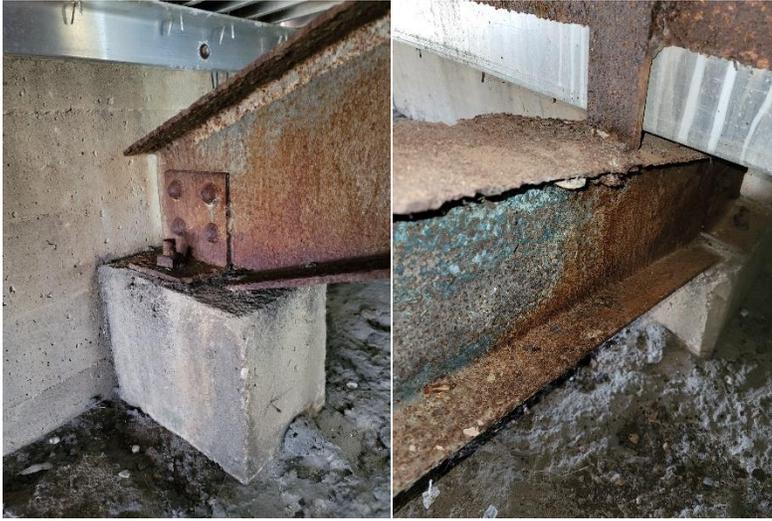
**Over CB 1\*** - Active corrosion with insignificant pitting, less than 5% to upper flange, 25% section loss 12" from bearing 18" length x 1" width.

Corrective Action Required: Repair section loss at base of the column flange.

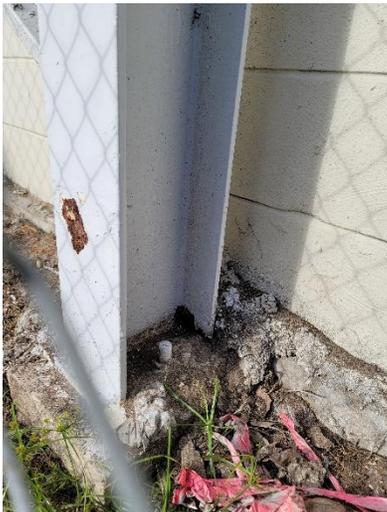
**Column 5** - North face of web less than 10% section loss in lower 1 ½" at base.

Corrective Action Required: Repair section loss at base of the column flange.

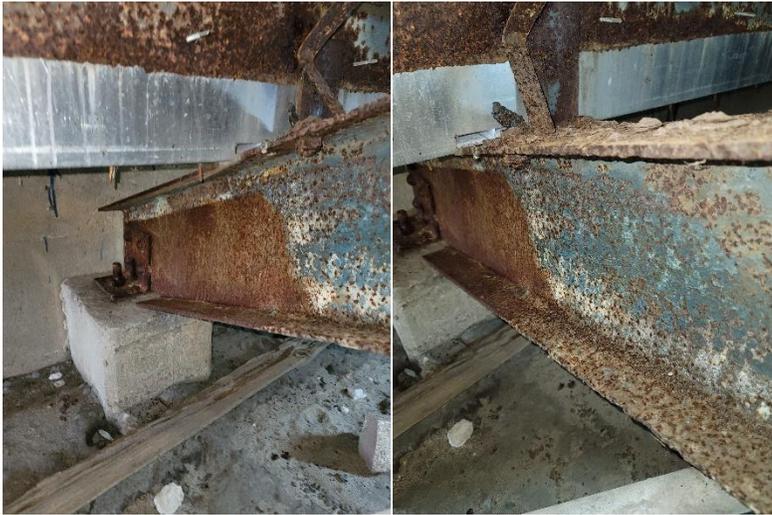
**Over CB 1\*** - Top and bottom flange, 2" from bearing up to 40% section loss to flange edges of the floor beam 1" H x 18" long.

Corrective Action Required: Repair section loss at base of the column flange.

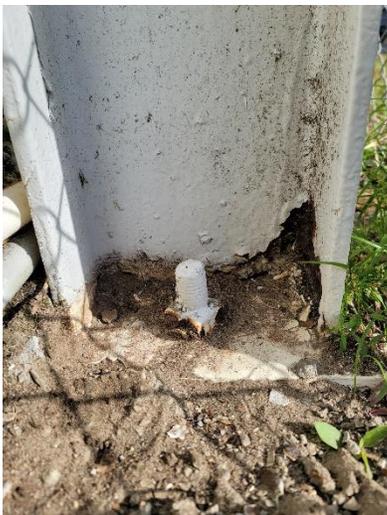
**Column 5** - Up to 100% section loss to web in a 6"x 4" area at base.

Corrective Action Required: Repair section loss at base of the column flange.

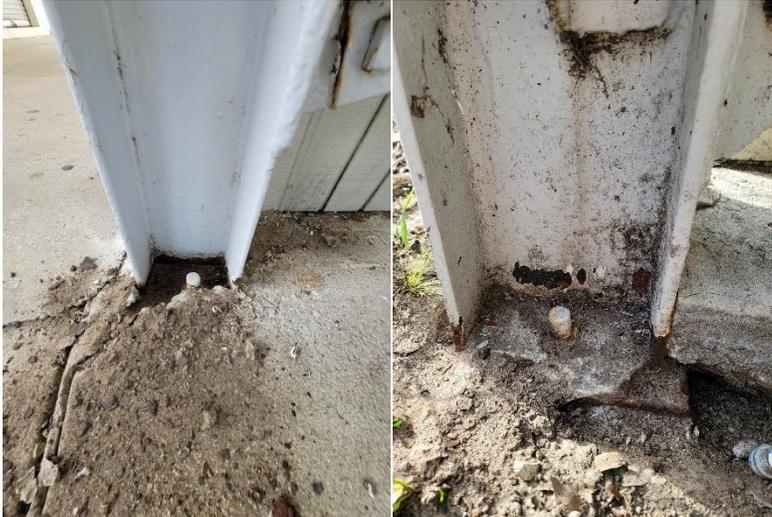
**Column 3** - Up to 20% section loss at base predominately in web 2" high.

Corrective Action Required: Repair section loss at base of the column flange.

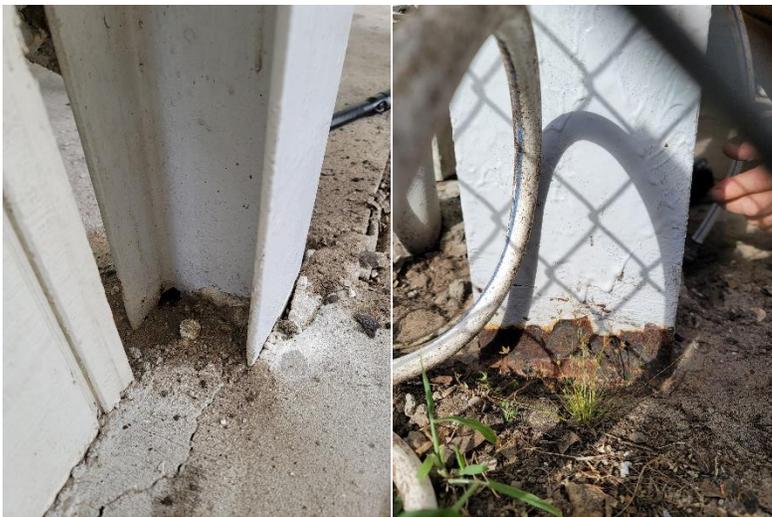
**Column 5** - At base, up to 15% section loss to web 1 ½" high of South face and North face of flange edges.

Corrective Action Required: Repair section loss at base of the column flange.

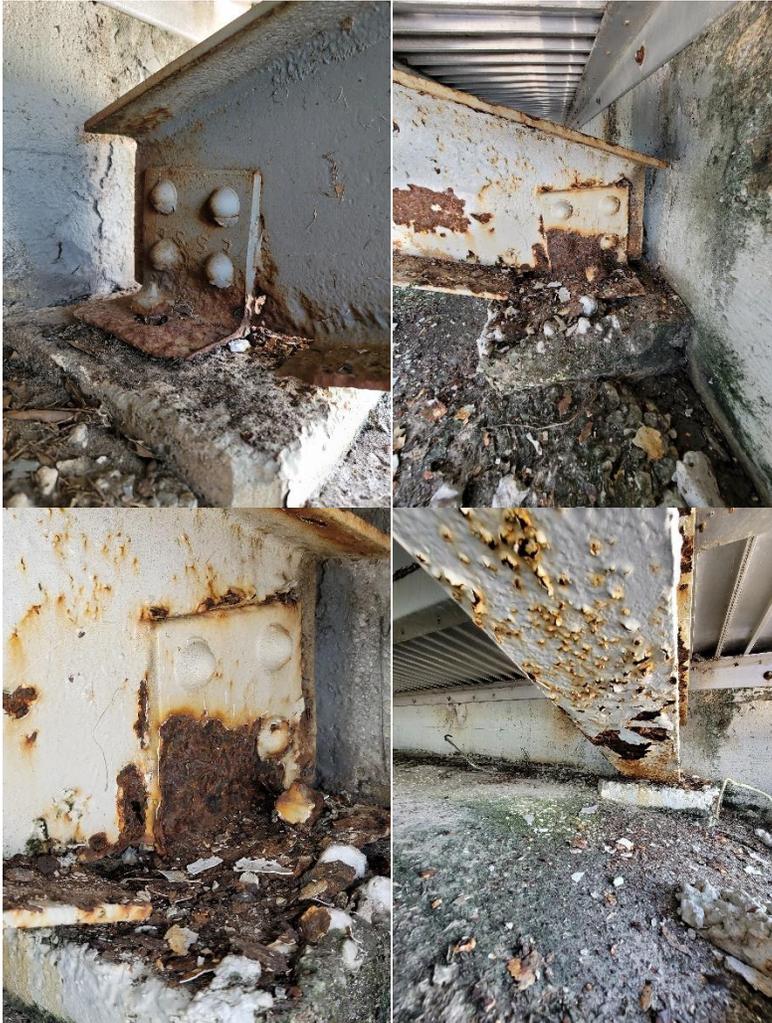
**Over CB 1\*** - 100% section loss to web at bearing 2" x 2" area. Deep pitting, 25% section loss to lower web in a 10" long x up to a 2" wide area, South face. North angle in clip anchoring the floor beam to cap block is 40% due to corrosion.

Corrective Action Required: Repair section loss at base of the column flange.

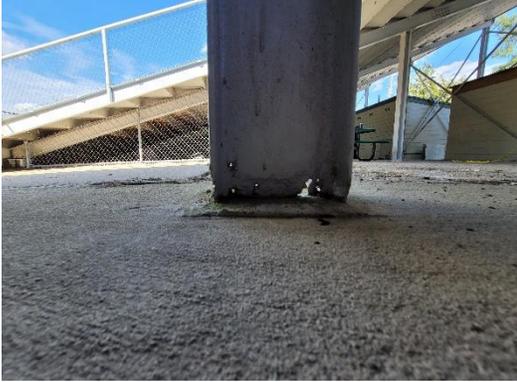
**Column 2** - 50-80% overall section loss with areas of 100% section loss within the web and flange at base 3-4" in height.

Corrective Action Required: Repair section loss at base of the column flange.

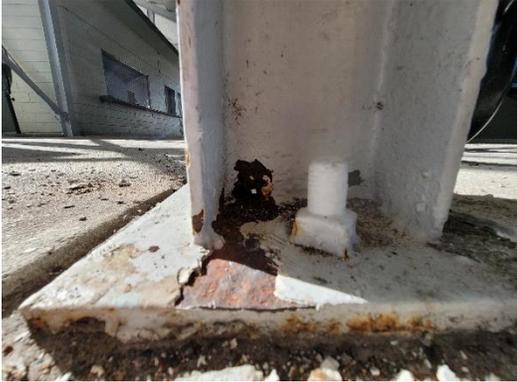
**Column 3** - 50-70% section loss to web with a  $\frac{1}{4}$ " hole to lower  $2\frac{1}{2}$ ".

Corrective Action Required: Repair section loss at base of the column flange.

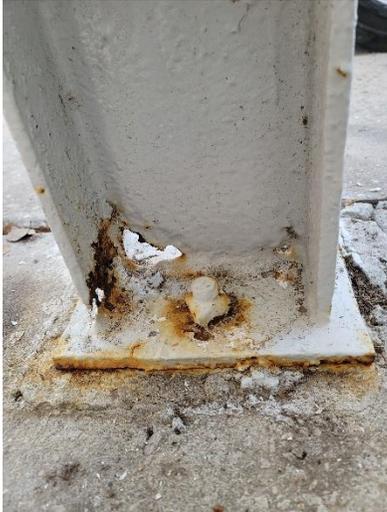
**Column 4** - At base up to 100% section loss to lower 3" of web and Southwest flange. Also, a 2 1/2" x 2 1/4" hole and 3/4" x 1/2" hole. Remainder of web 70% section loss.

Corrective Action Required: Repair section loss at base of the column flange.

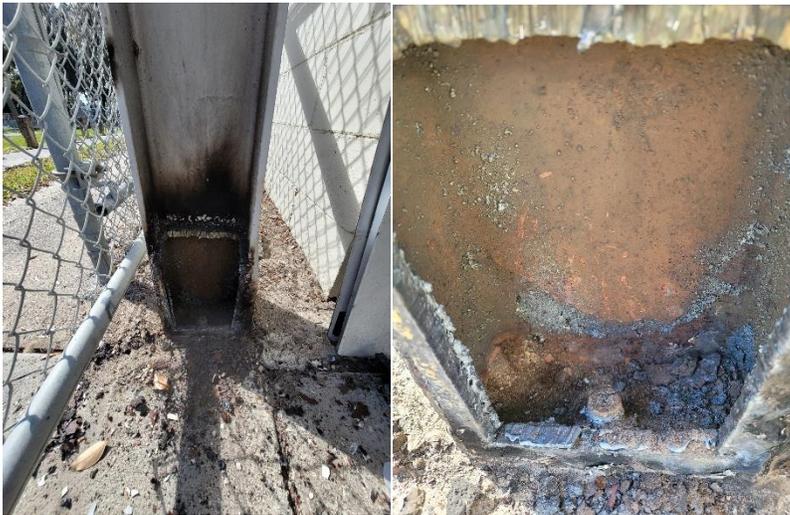
**Column 5** - Repair plates removed for web access. Up to 100% section loss to original web at base.

Corrective Action Required: Repair section loss at base of the column flange.

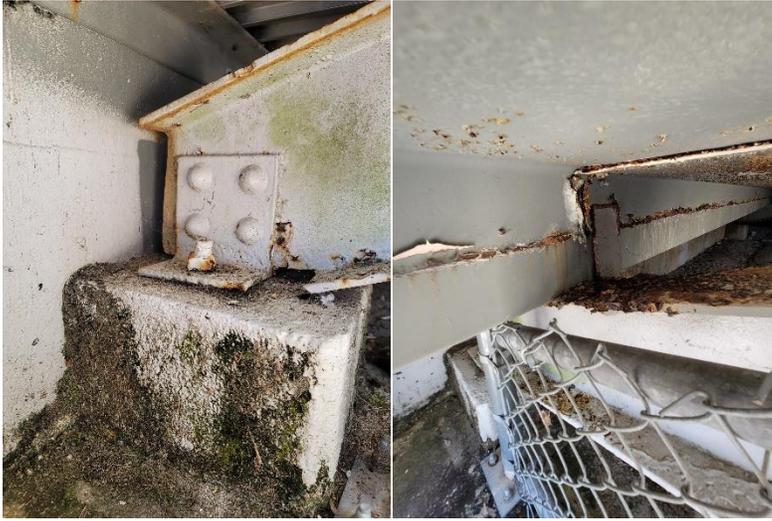
**Over CB 1\*** - Adjacent to anchor clip the web of the floor beam exhibits up to 20% section loss in a 2" x 1 ½" area on south face. The upper flange 2" from bearing South flange 25% section loss 12" in length.

Corrective Action Required: Repair section loss at base of the column flange.

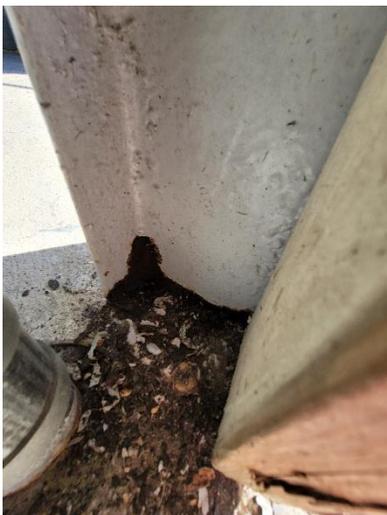
**Column 2** - up to 70% section loss to North face of web and North flanges. Limited access to South face. Concrete encased.

Corrective Action Required: Repair section loss at base of the column flange.

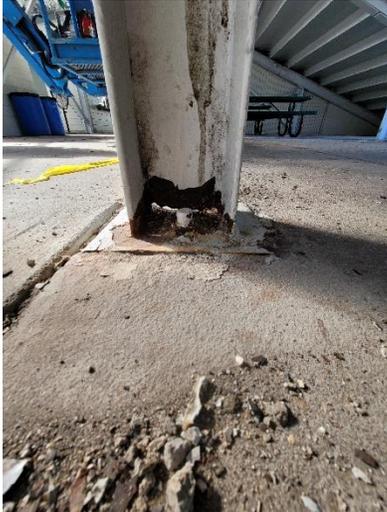
**Column 3** - 100% section loss to entire web 1 ¼" high. Flanges exhibit 50-60% overall section loss.

Corrective Action Required: Repair section loss at base of the column flange.

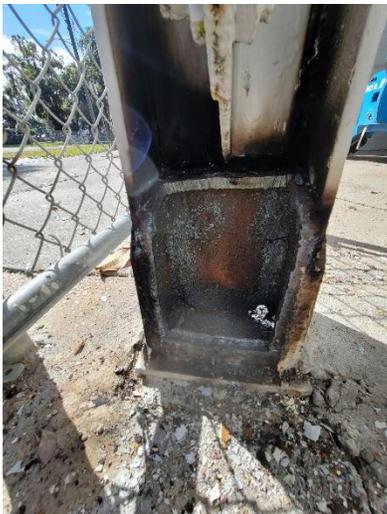
**Column 5** - Repair plates removed for access. Up to 100% section loss to original web at base.

Corrective Action Required: Repair section loss at base of the column flange.

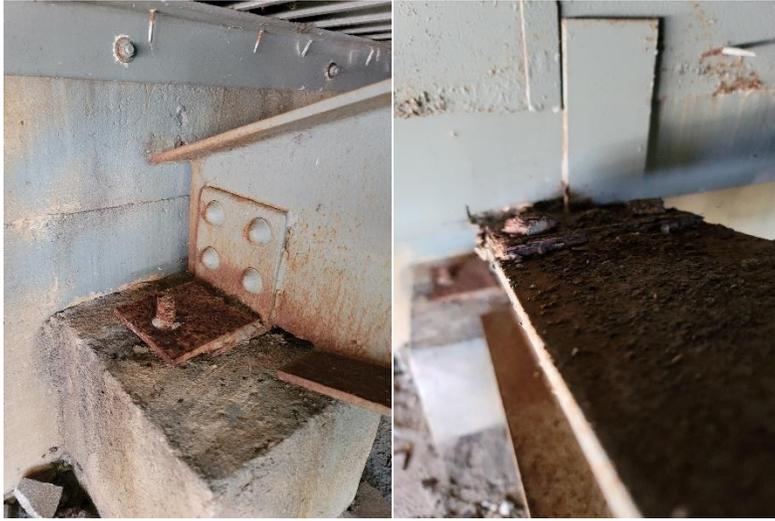
**Over CB 1\*** - Anchor bolt nut missing at bearing. Insignificant pitting, less than 5% bottom flange 2' in length, upper flange 2' from bearing 20% section loss in a 2" x 2" area around  $\frac{3}{4}$ " drilled hole.

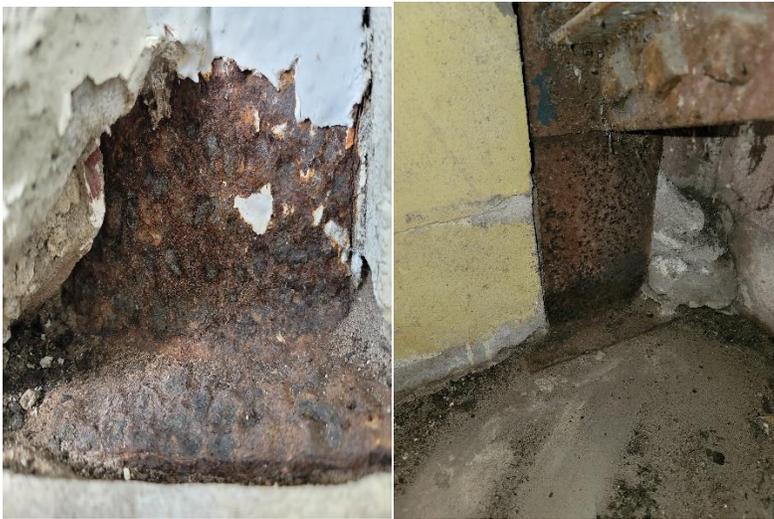
**Column 3** - Limited access; Concrete block construction. East face, East flange up to 20% section loss, West face, West flange up to 20% section loss.

Corrective Action Required: Repair section loss at base of the column flange.

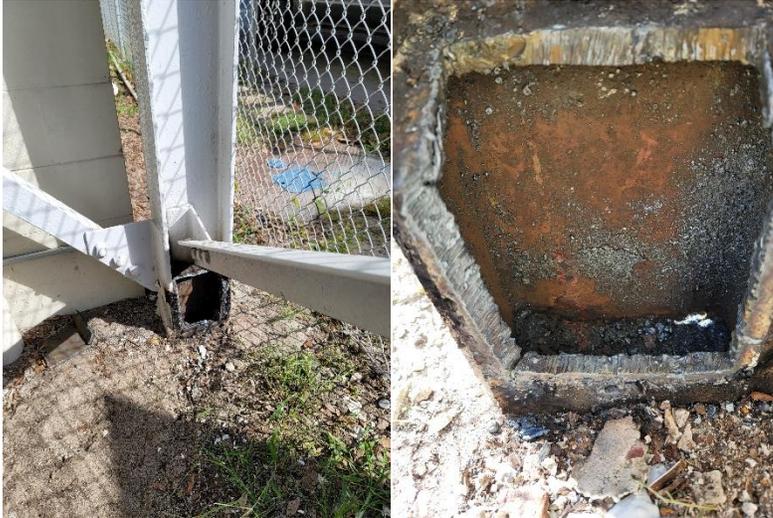
**Column 5** - Repair plates removed for access. Up to 100% section loss to original web at base.

Corrective Action Required: Repair section loss at base of the column flange.

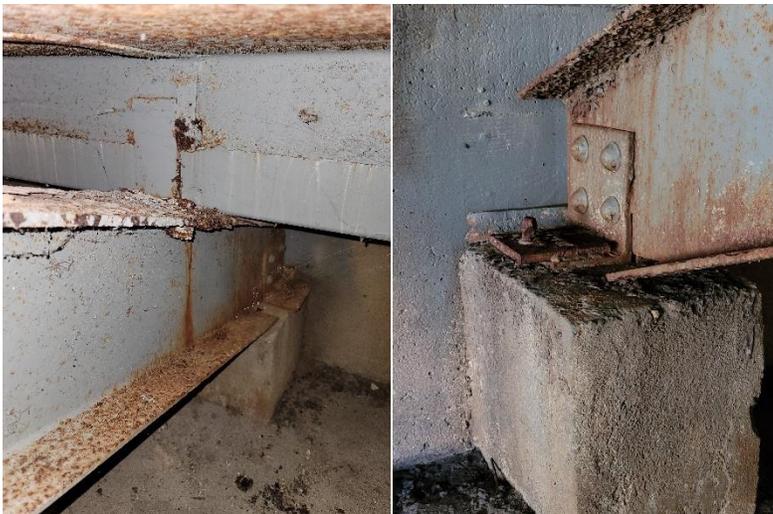
**Over CB 1\*** – pitting section loss up to 25% to top and bottom flange of floor beam up to 3' in length. 10% section loss to lower web 1" wide up to 20" long south face. Anchor bolt nuts missing.

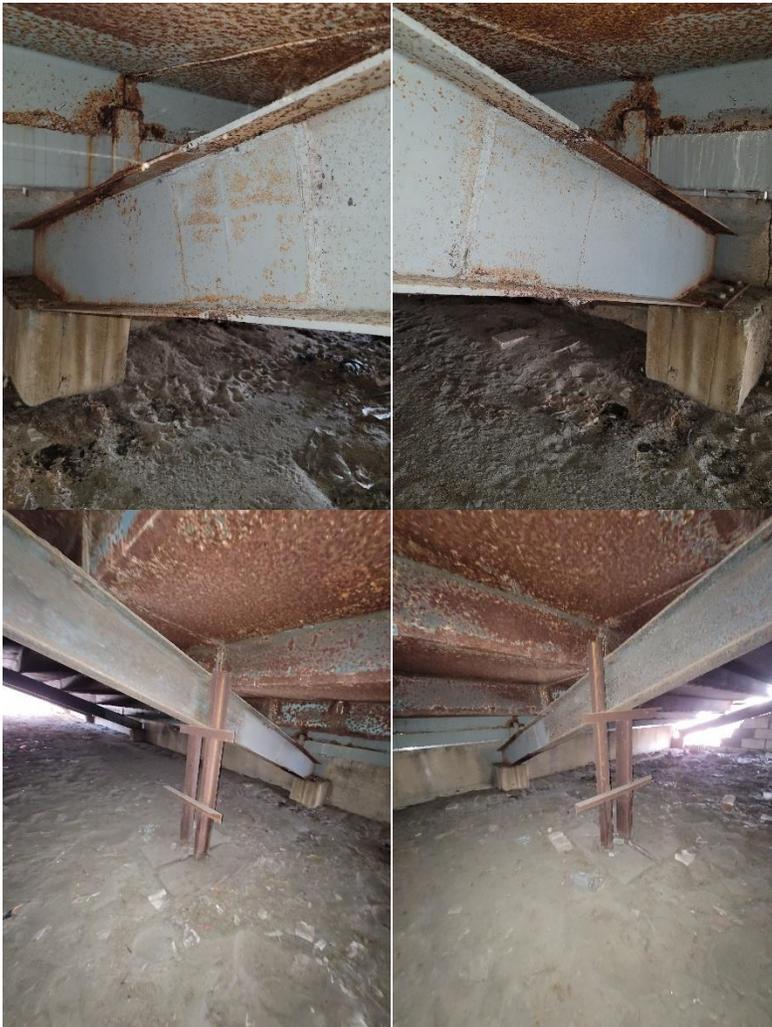
**Over CB 1\*** - 34" from the bearing of the floor beam has been spliced by butt welding floor beam and augmented with 2 full height of web x 10" long steel plates welded around full perimeter.

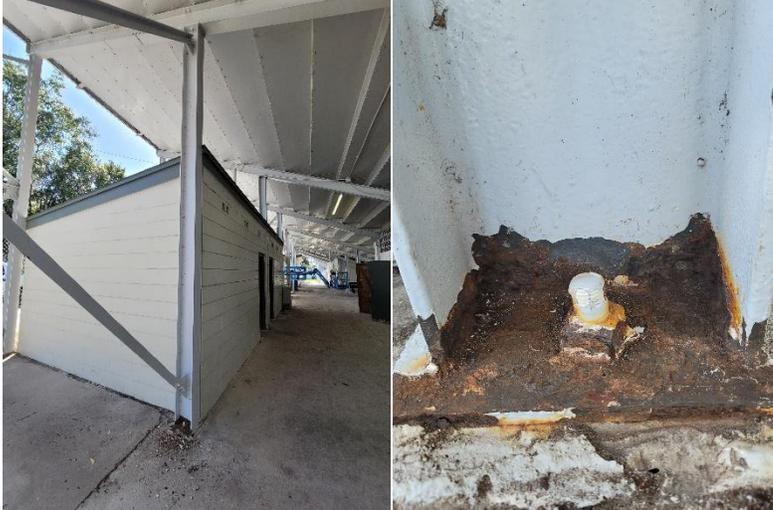
**Column 4** - South Face inaccessible (block wall) North face, North web 40-50% section loss with 100% section loss in a  $\frac{3}{4}$ " area lower 3" at base. Inside Face of East and West flanges up to 50 % section loss.

Corrective Action Required: Repair section loss at base of the column flange.

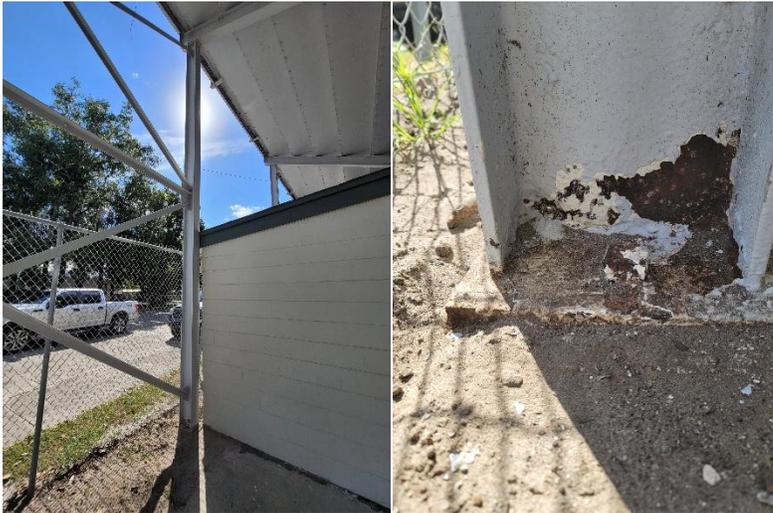
**Column 5** - Up to 100 % section loss in a 1" x  $\frac{3}{4}$ " area in web at base. Up to 25% overall section loss to lower 1  $\frac{1}{2}$ " at base. Up to 30 % section loss Inside face Northeast flange.

Corrective Action Required: Repair section loss at base of the column flange.

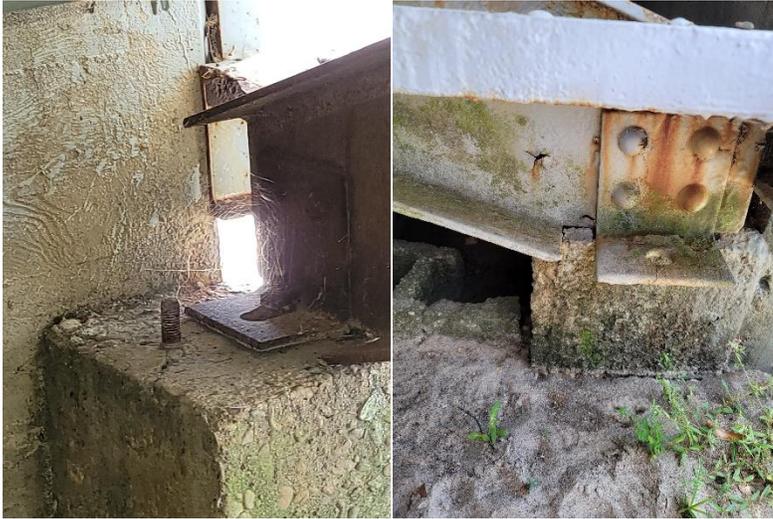
**Over CB 1\*** - Surface corrosion, no section loss, no functioning anchor bolt.

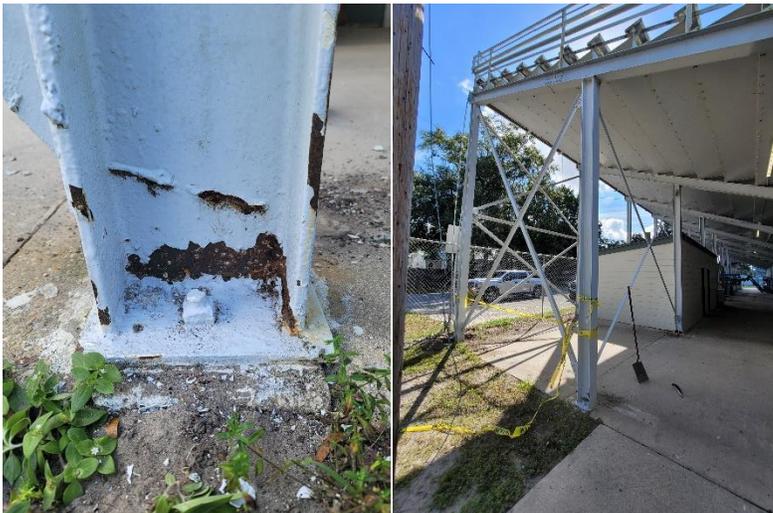
**Column 4** - 50% section loss overall in web with a 2" x 1" area up to 100% (pin hole).

Corrective Action Required: Repair section loss at base of the column flange.

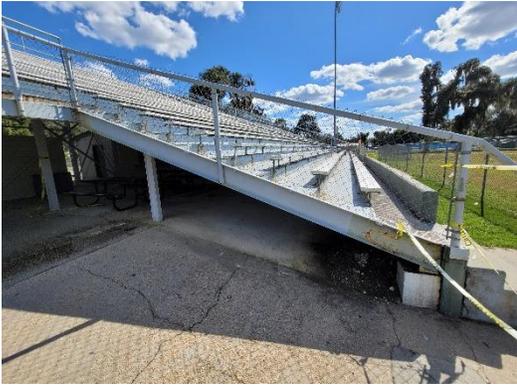
The channel, parallel and approximately 3' North of Frame Line Cap 5 extends from Cap Block 5A and runs 2' beyond Column 2 at Frame Line 5.

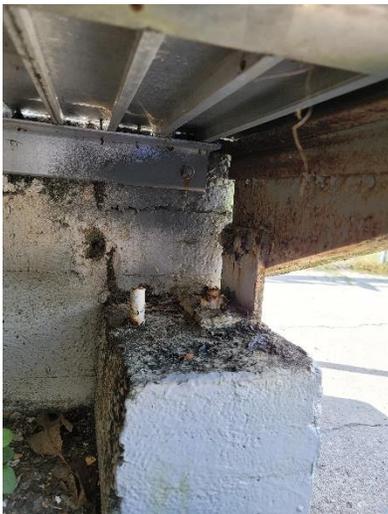
Single anchor bolt at Cap Block 5A is 25% deteriorated.

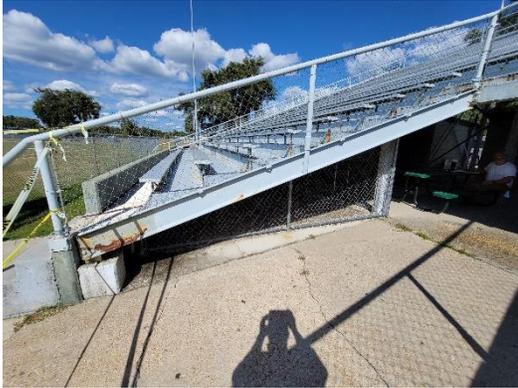
The channel, parallel and approximately 3' South of Frame Line Cap 6 extends from Cap Block 5B and runs 2' beyond Column 2 at Frame Line 6.

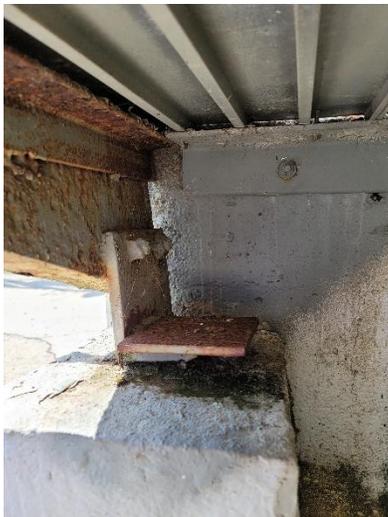
No functioning anchor bolt, A 4" x 5" x 1/4" plate is welded atop.

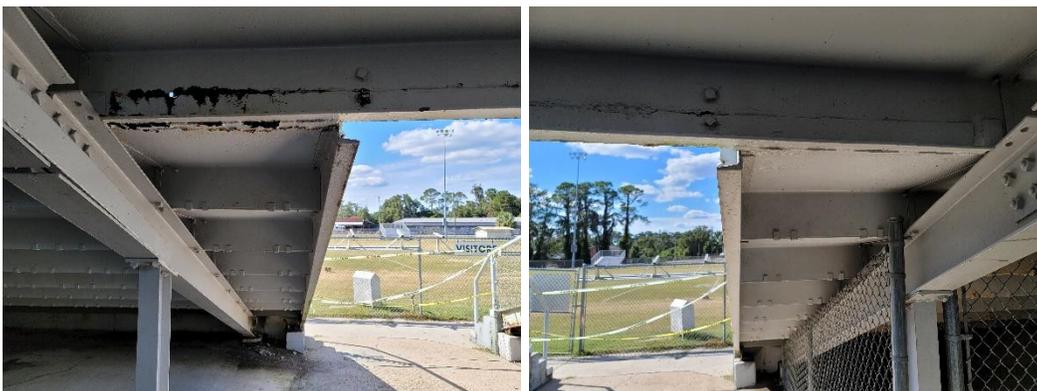
The South to North 4" angle between Bent 5 and 6, 36" East of Column 2 is welded to the decking only. The decking and portions of the 4" angle exhibit 100% section loss along the welded seam 27" x up to 1" wide (adjacent to Bent 5).

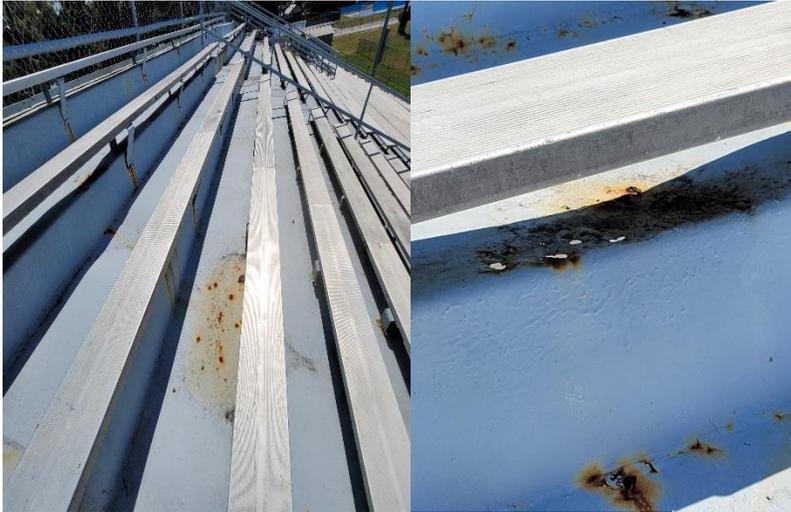
Located 4' South of Frame Line 4, top row of seats a 14" x 6" depression/ low spot exhibits significant deterioration with 6 holes from 1/2" to 3/4" in diameter.

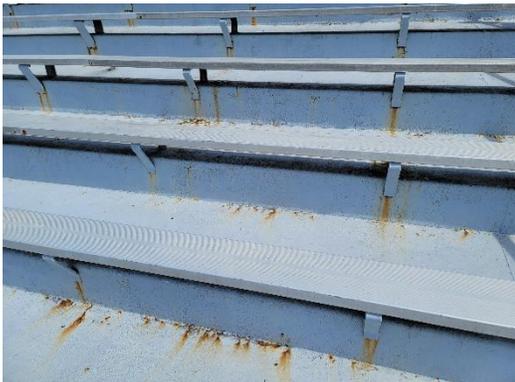
Throughout the decking areas exist with cracked and blistered paint, active corrosion, and minor section loss.

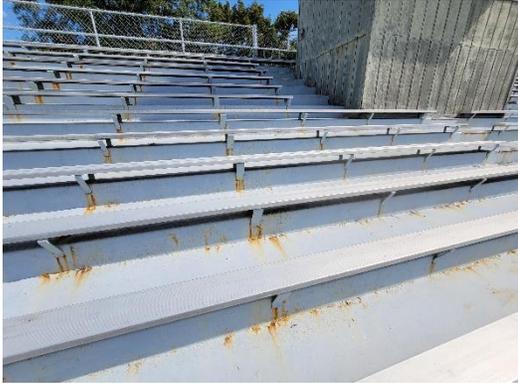
Typically, throughout, the angle clips securing the aluminum bench seating to the steel decking at the welded connection to steel decking, exhibit active corrosion, rust bleed out, and varying amounts of section loss up to 20%, isolated in the welded connection.

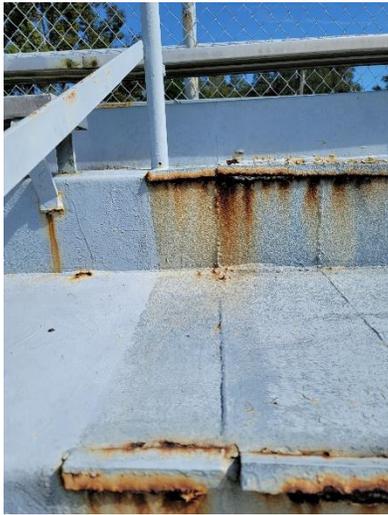
Additionally, the steel decking joints along the longitudinal/horizontal welded seams exhibit cracked paint, active corrosion, rust bleed out. Section loss is less than 10% in areas chipped out.

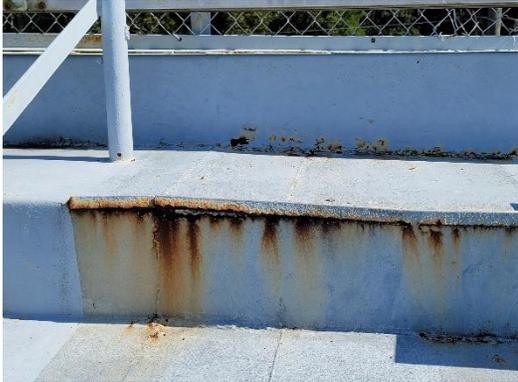
Throughout, the steps/stairs have a 1" angle stitch welded to the 90-degree bend at the riser/tread. Typically, these locations exhibit active corrosion and rust bleed out between the decking and angles.

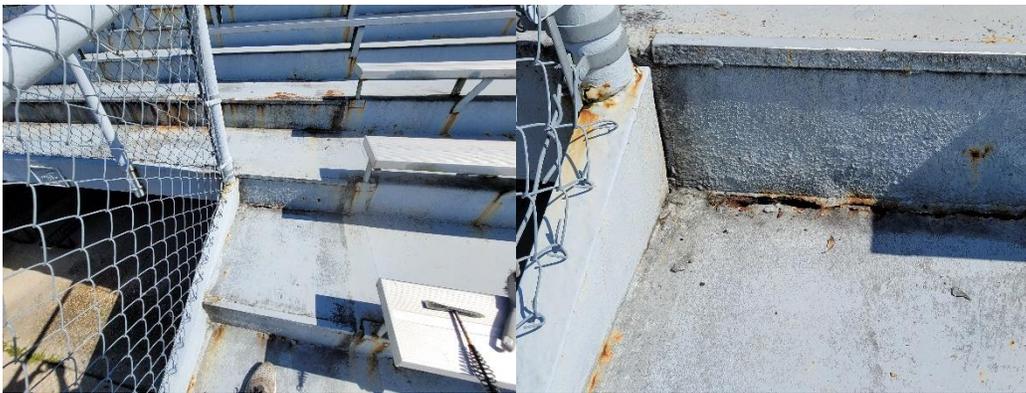
Over/near Frame Line 5. Of the grandstand, column 2 inside corner of deck and stair riser 100% section loss in an 18" x 1" area.

Corrective Action Required: Repair holes in deck pans, repair or replace seat brackets as needed. Sandblast and paint.

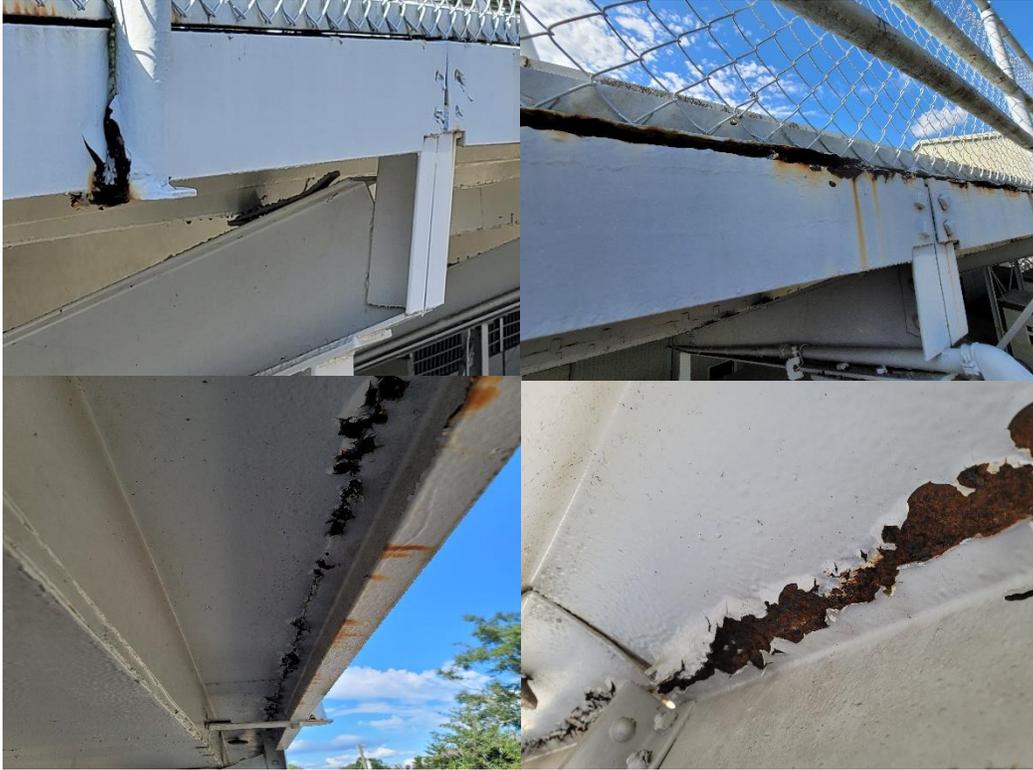
The pipe frames, for the chain link fencing at the stadium top, exhibits 100% section loss at the welded connection to the 6" channel predominately in the pipe, up to half the circumference x 4" high. The 6" channel at this location is heavily deteriorated along the entire length of the main bleachers. The decking is welded at the top. Pack rust has pried apart up to 1 ¼". Top flange of channel has up to 100% section loss to the outer flange edge up to 1" in width.

Corrective action required: Reinforce top flange as needed. Replace pipe frames and attachments as needed.

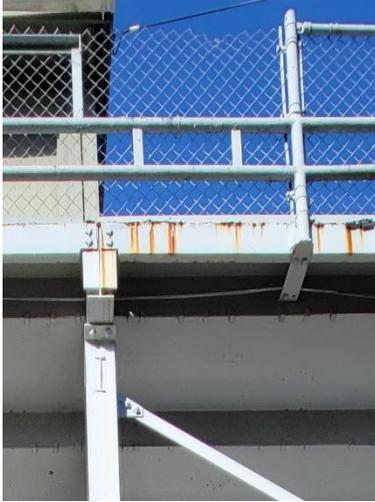
A 4' section of top rail is missing located adjacent to the NE corner of the press box.

Corrective Action Required: Repair top rail pipe frame and secure fencing.

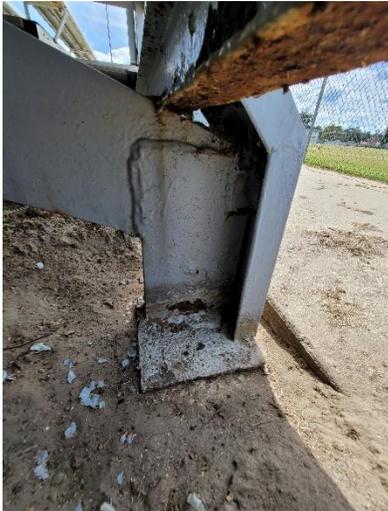
**Column 1** - (6" channel) Active corrosion, pitting with 10% loss of section isolated in lower web only.

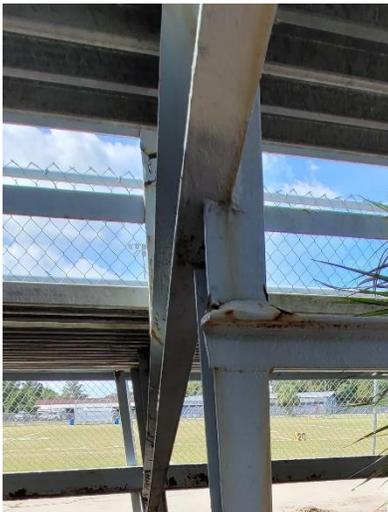
**Column 2** - (H-pile) Overall section loss less than 5% in lower 2". The Northwest flange has been removed (flame cut).

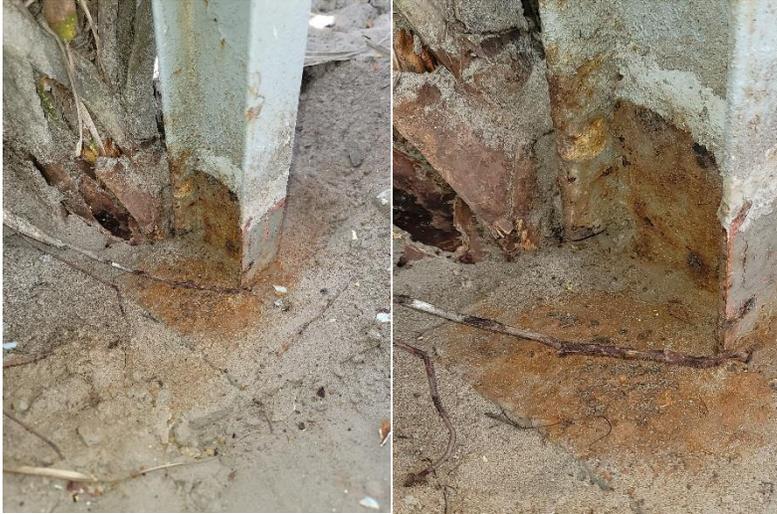
**Column 2** - less than a 5% section loss to the lower 1" of web Southwest flange removed (flame cut)

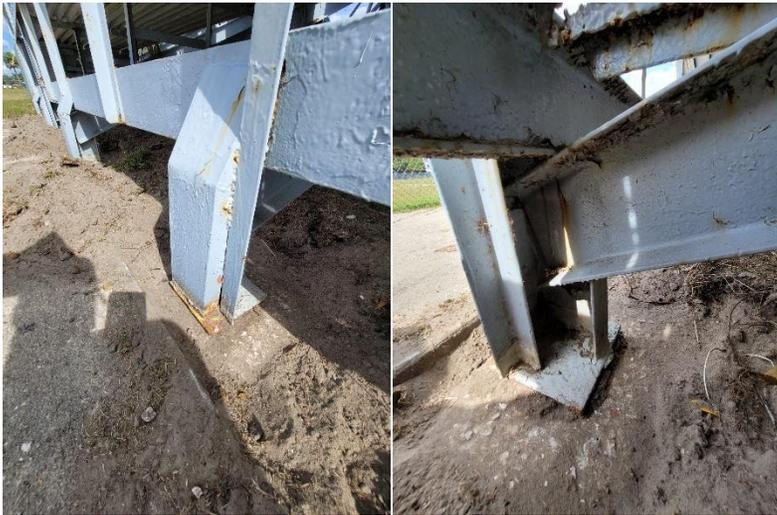
**Column1** - (6" channel) Section loss up to 10% in the lower 2" of the web. The channel and base plate are floating above the footer with no bearing.

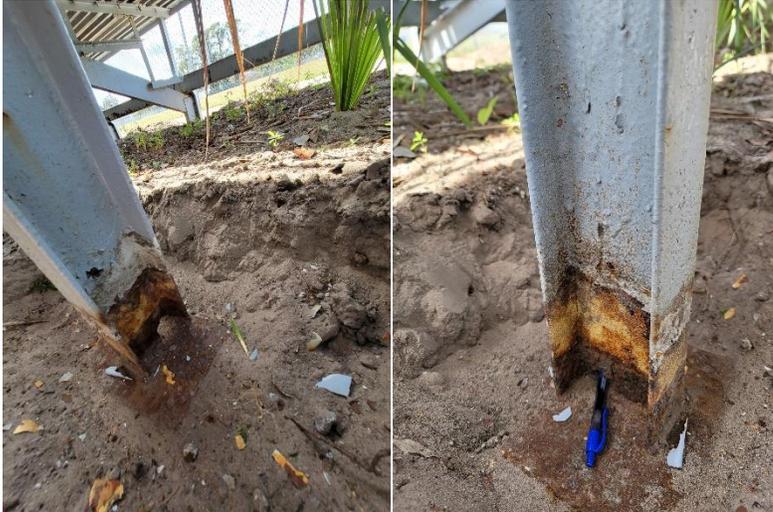
**Column 2** - 25% overall section loss within the lower 2" with a 1 ¼" x 1" area of 100% section loss, bottom of web.

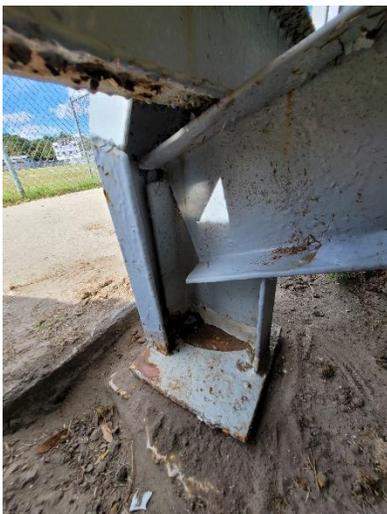
**Column 1** - (6" channel) 15% section loss to lower 2" of web. The channel and base plate are floating with no bearing.

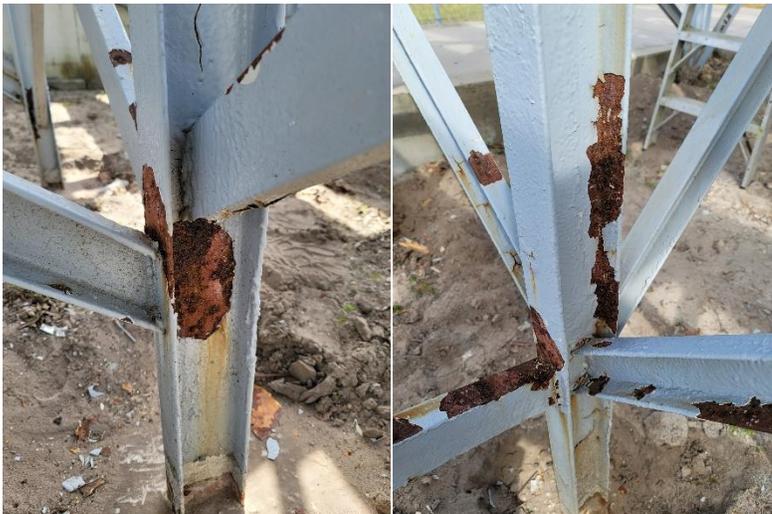
Randomly throughout the North bleacher addition areas exist where paint failure has revealed active corrosion and insignificant section loss

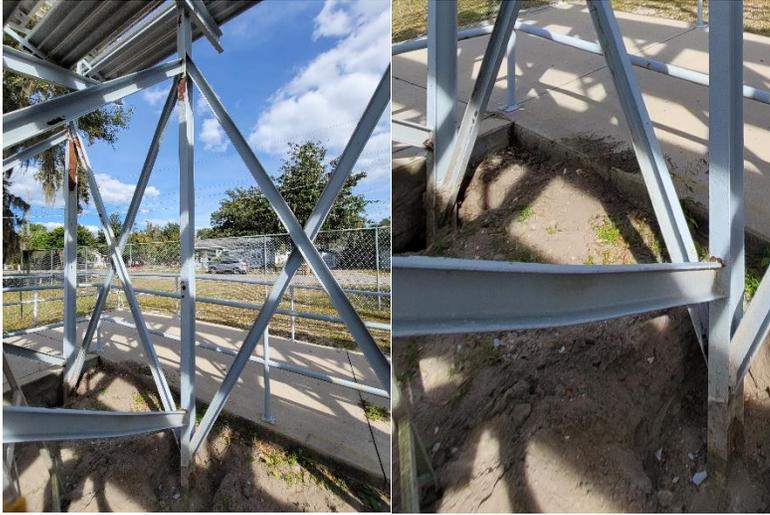
Frame 5 between Columns 4 and 5 the South leg is bent to the South up to 3”.

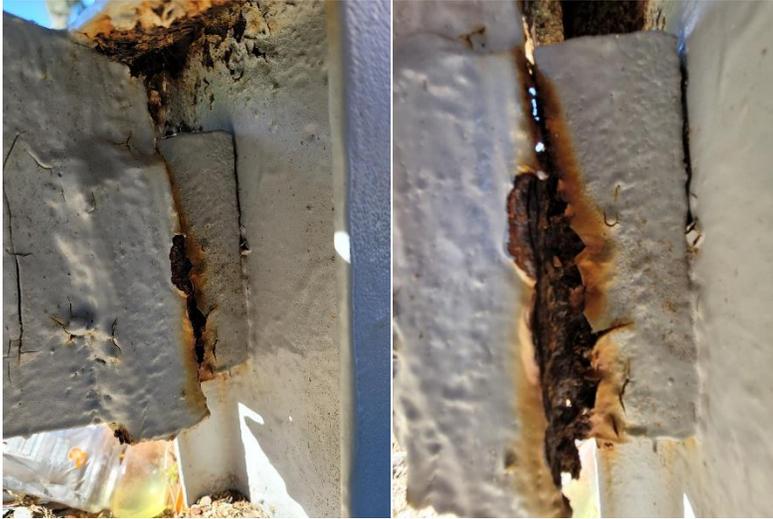
**Column 1** (6" channel) The built-up welded connection to column 1 exhibits heavy active corrosion with section loss up to 80% within the weld.

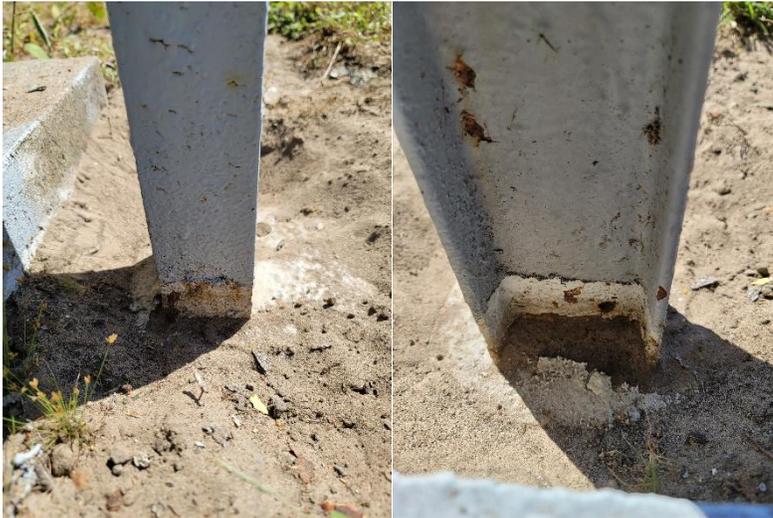
**Column 2** (H-pile) Approximately 20% overall section loss at interface of concrete footing.

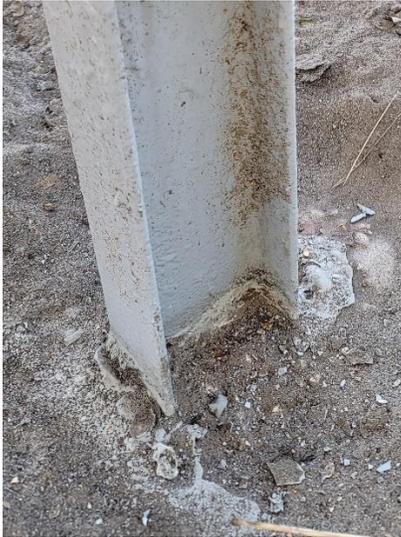
**Column 3** Southeast Flange 100% section loss in a 1" H x  $\frac{3}{4}$ " W.

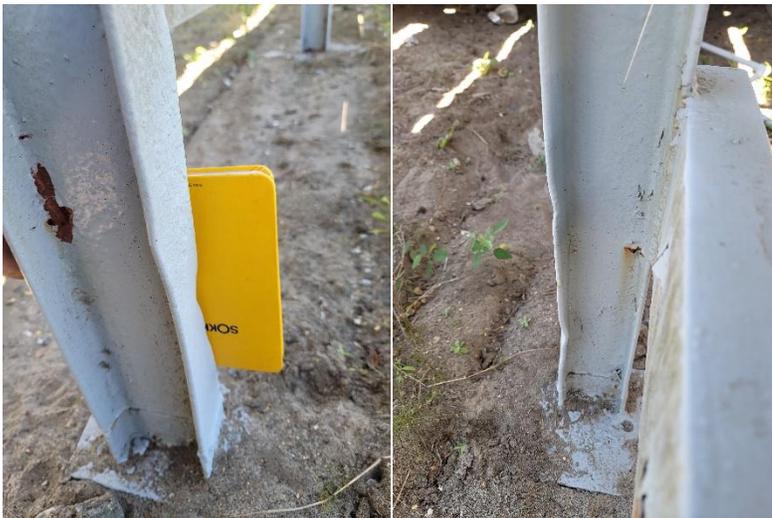
**Column 2** (H-pile) 10" above groundline, Southwest flange bent in a 4" area up to  $\frac{3}{4}$ ".

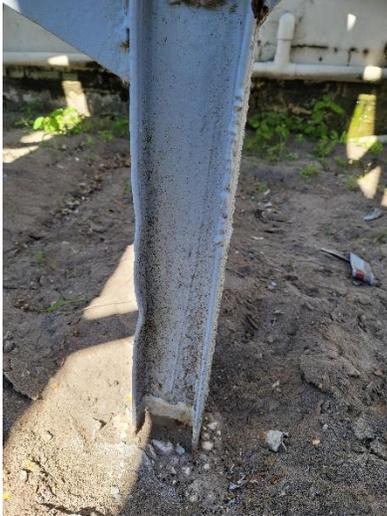
**Column 4** Overall section loss less than 10% at base, Southwest flange bent in 2 locations up to  $\frac{1}{2}$ " in a 16" area.

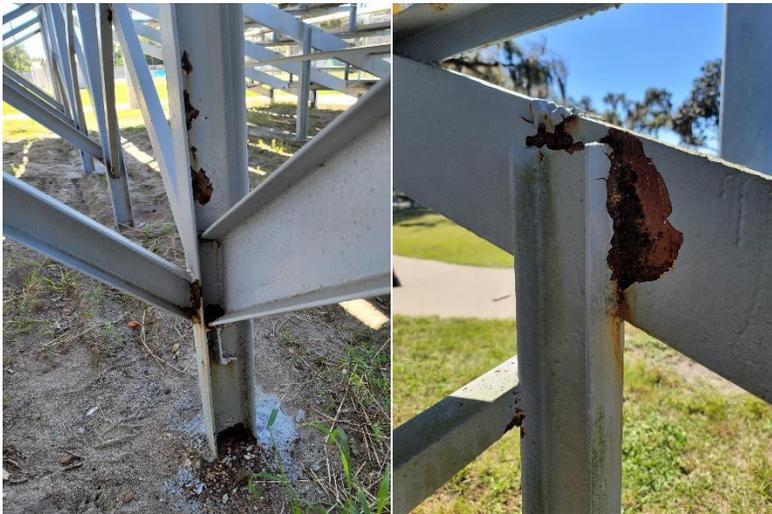
Randomly throughout the South bleacher addition areas exist where paint failure has revealed corrosion with insignificant section loss.

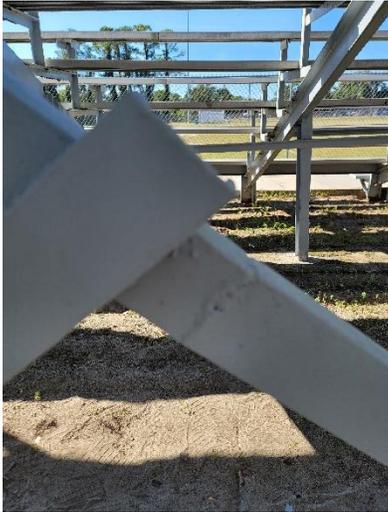
Between Frame 3, Column 3 and Frame 4, Column 4, The upper North channel leg has been removed.

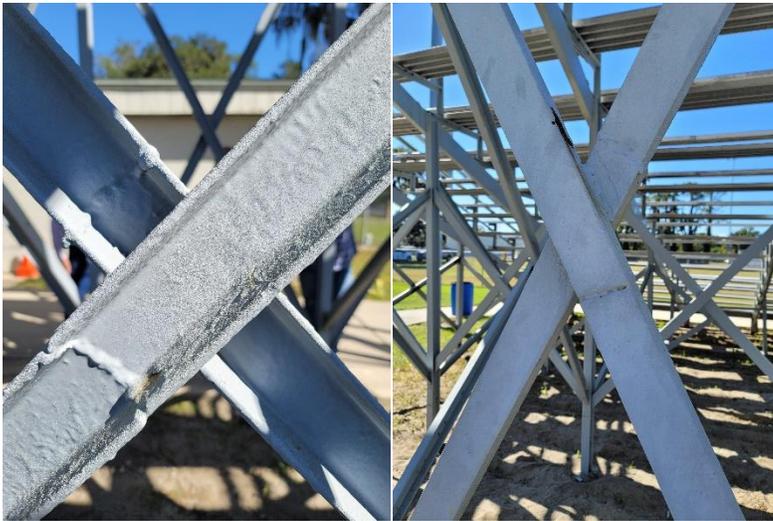
Between Frame 3 and Frame 4 at columns 4 and 5 (2 locations) The Sway Brace legs have been spliced together with butt weld.
