# RaceTrac Lake City Arborist Report

Report Prepared by: Derek Lee  
International Society of Arboriculture Certified Arborist  
ISA Certification No. FL-338502A

February 2026

### Landscape Plan

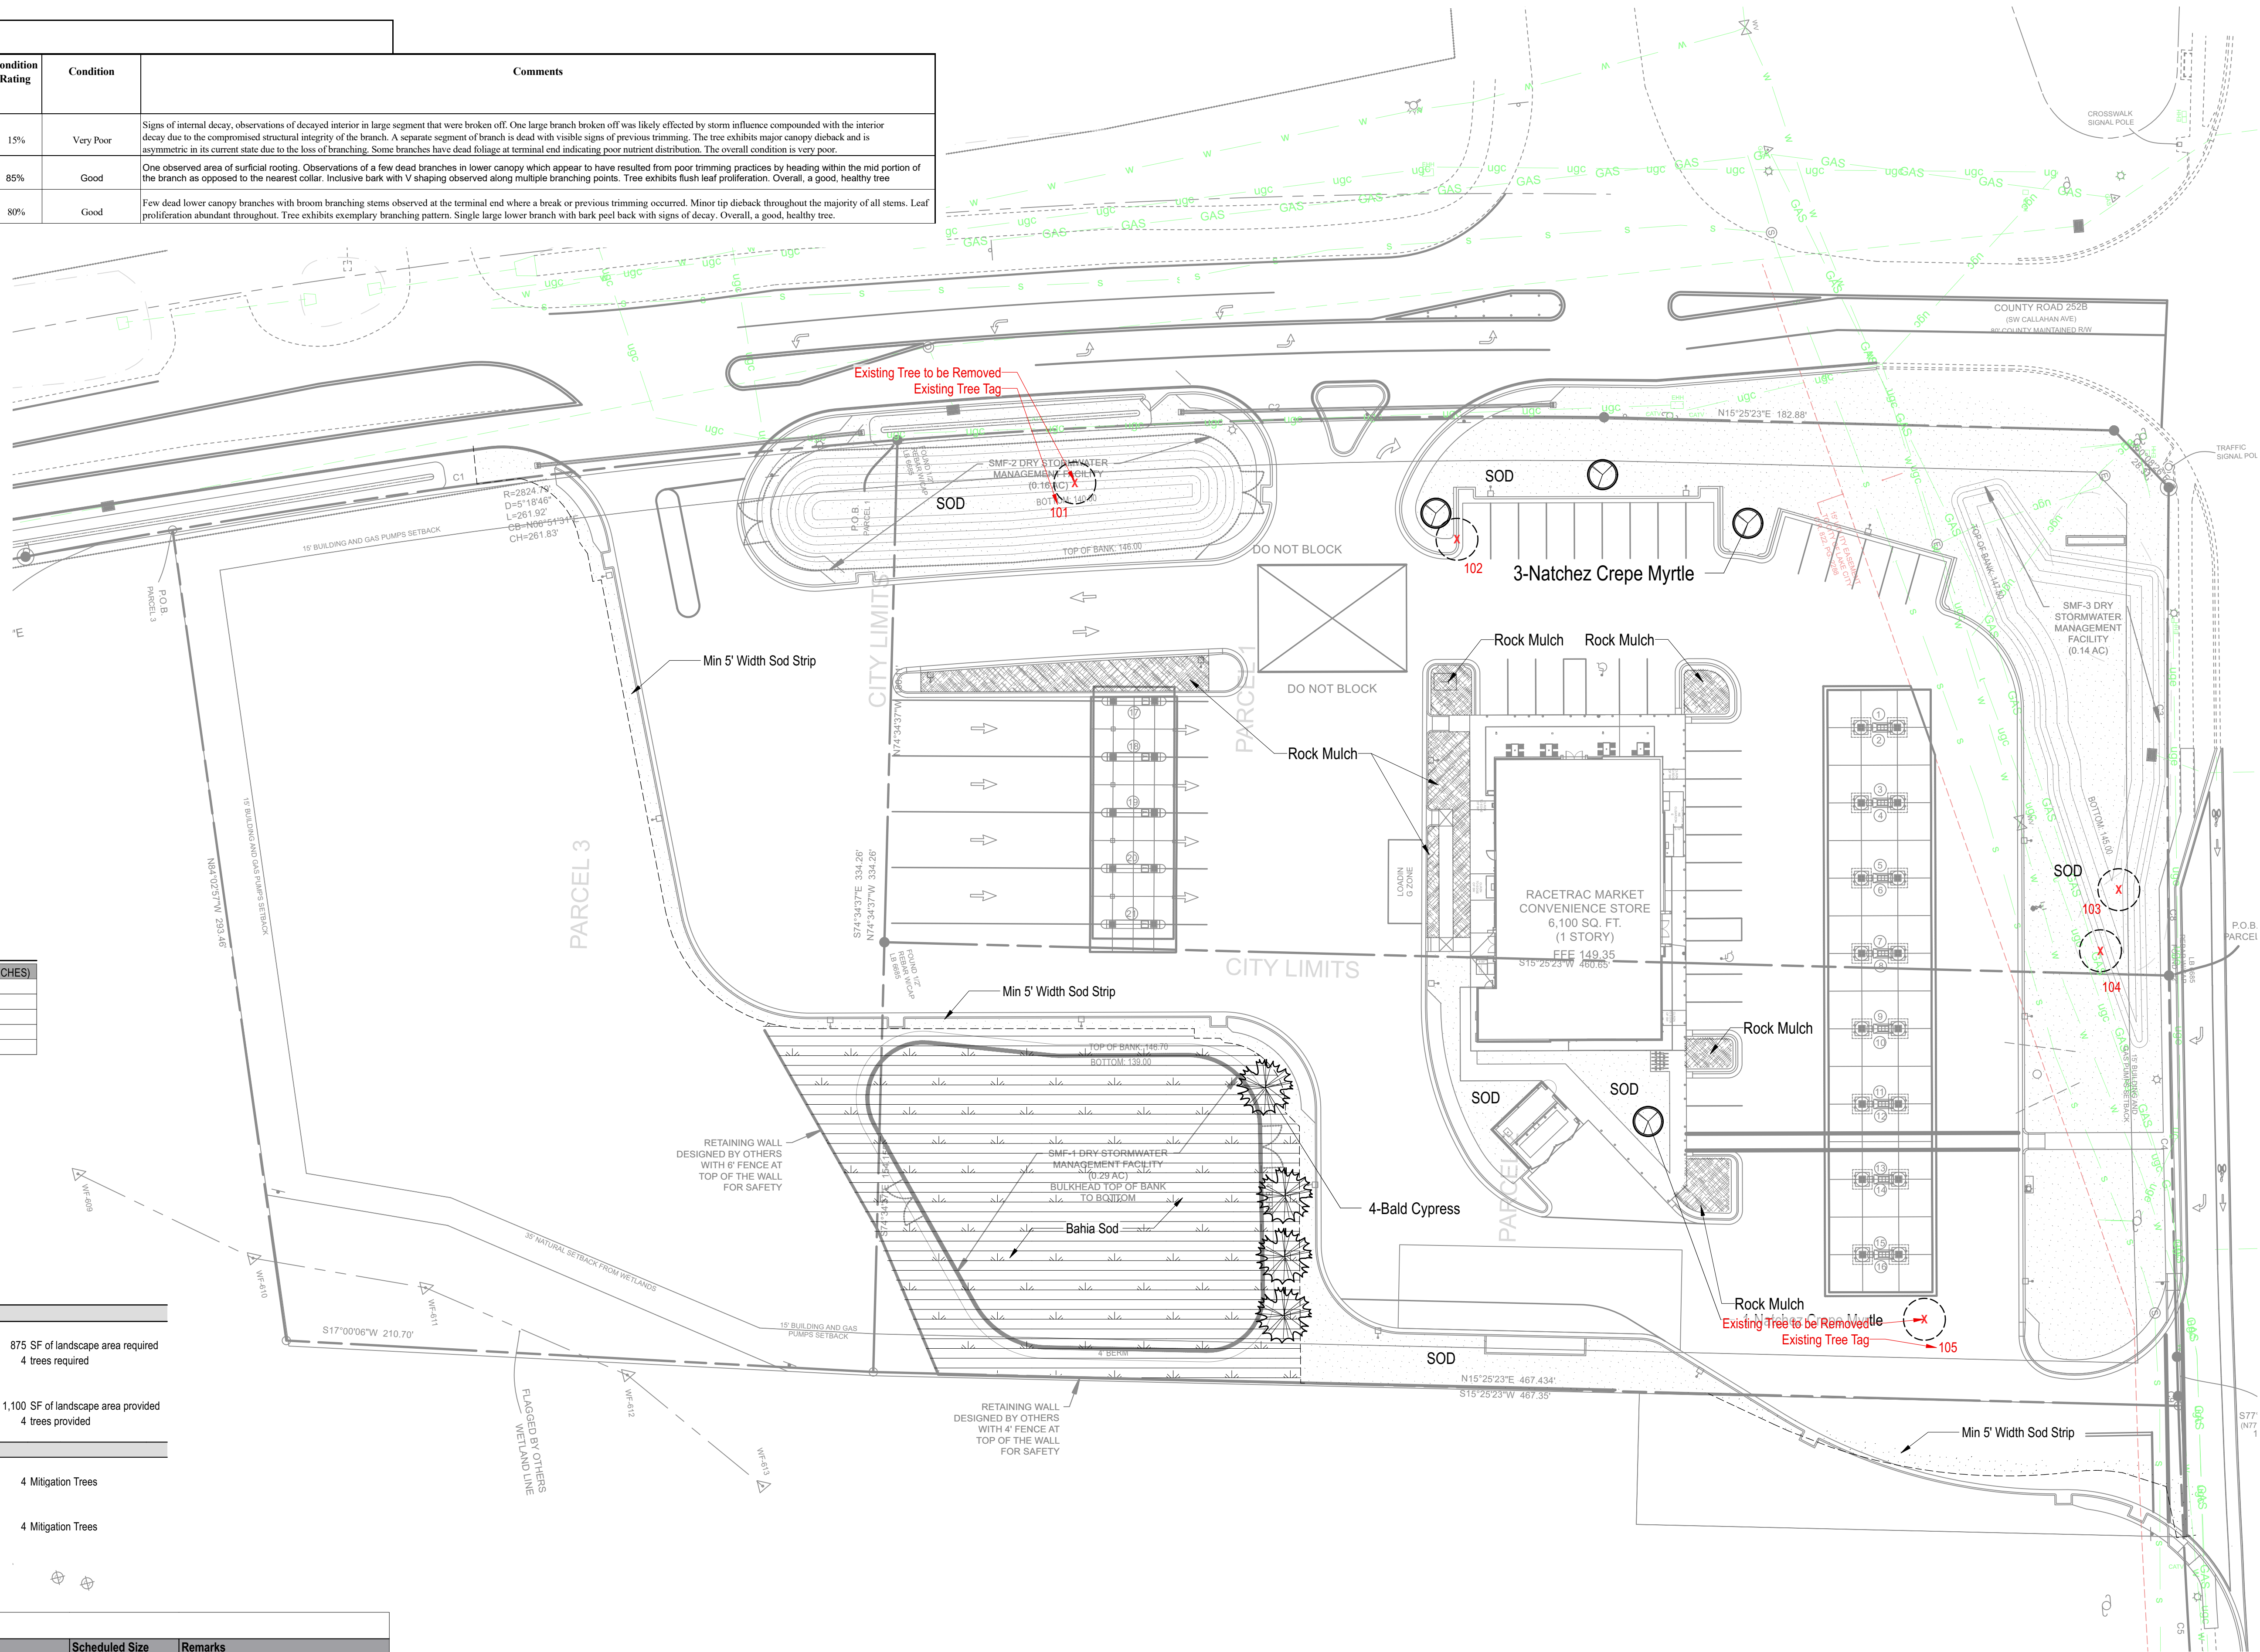
L-1.1

#	TREE	DBH (INCHES)	CONDITION	STATUS	REMOVED (INCHES)
101	LAUREL OAK	30	VERY POOR	REMOVED	29.5
102	LIVE OAK	18	GOOD	REMOVED	18.0
103	CYPRESS	8	GOOD	REMOVED	8.0
104	CYPRESS	6	GOOD	REMOVED	6.0
105	LIVE OAK	59	GOOD	REMOVED	59.0
