June 11, 2024

Subject: **Report of Structural Condition Survey for Damaged Truss Members**  
**The Woman's Club of Lake City**  
257 SE Hernando Ave,  
Lake City, FL 32025  
NOVA Project No: 10124-2524088

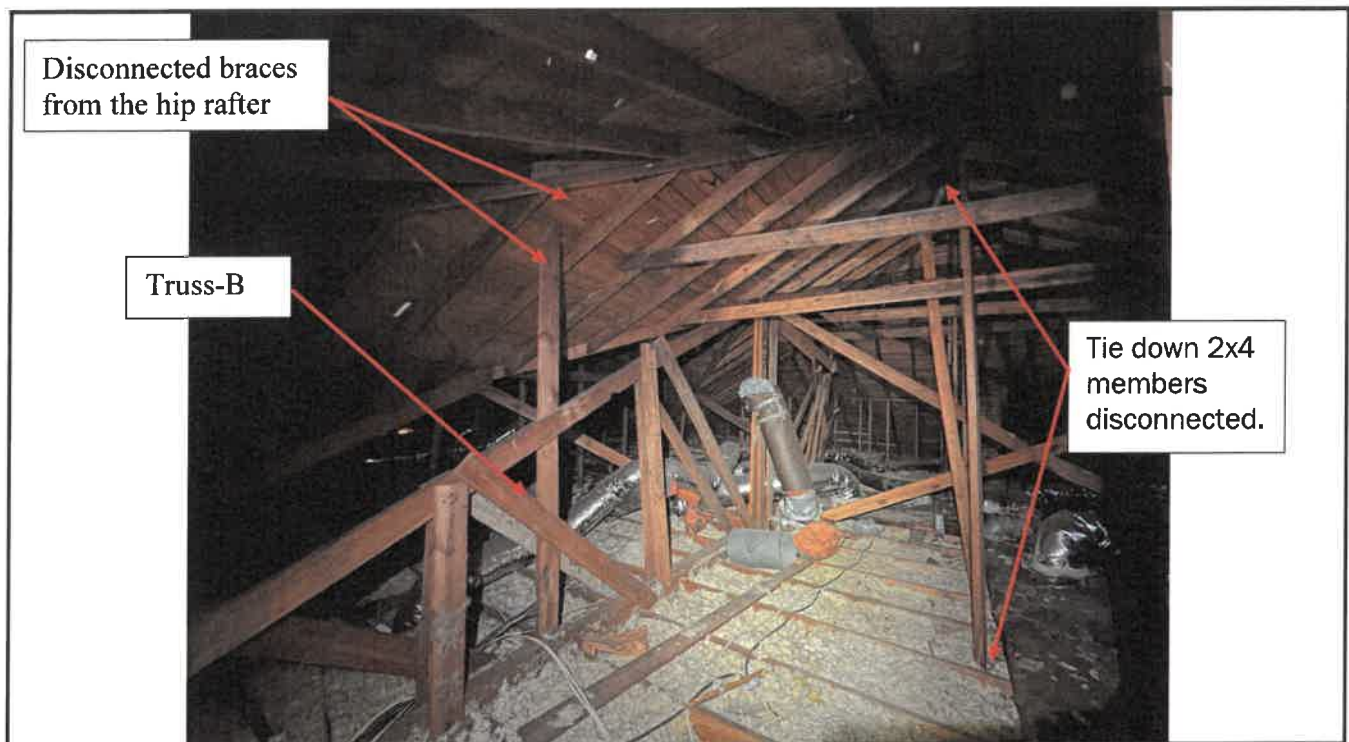
- Truss-B appeared to be damaged. The top chord member of the truss was broken (see attached drawings for location). The broken top chord members have displaced laterally (buckled) which indicates a failure mode of the truss top chord members in compression. The top chord of the broken truss appeared to be not laterally braced and the existing vertical 2x6 braces of the hip rafters were disconnected from the rafters. The unbraced length of the top chord was approx. twenty-two (22) feet.

- The unbraced length in members working in compression significantly reduces the compression capacity of the member due to buckling. Our initial calculations indicate that the top chord of the subject truss should be laterally braced at least every six (6) feet along the entire length to be able to support the estimated loads of the roof and ceiling. The truss extension noted on the NOVA drawings 2/F-2, does provide some lateral support (bracing) but the connection on top has failed and no longer provides lateral support. We could not determine if the lateral support failed and caused the truss failure, or if the top chord truss failure caused the failed connection.

Photo 1: Attic view – Main Truss-B

- Shore the attic floor joists, and roof rafters supported by Truss-B to decrease the load on the roof framing (main trusses) and provide safe access to the attic. Do NOT attempt to lift the attic joists/trusses. We recommend the shoring be designed by a professional engineer and installed by a licensed framing contractor.
- Once the main roof truss and attic joists have been shored, it is possible to further investigate and evaluate the roof framing. This evaluation is recommended to determine whether it is more feasible and cost-effective to repair or replace the roof framing.
- Further investigate the top of the perimeter wall, to ensure the presence of a bond beam at top of the wall is recommended. If no bond beams are present, we recommend the installation of a bond beam to provide continuity and mitigate the observed cracks on the masonry walls.

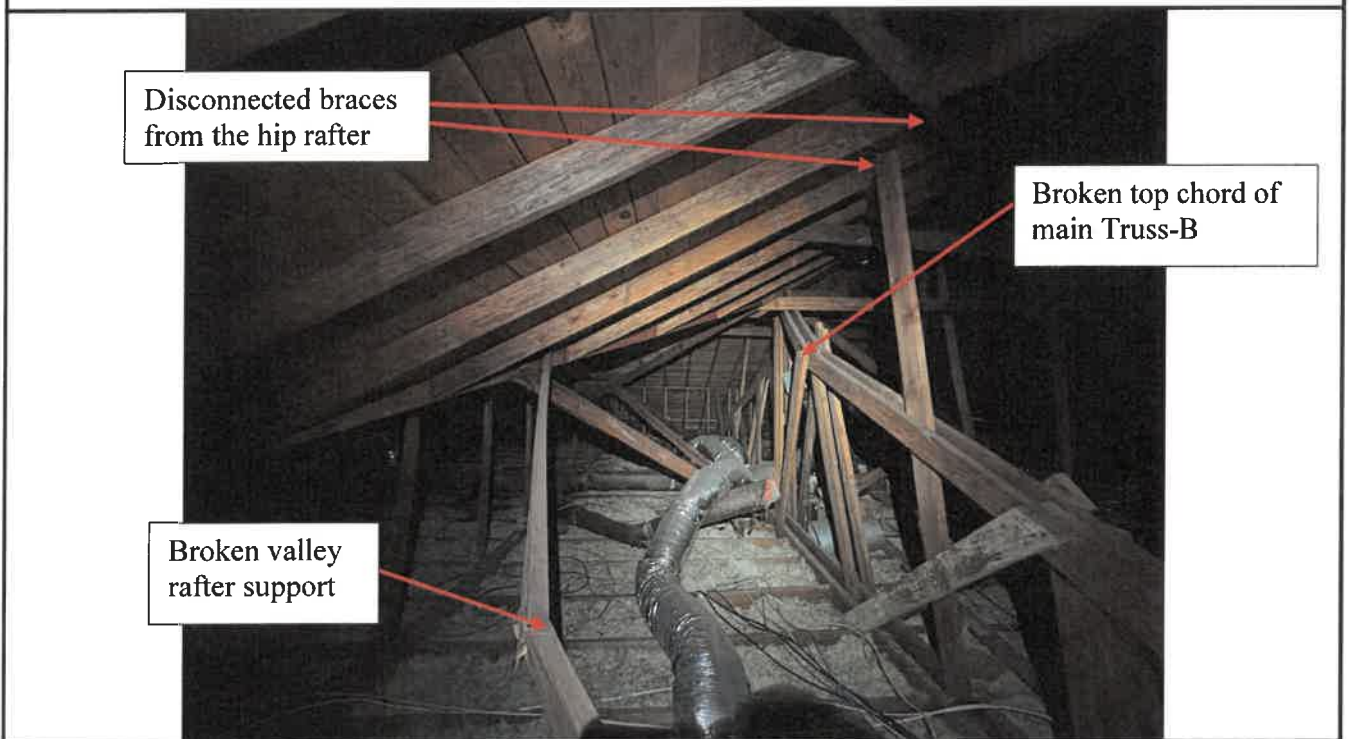
Photo 2: Attic View – Main Truss-B without truss extensions

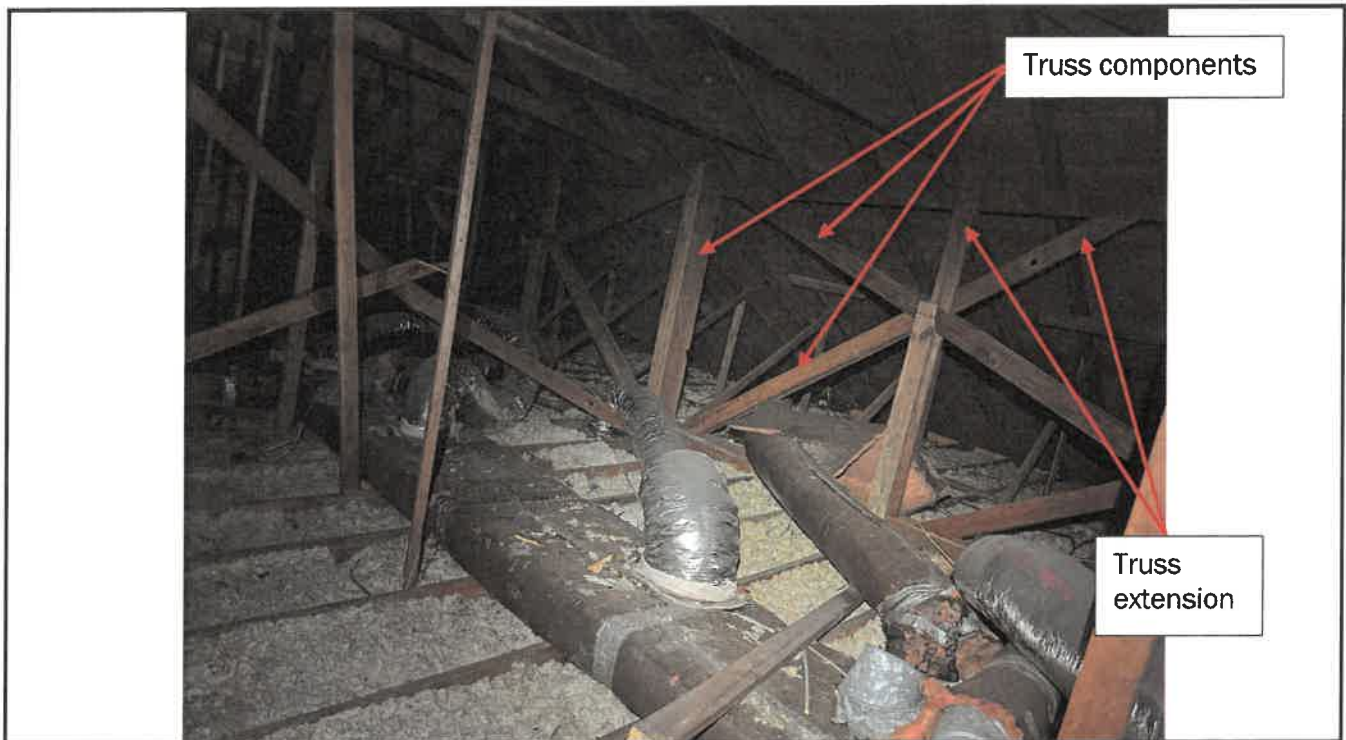
- Truss-A appeared to have a similar configuration as the failed truss (Truss-B), has slightly less load and more evenly distributed than the failed truss. The truss extensions shown on NOVA drawing 1/F-2, were in place and do provide some lateral support (bracing) of the top chord but additional, adequate bracing is required.

Photo 3: Attic view – Truss-A

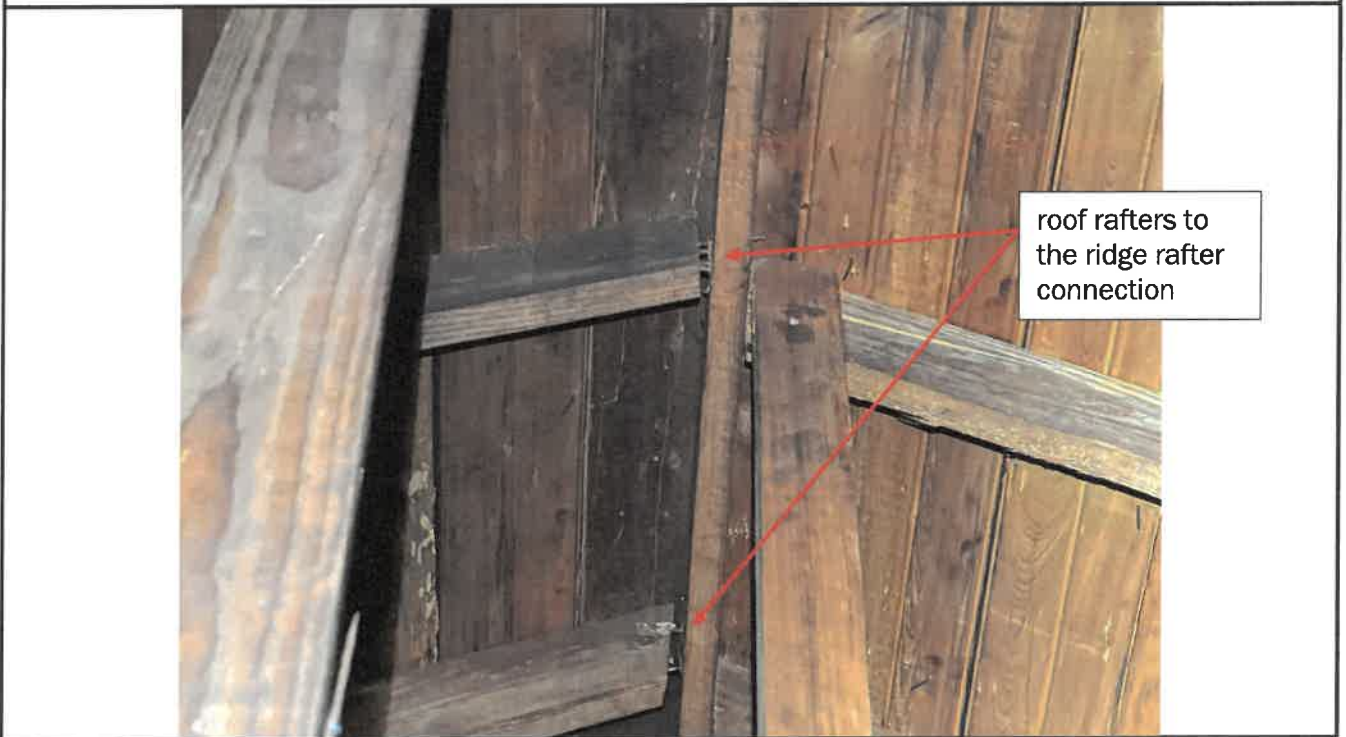
- Signs of connection failure of the roof rafters to the ridge rafter were noted and the tie down 2x4 members of the ridge rafter were disconnected from the ridge rafter or the attic floor joist.

Photo 4: Failed connection at ridge rafter

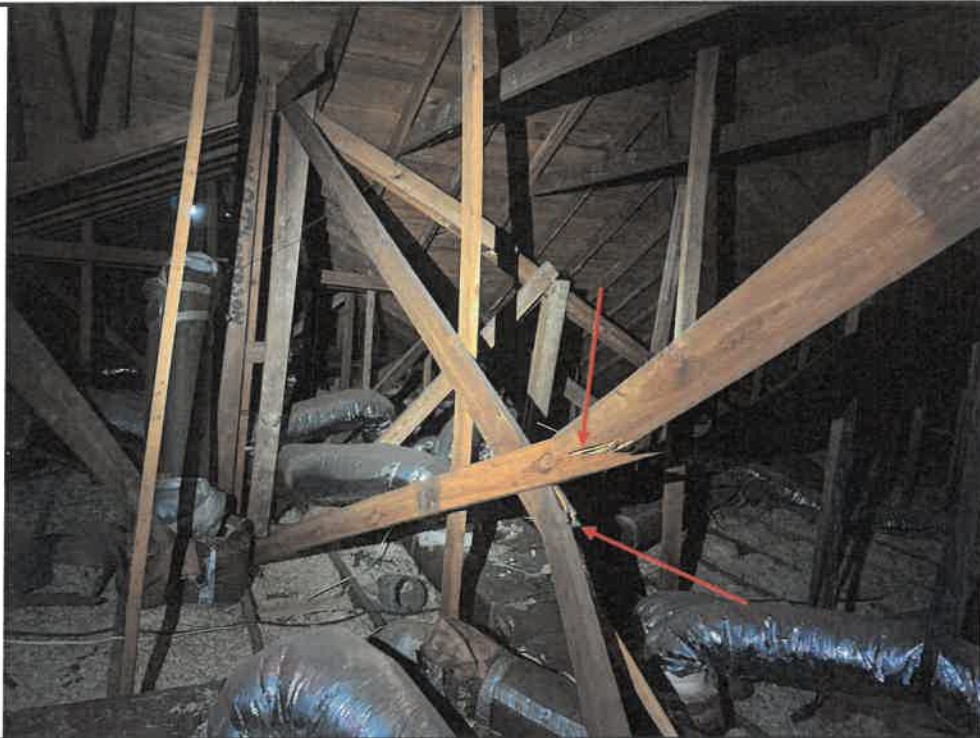
- An x-brace between Truss-A and Truss-B was present and both x-bracing members were broken. These bracing members were approx. nineteen (19) feet long and did not appear to be braced. The broken x-brace indicates significant horizontal and/or vertical differential displacement between these trusses.

Photo 5: Broken x-bracing between Truss-A and Truss-B

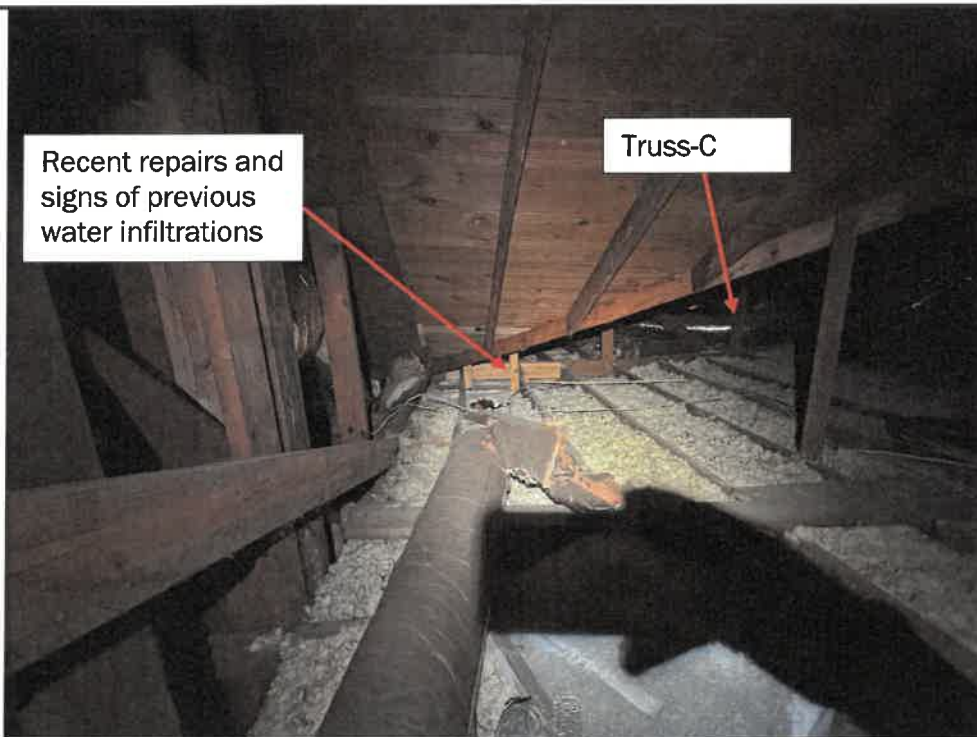
Photo 6: Signs of recent repairs

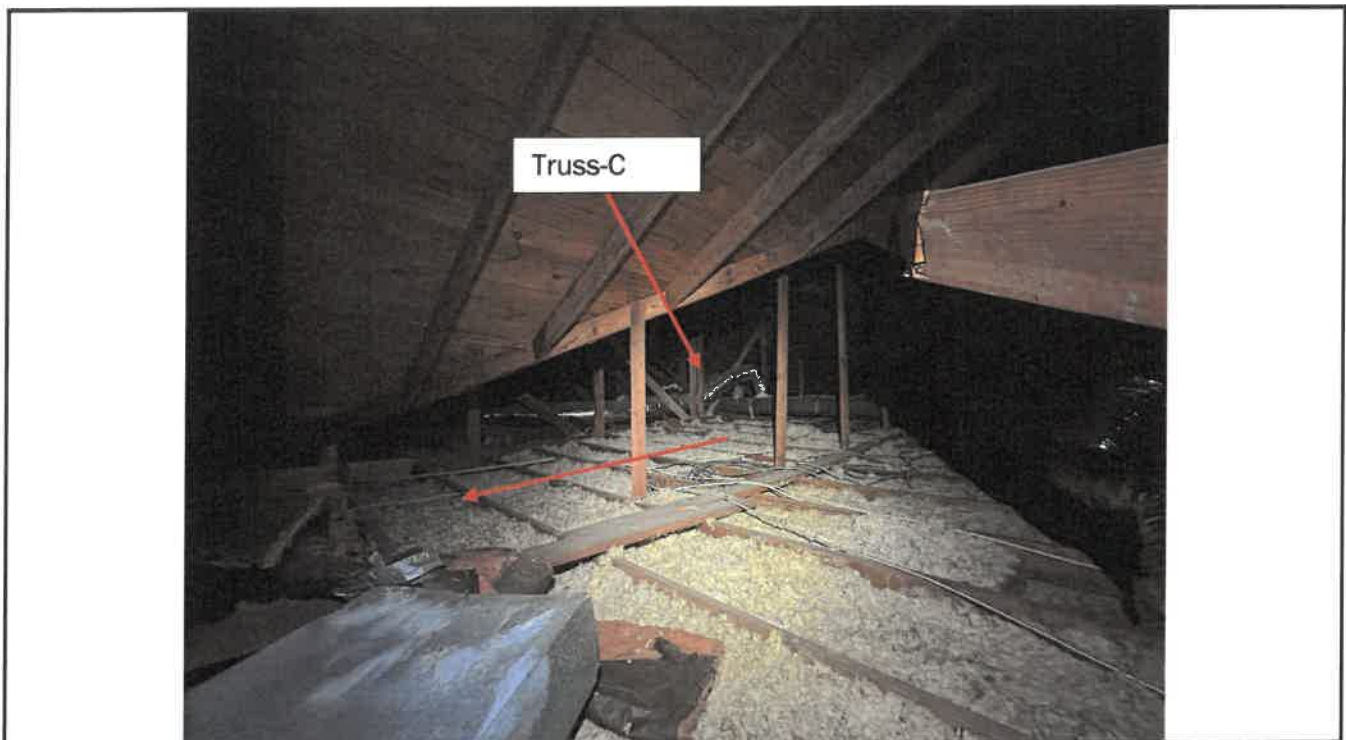
- Truss-C appeared to be in poor condition. We couldn't observe this truss from close distance due to safety concerns. Recent repairs and previous signs of water infiltrations appeared to be present at the north support of the truss and the bottom chord of the truss appeared to be sloping toward the north support. The sag on the ceiling joists (which bare on the bottom chord of the truss) also indicate the noted slope on the bottom chord.

**Photo 7:** Attic view – Attic joists and bottom chord of the Truss-C sloping toward north

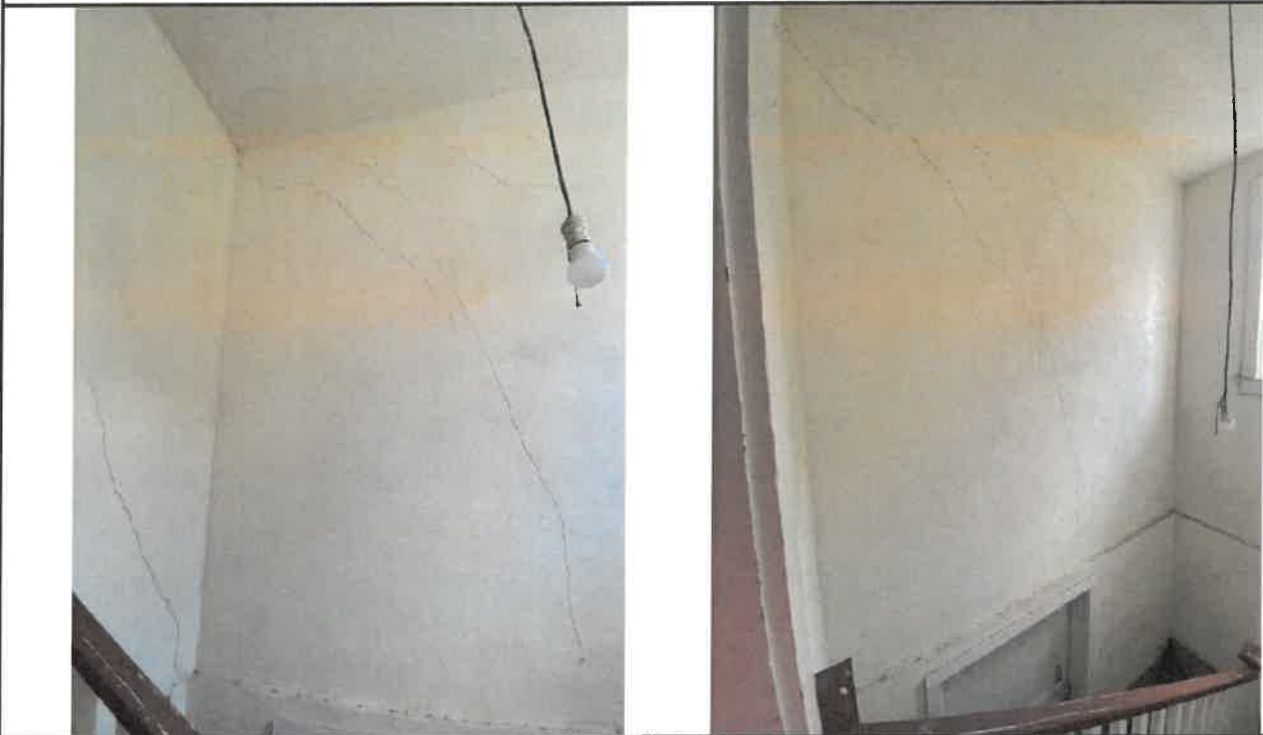
- Two (2) of the valley rafter supports were also broken. They also appeared to be buckling and had significant length without lateral support.
- The exterior and interior bearing walls appeared to be in fair condition, but signs of marginal cracks were present. Further investigation might be required to determine the presence of a bond beam on top of the wall.

**Photo 8:** Cracks on the walls – Signs of marginal differential settlement and absence of a bond beam at the top of the wall.
