# City of Lake City Street Assessment February 22, 2023

SW James Montgomery Avenue  
SE Camp Street / SE Marsh Terrace Intersection  
SW Rossborough Court  
SW Alexandria Boulevard  
SW Grandview Street East of McFarlane Avenue  
SW Chapel Hill Street

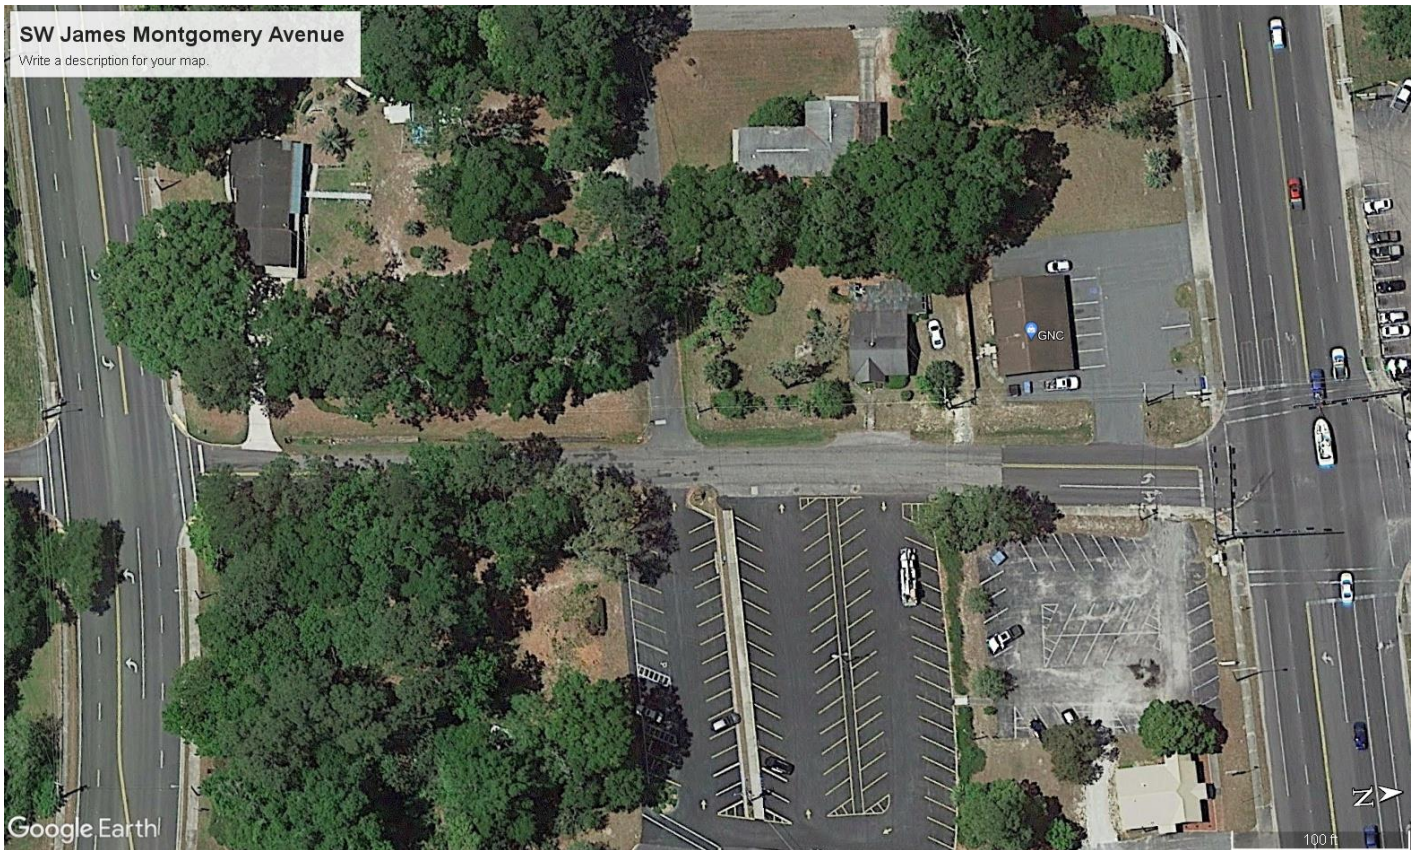
# SW James Montgomery Avenue

Street carries above normal traffic. Pavement is severely distressed. There are numerous patches. The side drain under Laurel Street is crushed and clogged. The ditch paving on the east and west side is failing. Tree roots are causing damage to the ditch paving on the east side.

Prepare engineered plans for the complete reconstruction of the street and associated drainage system. Plans should include reclaiming the base and pavement, new pavement (2" minimum), replace all drain pipes, install new inlets as needed, remove trees causing damage to drainage system, and replace ditch pavement.

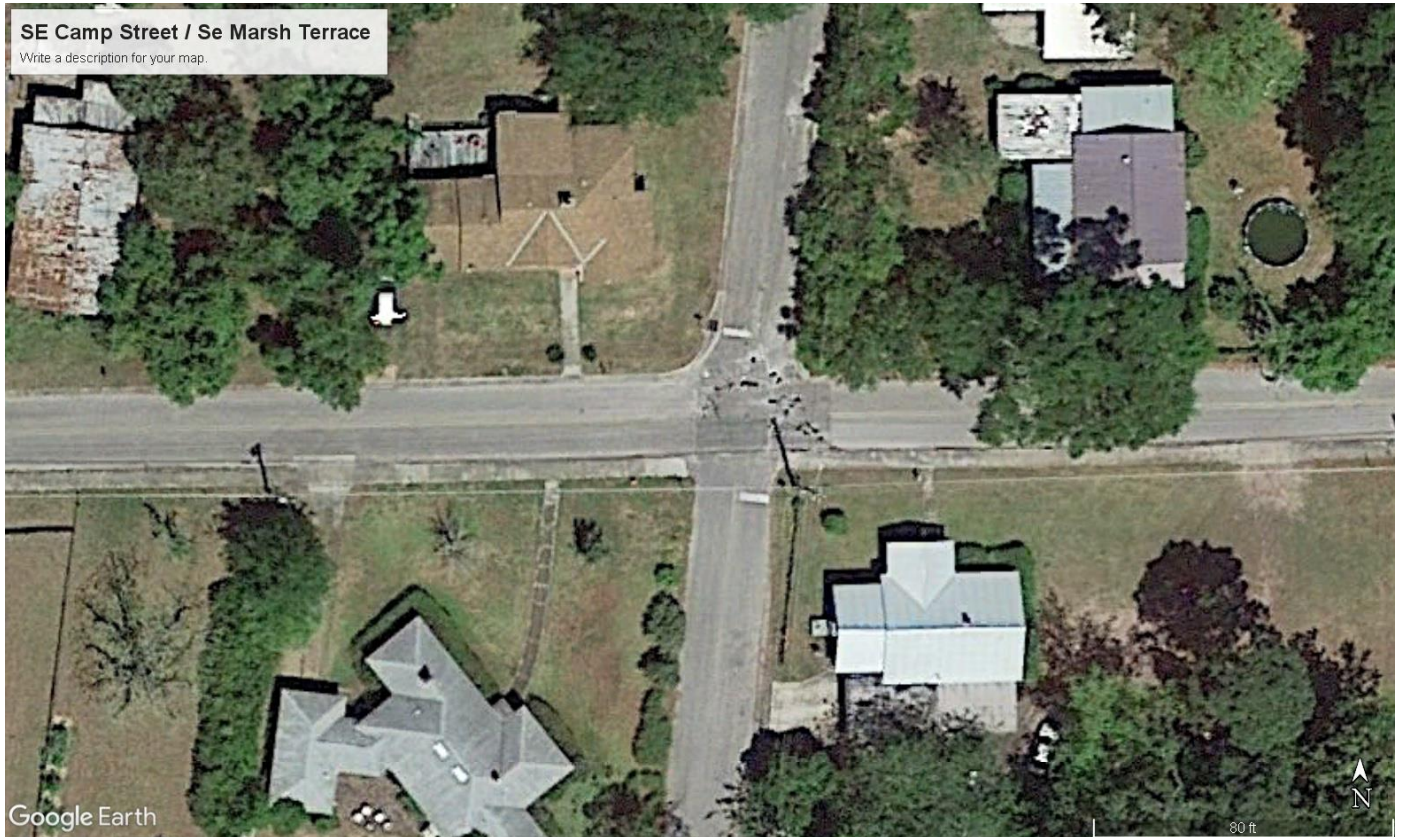
# SE Camp Street / SE Marsh Terrace Intersection

Pavement is patched and unlevel. There is oxidation and cracking due to weather and age.

Mill the pavement at variable depth (approximately 1") to establish uniform slope. Resurface with new asphalt (minimum 1 ¼").

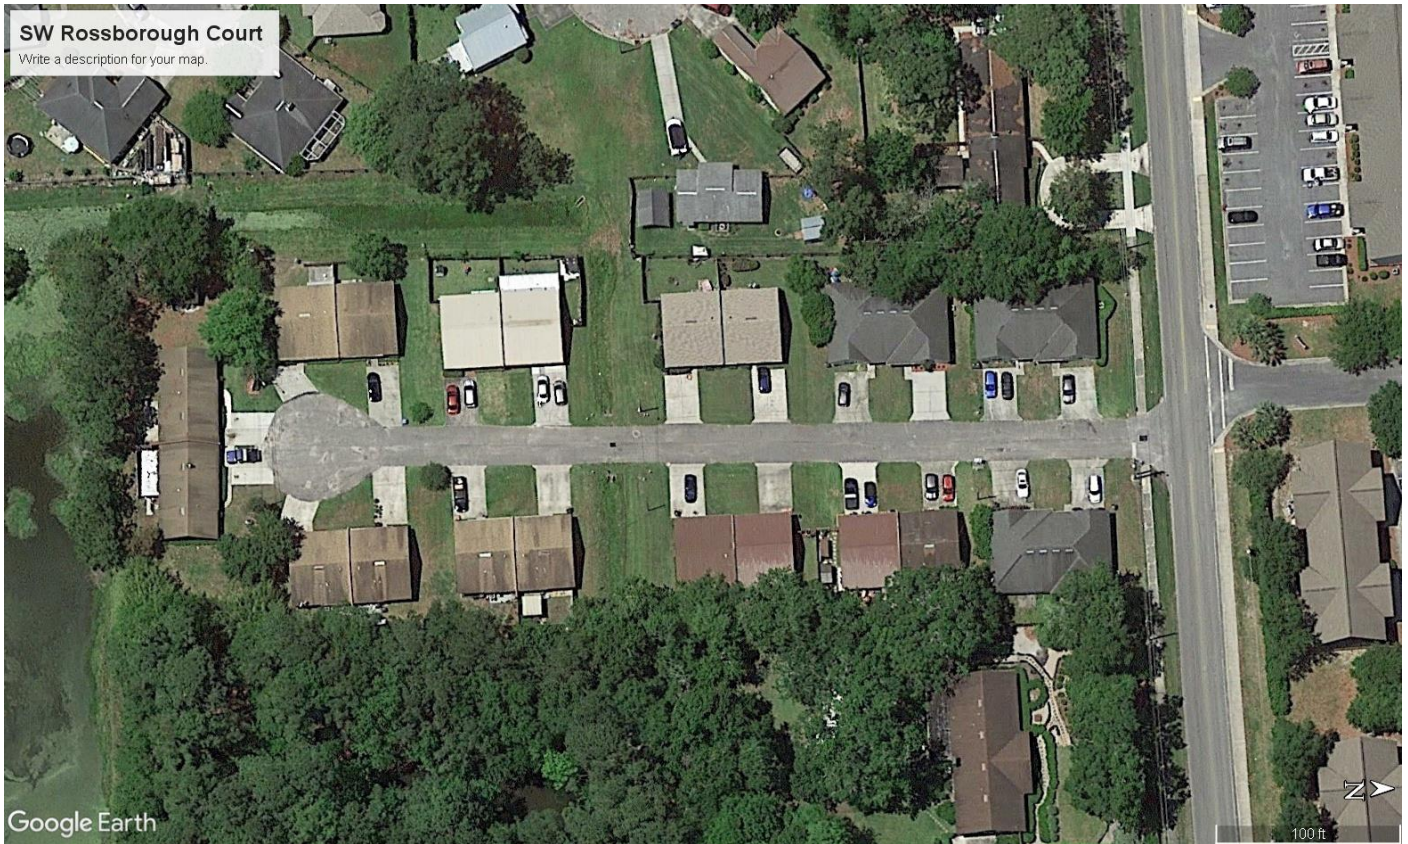
# SW Rossborough Court

Street has inverted crown with inlets in center. Pavement is distressed with patched and unlevel areas. There is oxidation and cracking due to weather and age. There is very little cover over cross drain.

Blade and remove existing pavement. Add additional limerock base and reshape to establish uniform slope. Resurface with new asphalt (minimum 1 ½").

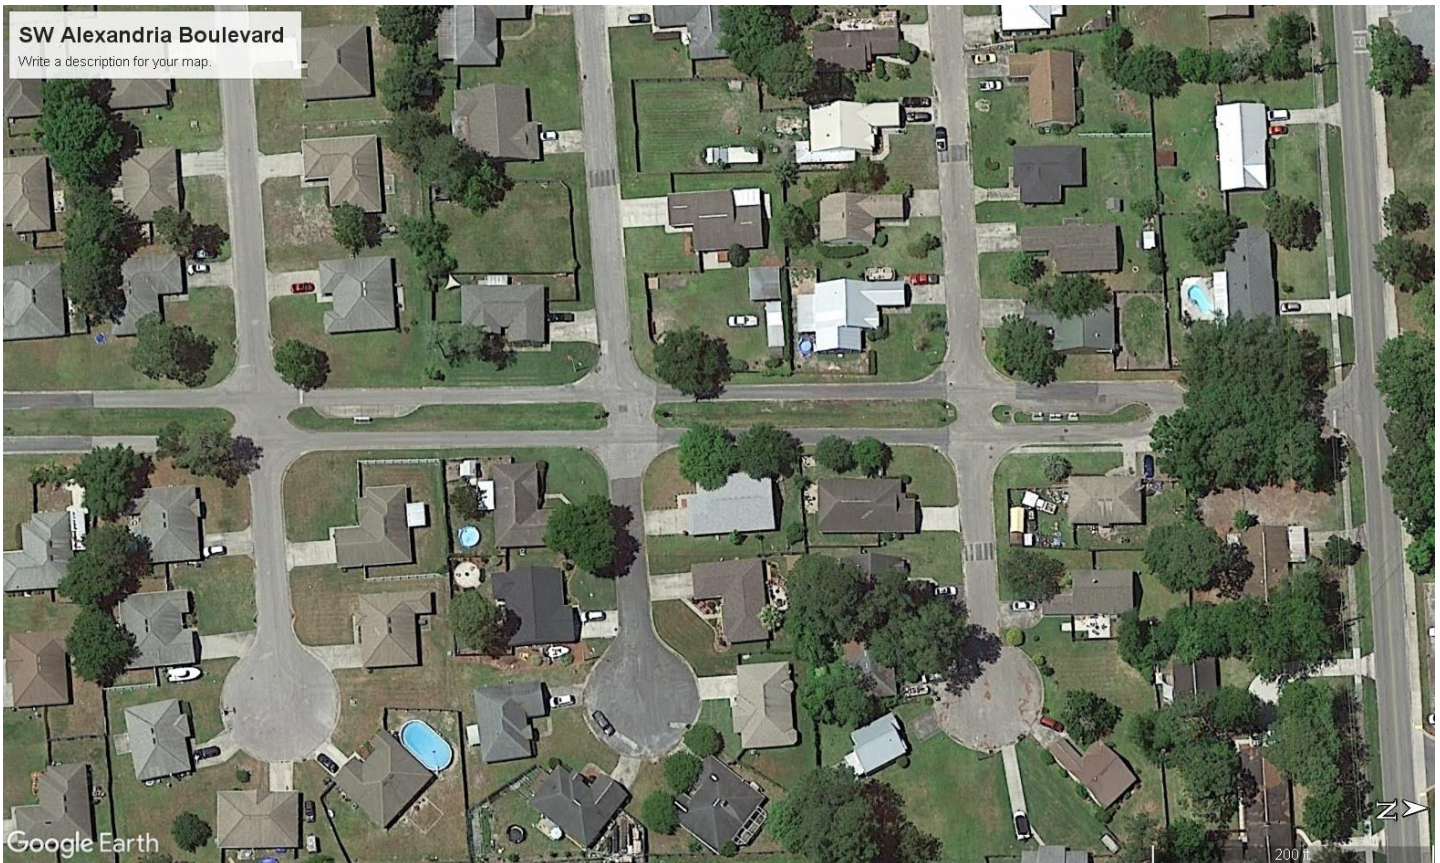
# SW Alexandria Boulevard

Street has depressed grass median. The roadways slope to the median. The pavement between Grandview and south of Jamestown is distressed with patched and unlevel areas. There is oxidation and cracking due to weather and age. The remaining segment south to Yorktown Glen has some minor cracking but appears to be in a serviceable condition.

Reclaim the pavement and base from Grandview Street to south of Jamestown Glen. Add additional limerock base and reshape to establish uniform slope and profile. Resurface with new asphalt (minimum 1 ½").

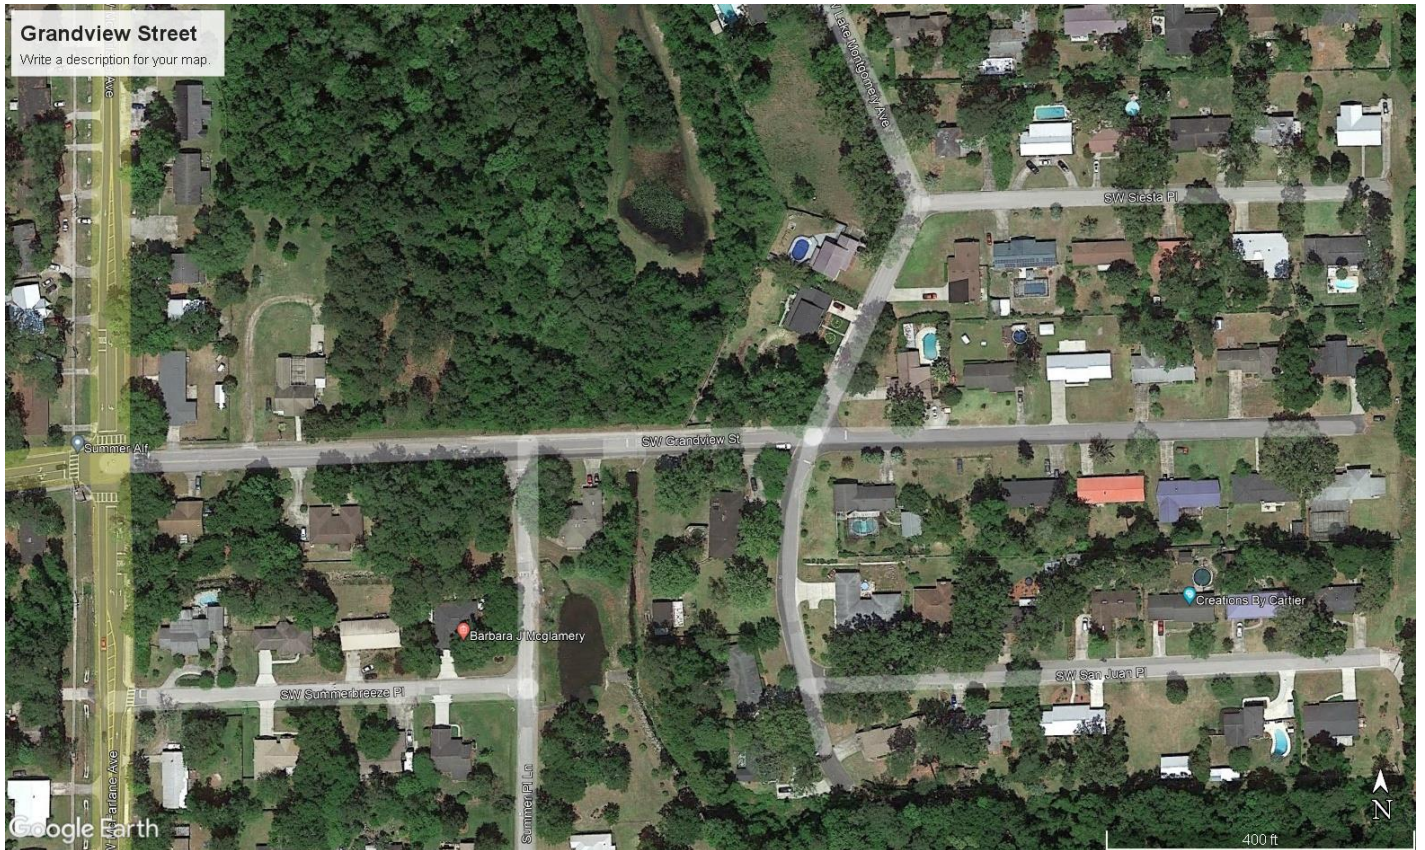
# SW Grandview Street East of McFarlane Avenue

The pavement is distressed with patched and unlevel areas. There is oxidation and cracking due to weather and age.

Mill existing pavement 1" to 1 ½ " to provide uniform slope. Resurface with new asphalt (minimum 1 ½ ").

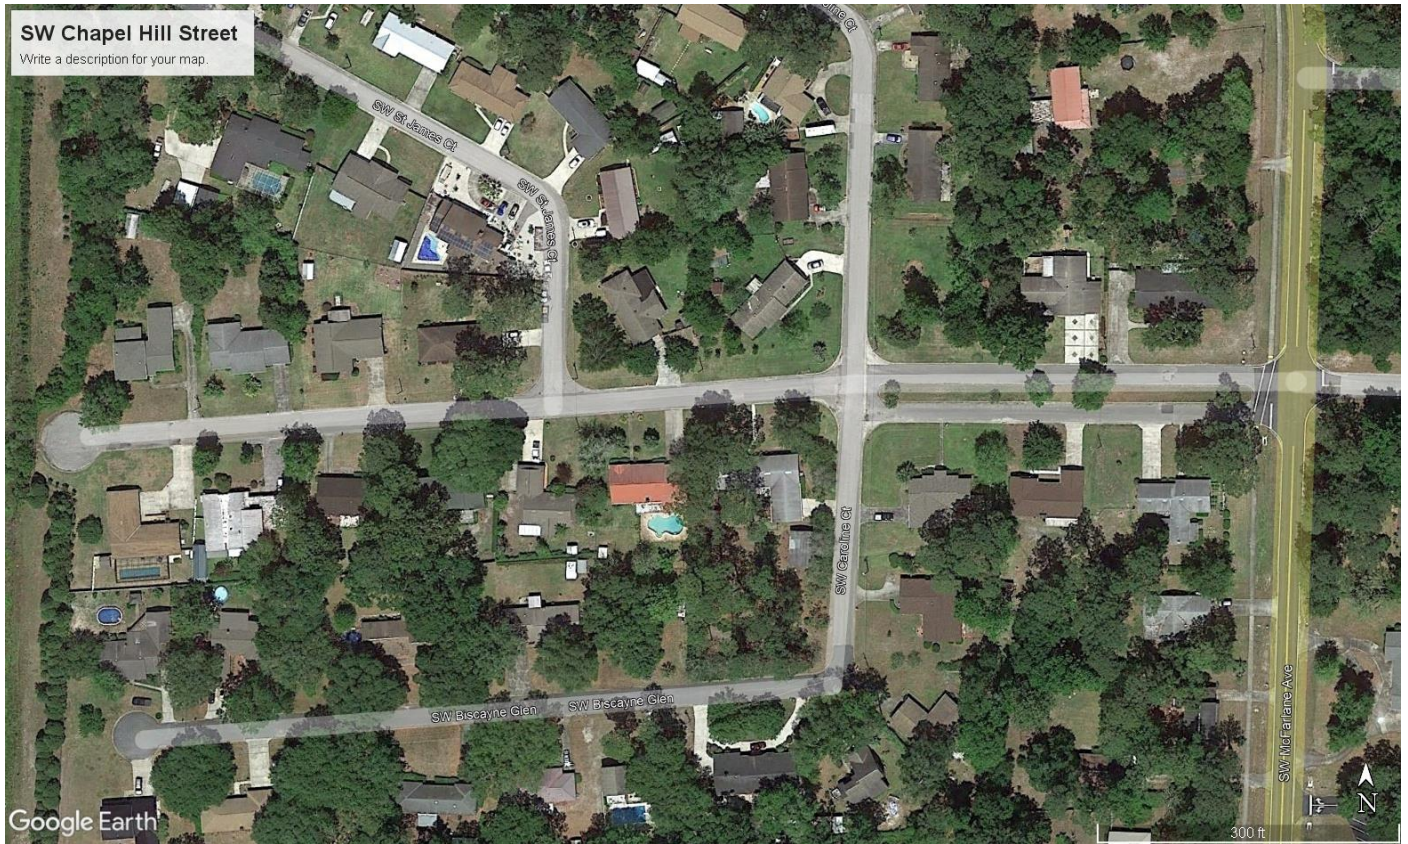
# SW Chapel Hill Street

The pavement is distressed with patched and unlevel areas. There is oxidation and cracking due to weather and age.

Mill existing pavement 1" to 1 ½ " to provide uniform slope. Resurface with new asphalt (minimum 1 ½ ").
