**Re: 918 Park Avenue Historic Preservation Board Appeal**

# STRUCTURAL ASSESSMENT

918 Park Avenue

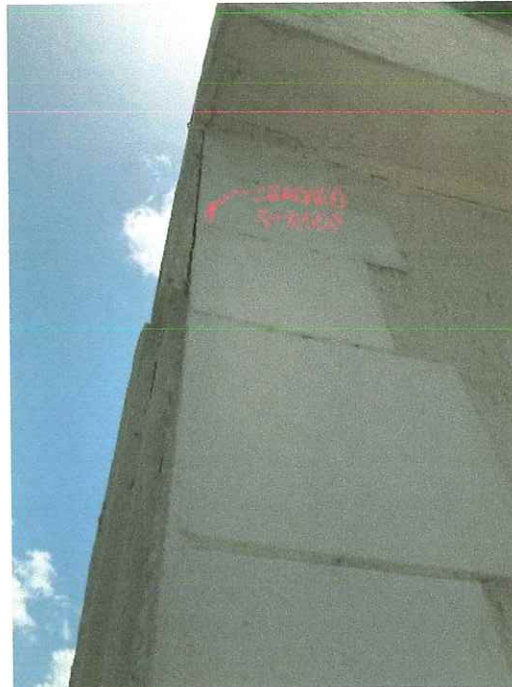
Photo No. 002  
Date Taken: 07/10/2023  
File Name: 20230710\_173333447  
Description: Cracked stucco at top of Northeast corner of building  
Comments: Cracked stucco allows for water infiltration, allowing for structural water damage to wood framing members

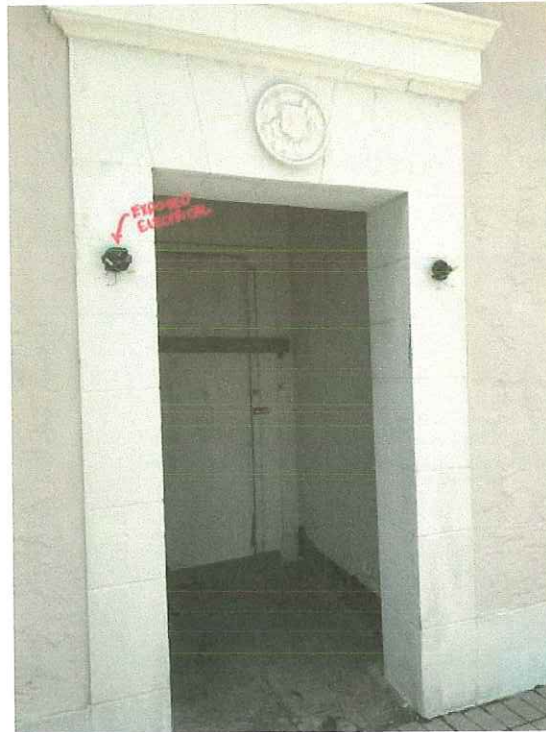
Photo No. 003  
Date Taken: 07/10/2023  
File Name: 20230710\_173546857  
Description: Entrance doorway

Comments: Exposed electrical wires on the exterior of the building should be capped.

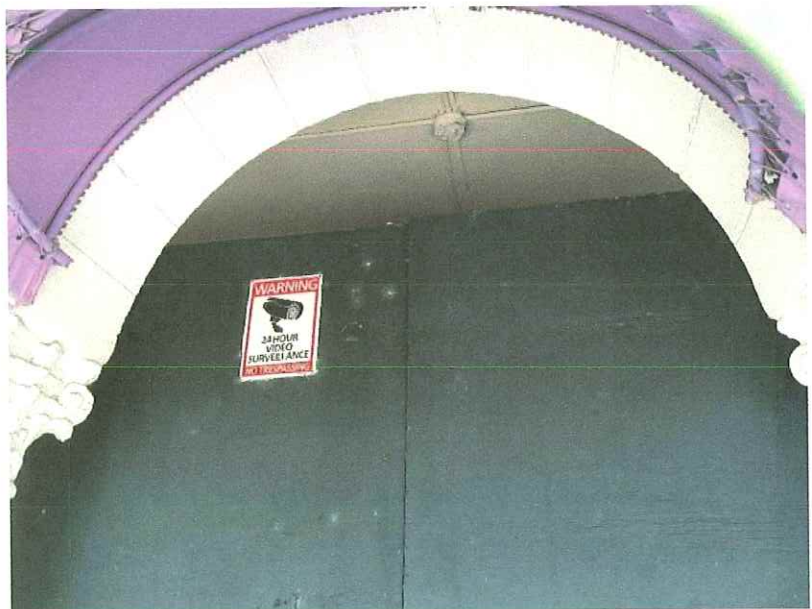
Photo No. 004  
Date Taken: 07/10/2023  
File Name: 20230710\_173527910  
Description: Boarded storefront openings.

Comments: Boards do not fully enclose the openings allowing for water and pest infiltration into the building.

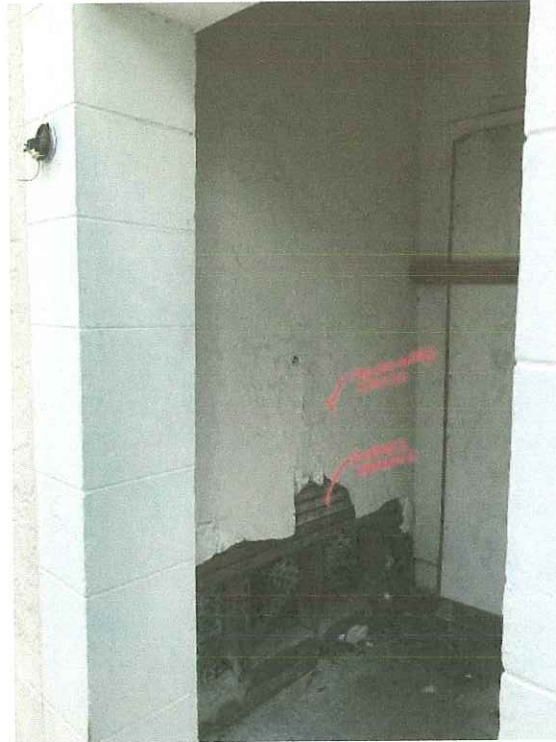
Photo No. 005  
Date Taken: 07/10/2023  
File Name: 20230710\_173640515  
Description: Front entrance vestibule  
with spalled stucco and  
exposed framing

Comments: Spalled stucco finish allows  
for water and pest  
infiltration into the building.

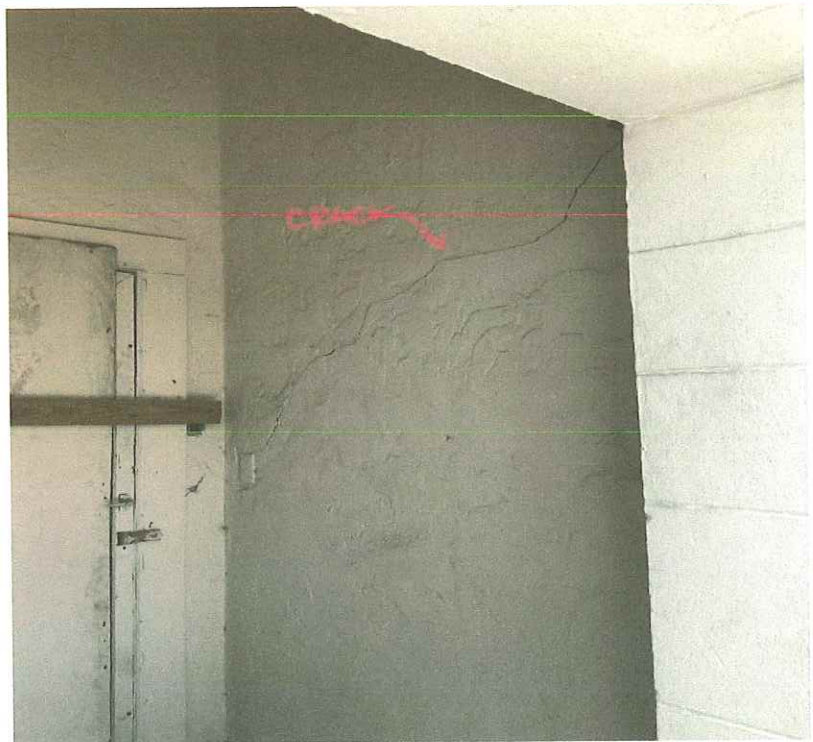
Photo No. 006  
Date Taken: 07/10/2023  
File Name: 20230710\_173848196  
Description: Front entrance vestibule  
with cracked stucco

Comments: Full horizontal stucco crack  
may indicate in-plane  
lateral distress

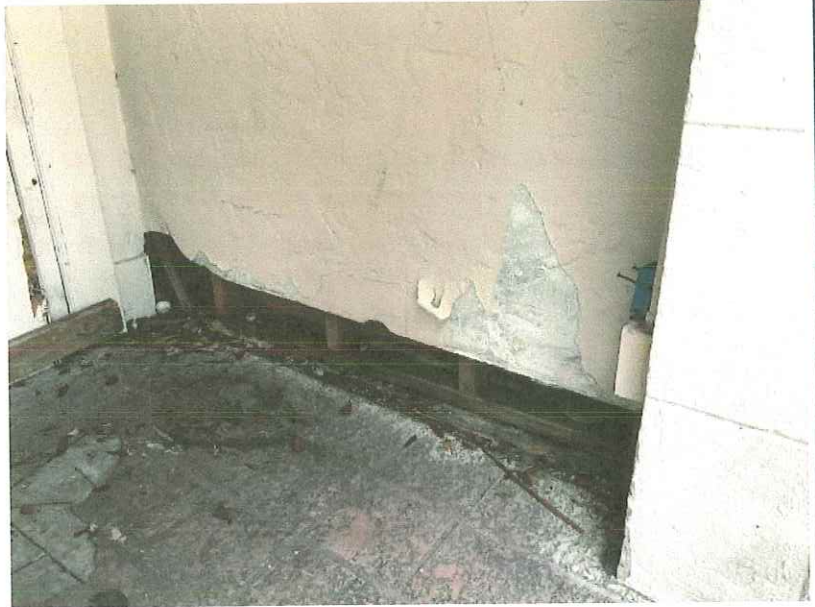
Photo No. 007  
Date Taken: 07/10/2023  
File Name: 20230710\_173938121  
Description: Front entrance vestibule  
with spalled stucco and  
exposed framing

Comments: Spalled stucco finish allows  
for water and pest  
infiltration into the building.

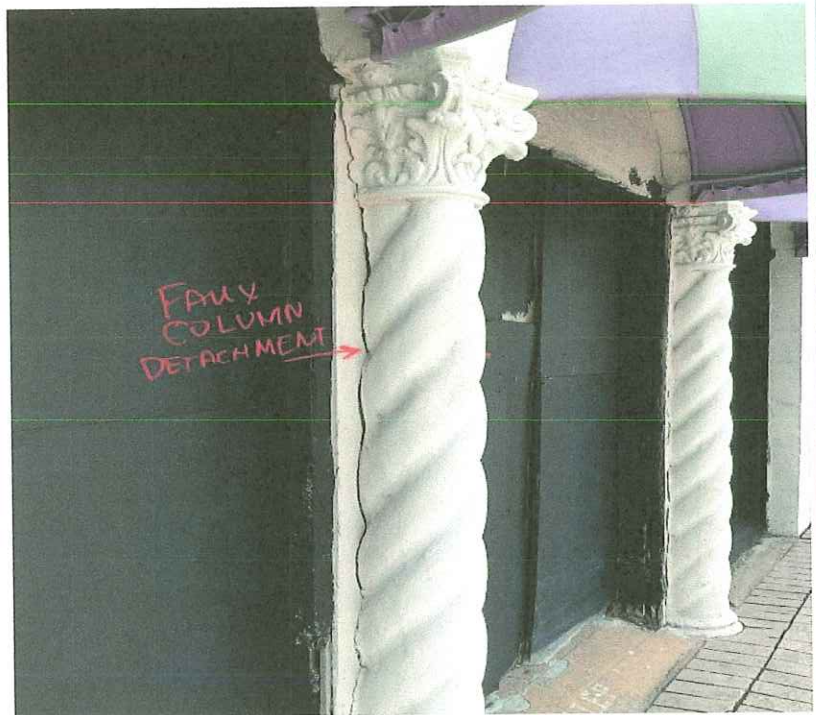
Photo No. 008  
Date Taken: 07/10/2023  
File Name: 20230710\_173954446  
Description: Detached faux column

Comments: Susceptible to falling and  
injuring a pedestrian.

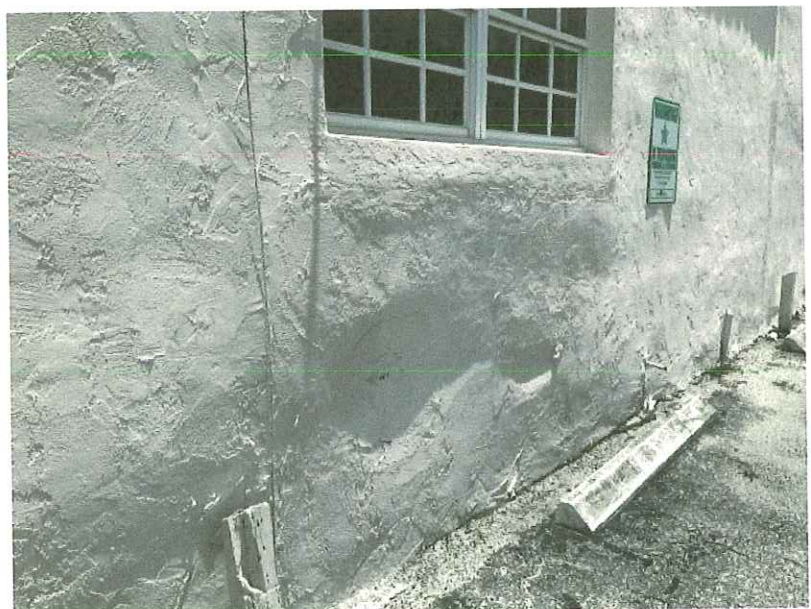
Photo No. 010  
Date Taken: 07/10/2023  
File Name: 20230710\_174453683  
Description: Large indentation on stucco finish

Comments: Presumed vehicle impact. Wall framing needs to be inspected for damage.

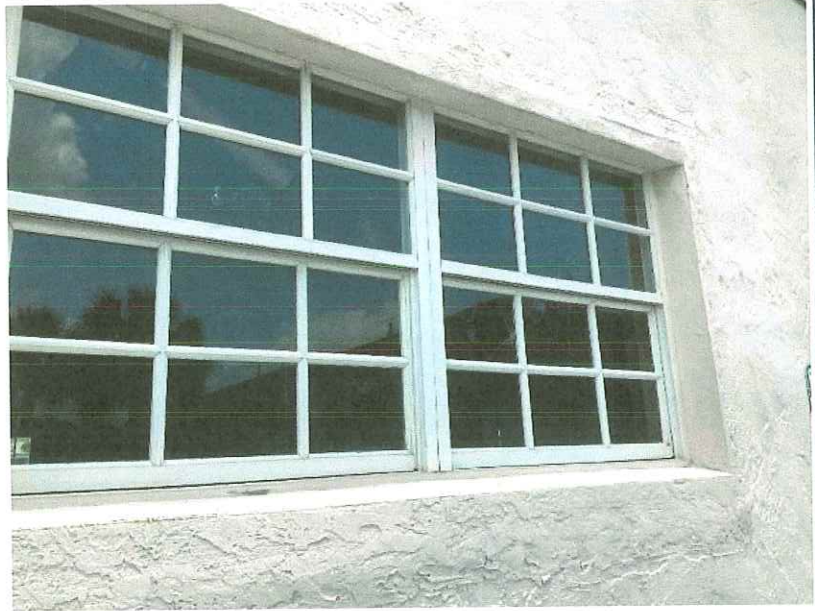
Photo No. 011  
Date Taken: 07/10/2023  
File Name: 20230710\_174515638  
Description: Broken window on West side of building

Comments: Broken glass window allows for water and pest infiltration into the building

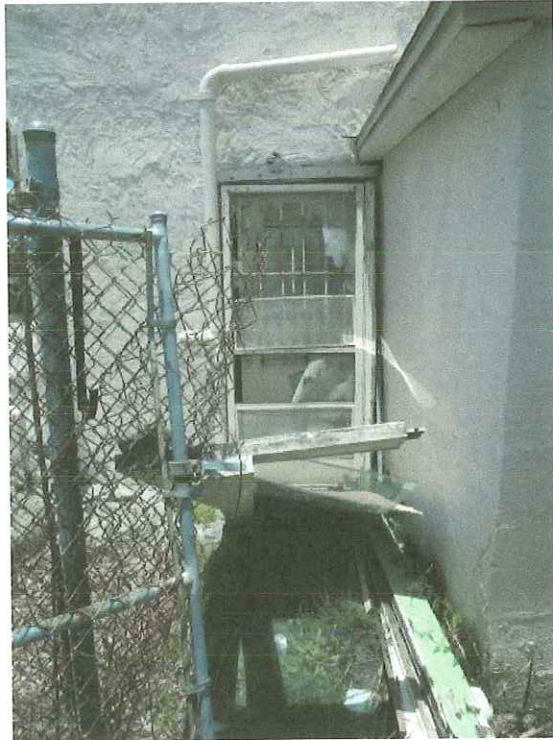
Photo No. 013  
Date Taken: 07/10/2023  
File Name: IMG\_7937  
Description: Broken screen door and exposed door frame at Southwest corner of building

Comments: Dangerous debris needs to be removed

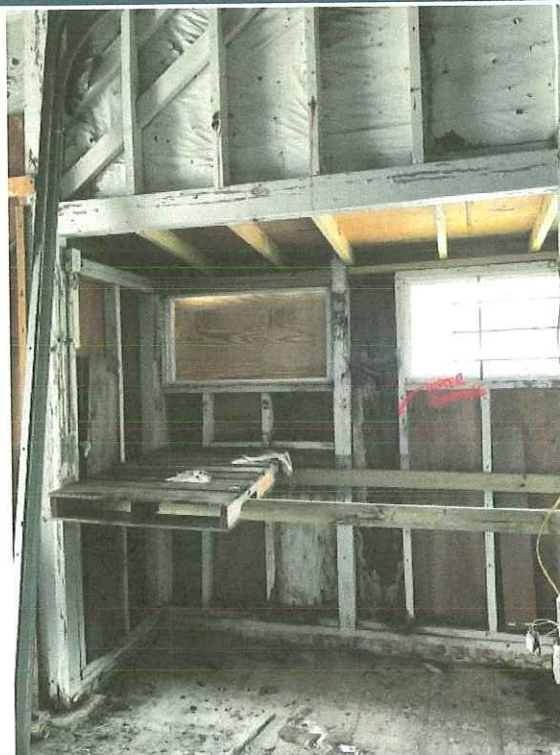
Photo No. 019  
Date Taken: 07/10/2023  
File Name: 20230710\_175620887  
Description: Interior of rear expansion framing

Comments: Extensive water damage and mold

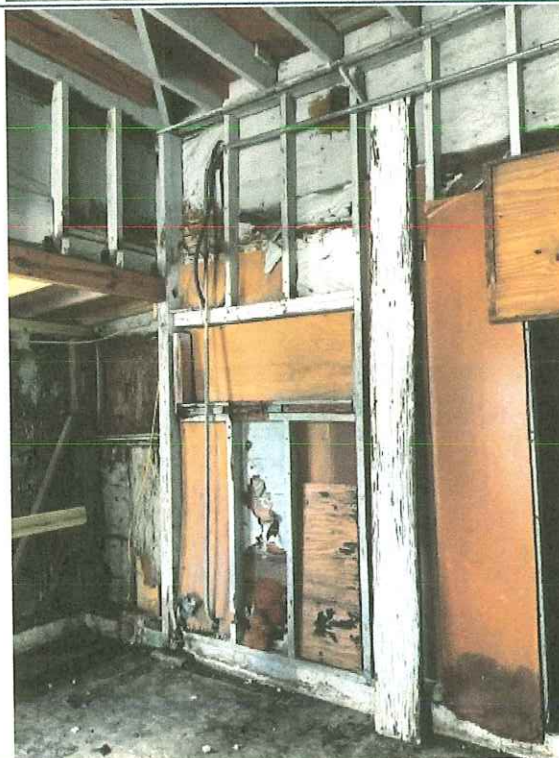
Photo No. 020  
Date Taken: 07/10/2023  
File Name: 20230710\_175943565  
Description: Interior of rear expansion framing

Comments: Extensive water damage and mold

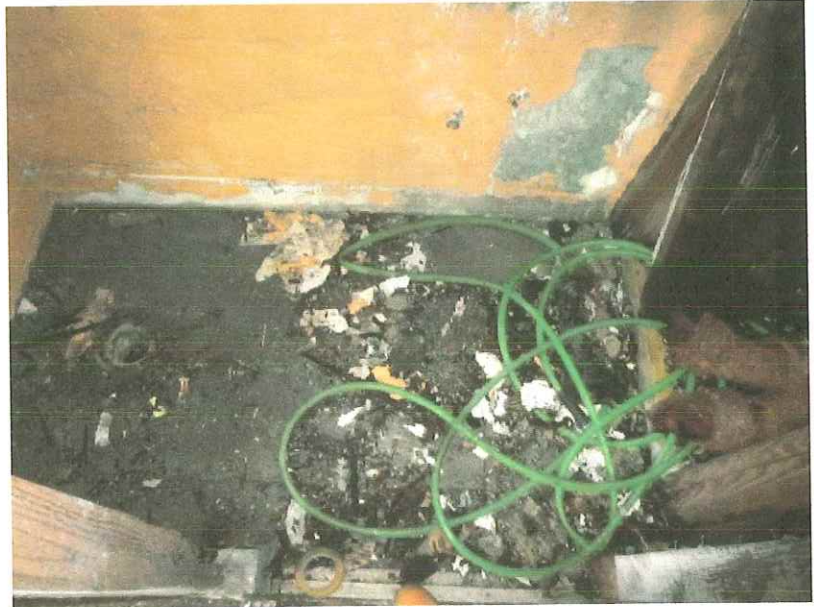
Photo No. 021  
Date Taken: 07/10/2023  
File Name: IMG\_7961  
Description: Interior of rear expansion -  
uncapped drain hole and  
unfinished floor

Comments: Extensive water damage,  
mold, paint delamination  
and loose debris

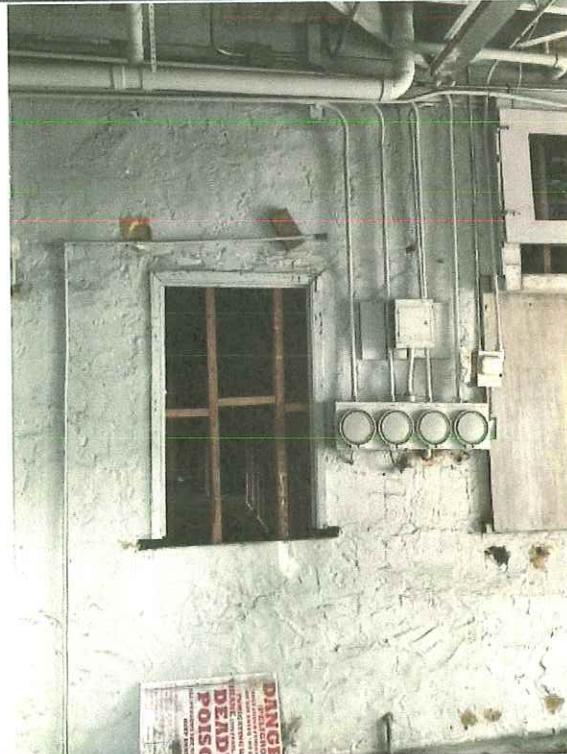
Photo No. 022  
Date Taken: 07/10/2023  
File Name: 20230710\_180136250  
Description: Interior of rear expansion -  
Opening

Comments: Infill framing and finish  
required in existing  
opening

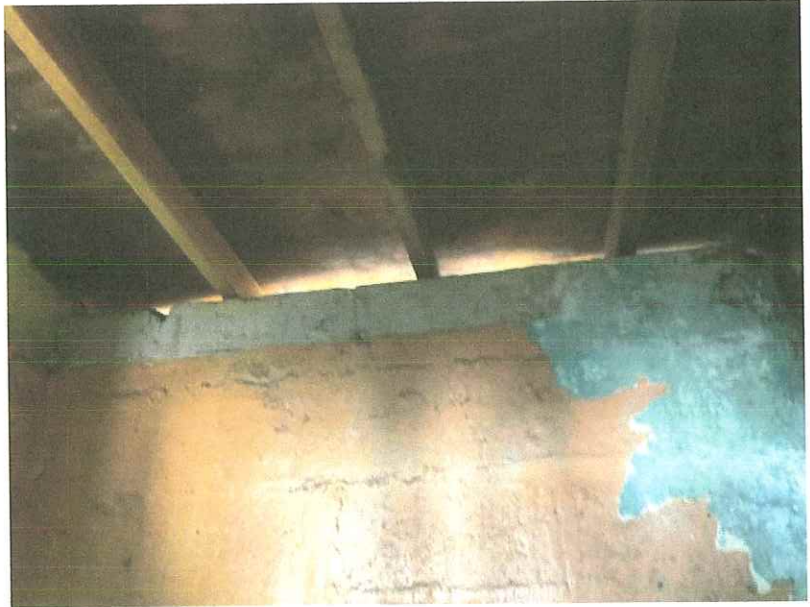
Photo No. 023  
Date Taken: 07/10/2023  
File Name: 20230710\_180047399  
Description: Interior of rear expansion –  
Un-blocked roof framing  
over masonry wall

Comments: An unblocked gap allows  
for water and pest  
infiltration into the building.  
There is not lateral load  
transfer from the roof  
framing onto the wall.

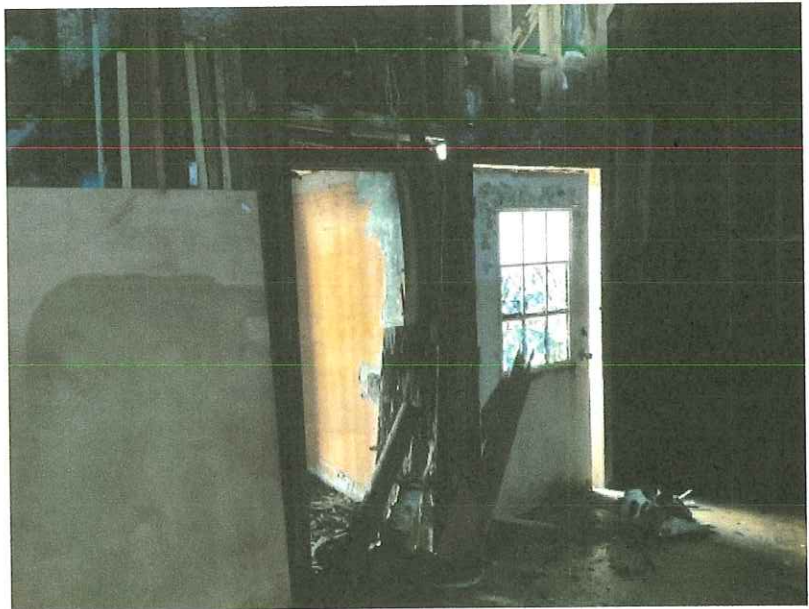
Photo No. 024  
Date Taken: 07/10/2023  
File Name: 20230710\_180212710  
Description: Southwest corner of  
building – Gapped door  
frame, unsheathed walls,  
missing door headers,  
water damage, debris

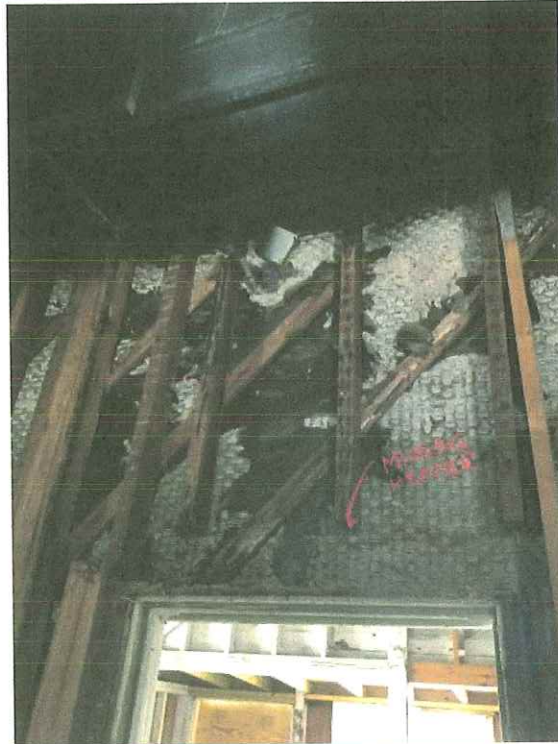
Photo No. 025  
Date Taken: 07/10/2023  
File Name: 20230710\_180559152  
Description: Original building rear wall

Comments: Missing door header,  
exposed stucco lath,  
spaced diagonal exterior  
sheathing, missing interior  
wall finish

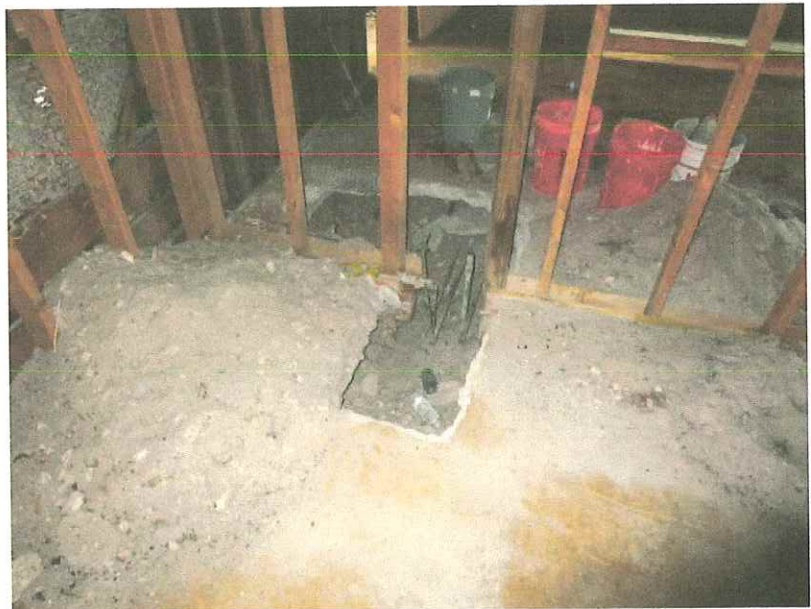
Photo No. 026  
Date Taken: 07/10/2023  
File Name: IMG\_7970  
Description: Slab demolition at rear of building

Comments: Exposed utilities should be  
capped. Sill plate for  
interior shear wall should  
not be cut

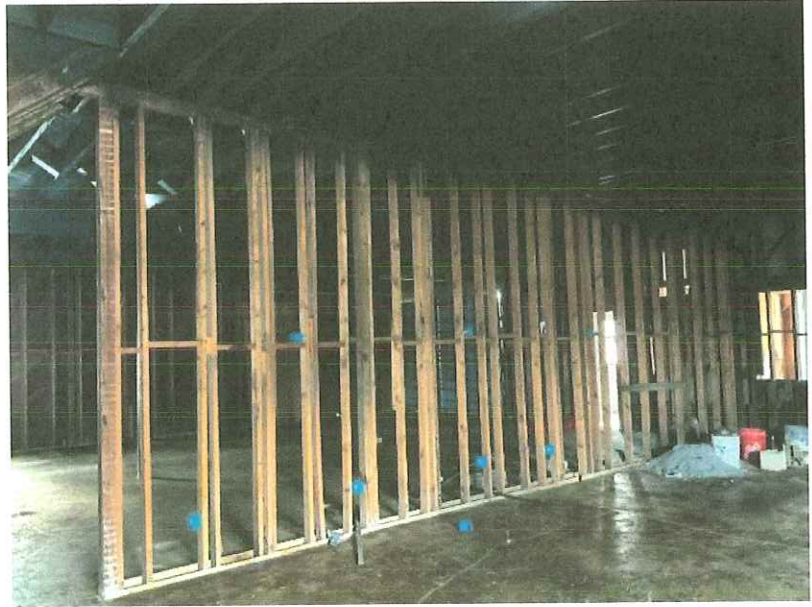
The interior bearing/shear wall is not sheathed, the bearing studs are completely exposed (see photo 027). In its current condition, this wall is subjected to combined bending and in-plane structural failure, since it's missing the wall sheathing, which provides lateral resistance and out-of-plane bracing. A continuously anchored bottom sill was not noticed on the interior bearing/shear wall, leaving the structure vulnerable and undermined. Also, it was observed that in some locations the bottom and top plate of the wall had been cut to allow for plumbing. Without proper splicing of the top and bottom plates the shear wall is deemed structurally inadequate.

Photo No. 027  
Date Taken: 07/10/2023  
File Name: 20230710\_180253426  
Description: Interior wall framing

Comments: Unsheathed bearing shear wall. Interrupted sill plate, and missing hold-downs.

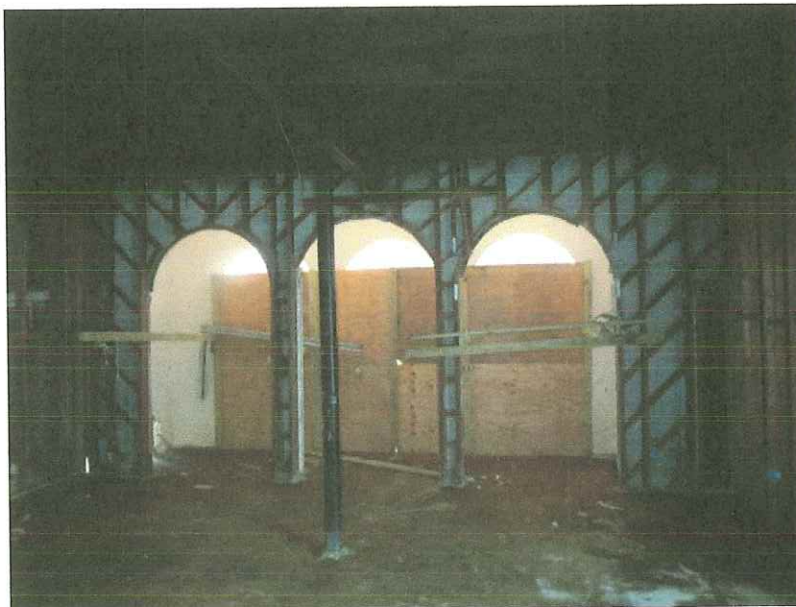
Photo No. 029  
Date Taken: 07/10/2023  
File Name: IMG\_7974  
Description: Interior front wall at  
Northeast side of building

Comments: Missing sheathing, missing  
headers over arched  
openings

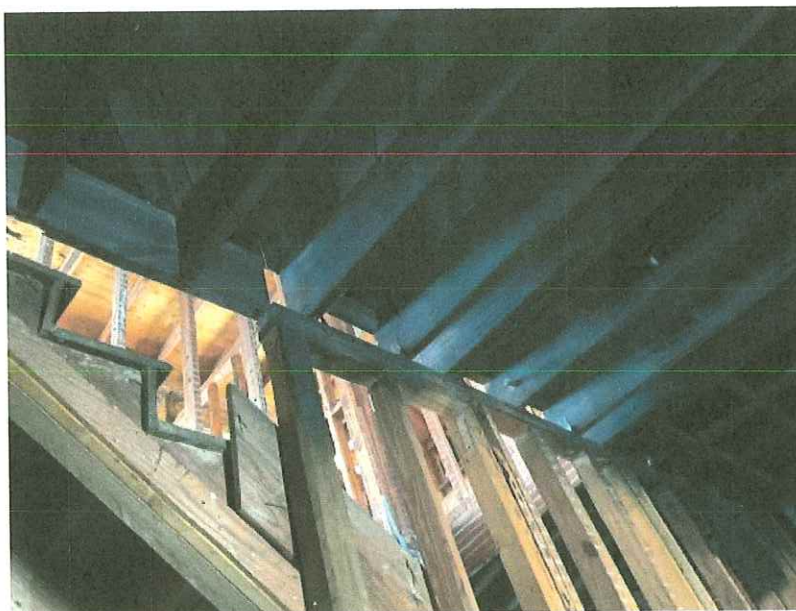
Photo No. 030  
Date Taken: 07/10/2023  
File Name: 20230710\_181856779  
Description: Floor girder by top of stairs

Comments: Bearing of girder is less  
than 1 inch.

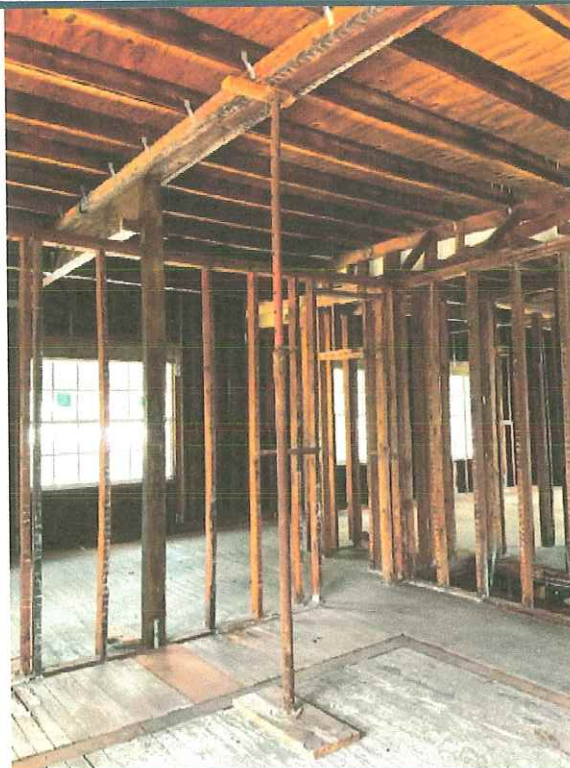
Photo No. 031  
Date Taken: 07/10/2023  
File Name: 20230710\_183906548  
Description: Roof framing temporarily shored

Comments: Near the Northwest corner of the 2nd floor a shallow roof girder is temporarily shored

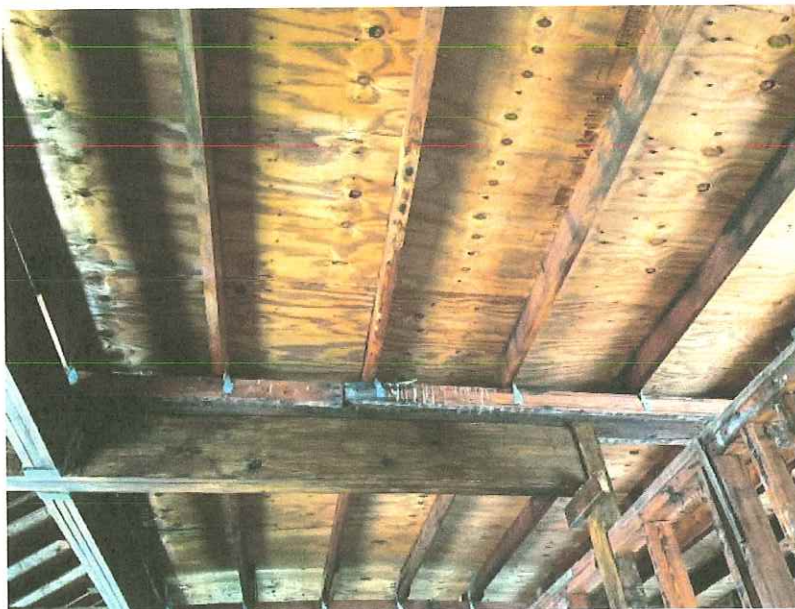
Photo No. 032  
Date Taken: 07/10/2023  
File Name: 20230710\_182541168  
Description: Roof framing girder bearing over nailed stub

Comments: Framing of girder is unconventional and needs to be analyzed. Water stains on roof deck sheathing.

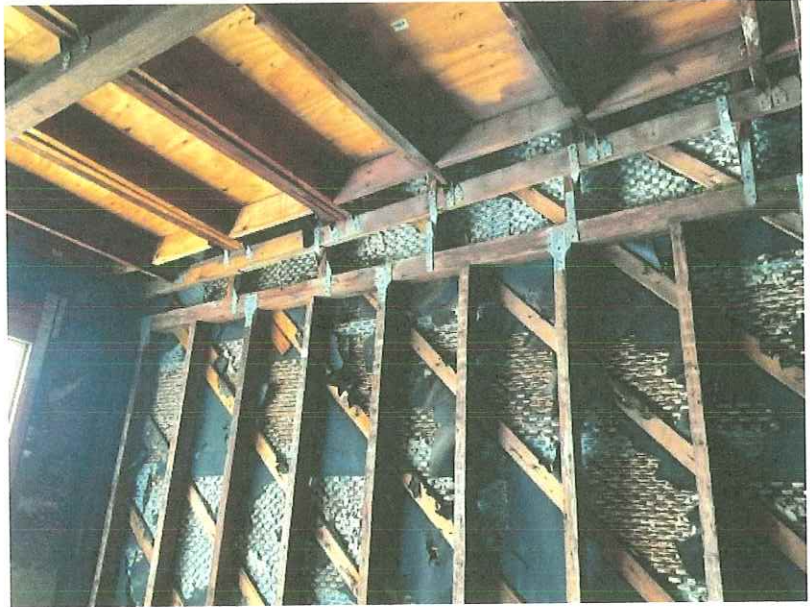
Photo No. 033  
Date Taken: 07/10/2023  
File Name: 20230710\_183444030  
Description: Northeast corner of building

Comments: Diagonal board sheathing spaced, exposed stucco lath, unconventional framing at top of wall to be analyzed

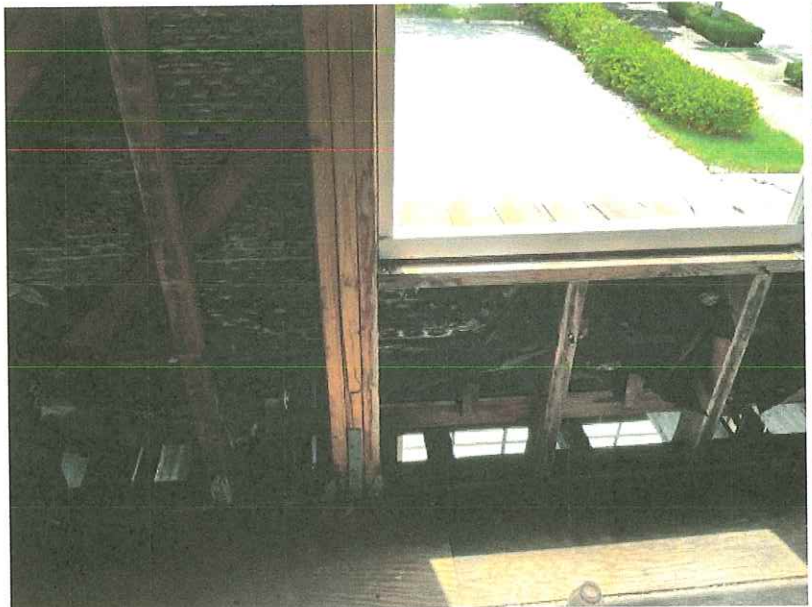
Photo No. 034  
Date Taken: 07/10/2023  
File Name: 20230710\_183718585  
Description: Window vertical framing at West side of building

Comments: Roof and 2<sup>nd</sup> floor wall framing bearing over unblocked floor joists

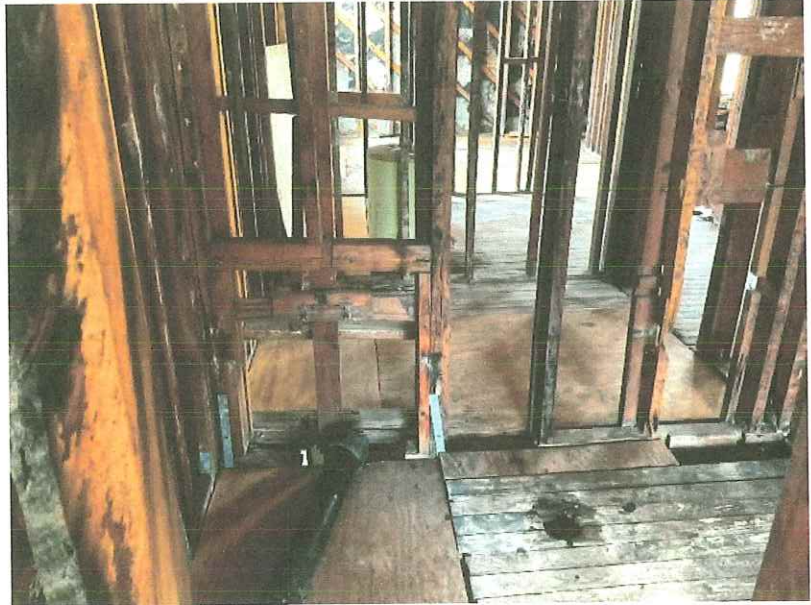
Photo No. 035  
Date Taken: 07/10/2023  
File Name: 20230710\_183145784  
Description: Decayed wood framing  
and discontinuous deck  
framing  
Comments:

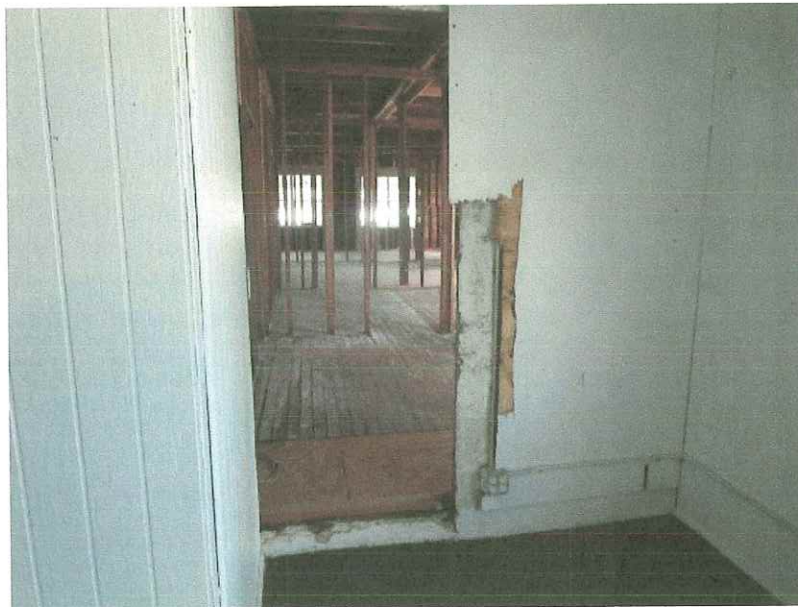
Photo No. 039  
Date Taken: 07/10/2023  
File Name: IMG\_8025  
Description: Threshold at rear  
expansion

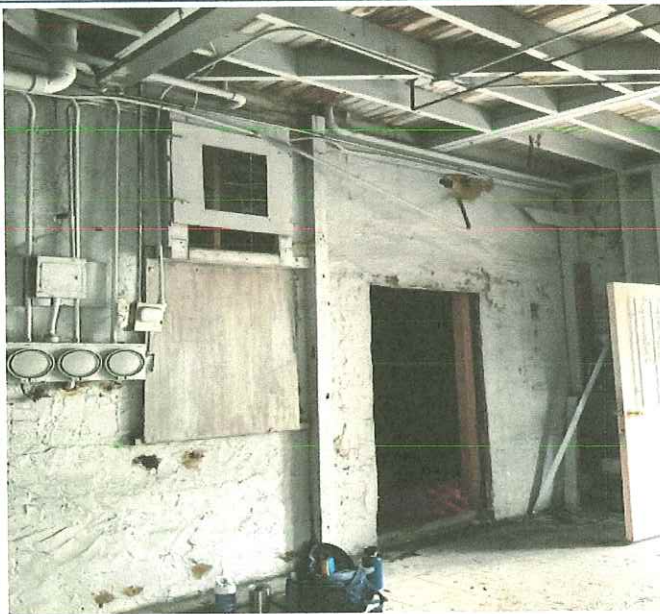
Broken top of bearing wall, joist not supported  
PHOTO NO. 20230710\_180056949

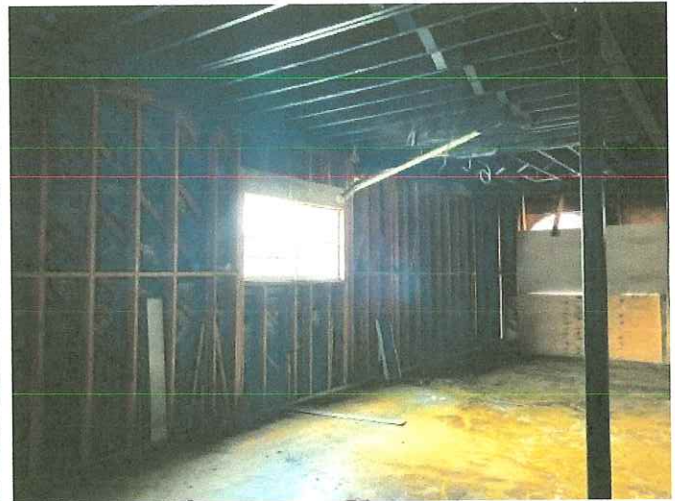
Original back wall, water damage, unfastened stucco finished  
PHOTO NO. 20230710\_180139050

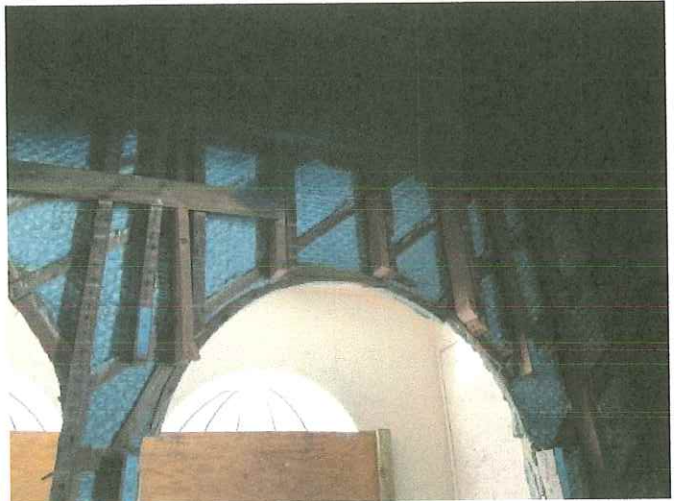
Spalled stucco finish  
PHOTO NO. 20230710\_181632154
