STRUCTURAL ASSESSMENT

230606-FL

918 Park Avenue

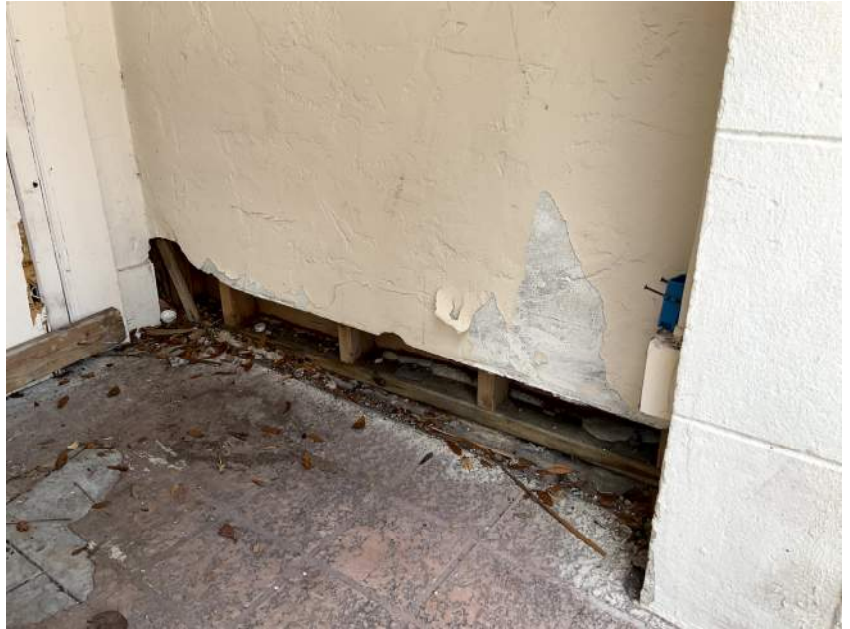
Photo No. 007
Date Taken: 07/10/2023
File Name: 20230710_173938121
Description: Front entrance vestibule with spalled stucco and exposed framing

Comments: Spalled stucco finish allows for water and pest infiltration into the building.

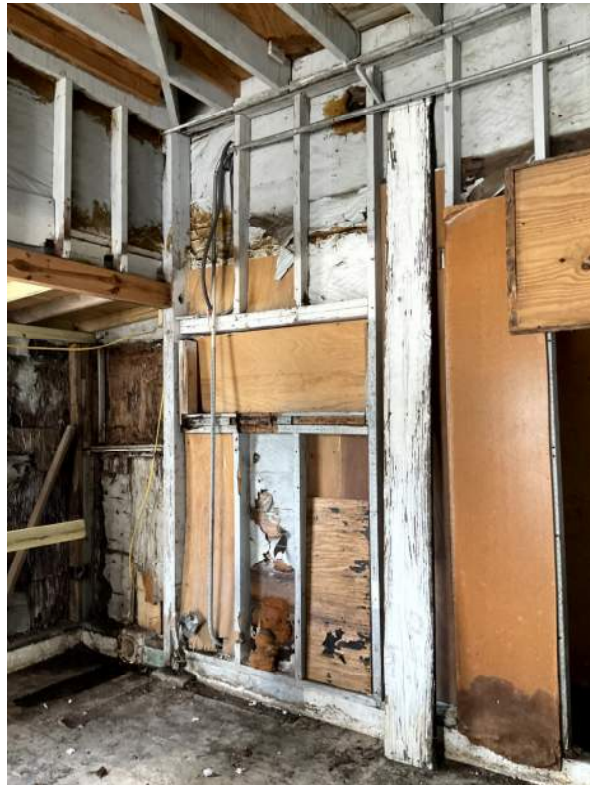
Significant mold and water damage is present at the rear/South area of the building (see photos 019 and 020). This area of the structure seems to be an addition to the original building. The structural framing elements are substantially rotted and damaged; they are viewed as unsafe and will require complete demolition and replacement.

Photo No. 020
Date Taken: 07/10/2023
File Name: 20230710_175943565
Description: Interior of rear expansion framing

Comments: Extensive water damage and mold

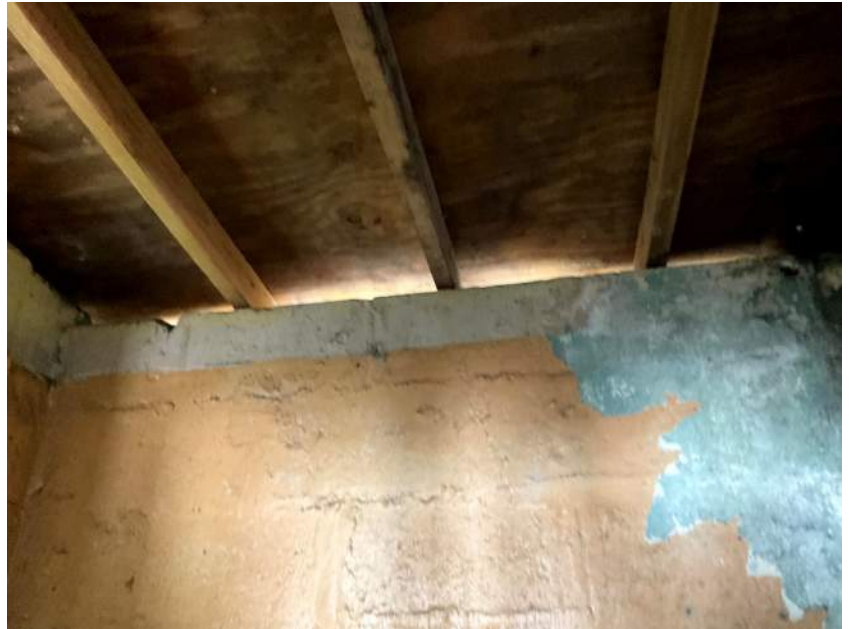
Photo No. 023
Date Taken: 07/10/2023
File Name: 20230710_180047399
Description: Interior of rear expansion –
Un-blocked roof framing
over masonry wall

Comments: An unblocked gap allows
for water and pest
infiltration into the building.
There is not lateral load
transfer from the roof
framing onto the wall.

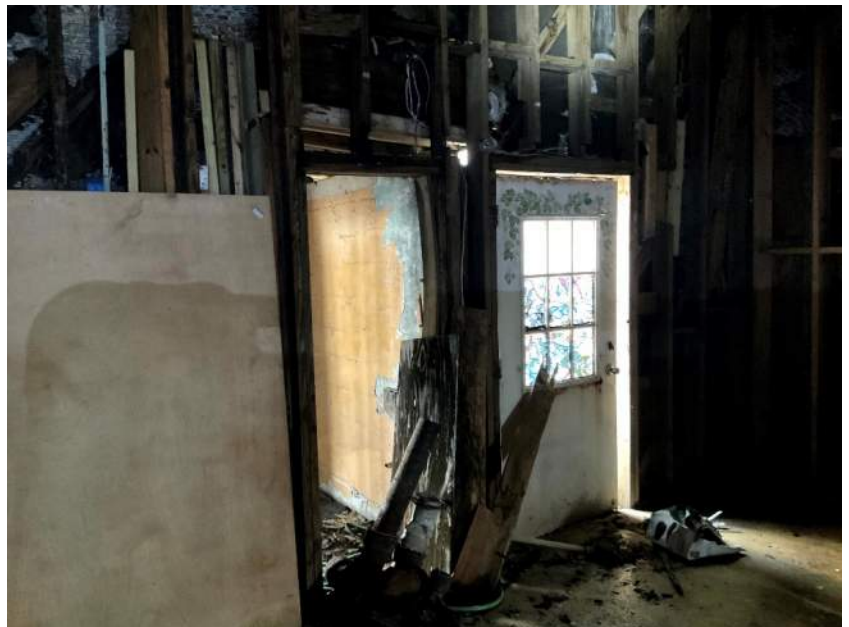
Photo No. 024
Date Taken: 07/10/2023
File Name: 20230710_180212710
Description: Southwest corner of
building – Gapped door
frame, unsheathed walls,
missing door headers,
water damage, debris

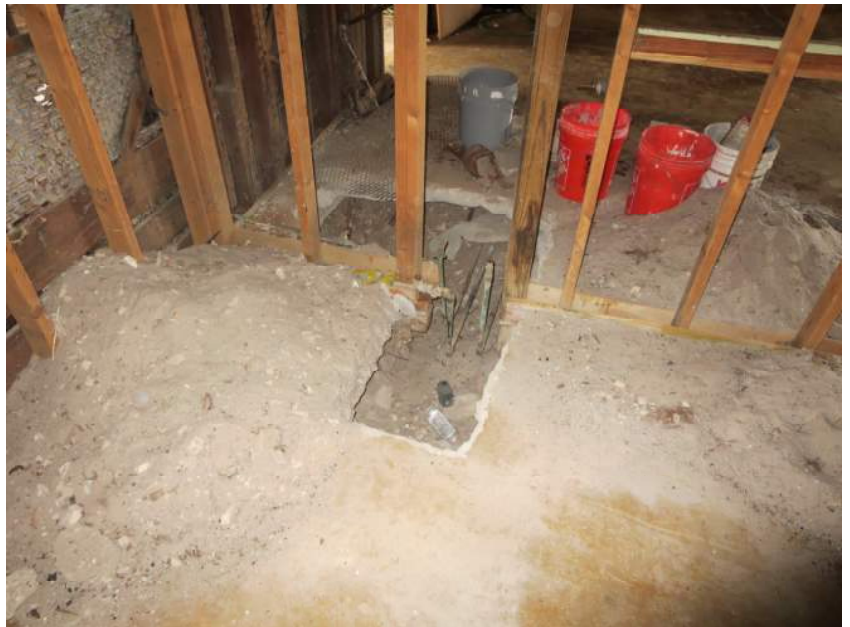
Partial slab demolition was noted towards the back of the interior space. The partial slab demo seems to be for utility repair reasons. The concrete slab will need to be properly repaired.

Photo No. 026
Date Taken: 07/10/2023
File Name: IMG_7970
Description: Slab demolition at rear of building

Comments: Exposed utilities should be capped. Sill plate for interior shear wall should not be cut

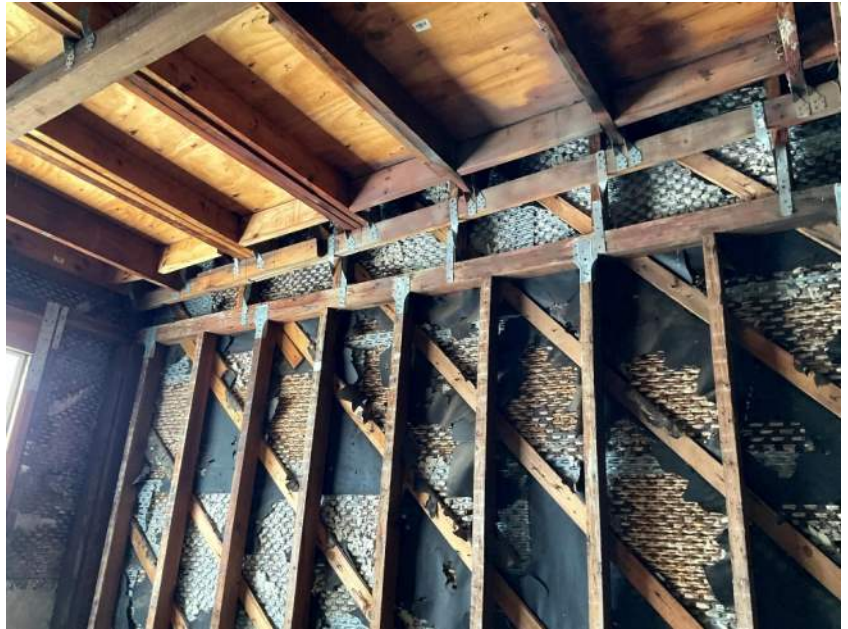
Photo No. 033
Date Taken: 07/10/2023
File Name: 20230710_183444030
Description: Northeast corner of building

Comments: Diagonal board sheathing spaced, exposed stucco lath, unconventional framing at top of wall to be analyzed

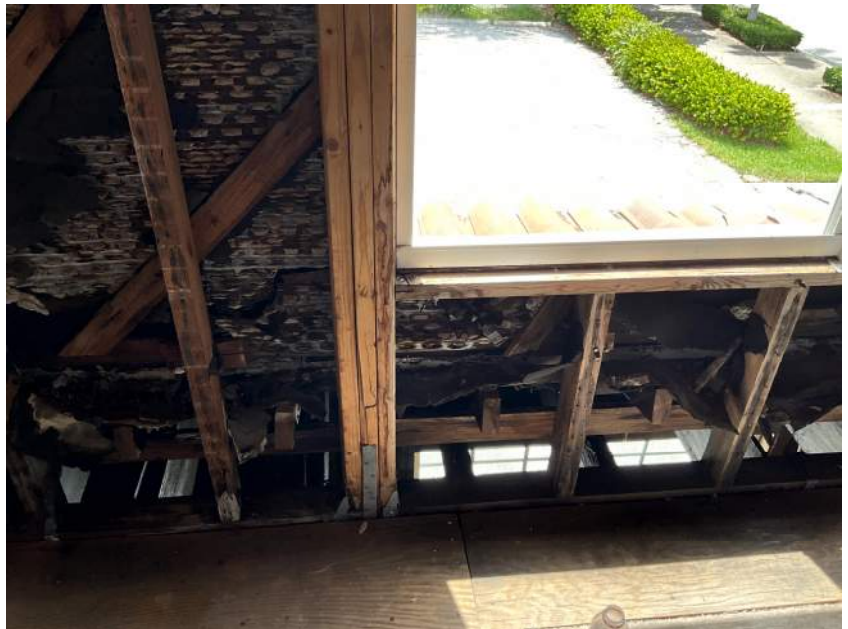
The second-floor deck diaphragm was observed to have different types of materials and changes in span direction, without proper fastening to allow for lateral load transfer (see photos 034 and 035). At the back portion of the building the floor was covered with a green rug. The floor deflected a lot as one walked on it, indicating probable water damage due or deficient deck/joist spans. In this area mold was very noticeable on the walls, and bathroom shower.

Photo No. 034
Date Taken: 07/10/2023
File Name: 20230710_183718585
Description: Window vertical framing at West side of building

Comments: Roof and 2nd floor wall framing bearing over unblocked floor joists

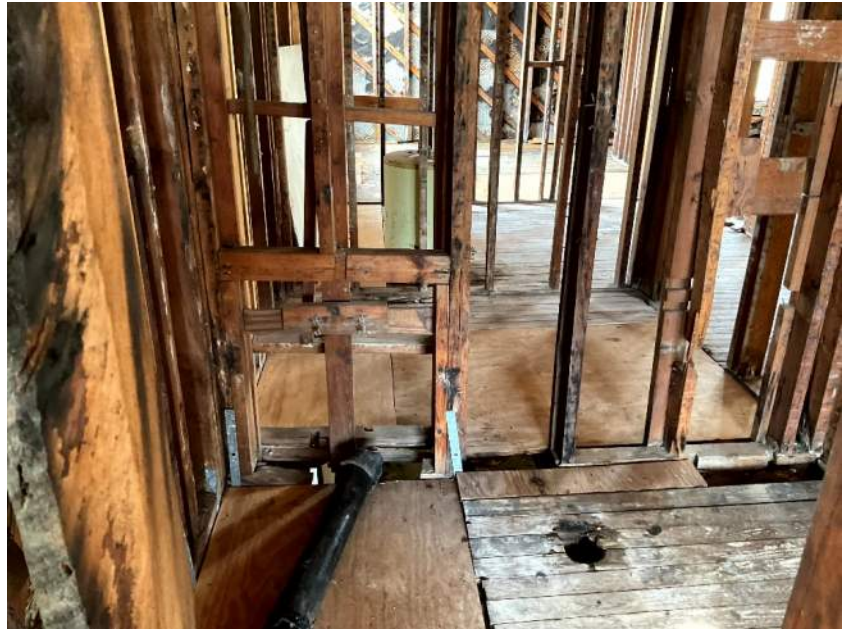
Photo No. 035
Date Taken: 07/10/2023
File Name: 20230710_183145784
Description: Decayed wood framing and discontinuous deck framing
Comments:

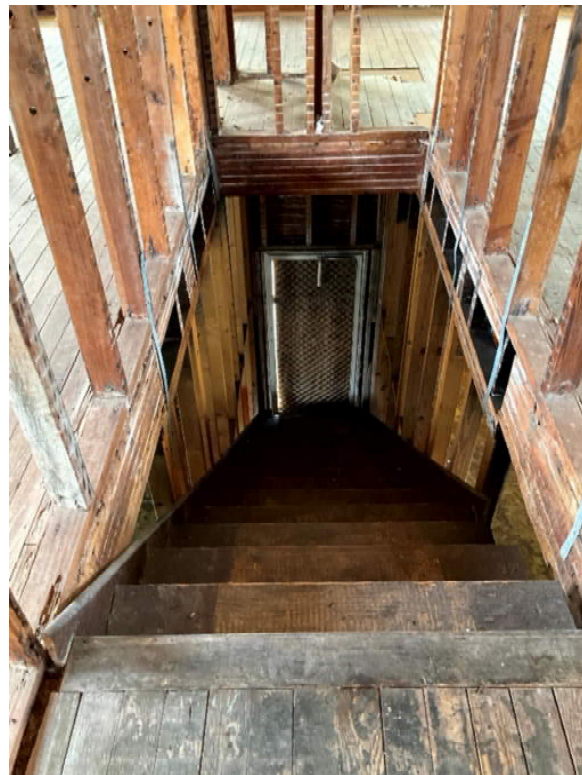
The bottom of the interior stair is immediately adjacent to the exterior door, and does not provide the necessary landing space as required by the FBC and the American with Disabilities Act (ADA). The stairs are not properly supported and fastened at the top bearing condition to meet the minimum requirements of the FBC. These conditions would require code analysis to determine if redesigning the stairs would be deemed necessary.

Photo No. 036
Date Taken: 07/10/2023
File Name: 20230710_184057412
Description: Interior stair – Bottom door is immediately adjacent to bottom step
Comments:

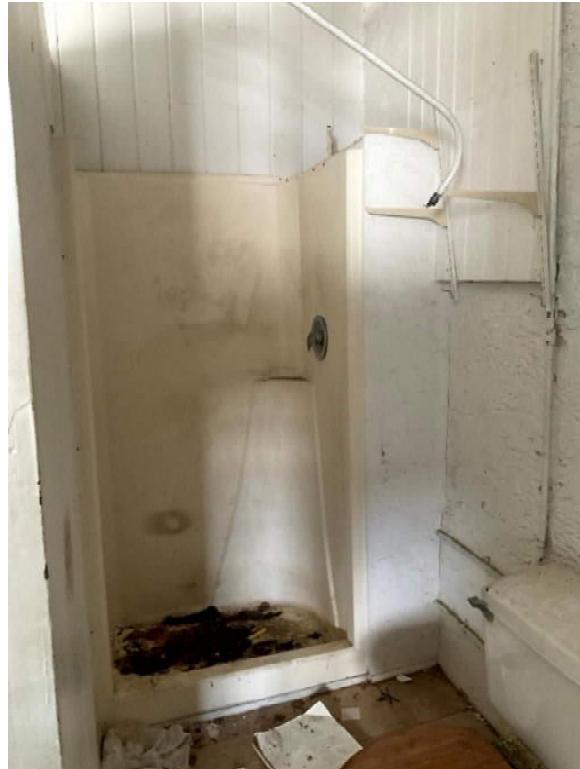
Photo No. 037
Date Taken: 07/10/2023
File Name: 20230710_183316911
Description: Rear expansion – Mold at shower

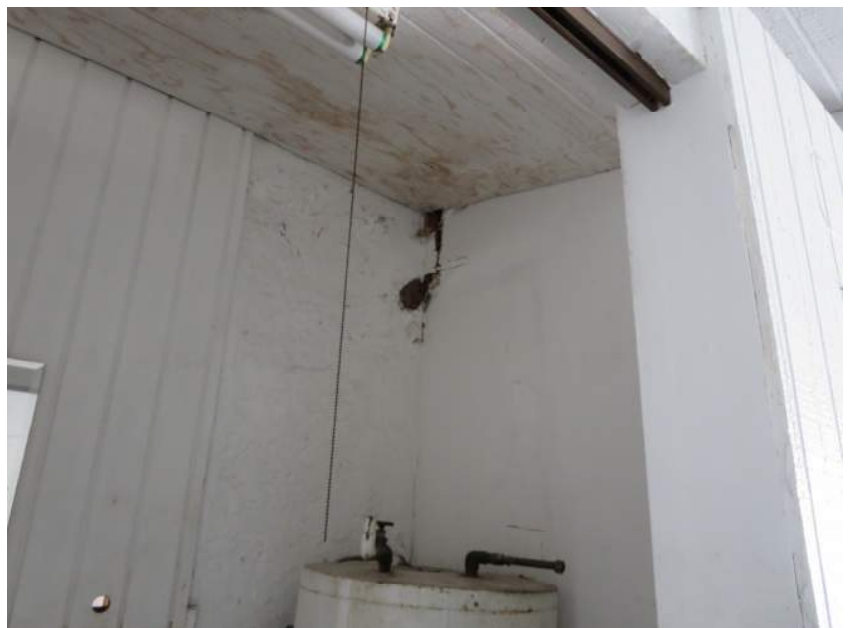
Photo No. 038
Date Taken: 07/10/2023
File Name: IMG_8018
Description: Rear expansion – Mold at wall top corner

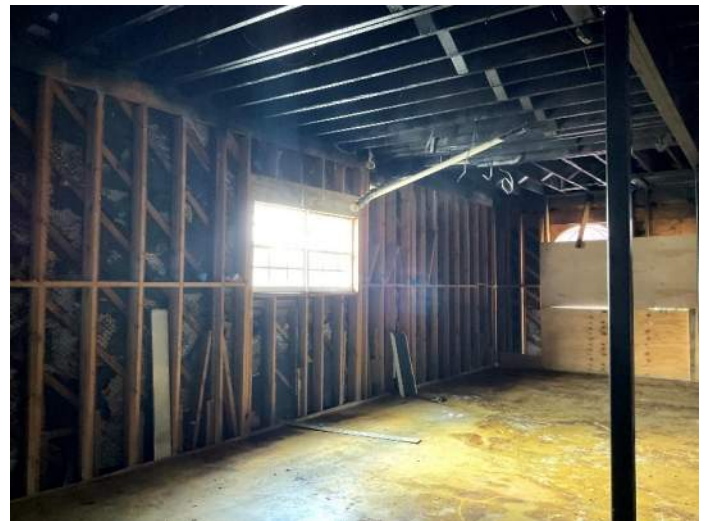
Original back wall, water damage, unfastened stucco finished
PHOTO NO. 20230710_180139050

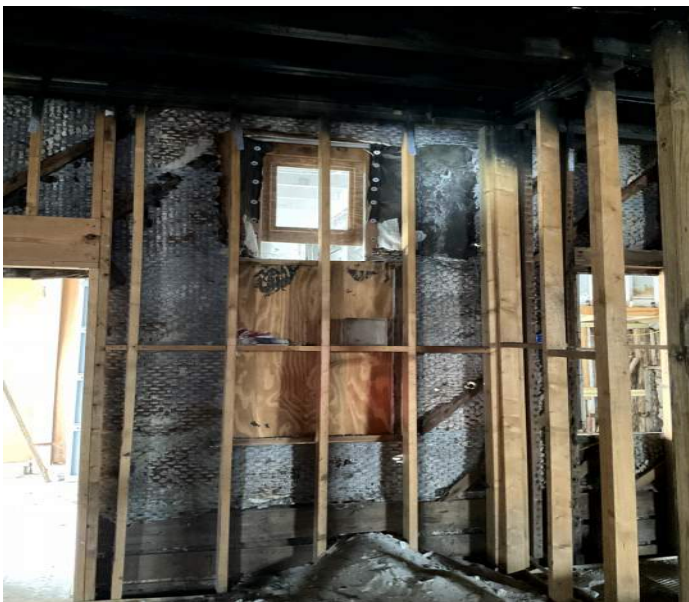
Underside of 2nd floor framing, discontinued top plate
PHOTO NO. 20230710_180448544
