# STRUCTURAL ASSESSMENT

230606-FL

918 Park Avenue

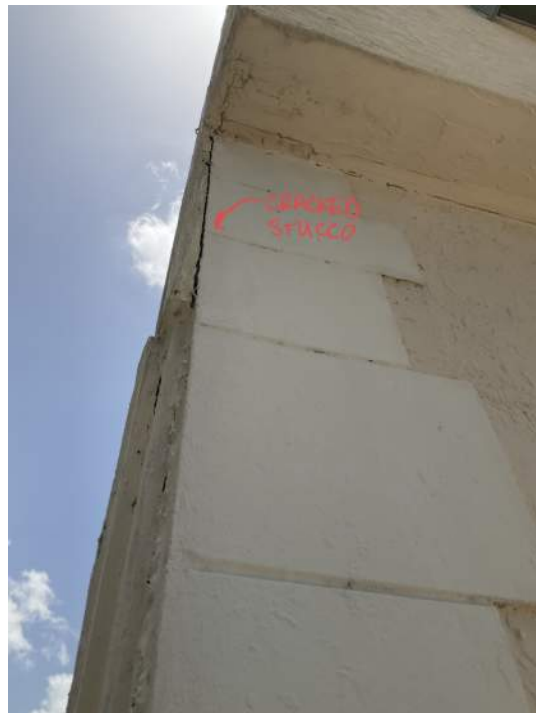
Photo No. 002  
Date Taken: 07/10/2023  
File Name: 20230710\_173333447  
Description: Cracked stucco at top of Northeast corner of building

The exterior stucco is delaminating and spalling (see photos 002 and 009), loss of bonding to the structural frame, damage from water penetration, failed lath attachments, or damage to the wood framing from termites or dry rot. Significant exterior finish damage was observed by the entrance of the building, where pieces of stucco were severely damaged and cracked, or completely missing (see photos 005, 006 and 007). A significant indentation on the West side of the building was observed on the wall (see photo 010). This may have been caused by a vehicle crashing into the wall since parking stalls are noted perpendicular to the wall. The stucco finish at this location has been improperly patched and would require repair and further assessment of the existing wall framing.

Comments: Cracked stucco allows for water infiltration, allowing for structural water damage to wood framing members

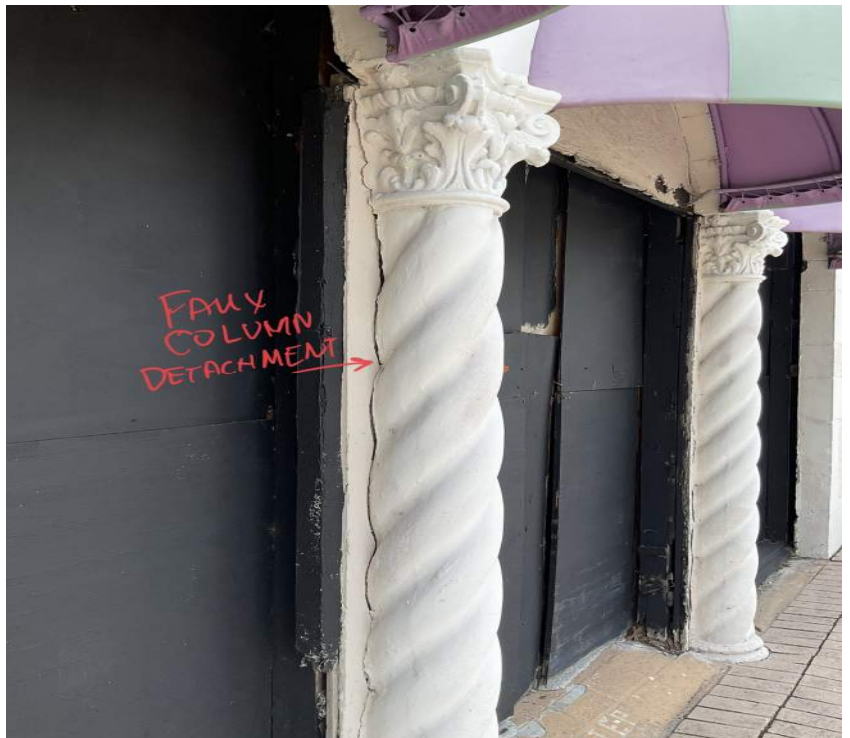
Photo No. 008  
Date Taken: 07/10/2023  
File Name: 20230710\_173954446  
Description: Detached faux column

Comments: Susceptible to falling and injuring a pedestrian.

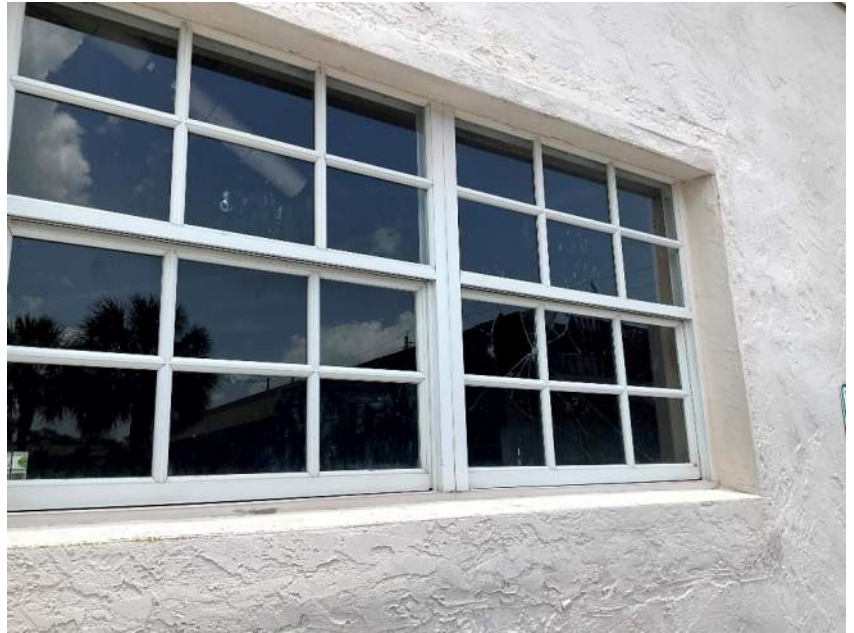
Photo No. 011  
Date Taken: 07/10/2023  
File Name: 20230710\_174515638  
Description: Broken window on West side of building

The windows seem to have been installed in recent times, but some are shattered (see photo 011) indicating that they are not impact resistant. Some exterior door frames show a large gap around the opening which allows for pest and water intrusion (see photos 013 and 024).

Comments: Broken glass window allows for water and pest infiltration into the building

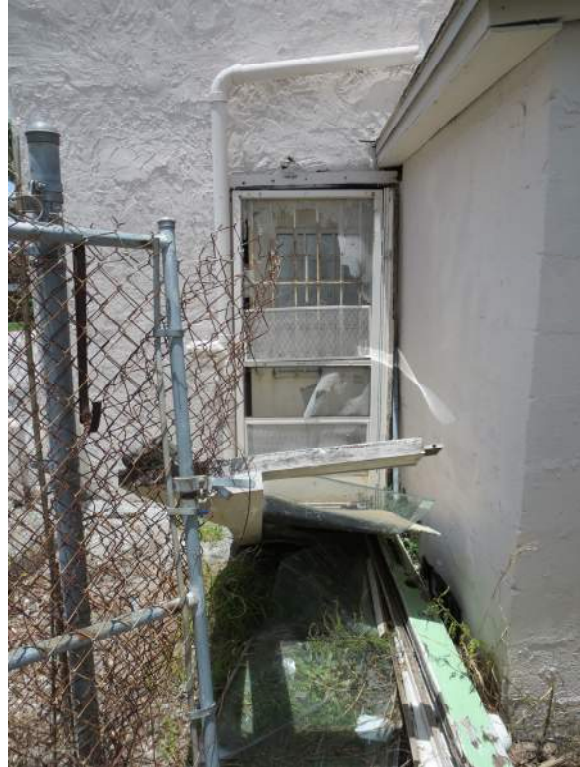
Photo No. 013  
Date Taken: 07/10/2023  
File Name: IMG\_7937  
Description: Broken screen door and exposed door frame at Southwest corner of building

Comments: Dangerous debris needs to be removed

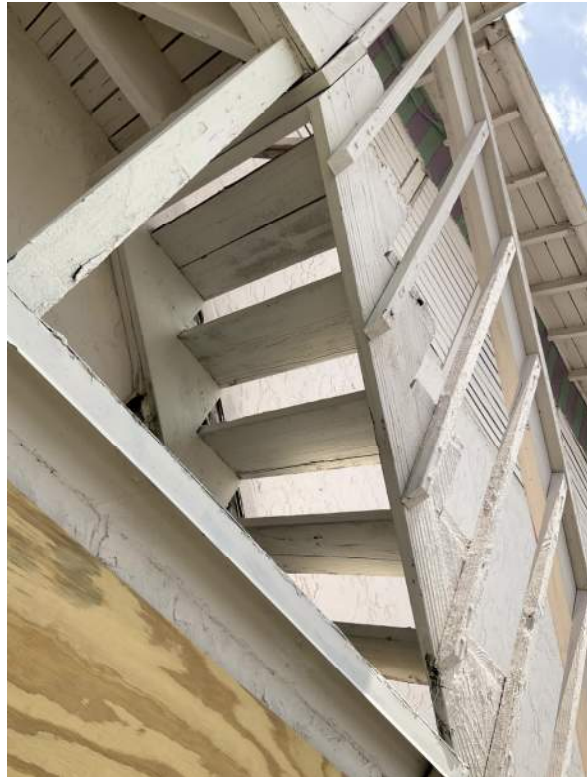
Photo No. 015  
Date Taken: 07/10/2023  
File Name: 20230710\_174932538  
Description: Underside of exterior wood-framed stairs

Comments: Toenailing of threads and stringers is not acceptable per the FBC. Railing does not meet FBC height and spacing requirements

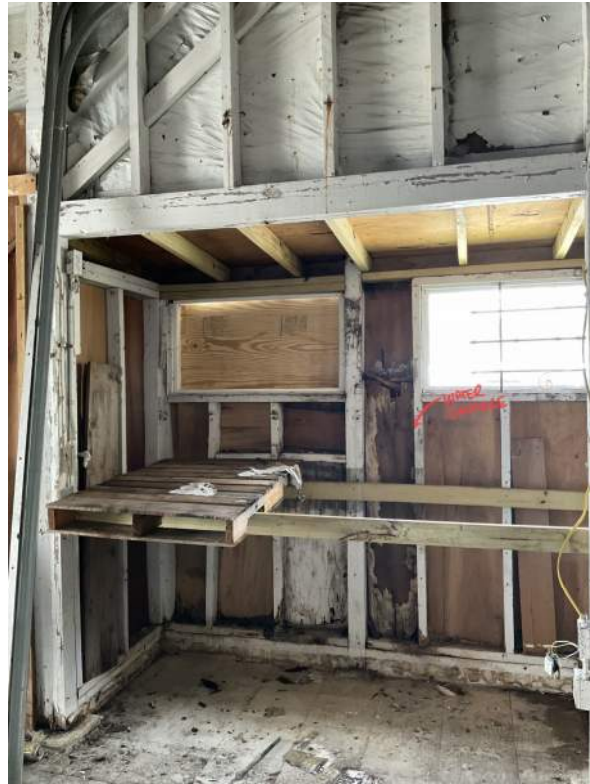
Photo No. 019  
Date Taken: 07/10/2023  
File Name: 20230710\_175620887  
Description: Interior of rear expansion framing

Significant mold and water damage is present at the rear/South area of the building (see photos 019 and 020). This area of the structure seems to be an addition to the original building. The structural framing elements are substantially rotted and damaged; they are viewed as unsafe and will require complete demolition and replacement.

Comments: Extensive water damage and mold

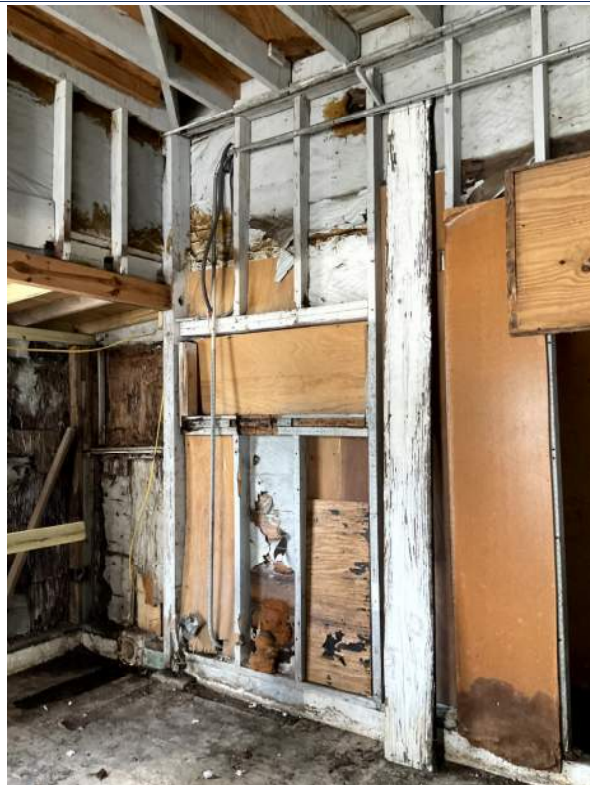
Photo No. 020  
Date Taken: 07/10/2023  
File Name: 20230710\_175943565  
Description: Interior of rear expansion framing

Comments: Extensive water damage and mold

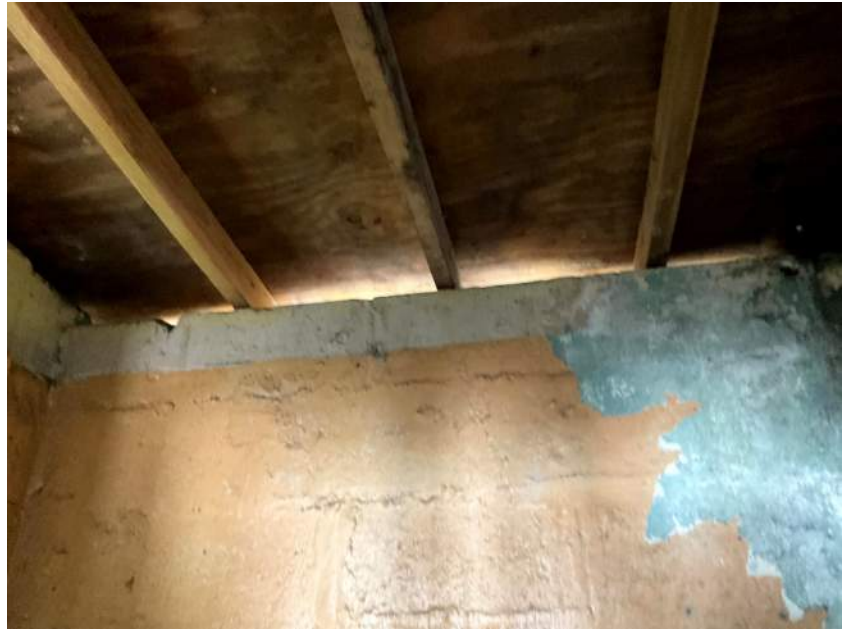
Photo No. 023  
Date Taken: 07/10/2023  
File Name: 20230710\_180047399  
Description: Interior of rear expansion –  
Un-blocked roof framing  
over masonry wall

Comments: An unblocked gap allows  
for water and pest  
infiltration into the building.  
There is not lateral load  
transfer from the roof  
framing onto the wall.

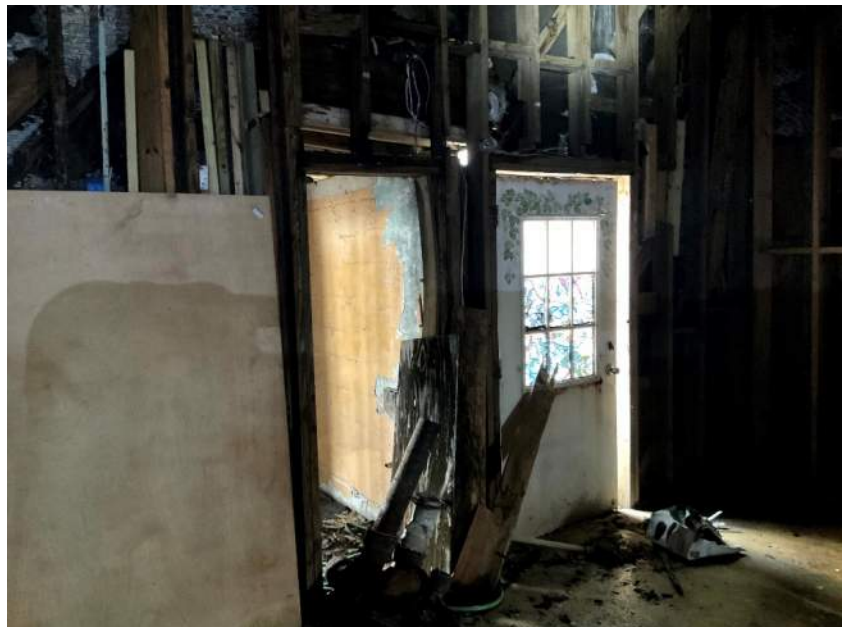
Photo No. 024  
Date Taken: 07/10/2023  
File Name: 20230710\_180212710  
Description: Southwest corner of  
building – Gapped door  
frame, unsheathed walls,  
missing door headers,  
water damage, debris

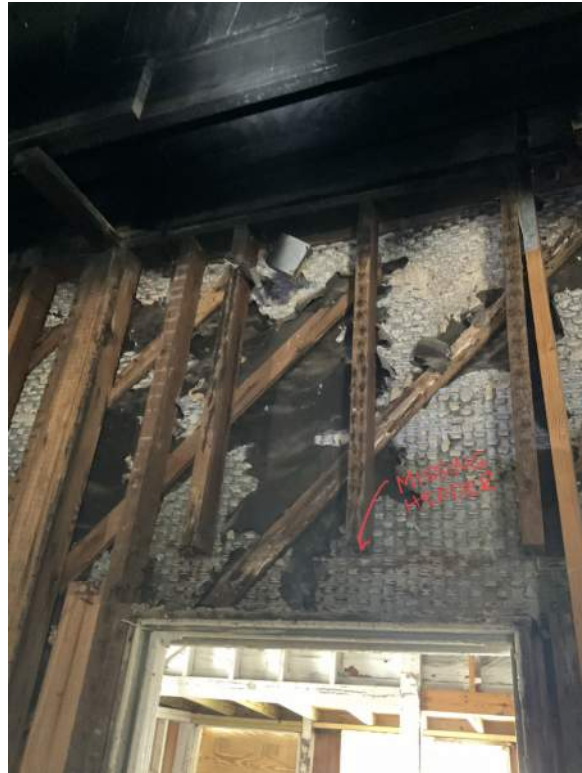
Photo No. 025  
Date Taken: 07/10/2023  
File Name: 20230710\_180559152  
Description: Original building rear wall

The front and back interior walls are missing headers above the openings (see photos 025 and 029). This condition renders the wall inadequate for proper door/window framing, gravity support, and for lateral resistance, since there is no transfer of the in-plane forces along the North and South walls.

Comments: Missing door header,  
exposed stucco lath,  
spaced diagonal exterior  
sheathing, missing interior  
wall finish

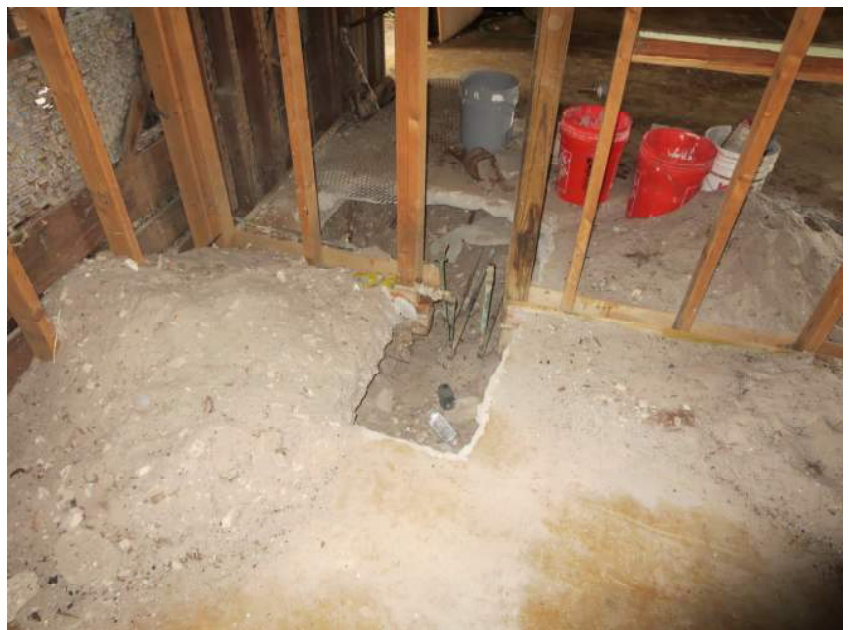
Photo No. 026  
Date Taken: 07/10/2023  
File Name: IMG\_7970  
Description: Slab demolition at rear of building

Partial slab demolition was noted towards the back of the interior space. The partial slab demo seems to be for utility repair reasons. The concrete slab will need to be properly repaired.

Comments: Exposed utilities should be capped. Sill plate for interior shear wall should not be cut

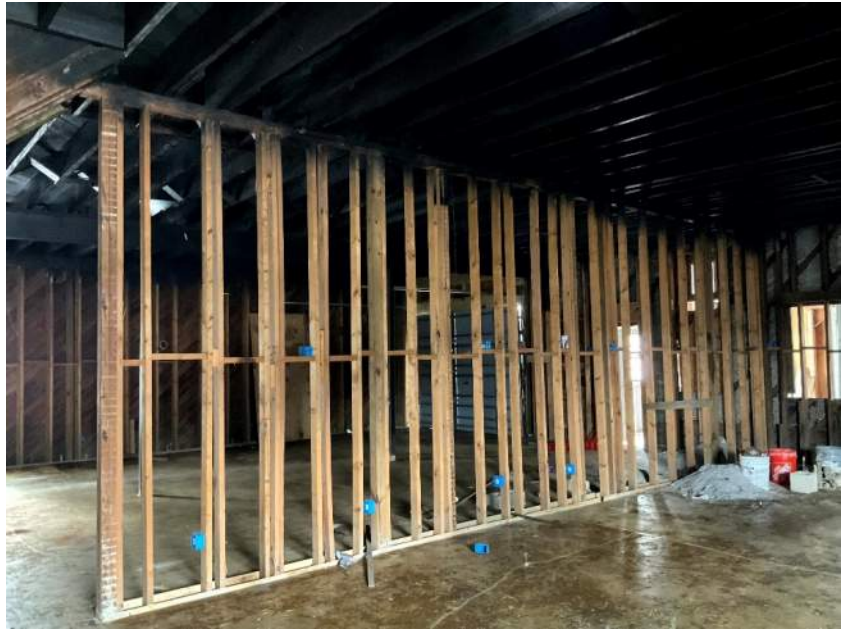
Photo No. 027  
Date Taken: 07/10/2023  
File Name: 20230710\_180253426  
Description: Interior wall framing

The interior bearing/shear wall is not sheathed, the bearing studs are completely exposed (see photo 027). In its current condition, this wall is subjected to combined bending and in-plane structural failure, since it's missing the wall sheathing, which provides lateral resistance and out-of-plane bracing. A continuously anchored bottom sill was not noticed on the interior bearing/shear wall, leaving the structure vulnerable and undermined. Also, it was observed that in some locations the bottom and top plate of the wall had been cut to allow for plumbing. Without proper splicing of the top and bottom plates the shear wall is deemed structurally inadequate.

Comments: Unsheathed bearing shear wall. Interrupted sill plate, and missing hold-downs.

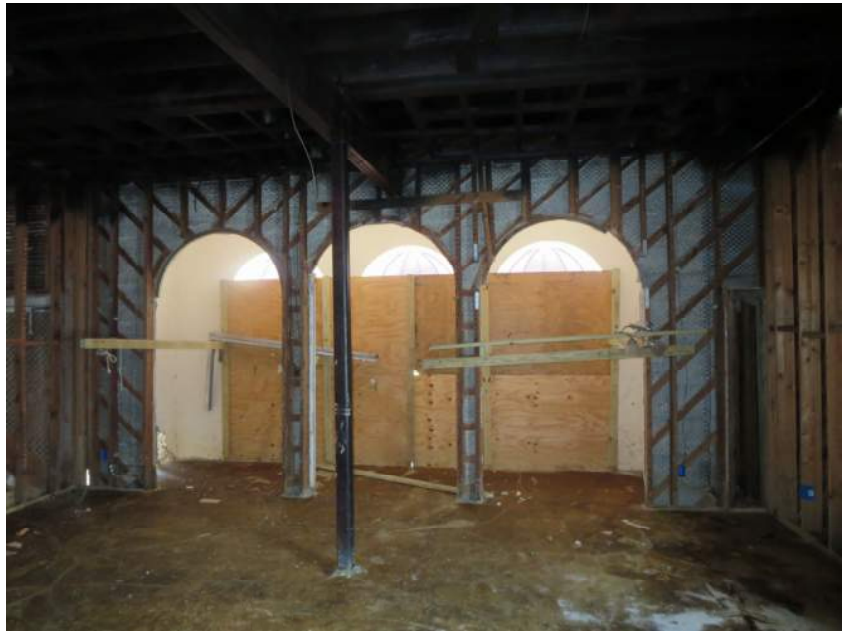
Photo No. 029  
Date Taken: 07/10/2023  
File Name: IMG\_7974  
Description: Interior front wall at  
Northeast side of building

Comments: Missing sheathing, missing  
headers over arched  
openings

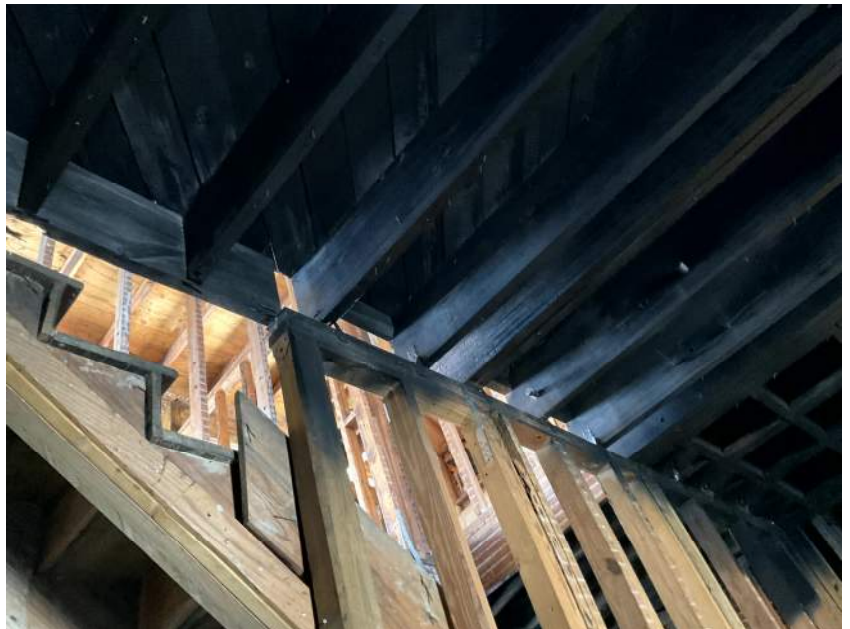
Photo No. 030  
Date Taken: 07/10/2023  
File Name: 20230710\_181856779  
Description: Floor girder by top of stairs

The interior stair does not seem to comply with today's FBC and ADA requirements/standards. The stringers top bearing end is be notched more than  $\frac{1}{4}$  the depth of the stringer, which is not permitted by the NDS. The wall adjacent to the stair is a bearing wall, supporting the floor joists (see photo 030). It was observed that the wall ends near the top 3<sup>rd</sup> of the staircase, and two of the floor joists are supported by a 2x8 girder, which is supported on top of the bearing wall by less than 1 inch. This bearing condition of the girder seems insufficient and would require further investigation to validate if it allows for the proper transfer of lateral forces distributed by the floor diaphragm. A small lateral force applied to the building may cause the girder to move and lose its bearing, prompting a collapse of the floor joists. It is imperative that this condition is repaired as soon as possible, since a tropical storm or hurricane can apply enough lateral force to the building that could potentially cause this failure.

Comments: Bearing of girder is less  
than 1 inch.

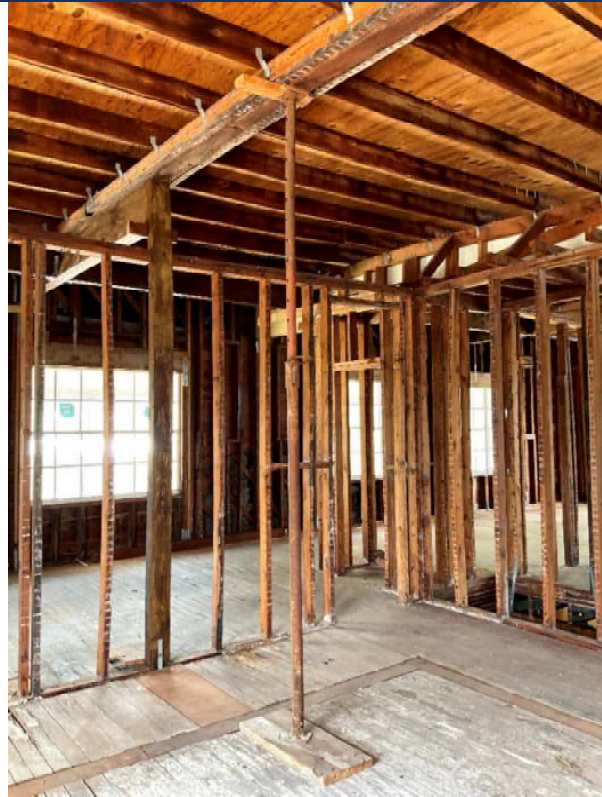
Photo No. 031  
Date Taken: 07/10/2023  
File Name: 20230710\_183906548  
Description: Roof framing temporarily shored

Near the Northwest corner of the roof framing, a temporary steel-shoring-column has been placed to support a joist bearing line (see photo 031). It is presumed that the joists were bearing over a wall, that since then has been

removed and the top plate of the wall is too shallow to span the unsupported distance. Also, near this area a post installed roof girder has been added and it is improperly supported by a 2x ledge nailed to the face of a timber column (see photo 032). In general, the roof framing does not present a proper load path to transfer the roof diaphragm forces down to the shear walls (see photo 033).

Comments: Near the Northwest corner of the 2nd floor a shallow roof girder is temporarily shored

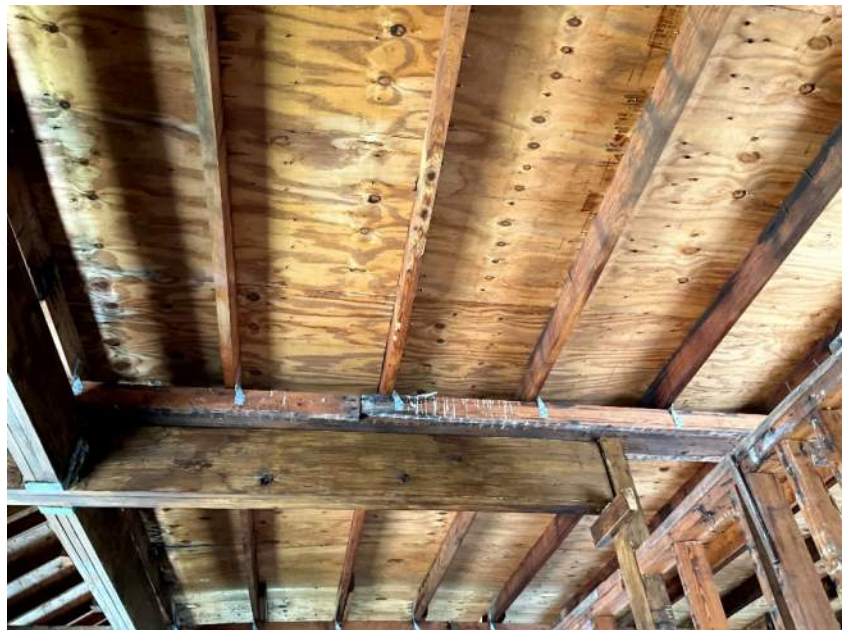
Photo No. 032  
Date Taken: 07/10/2023  
File Name: 20230710\_182541168  
Description: Roof framing girder bearing over nailed stub

Comments: Framing of girder is unconventional and needs to be analyzed. Water stains on roof deck sheathing.

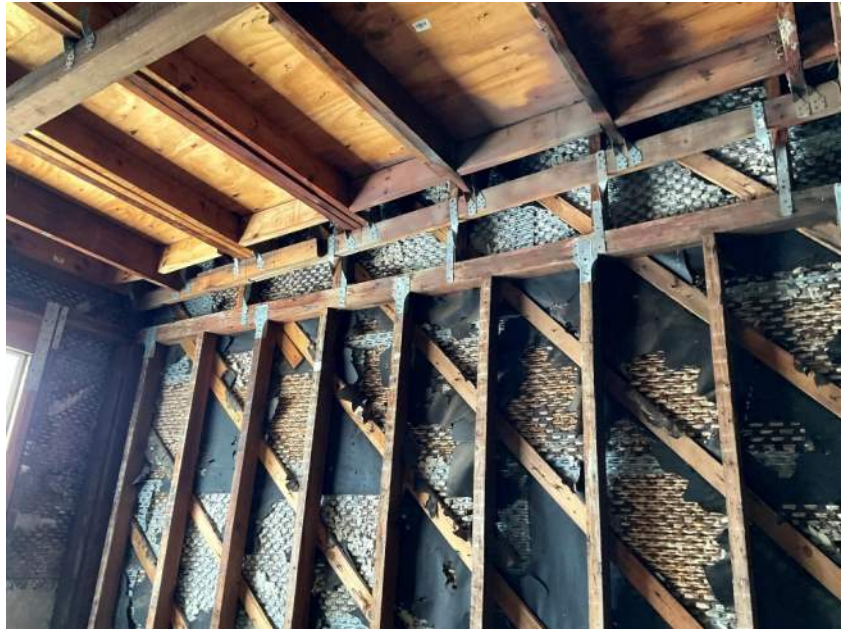
Photo No. 033  
Date Taken: 07/10/2023  
File Name: 20230710\_183444030  
Description: Northeast corner of building

Comments: Diagonal board sheathing spaced, exposed stucco lath, unconventional framing at top of wall to be analyzed

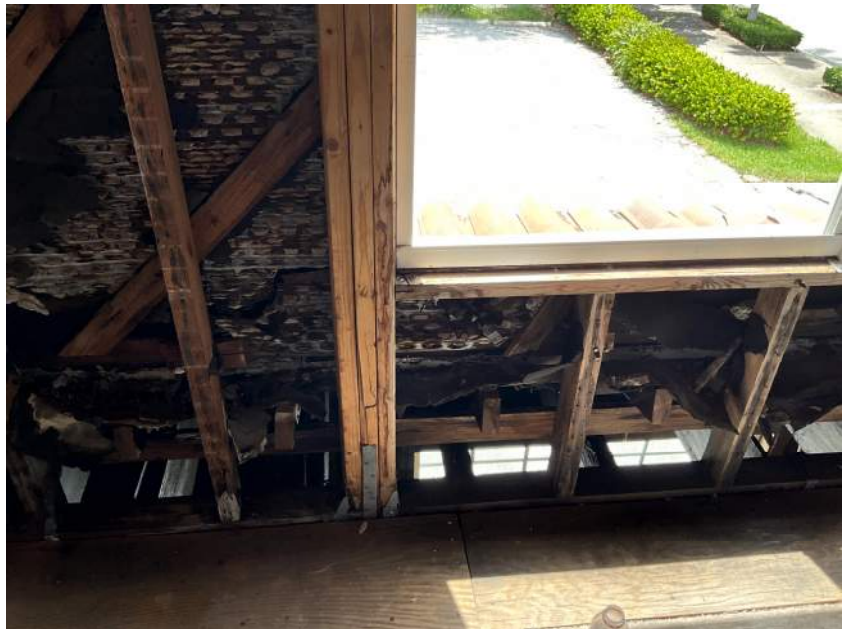
Photo No. 034  
Date Taken: 07/10/2023  
File Name: 20230710\_183718585  
Description: Window vertical framing at West side of building

The second-floor deck diaphragm was observed to have different types of materials and changes in span direction, without proper fastening to allow for lateral load transfer (see photos 034 and 035). At the back portion of the building the floor was covered with a green rug. The floor deflected a lot as one walked on it, indicating probable water damage due or deficient deck/joist spans. In this area mold was very noticeable on the walls, and bathroom shower.

Comments: Roof and 2<sup>nd</sup> floor wall framing bearing over unblocked floor joists

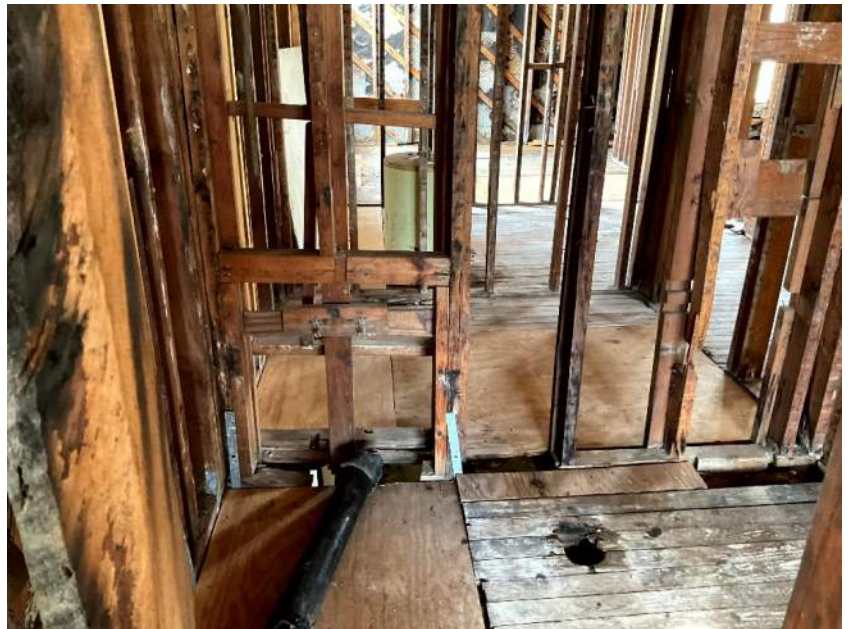
Photo No. 035  
Date Taken: 07/10/2023  
File Name: 20230710\_183145784  
Description: Decayed wood framing and discontinuous deck framing  
Comments:

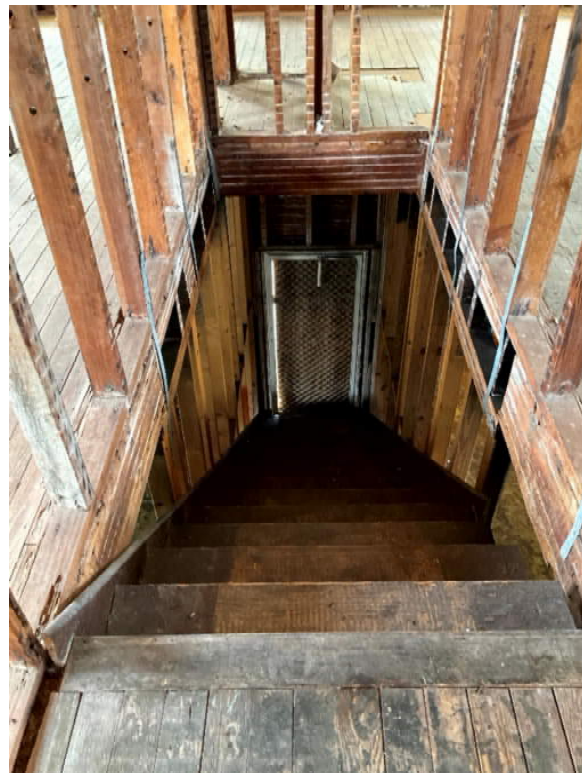
The bottom of the interior stair is immediately adjacent to the exterior door, and does not provide the necessary landing space as required by the FBC and the American with Disabilities Act (ADA). The stairs are not properly supported and fastened at the top bearing condition to meet the minimum requirements of the FBC. These conditions would require code analysis to determine if redesigning the stairs would be deemed necessary.

Photo No. 036  
Date Taken: 07/10/2023  
File Name: 20230710\_184057412  
Description: Interior stair – Bottom door is immediately adjacent to bottom step  
Comments:

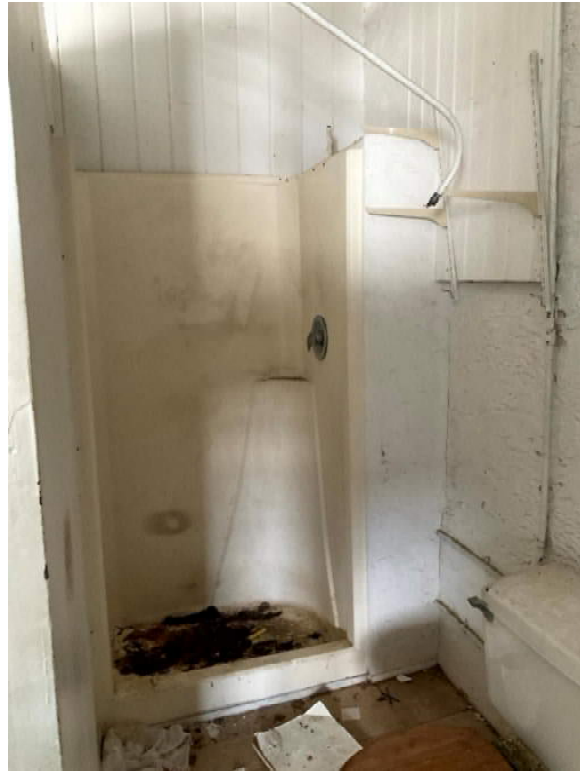
Photo No. 037  
Date Taken: 07/10/2023  
File Name: 20230710\_183316911  
Description: Rear expansion – Mold at shower

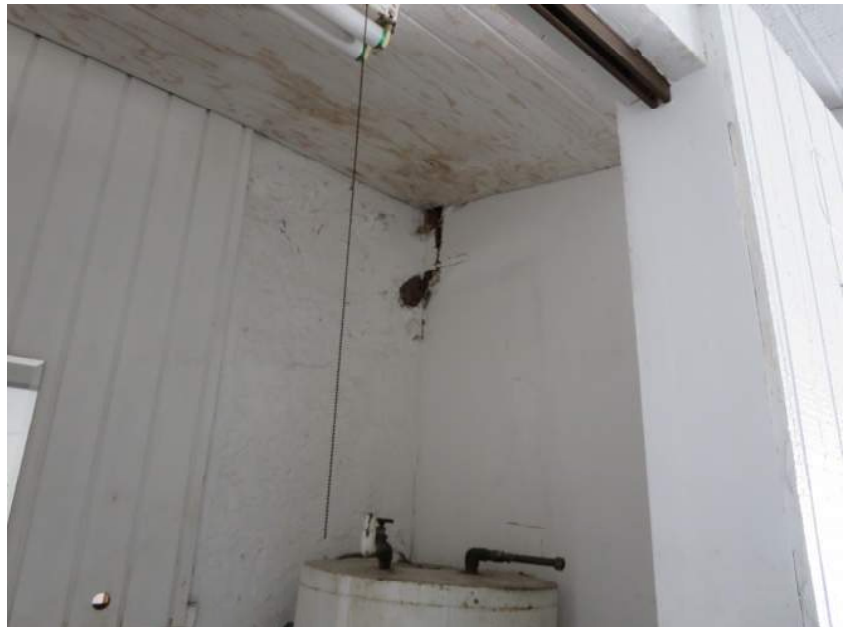
Photo No. 038  
Date Taken: 07/10/2023  
File Name: IMG\_8018  
Description: Rear expansion – Mold at wall top corner

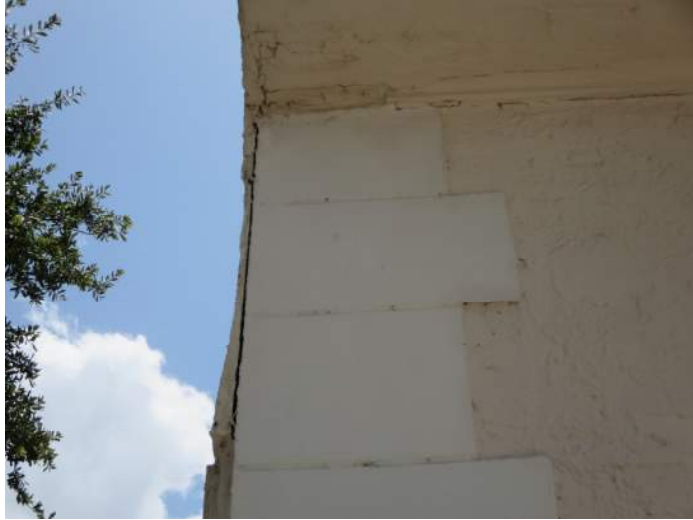
Finish separation  
PHOTO NO. IMG\_7919

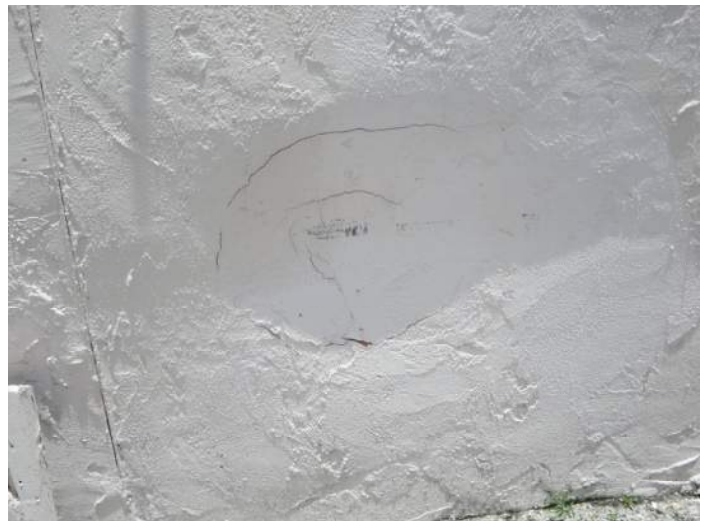
Stucco finish indentation  
PHOTO NO. IMG\_7931

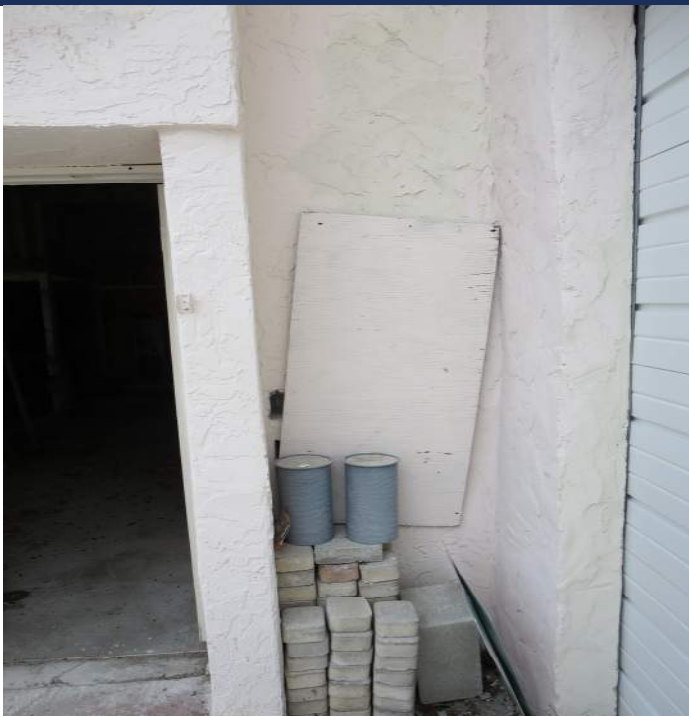
Unfastened board at wall opening  
PHOTO NO. IMG\_7946

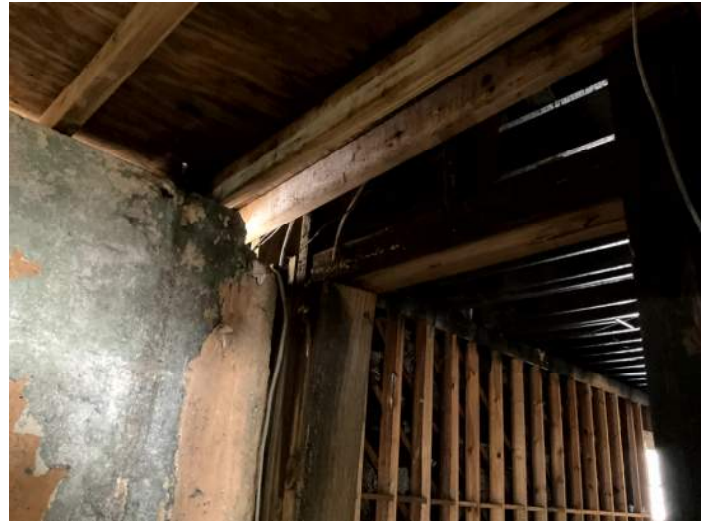
Broken top of bearing wall, joist not supported  
PHOTO NO. 20230710\_180056949

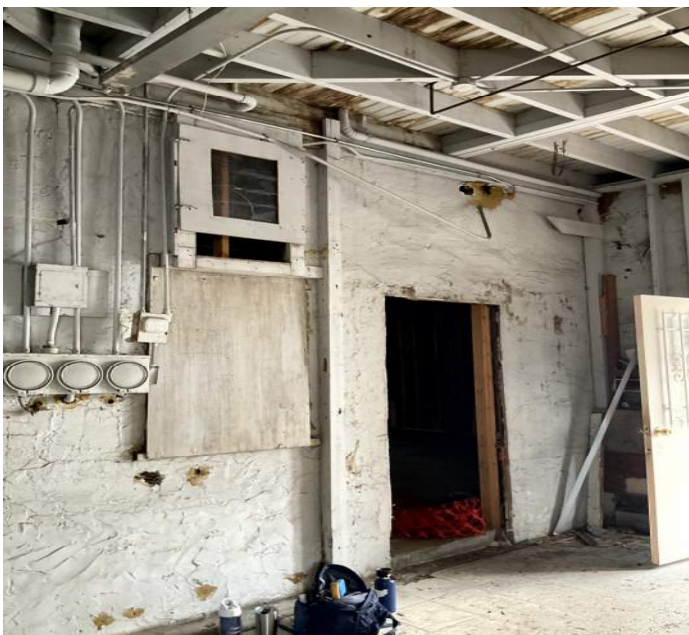
Original back wall, water damage, unfastened stucco finished  
PHOTO NO. 20230710\_180139050

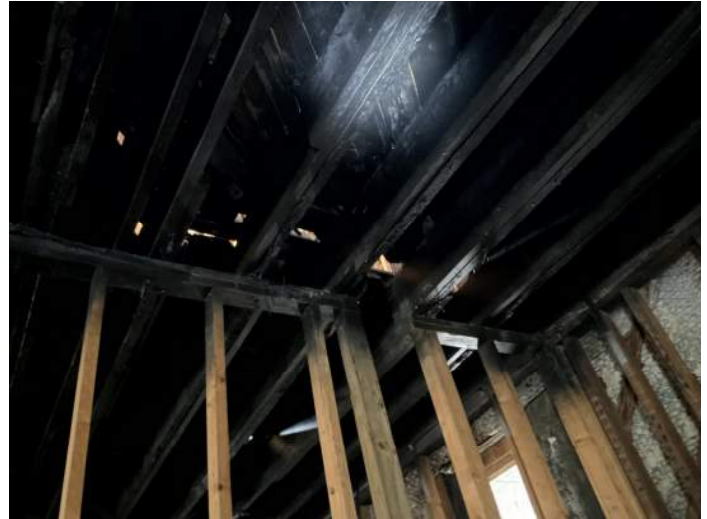
Underside of 2<sup>nd</sup> floor framing, discontinued top plate  
PHOTO NO. 20230710\_180448544

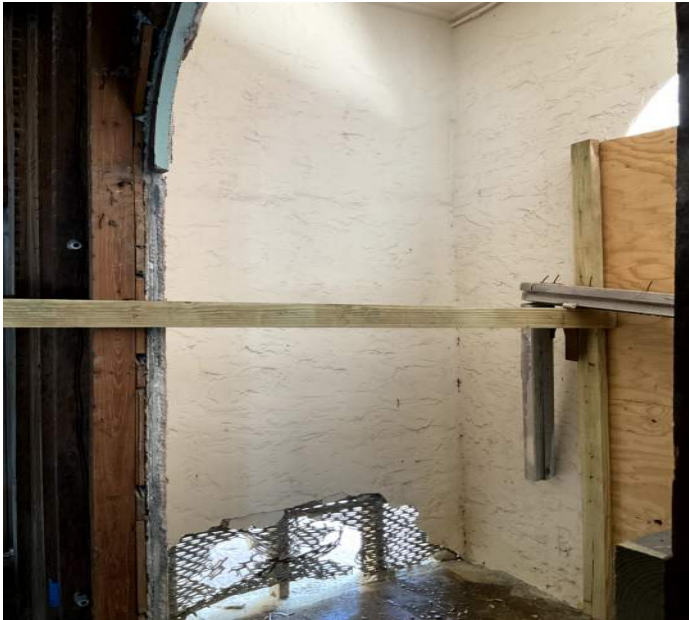
Spalled stucco finish  
PHOTO NO. 20230710\_181632154

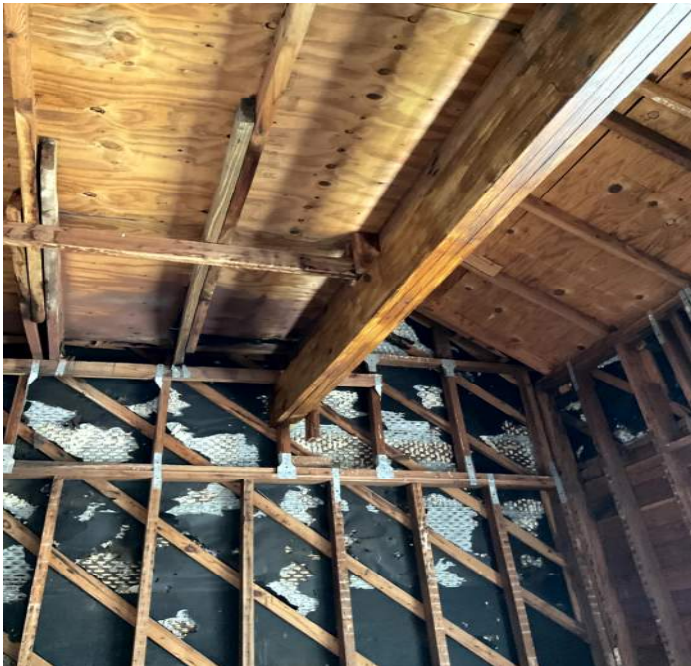
Unconventional top of wall framing  
PHOTO NO. 20230710\_182333863

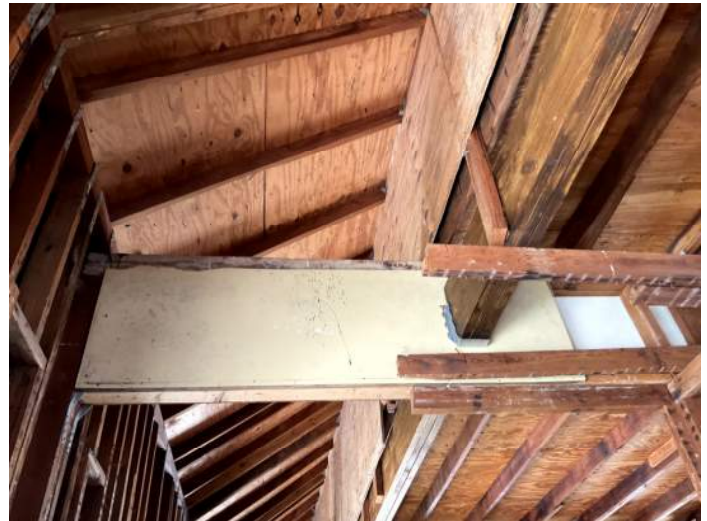
Unconventional roof framing by the North wall  
PHOTO NO. 20230710\_182644649

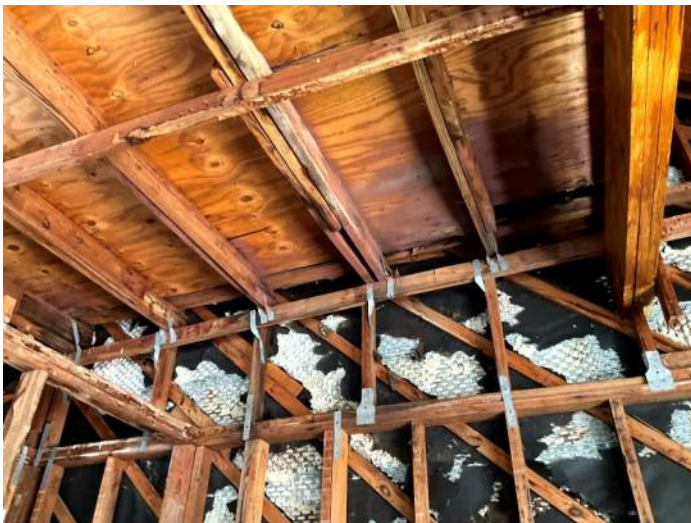
Spliced roof joist framing at bearing ends  
PHOTO NO. 20230710\_182352450

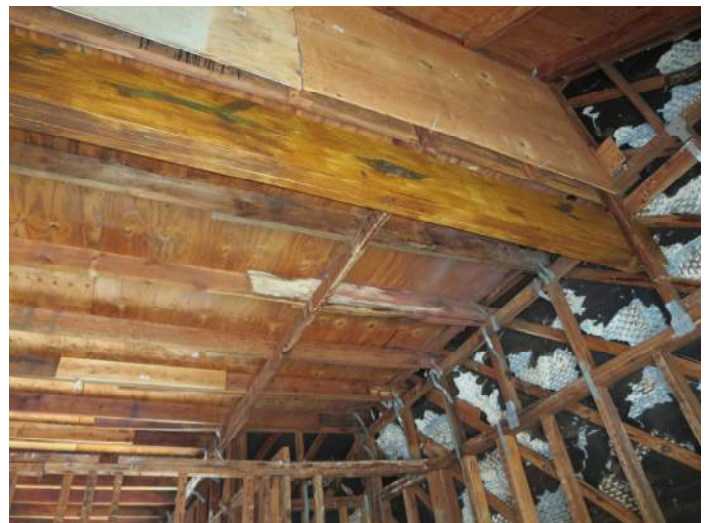
Unconventional roof framing  
PHOTO NO. IMG\_7993

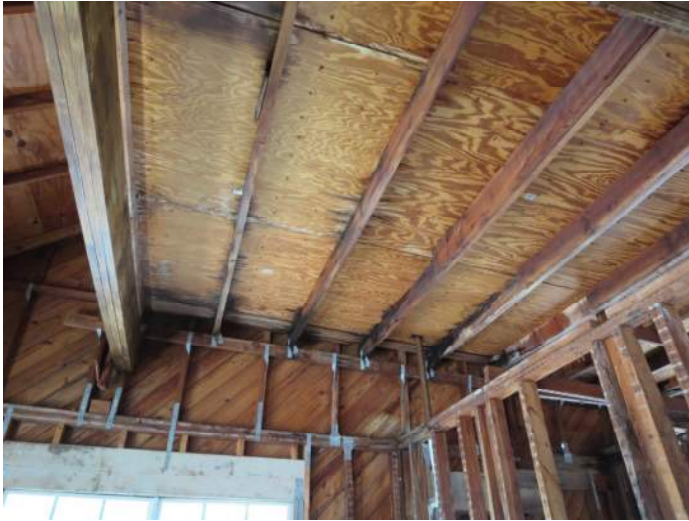
Roof framing and water stains at roof deck sheathing  
PHOTO NO. IMG\_7999

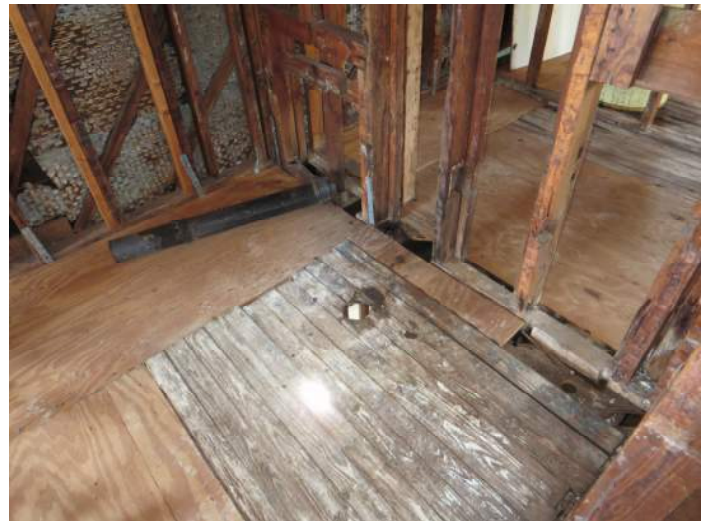
Discontinuous floor deck sheathing  
PHOTO NO. IMG\_8011
