# PAVEMENT MANAGEMENT FINAL PROJECT REPORT

**LAKE PARK, FL**

**Monday, June 20, 2022**

**Pavement Management Group**

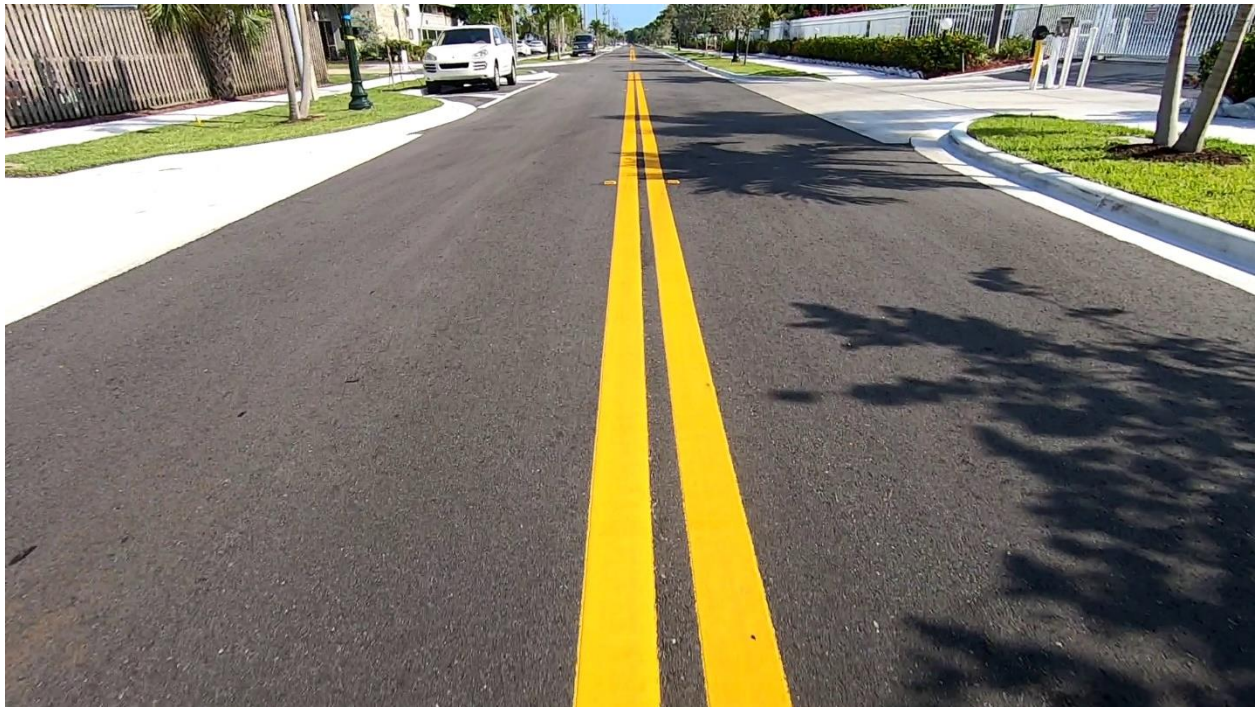
#### EXCELLENT CONDITION

LAKE SHORE DR | SECTION 03 | PCI 100

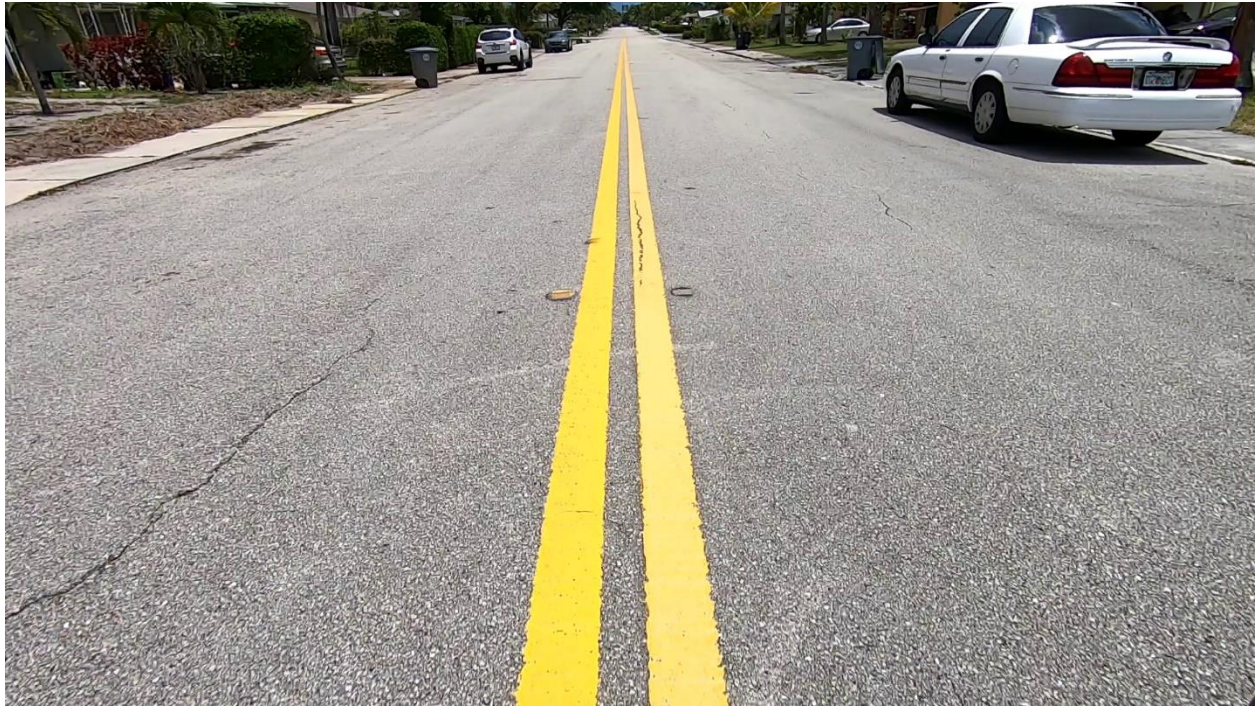
VERY GOOD CONDITION

FORRESTERIA DR | SECTION 04 | PCI 88

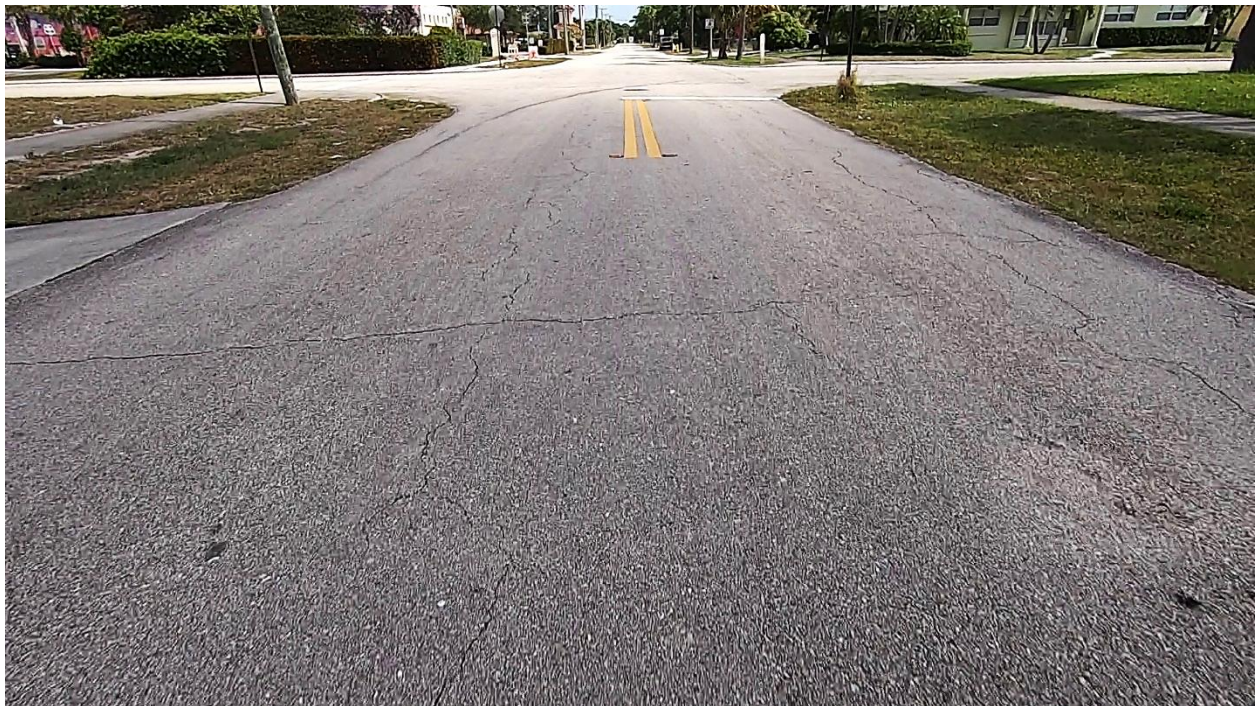
GOOD CONDITION

POPLAR DR | SECTION 01 | PCI 78

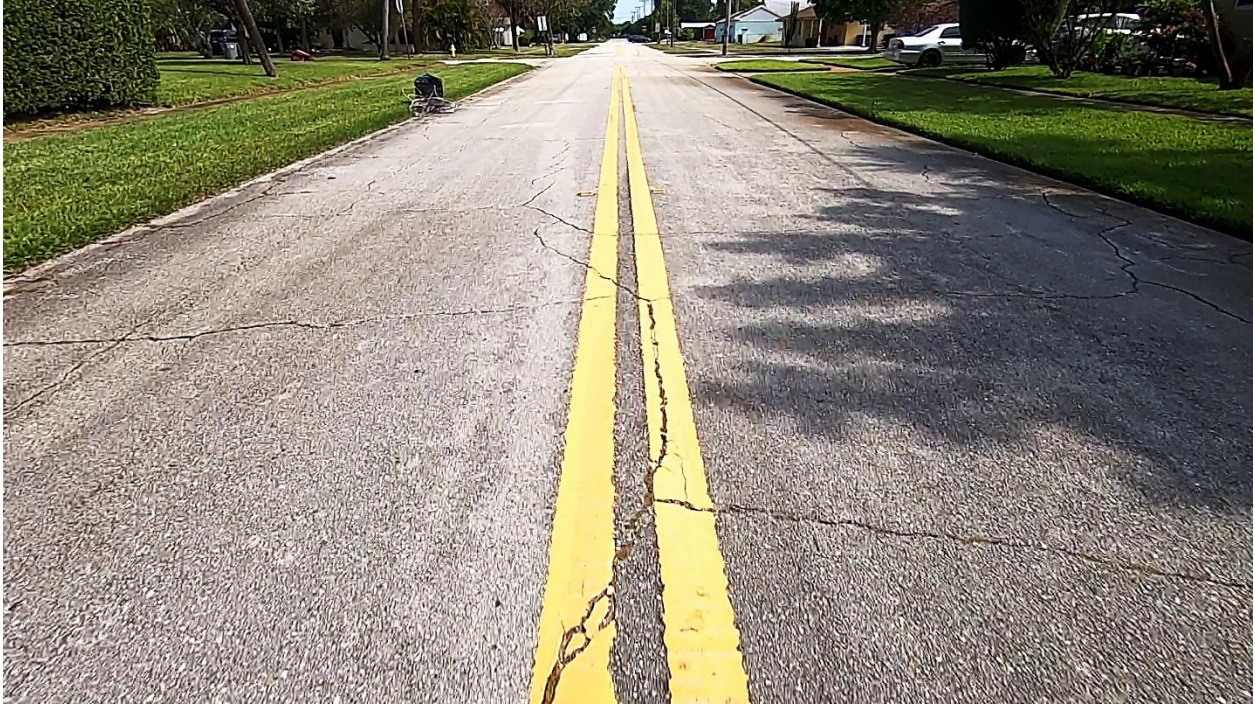
FAIR CONDITION

4<sup>TH</sup> ST | SECTION 04 | PCI 58

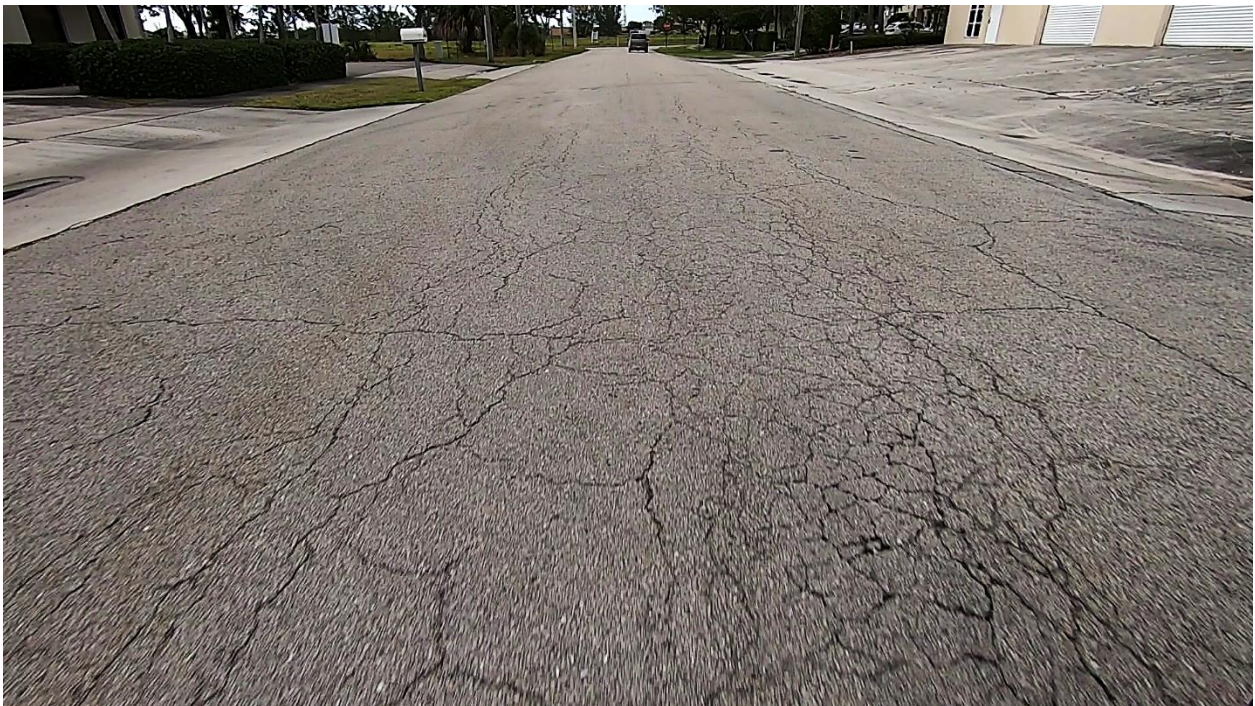
POOR CONDITION

13<sup>TH</sup> ST | SECTION 02 | PCI 49

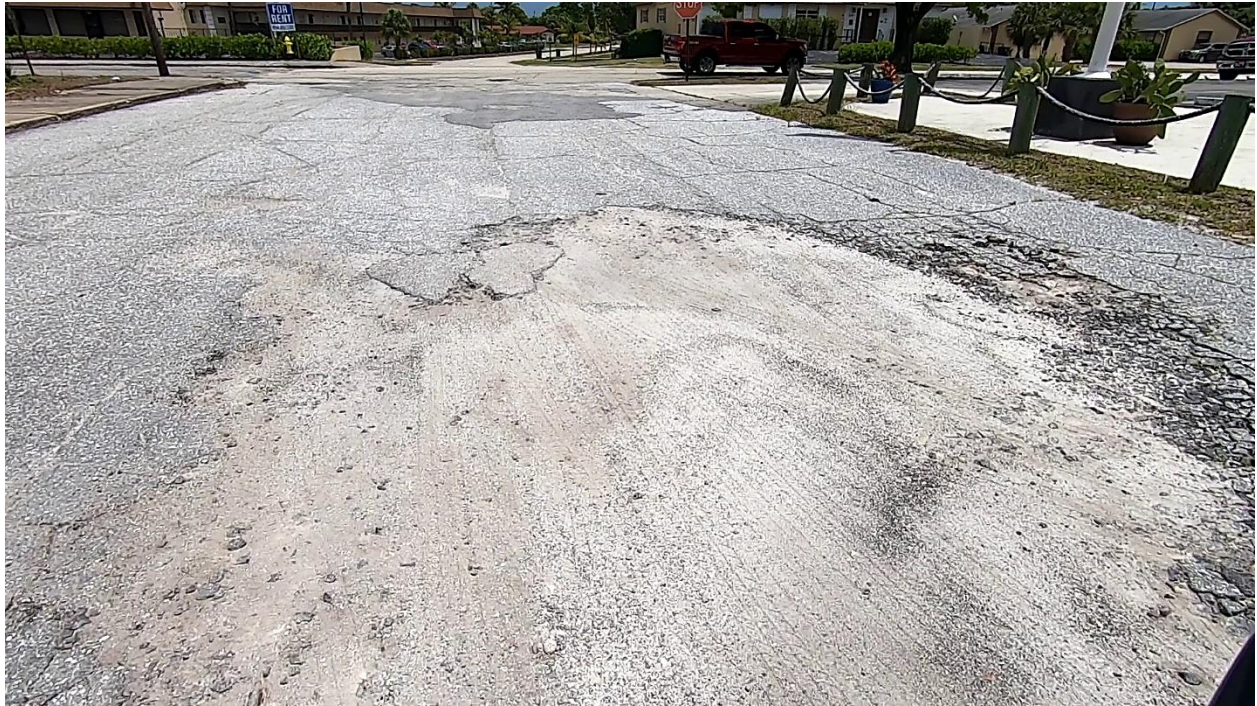
VERY POOR CONDITION

EVERGREEN DR | SECTION 01 | PCI 29
