ARBORICULTURAL ASSESSMENT

# Relocation Feasibility Assessment

**Tree 105 - Banyan Tree** (*Ficus benghalensis*) — 98-inch DBH

**Site:** Pinnacle on 6th - Lake Worth Beach, Florida

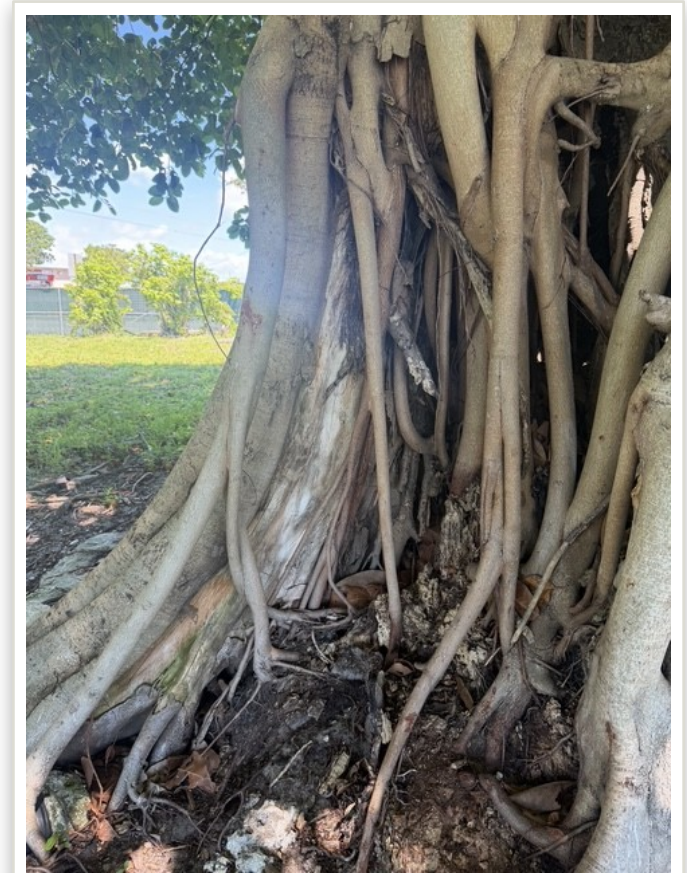
- Open basal cavities and advanced internal decay, with a hollowing central column visible through the stem.
- Degraded, fibrous wood and sloughing bark consistent with active wood decay.
- Decay is not confined to the base — exposed decayed wood is present at major trunk unions well above grade.
- Woundwood is limited and has not occluded existing wounds, indicating decay is likely to continue to progress.

**Fig. 1** Subject tree — buttressed base and fused aerial-root complex, with decayed wood visible within the stem column.

The tree is not a suitable candidate for relocation.

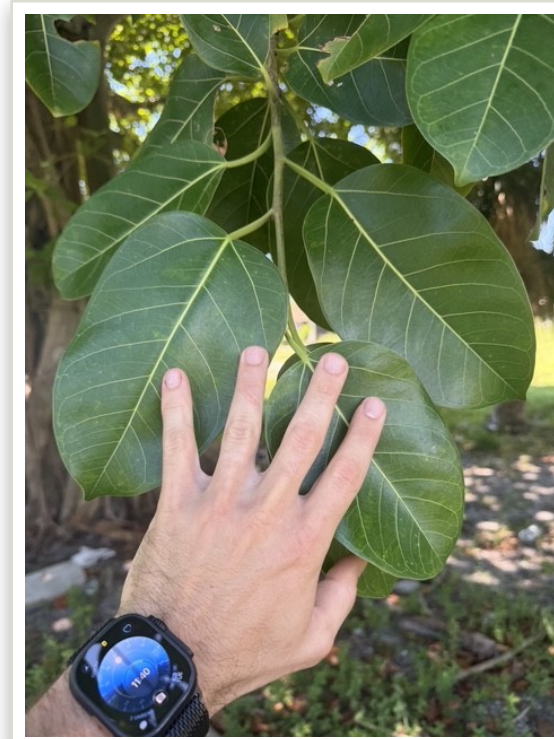
Species confirmed as *Ficus benghalensis* (Banyan tree) from the large, leathery, entire ovate leaves and the small, sessile, paired red-orange figs (syconia) observed in the field.

**Fig. 2** Foliage — large entire ovate leaves; hand shown for scale.

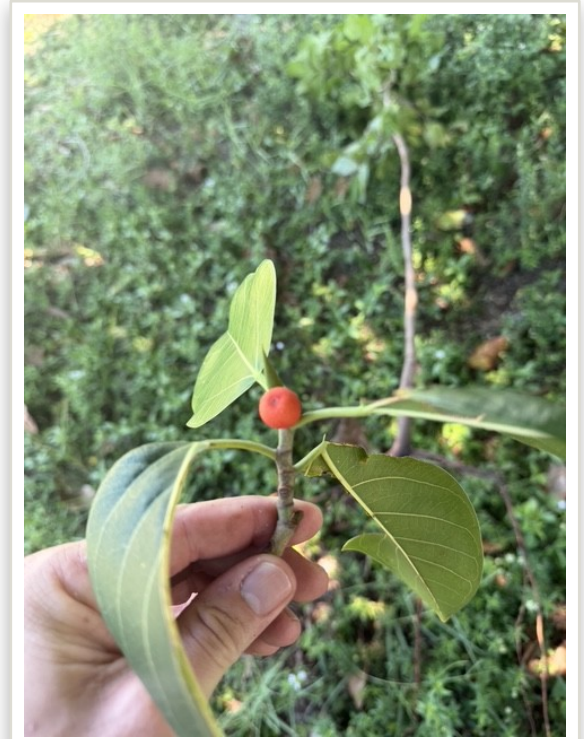
**Fig. 3** Sessile red-orange syconium (fig), diagnostic for the species.

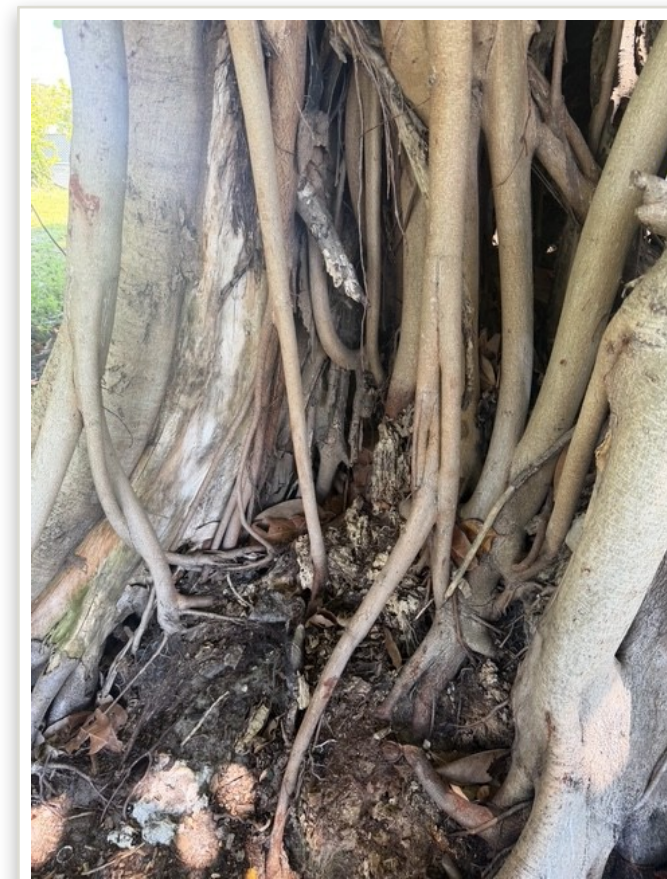
**Fig. 4** Root collar and stem base — the zone of primary structural concern.

**A Level 3 Advanced Assessment** (e.g., sonic tomography and/or resistance drilling) is required to confirm the extent of decay and residual wall thickness before any final decision.

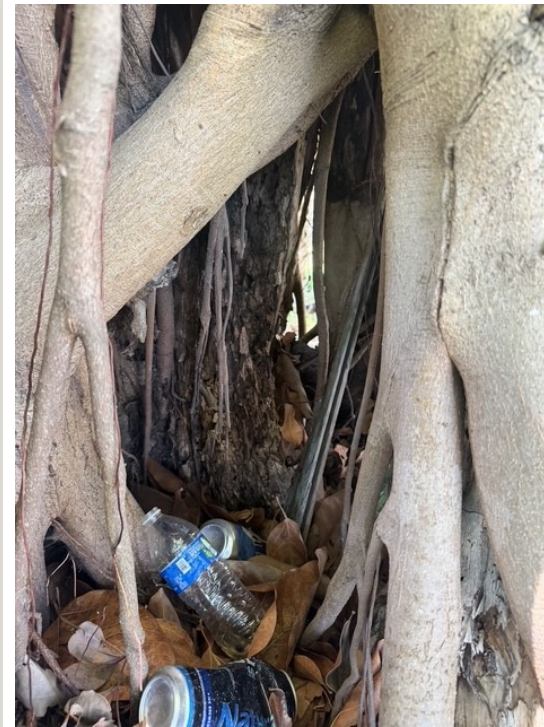
- Open cavities at the stem base.
- Exposed, discoloured wood at the buttress; loss of bark and sapwood continuity.
- Cavities within the interior of the trunk.

Basal cavitation at this scale reduces the load-bearing cross-section at the most highly stressed part of the stem and provides an established path for continued decay.

**Fig. 5** Open basal cavity collecting leaf litter and debris.

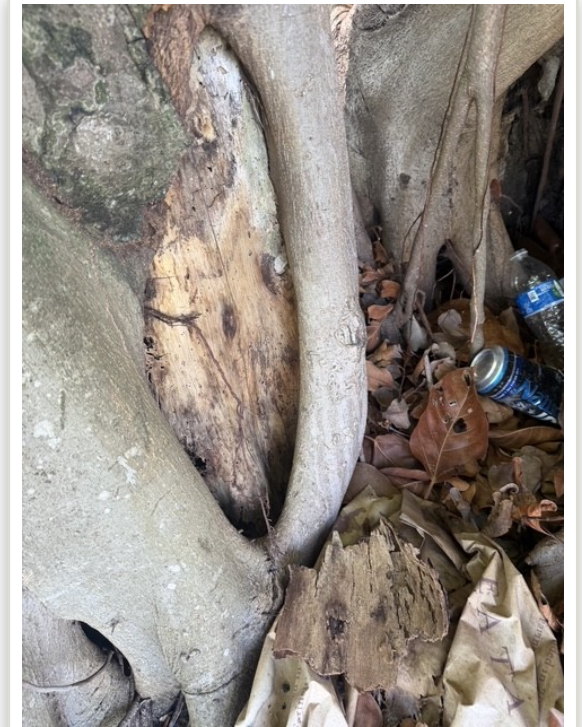
**Fig. 6** Exposed decayed wood at the buttress; bark and sapwood lost.

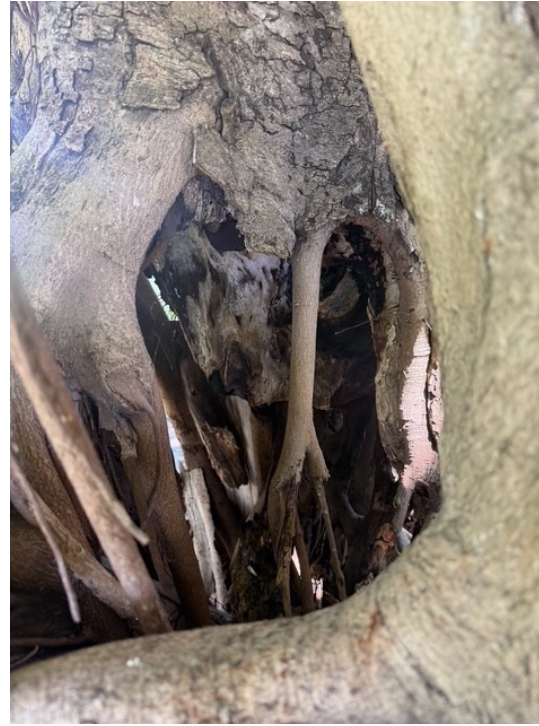
- A central decay column is visible within the trunk.
- Remaining internal wood is soft, fibrous and degraded.

Extensive internal hollowing indicates that a large proportion of the stem's cross-section is no longer contributing structural support — a primary contraindication for lifting and relocation.

**Fig. 7** Interior cavity — degraded wood and open voids within the stem.

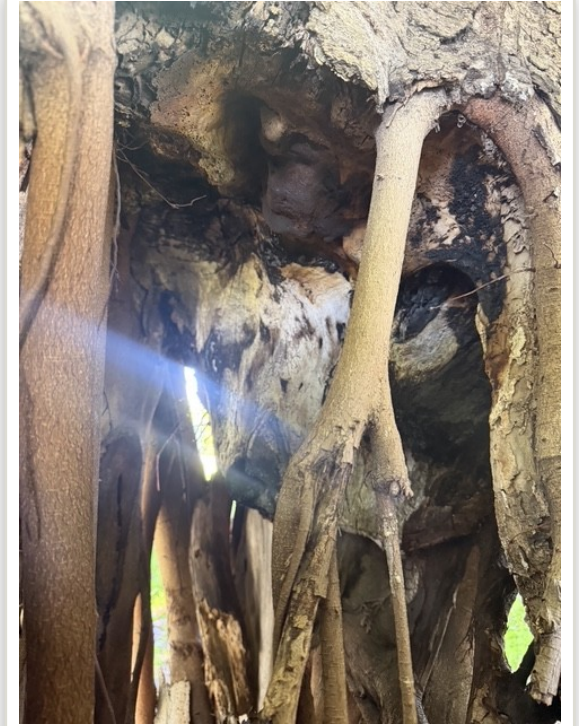
**Fig. 8** Hollowing central column; light passes through the decayed interior.

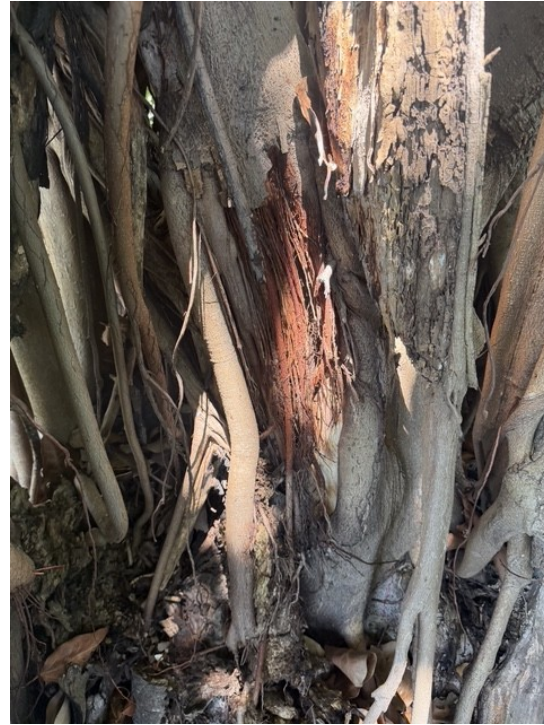
- Reddish-brown, stringy/fibrous decayed wood consistent with a white-rot fungus.
- Sloughing and missing bark over the affected column.

The character of the decayed wood indicates active, ongoing decomposition rather than a stable, old wound — consistent with a process that is expected to continue to advance.

**Fig. 9** Fibrous, discoloured decayed wood with bark sloughing.

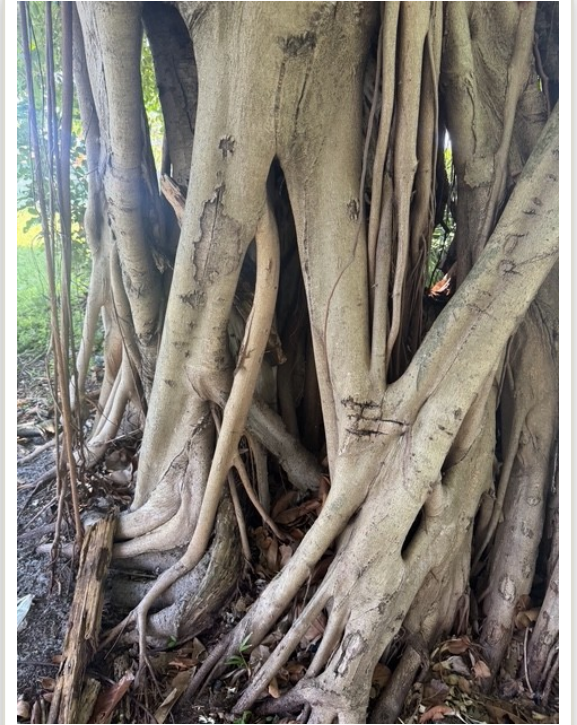
**Fig. 10** Old wounds and cracking at the buttress; little effective closure.

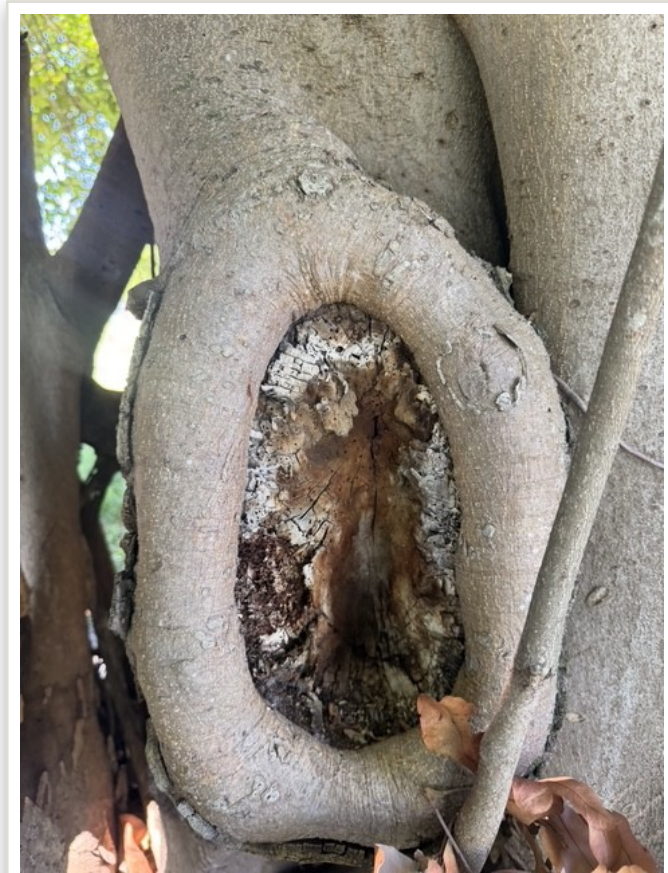
- Woundwood (callus) rolls are present at some wound margins.
- However, the rolls have not occluded — wounds remain open with decayed wood inside.
- The rate of response growth is not keeping pace with the rate of decay.

Limited, non-occluding woundwood is a key indicator that the tree is losing the race against decay. It supports the opinion that the decay will continue to progress and that the defect is not being effectively walled off.

**Fig. 11** Woundwood roll surrounds an open cavity; interior wood remains decayed and cracked — closure is not being achieved.

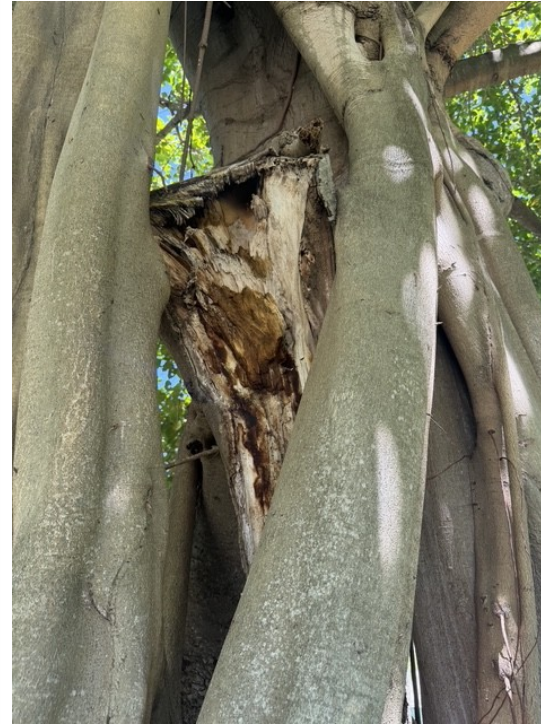
- Exposed decayed wood at major trunk / scaffold unions well above grade.
- Cavities and degraded heartwood present within the upper stem.
- Decay is therefore distributed through the structure, not localized at the base.

Decay at elevated unions compounds the structural concern: it further reduces the sound wood available to resist rigging and lifting loads and raises the likelihood of failure during any attempt to move the tree.

**Fig. 12** Open cavity with decayed heartwood at an upper union.

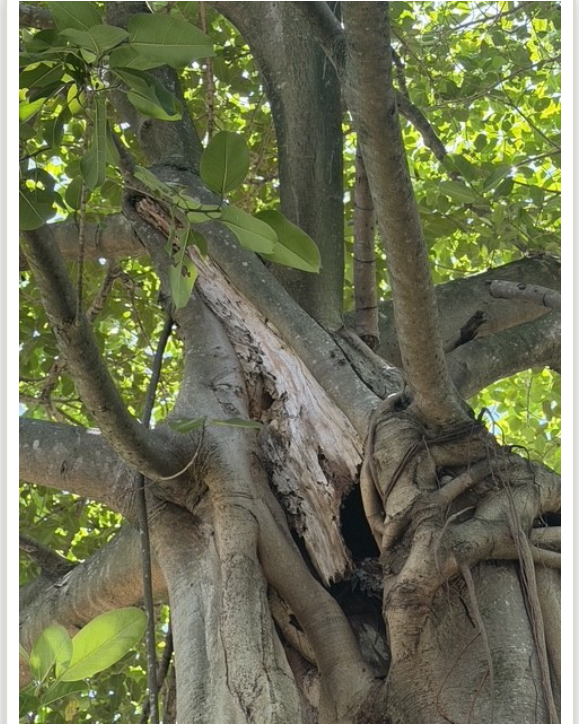
**Fig. 13** Exposed, degraded wood at a second elevated union.

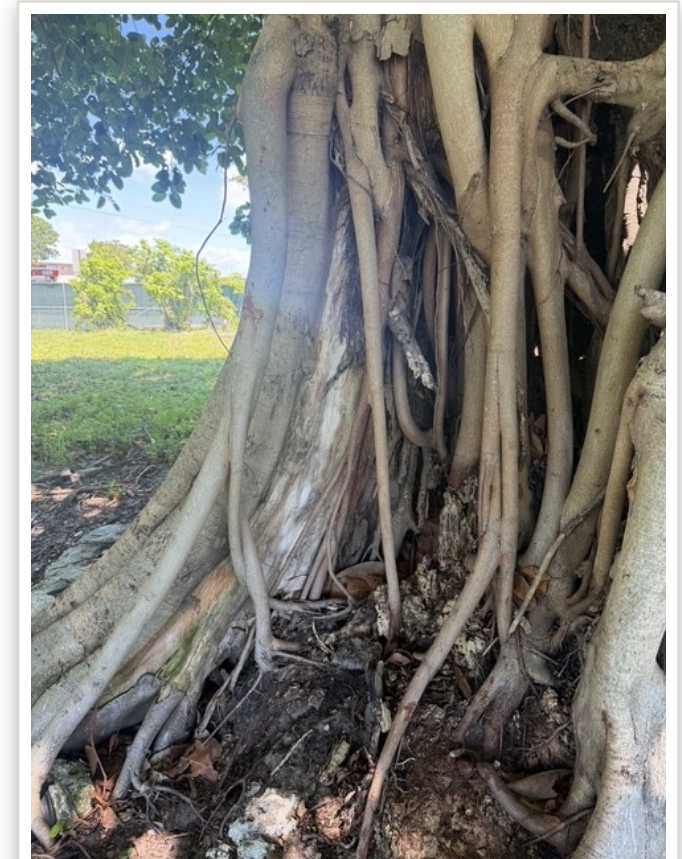
Moving a 98-inch stem requires it to withstand large rigging, lifting and handling loads. Extensive internal and union decay means the sound wood needed to carry those loads may not be present — risking failure during the move.
- 2 Transplant survivability**

Limited woundwood and active white-rot indicate decay is likely to continue advancing, so the defect that makes relocation risky today is expected to worsen — not stabilize.
- 4 Method constraints**

At this size, tree-spade relocation is not feasible; boxing/root-pruning and a crane lift would impose exactly the loads the decayed stem is least able to resist.

**Fig. 14** The compromised stem is the governing constraint on any relocation attempt.

**Do not relocate the tree.** The visible extent of trunk decay makes relocation an unacceptable arboricultural and safety risk.

**Advanced (Level 3) assessment** Quantify decay extent and residual wall thickness via sonic tomography and/or resistance drilling.

**Formal tree risk assessment** Complete a full ISA (TRAQ) risk assessment to assign a defensible risk rating and inform the disposition decision.

**If retained: manage in place** Consider targeted pruning to reduce end loads, establish an inspection interval, and manage the target/use zone beneath the canopy.

**If risk is unacceptable: removal** Where advanced assessment confirms unacceptable risk, removal — not relocation — is the appropriate course.
