# CITY HALL ANNEX

Lake Worth Beach, Florida

Building Condition Assessment

March 3rd, 2025

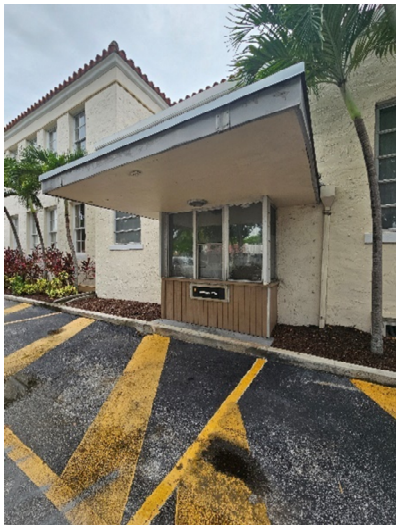
*Figure 1: Customer Service Window*

The customer service window is intact but has some major wind and water damage to be repaired at the roof, storefront systems, and base of the structure. The roof fascia is bent out of place and the electrical receptacle located on the soffit shall be replaced to meet the necessary codes. The wood siding is slightly warped, and all associated components are aged.

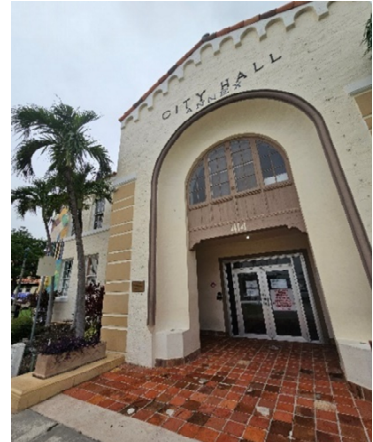
Figure 2: South Entrance

The main entry into the building previously included a public drop box that is now boarded. It will need to be removed and sealed according to code. Existing bike rack, also located in entry, may deter access into the building. Final location shall be coordinated with city at time of design. All plaques and signage installed on the building appear in good condition and can be reinstalled in existing locations.

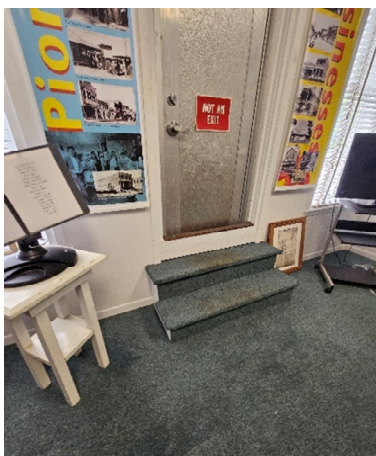
Figure 3 Roof Access

Existing interior doors appear to be in good condition but may require a level of refinishing to achieve and maintain historical aesthetic, but there is a possibility of reuse for interior doors. Some of the door openings require widening for ADA accessibility. Interior glass appears to have been painted or superficially covered in some locations. Top floor roof access is a trip hazard as well as a water infiltration concern because the bottom of the door is flush with the top of roof.

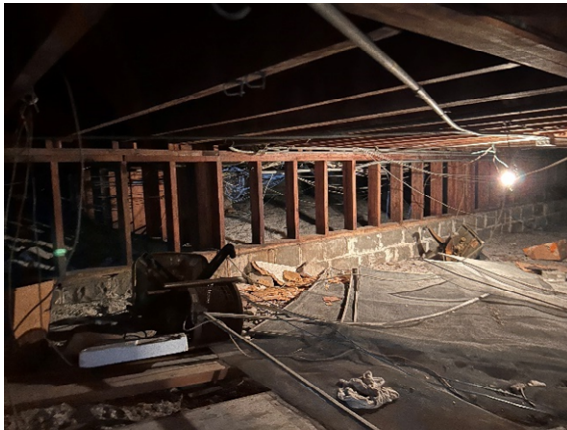
There is a crawl space under the first-floor framing where floor framing is exposed. The floor is framed with wood joists that bear on a wood-framed stem wall. The wood stem wall sits on top of an 8-inch masonry stem wall that is supported by a continuous concrete foundation wall. The

Photo 1. Floor joist bearing on Wood Stem wall at the crawl space

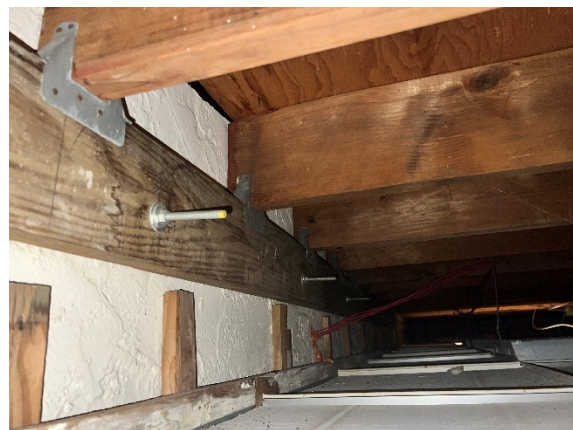
The majority of the first-floor area is framed with 2x14 wood joists spaced at 12" on center and some areas are framed with 2x8 wood joists at 12" on center. This is confirmed with the drawings prepared by Botkin and Associates. The floor joist spans from the 8-inch exterior concrete masonry unit (CMU) wall to the interior wood stem wall. The second floor is framed similar to the first floor. The floor joist is secured with one 16d toenailed to the top plate of the wood stem wall and bearing wood framed interior wall. At some locations, the top plate is a single 2x6, and in some locations is a double 2x6. The joist is supported on the 2x4 wood ledge bolted to the exterior CMU wall. The joist is secured with a Simpson-strong type connection. The exact model and capacity cannot be confirmed.

Photo 2. Floor joist to exterior CMU wall

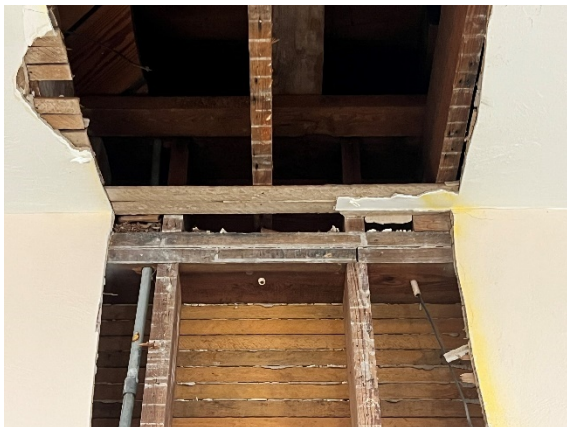
Photo 3. Floor joist bearing on the wood framed wall

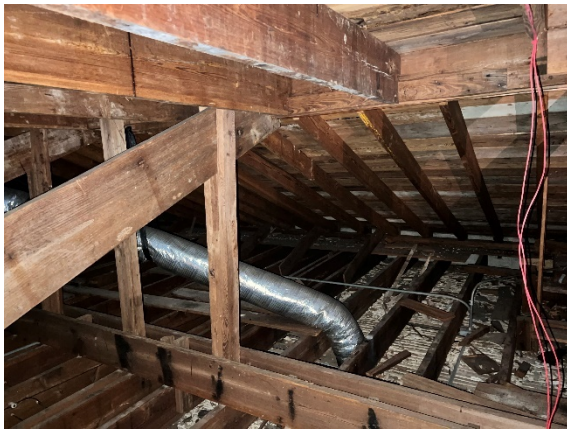
The roof has an attic space with approximately 5 feet of clear height from the finish floor to the bottom of the roof joist. The roof consists of a flat roof with a mansard on the perimeter edges of the roof. The attic floor is framed with 2x10 wood joist spaced 16" on center. The attic floor currently houses the HVAC unit. The flat portion of the roof is framed with 2x6 wood spaced at 24" on center and 2x6 wood joists at 16" on center for the mansard portion.

Photo 4. Roof framing view from attic space
