**CITY OF LAKE WORTH,
AQUATICS AND BEACH COMPLEX**
Supplement to Property Condition Assessment

**RE: *Supplement to Aquatics and Beach Complex Baseline Property Condition Assessment
KH Job #140335001***

**Re: Inspection of Lake Worth Casino Pool
10 Ocean Avenue, Lake Worth, FL 33460**

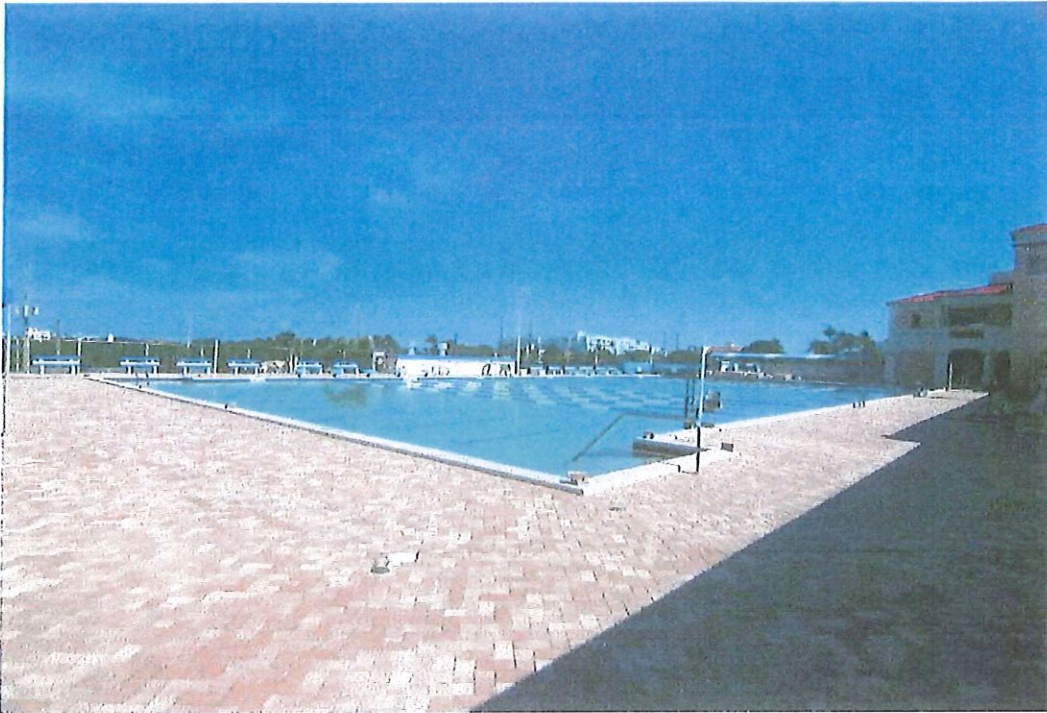
EXHIBIT 1. OVERALL VIEW OF POOL AND DECK LOOKING NORTHWEST

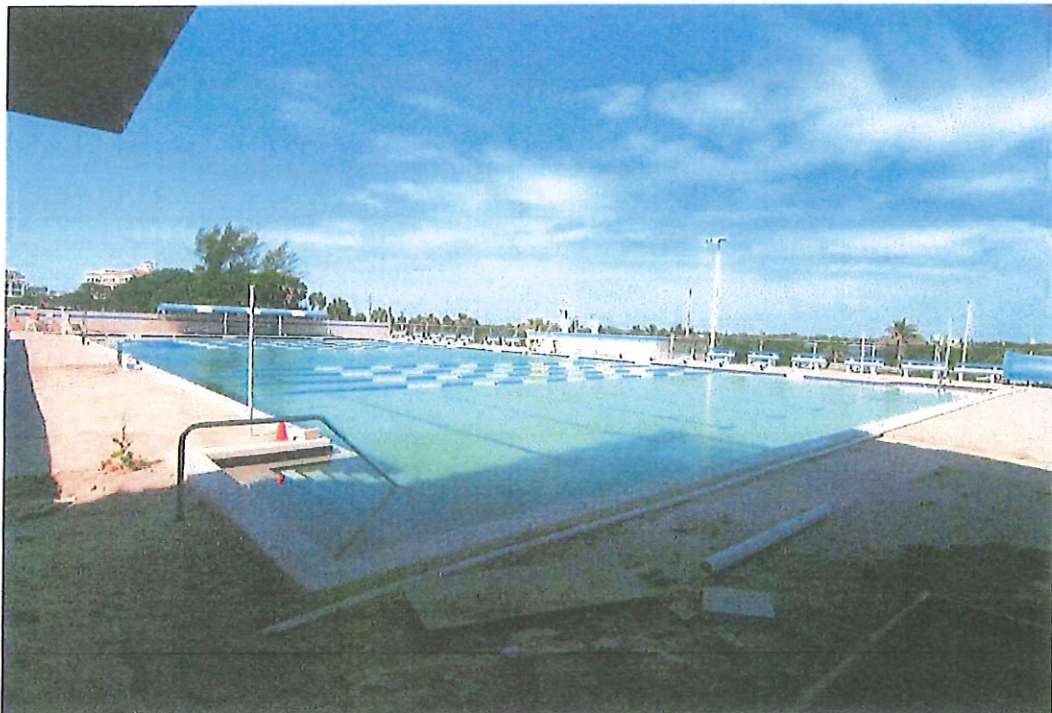
EXHIBIT 2. OVERALL VIEW OF POOL AND DECK LOOKING SOUTHWEST

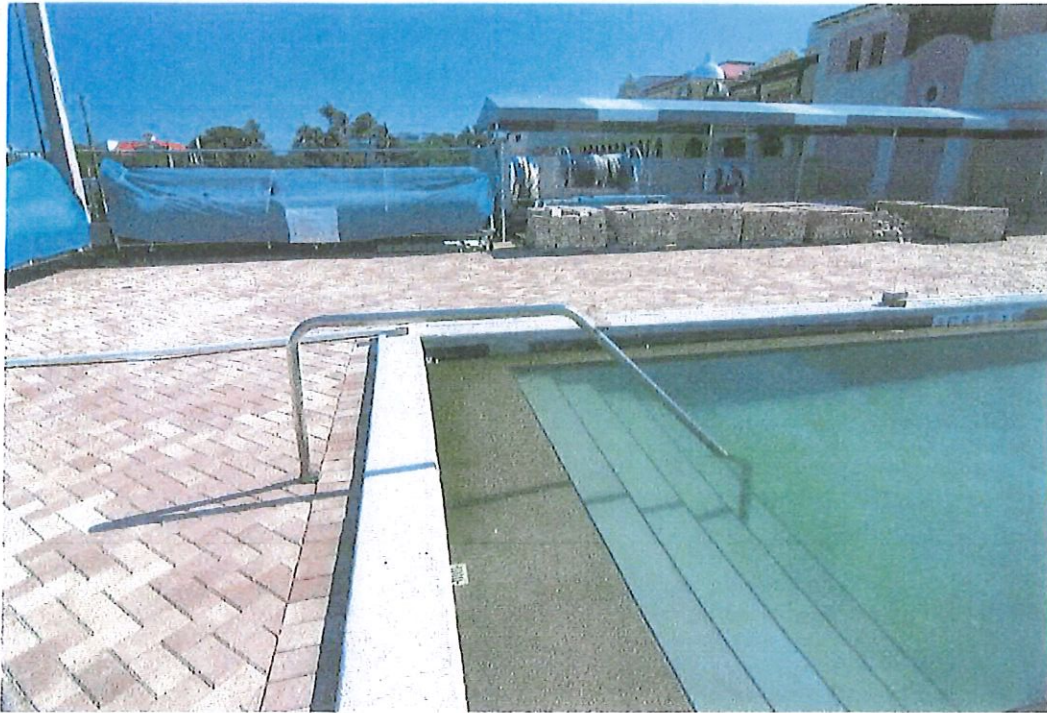
4. Examination of the pool rollout gutter revealed that the water level was slightly higher along the West side of the pool than in the center and East side of the pool, indicating that the West side of the pool shell may have settled unevenly relative to the remainder of the pool shell.

EXHIBIT 3. VIEW OF NORTHWEST AREA OF POOL

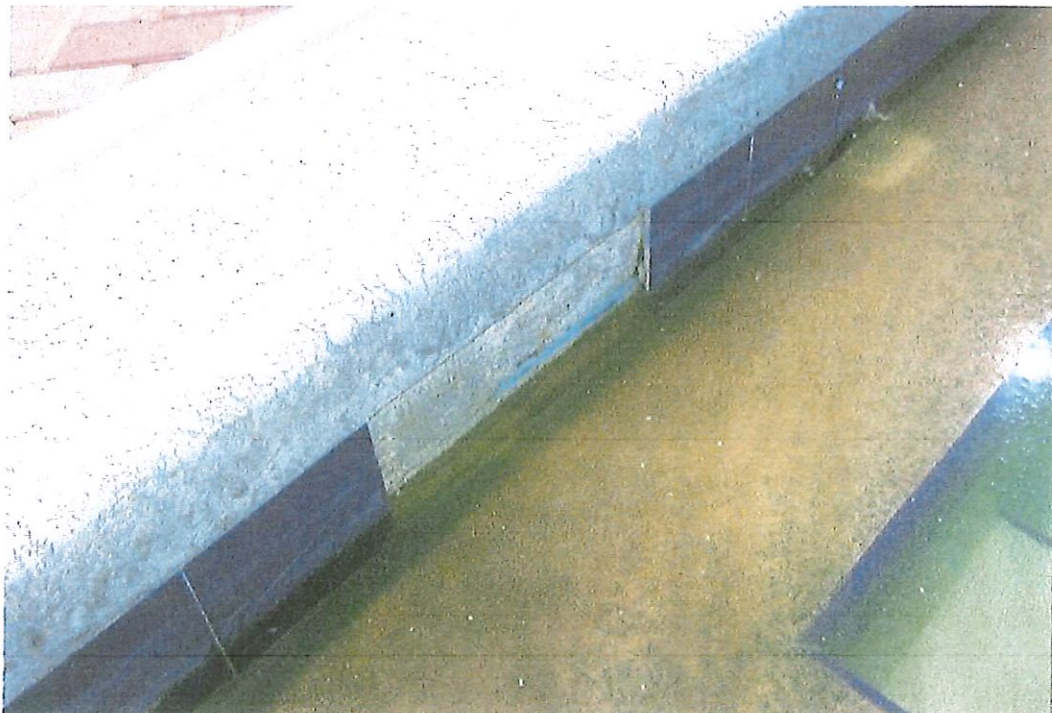
The observations noted in the SECO report were reviewed, evaluated, and compared to our field notes and findings summarized in the PCA. Of particular interest were SECO's observation numbers 6 and 7 referring to a "horizontal cracks in the pool beam". After reviewing that photos in exhibit 4 of SECO's report, the mentioned horizontal crack is actually the cold joint between the structural wall of the pool and the precast coping. The coping is adhered to the top of the wall, similar to a tile installation, so a joint occurs at that interface. This joint is located at or near the finished grade elevation of the surrounding pool deck pavers and is located above the waterline. This is not a structural joint and it is not meant to be watertight.

6. Examination of the pool beam in the Northwest corner of the pool, where a waterline tile was missing, revealed a horizontal crack in the pool beam.
7. Examination of the horizontal crack in the pool beam revealed that it appeared to be a cold joint between the previously existing concrete pool beam and a concrete overpour.

8. Continued examination of the horizontal crack in the pool beam revealed the presence of a caulking material along the crack, presumably installed to prohibit water seepage and/or prevent the crack from telegraphing into the waterline tile. It was noted that the caulking material did not extend along the entire length of the crack.

EXHIBIT 4. VIEW OF CRACKED WATERLINE TILES AND CRACKED POOL BEAM

- d. Install a properly-reinforced and attached pool beam.
 - e. Replace the precast coping stones and install new waterline tiles.
4. There are disbonded / loose precast coping stones which are to be reinstalled with an elastomeric thinset.

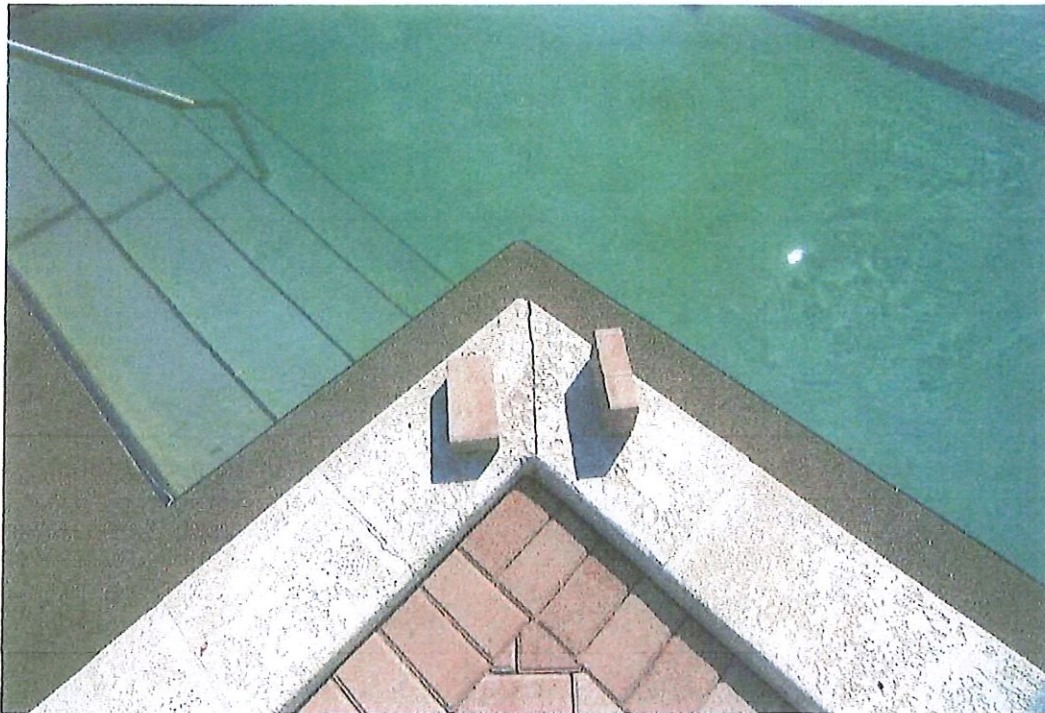
9. Examination of the precast coping stones revealed a number of cracks in the mortar joints. Further, a number of the coping stones were "hollow" and had disbonded from the pool shell.

EXHIBIT 5. VIEW OF CRACKED MORTAR JOINT BETWEEN ADJOINING COPING STONES

5. It is also recommended that the precast coping stone mortar joint be filled with elastomeric grout to allow for expansion and contraction forces between the coping and the pool shell. Note that this expansion joint is to be installed on 10' to 12' centers and at the corners.

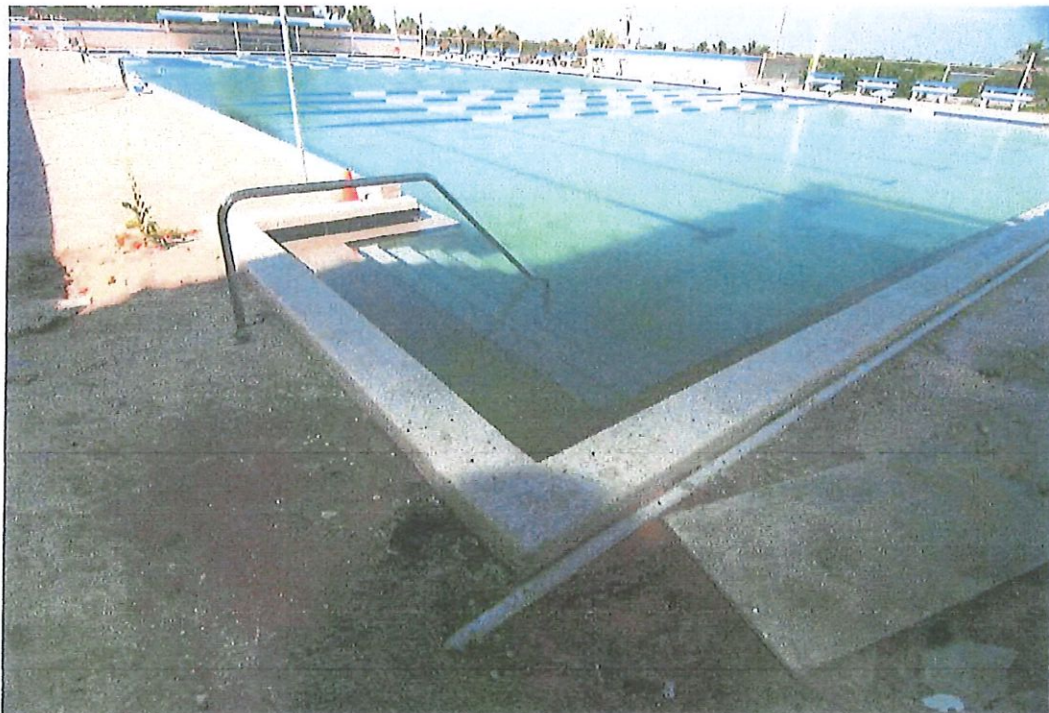
EXHIBIT 6. VIEW OF STEPS IN NORTHEAST AREA OF POOL

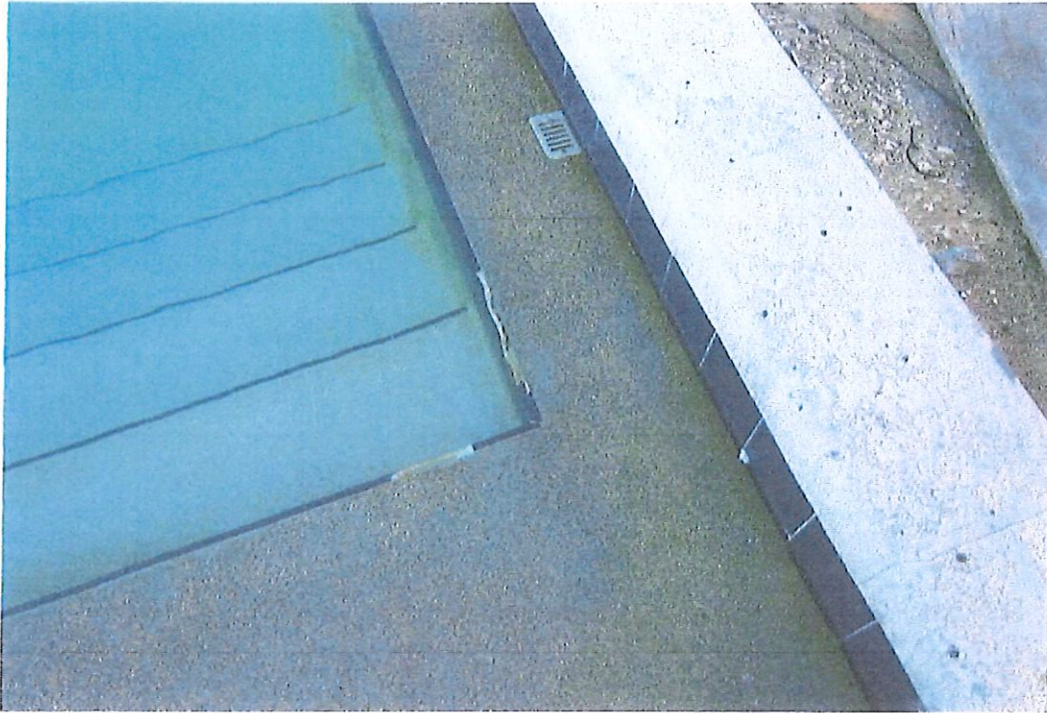
2. Examination of the pool shell revealed no visible evidence of cracks in the pool floor or walls.
3. Continued examination of the pool shell and gutter revealed missing bullnose tile on the inner face of the gutter, primarily adjacent to the steps in the Northeast corner of the pool.

EXHIBIT 7. VIEW OF MISSING BULLNOSE TILE (REFERENCE EXHIBIT 6.)

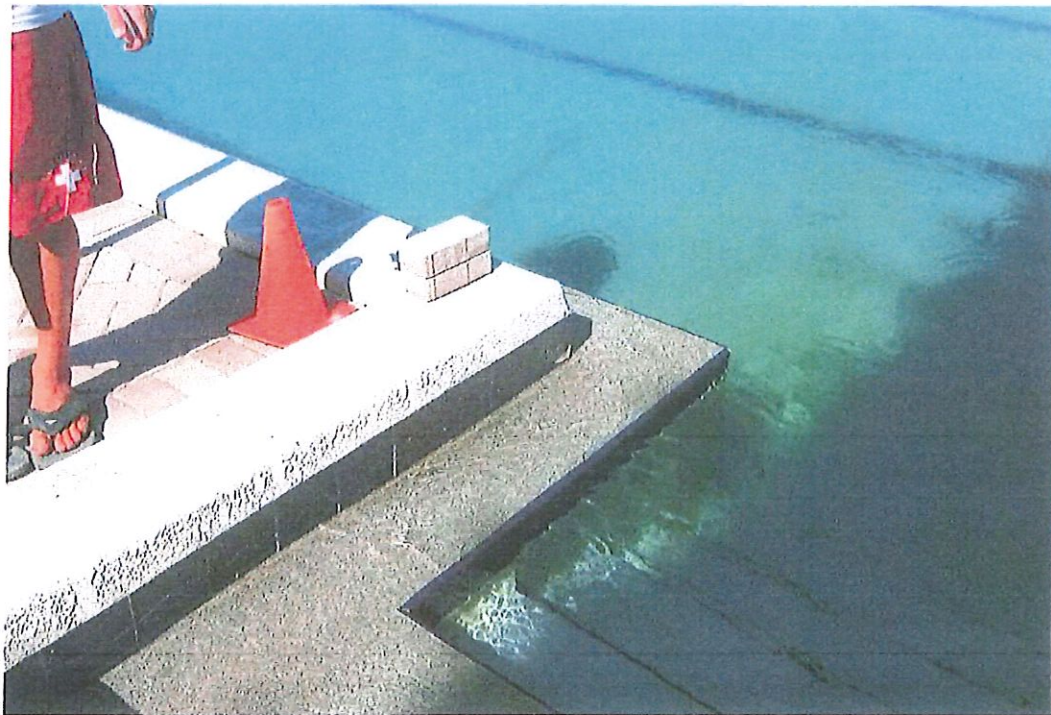
5. Examination of the waterline tiles revealed a horizontal crack at approximately the mid-height of the waterline tiles at the back of the gutter. This condition was noted in several areas.

EXHIBIT 8. VIEW OF HORIZONTAL CRACK IN WATERLINE TILES (REFERENCE EXHIBIT 6.)
