SUBJECT: Lake Orion Dam, Dam ID No. 259, Oakland County

**DAM SAFETY INSPECTION REPORT
LAKE ORION DAM – DAM ID NO. 259
PAINT CREEK
OAKLAND COUNTY – SECTION 2, T04N, R10E**

INSPECTION DATE: October 24, 2024

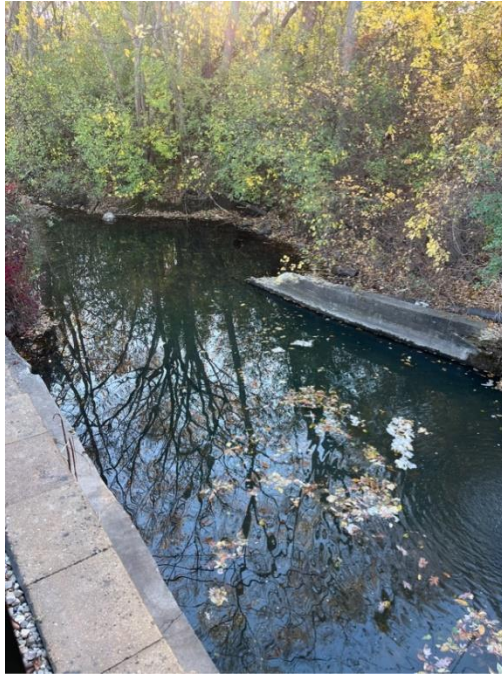
Auxiliary Spillway		
Issues Present	<i>Deteriorating Material</i>	
Deteriorating Material		
Describe Issue	<i>Significant spalling and deterioration were observed at the concrete retaining wall at the outlet, and the concrete headwall and upstream columns of the auxiliary spillway.</i>	
Component	<i>Outlet Conduit</i>	<i>Headwall</i>
Photo(s)	15	21 , 22 , 23 , 24
Action Required	<i>Monitor, Maintenance</i>

Photo #15: Auxiliary Spillway Outlet Conduit. Note spalling and deterioration of retaining wall on right side.

Issue: Deteriorating Material, Action: Monitor, Maintenance

Describe Action Required	<i>Inspect locations of concrete deterioration, a minimum of twice per year, to ensure the deterioration is not increasing in size. Consider concrete repairs in the next five (5) years to prevent concerns.</i>
--------------------------	---

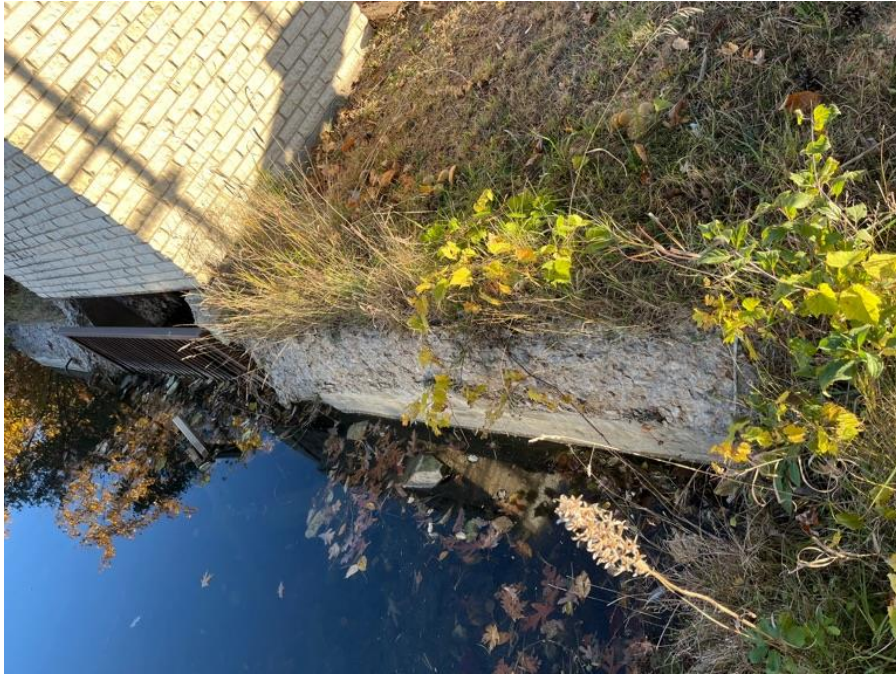
Photo #21: Auxiliary Spillway Headwall.
Issue: Deteriorating Material, Action: Monitor, Maintenance

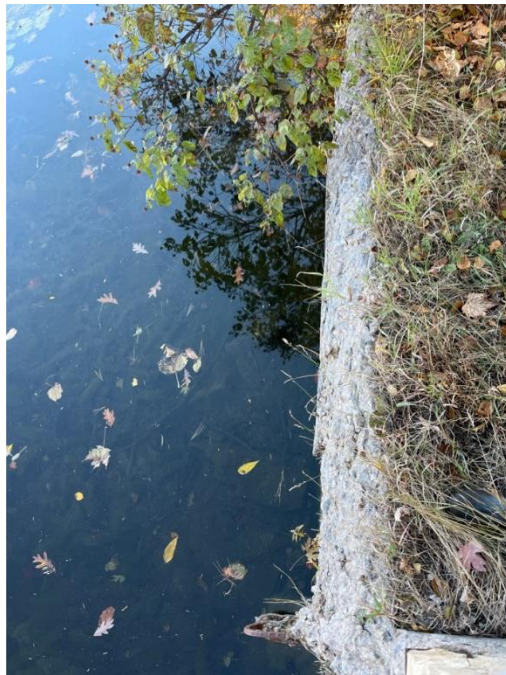
Photo #22: Auxiliary Spillway Headwall.
Issue: Deteriorating Material, Action: Monitor, Maintenance

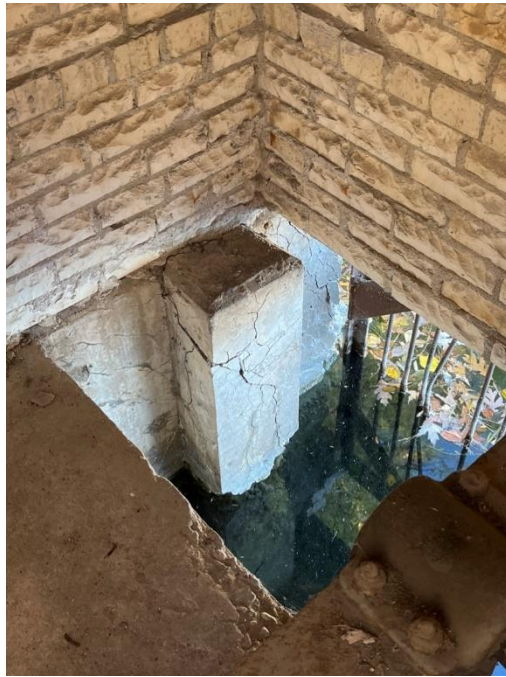
Photo #23: Auxiliary Spillway Headwall. Note deteriorating concrete column.
Issue: Deteriorating Material, Action: Monitor, Maintenance

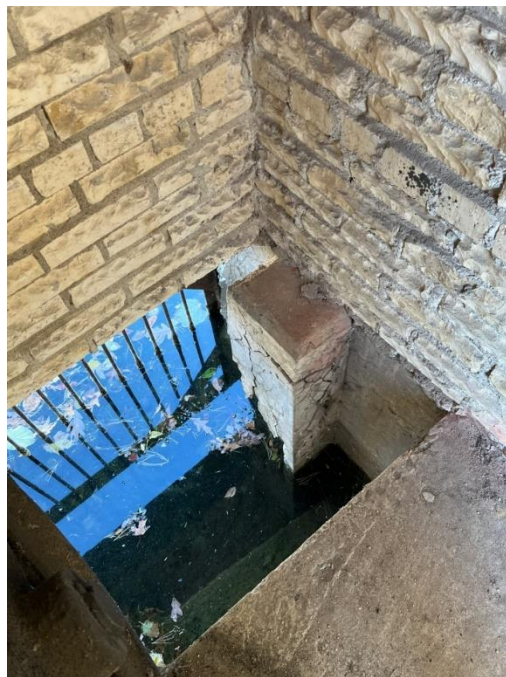
Photo #24: Auxiliary Spillway Headwall. Note deteriorating concrete column.
Issue: Deteriorating Material, Action: Monitor, Maintenance

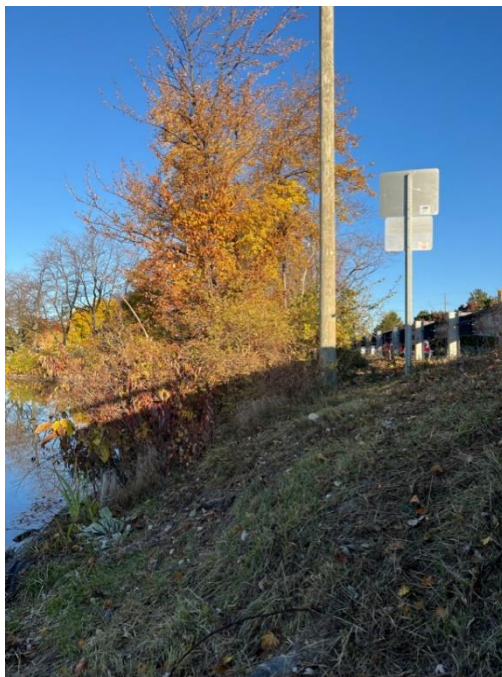
Embankment	
Upstream Slope	
Issues Present	<i>Trees and Brush</i>
Trees and Brush	
Describe Issue	<i>Trees, brush, and woody vegetation were observed on the upstream embankment slope.</i>
Photo(s)	28 , 29 , 30
Action Required	<i>Maintenance</i>
Describe Action Required	<i>Continue efforts to remove all trees and brush from the earthen embankments. Trees should be removed to 10 feet beyond the downstream toe of slope. Once cleared, embankments should be mowed or treated with herbicide a minimum of two (2) times per year to prevent further establishment of woody vegetation and to facilitate visual inspection.</i>

Photo #28: Embankment Upstream Slope. Left slope shown.
Issue: Trees and Brush, Action: Maintenance

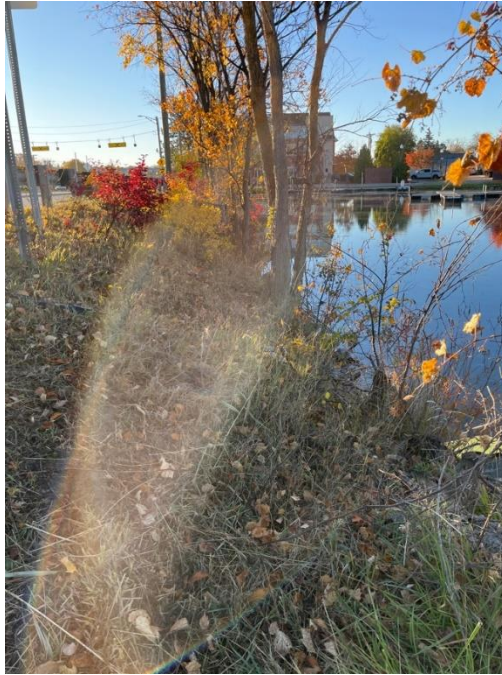
Photo #29: Embankment Upstream Slope. Right slope shown.
Issue: Trees and Brush, Action: Maintenance

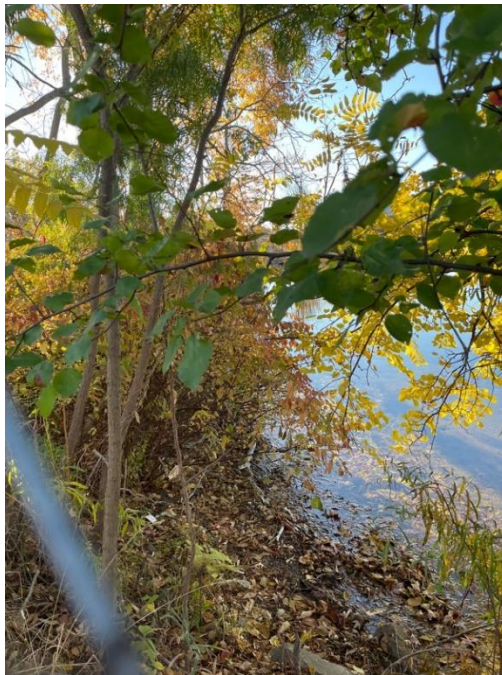
Photo #30: Embankment Upstream Slope. Left slope shown.
Issue: Trees and Brush, Action: Maintenance

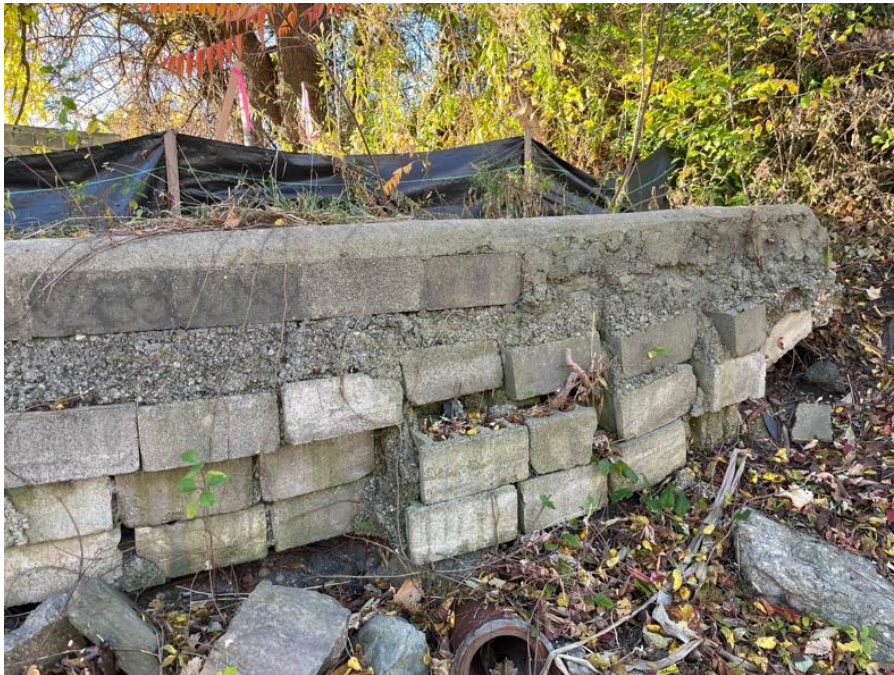
Photo #33: Embankment Downstream Slope. Deteriorating concrete block retaining wall shown with drain outlet on right downstream slope.

Issue: Deteriorating Material, Action: Monitor, Maintenance

Describe Action Required	<i>Continue efforts to establish appropriate vegetation cover to stabilize the slope. Monitor this area for loss of earth material.</i>
Deteriorating Material	
Describe Issue	<i>The concrete block retaining wall at the drain outlet on the right downstream embankment slope has deteriorated over time.</i>
Photo(s)	33 , 34
Action Required	<i>Monitor, Maintenance</i>
Describe Action Required	<i>Monitor this area to ensure deterioration is not accelerating. Consider replacement of the concrete block retaining wall.</i>

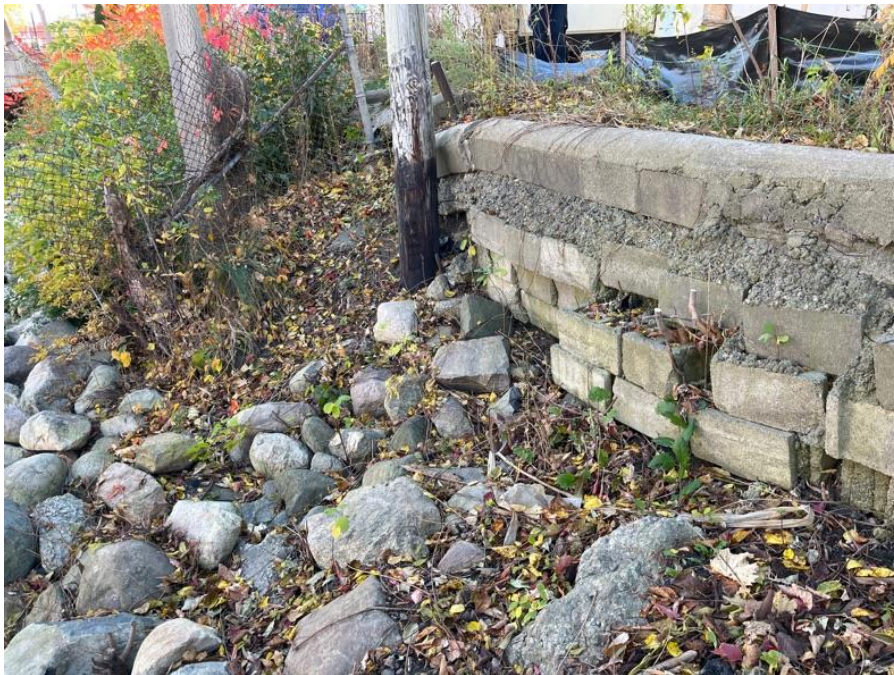
Photo #34: Embankment Downstream Slope. Deteriorating concrete block retaining wall shown with drain outlet on right downstream slope.

Issue: Deteriorating Material, Action: Monitor, Maintenance

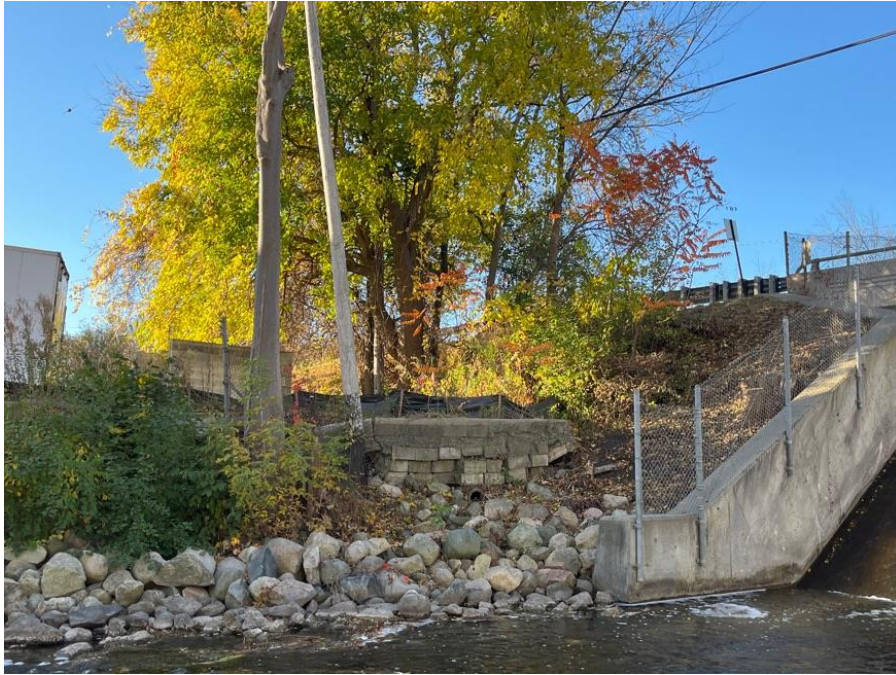
Crest	
Issues Present	<i>None</i>
Downstream Slope	
Issues Present	<i>Trees and Brush, Ground Cover, Deteriorating Material</i>
Trees and Brush	
Describe Issue	<i>Trees, brush, and woody vegetation were observed on the downstream embankment slope.</i>
Photo(s)	35 , 36 , 37 , 38 , 39
Action Required	<i>Maintenance</i>
Describe Action Required	<i>Continue efforts to remove all trees and brush from the earthen embankments. Trees should be removed to 10 feet beyond the downstream toe of slope. Once cleared, embankments should be mowed or treated with herbicide a minimum of two (2) times per year to prevent further establishment of woody vegetation and to facilitate visual inspection.</i>
Ground Cover	
Describe Issue	<i>A large area of bare ground with exposed soil was observed on the right downstream embankment slope, specifically adjacent to the principal spillway wall.</i>
Photo(s)	35
Action Required	<i>Monitor, Maintenance</i>

Photo #35: Embankment Downstream Slope. Right slope shown.
Issue: Trees and Brush, Ground Cover, Action: Monitor, Maintenance

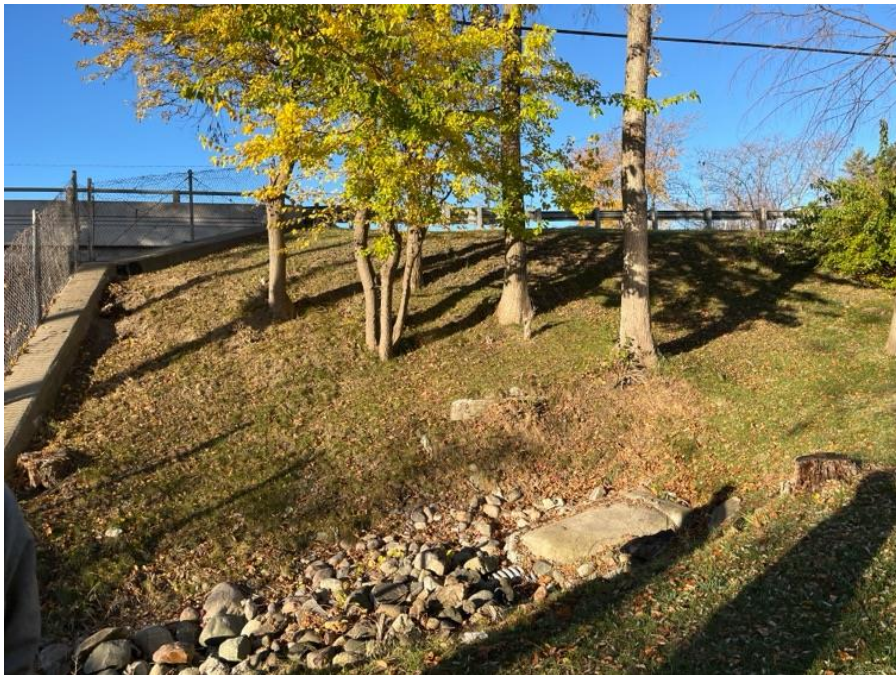
Photo #36: Embankment Downstream Slope. Left slope shown.
Issue: Trees and Brush, Action: Maintenance

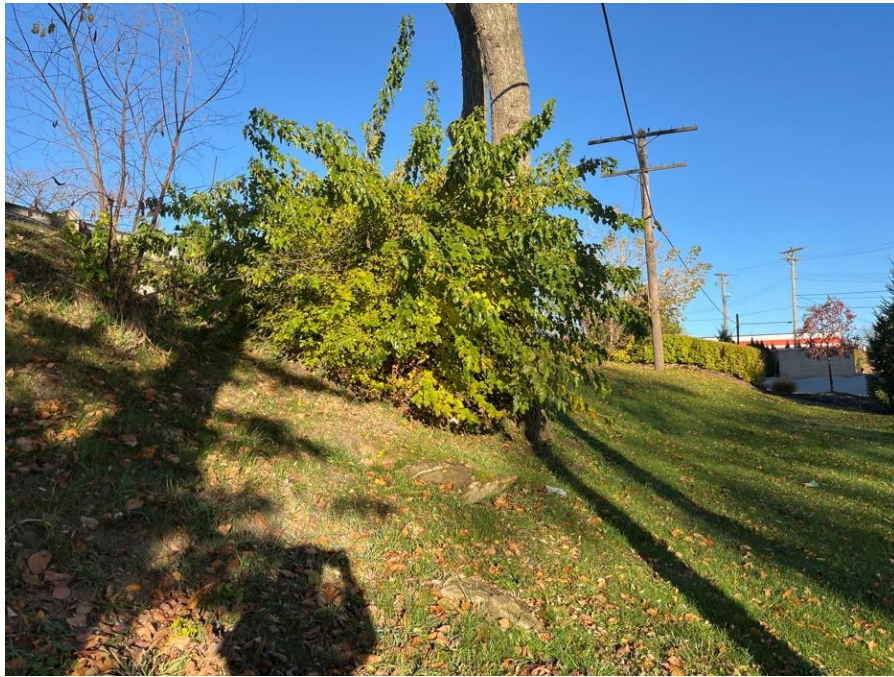
Photo #37: Embankment Downstream Slope. Left slope shown.
Issue: Trees and Brush, Action: Maintenance

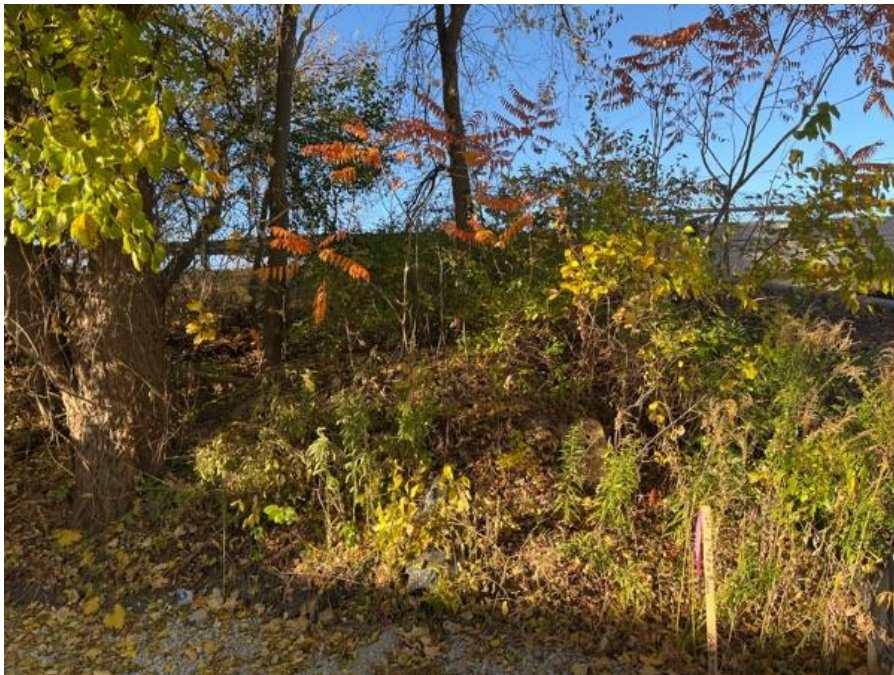
Photo #38: Embankment Downstream Slope. Right slope shown.
Issue: Trees and Brush, Action: Maintenance

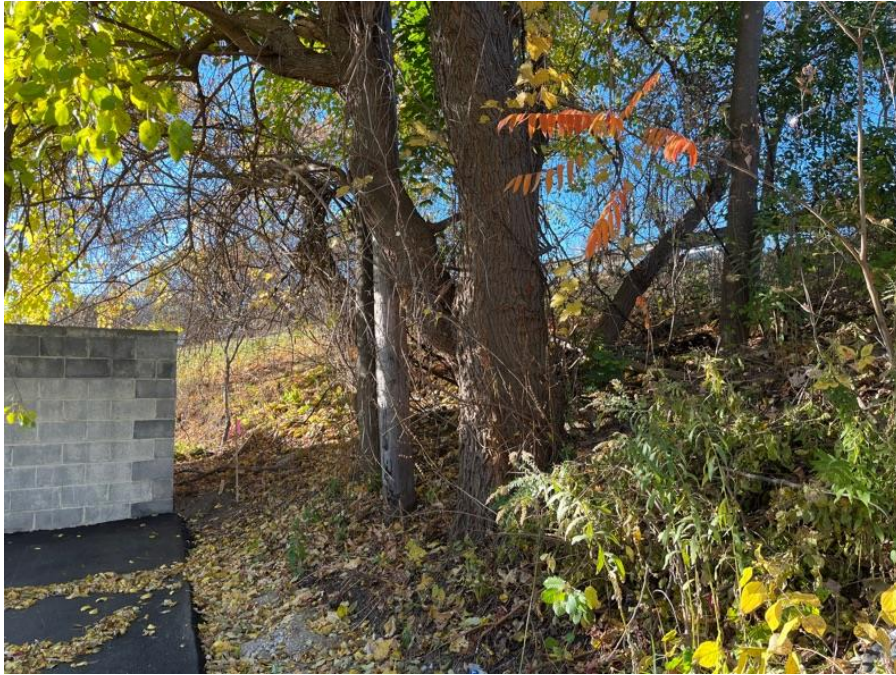
Photo #39: Embankment Downstream Slope. Right slope shown.
Issue: Trees and Brush, Action: Maintenance

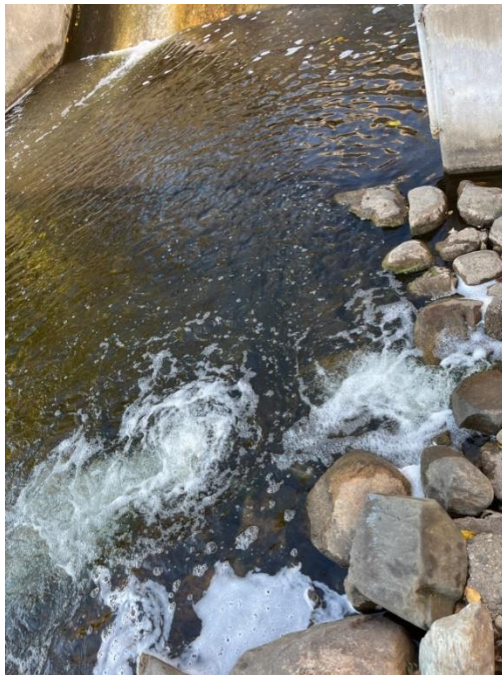
Photo #42. Cold water outlet pipe appears to have compromised joints. Water was observed bubbling up to the surface along the pipe.
