Hazardous Material Report for the Former Lake Orion Lumber Yard

**Prepared for:
Village of Lake Orion
Downtown Development Authority**

Date: April 11, 2024

Re: Pre-Demolition Hazardous Materials and Asbestos Survey

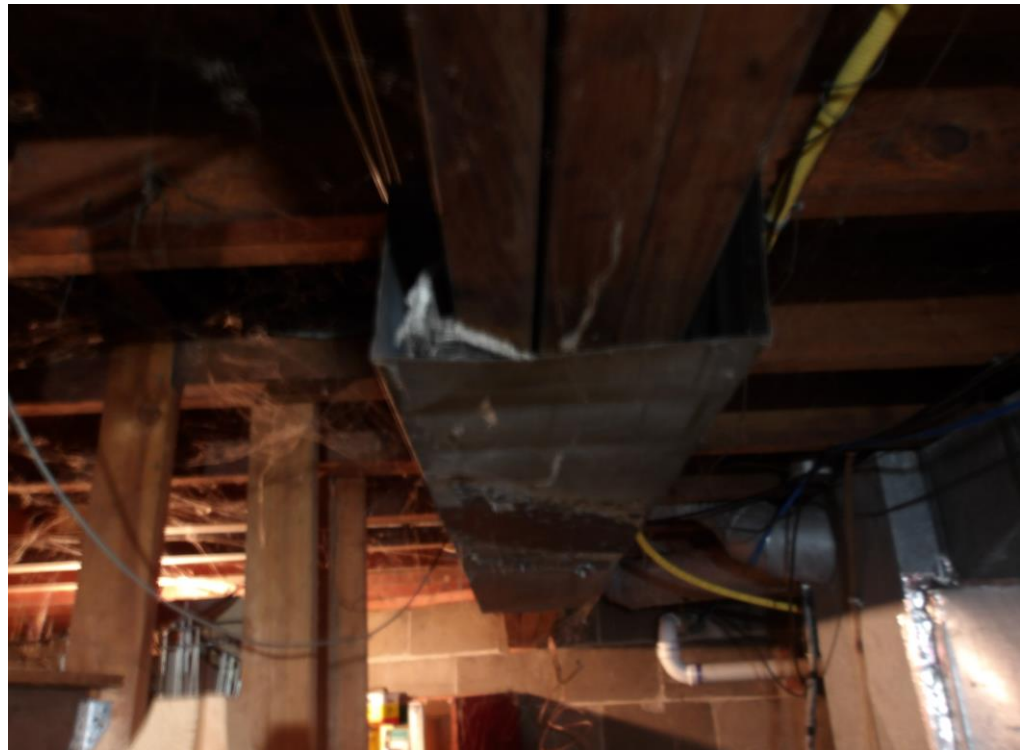
Building	Material Number	Material	Location(s)	Quantity
1	#11	Thermal Insulation Board (White)	Room 1	4 Square Feet
1	#15	Vinyl Floor Tile and Floor Adhesive (12"x12" White VFT & Black FA)	Room 3	20 Square Feet
24	#49	Asphaltic Roofing Material (Gray Rolled Sheeting and Tar Materials)	Roof	600 Square Feet

Homogeneous Material Number	Material Type	Material Description	Category of ACM	Approximate Quantity of Asbestos	Condition of Material
11	Thermal Insulation Board	White	Friable ACM	4 Square Feet	Damaged
15	Vinyl Floor Tile and Floor Adhesive	12" x 12" White VFT and Black FA	Category I Non-friable ACM	20 Square Feet	Damaged
49	Asphaltic Roofing Material	Gray Roll Sheeting and Tar Materials	Category I Non-friable ACM	600 Square Feet	Damaged

Comments: ACM – Material 11 – Thermal Insulation Board (White)

While the materials can be managed in-place with little potential hazard, due to the proposed demolition project, all of the ACM that will be impacted or disturbed should be safely removed and disposed of, accordingly, by an asbestos abatement firm that is licensed by the State of Michigan. Abatement plans for the regulated ACM should be designed in accordance with USEPA and other federal, state, and local regulations and/or using appropriate guidelines by an Asbestos Project Designer. All abatement activities should be overseen and managed by an experienced and licensed Asbestos Supervisor. Removal notifications, activities, and disposal must be completed in accordance with USEPA (40 CFR Part 61), OSHA (29 CFR 1926.1101), and Michigan regulations, as well as other applicable federal, state, and local regulations.

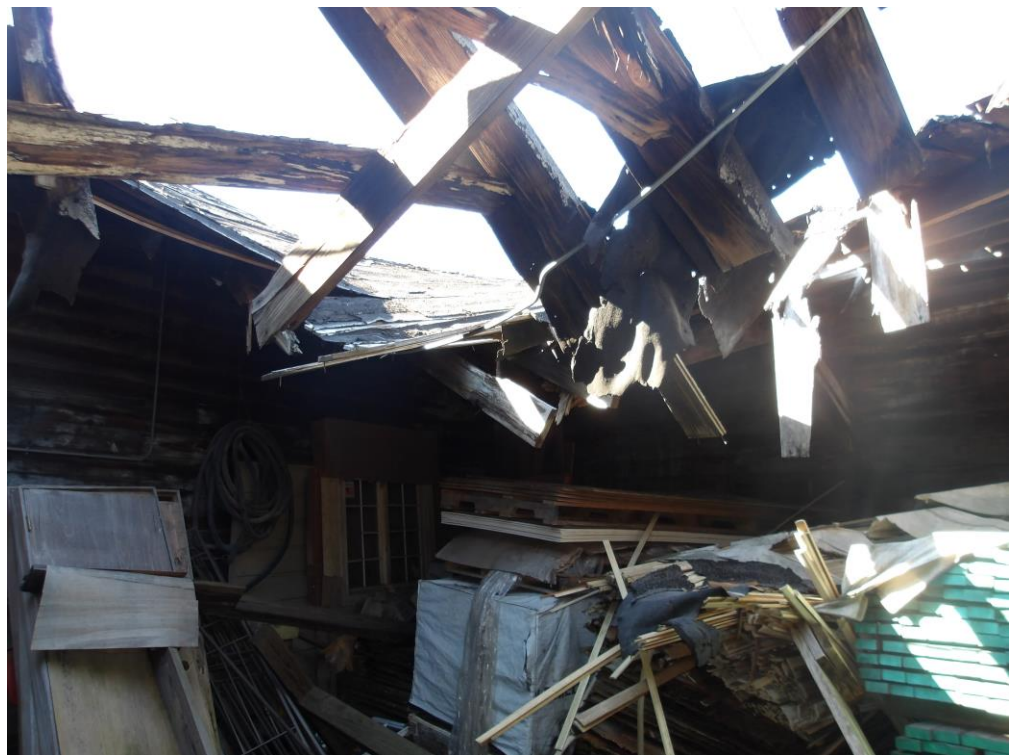
Homogeneous Material Number	Material Type	Material Description	Material Locations	Friable	Sample Numbers	Sample Results	Sample Locations	Asbestos-Containing Material	Approximate Quantity of Asbestos	Condition of Material
49	Asphaltic Roofing Material	Gray Roll Sheeting and Tar Materials	Exterior Roof	No	LC - 49A LC - 49B	4% Chrysotile Not Analyzed	Roof Roof	Yes	600 Square Feet	Damaged

Comments: ACM – Material 49 – Asphaltic Roofing Material (Gray Roll Sheeting and Tar Materials)
