SITE OBSERVATION REPORT

Date of Observation:	February 18, 2025	Project:	Lake Landis Dam
Schnabel Rep:	Corey Schaal, PE, PG	Project Number:	23210051.000 Task Number(s): 03
Schnabel PM:	Jonathan Pittman, PE	Building Permit No.	N/A
Arrival Time:	9:00 AM	Departure Time:	11:05 AM
Contractor:	Alliance Integrated Solutions, LLC	Superintendent:	Jason Smith, Town of Landis Fire Chief
Air Temp ° F:	40°	Weather:	Mostly Sunny

**Town of Landis, North Carolina
Landis Lake Dam (ROWAN-025)**

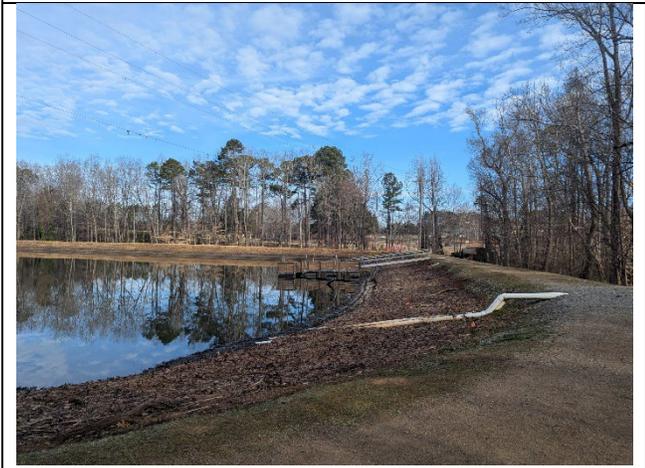
The Lake Landis water level was drawn down about 8 to 10 feet below the normal elevation using two 6-inch diameter PVC siphons. According to Mr. Smith, the siphons lowered the lake level to the observed elevation in about one week. The siphons were discharging water at the time of our site visit, and the invert elevation was less than 1 foot below the water surface.

<p>Current Lake Landis water level. View from right abutment.</p>	<p>North embankment. View from east end of embankment. Note straw on crest and slope, as well as stump on outboard slope.</p>

1. Maintain lake level down at about siphon invert elevation.
2. Develop a plan to deploy additional pumps to maintain the lowered lake level during large rain events that could significantly raise the lake level.

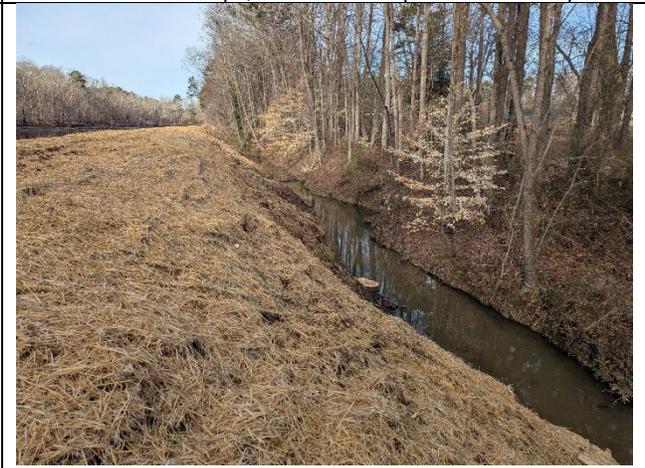
Trees were recently cleared from the north embankment. Stumps were not removed. Observed stump diameters were as large as approximately 12 to 18 inches. We understand that the Town does not intend to remove the root balls. Seed and straw were recently placed on the crest and outboard slope. We also observed significant outboard toe undermining and sloughing, likely resulting from flows in the stream along the toe of the embankment. In general, the outboard slope appeared to be steeper than 2H:1V, and multiple near-vertical scarps were observed near the upstream end of the lake. We were not able to evaluate whether tension cracks were present along the crest as these areas were covered with straw. The embankment crest and both slopes were saturated with standing water and soft surficial soils from recent rain. Construction equipment ruts were observed on the crest.

3. It is our opinion that the root balls are serving to increase embankment slope stability and recommend against their removal at this time. Paint stumps with tar, polyurethane, or similar, to the extent practical, to slow decay process.

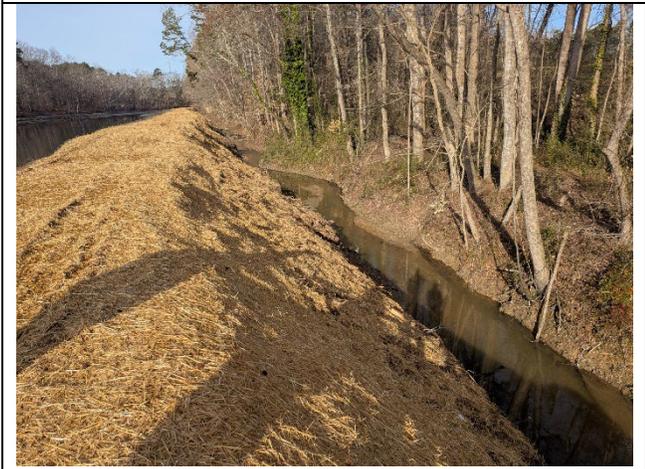
<p>North embankment. View looking upstream along outboard slope. Note seed and straw on slope.</p>	<p>North embankment. View looking upstream along outboard slope. Note scarps.</p>

4. Prevent vehicular and foot traffic on the embankment crest for safety reasons. No trespassing signs, barriers, and public notices are warranted.
5. Establish a healthy stand of grass cover to mitigate the development of erosion features.

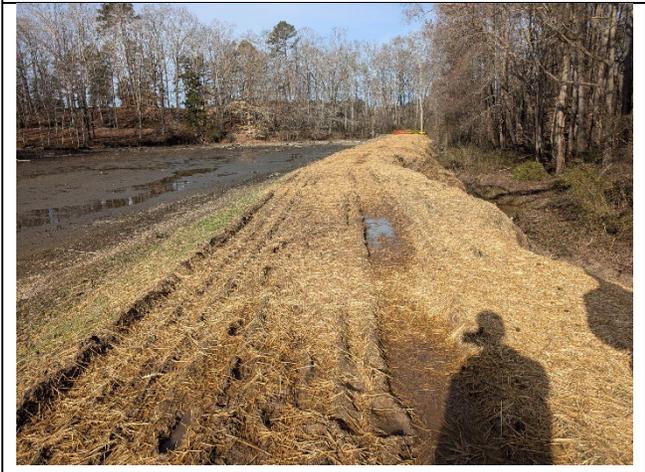
<p>North embankment. View looking upstream along crest. Note standing water and ruts.</p>	<p>North embankment crest. View looking downstream. Note near-vertical scarp and undermining of crest.</p>

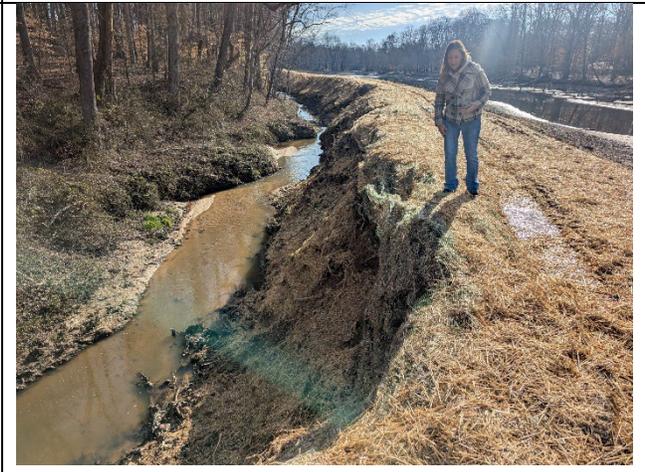
Clear cutting of the trees from the north embankment slope is a positive step and will prevent further damage to the embankment due to fallen trees. However, given the observations noted above and the constant stream flow along the toe of the embankment, our previous concerns with the long-term stability of the north embankment, as outlined in the Corrective Action Plan, remain. As such, we recommend the Town continue to consider options to rehabilitate the embankment. The following is a list of recommended risk reduction measures to be implemented until a rehabilitation can be completed:

6. Town staff should perform weekly walkovers of the embankment and note any changes in conditions, such as new erosion rills, additional slumping, and tension cracks. Staff should not walk along the outboard edge of the embankment crest due to stability concerns.
