**STATUS REPORT ON
PHASE II STORM WATER PERMIT
ILLICIT DISCHARGE AND ELIMINATION PROGRAM
OUTFALL INSPECTION AND MONITORING
FOR
LATHRUP VILLAGE**

AUGUST 2021

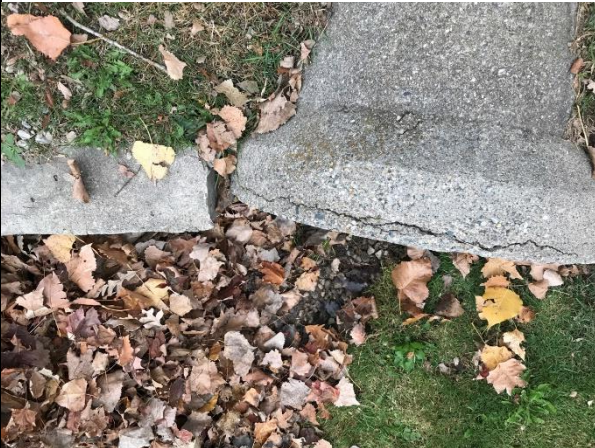
Outfall ID: 1	Outfall Material: RCP
Size: 24"	Condition: Fair – Crack on top of structure and wing wall is separating. Exposed on top.

It is recommended that the City should inspect Outfall 1 due to the deterioration of the crack on top of the structure and the exposed wing wall that has been separated to determine next steps to fixing the structure. The City should clean out or grade the section around Outfall 2 to remove the stagnant water and dirt in outfall.

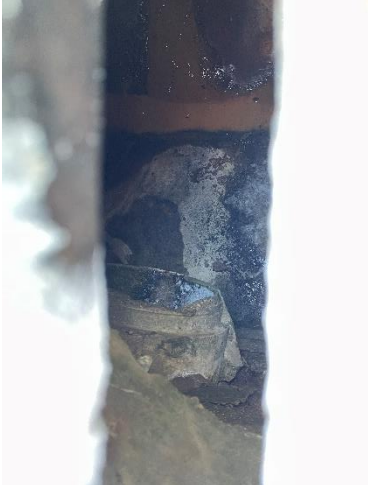
Outfall ID: 5	Outfall Material: RCP
Size: 36"	Condition: Fair – Could not open crate over manhole.

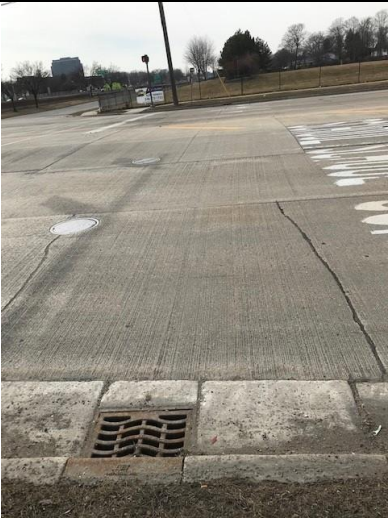
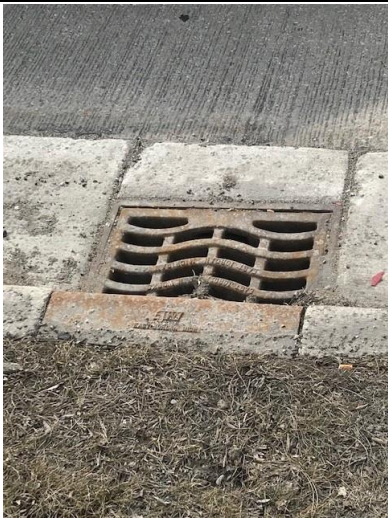
Outfall ID: 6 – Remove	Outfall Material:
Size: 12"	Condition: Road catch basin

Outfall ID: 7	Outfall Material: RCP
Size: 84"	Condition: Good

Outfall ID: 8	Outfall Material: Unknown
Size: 54"	Condition: Good

The sample taken at Outfall 4 did not result in high levels of E. coli so no further action is required there. Lathrup Village should eliminate Outfall 6 and update any documents to reflect this change. This should be added to the number of catch basins the City has. During the next permit reissuance cycle, EGLE should be notified of this change.

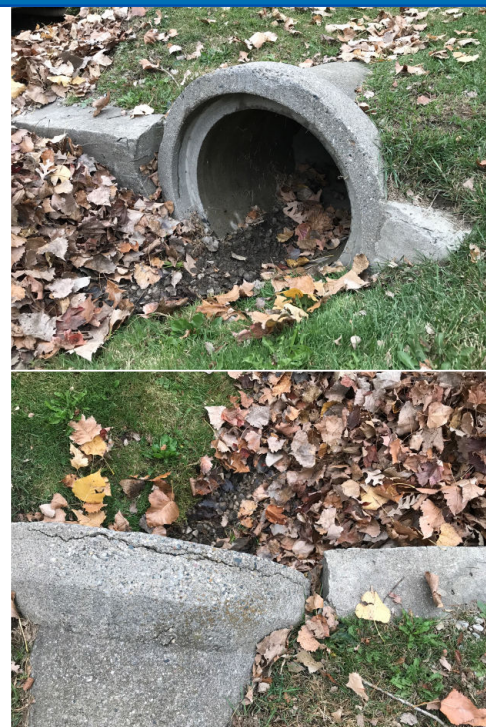
Outfall ID: LV1

Location:	Lathrup Village	Flow Comments:	N/A
Date Inspected:	10/29/2020 12:39:26 PM	Water Turbidity:	N/A
Investigator:	A. Allen	Water Color:	N/A
Address:	19030 Roseland	Other Color:	N/A
Drain Name:	Rummell Drain	Temperature:	0
Last Rainfall:	10/27/2020	Odor:	N/A
Blockage:	Clean	Floatables:	N/A
Size Inches:	24"	Other Floatables:	N/A
Comments: Crack on top of structure and wing wall is separating. Exposed on top.			
Material:	RCP	Deposits Stains:	N/A
Other Material:	N/A	Other Deposits Stains:	N/A
Dry Flow:	No	Visible Debris:	None
Flow Rate:	N/A	Structural Condition:	Fair
Presence/Absence of Flow:	No - Absence	Complete:	Yes

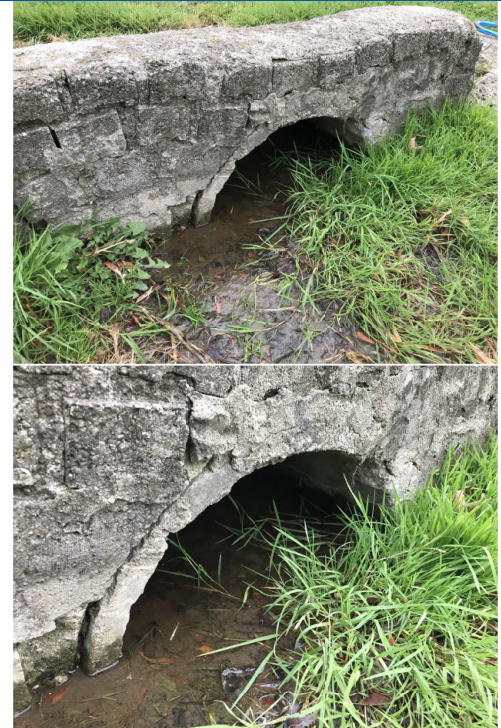
Outfall ID: LV2

Location:	Lathrup Village	Flow Comments:	N/A
Date Inspected:	10/29/2020	Water Turbidity:	N/A
Investigator:	A. Allen	Water Color:	N/A
Address:	19120 Wiltshire	Other Color:	N/A
Drain Name:	Rummell Drain	Temperature:	N/A
Last Rainfall:	10/27/2020	Odor:	N/A
Blockage:	25%	Floatables:	N/A
Size Inches:	Other	Other Floatables:	N/A
Comments: Stagnant water and dirt in outfall. Recommend cleaning out or grading section.			
Material:	RCP	Deposits Stains:	N/A
Other Material:	N/A	Other Deposits Stains:	N/A
Dry Flow:	No	Visible Debris:	Natural
Flow Rate:	N/A	Structural Condition:	Poor
Presence/Absence of Flow:	No - Absence	Complete:	Yes

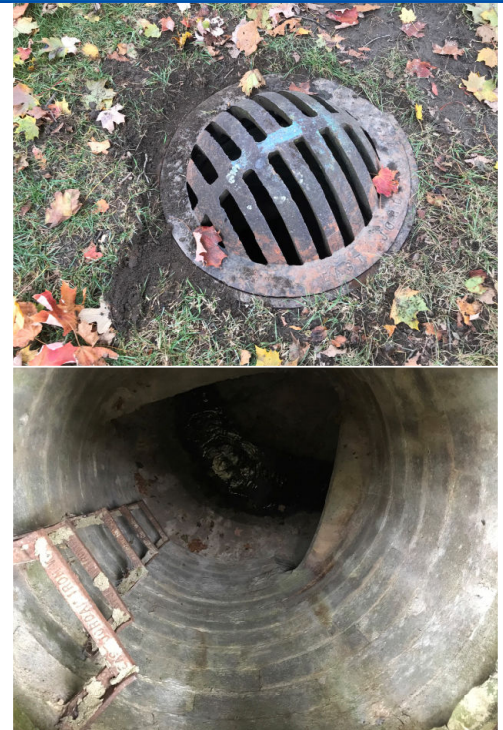
Outfall ID: LV3

Location:	Lathrup Village	Flow Comments:	Not enough water flow to sample.
Date Inspected:	10/29/2020	Water Turbidity:	N/A
Investigator:	A. Allen	Water Color:	N/A
Address:	28425 Woodworth Way	Other Color:	N/A
Drain Name:	Rummell Drain	Temperature:	N/A
Last Rainfall:	10/27/2020	Odor:	N/A
Blockage:	N/A	Floatables:	N/A
Size Inches:	Other	Other Floatables:	N/A
Comments: Upstream manhole. Original outfall cannot access as it's buried.			
Material:	N/A	Deposits Stains:	N/A
Other Material:	N/A	Other Deposits Stains:	N/A
Dry Flow:	Yes	Visible Debris:	None
Flow Rate:	N/A	Structural Condition:	Poor
Presence/Absence of Flow:	No - Absence	Complete:	Yes

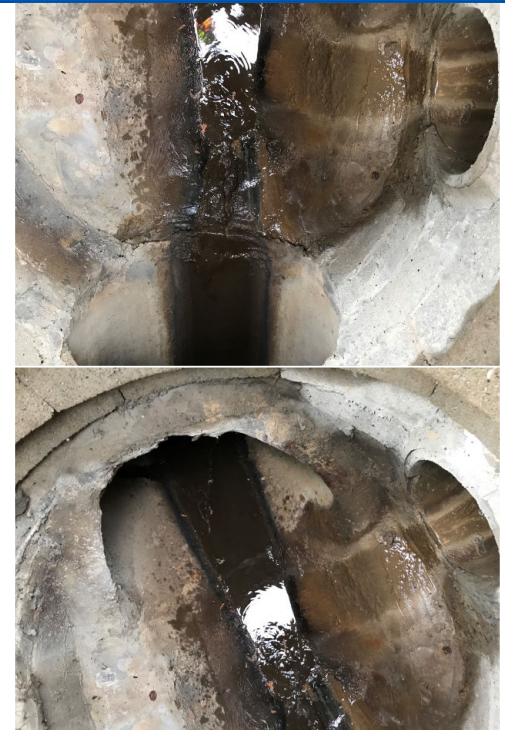
Outfall ID: LV4

Location:	Lathrup Village	Flow Comments:	N/A
Date Inspected:	10/29/2020 2:40:41 PM	Water Turbidity:	Clear
Investigator:	A. Allen	Water Color:	Clear
Address:	Saratoga and Evergreen	Other Color:	N/A
Drain Name:	Rummell Drain	Temperature:	0
Last Rainfall:	10/27/2020	Odor:	None
Blockage:	Clean	Floatables:	None
Size Inches:	Other	Other Floatables:	N/A
Comments: At intersection. Manhole on South side of Saratoga as you turn from Evergreen.			
Material:	RCP	Deposits Stains:	Other
Other Material:	N/A	Other Deposits Stains:	N/A
Dry Flow:	Yes	Visible Debris:	None
Flow Rate:	Slow	Structural Condition:	Good
Presence/Absence of Flow:	Yes - Presence	Complete:	Yes

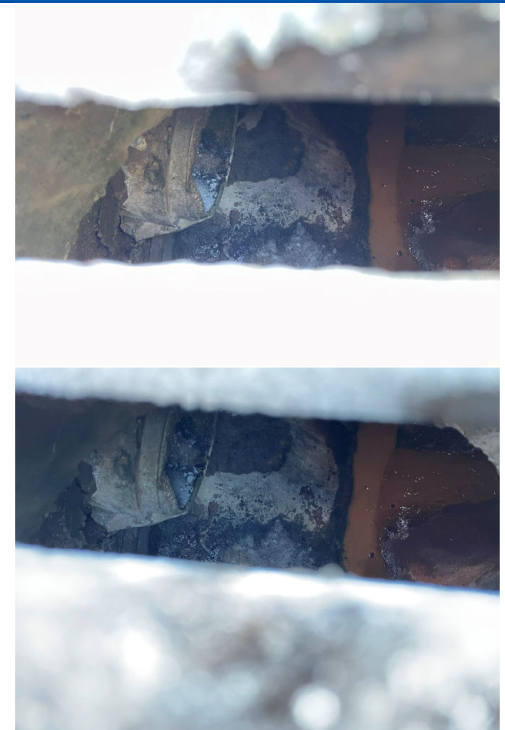
Outfall ID: LV5

Location:	Lathrup Village	Flow Comments:	N/A
Date Inspected:	2/11/2021 3:05:52 PM	Water Turbidity:	N/A
Investigator:	A. Allen	Water Color:	N/A
Address:	27456 Evergreen	Other Color:	N/A
Drain Name:	Rummell Drain	Temperature:	0
Last Rainfall:	2/9/2021	Odor:	N/A
Blockage:	N/A	Floatables:	N/A
Size Inches:	36"	Other Floatables:	N/A
Comments: Could not open crate over manhole. Pipe connecting to the north and to the east.			
Material:	RCP	Deposits Stains:	N/A
Other Material:	N/A	Other Deposits Stains:	N/A
Dry Flow:	No	Visible Debris:	N/A
Flow Rate:	N/A	Structural Condition:	Fair
Presence/Absence of Flow:	No - Absence	Complete:	Yes

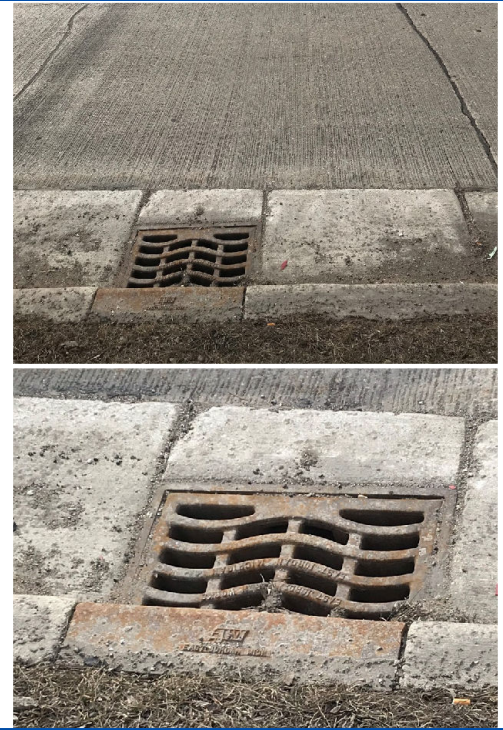
Outfall ID: LV6

Location:	Lathrup Village	Flow Comments:	N/A
Date Inspected:	3/9/2021	Water Turbidity:	N/A
Investigator:	A. Allen	Water Color:	N/A
Address:	Evergreen	Other Color:	N/A
Drain Name:	Rummell	Temperature:	N/A
Last Rainfall:	2/28/2021	Odor:	N/A
Blockage:	N/A	Floatables:	N/A
Size Inches:	N/A	Other Floatables:	N/A
Comments: Road catch basin located here off of Evergreen. Intake of flow from road and nothing else.			
Material:	N/A	Deposits Stains:	N/A
Other Material:	N/A	Other Deposits Stains:	N/A
Dry Flow:	No	Visible Debris:	N/A
Flow Rate:	N/A	Structural Condition:	N/A
Presence/Absence of Flow:	No - Absence	Complete:	Yes

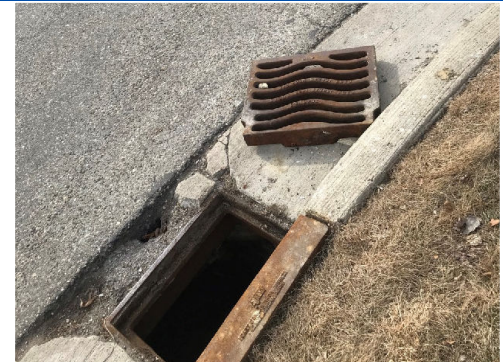
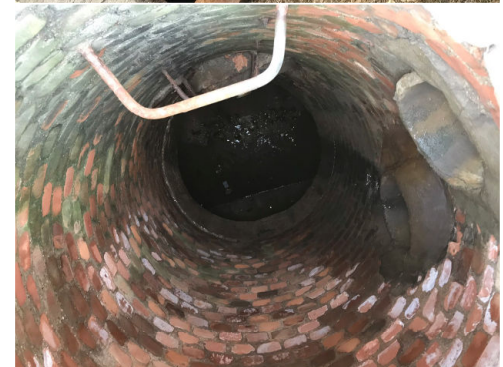
Outfall ID: LV7

Location:	Lathrup Village	Flow Comments:	N/A
Date Inspected:	3/9/2021 7:41:53 PM	Water Turbidity:	N/A
Investigator:	A. Allen	Water Color:	N/A
Address:	Red Run Dr and 11 Mile	Other Color:	N/A
Drain Name:	Rummell	Temperature:	0
Last Rainfall:	2/28/2021	Odor:	N/A
Blockage:	N/A	Floatables:	N/A
Size Inches:	12"	Other Floatables:	N/A
Comments: Catch basin on curb off of 11 Mile. Very slow flow coming from northeast pipe. Could not catch enough water. Could not capture water on very bottom of pipe as stick was not long enough. Water was flowing west.			
Material:	RCP	Deposits Stains:	N/A
Other Material:	N/A	Other Deposits Stains:	N/A
Dry Flow:	No	Visible Debris:	N/A
Flow Rate:	Slow	Structural Condition:	Good
Presence/Absence of Flow:	No - Absence	Complete:	Yes

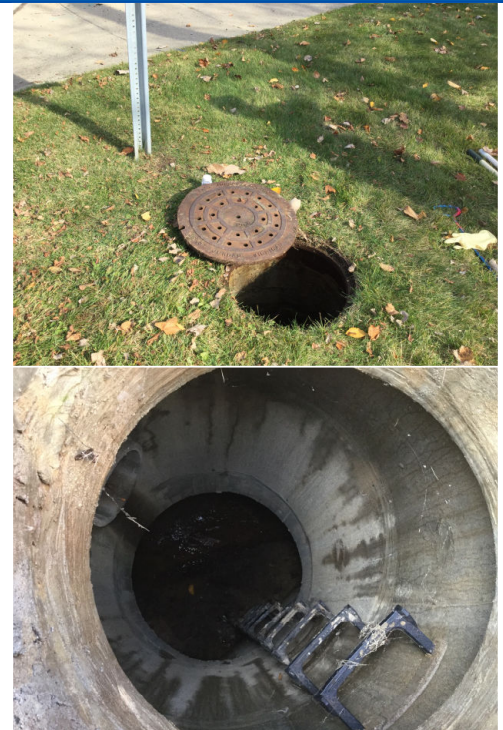
Outfall ID: LV8

Location:	Lathrup Village	Flow Comments:	Minimal flow. Cannot capture.
Date Inspected:	10/29/2020	Water Turbidity:	N/A
Investigator:	A. Allen	Water Color:	N/A
Address:	18951 Rainbow Ct	Other Color:	N/A
Drain Name:	Rummell Drain	Temperature:	N/A
Last Rainfall:	10/27/2020	Odor:	N/A
Blockage:	Clean	Floatables:	N/A
Size Inches:	54"	Other Floatables:	N/A
Comments: Cannot see structure.			
Material:	N/A	Deposits Stains:	N/A
Other Material:	N/A	Other Deposits Stains:	N/A
Dry Flow:	Yes	Visible Debris:	None
Flow Rate:	Moderate	Structural Condition:	Good
Presence/Absence of Flow:	No - Absence	Complete:	Yes
