CITY OF LAUREL
ROADWAY IMPROVEMENT CONCEPT STUDY
[DRAFT]

VAN DUSEN ROAD IMPROVEMENTS

(CONTEE ROAD TO OLD SANDY SPRING ROAD)

November 26, 2023

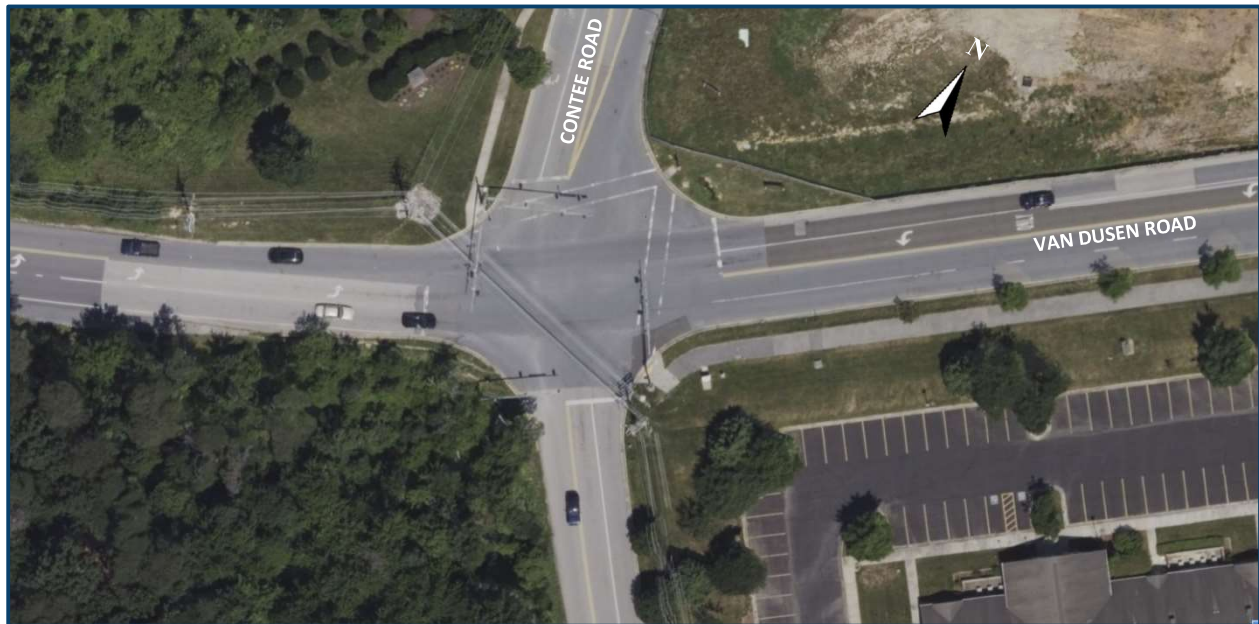
Figure 2
VAN DUSEN ROAD AT CONTEE ROAD

- Southbound Van Dusen Road exclusive/permissive left-turn and through signal indications were activated concurrently during every signal phase, even when there were no left-turning vehicles.
- Accessible Pedestrian Signal (APS)/Countdown Pedestrian Signal (CPS) are ono-compliant.
- Durations of the pedestrian clearance phases appear to be insufficient. They were observed at 16 seconds on the north leg and 18 seconds on the west leg. They should be 23/24 seconds.
- The signal appears to have been installed more than seventeen (17) years ago. Need to confirm the signal has routine operational and structural inspections.

- Southbound Van Dusen Road left-lane drops does not appear to be necessary.
- The eastbound and westbound Contee Road right turn bays have signing and/or pavement markings for a right lane drop.
- The north and west leg crosswalks are marked with 12 in. transverse pavement markings.

- All pedestrian ramps at this location are non-compliant due to 4 ft. ramp widths.
- The pedestrian bus pad along southbound Van Dusen Road is non-compliant due to slope.
- The bus stop along northbound Van Dusen Road is non-compliant due to no bus pad connection from the Hiker-Biker trail to Van Dusen Road.
- The north leg has 5 ft. sidewalk along southbound Van Dusen Road and an approximately 10 ft. Hiker-Biker trail along northbound Van Dusen Road.
- Also, the south leg has a goat path along northbound Van Dusen Road.

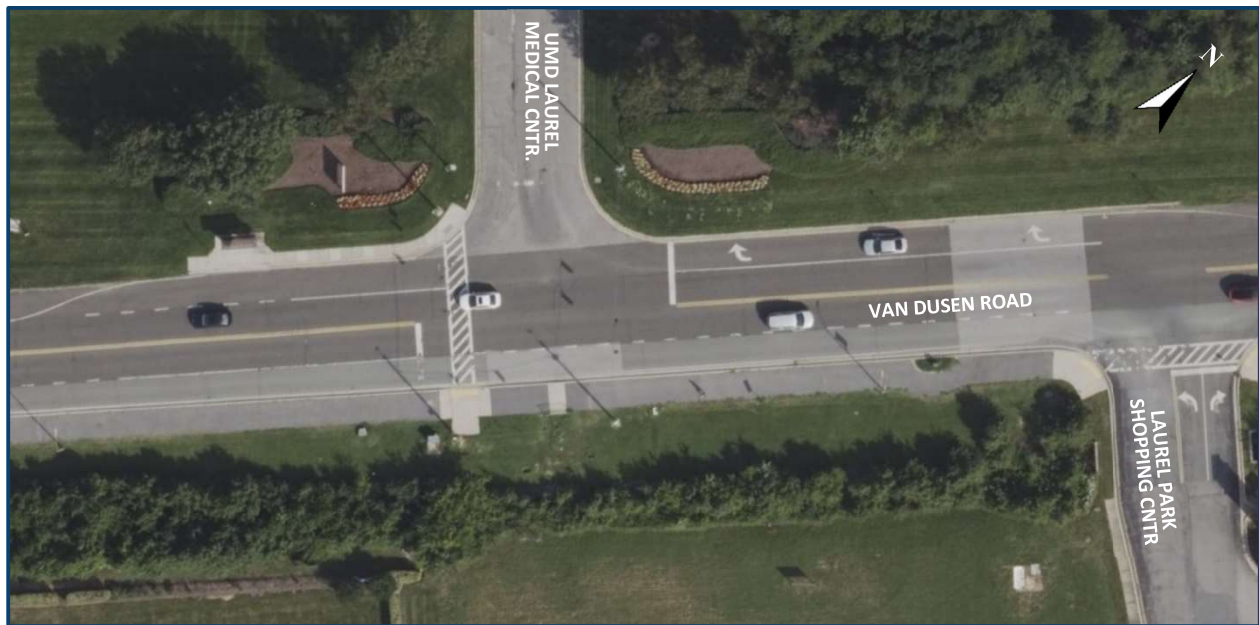
Figure 3
VAN DUSEN ROAD AT UMD LAUREL MEDICAL CENTER

- Pedestrian signals and pushbuttons are not APS/CPS-compliant.
- The signal appears to have been installed more than twenty-eight (28) years ago.
- Need to confirm the signal has routine operational and structural inspections.

- The south leg crosswalk is marked with 12 in. transverse pavement markings and additional 12 in. diagonal hatching.
- The diagonal hatching is angled the wrong way.
- The UMD Laurel Medical Center access pavement markings are faded so it is no longer visible.

- The pedestrian ramp within the southwest corner of the intersection at the UMD Laurel Medical Center is non-compliant due to a 4 ft. width.
- The bus stop at the southwest corner is compliant but the sidewalk is 4 ft. wide.
- There is an approximate 10 ft. Hiker-Biker trail along northbound Van Dusen Road.
- Additionally, the handrail at the inlet along northbound Van Dusen Road is non-compliant due to insufficient height requirements.

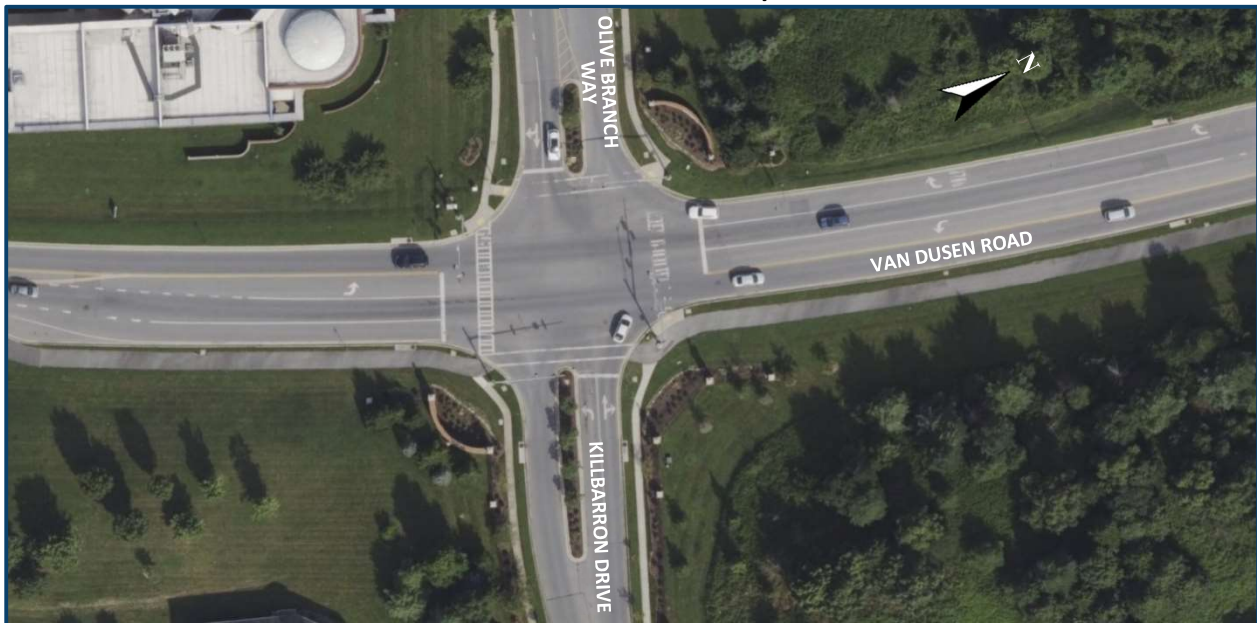
Figure 4
VAN DUSEN ROAD AT OLIVE BRANCH WAY/KILLBARRON DRIVE

- The northbound Van Dusen Road exclusive/permissive left turn phase was not operating correctly. The left turn phase would come up at multiple times during the through phase, when no vehicles were present. In addition, a resident commented that the southbound exclusive/permissive left turn phase is extremely short and only allows for one to two vehicles. This happens at all times of the day. A different resident commented that there is a lot of red light running at the intersection and was concerned about safety. The red-light-running was observed many times during the field observations.

- The pedestrian pushbuttons in the northeast and southwest quadrants were broken and not APS/CPS compliant. The duration of the pedestrian clearance phases appears to be insufficient. They were observed at 16 seconds but should be 20 seconds.

- The signal appears to have been installed more than eighteen (18) years ago. Need to confirm the signal has routine operational and structural inspections.

- The east and west leg crosswalks are marked with 12 in. transverse pavement markings.
- The north and south leg crosswalks are marked with 12 in. transverse pavement markings with additional 12 in. longitudinal lines.

- All pedestrian ramps at this location are non-compliant. The pedestrian ramps along the east leg of the intersection are missing detectable warning surfaces; all the other ramps are non-compliant due to 4 ft. width and slope requirements.
- There are non-compliant bus stops in the northwest and southeast corners without pedestrian bus pads.
- The sidewalks along Olive Branch Way are approximately 4 ft. wide.
- The Hiker-Biker trail along northbound of Van Dusen Road is approximately 10 ft. wide and has overhanging tree branches.

- A roadside swale conveys runoff from the adjacent property from the south towards the intersection. A low spot in topography was observed at the southwest quadrant of the intersection. It is likely during high intensity storm events that runoff will pond at this low spot and spill into the roadway. Runoff will continue to flow north, across the Olive Branch Way intersection towards the next downstream inlet located approximately 260 ft. north of the intersection. Runoff from these high intensity storm events are likely excessive with the potential to create an adverse safety condition for drivers.

A low spot in topography was observed at the southwest quadrant of the Van Dusen Road and Olive Branch Way/Killbarron Drive intersection. During heavy rainfall events, runoff may pond at this location and spill into the roadway, with the potential to create an unsafe condition for motorists. Drainage computations may be required to demonstrate the existing storm drain system has the capacity to convey the additional runoff. In addition, Utility test pits may be necessary at a later design phase of the project to identify and avoid utility impacts.

A low spot in topography was observed at the southwest quadrant of the Van Dusen Road and Olive Branch Way/Killbarron Drive intersection. During heavy rainfall events, runoff may pond at this location and spill into the roadway, with the potential to create an unsafe condition for motorists. **Recommend**

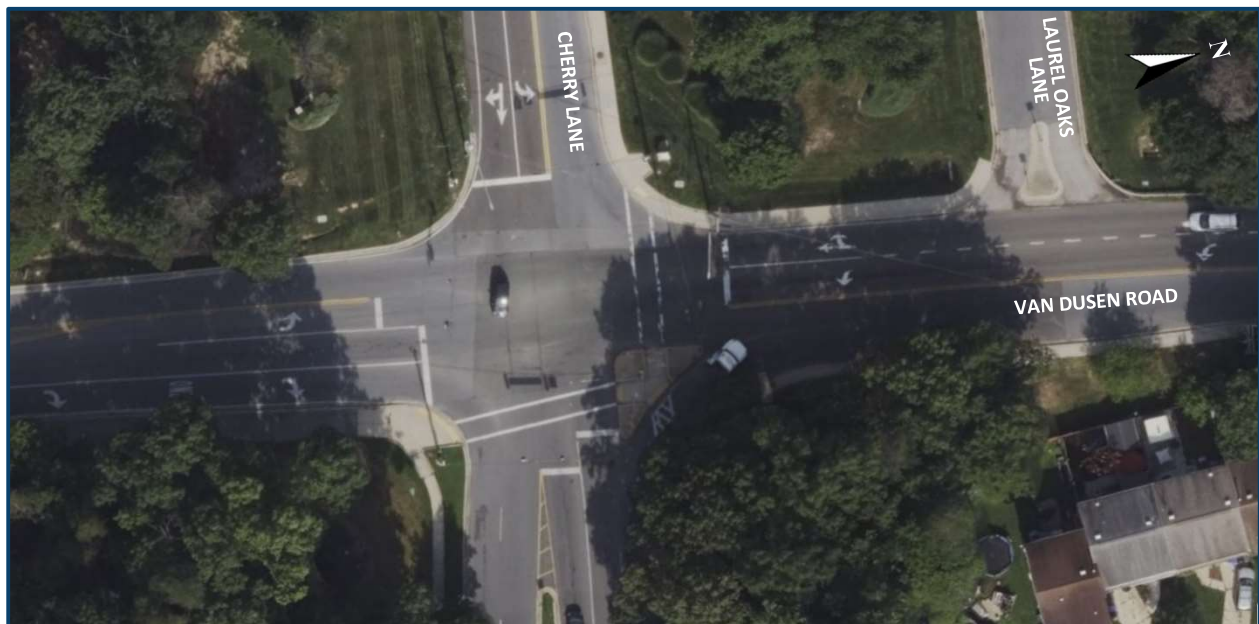
Figure 5
VAN DUSEN ROAD AT CHERRY LANE

- The pedestrian pushbuttons are not APS/CPS compliant.
- The durations of the pedestrian clearance phases are insufficient. They were observed at 12 seconds and should be 15 seconds.
- The signal appears to have been installed more than eighteen (18) years ago. Confirm the signal has routine operational and structural inspections.

- The north and east leg crosswalks are marked with 12 in. transverse pavement markings.
- The east leg channelized right turn pedestrian crossing is diagonally hatched.
- Many school children use the crosswalks. All of them used the pushbuttons.
- There are no school crossing or standard school zone signs.
- The pavement markings and signing for the westbound Cherry Lane right and left lane drops are not correct.
- The MD 198 and I-95 trailblazer assemblies along Cherry Lane are not correct.

- All pedestrian ramps in the concrete island at Cherry Lane are ADA-compliant, including the ramp in the northeast corner of Van Dusen Road and Cherry Lane.
- The northeast ADA ramp is adjacent to a 4 ft. sidewalk that transitions to 5 ft. just for the ramp.
- The southeast ADA ramp has a detectable warning surface that is too long and there is no connecting ramp in the southwest corner.
- The sidewalk in the northeast corner is 4 ft. wide, the northwest sidewalk along Van Dusen Road is 5 ft. wide, and the Hiker-Biker trail along the southeast leg of Van Dusen Road is approximately 10 ft. wide.
- There is an ADA ramp at Laurel Oaks Lane that leads to a raised island without pedestrian cut-through access.

- Traffic barrier at this location is non-compliant due to insufficient height requirements.

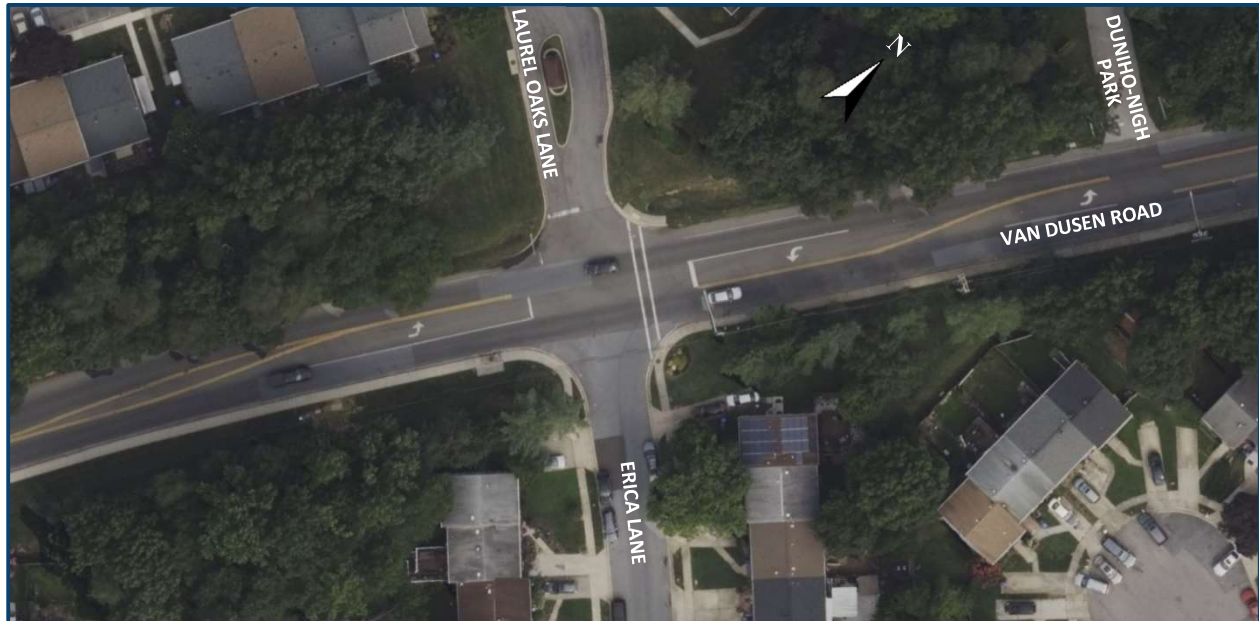
Figure 6
VAN DUSEN ROAD AT LAUREL OAKS LANE/ERICA LANE

- Northbound and southbound Van Dusen Road are uncontrolled but there are stop lines in the northbound and southbound left turn bays.
- The north leg crosswalk is marked with 12 in. transverse pavement markings.
- There is no stop line for westbound Erica Lane.

- There is a school bus stop in the northwest quadrant that served 10-15 students.
- All pedestrian ramps are non-compliant in this location due to 4 ft. ramp widths and the adjacent 4 ft. sidewalk.
- There is a bus stop sign at the north leg but there is no bus pad.
- The bus stop in the south leg is compliant but the sidewalk is 4 ft. wide.
- There is no crosswalk across Erica Lane connecting the ADA ramps.

- The 24 in. concrete culvert located under Laurel Oaks Lane was observed to be clogged with sediment.

Recommend **trimming existing ditch** from approximately STA 158+50 LT to STA 160+00 LT (at upstream end of culvert under Laurel Oaks Lane) and from STA 160+30 LT (downstream end of culvert) to STA 162+80 LT.

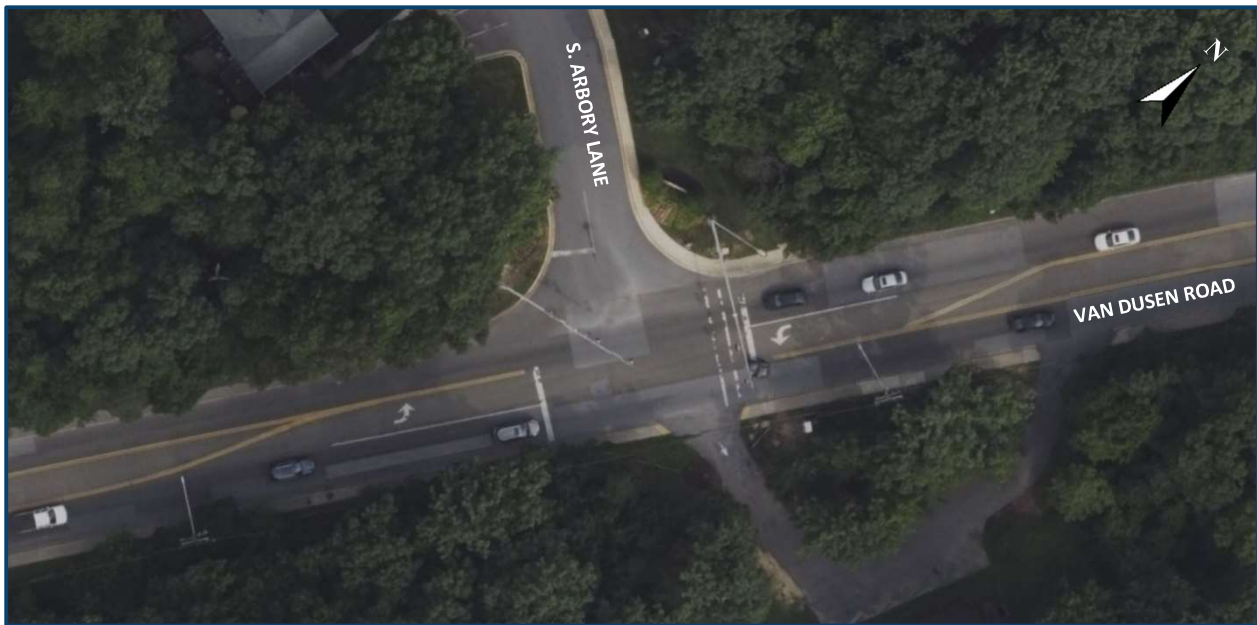
Figure 7
VAN DUSEN ROAD AT SOUTH ARBORY LANE

- The presence detection for the northbound Van Dusen Road left turn lane is not working properly. The exclusive/permissive left turn phase came up multiple times during the through phase when no vehicles were in the left turn lane. This causes southbound Van Dusen Road through vehicles to stop and queue unnecessarily.
- The pedestrian pushbuttons are not APS/CPS compliant.
- The signal appears to have been installed more than thirty-three (33) years ago. Need to confirm that the signal undergoes routine operational and structural inspections.

- The north leg crosswalk is marked with 12 in. transverse pavement markings.

- All pedestrian ramps at this location are non-complaint. Both pedestrian ramps along the east leg are non-complaint due to slope and adjoining 4 ft. sidewalk on both sides.
- There is no crosswalk connecting the east leg of the intersection.
- The north leg pedestrian ramp is non-complaint due to 4 ft. sidewalk width requirements.
- There is a bus stop sign in the northwest corner but no bus pad.

- The traffic barrier along southbound Van Dusen Road is non-compliant due to insufficient height requirements.

- Install a raised median within the footprint of the existing flush median north and south of S. Arbory Lane.
- Reconstruct all pedestrian ramps to meet ADA requirements.
- Install a pedestrian bus pad for the existing bus stops at STA 167+85 LT and STA 170+20 RT. The pedestrian bus pad at STA 170+20 RT will require a backer-curb and handrail due to a steep slope.
- Upgrade the Van Dusen Road at S Arbory Lane signal to include APS/CPS.
- Repair the northbound exclusive/permissive left turn presence detection so this phase only comes up when a vehicle is present.

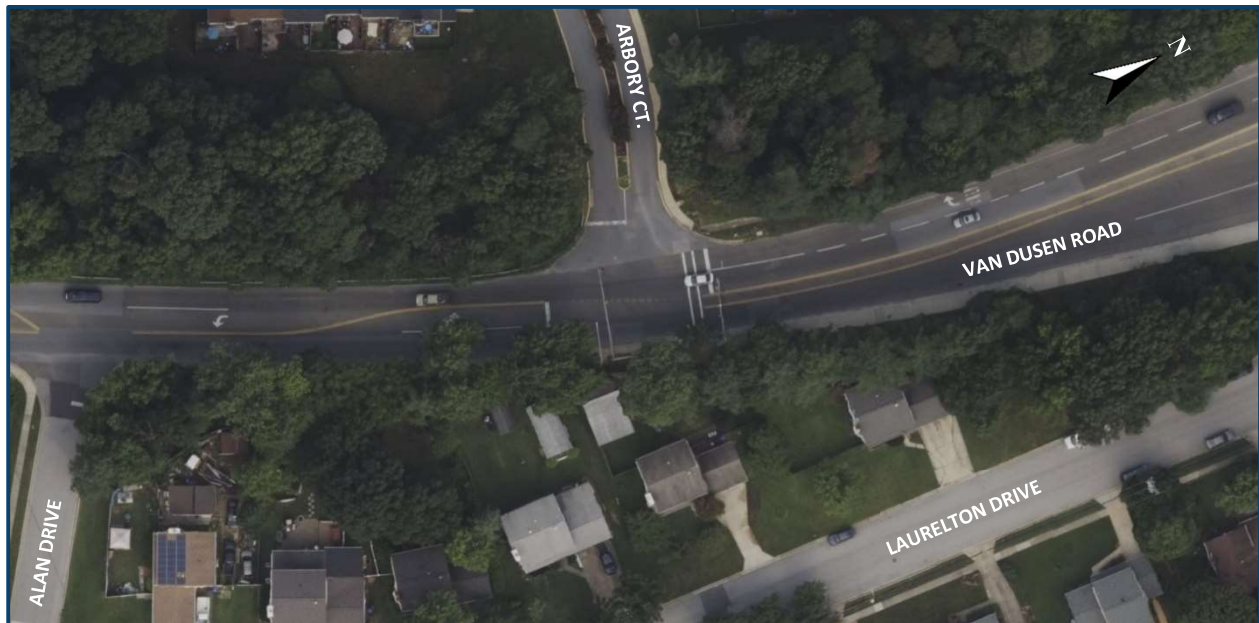
Figure 8
VAN DUSEN ROAD AT ARBORY COURT

- The presence detection for the northbound Van Dusen Road left turn lane is not working properly.
- The exclusive/permissive left turn activates when no vehicles are present in the left turn lane. This causes the southbound Van Dusen Road through vehicles to stop and queue unnecessarily.
- Also, the presence detection for eastbound Arbory Court is not working properly. A resident commented that a vehicle at the stop line does not always send a call. This delay causes some drivers to run the red light or turn right and turn around.
- The pedestrian pushbuttons are not APS/CPS compliant.
- The walk phase (16 seconds) and pedestrian clearance phase (7 seconds) are reversed.
- The signal appears to have been installed more than 24 years ago. Confirm the signal has routine operational and structural inspections.

- The pavement markings and signing for the southbound Van Dusen Road lane-drops are not correct.
- The north leg crosswalk is marked with 12 in. transverse pavement markings.

- Both pedestrian ramps at this intersection are non-compliant. The ramp in the northwest corner does not have a detectable warning surface and the ramp in the northeast corner does not meet slope requirements.
- The 8 ft. sidewalk along northbound Van Dusen Road transitions into a 4 ft. non-compliant sidewalk.

- The traffic barrier along southbound of Van Dusen is not the proper height.

- The 18 in. concrete culvert located under Arbory Court was observed to be clogged with sediment.

- Reconstruct all pedestrian ramps to meet ADA requirements.
- Upgrade the Van Dusen Road at Arbory Court signal to include APS/CPS and evaluate the pedestrian clearance intervals. Repair the northbound exclusive/ permissive left turn presence detection so this phase only comes up when a vehicle is present. Also repair the eastbound Arbory Court presence detection so it does detect a vehicle on Arbory Court.
- Trim existing ditch from approximately STA 172+00 LT to STA 173+60 LT (at downstream end of culvert under Arbory Court).

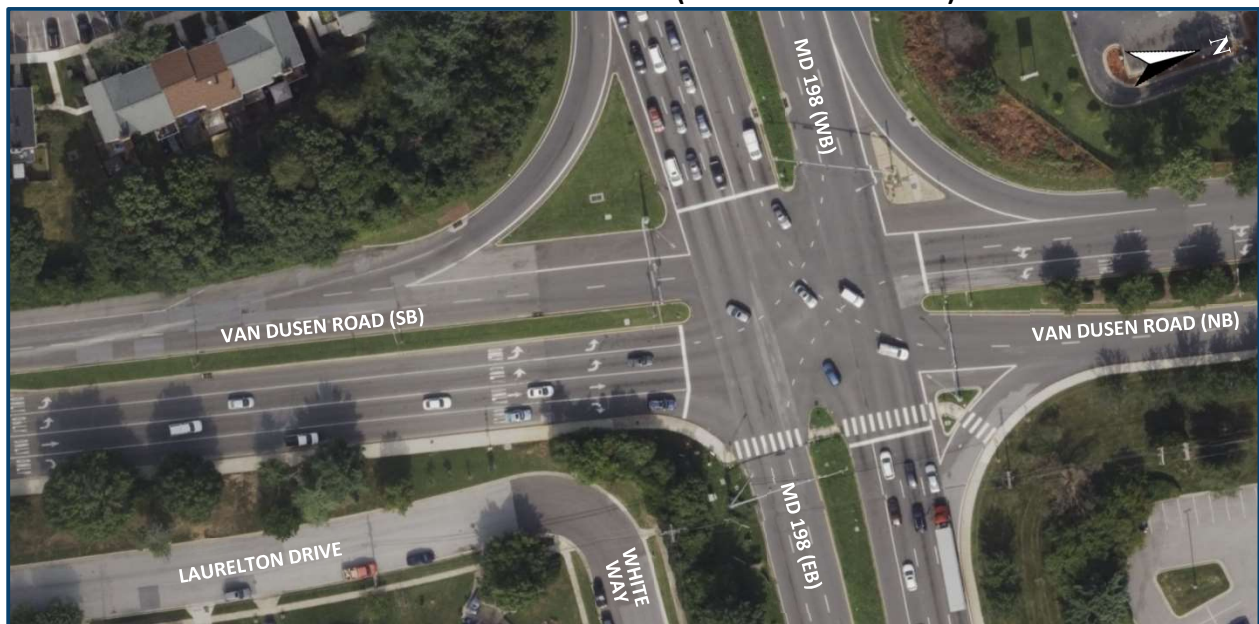
Figure 9
VAN DUSEN ROAD AT MD 198 (SANDY SPRING ROAD)

- The ONLY pavement markings are not necessary in the northbound and southbound Van Dusen Road left turn bay or the northbound right turn bay.
- There are no advanced trailblazer assemblies for MD 198 along southbound Van Dusen Road.
- The northbound Van Dusen Road pavement markings are incorrect.
- The advanced signing along northbound Van Dusen Road is in poor condition and incorrect.
- The W6-1 divided highway sign in the south leg median nose and the southbound W4-2R sign, south of MD 198 are not correct.

- All ramps and sidewalk at this intersection are compliant.
- The sidewalk along northbound of Van Dusen Road is 8 ft. wide.

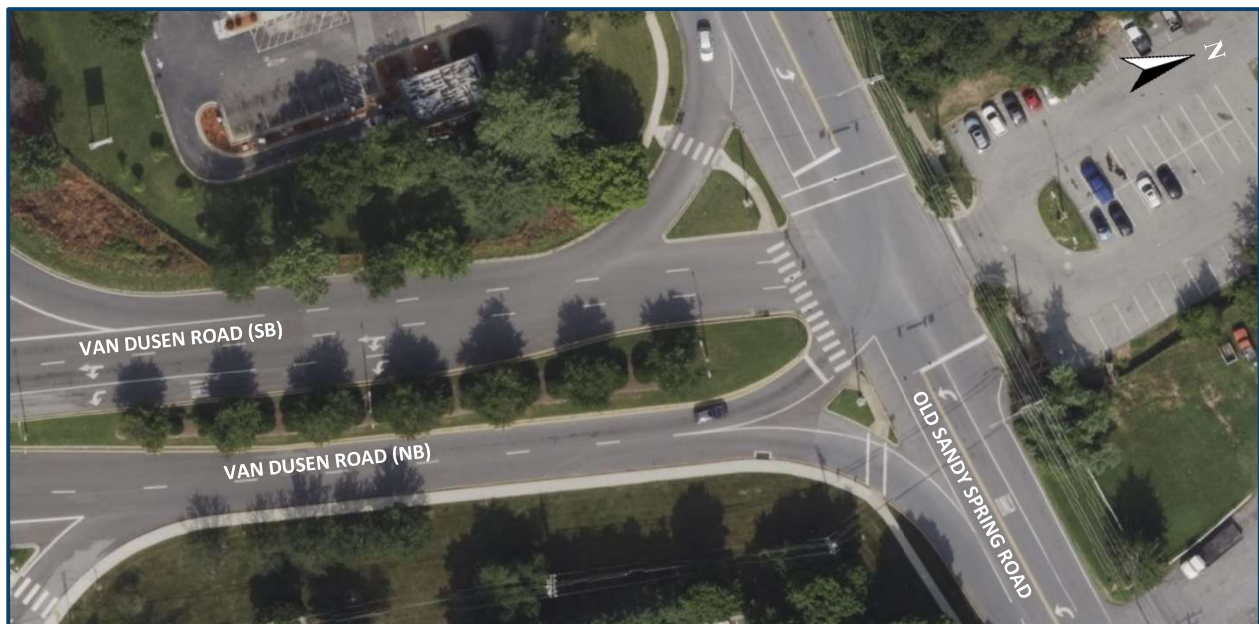
Figure 10
VAN DUSEN ROAD AT OLD SANDY SPRING ROAD

- The west leg and north leg channelized right turn crosswalks are marked with 12 in. transverse pavement markings.
- The existing high visibility continental crosswalk on the south leg does not align with vehicle wheel paths.
- The 5 in. solid white, arrow and ONLY pavement markings for the eastbound and westbound left turn bays are incorrect.
- The location of the north leg stop line encourages vehicles to block the sidewalk path.
- The R4-7a sign in the south leg median nose and yield signs are in poor condition.
- The pedestrian and down arrow signs for the channelized crossings are fluorescent yellow green.
