STORM WATER MASTER PLAN & CAPITAL IMPROVEMENT PROGRAM

CITY OF LAWRENCEVILLE
GWINNETT COUNTY, GEORGIA

Hussey Gay Bell Project No. 22-0006-C
OCTOBER 2023

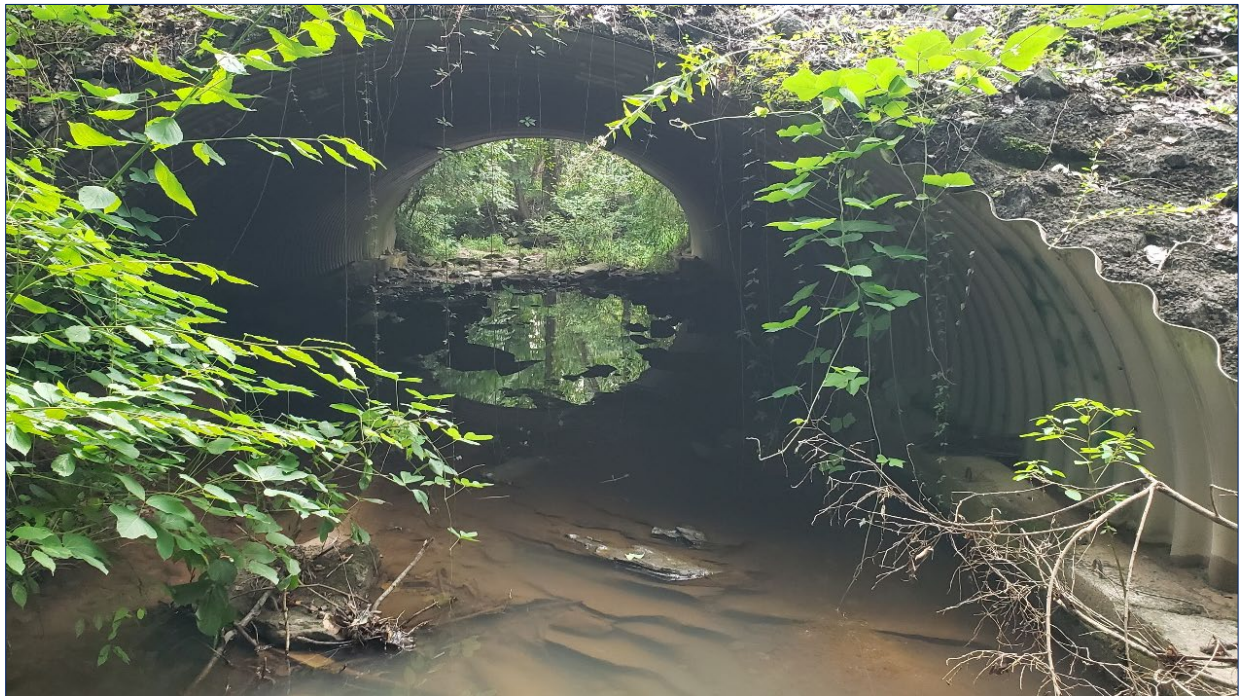
The culvert shown above is listed as an 84"x240" elliptical CMP that is part of a double barrel road crossing of Sarah Lane in the Pew Creek basin. It has an approximate watershed basin of 1,140 acres for storm water conveyance.

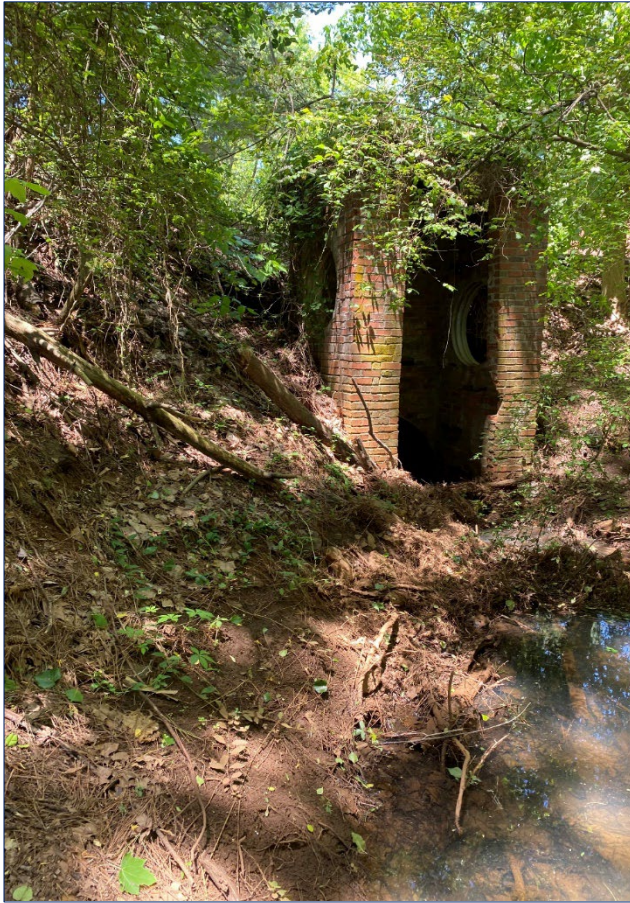
The pond shown at left has an outlet control structure that is in disrepair, has invasive growth, and can no longer function as designed.

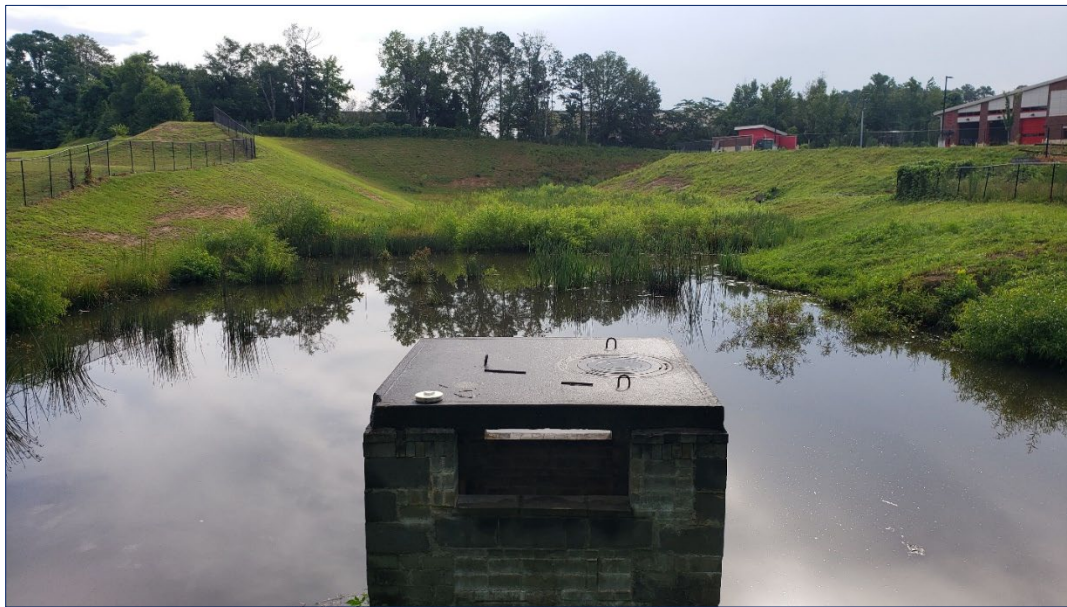
The pond, below, is well maintained and is able to treat the storm water runoff as well as detain water in the event of heavy rainfall.

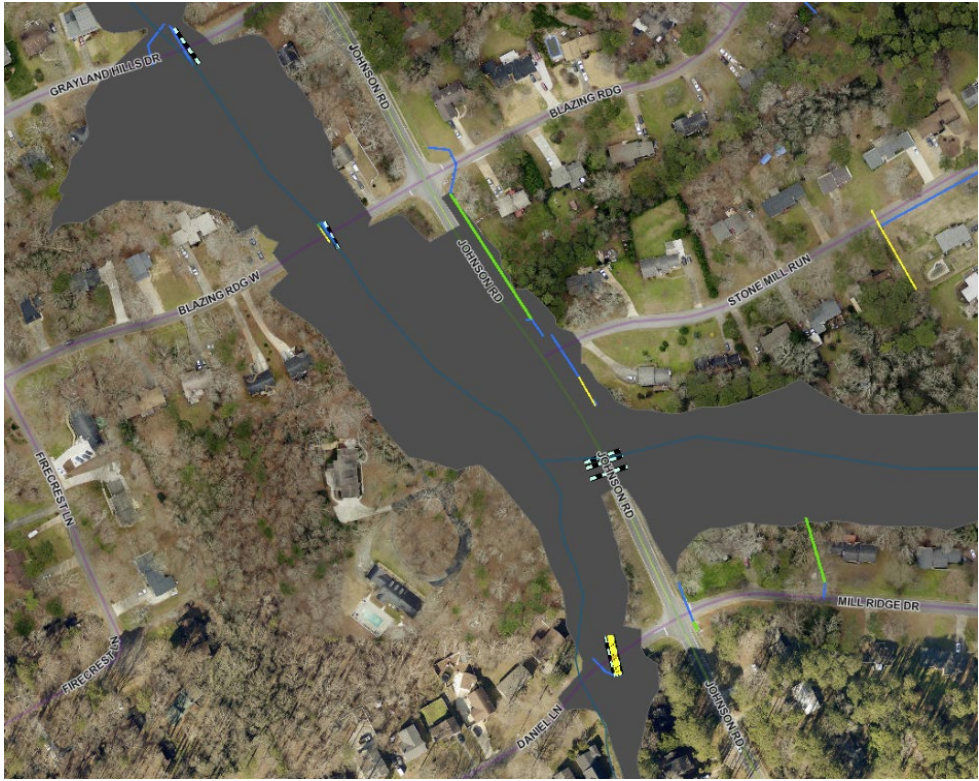
1-Blazing Ridge, 5-Daniel Lane and 8-Grayland Hills Dr.

No.	Street Name	Comment
1 A	Blazing Ridge W	96" CMP with moderate corrosion. Backwater does not appear to place houses within the flood plain.
2	Carithers Rd.	Shows on Gwinnett flood map. Drainage area less than 100 acres.
3 A	Channel Dr.	(2) 60" RCP. Upstream houses do not appear to be within the 100-year boundary.
4 I	Clearsprings Dr.	(2) 54" CMPs with moderate-severe corrosion. Eleven upstream houses are within the 100-year flood boundary.
5 I	Daniel Lane at Johnson Rd. and Mill Ridge	(3) 48" CMP with moderate to severe corrosion. One house may be within the 100-year flood plain due to backwater.
6	Dogwood Dr.	There are multiple private driveway culverts that may be contributing to backwater in road. No houses appear to fall within the 100-year flood limit.
7	Forest Valley Rd.	Flooding appears to be a result of culvert under Scenic Hwy. – study by Gwinnett County. Maple Wood Dr. also overtops. Four houses appear to be within the 100-year backwater from Scenic Hwy.

8 I A	Grayland Hills Dr.	72" CMP with moderate to severe corrosion, backwater appears to place four houses in the 100-year flood plain.
9	Grizzly Pkwy. near Spring Cir. and Northdale Rd.	Grizzly Pkwy. was constructed after the flood study was completed. Update study. Northdale Rd. overtops – Gwinnett Study.
10 I A	Gwinnett Dr. – near Nash	The 36" CMP (moderate to severe condition) under Gwinnett Drive and connecting downstream pipes through school property are undersized. Flows overtopping the Gwinnett Dr. travel through the school's parking lot. One building falls within the 100-year flood zone. Significant base flow through system.
11 A	Gwinnett Dr. near Stone Mountain St.	Culverts under Gwinnett Dr. appear undersized. Fairly recently culvert replacement/relining occurred in this area. 3-4 commercial buildings appear to be within the flood plain limit.
12	Harris Dr.	The downstream ditch is full of water year-round and does not drain. Two houses, downstream of crossing, appear to be in the 100-year flood limit and backwater from Industrial Park Dr.

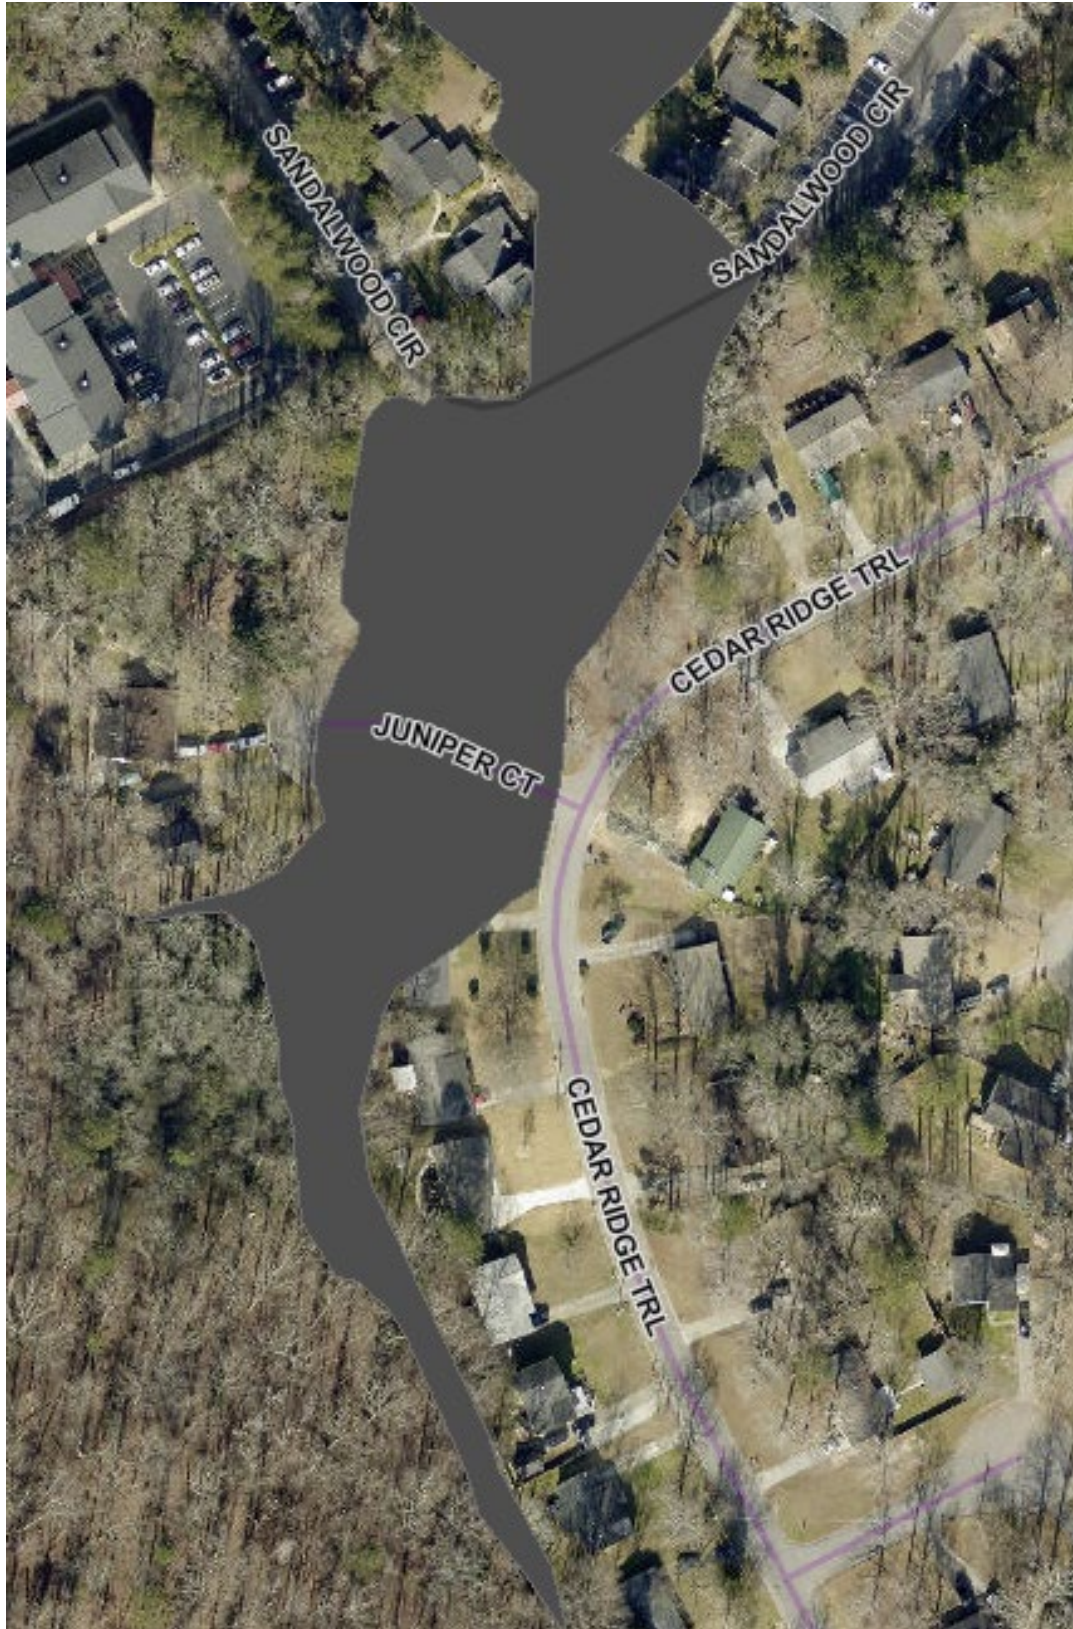
17-Juniper Ct. and 28-Sandalwood Cir.

* 15 A	Hurricane Shoals – 316	Upstream buildings appear to be outside of the flood limits.
* 16	Hurricane Shoals – Old Norcross	One upstream commercial building appears to be within the 100-year flood plain.
17 IA	Juniper Ct.	The 66" CMP under Juniper has significant sediment buildup and corrosion. Additionally, the downstream channel is full of water and sediment and does not drain. The downstream private piped system is inadequate for a 100-year storm. Four houses appear to be within the 100-year flood limit. This location require further detailed study to determine the best solution. Immediate clearing of downstream channel is recommended.
*18 I	Lakeview Road (City Park)	No buildings within the 100-year flood limit. Maintenance for culvert is in question. GIS shows city-maintained road within Rhodes Jordan Park.
*19	Langley Dr.	Backwater from culvert under Langley and/or contributing upstream pipe systems results in one or two upstream office buildings within the flood plain. Portions of the upstream area may have been developed after flood study was completed.

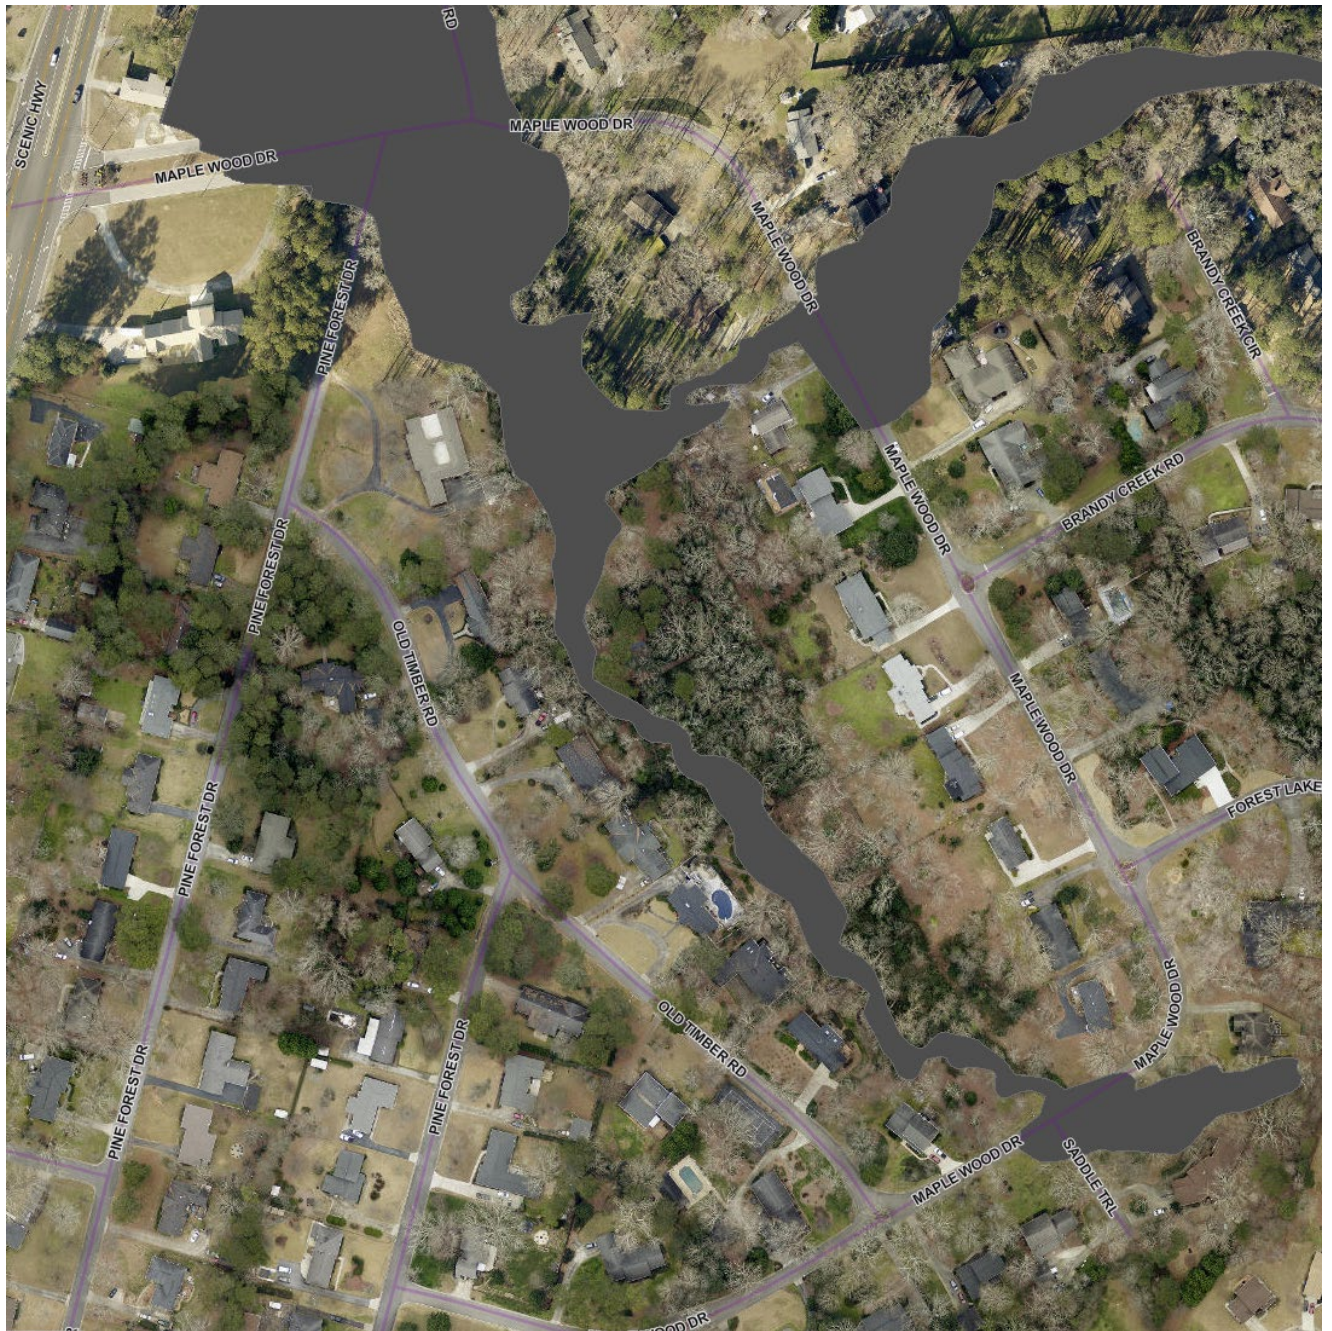
20-Maplewood Dr. – three (3) crossings

20	Maplewood Dr. (3 crossings)	48" HDPE north of Brandy Creek Rd. intersection appears to be undersized resulting in two houses being within the flood boundary. The 48" CMP crossing near Saddle Trail appears undersized; however, no houses appear to be within the flood limit as a result. See Forest Valley Rd. for the third crossing.
21	Paper Mill Rd. – near Paper Mill Dr.	Two 36" h x 54" w Elliptical RCPs appear undersized. No upstream houses adversely affected.
22 IA	Pike Park Dr.	Two 72" CMP in poor condition. One commercial building is near the flood boundary.
23 A	Private drive at Mulberry Place Apartments	No buildings appear to be affected by the undersized culvert.
24	Nash St. (Update required)	Nash St. is shown in the flood plain; however, the flood study was done prior to Nash St. extension to Gwinnett Dr. Refer to Gwinnett Dr. – near Nash St. for description.

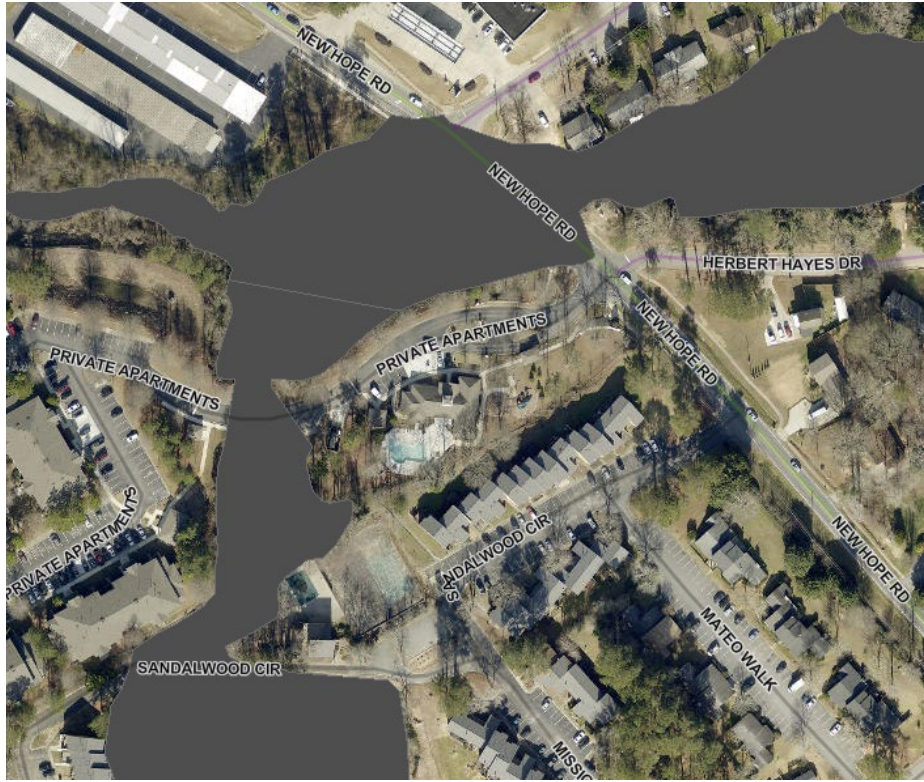
27-New Hope Rd. near Herbert Hayes Dr. and
25-Private drive to the Oaks at New Hope Rd.

25 A	Private drive to Oaks at New Hope	84" RCP is in good condition. Appears to overtop in 100-year storm. No buildings appear to be within the flood limit.

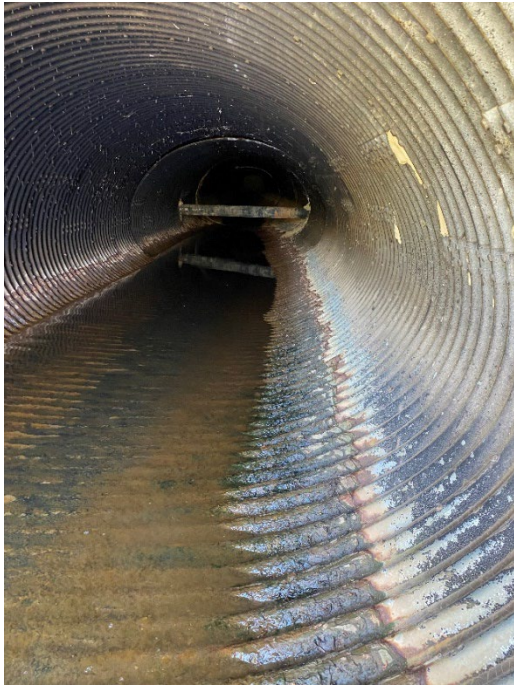
View of interior of pipe. Corrosion evident at interface of baseflow (water), air and steel pipe. An obstruction (gasline) is evident in this photograph.

downstream end of the pipe. Thus, if a pipe is listed as poor condition, it is important to collect more information on that pipe. A closed-captioned television (CCTV) inspection of the pipe will be necessary to obtain more reliable information and is less expensive than other methods of evaluating pipe conditions between structures.
