**RE: TECHNICAL MEMORANDUM**

**Follow Up Traffic Safety Assessment of the Evers Road and Adair Drive  
Leon Valley, Texas**

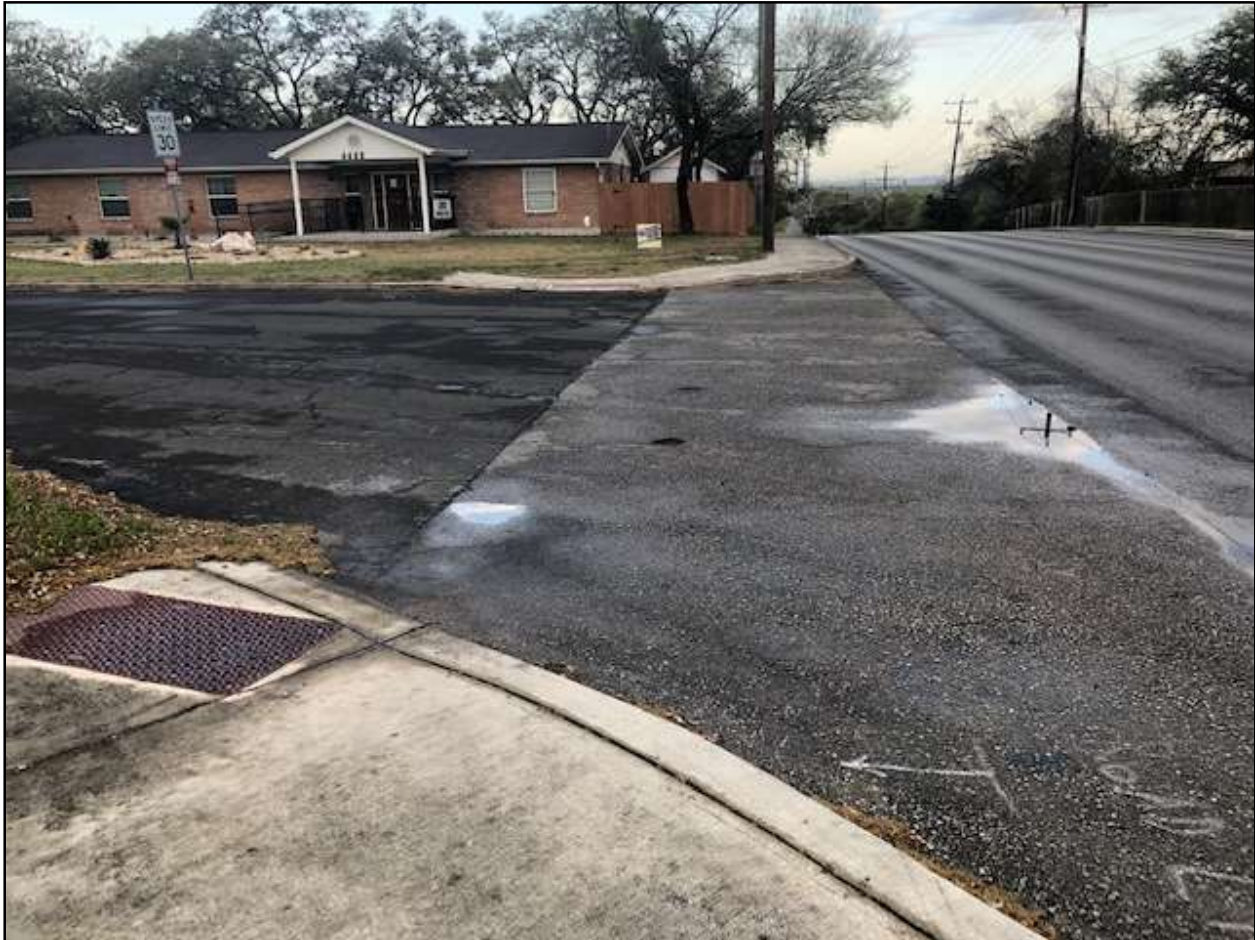
**Figure 3. View from the Adair Drive approach to Evers Road**

Intersection Sight Distance (ISD) is the length of roadway visible to the driver at a stopped condition, typically at the stop bar of a stop-controlled intersection. Intersection sight distance is measured from a point located approximately 3.5’ above ground level (driver’s eye height for passenger cars) and approximately 14.5’ from the edge of travel lane to a point located approximately 335’ (assuming 30 miles per hour) from the intersection and 3.5’ above ground level. Figure 2 below illustrates the intersection sight distance triangles for vehicles at a stop-controlled intersection. Intersection sight distance for the Adair Drive approach to Evers Road is observed to be less than the required 335’ and may benefit from warning signage. Figure 3 illustrates the existing intersection sight distance, facing west along Evers Road.

Sight distance is also obstructed by an existing privacy fence at the south-west corner of the intersection, further limiting visibility of vehicles approaching along eastbound Evers Road towards Adair Drive, shown in Figure 3.

Currently, the Evers Road approaches to Adair Drive are striped for two-lanes in each direction of travel and no shoulders. Adair Drive does not currently have any pavement markings. It may be beneficial to provide a stop bar at the Adair Drive approach to Evers Road to increase sight distance around the existing privacy fence however; a stop bar located much closer to the Evers Road travel lanes would also conflict with the existing pedestrian ramps. The placing of a stop bar closer to the travel lanes would require adjustments to the existing pedestrian ramps to remain between the Evers Road travel lanes and the Adair Drive approach stop bar.

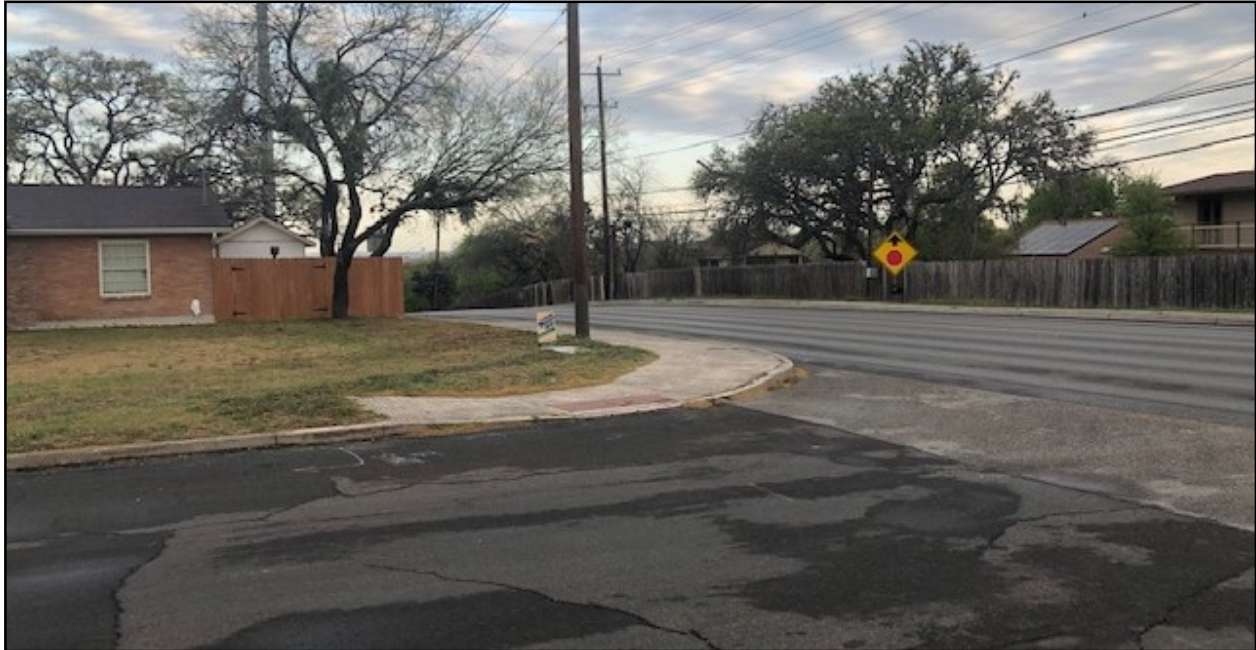
**Figure 6. Wooden Fence Obstruction on South-West Corner of Intersection**

In addition to the installation of signage and conflicting warning system, it may be recommended that a clear zone be established using the intersection sight distance sight triangles, specifically along the eastbound Evers Road approach to Adair Drive which may require the removal of a wooden picket fence on the south-west corner of the intersection, shown in Figure 6 below.

Based on the existing 30 mile per hour speed limit along Evers Road and the lack of crash history at the intersection of Evers Road and Adair Drive, there remains insufficient evidence to warrant the implementation of additional roadway improvements at the intersection. However, in addition to the previously relocated “Side Road” advanced warning sign from its previous 560’ from Adair Drive to approximately 250’ from Adair Drive, consideration may be given to the installation of an Intersection Conflicting Warning System and the clearing of the Adair Drive sight distance triangles.
