# **#4 BRIDGE FISHING PIER CEDAR KEY, FLORIDA**

## **INSPECTION REPORT**

July 23, 2025  
CEC File No. 25.907

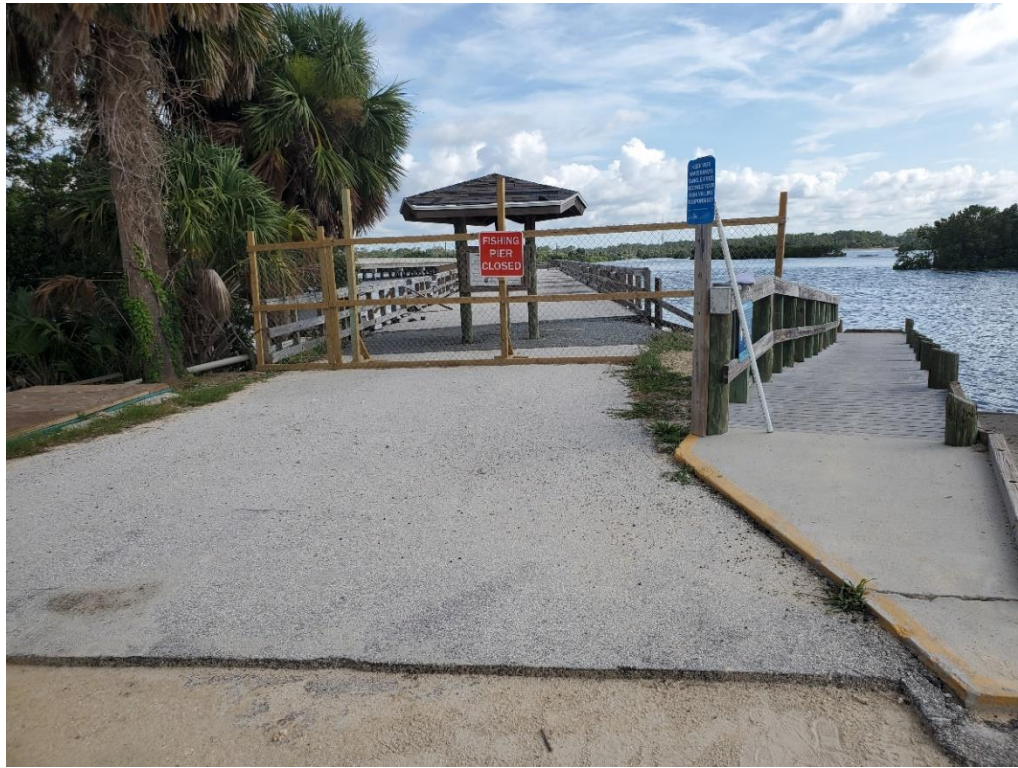
**Photo 1:** View looking north at asphalt approach of fishing pier. Pier closed.

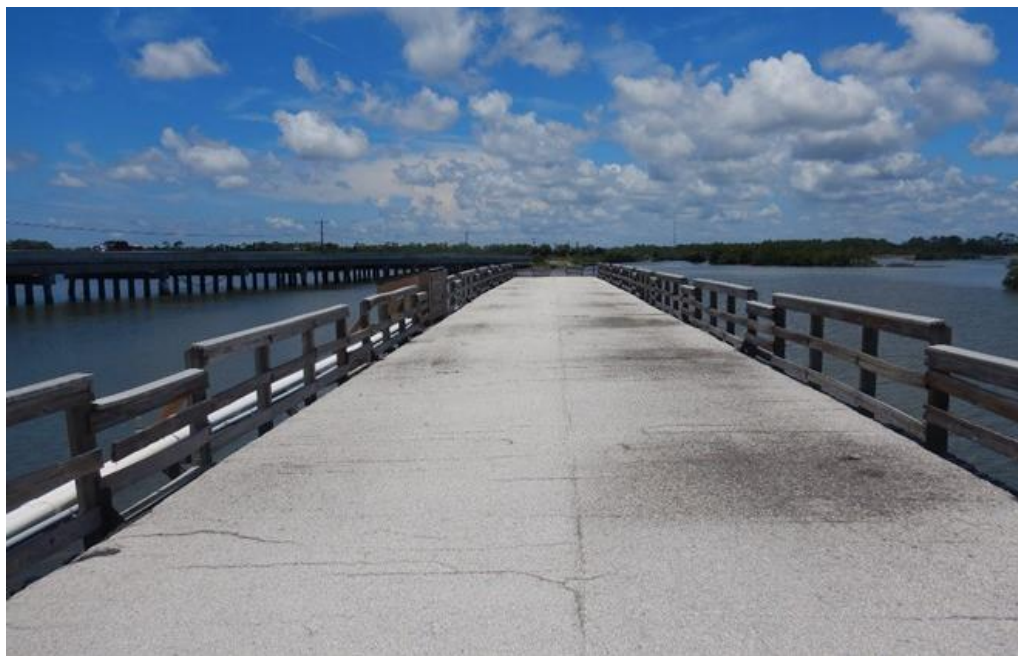
**Photo 2:** View looking north. Note transverse cracks in asphalt overlay and lowered rail sections.

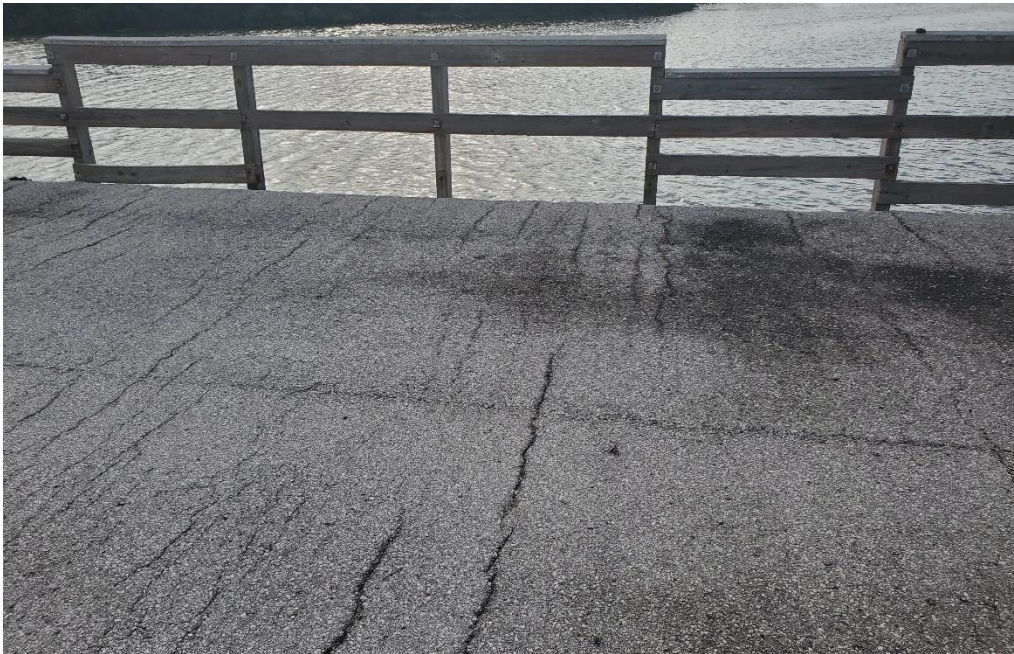
**Photo 3:** View looking east. Note transverse cracks in asphalt overlay and lowered rail sections.

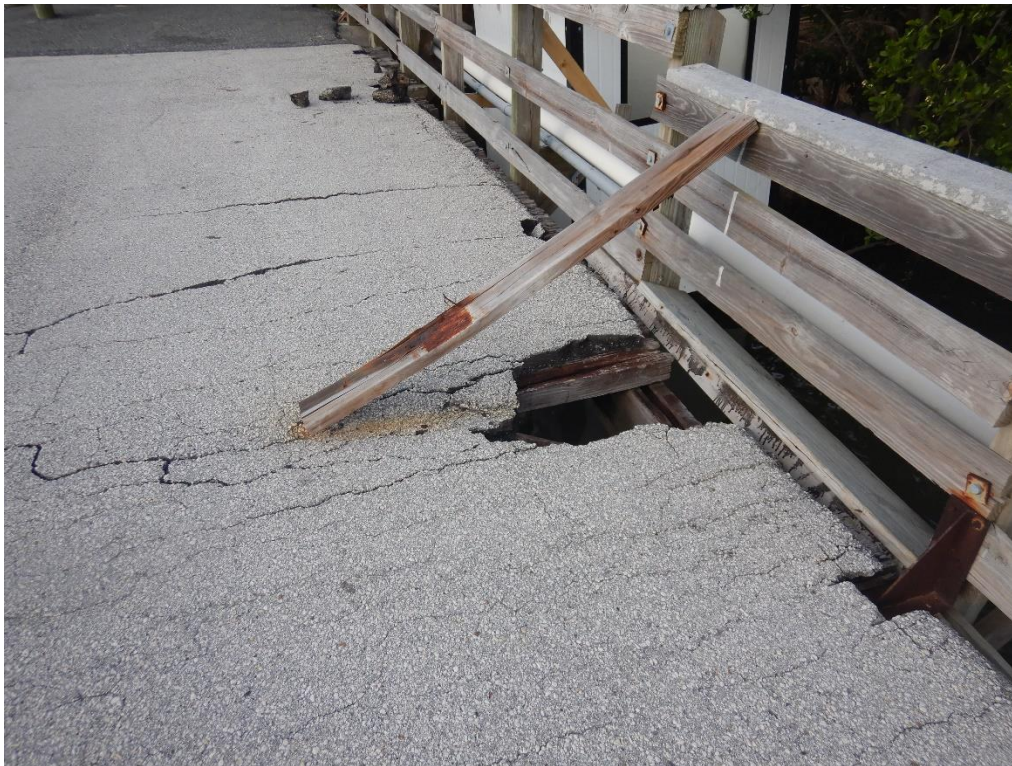
**Photo 4:** Failed timber deck and asphalt overlay. Note steel bracket supporting stanchion at bottom right.

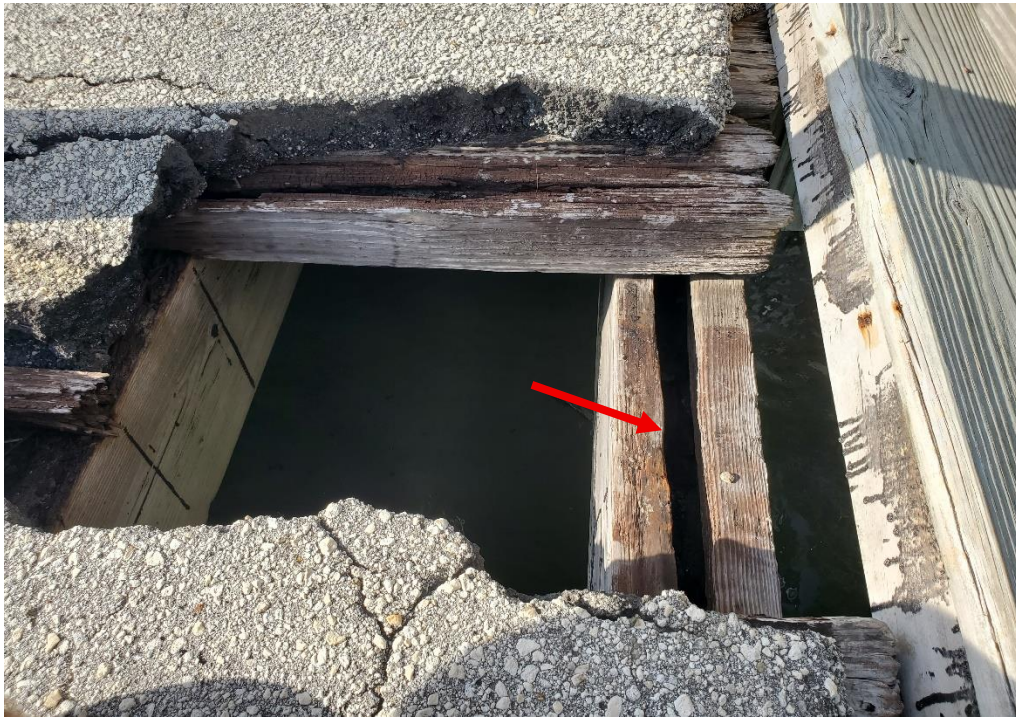
**Photo 5:** Deteriorated timber deck and failed asphalt overlay. Note void in center of 6x12 stinger (right). Moisture accessed interior heartwood through fasteners securing timber decking to stinger.

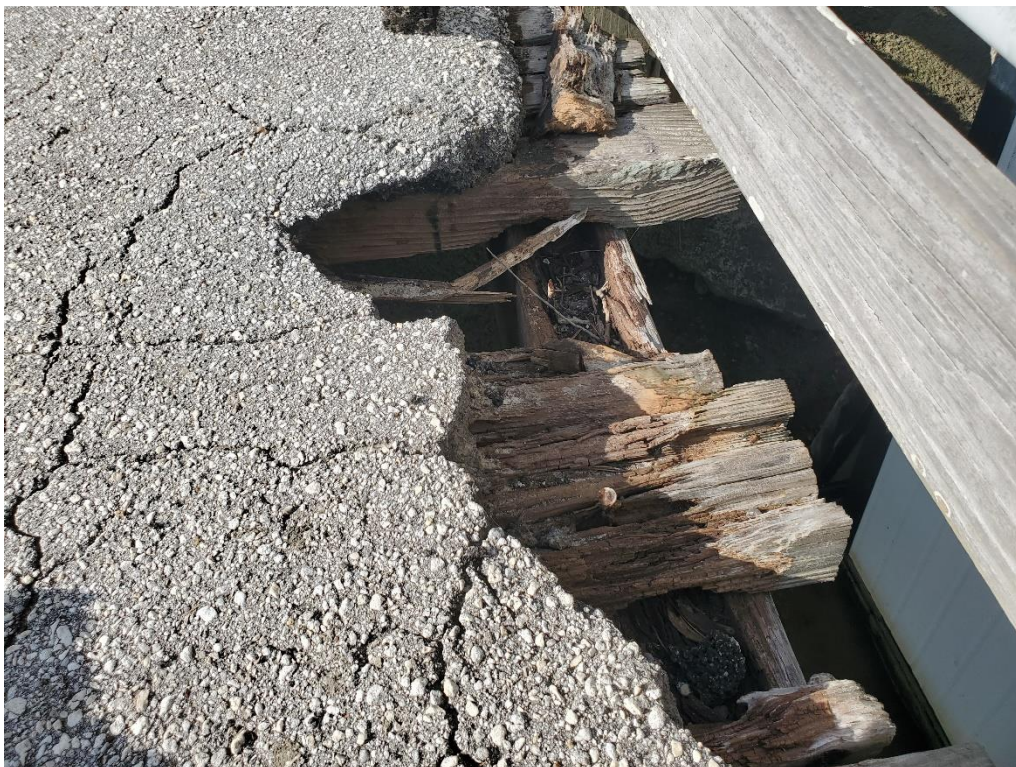
**Photo 6:** Deteriorated timber deck and failed asphalt overlay.

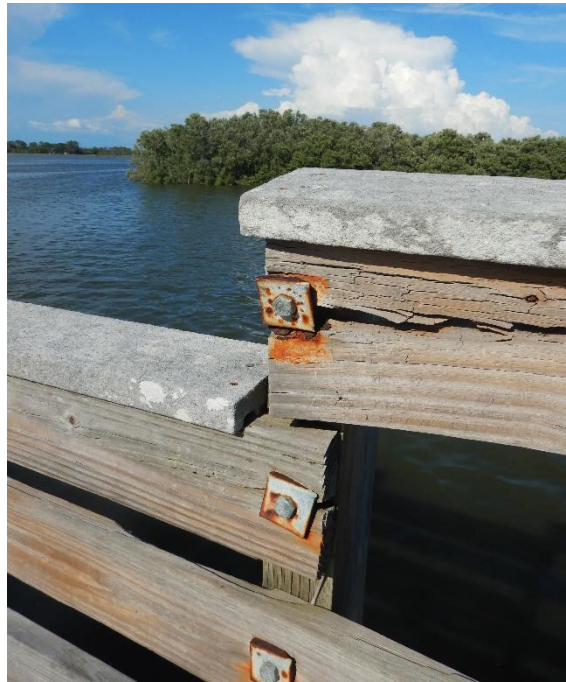
**Photo 7:** Typical conditions of railing timber and fasteners. Note checks and corroding fasteners.

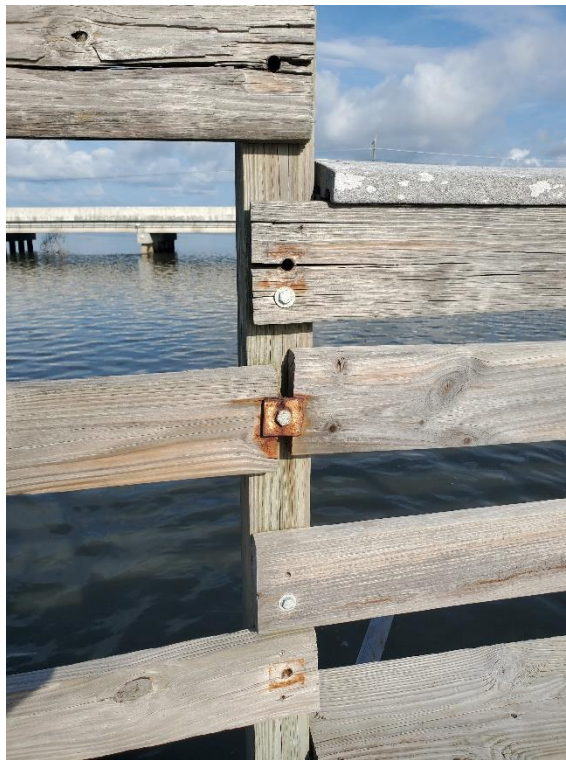
**Photo 8:** Typical conditions of railing timber and fasteners. Note checks and abandoned fastener holes in timber rails along with mix-matched and corroding fasteners.

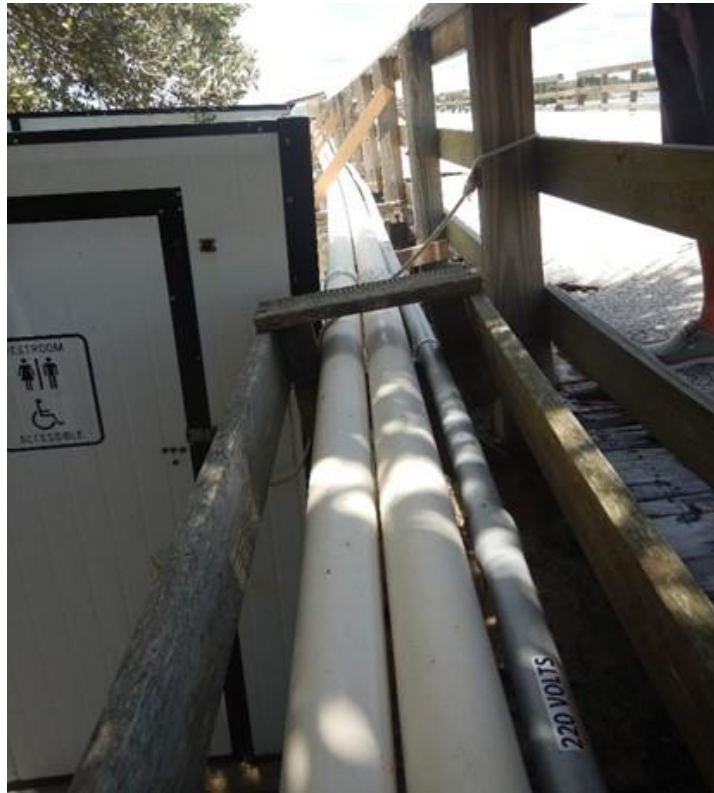
**Photo 9:** Three conduit secured to outboard side of western rail. Gray conduit on right labeled as “220 Volts”.

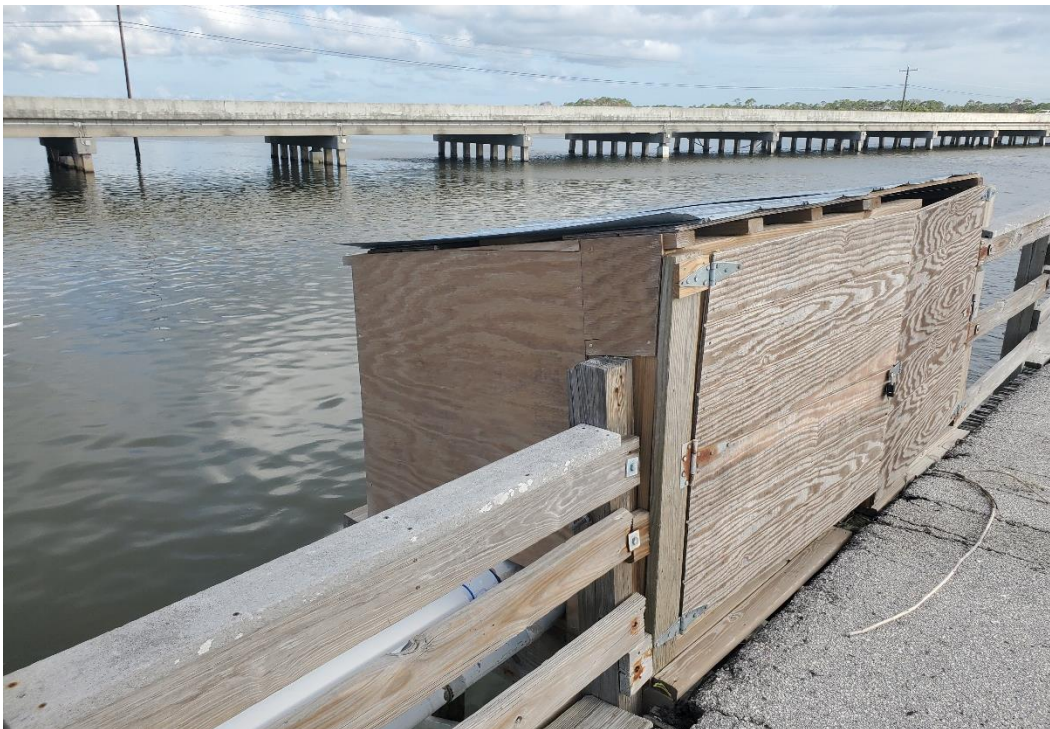
**Photo 10:** Pump enclosure at Bent 7 where conduits terminate.

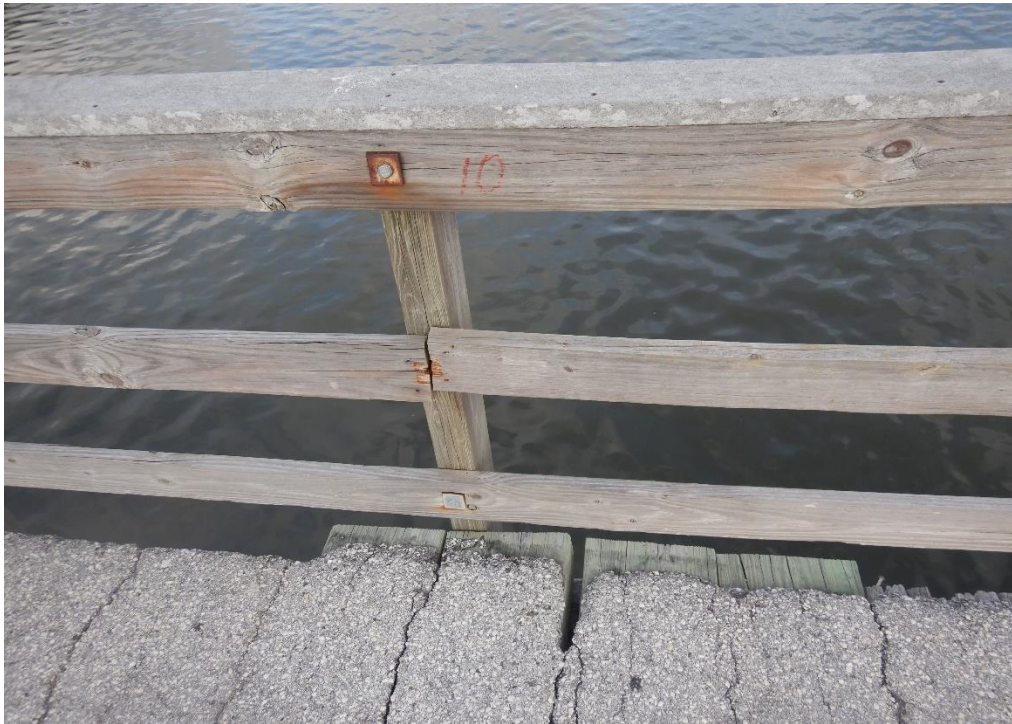
**Photo 11:** Bent 10. Original timber decking removed and replaced with four CCA treated 4 x 12 members when piles were replaced. Note transverse cracks in asphalt overlay.

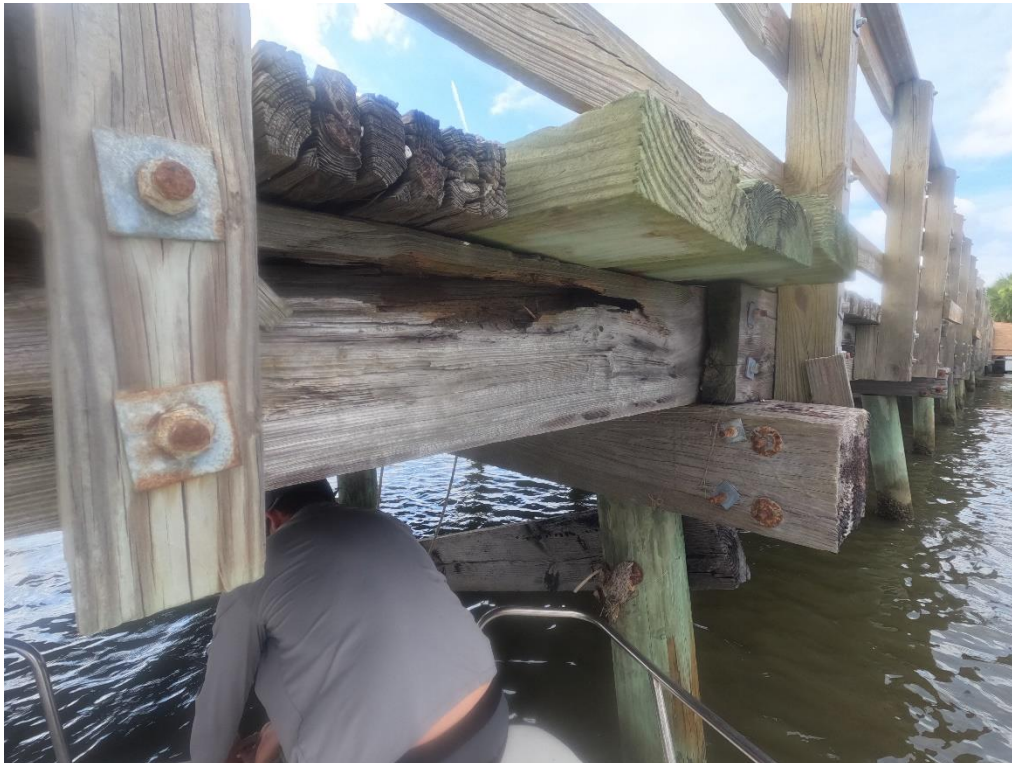
**Photo 12:** Bent 14. View comparing original 2 x 4 timber decking and CCA treated 4 x 12 members. Note large void in stringer from fungal decay.

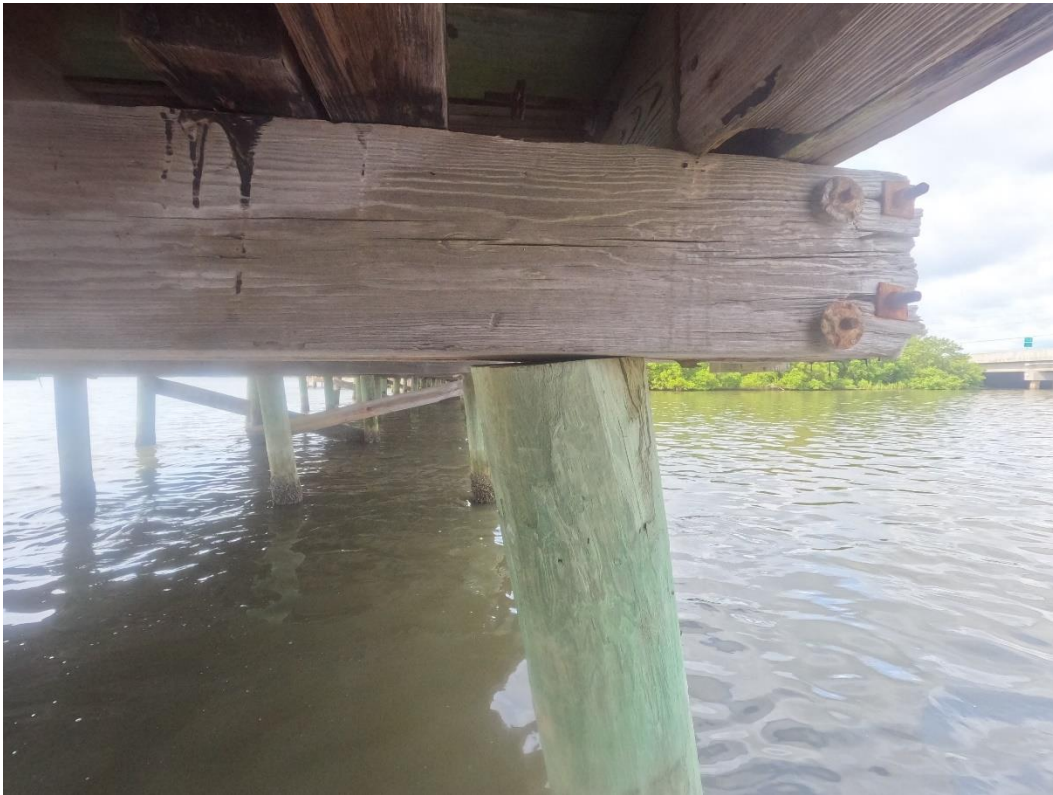
**Photo 13:** Typical CCA treated pile. Note pile not fully engaged with pile cap and large void in end of stringer (upper right). See below images.

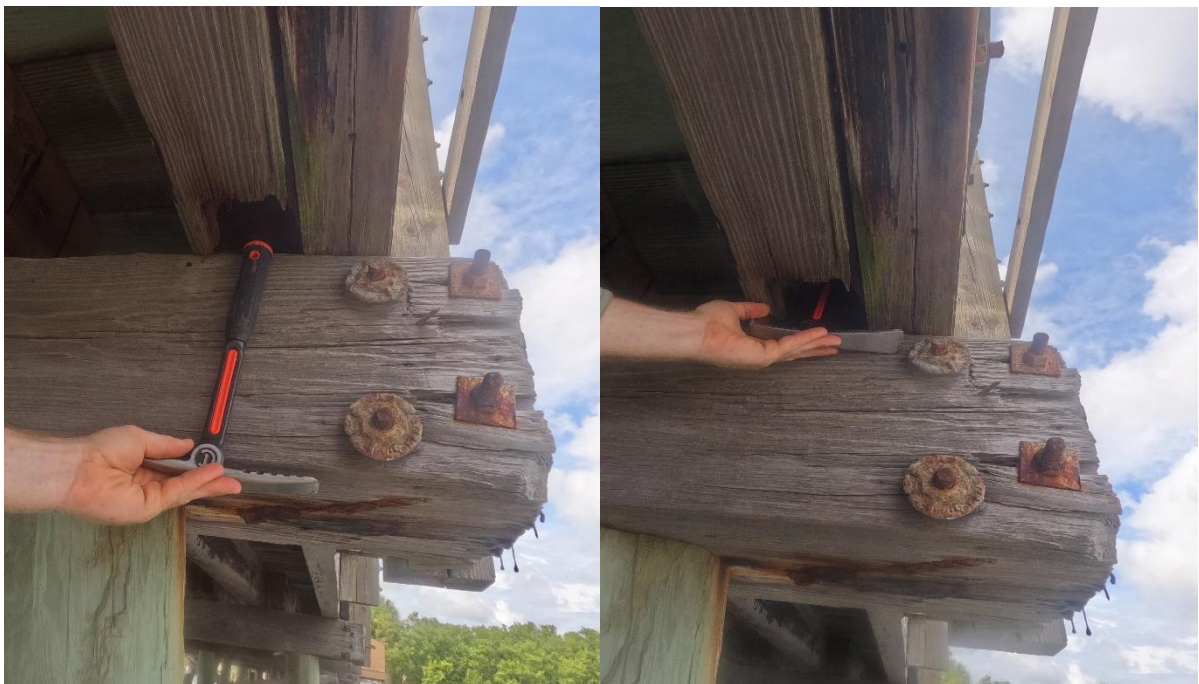
**Photo 14 (L) and 15 (R):** Void at end of stringer resulting from deterioration accommodating 10-inch inspection hammer handle.

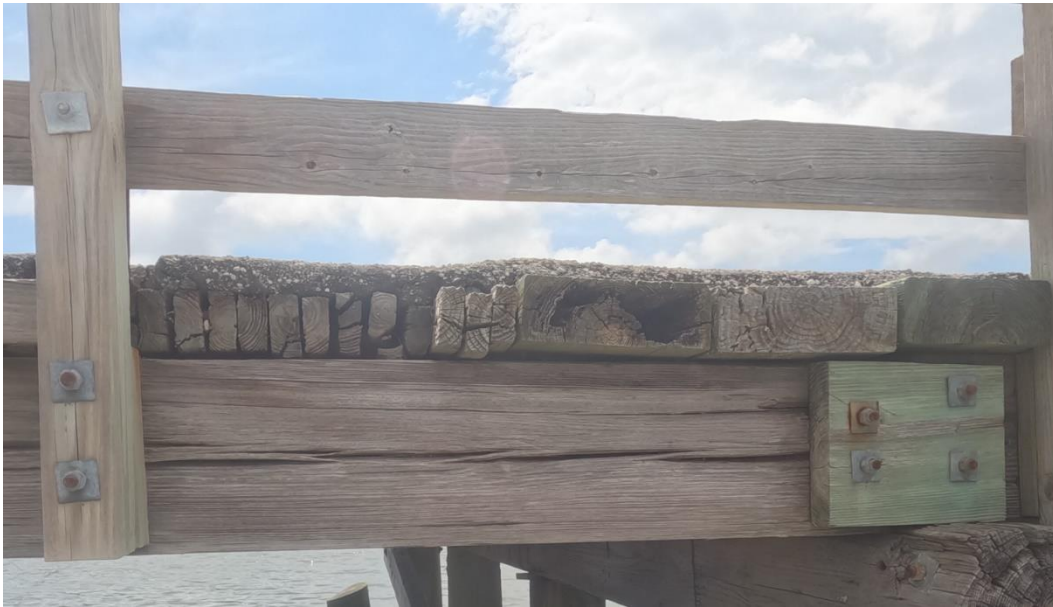
**Photo 16:** Original 2 x 4 timber decking exhibiting significant checks and shakes. CCA treated 4 x 12 exhibiting significant void due to fungal decay. Note longitudinal check in face of stringer.

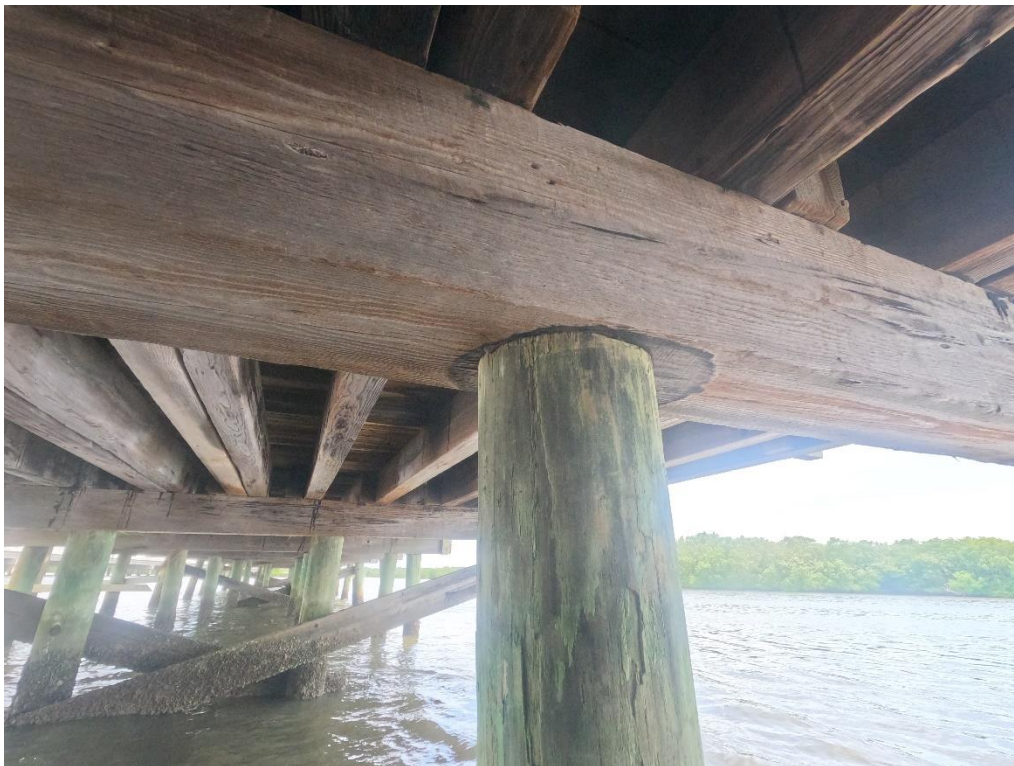
**Photo 17:** Underside of pile caps typically had dark circular stain indicative of creosote from original pile suggesting that the pile cap is original.

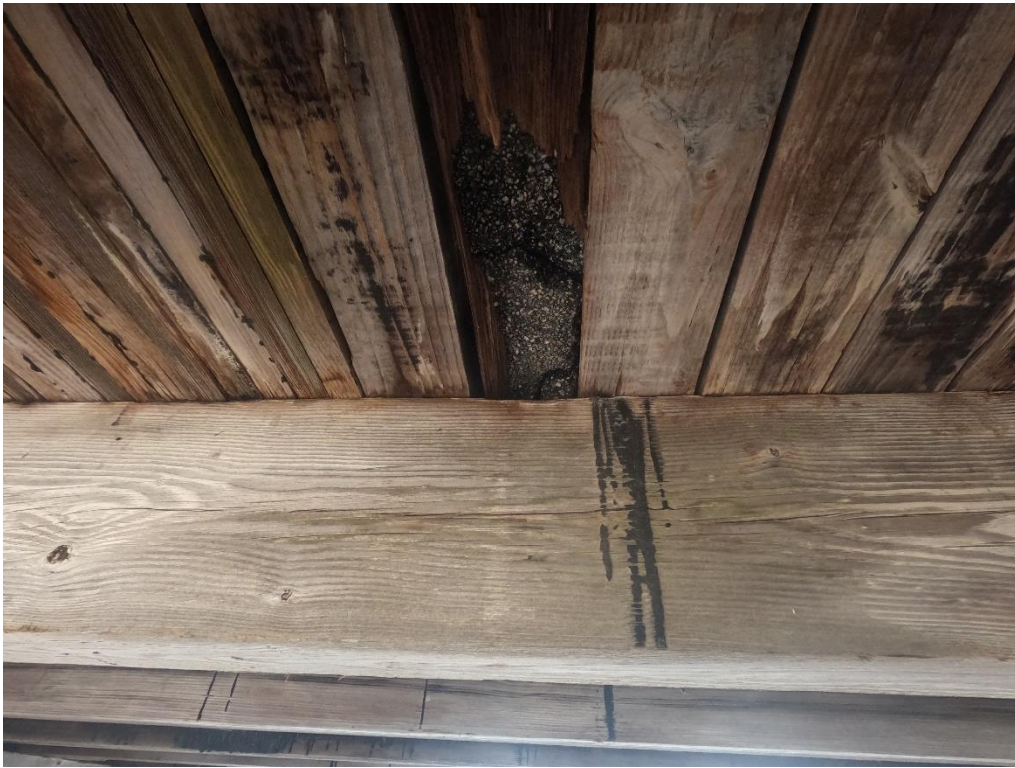
**Photo 18:** Timber decking deteriorated exposing asphalt overlay.

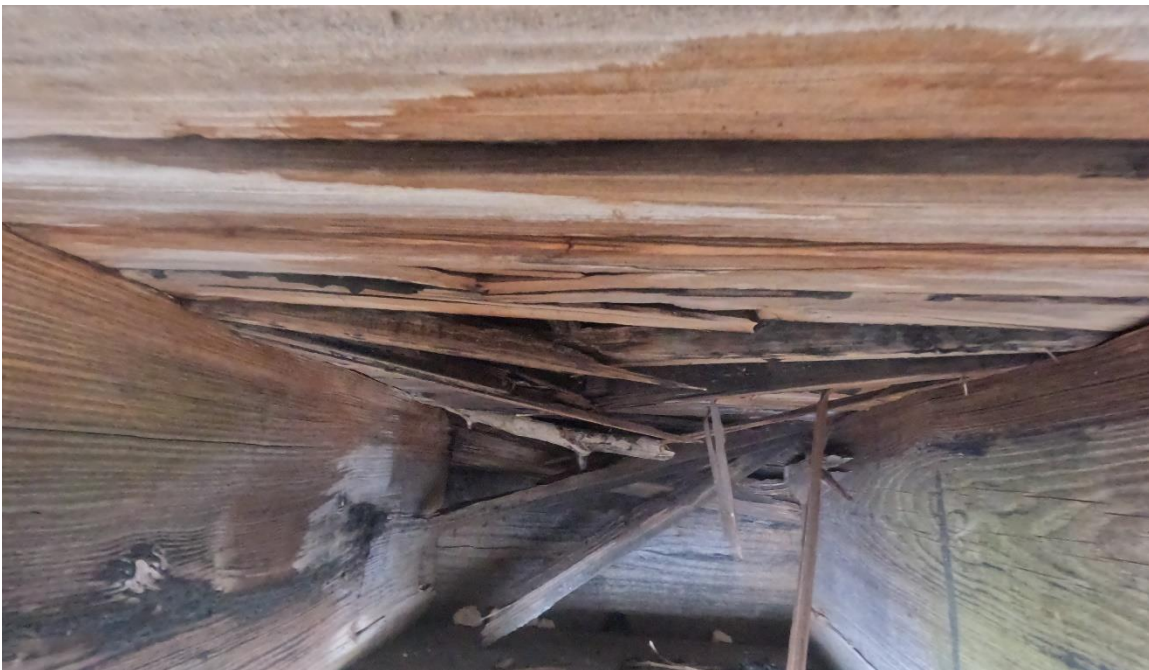
**Photo 19:** Timber decking failed due to deterioration.

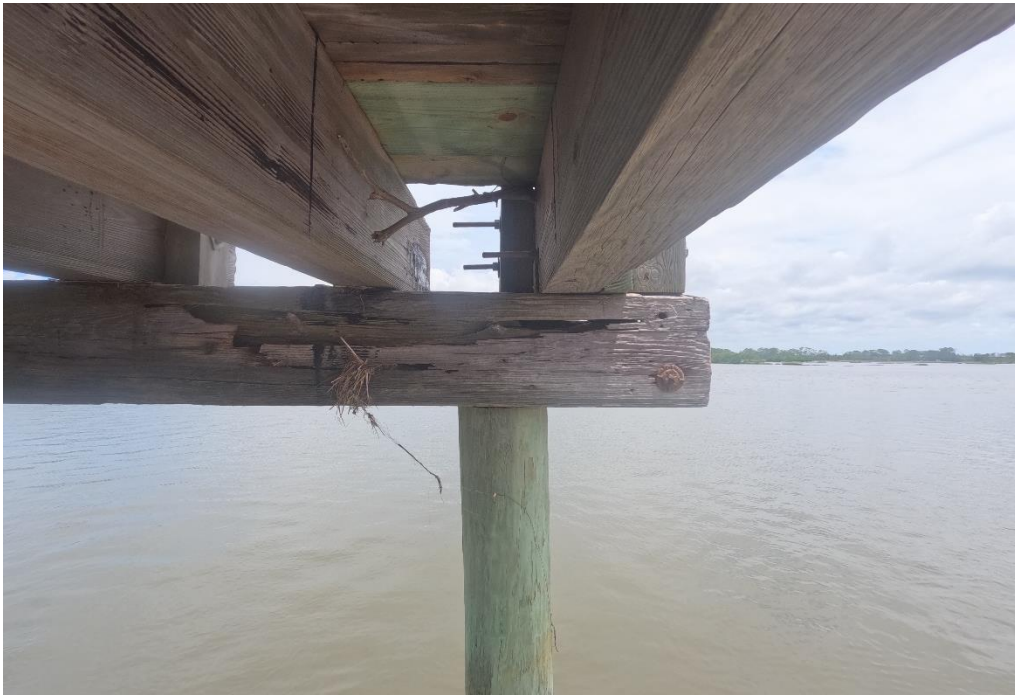
**Photo 20:** Bent 15. Internal voids within pile cap resulting from fungal decay.

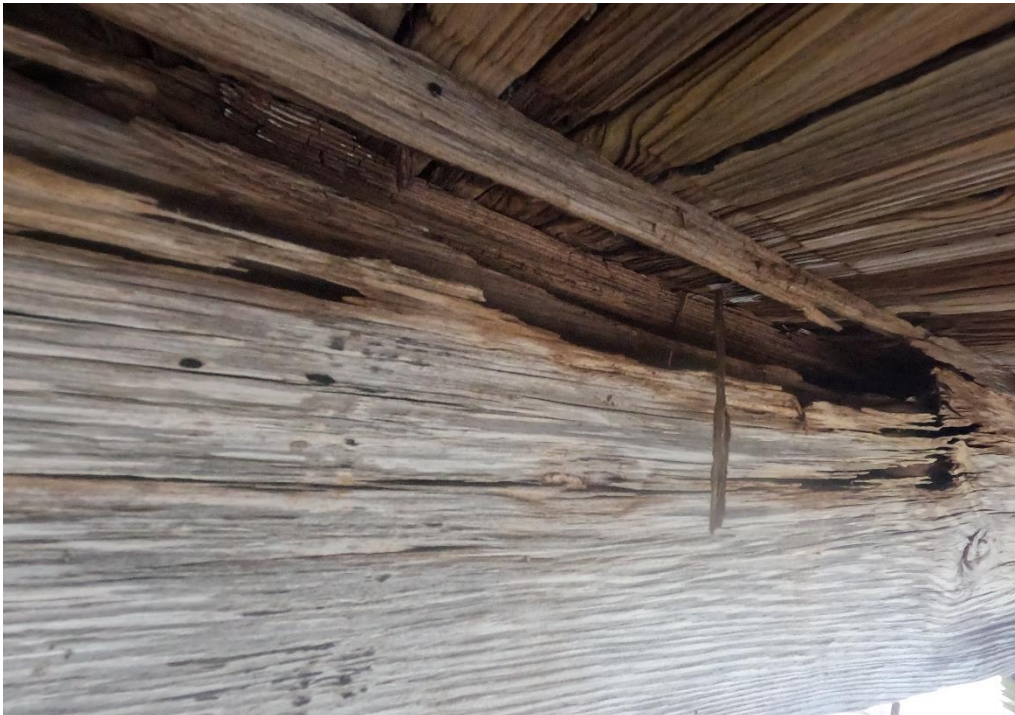
**Photo 21:** Significant void within stringer resulting from fungal decay.

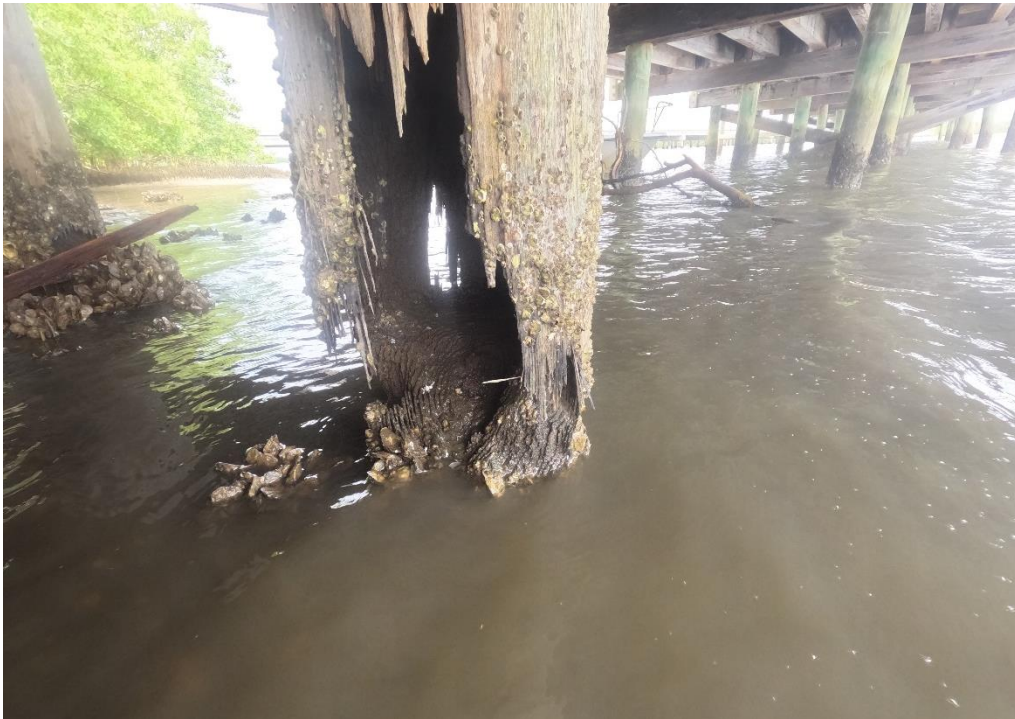
**Photo 22:** Pile 2C exhibiting significant loss of section due to marine borer attack. Pile is original.

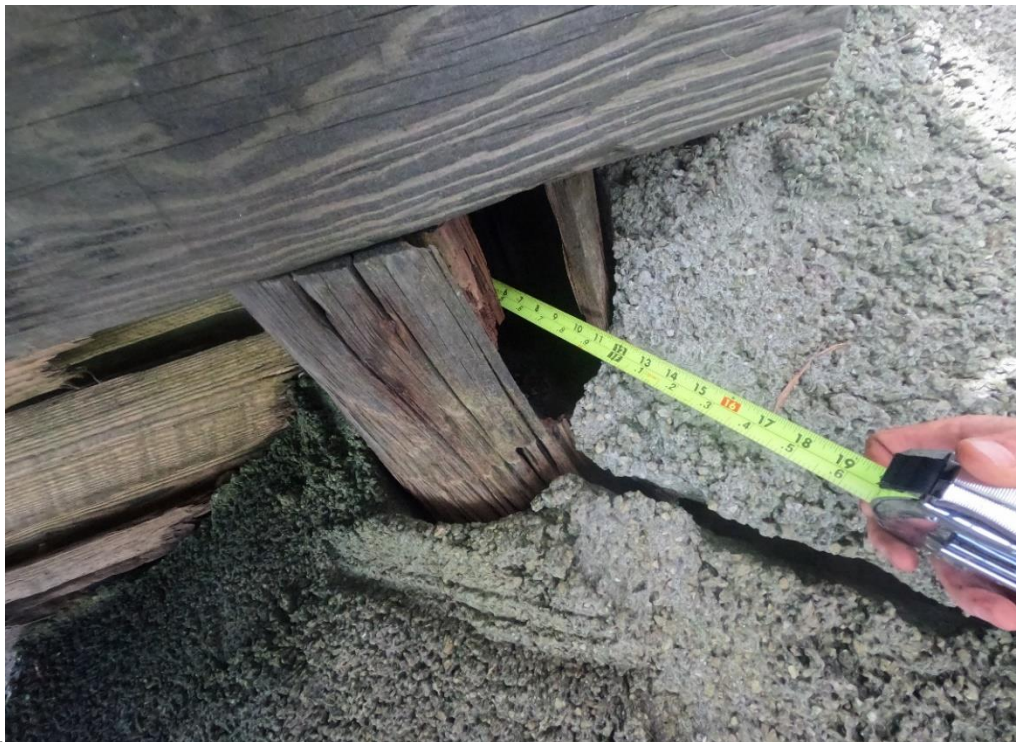
**Photo 23 (L) and 24 (R):** Pile 1A exhibiting significant loss of section. Inside of pile is completely deteriorated resulting in a 10-inch diameter void. Pile is original.

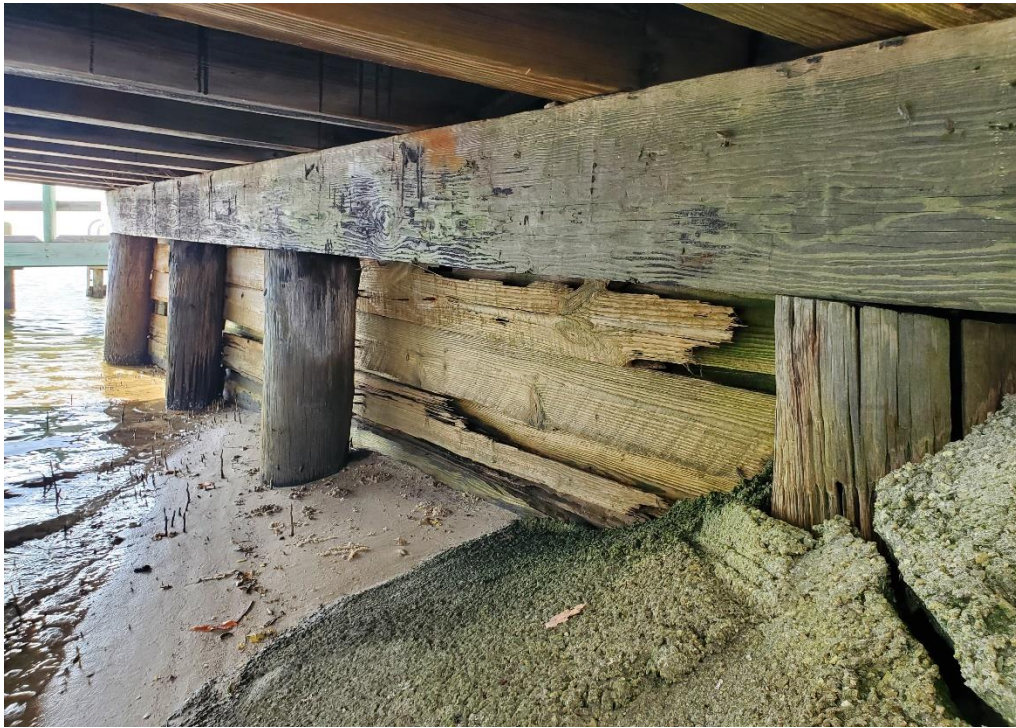
**Photo 25:** View looking east at backwall. Note multiple layers of timber and the outboard timber exhibiting loss of section caused by marine borer attack.

- Replacing the timber backwall with vinyl sheet piles will greatly reduce maintenance issues associated with the asphalt approach subsiding and erosion/scour of the exposed shoreline.

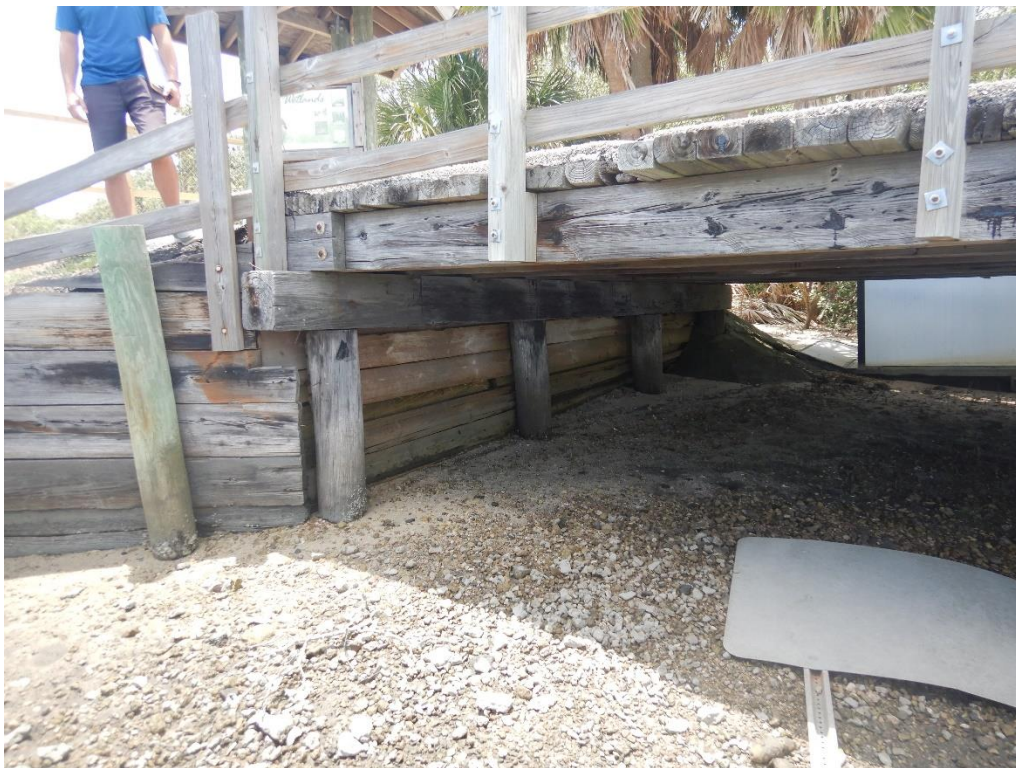
**Photo 26:** View looking west at backwall. Note multiple layers of timber and the outboard timber exhibiting loss of section caused by marine borer attack.

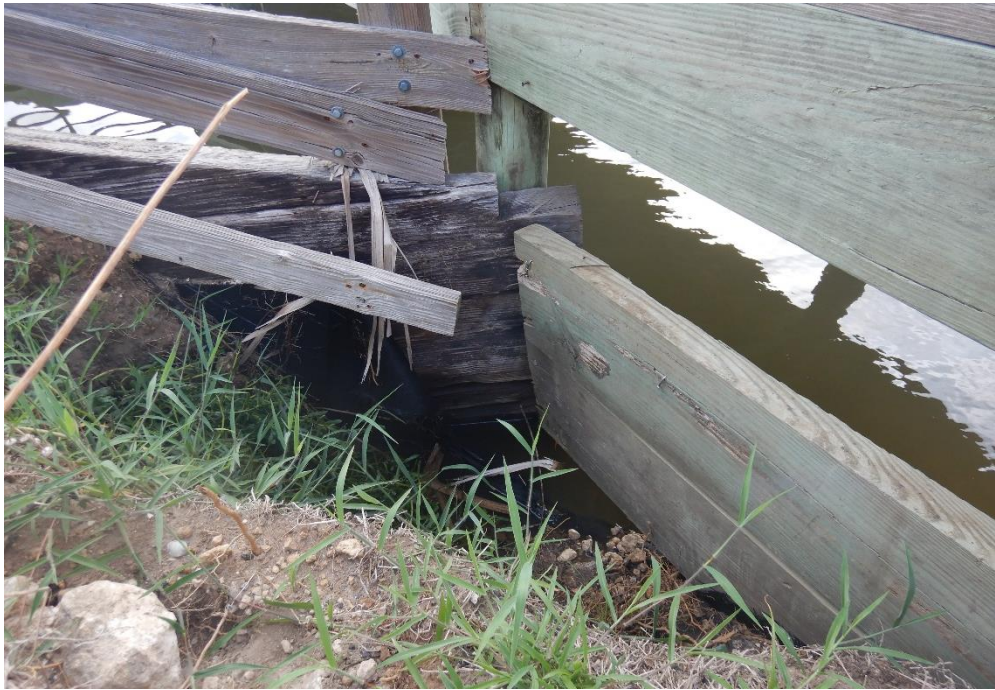
**Photo 27:** Timber along eastern side of backwall does not extend to mudline resulting in loss of backfill.

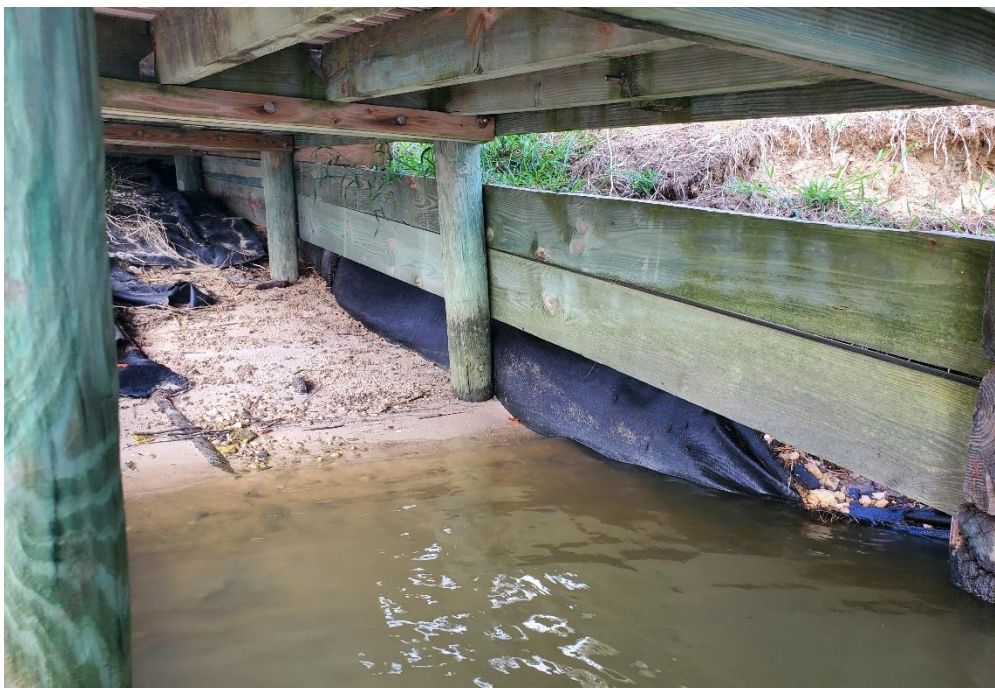
**Photo 28:** Timber along eastern side of backwall does not extend to mudline resulting in loss of backfill. Note boarding pier piles provide lateral support to backwall timber.
