FINE ART CONSERVATION

CONDITION REPORT, TREATMENT PROPOSALS AND ESTIMATES-REVISED 2024

DATE: June 11, 2024
CLIENT: City of Los Altos Hills Attn: Jon Maginot
PROJECT #: TBD
OBJECT: Outdoor Sculpture Collection-2 Sculptures
LOCATION: Los Altos Hills

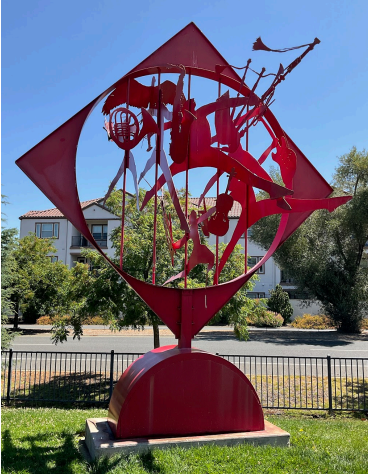
- The sculpture is structurally stable.
- There is possible corrosion under the paint, supported by the presence of blistering paint and some visible corrosion along bottom edge and along undersides of horizontal elements.
- There are several bent and misaligned elements: both legs are bent on the bottom figure; the proper left figure has a warped front leg; there is slight warping in the legs of the bagpipe and trumpet figures; the bagpipes are bent, the trumpet and bagpipes are intertwined.
- The paint is chalked and blanched.
- There is paint loss on vertical bars exposing a tan primer and a possible intermediate maroon colored primer.
- There are bird droppings, biogrowth, organic debris across the surface.
- There are mineral deposits across the front of the base.

- Photographic and written documentation will be completed before, during and after treatment.
- Paint samples will be taken and color matched to identify an appropriate paint system for repainting.
- The site will be prepared and include a scaffold for access and a fence to prevent public access to wet paint surfaces.
- The deteriorated red paint will be sanded back to provide a key for repainting, both by hand and with palm sanders.

- Corrosion will be converted and reduced.
- The bent and misaligned elements will be realigned as far as possible.
- The chosen industrial paint system will be spray applied including primer, two coats of paint, and possibly a clear top coat.

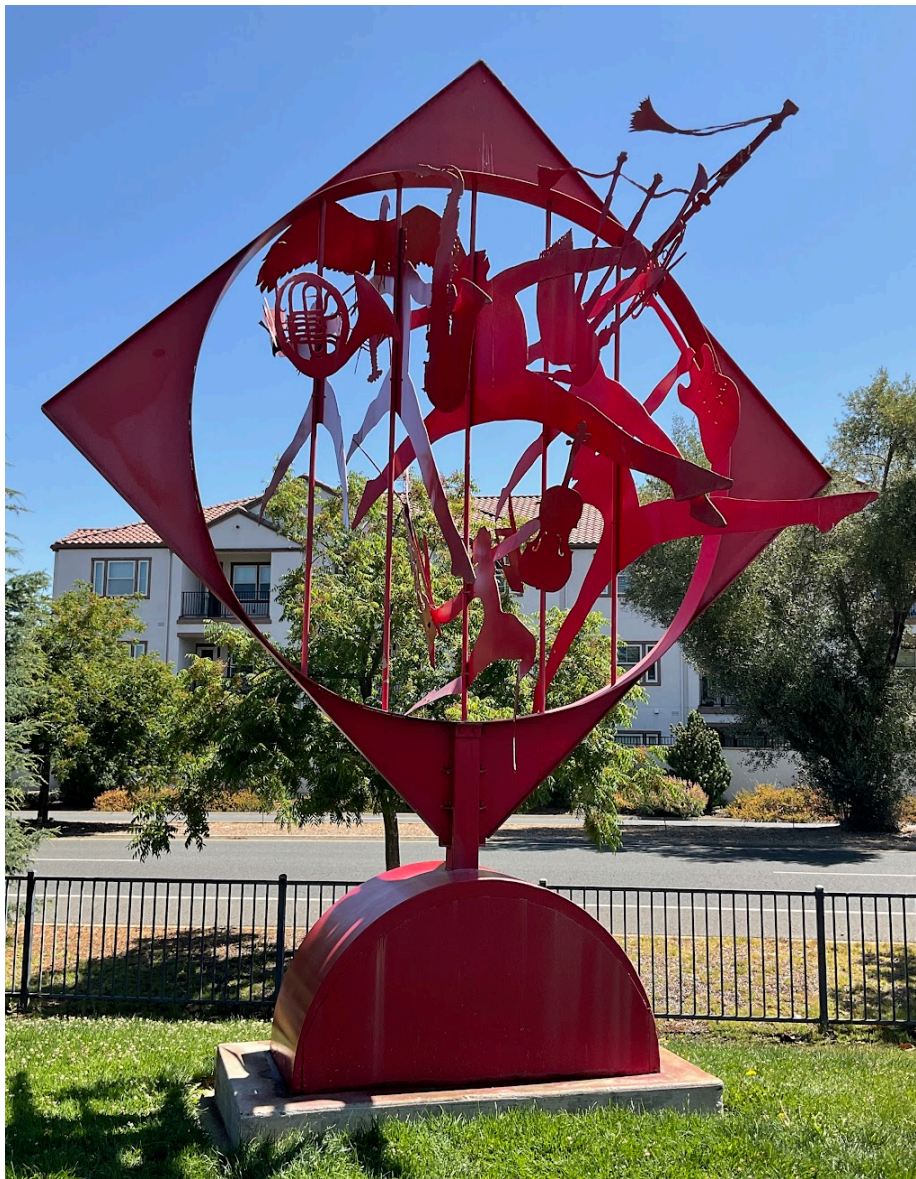
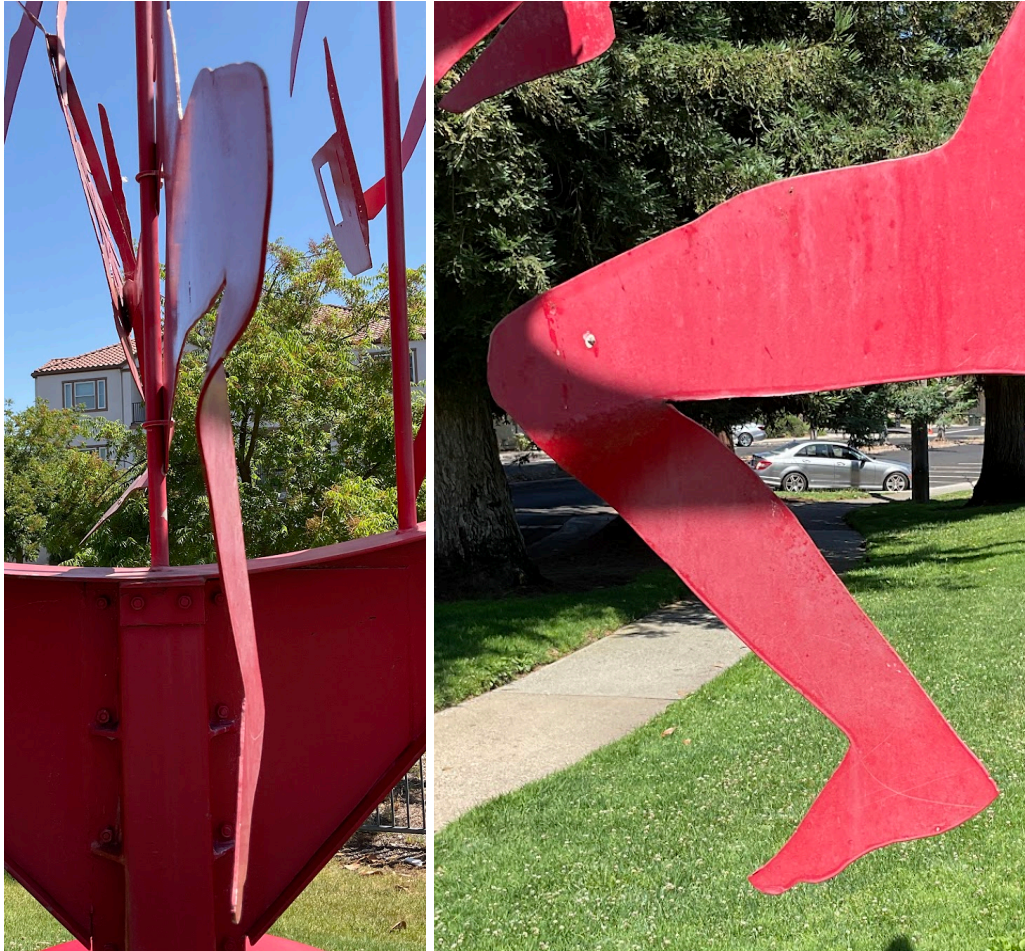
Details Showing Two Views of the Bend in Lower Figure's Leg

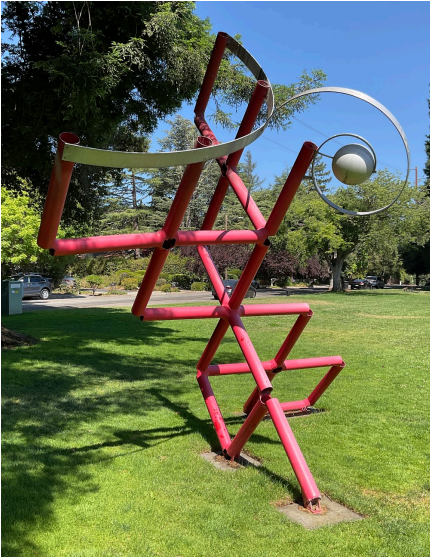
- The sculpture is structurally stable.
- There are gouges, dents and abrasions in lower pipes and attachment points to the concrete pads
- There is a crack in the weld on the unpainted aluminum loop.
- There is a slight downward bend in the longest red painted horizontal element at the top of the sculpture
- Two layers of red paint are visible. The top layer is chalking and blanching with losses exposing a lower paint layer. The lower layer is more saturated in color but cracked in all exposed areas;
- There are chips, nicks and losses in both layers of red paint
- The clear coat on the unpainted aluminum elements is failing with aluminum oxide forming in areas of coating loss.
- There are tags on the painted surface.
- There is trash and debris within the tubes.
- There is overall surface dirt and grime, organic debris, and biogrowth,

- Photographic and written documentation will be completed before, during and after treatment.
- Red paint samples will be taken and color matched to identify an appropriate paint system for repainting.
- The sculpture will be surrounded by a security fence during the treatment and a scaffold installed.
- The deteriorated red paint and clear coat will be reduced to a stable surface by sanding, both by hand and with palm sanders.

- The unpainted aluminum elements will be polished by hand and with orbital buffers.
- The crack in the loop will be welded.
- An attempt will be made to rebend the dented elements to align them.
- The chosen paint system will be applied to the painted area including primer, and two coats of paint.

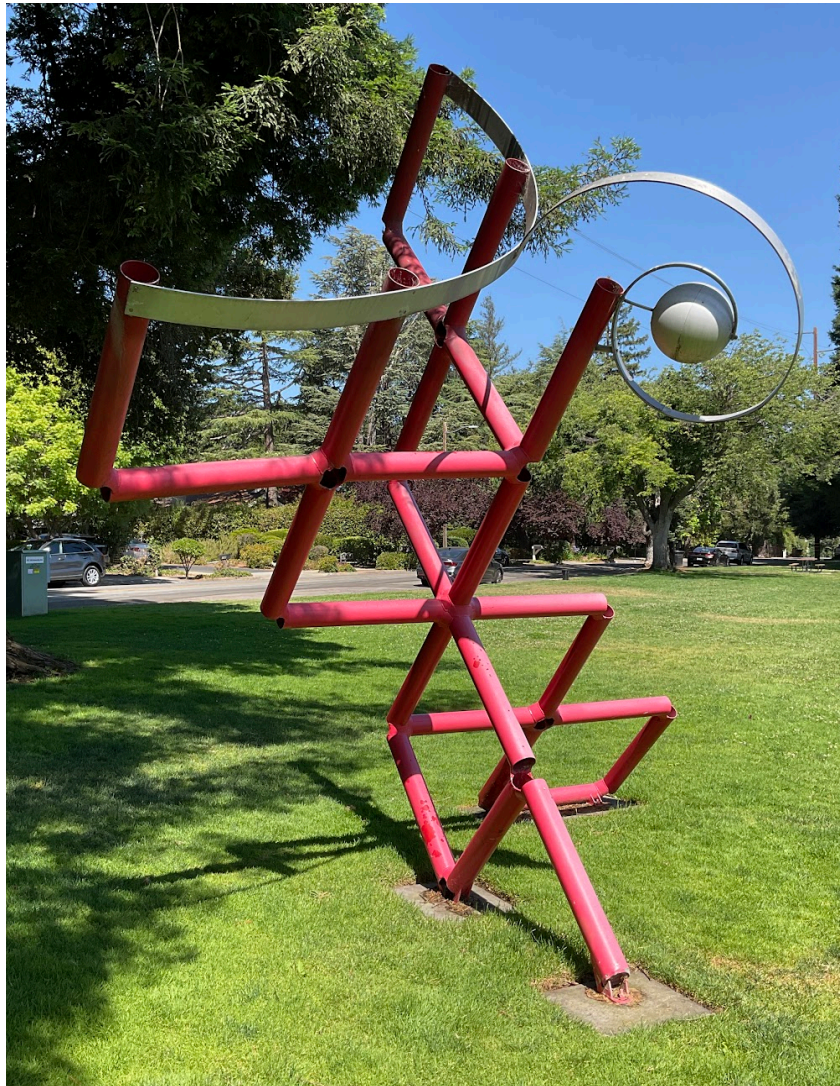
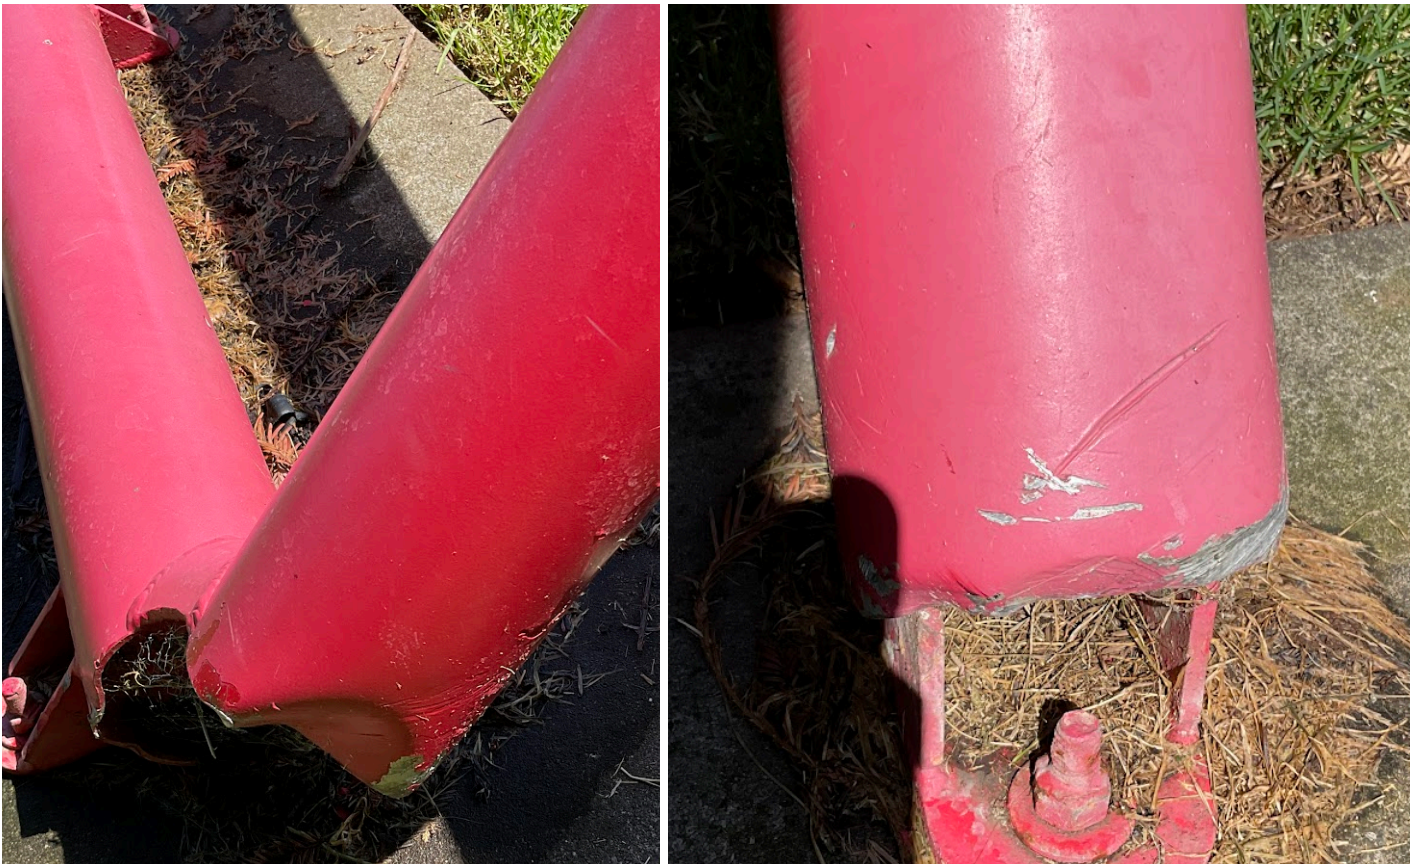
Details Showing Dents and Abrasions on the Bottom of the Lower Tubes
