PROPERTY CONDITION ASSESSMENT

1 North San Antonio Road
Los Altos, Santa Clara County, California 94022

RSB Project No. 2403055

Report Date: May 3, 2024

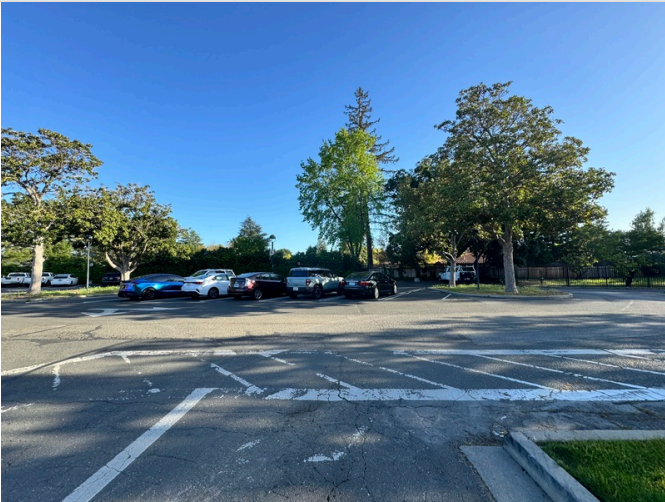
Condition: Overall the paving, curbing, and parking appeared to be in fair condition. Cracks were observed in the pavement at number of locations. Immediate Repairs are recommended for partial, full-depth repairs and asphalt overlay.

45. Cracks and alligating observed on the pavement

Cost Recommendation	EUL	EFF AGE	RUL	Year	Cost
Partial full depth asphalt repairs and overlay	25	25	0	Immediate	\$19,600
Patching, crack sealing, seal coating and striping	5	3	2	2	\$2,211
				7	\$2,211
				12	\$2,211
Total					\$26,233

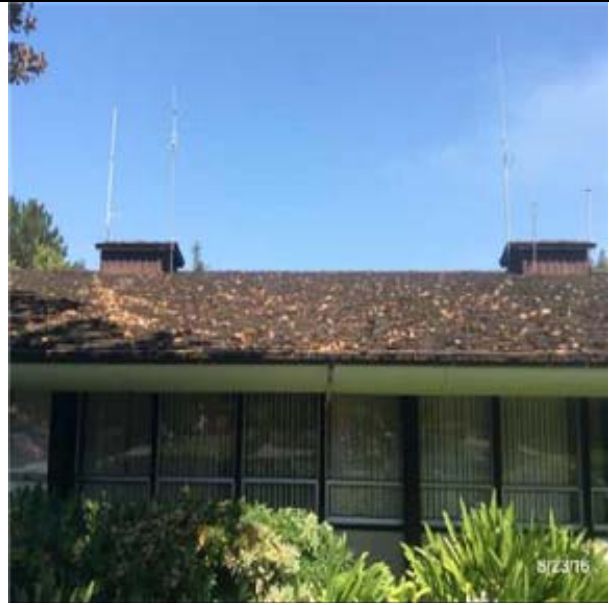
The wood shake roof appears to be in satisfactory condition. Roofs of this type typically have an average, effective useful life of approximately 30 years, depending on the property's location, material type and quality, quality of installation, roof maintenance and exposure, amount of roof traffic, and regional climatic conditions. Based on its current condition, and expected useful life, the roof is expected to reach its life expectancy during the evaluation period covered by this report. Accordingly, Replacement Reserves are recommended for roof replacement during the analysis term.

B3011 Roof Finishes:- View of Wood Shake Roof
